**Investigation of Multiple Tank Car Rollover Derailments
Related to Double Shelf Couplers and its Solutions**

Prepared for
Transport Dangerous Goods Directorate
of
Transport Canada

by
Centre for Surface Transportation Technology
of
National Research Council Canada

March 2009

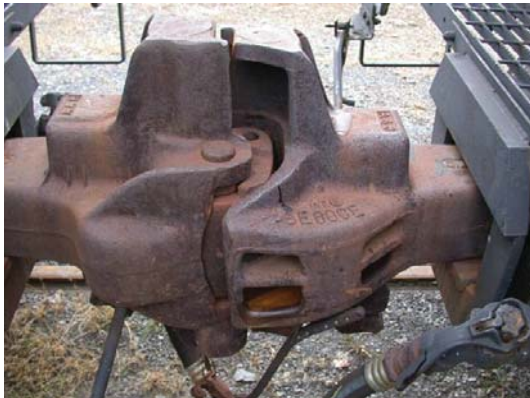
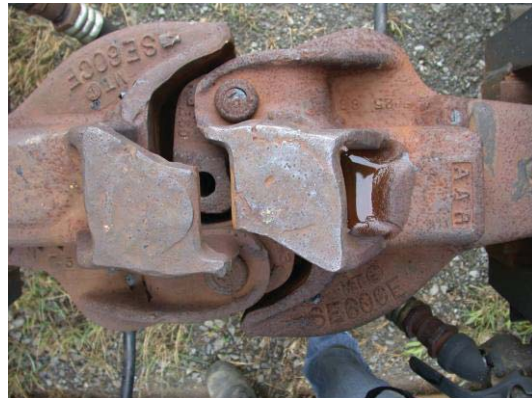
Figure 1: Double shelf couplers in service.

Double shelf couplers have proven very effective in preventing tank car punctures [1]. This is achieved by constraining knuckles with shelves to prevent couplers from disengaging vertically. The successful prevention of tank car puncture, however, has come at a cost. The introduction of double shelf couplers has resulted in a greater number of tank cars derailing when an accident occurs. Rollover and derailment of any single tank car in a train that contains a string of tank cars, for example unit trains, will frequently result in the rollover of many adjacent tank cars [2]-[7]. This creates a much larger derailment event known as a multiple tank car rollover derailment. TSB notes that empty tank cars are particularly susceptible to this event and that observation is confirmed by analysis in this report [2].

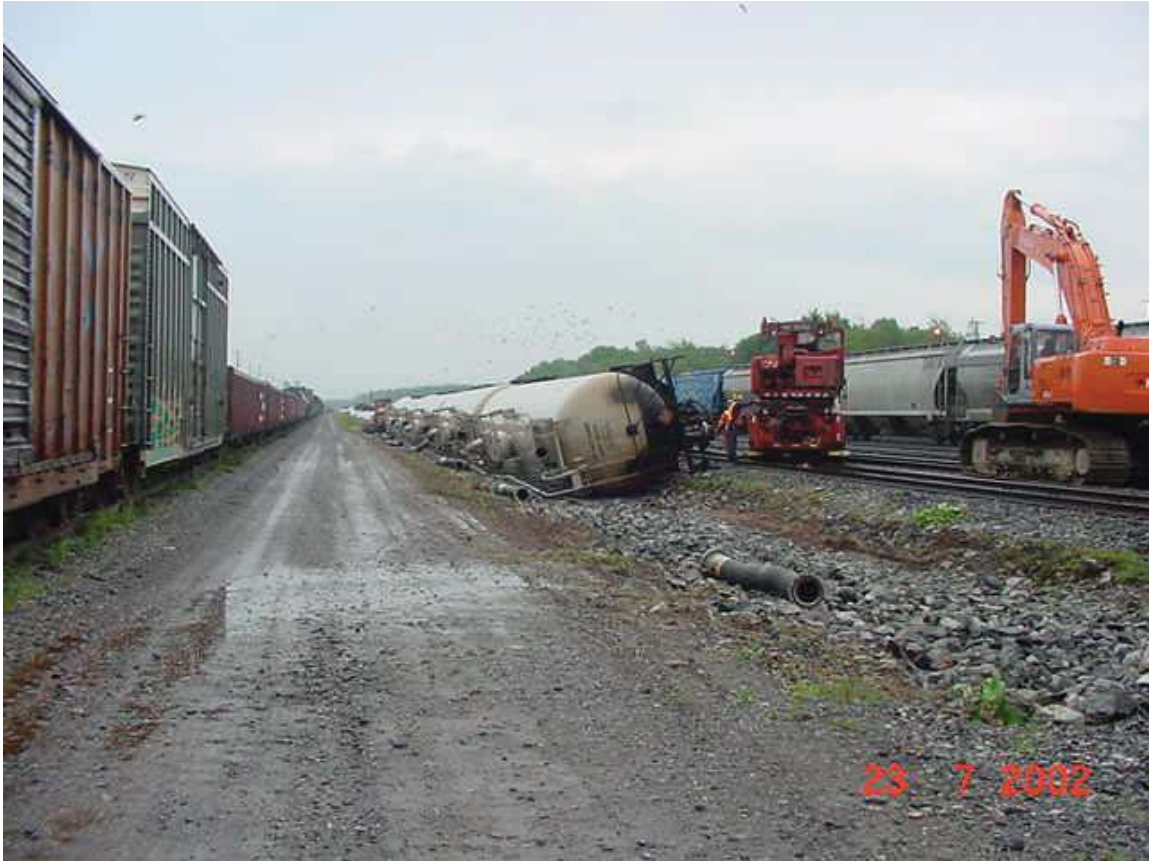
Figure 2: Rollover derailment of tank cars, Lévis, Québec, July 22, 2002 [8].

Since the introduction of double shelf couplers on tank cars, there have been many documented cases [2]-[7] where the derailment of a small number of tank cars has led to the rollover of many more coupled tank cars. During multiple tank car rollover derailments, an initial derailment of one or a few cars can lead to the progressive derailment of many tank cars. The progressive rollover derailment can be compared to dominos. An example of this is shown in Figure 2.

R02Q0041 – Lévis, Québec, July 22, 2002 [5] – a string of cars in a switching yard was set in motion by high winds which resulted in the derailment of 34 empty tank cars on one track. A struck tank car caused the remaining 33 cars to overturn and derail.

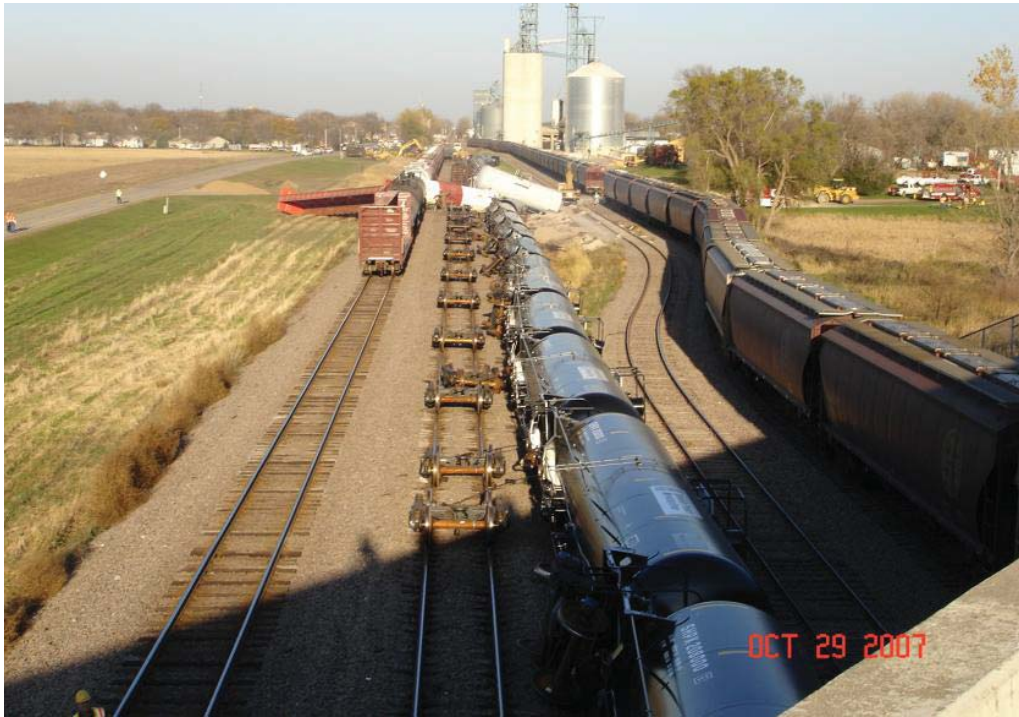
Figure 3: Multiple tank car rollover derailment, Clara City, Minnesota, October 2007 [8].

Figure 3 and Figure 4 are photographs of a tank car derailment that occurred in Clara City, Minnesota in October 2007. In this case, a train of empty tank cars was stationary on one track of a double-track main line. A moving train on the adjacent track derailed, and in the process derailed some cars of the empty tank car train. The tank cars that were initially struck on the stationary train then brought down much of the rest of the train. In Figure 3, the location of the initial derailment of the tank car train is seen near the top of the photograph. Figure 4 is a photograph of the derailed train taken from the opposite direction. This shows the extent of the tank cars which overturned following the initial derailment. It is also evident from the photographs that many of the trucks remained on the tracks and were essentially undisturbed. This is a very typical multiple rollover derailment related to the double shelf coupler. The field photos of the derailment have provided some important evidence in the present investigation on the mechanism of this kind of derailment.

It was noted in the Clara City derailment (Figure 3 and Figure 4) that the centre pins on many trucks were still in place and undamaged. Figure 13 shows a centre pin sitting in the centre bowl. It can be seen that there is a limited amount of lateral slack and resulting potential lateral movement with only 3/8 in. total clearance between the pin and the mating hole in the truck bolster (3/16 in. on each side of the pin). The centre pin is 15 in. tall and has a 1.75 in. diameter. The height of the pin is about 8 in. measured from the top of the pin to the inside of the centre bowl liner. This means that for the car body to roll off the truck without causing damage to the centre pin, at least 8 in. of vertical movement must be obtained without exceeding the allowable lateral movement of the pin.

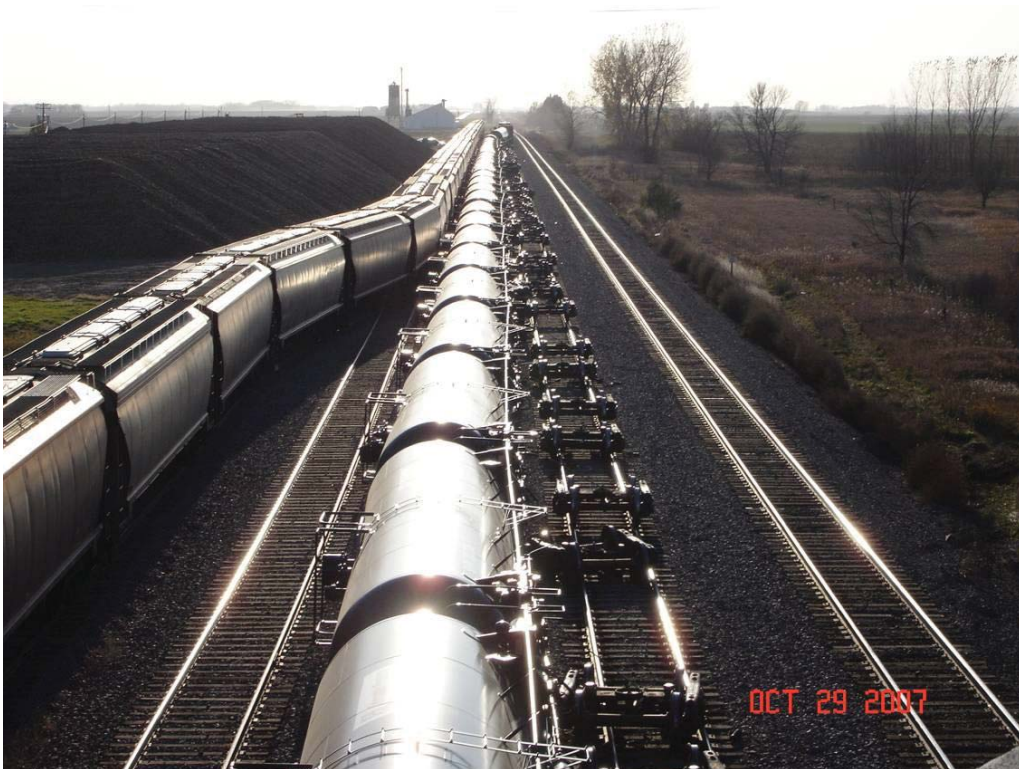
Figure 4: Multiple tank car rollover derailment, Clara City, Minnesota, October 2007 [8].

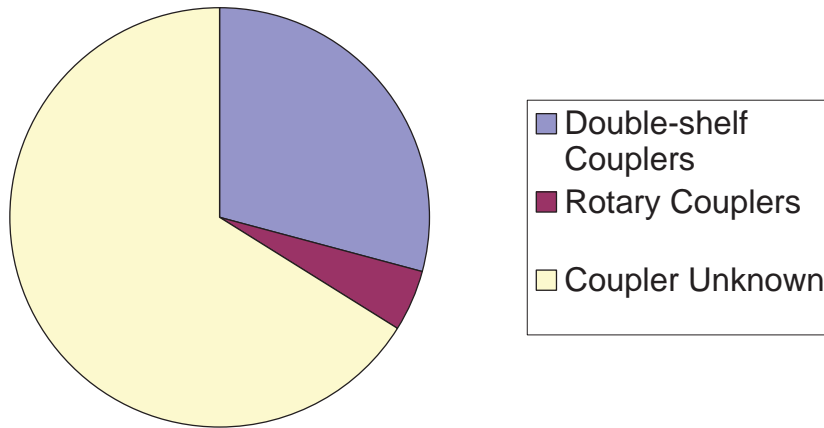
Figure 5: Double shelf couplers involved in a large number of multiple car derailments.

All the narratives from the accident reports were reviewed and summarised in Table 1. In the twelve years of available data, there have been 308 accidents (out of 44,749 reported for all causes) where multiple (two or more) cars had rolled over, or that cars with shelf couplers had derailed. Of these, nineteen cases were directly stated as being the result of the use of double shelf couplers. Seventy-two cases were indirectly linked

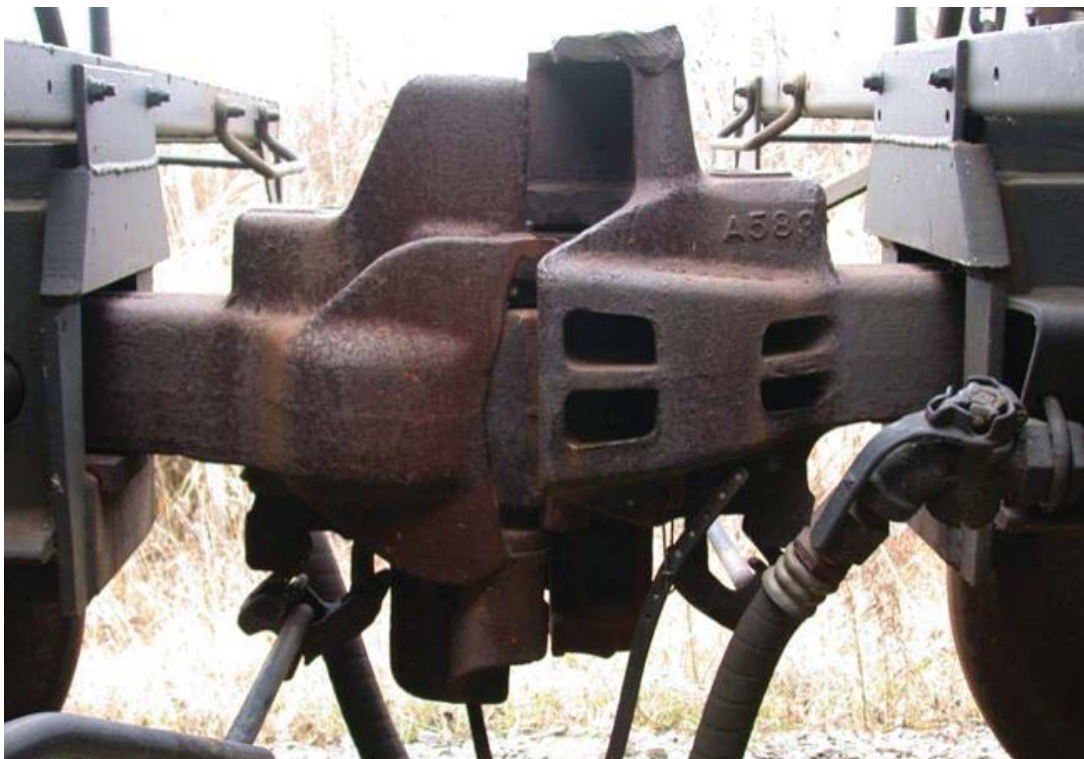
Figure 8: Double shelf couplers mated together showing height mismatch due to different coupler centreline heights, and a drooped coupler on the left car.

Assuming that two cars, at the opposite extreme limits of coupler height, could be joined together, they would have used 3.5 in. of the 6.375 in. clearance. The pulling faces of the knuckles would then be engaged over a length of 2.875 in. Note that continuous operation with less than approximately 3 in. of knuckle engagement is undesirable due to the risk of fracturing the corner of knuckle’s pulling face and subsequent car separation.

If these cars are rolling along a rough track, they can bounce or pitch on their trucks. This motion could consume an additional 1.25 – 1.5 in. of the clearance. This leaves a minimum of 1.375 in. of clearance, under poor or rough operating conditions, to ensure that unwanted contact between a knuckle and shelf does not occur.

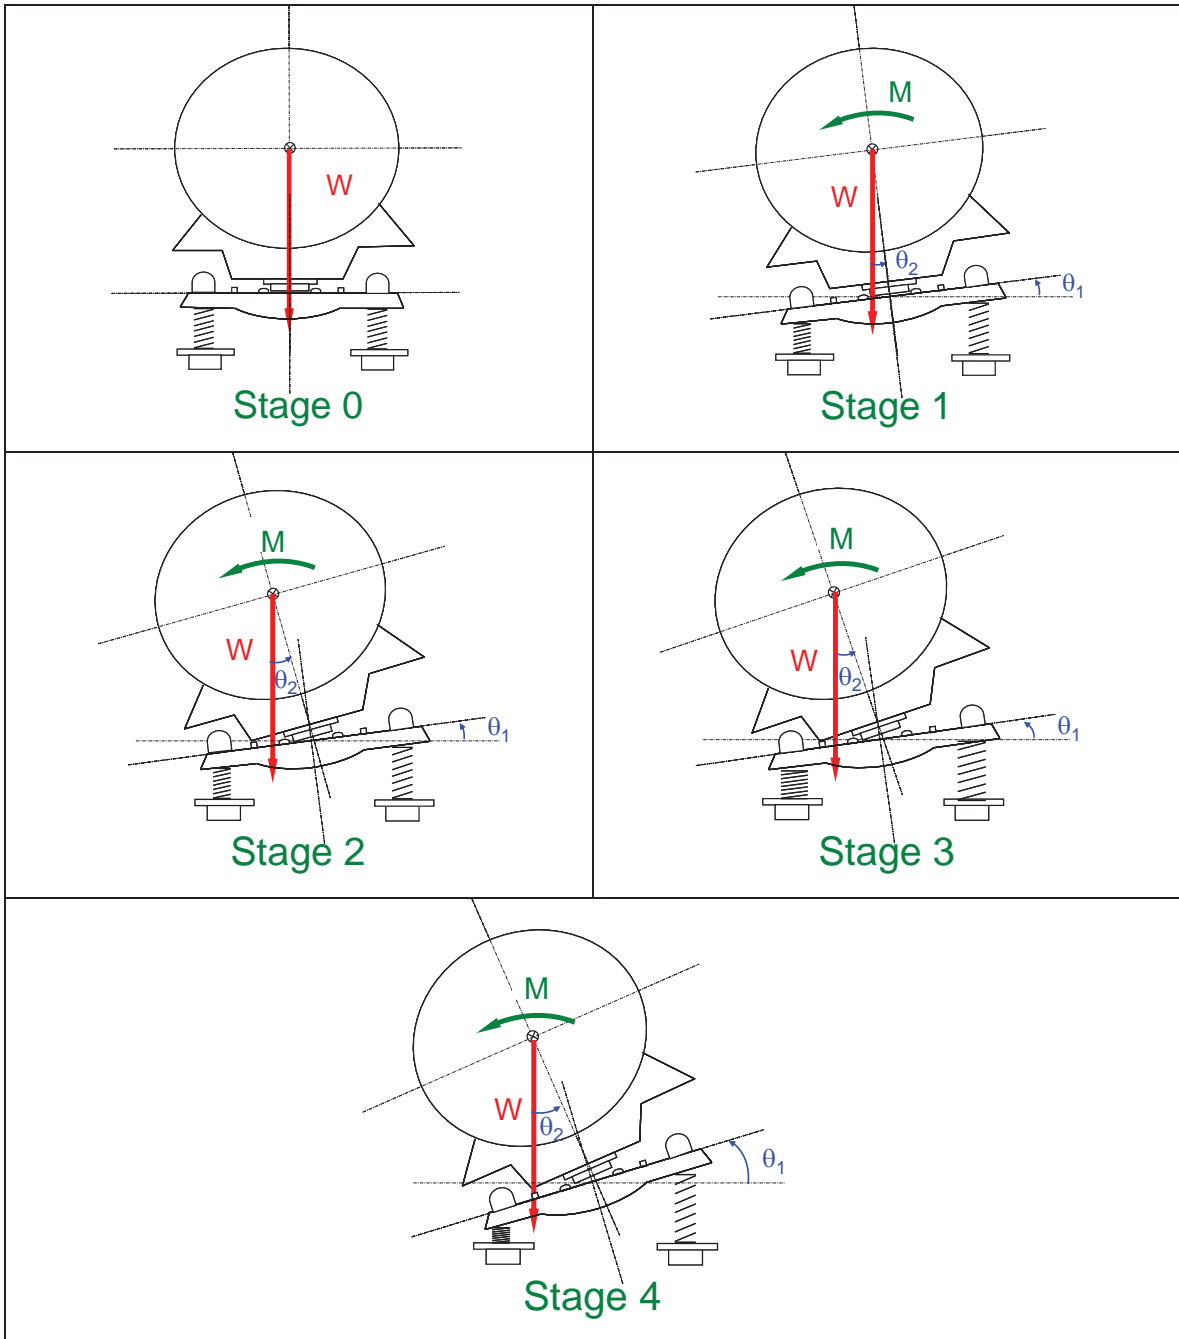
Figure 9: Stages of tank car rollover due to overturning moment – roller side bearings.

The car body rolls off the trucks onto its side on the ground. Before striking the ground, the car body bolster contacts the side frame.

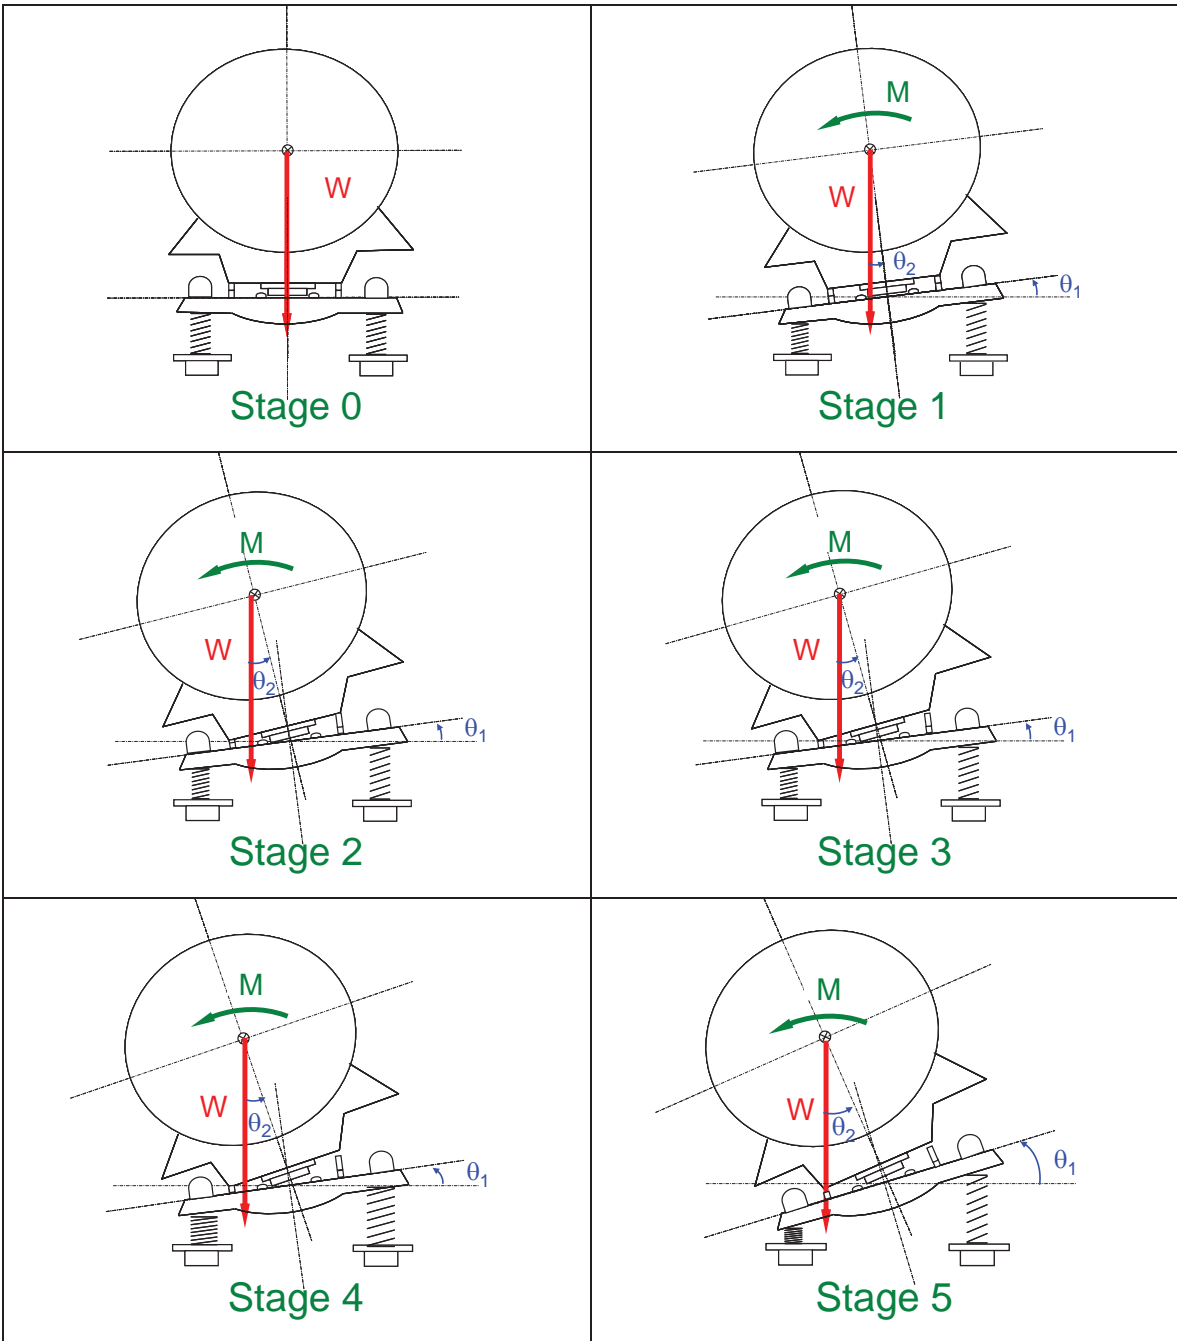
Figure 11: Stages of tank car rollover due to overturning moment – long travel constant contact side bearings.

The rail industry began replacing roller side bearings with long travel CCSB when tank cars were brought to repair facilities. Therefore, CSTT performed the same hand calculations presented in the previous section, but this time the addition of long travel constant contact side bearings were assumed. The model was of a single tank car, positioned on level track. No lateral forces were applied to the system, and locking centre pins were not used. There are several stages of rollover moment resistance, which vary piecewise-linearly with suspension roll angle, depending on the body roll angle with respect to the truck bolsters. The stages of rollover are described below and illustrated in Figure 11.

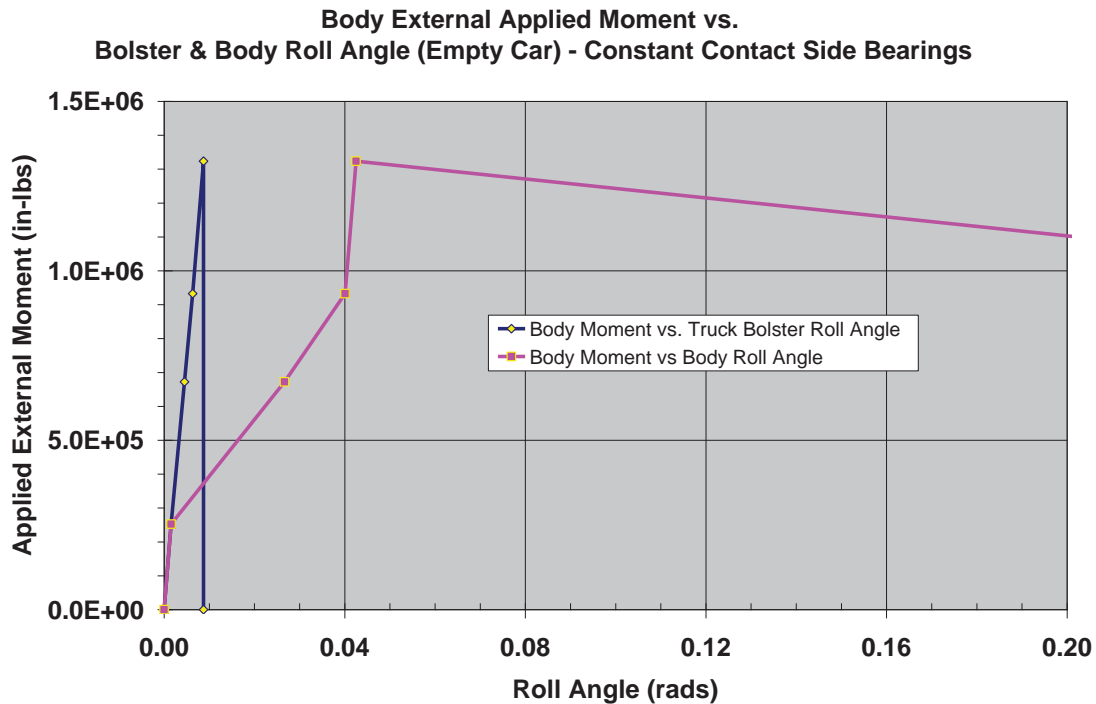
Figure 12: Applied external moment required for rollover of tank cars with long travel constant contact side bearings.

Table 3 shows the external quasi-static moments that must be applied to the body at each stage in order to roll it to the positions described. The progression of the external moment is plotted in Figure 12. The peak moment resistance to rollover is quite similar for both roller side bearings and long travel CCSB, so we can conclude that the type of side bearings should not significantly affect the amount of rollover resistance of an empty tank car. A very large torsional force must be transmitted through the coupler connection in order to roll over an empty tank car.

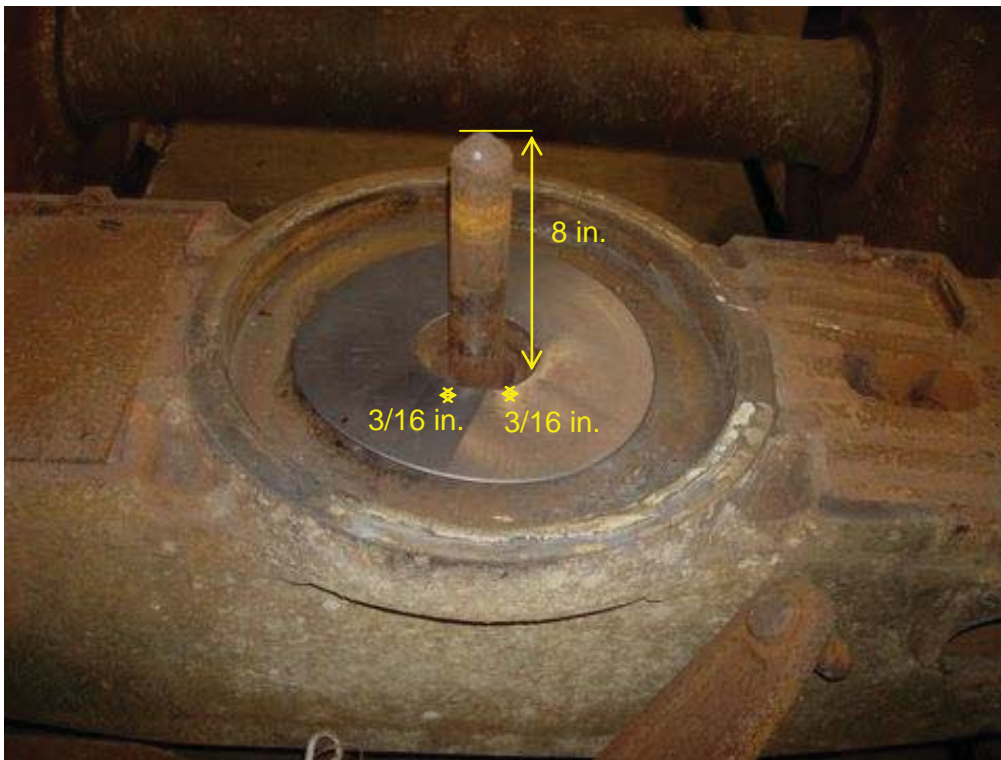
Figure 13: Centre pin height above centre bowl liner.

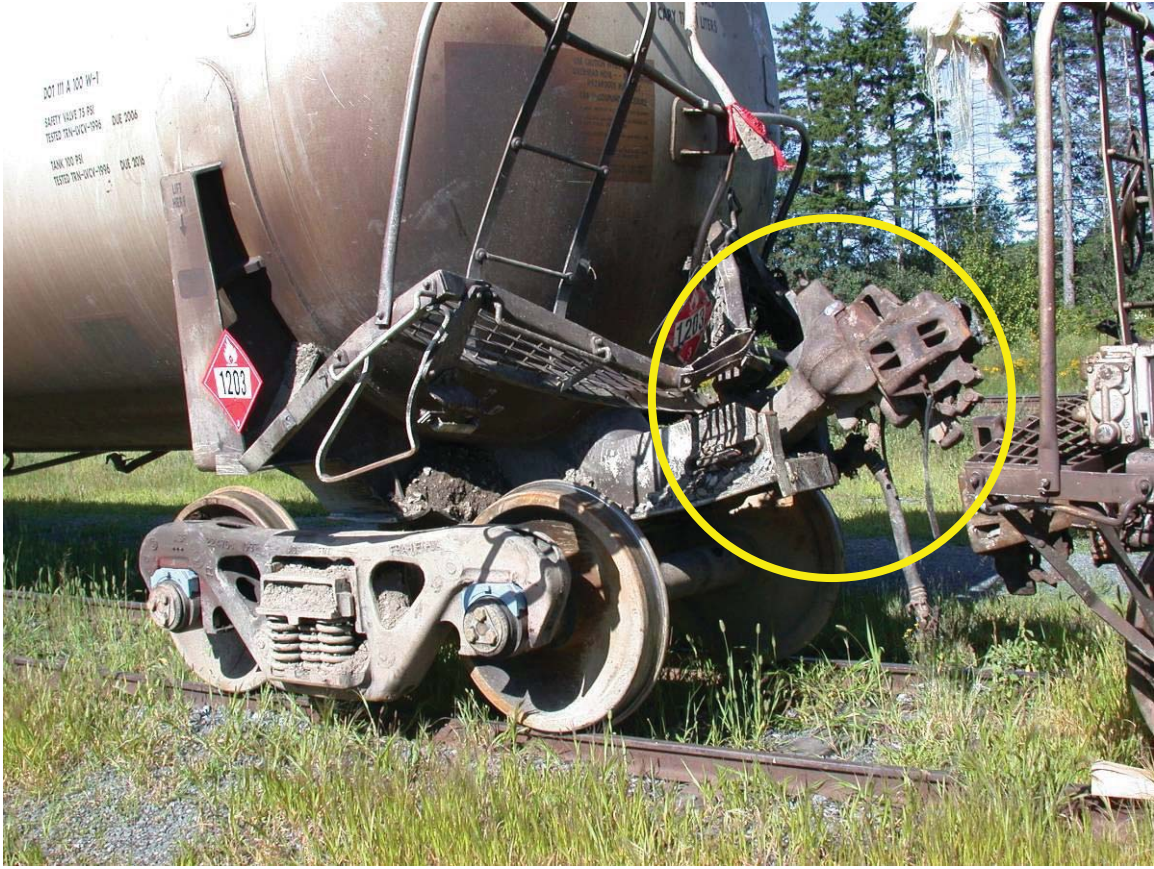
Figure 19: Coupler and end walkway bent up after derailment.

The end walkway of several tank cars can be seen in derailment photos to have been bent in an upward position. One example is shown in Figure 19. The photograph was taken after the same accident [7] was cleaned up, and this loaded tank car, which had derailed and rolled over, was placed upright on the tracks. This also suggests a significant vertical force being involved in the rollover mechanism.

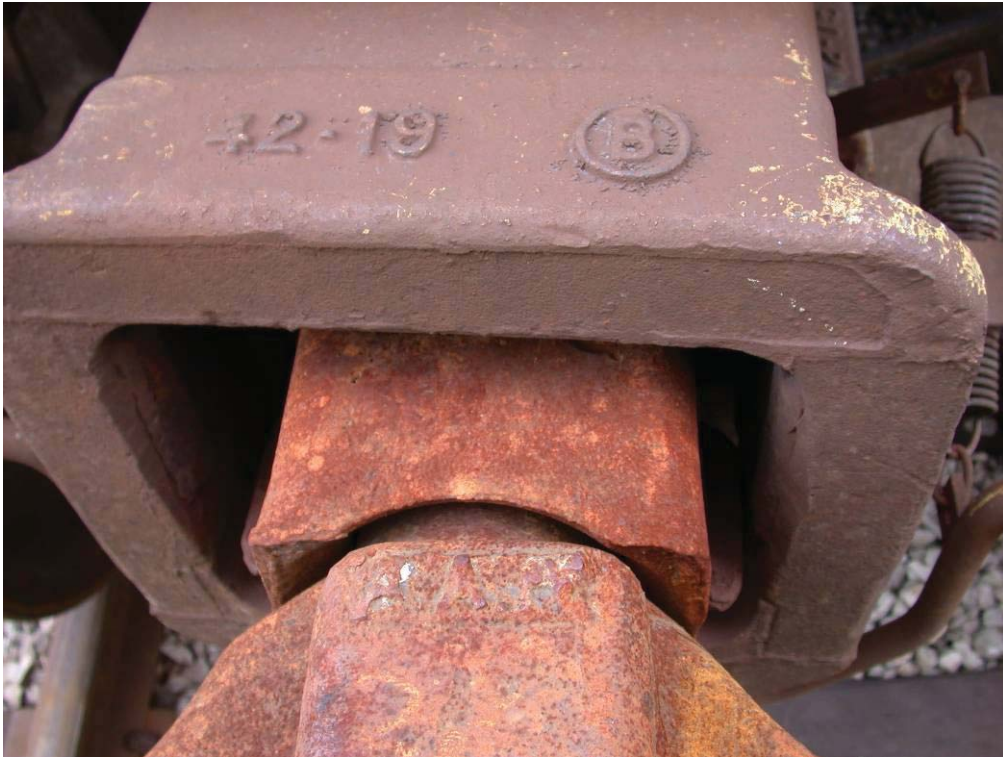
Figure 24: Rotary coupler.

The installation of a rotary coupler at each coupling position would likely eliminate the ability of a derauling car to transmit a torque to the adjacent car through the coupling. However, a rotary coupler would still permit the transfer of horizontal and vertical force components. There are no AAR specifications for rotary couplers. Several manufacturers offer rotary couplers. Several rotary coupler connections are shown in Figure 24, Figure 25, and Figure 26.

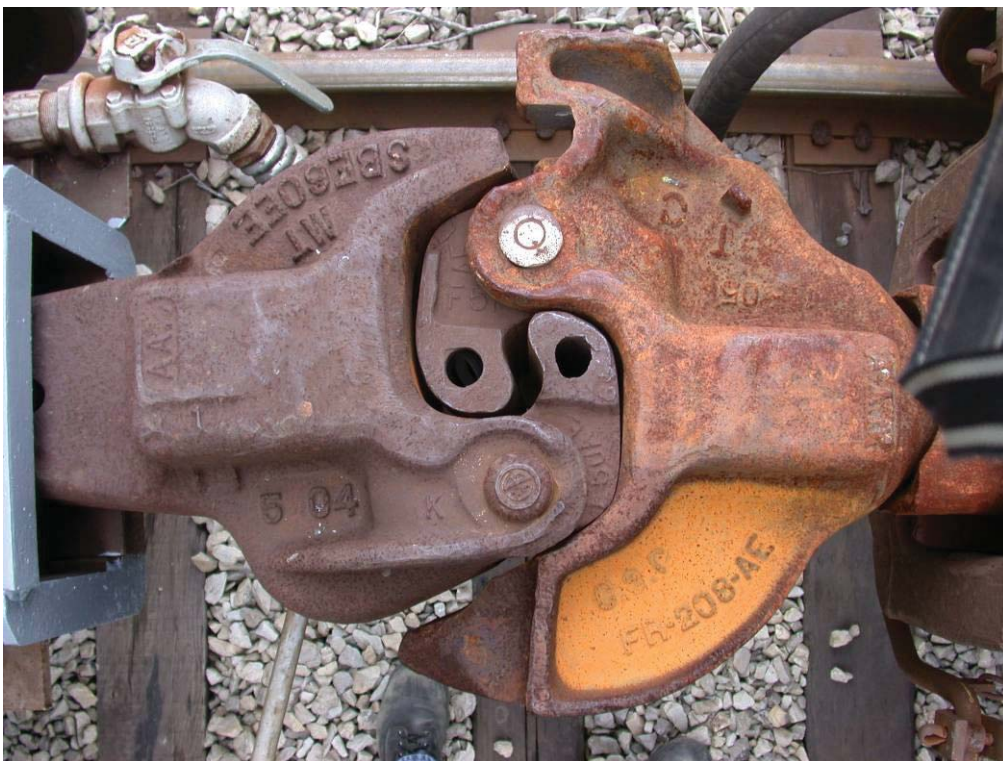
Figure 25: F-type rotary coupler (right) mated with non-rotary E-type coupler (left).

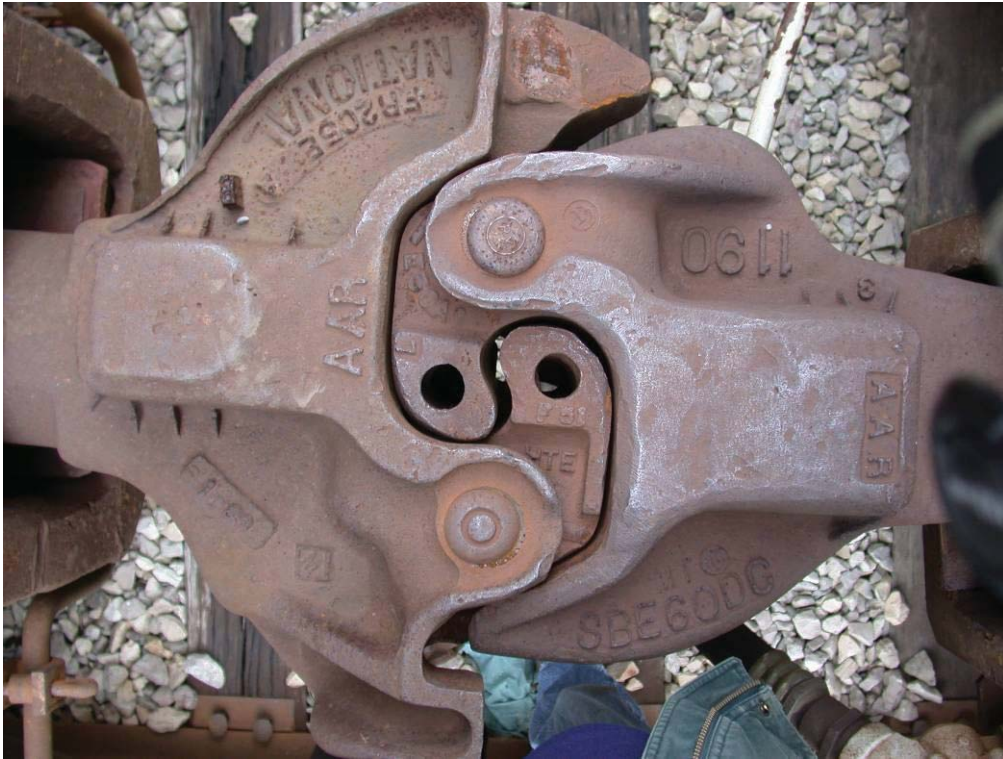
Figure 26: F-type rotary coupler (left) mated with non-rotary E-type coupler (right).

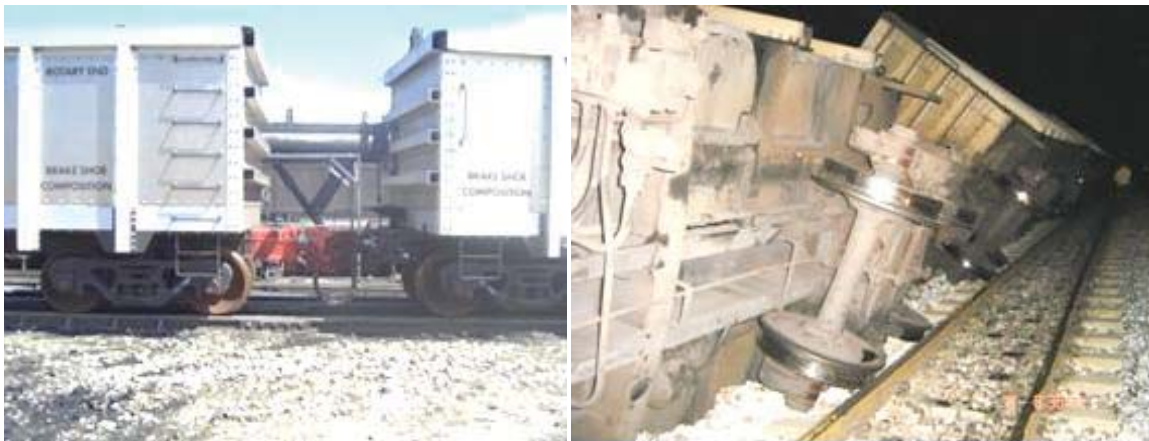
Figure 27: Rotary couplers used in coal cars in South America.

However, use of rotary couplers will not be a guarantee against car body rollovers. In unit trains operating in rotary dumper service, F-type interlocking couplers are used. One of the two couplers at the coupling intersection between cars is a rotary coupler. Nevertheless, in these unit trains, several cars may derail in a train derailment, and roll over sequentially without uncoupling. An example of this is shown in Figure 27. The cars shown are rotary dump gondolas, used for coal service on a narrow gauge South American railway. As a result of a sideswipe collision at the entrance to a mainline siding, many (approximately fifteen) loaded cars overturned. These cars use F-type couplers with one rotary connection per car. In addition, the trucks are locked to the car body and the wheelsets are locked to the trucks.
