**Investigation of Multiple Tank Car Rollover Derailments – Standard Type E
Double-shelf Coupler, and Modified Rotary Coupler**

Phase 2

Prepared for
Transport Dangerous Goods Directorate
of
Transport Canada

CSTT-RVC-TR-216

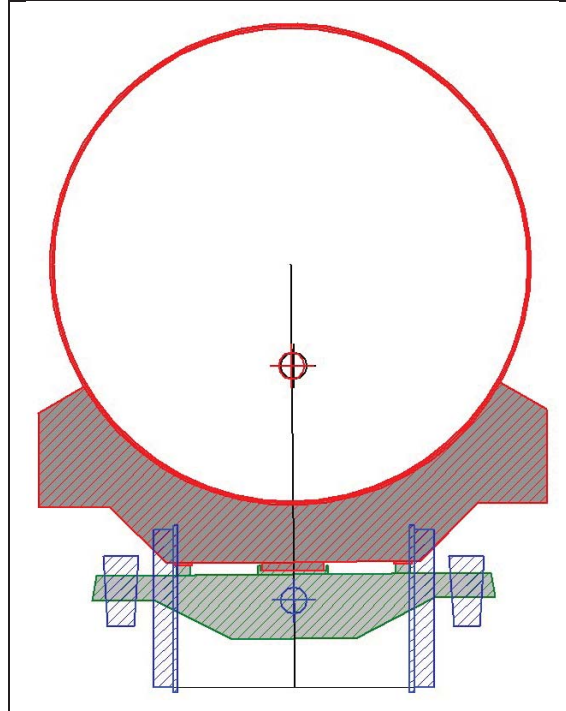
Figure 2: Car body rolled onto the side bearings.

The weight of the car body deflects the truck bolsters on their springs, when the car is undisturbed (Stage 1). Since the car body weight is still entirely supported by the truck bolsters in Stage 2, the motion of the truck bolsters is to roll about their centres, compress the left side springs by an additional amount, and allow the right side springs to extend by the same amount. This motion causes the centre of gravity of the car body to drop slightly and move to the left. The small displacement of the centre of gravity can be seen in Figure 2. The centre of gravity of the truck bolster does not displace. Note that the spring rate in Table 2 is for the two truck spring groups on each side of the car.

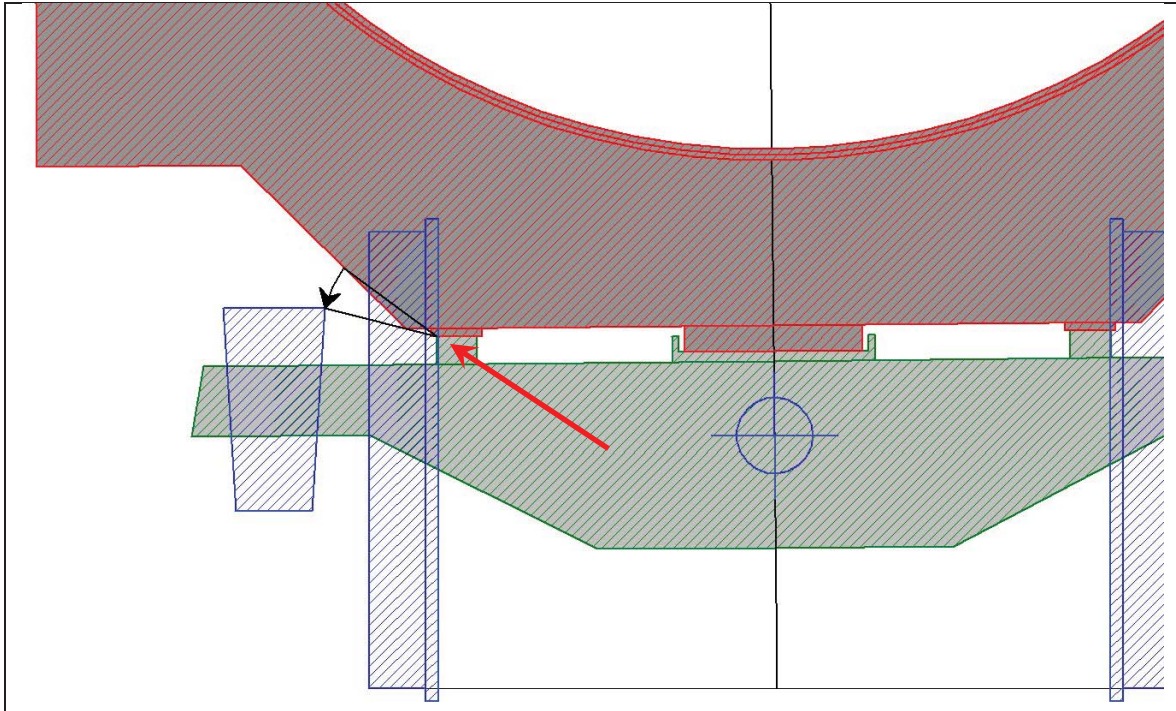
In this stage, the car body must roll about the outside edge of the side bearings through an angle to bring the car body bolster into contact with the side frame. Contact will occur at the inside edge of the side frame. The geometry of the situation is shown in Figure 3; the black arrow indicates the arc through which the body must roll and the red arrow shows the pivot point.

Figure 3: Car body rolls about the side bearings until contact occurs with the side frame.

The actual angle through which the car body will roll in this stage depends on the geometry of the car body bolster. The car body bolster has been drawn using the dimensions found on drawings supplied to NRC-CSTT by GATX for earlier work in this project. Not all dimensions were included, so the angle at the sloped portion of the car body bolster was taken as 45° . It is this part of the body bolster that contacts the side frame. Note that the construction details of the body bolster vary from one tank car design to the next, so contact may occur at different locations on other cars. Based on a 45° body bolster construction angle, the roll angle to bring the body bolster into contact with the side frame is roughly 22° . The car body is just touching the side frame and the load is still on the truck side bearing. Therefore, the truck bolster remains rolled as in Stage 2.

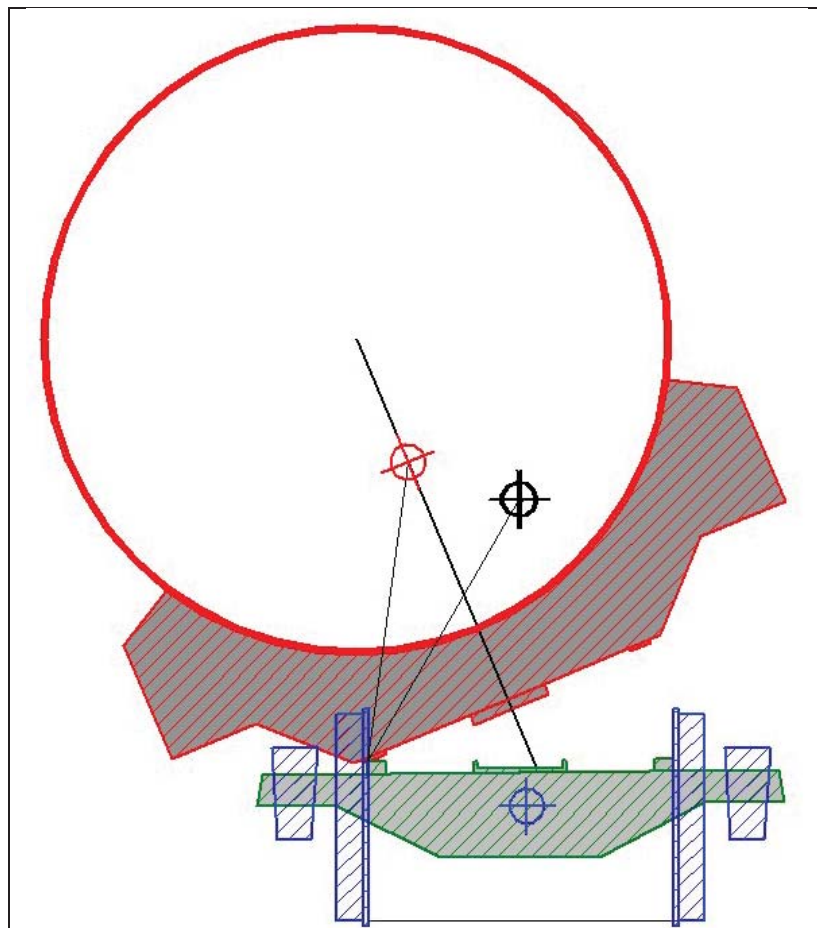
The final position of the car for this stage is shown in Figure 4.

Figure 4: Car body rolled contacting the side frame at the end of Stage 3.

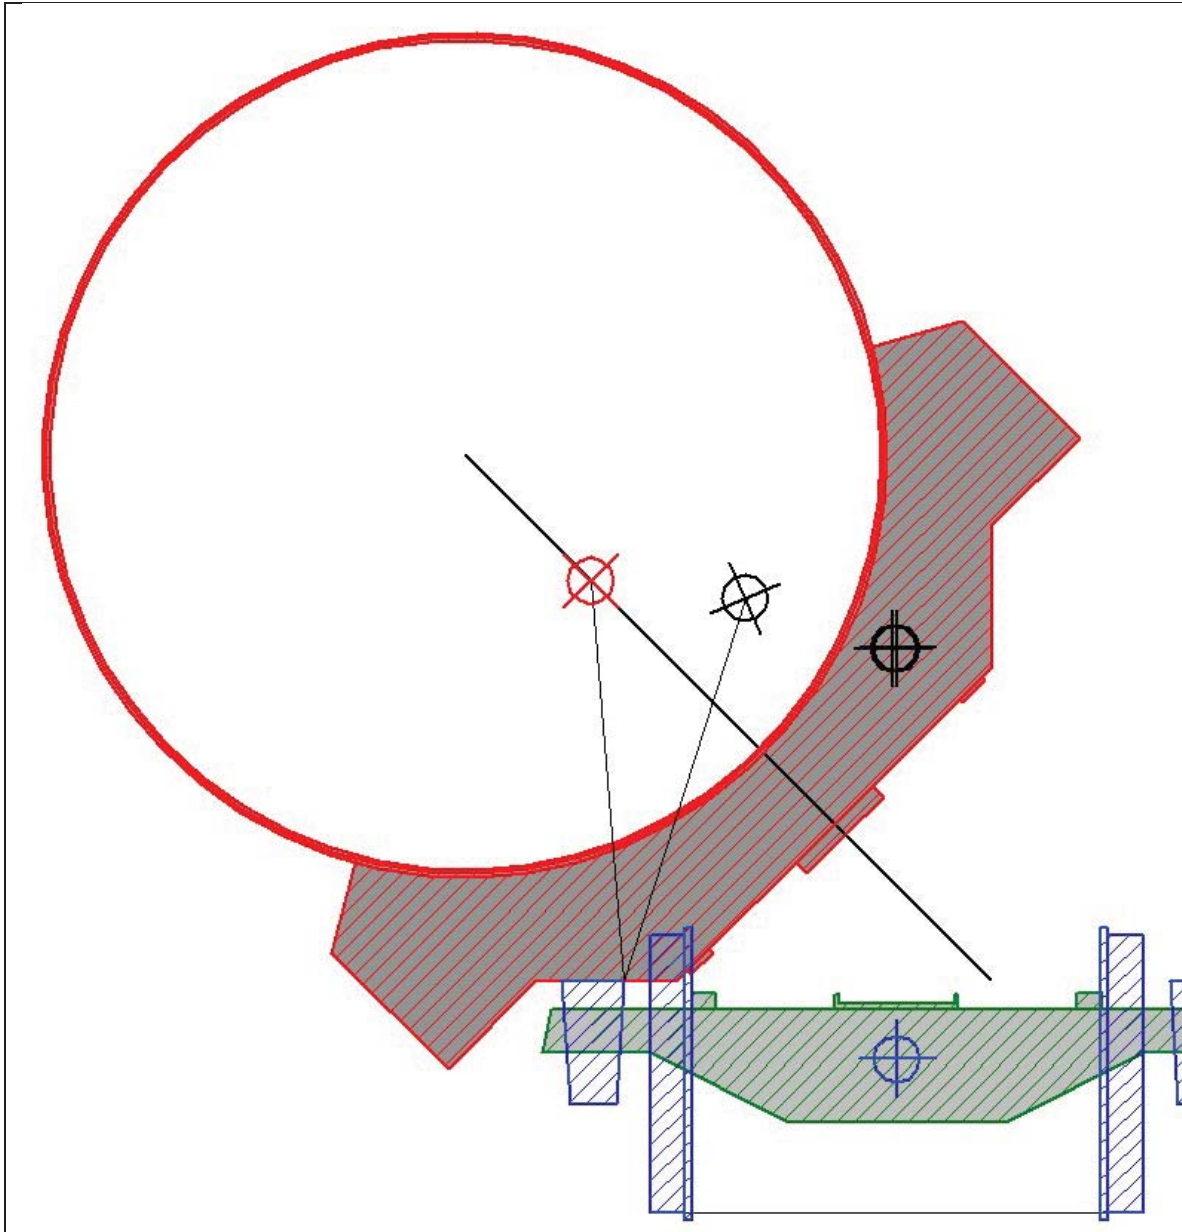
In this stage, the car body must roll about the inside corner of the top chord of the truck side frame through an angle that causes the car body bolster to just lie flat on the top chord of the side frame, while the vertical load (the car body weight) is assumed to still pass through the inside corner of the side frame. The car body is no longer in contact with the truck bolster, so the bolster has rolled back to level and the springs have lifted it vertically to a new static position. The geometry of the situation is shown in Figure 5. The car reaches its maximum potential energy during this stage.

Figure 5: Car body has rolled about the inside corner of the side frame, until the body bolster lies flat on the side frame.

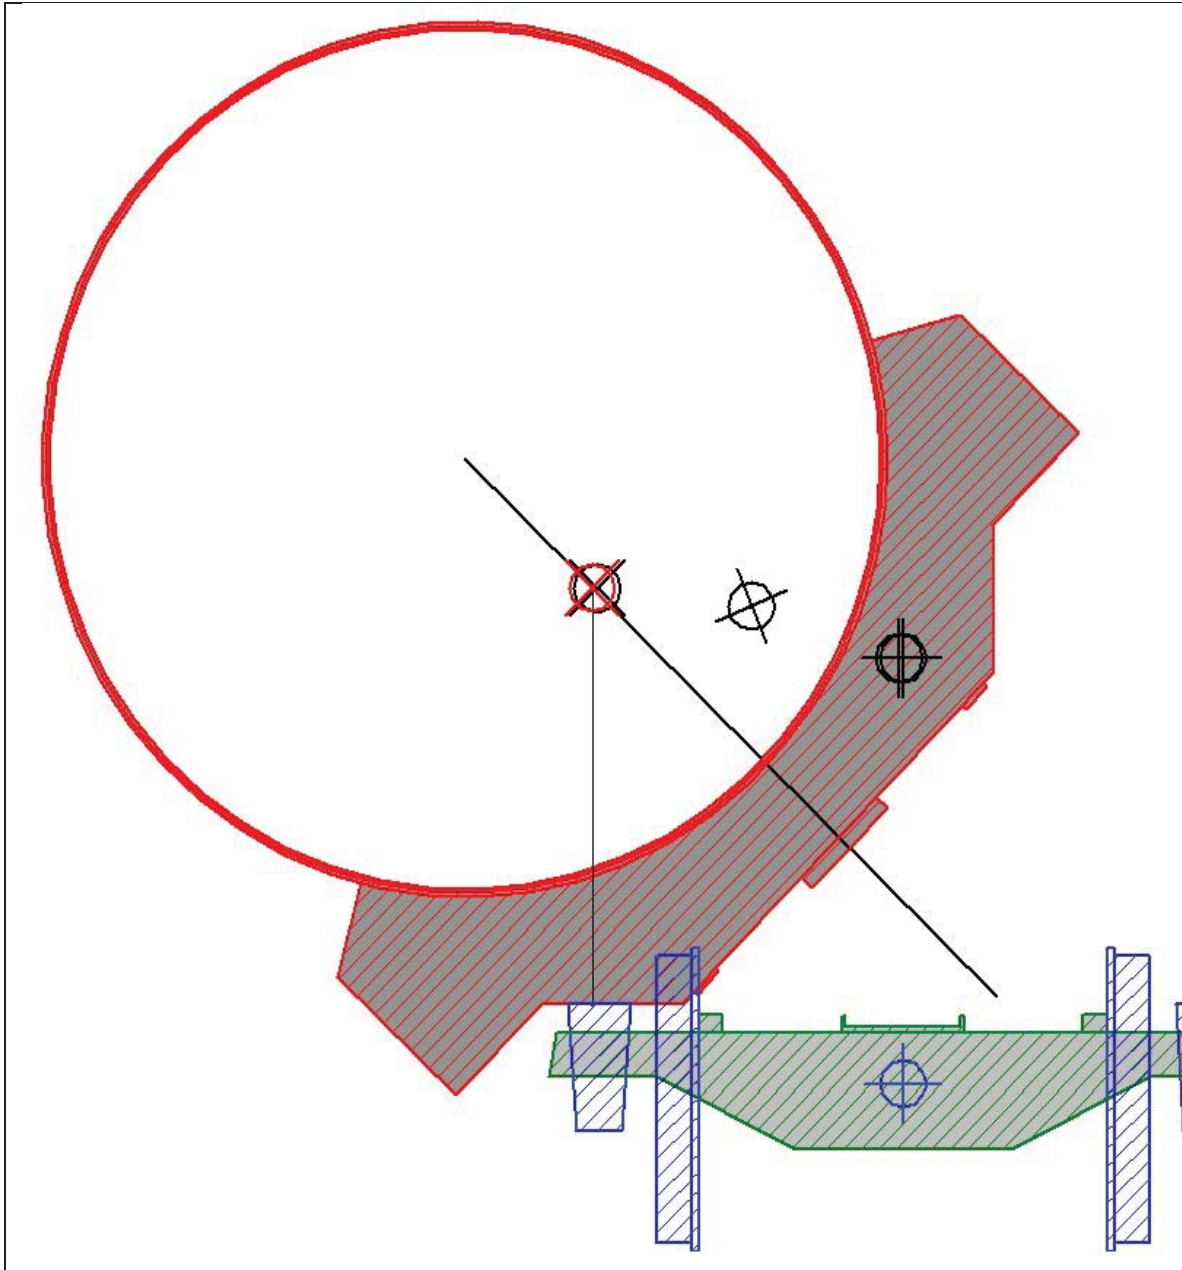
This stage is identical to the previous one, except that the car body weight is now carried at the outside corner of the side frame (Figure 6). Only an infinitesimal amount of roll has occurred during this stage, so the positions of the centres of gravity have not changed. Therefore, the potential energies are also the same as in Stage 4.

Figure 6: Car body carried on the outside corner of the side frame.

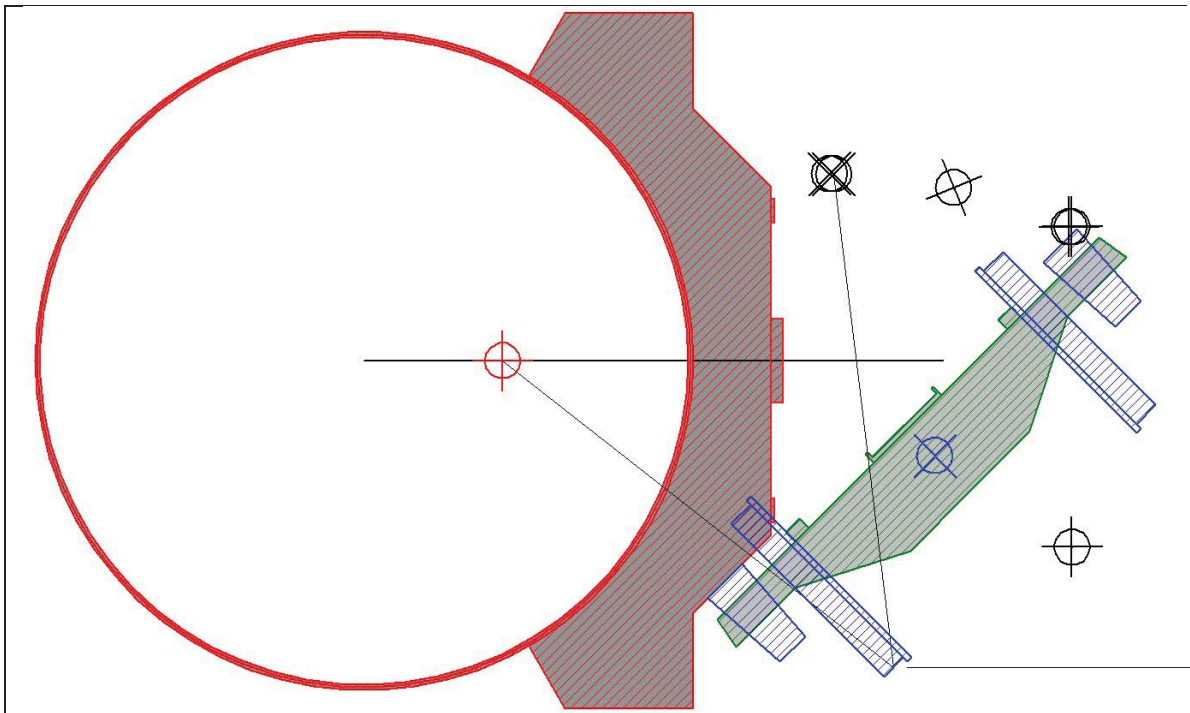
Figure 7: Car body has rolled about the wheel/rail contact points until the body contacts the ground below the TOR.

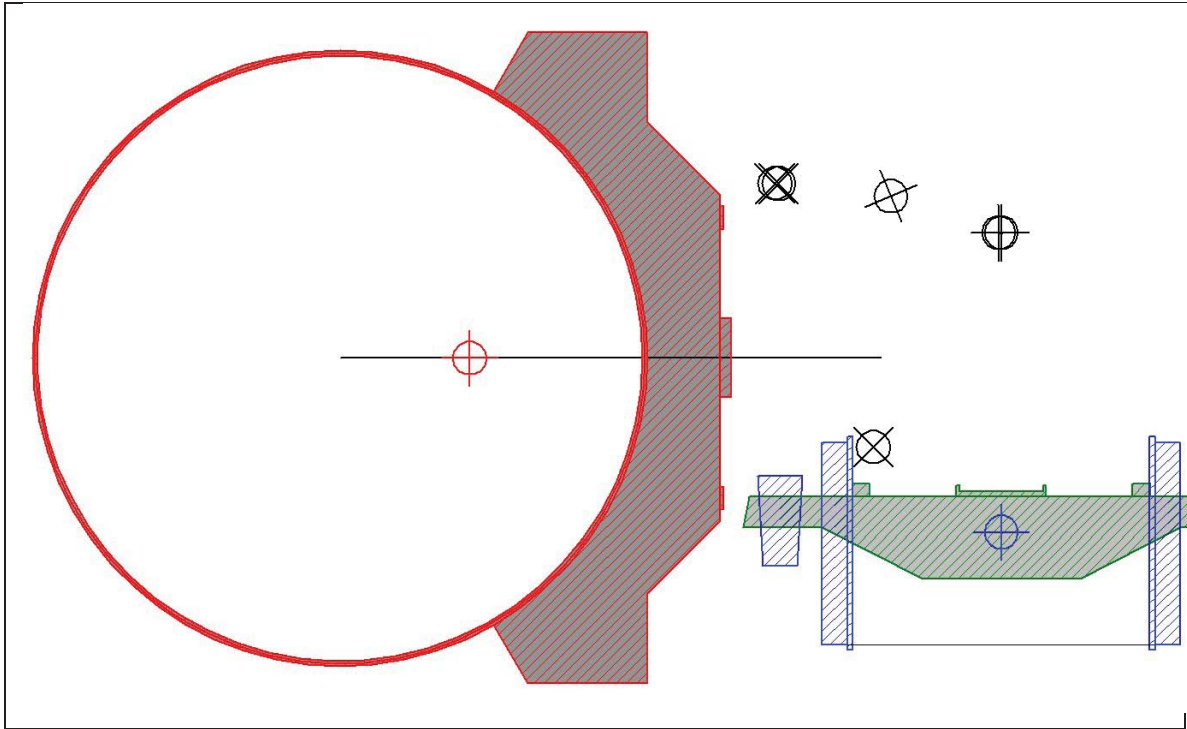
In the final stage, the body has fallen away from the truck sufficiently to allow the truck to fall back onto the rails (Figure 8). The change in potential energy at this stage comes from the change in height of the centre of gravity of the truck assembly.

Figure 8: Truck falls back on the rails after the car body has rolled sufficiently far away on the ground.

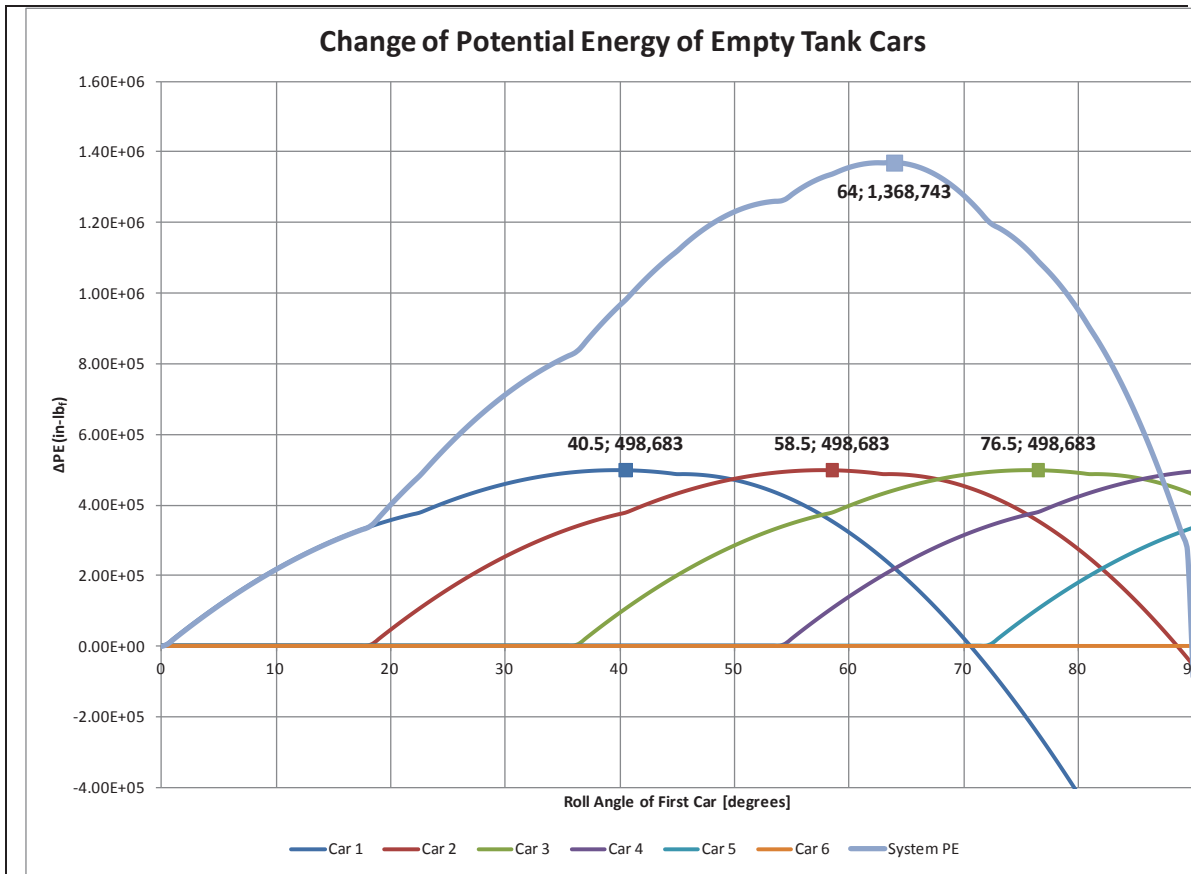
A necessary condition for the domino effect to begin is that sufficient energy must be transferred to the undisturbed system to roll the first car to 64°; this puts the system at the point of maximum energy (a system meta-stable point). The change in potential energy required is 1,368,743 in-lb above the potential energy for four similar empty cars sitting undisturbed on level track. This increase in potential energy could come from a sideswipe impact with another train. An empty tank car travelling at roughly 6.6 miles/hour has this amount of kinetic energy, as does a loaded tank car travelling at roughly 3.6 miles/hour. In a collision, not all of this energy will be transferred from the striking car to the struck car. Some energy will likely remain in the striking car (it may continue to roll along its track), energy may be used to crumple the tank walls, etc. Therefore, actual collision speeds would need to be higher.

Figure 9: Change in potential energies of empty tank cars and change in total potential energy of a system, as a function of the car body roll angle of the first car.

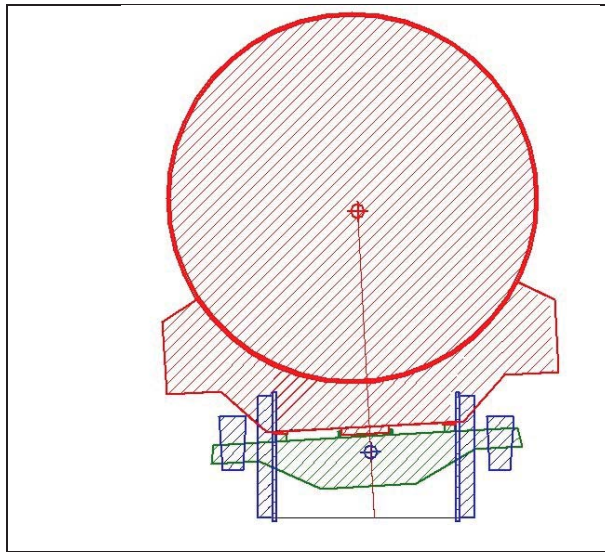
In this stage, the car body has rolled (counter clockwise for this analysis) sufficiently to fully compress the truck suspension springs on the rolled (left) side. The weight of the car body deflects the truck bolsters on their springs, when the car is undisturbed (Stage 1). Since the car body weight is still entirely supported by the truck bolsters in Stage 2, the motion of the truck bolsters is to roll about their centres, compress the left side springs by an additional amount, and allow the right side springs to extend by the same amount. This motion causes the centre of gravity of the car body to drop slightly and move to the left. The small displacement of the centre of gravity can be seen in Figure 11.

Figure 11: Car body compresses truck suspension springs.

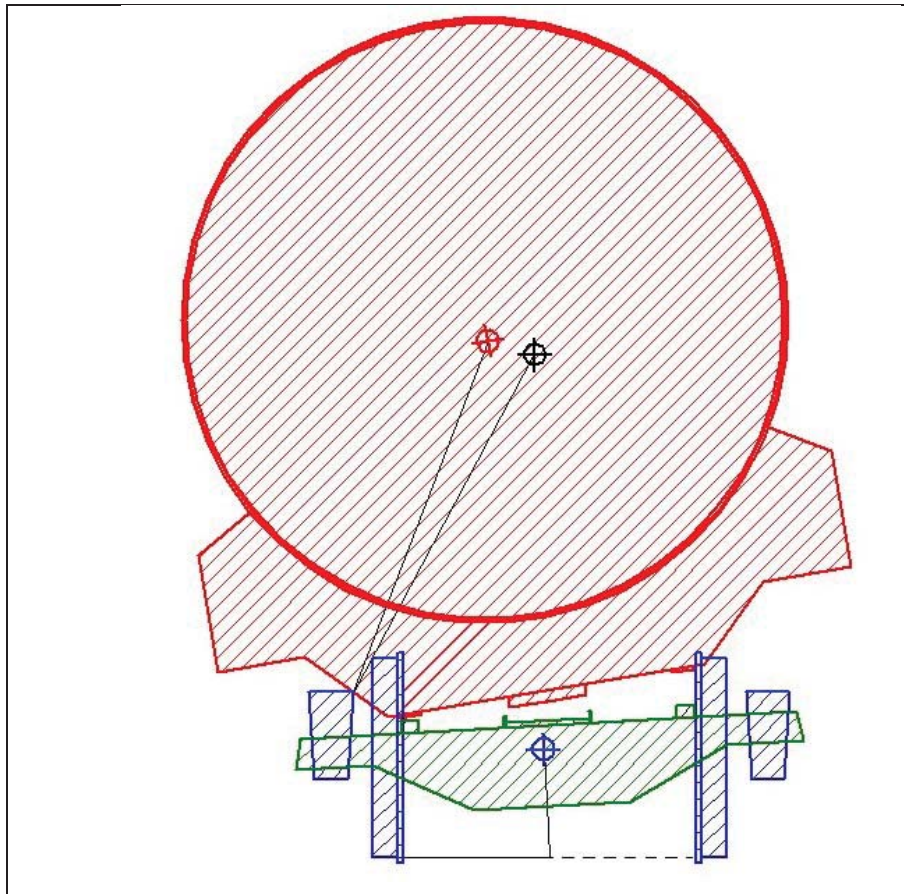
The final position of the tank car at the end of Stage 4 is shown in Figure 14.

Figure 14: Final position of Stage 4 - car body just contacts inside corner of side frame without loading it.

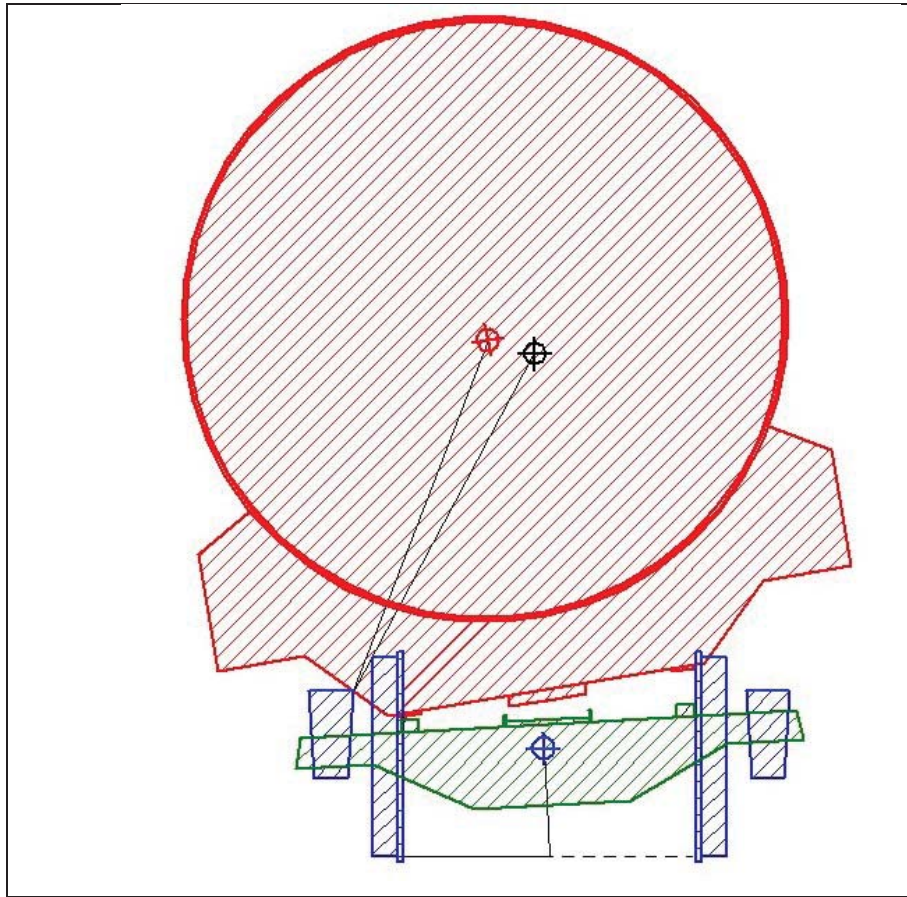
This stage is identical to the previous one, except that some of the car body weight is now carried at the inside corner of the side frame (Figure 15), relieving the load on the side bearings on the rolled side. The side bearings are now only carrying the load required to fully compress the suspension springs; they are no longer overloaded. Only an infinitesimal amount of roll has occurred during this stage, so the positions of the centres of gravity have not changed. Therefore, the potential energies are also the same as in Stage 4.

Figure 15: Car body load transferred to inside corner of the side frame.

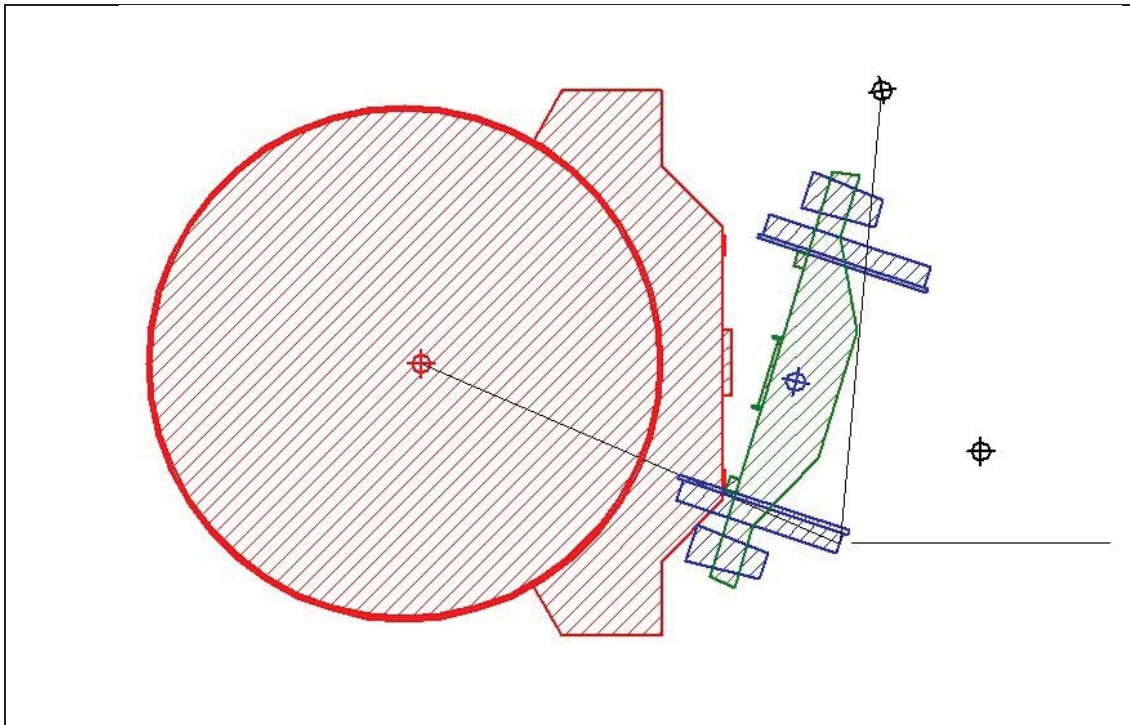
Figure 17: Car body has rolled about the wheel/rail contact points until the body contacts the ground below the TOR.

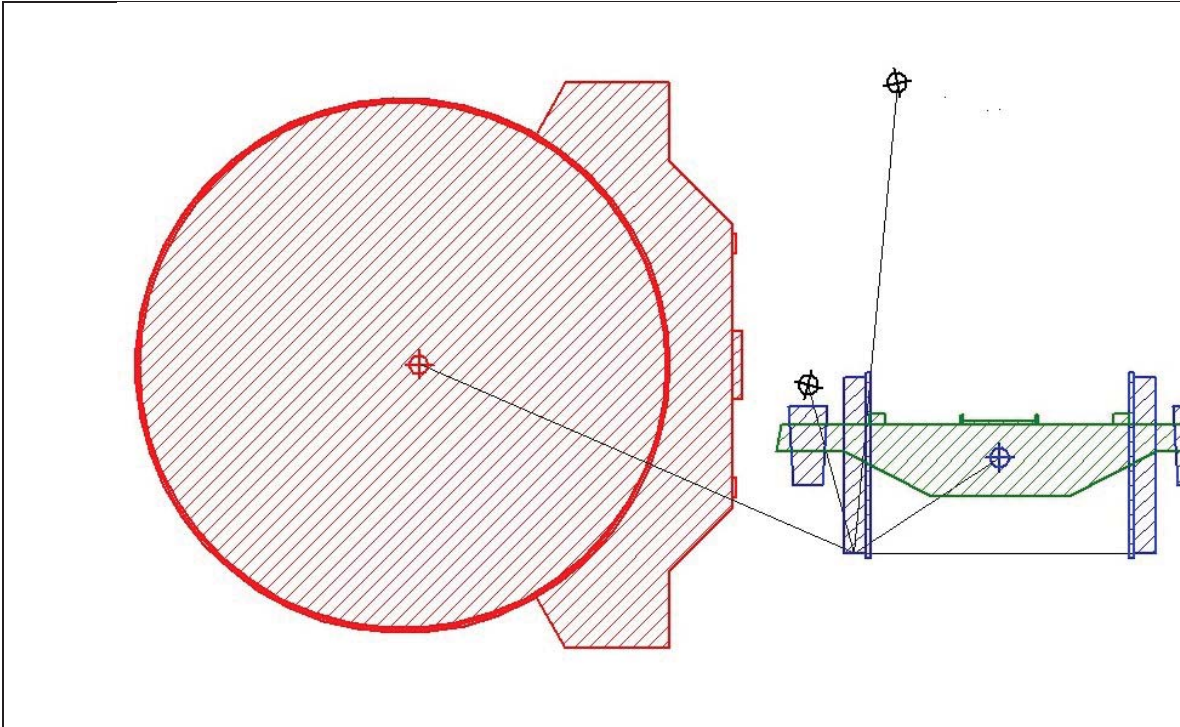
In the final stage, the body has fallen away from the truck sufficiently to allow the truck to fall back onto the rails (Figure 18). The change in potential energy at this stage comes from the change in height of the centre of gravity of the truck assembly.

Figure 18: Truck falls back on the rails after the car body has rolled sufficiently far away on the ground.

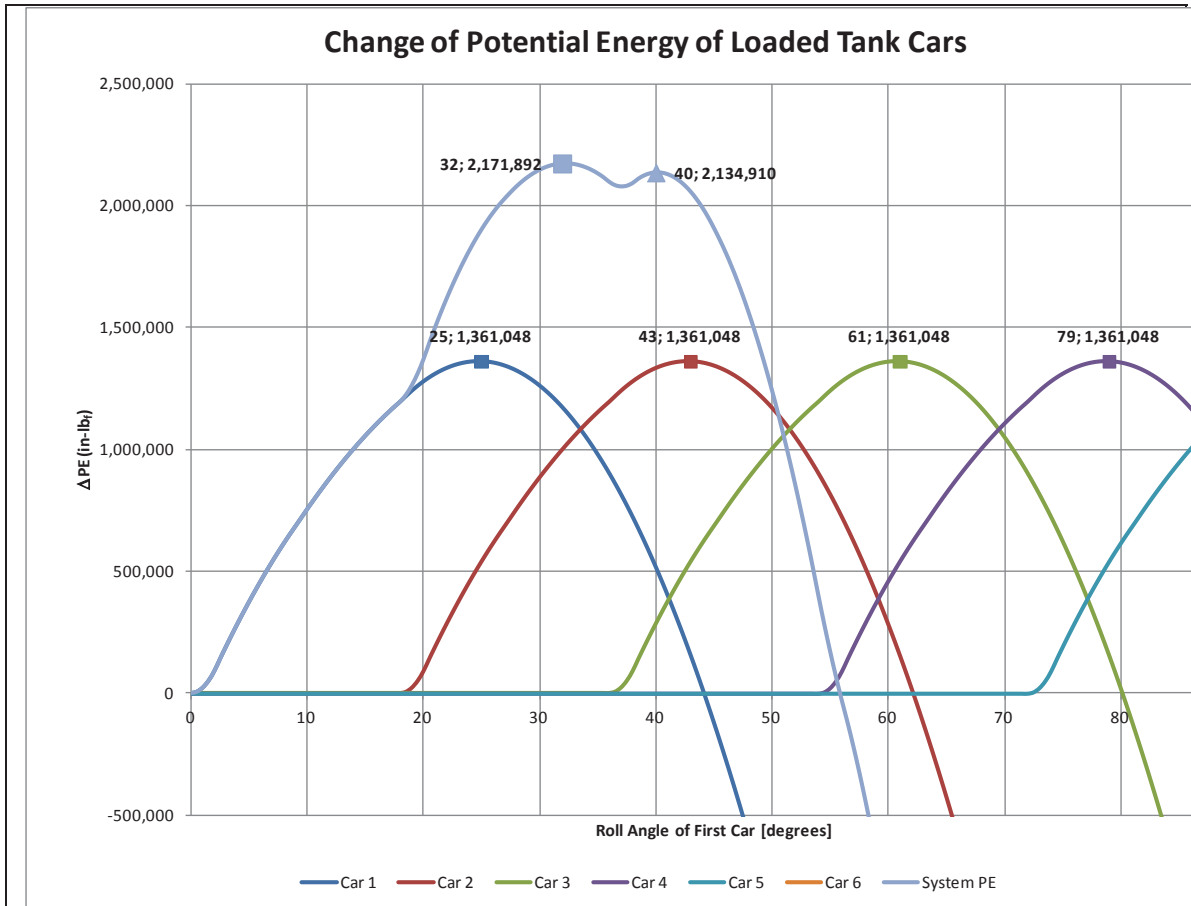
A necessary condition for the domino effect to begin is that sufficient kinetic energy must be transferred to the undisturbed system to roll the first car to 32° ; this puts the system at the point of maximum potential energy (a system meta-stable point). The energy required is 2,171,892 in-lb. This energy could come from a sideswipe impact with another train. An empty tank car travelling at roughly 8.4 miles/hour has this amount of

kinetic energy, as does a loaded tank car travelling at roughly 4.5 miles/hour. In a collision, not all of this energy will be transferred from the striking car to the struck car. Some energy will likely remain in the striking car (it may continue to roll along its track), energy may be used to crumple the tank walls, etc. Therefore, actual collision speeds would need to be higher.

Figure 19: Change in potential energies of loaded tank cars and change in total potential energy of a system, as a function of the car body roll angle of the first car.

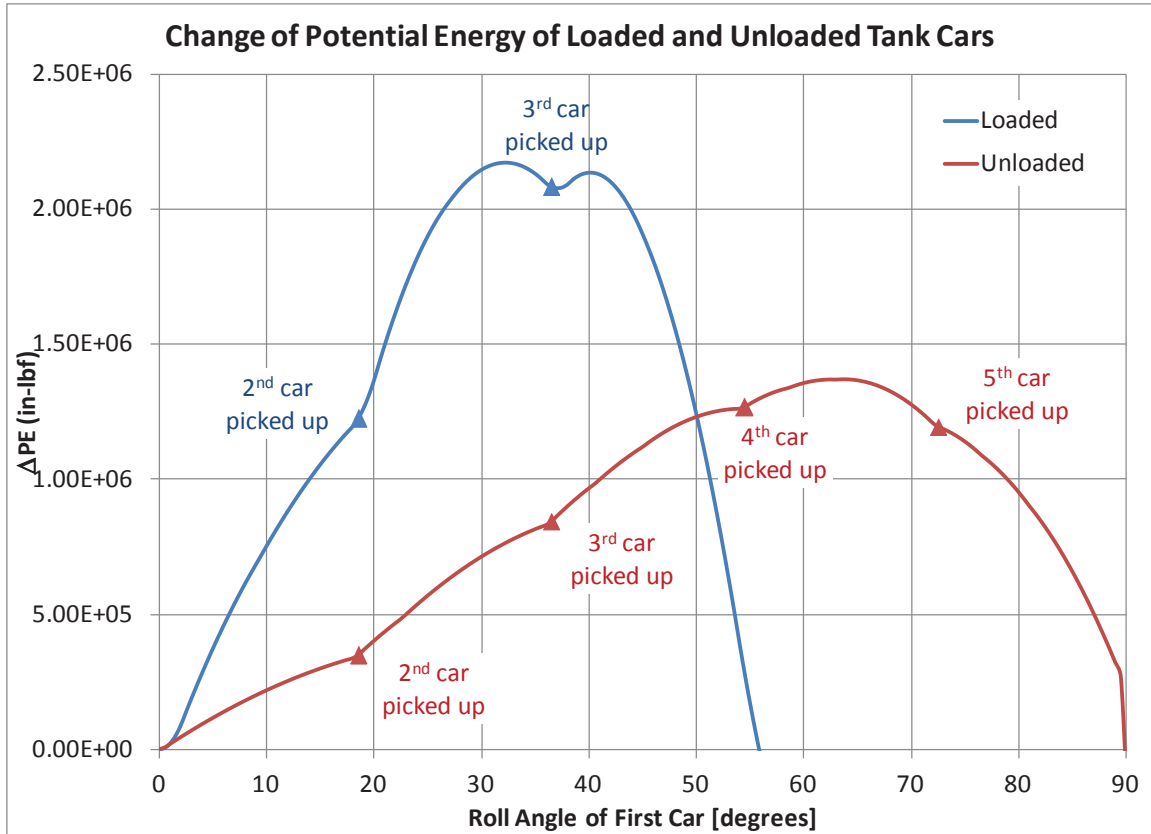
The kinetic energy that must be added to the system to initiate a loaded car domino rollover is 1.6 times that required for the empty car case (Figure 20). Fewer cars are required to initiate a loaded car domino derailment. Since the weight of the loaded car compresses the secondary suspension springs far more than does the weight of the empty car, the car body bolster can contact the side frame with much less car body roll. The greater weight of the loaded car body can also transfer enough load to the side frame to destabilize the truck without very much additional car body roll. Therefore, the meta-stable point is reached at a reduced car body roll angle for the first car (32° vs. 64° for the empty car case) and at this point the second car has only rolled by 14°.

Figure 20: Comparison of system variation in potential energy between loaded and unloaded tank cars.

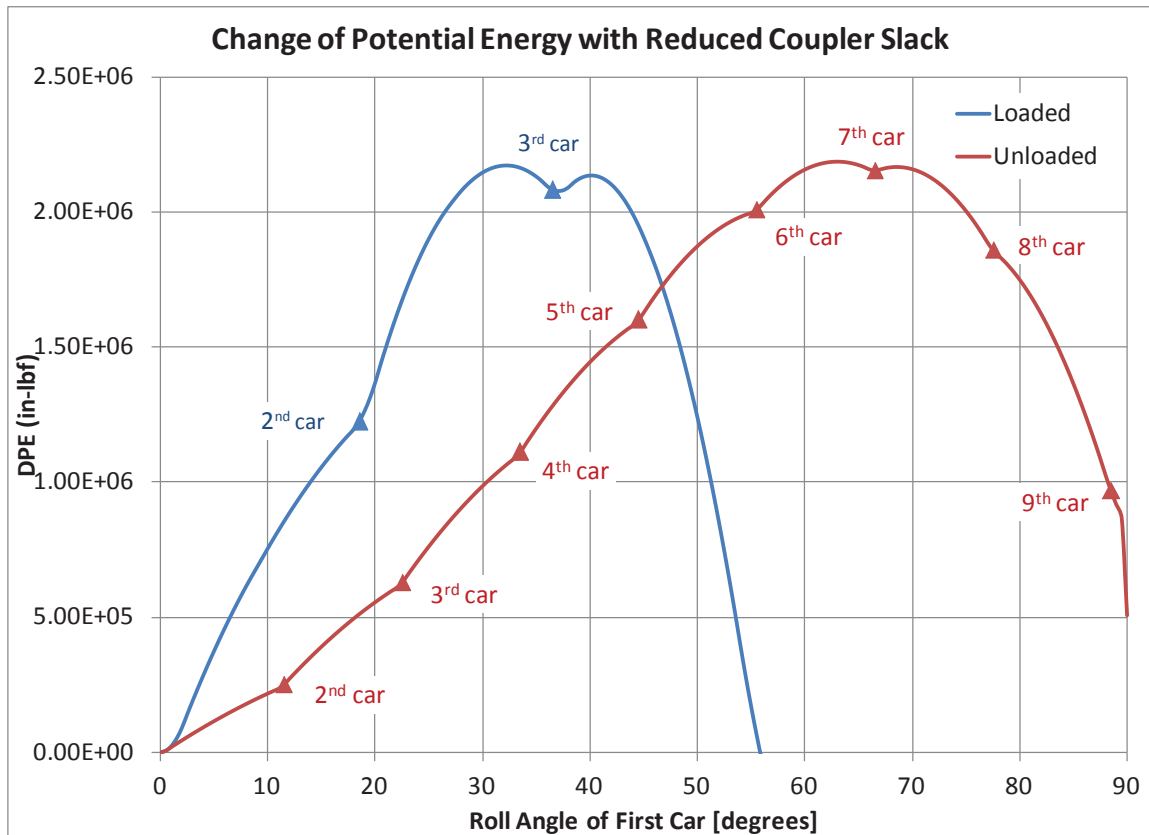
Building on the fact that component failures stopped the domino effect, increasing the amount of energy required to roll over a string of cars could serve as an alternative or addition to the potential solution of a rotary double-shelf coupler (discussed in Section 1 of this report). Increasing the system energy will result in higher stress on the components, effectively making them act as fuses. In order to increase the system energy, the simplest approach is to reduce the amount of angular lag (currently assumed at 18°). Reducing the lag between the cars will force the domino roll to pick up the next cars in the system at a smaller roll angle, adding their weight and resistance to the system. Figure 21 compares the current loaded case analysis with a lag of 18° (blue) to

the unloaded case with a lag of only 11° (red). The energy required to reach the system's meta-stable point is similar in both cases, but seven cars are now involved in the unloaded car string. This alternative solution requires further study: what potential energy level is required to systematically obtain this fuse effect, is it possible to sufficiently reduce coupler roll slack without affecting car operations or increasing puncture risk and are there more efficient or complementary ways to increase the energy to reach the system's meta-stable point?

Figure 21: Effect of reducing coupler slack on system energy.

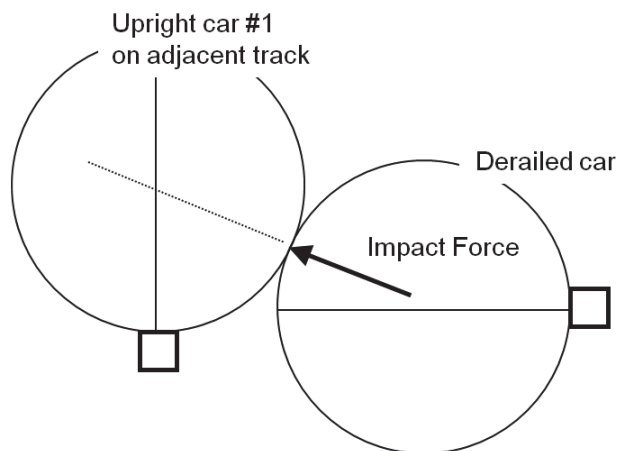
To simulate a rollover derailment in the field, a dynamic force is applied to Car #1 at the centre of gravity position. The assumed scenario is that a derailed car impacts Car #1 dynamically as shown in Figure 23. The maximum impact force is estimated approximately as 125 kips, which is about 25% of typical impact force observed when a typical empty freight car impacts head-to-head to a string of cars under a speed of around 8 mph. As the purpose of the simulation was mainly to investigate the effect of the double-shelf coupler on a domino rollover, the impact scenario used here is to duplicate one observed in the field. It was believed that the initiation event would have an insignificant effect on the domino behaviour.

Figure 23: Assumed impact scenario.

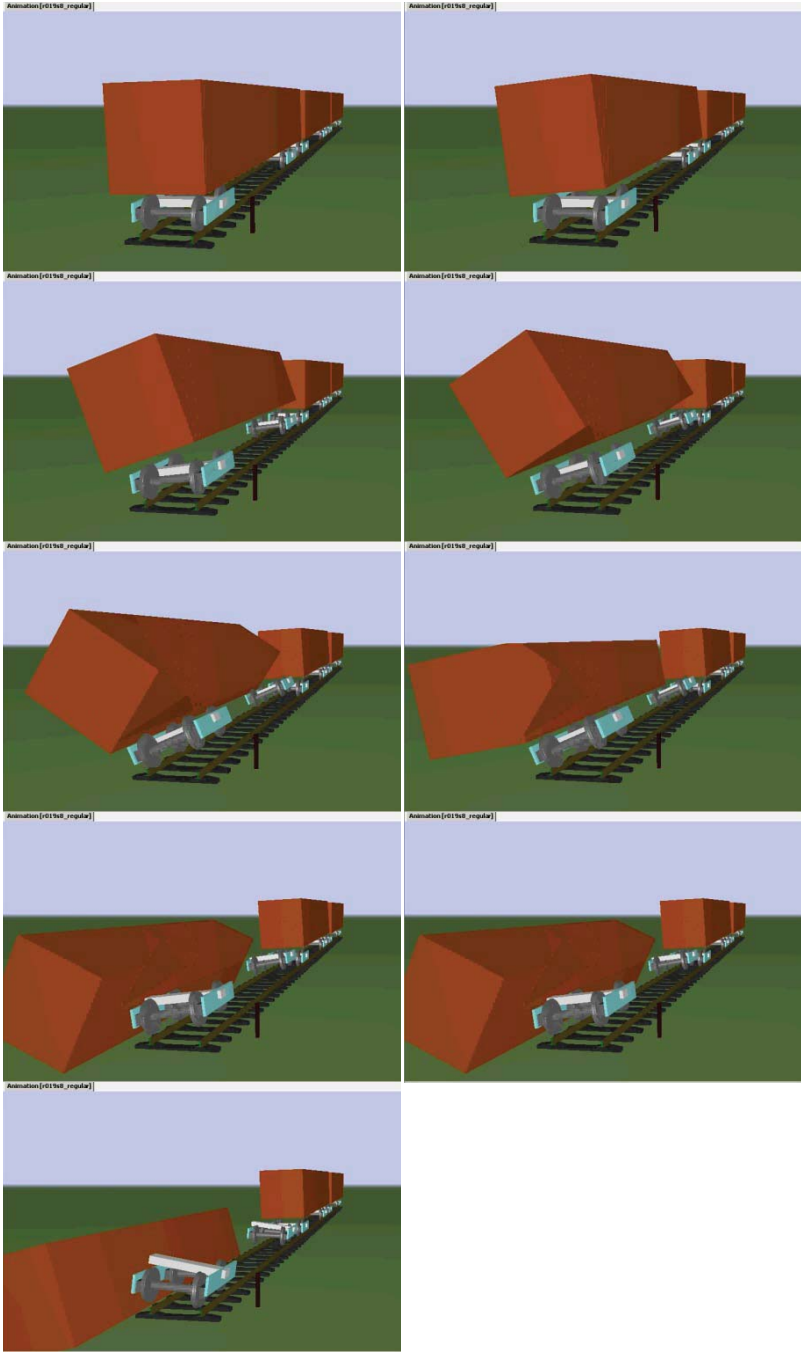
In the case of the regular E coupler, Figure 24 shows that no domino rollover occurs because the coupler disengages. From the animation it can be observed that Car #2 is actually rotated a few degrees at the beginning. This can be seen clearly in Figure 25 where the rotation angles of the three car bodies are plotted, together with the impact force to Car #1 (as shown in Figure 23). This result is in agreement with the general observation that no domino type rollover derailment happened for the tank train equipped with regular E couplers about 30 years ago.

Figure 24: Animations of simulation results for regular Type E coupler case.

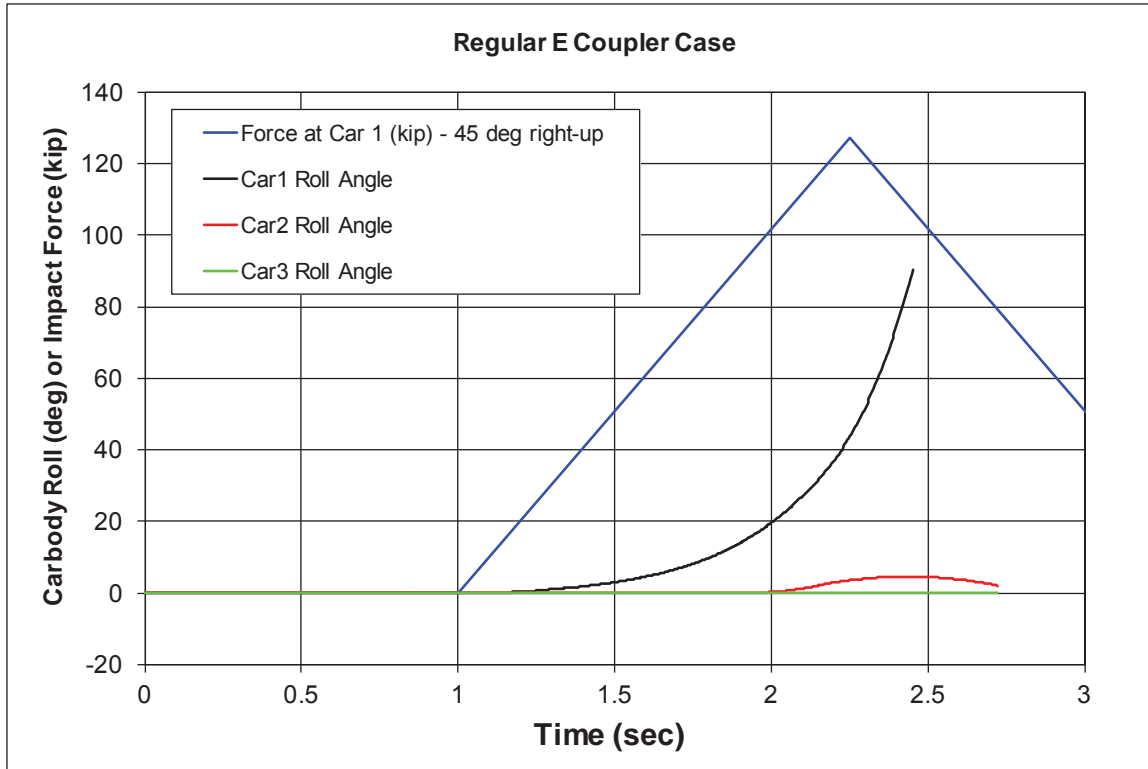
Figure 25: Car body roll angles obtained by simulation for regular Type E coupler case.

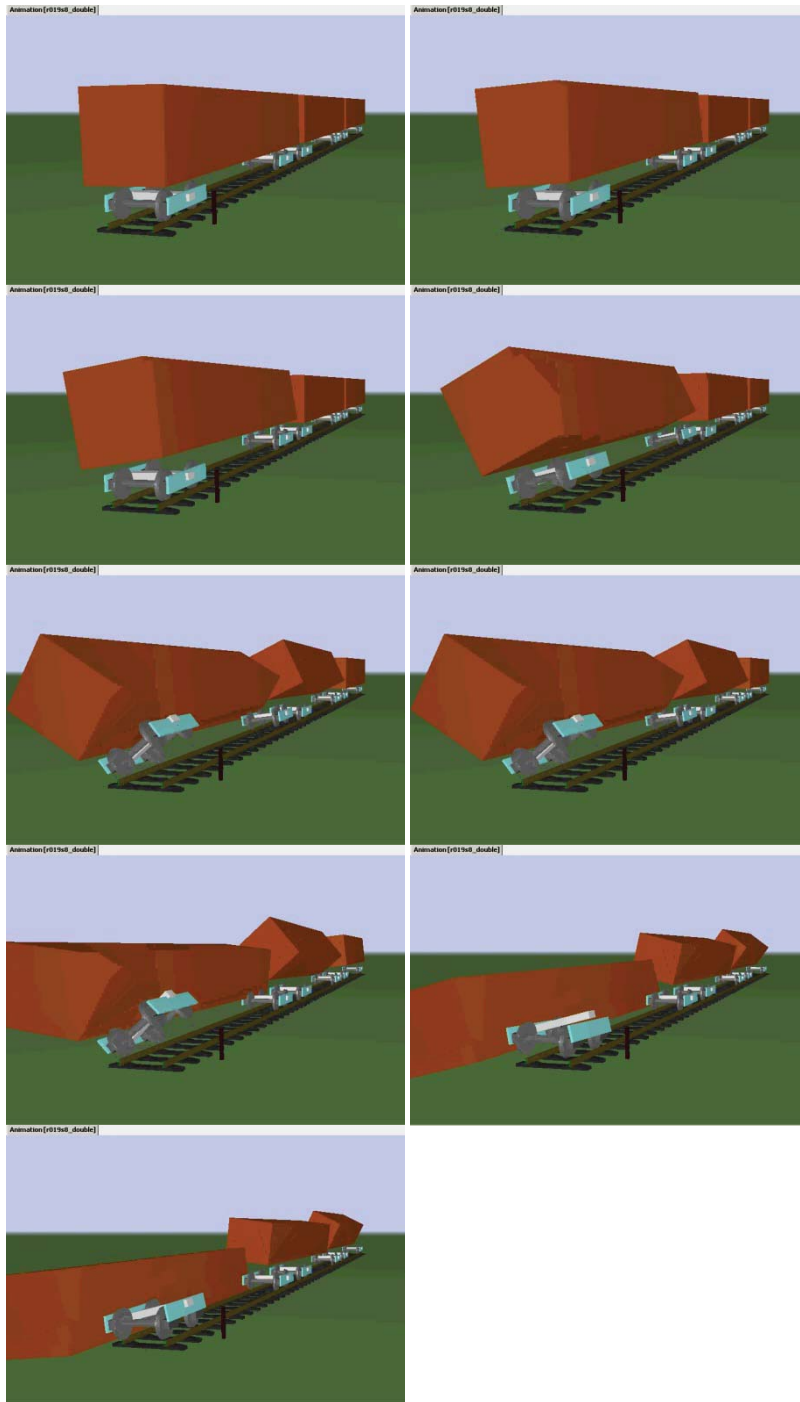
Figure 26 shows the domino type rollover when the double-shelf coupler is modeled in the simulation. Figure 27 gives time histories of the angles of the three car bodies. These results indicate the main reason for the domino rollover is the torque transfer between cars through the double-shelf coupler, which cannot be disengaged by the relative vertical motion of two adjacent couplers. The obtained domino rollover is in agreement with the general observation that tank trains equipped with double-shelf couplers are known to suffer domino type derailments. By obtaining the animation motion results shown in Figure 26, the developed VAMPIRE dynamic model shows good potential of the developed coupler models in the user subroutine as well as the whole rollover model. This is despite the limitation VAMPIRE software has that the moment and force are calculated based on small angle assumption (for example using θ to replace $\sin \theta$). The next step will be to assess the impact of small angle assumption to the obtained simulation results by comparing the simulation with the physical test. This was not done as the simulation work was put on hold.

Figure 26: Animations of simulation results for double-shelf coupler case.

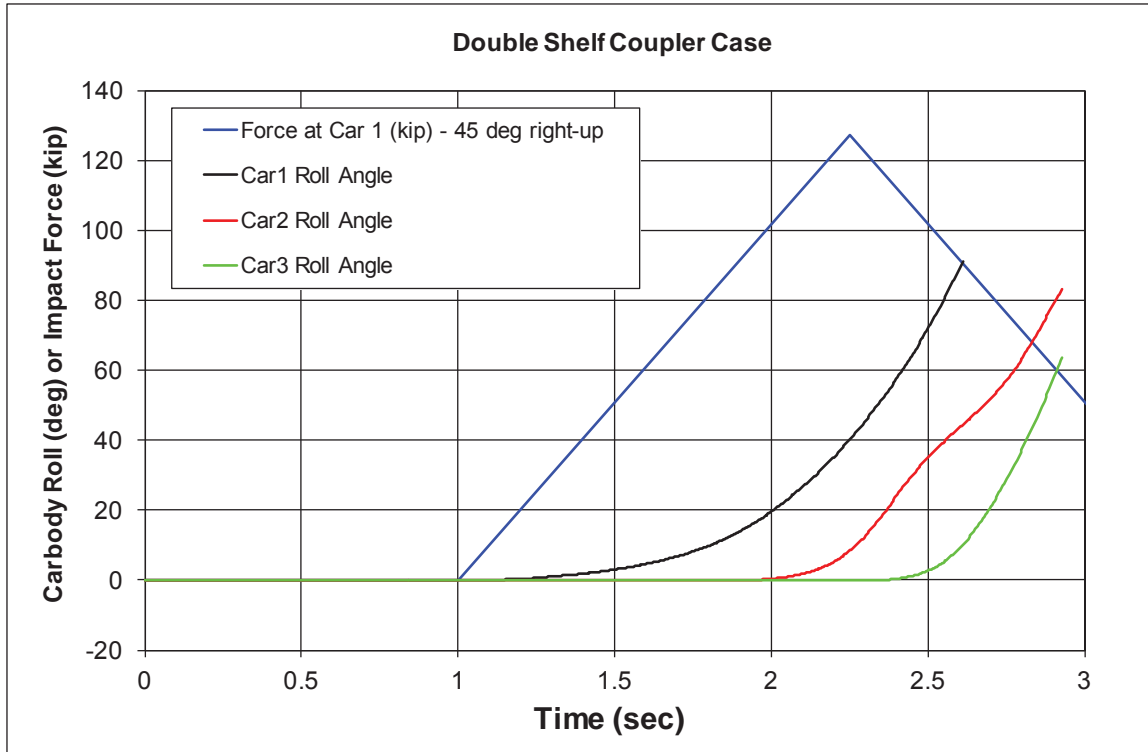
Figure 27: Car body roll angles obtained by simulation for double-shelf coupler case.

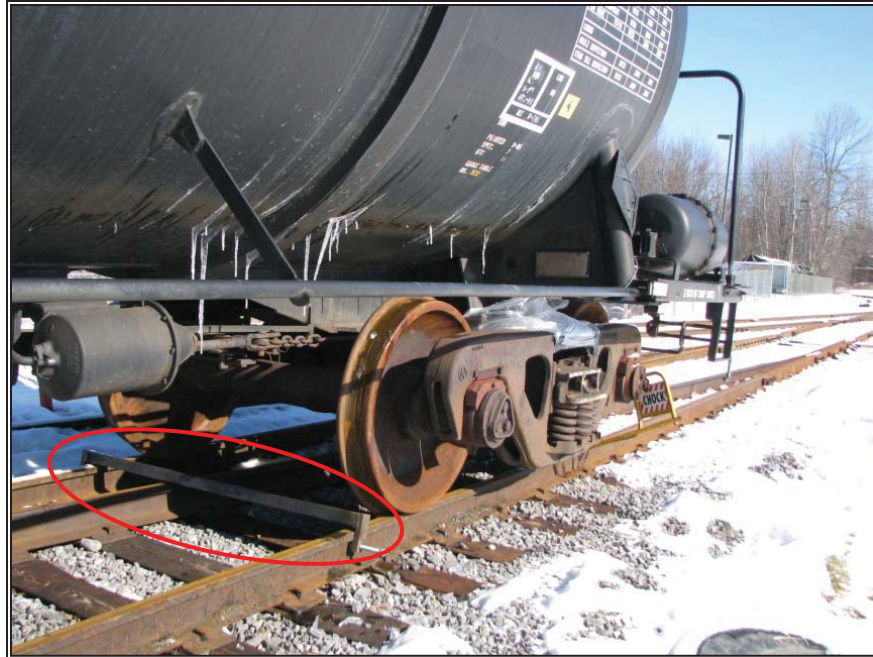
2. NRC-CSTT manufactured and installed 12 steel supports to strengthen the tracks at several locations along the test consist during testing; this is to eliminate the possibility of damaging the tracks during testing (Figure 38).

Figure 38: Track support.
