**Investigation of Multiple Tank Car Rollover Derailments – Standard Type E
Double-shelf Coupler, and Modified Rotary Coupler**

Phase 2

Prepared for
Transport Dangerous Goods Directorate
of
Transport Canada

CSTT-RVC-TR-216

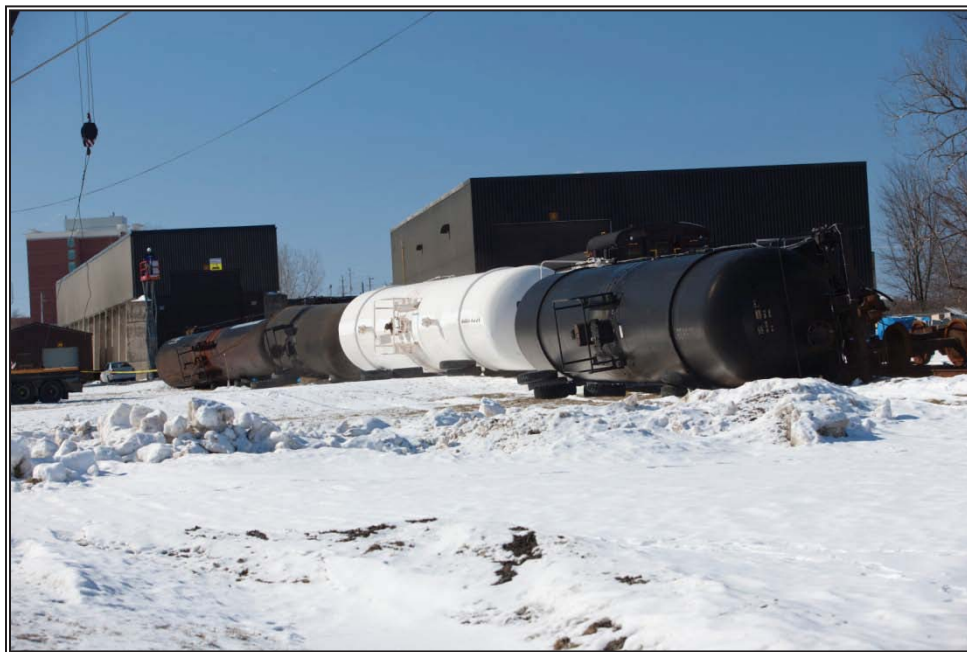
3. NRC-CSTT placed several truck tires under each tank car to prevent damaging underground communication cables, and to minimize the damage of the tank cars (Figure 39 and Figure 40).

Figure 39: Cars landing on tires.

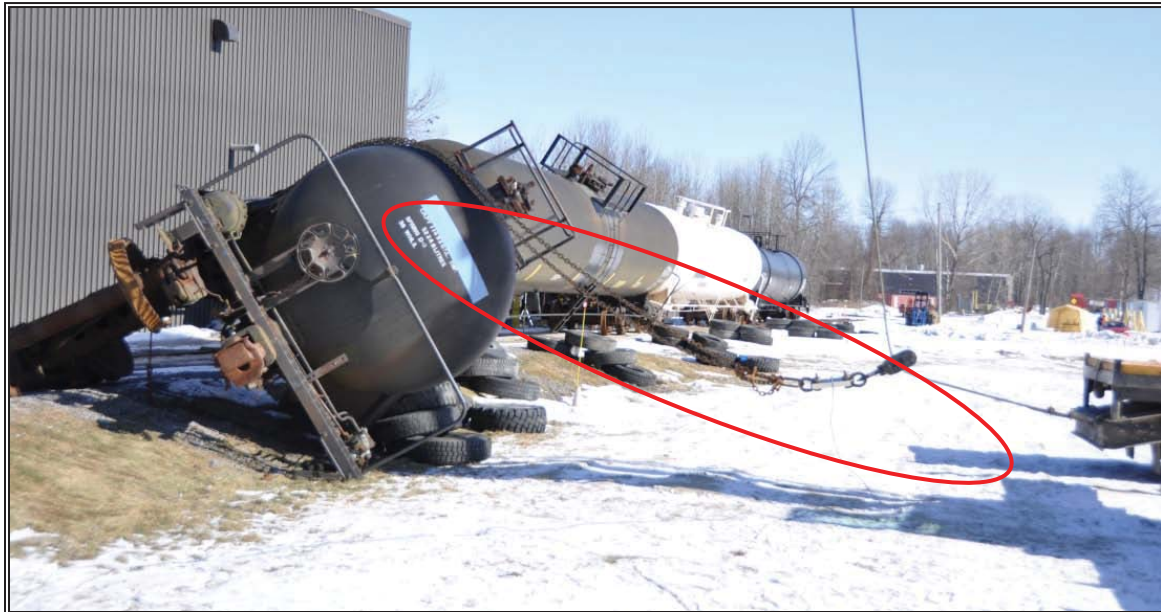
Due to a few issues related to the weight of the initiating car, and the way the lateral force was applied to the initiating car (pulling laterally at the near end of the initiating car from top), NRC-CSTT was unable to initiate the rollover domino effect on the first attempt (Figure 52).

Figure 52: Test #1, initiating car on ground, failed rollover attempt.

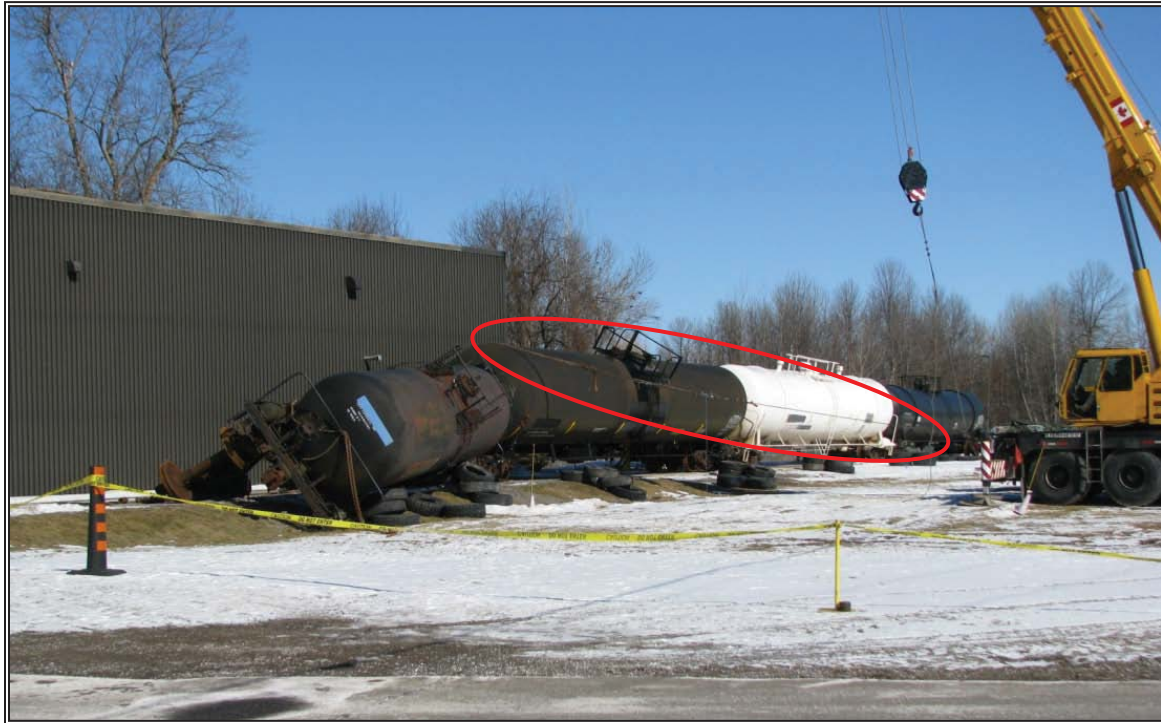
After taking the necessary actions, NRC-CSTT successfully initiated the rollover domino effect on a second attempt (pulling laterally at the near end of Car #1 from top) as shown in Figure 53. In this test the full test string (4 tank cars) rolled over as planned. As the initiating car was lightweight, the force was applied with a slight angle pointing down from the horizontal line to prevent the car from sliding sideways on top of the tracks.

Figure 53: Test #1, pulling laterally at the near end of Car #1 from top.

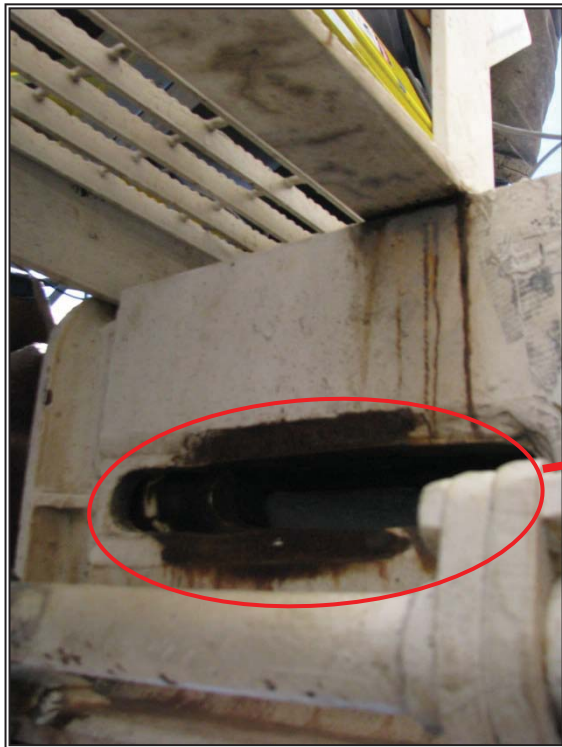
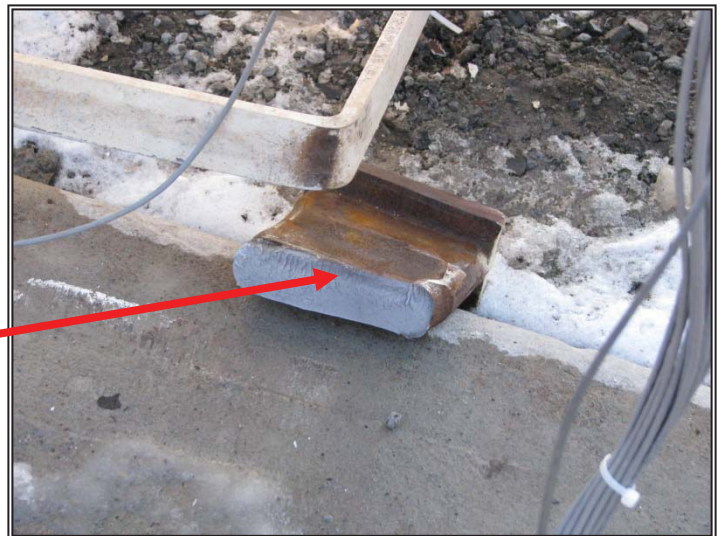
Figure 59: Test #1, broken coupler key of Car #II A-end.

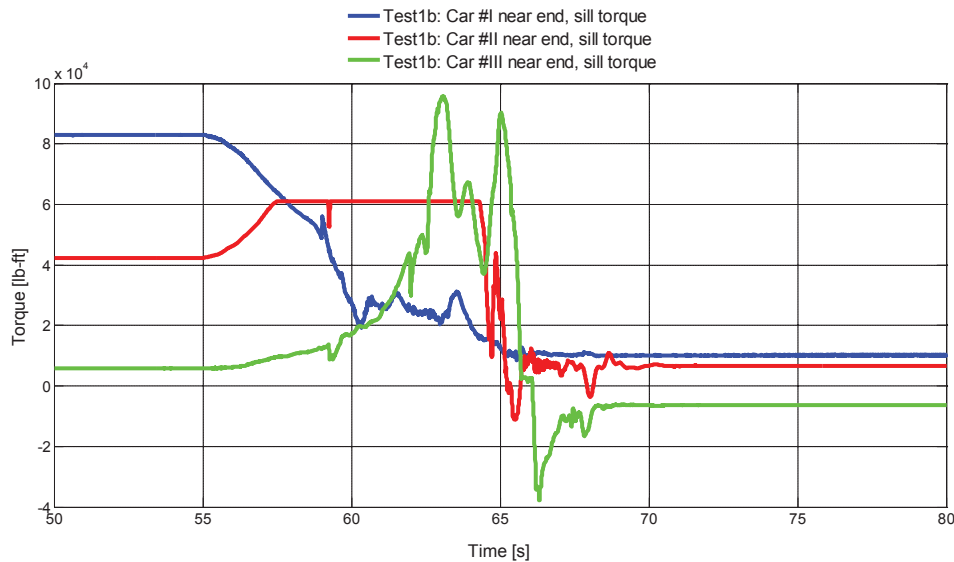
During the second roll attempt, the maximum measured torque was 95,730 lb-ft (Figure 70). Torque is expected to be maximum when the centre plates just lose contact with the centre bowls. At this point, the car is assumed to be supported vertically through contact at the side bearings, is held in this position by the torque applied via the coupler shank, and the centre of gravity of the car has only shifted laterally off-centre by a small distance (on the order of 2.4 in. as calculated in the energy analysis described in Section 3.2.2. The distance between the longitudinal centre lines of the truck's centre bowl and its side bearing is 25 inch. The moment required to hold the car in this position is therefore the product of 51,200 lb² and (25 – 2.4 in)/12 in/ft or 96,427 lb-ft; this is very close to the measured value of 95,730 lb-ft.

Figure 70: Test #1 second roll attempt, torques on near-end car sills.

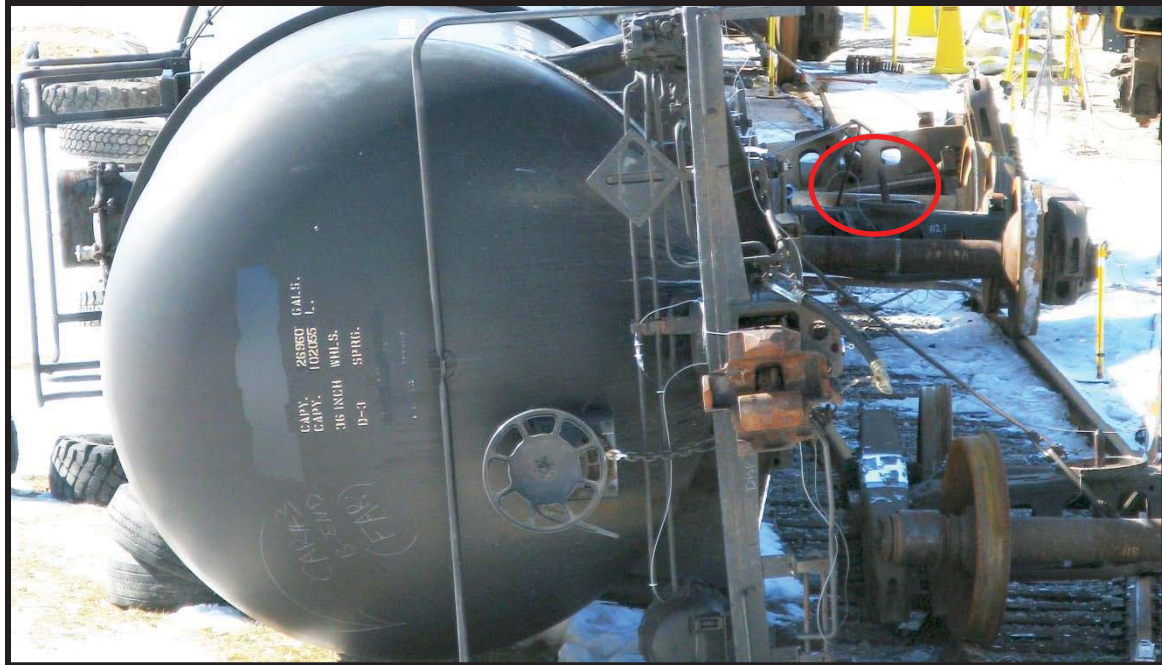
Therefore, the centre plate at the near end of Car #III was released from its truck's centre pin through a combination of car body roll and vertical displacement.

Figure 72: Test #1 second roll attempt, centre pin in Car #111 near truck.

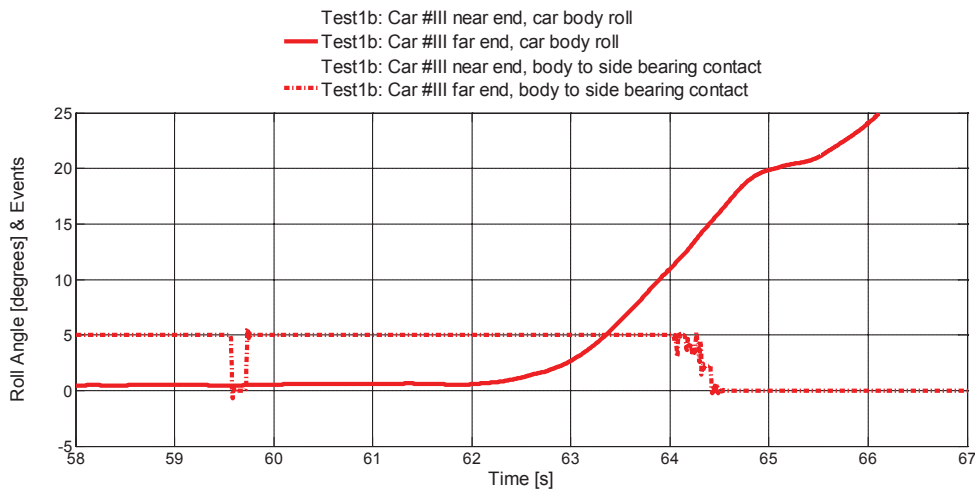
The eighth expectation was that the car body would roll about the side bearing on the far end truck, possibly jamming the centre pin between the truck and car body. The result would be that the truck would roll with the body. The far end car body roll angle and side bearing contact event for Car #III have been plotted for the second roll attempt in Figure 74. Although Car #III was not equipped with constant-contact side bearings, the side bearing gap at the far-end truck on the rolled side was closed up at the start of the second roll attempt. This side bearing remained in contact until 64.0 seconds, at which point the signal became noisy. Contact was lost permanently at 64.4 seconds. The car body began to roll at 62 seconds, and rolled 15 degrees from its starting position before side bearing contact was lost. The truck was also rolling at this time although not as quickly as the car body. It reached a maximum roll angle of 2.3° at 64.8 seconds. The data for the truck bolster roll angle then quickly and smoothly drops to -90°, indicating a problem with the roll sensor. Therefore, there is very limited data available to understand the behaviour of the truck.

Figure 74: Test #1 second roll attempt, Car #III roll and side bearing contact at far end.

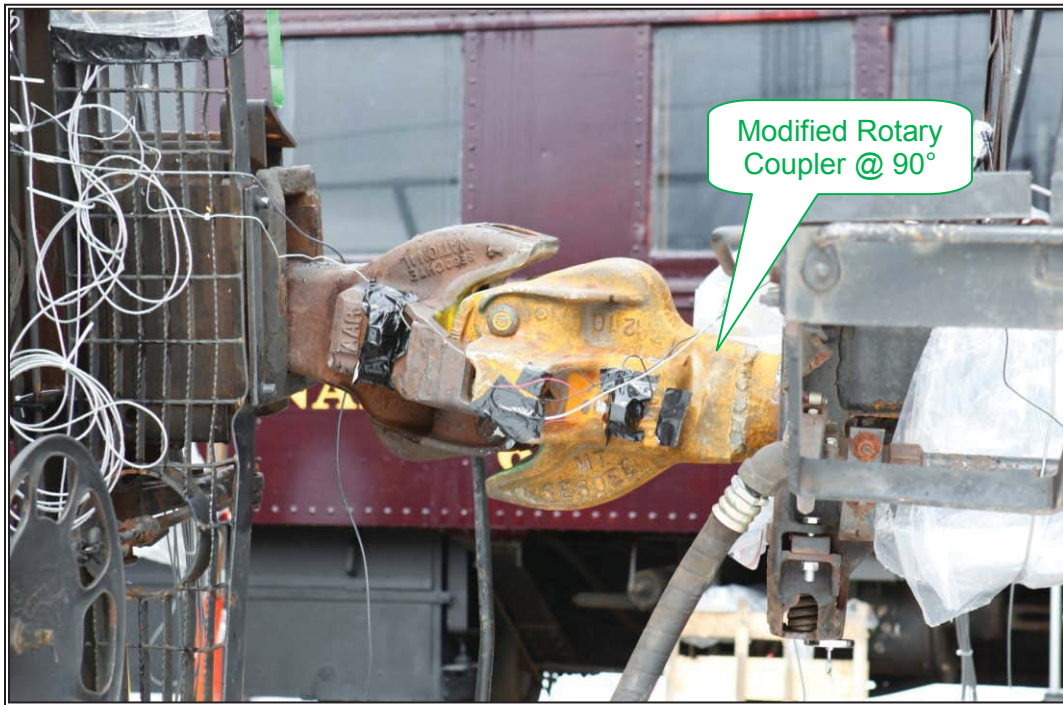
Figure 81: Test #2, rotary coupler after test.

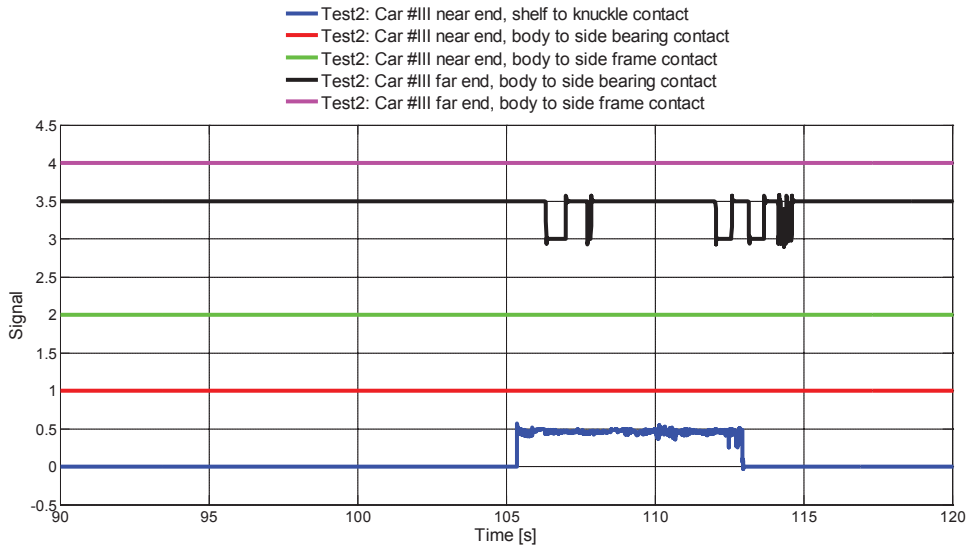
Shelf to knuckle contact did occur between the knuckle of Car #I and the top shelf of Car #III. Contact was sustained for 7.5 seconds beginning at 105.4 seconds. Contact can also clearly be seen to occur at 31 seconds into the video ("Rotary Coupler.mpg"). This is in contrast to Test #1, where shelf to knuckle contact never occurred because the knuckles bound together.

Figure 83: Test #2, events on Car #III.

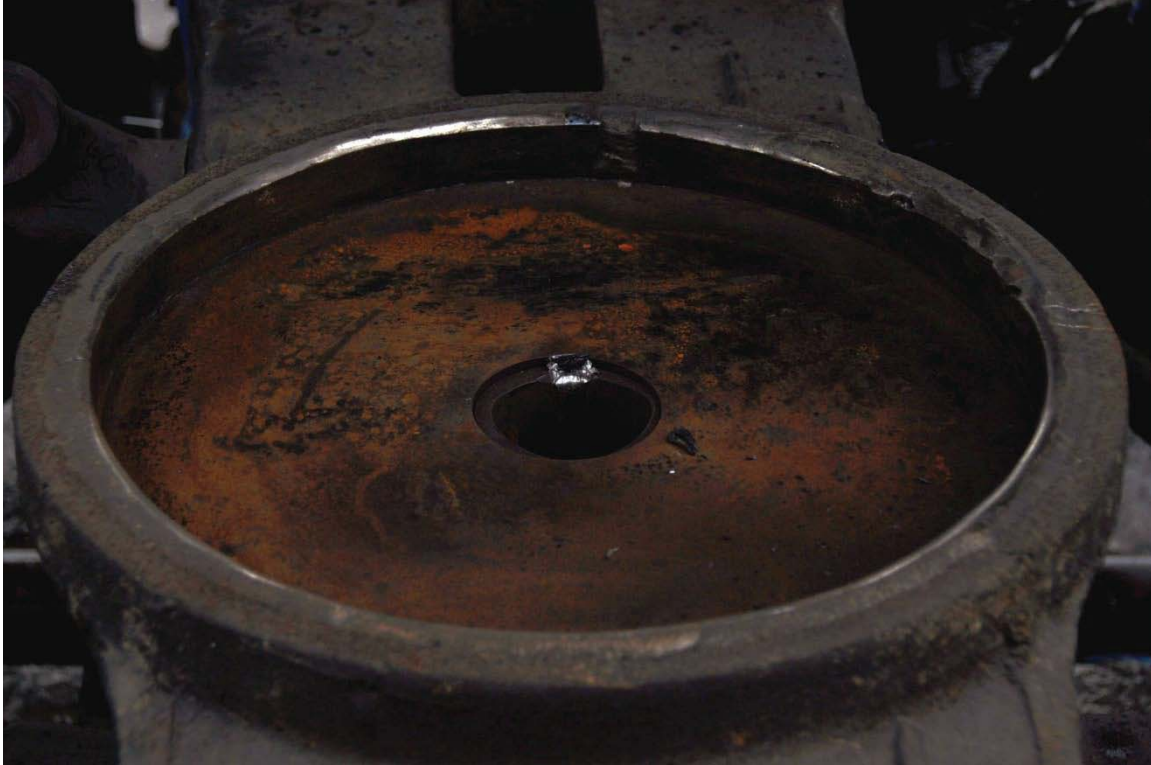
broke free of the truck, allowing the truck to drop back to the rails. The force between the centre pin and the opening for the pin in the truck's centre bowl was sufficient to crush the edge of the opening (Figure 89).

Figure 89: Damage to Car #III centre bowl on near truck.

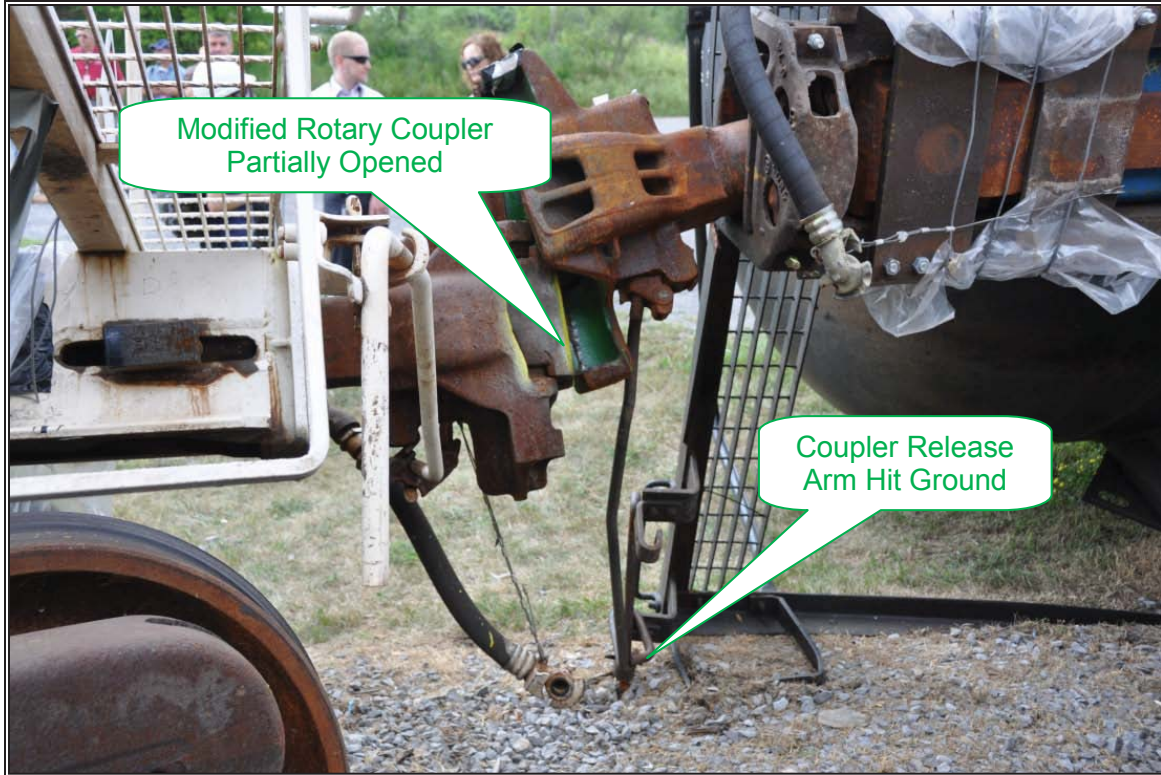
Figure 95: Test #3, rotary coupler partially opened after test, release arm hit ground.

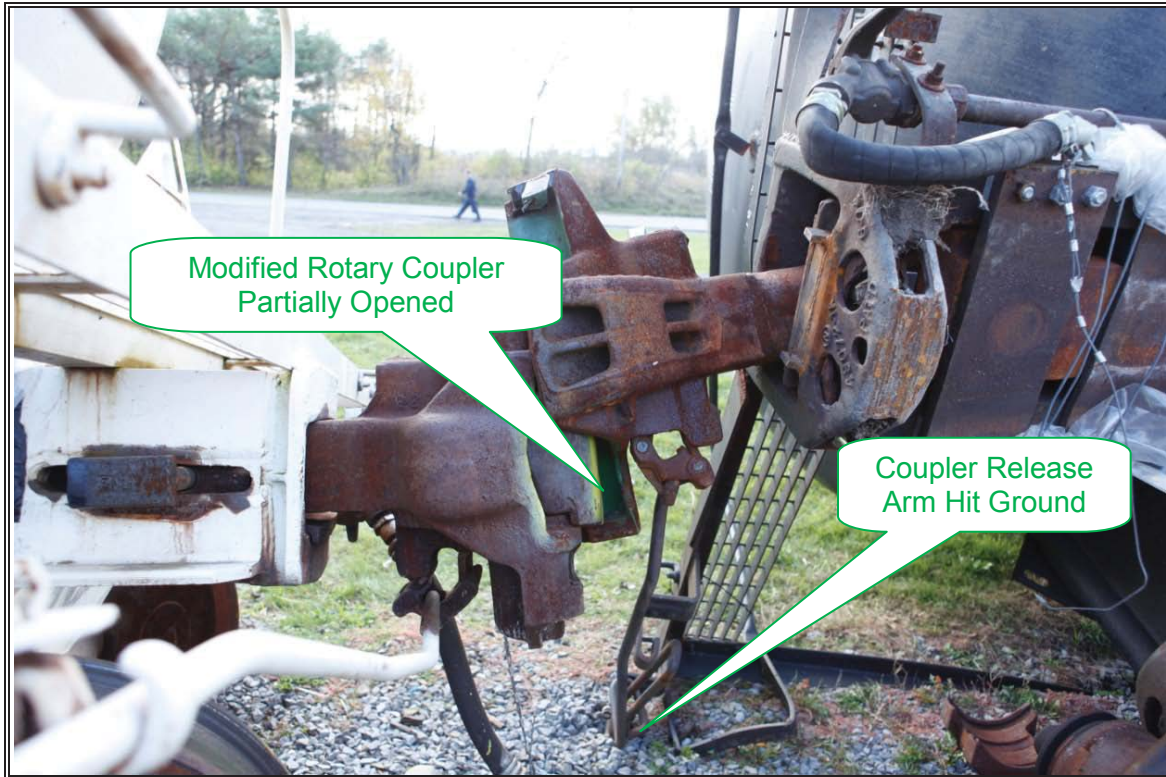
Figure 116: Test #4 modified rotary coupler partially opened after test, release arm hit ground.

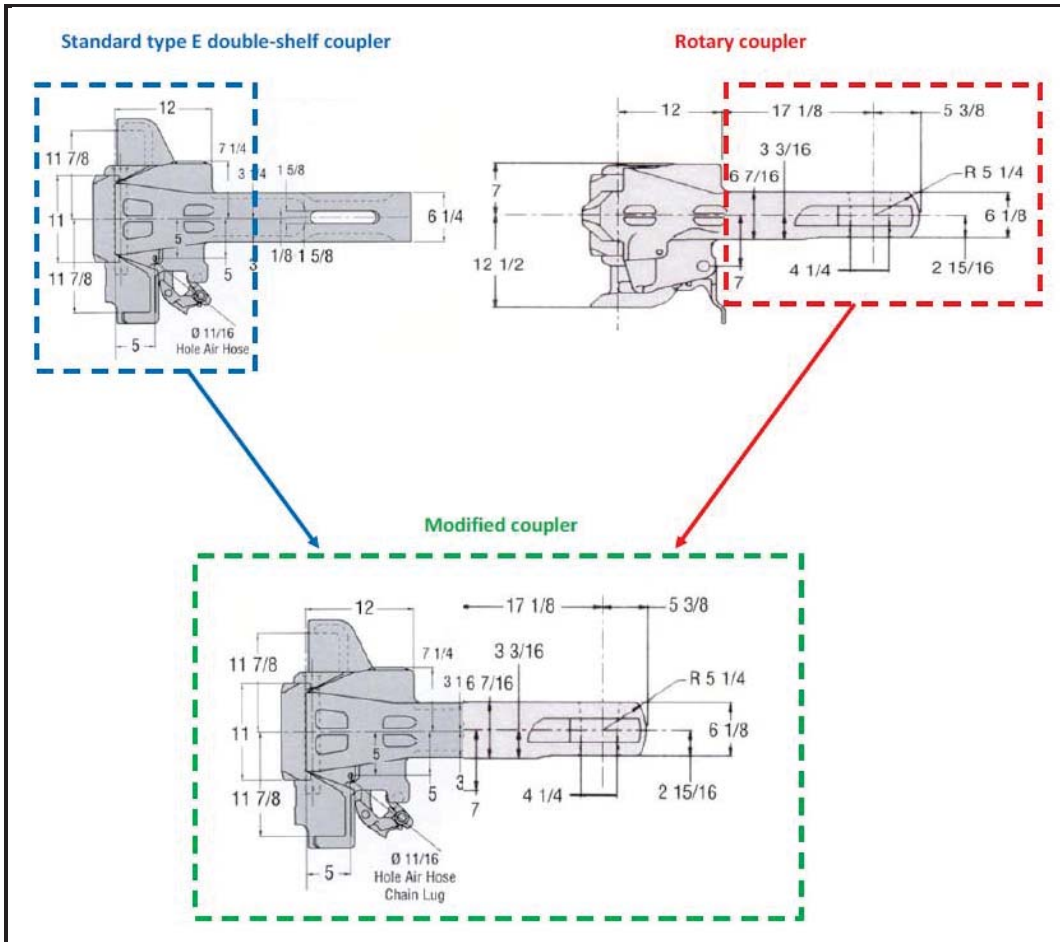
Figure 140: Rotary coupler modification schematic⁶.
