NATIONAL TRANSPORTATION SAFETY BOARD

Aerial Imagery Factual Report

A. ACCIDENT DCA17FA109

Operator: Air Cargo Carriers flight 1260
Location: Charleston, WV
Date: May 5, 2017
Time: 0651 Eastern Daylight Time (EDT)
Aircraft: Short Brothers Ltd. SD3-30 Variant 200
Registration: N334AC

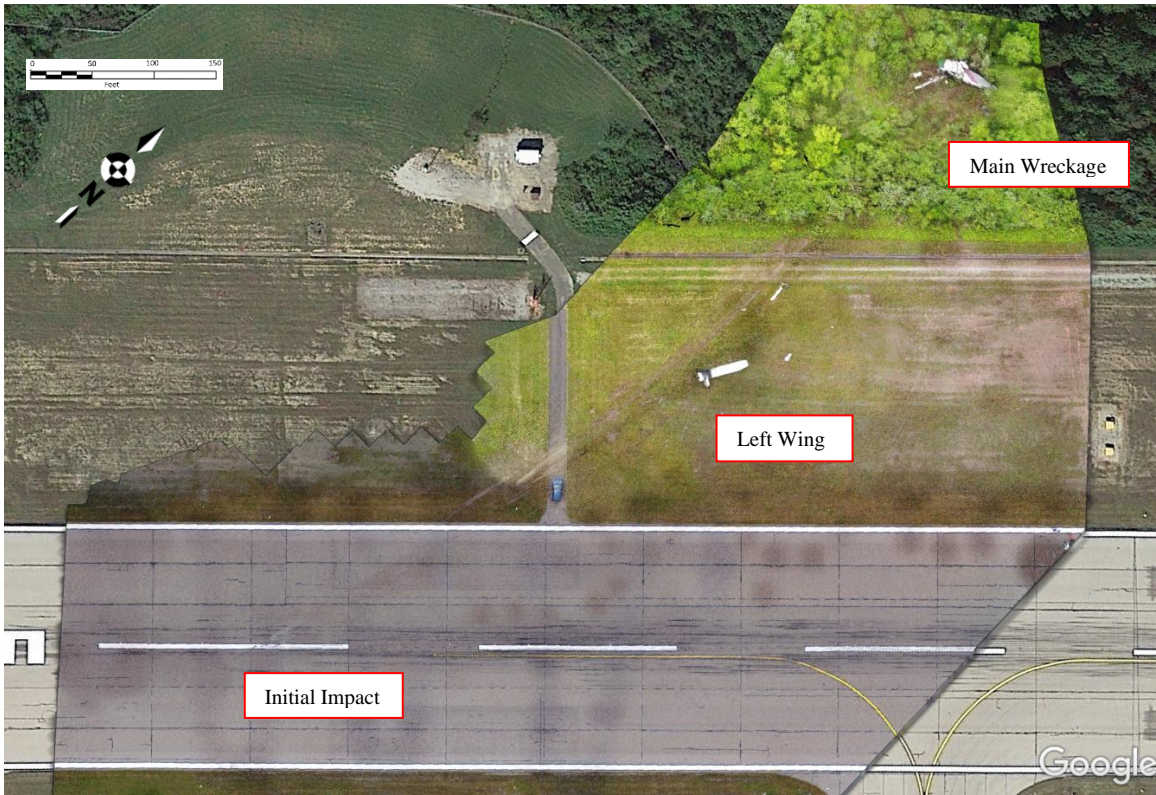
Figure 1 - Snapshot of Orthomosaic

While on scene, an initial low resolution orthomosaic map of the accident site was developed and exported in Google Earth kmz format for the use of investigators and recovery personnel. A full-resolution orthomosaic kmz was developed after the on-scene phase and is included as Attachment 1. Select snapshots of the orthomosaic and source point cloud are included below.

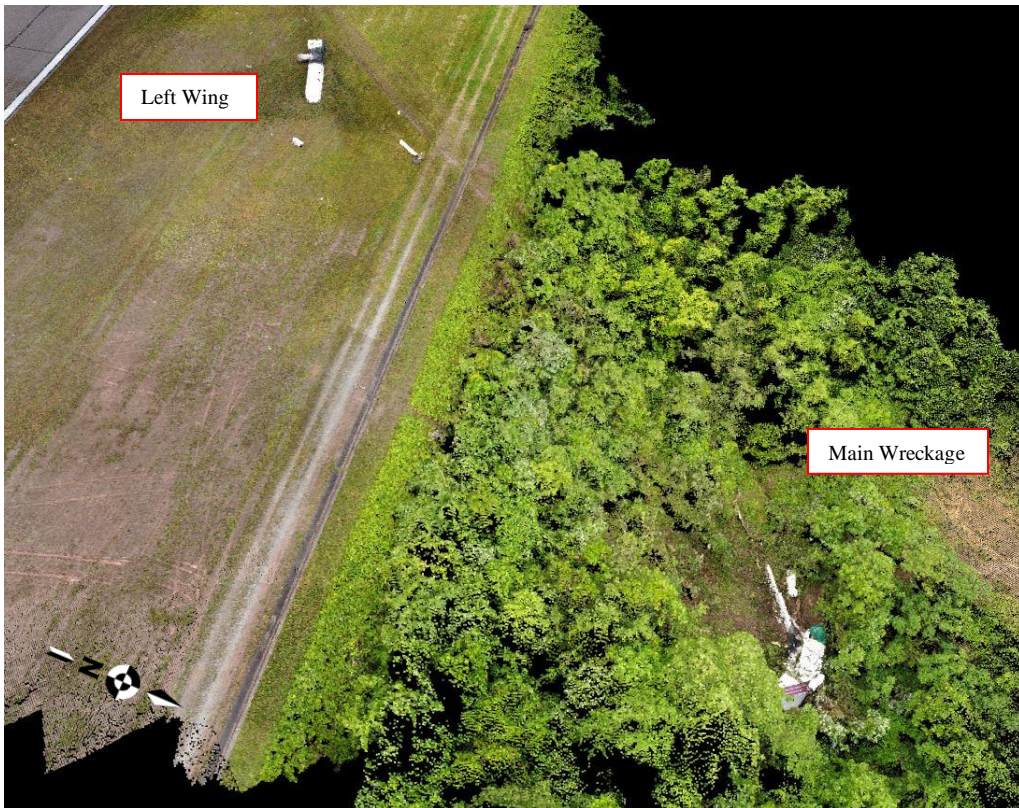
Figure 2 – Selection of Point Cloud

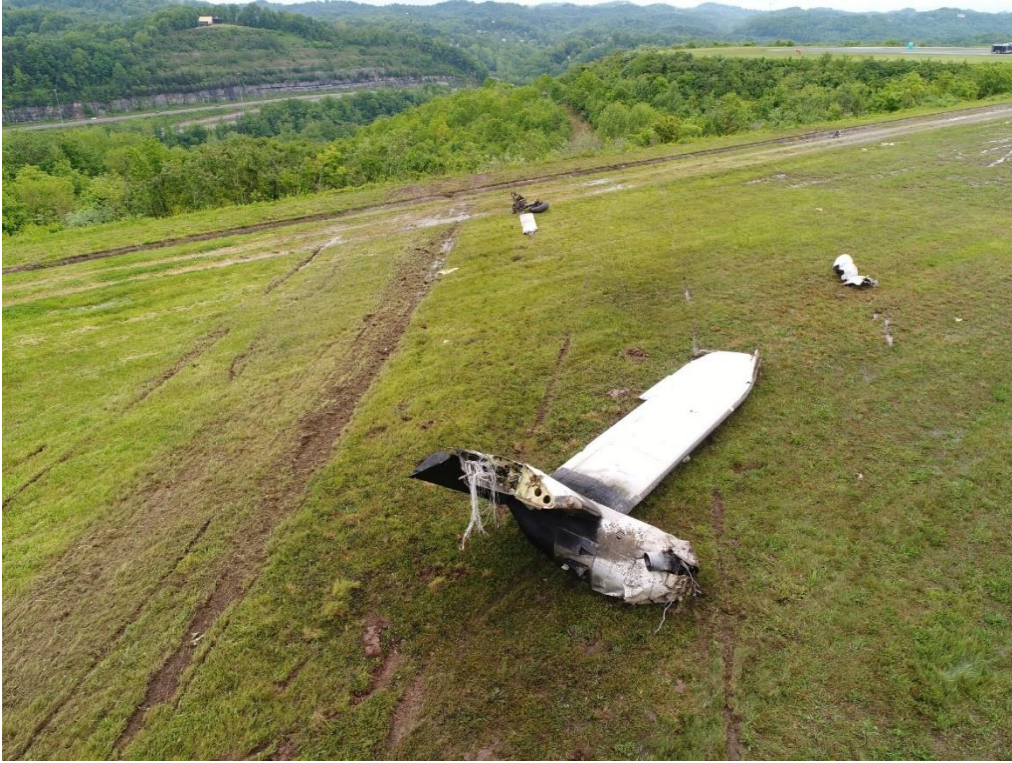
Figure 3 - Photo Left Wing and Witness Mark

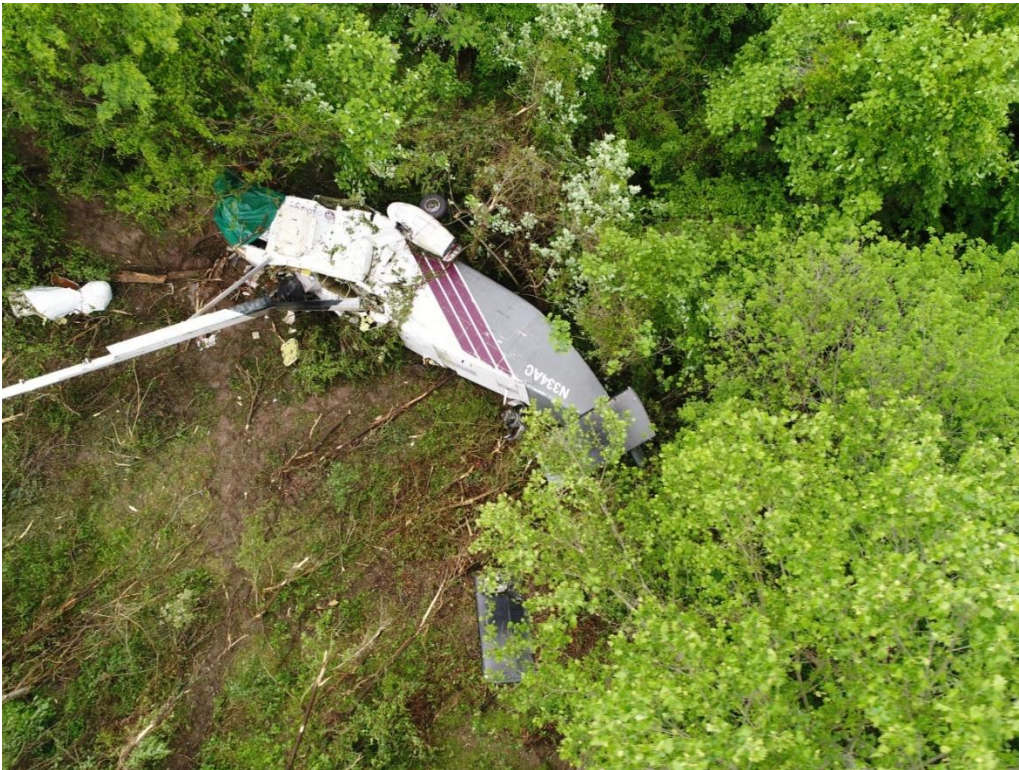
Figure 4 - Photo overhead main wreckage

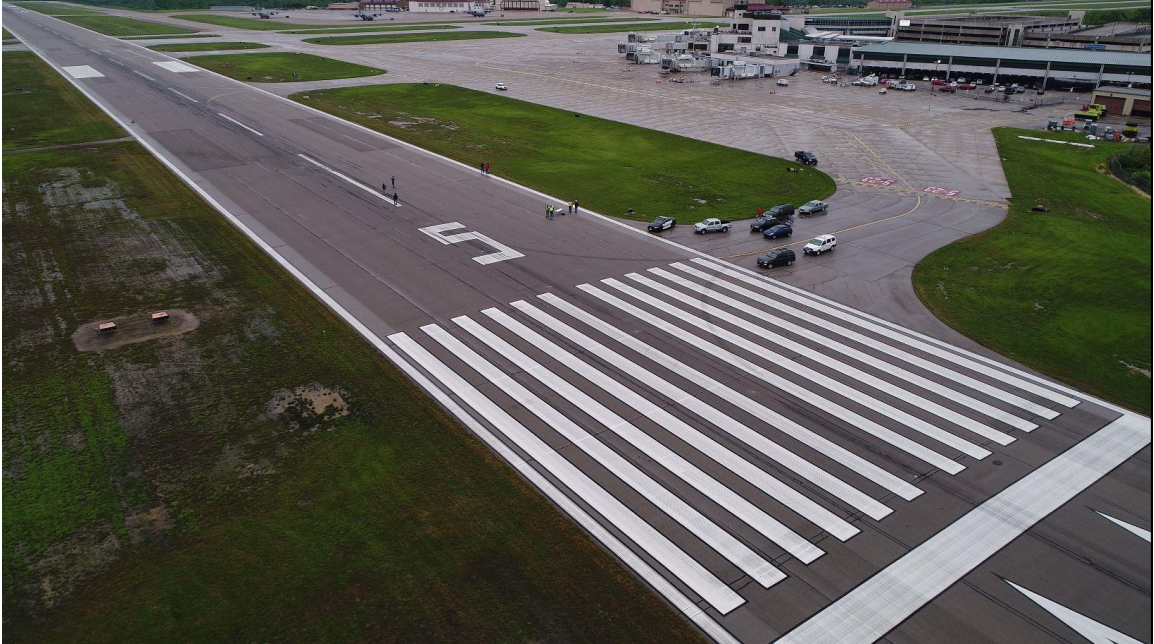
Figure 5 - View of approach end from approximate aircraft position at 150 feet agl

The drone was flown in a series of overlapping grids and oblique orbits at 50 and 100 feet agl obtaining still photos to develop a 3D model and orthomosaic. Coverage area extended from just past the painted runway 5 number, along the impact area to the final resting location of the main wreckage. Additional flights were taken to obtain video approximating the view to the initial impact point. Total flight time was less than 1 hour.
