VEHICLE FACTORS ATTACHMENT

Navistar Vehicle Recall G-05516

VEHICLE RECALL

**SUBJECT: SAFETY RECALL (U.S., EXPORT)
SPECIALTY MANUFACTURING CO. 5 Series Electric
Stop Arms on certain 3800 chassis, and CE, FE, and
RE School Buses built between 01/07/2002 and
06/22/2005**

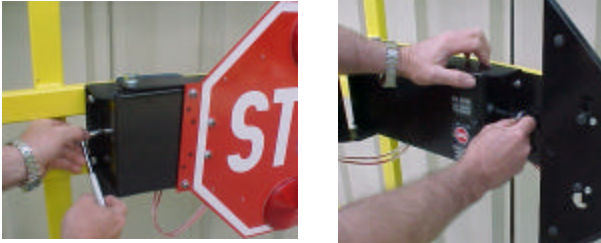
<p>1. Remove ½-20 nut at the bottom of control box w/ ¾" wrench.</p>	<p>2. Use a screwdriver (or similar tool) to tap the cam shaft back up inside the unit.</p>	<p>3. Using a utility knife, cut the silicone seal on both ends of the stop arm cover.</p>

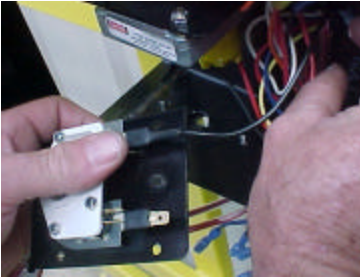
<p>7. Remove (2) 1 1/32" nuts holding micro switch assembly in position. DO NOT unscrew the four 1/4" nuts holding the micro-switches to the micro-switch assembly plate. The entire assembly will come out as one unit.</p>	<p>8. Carefully cut the wire ties.</p>

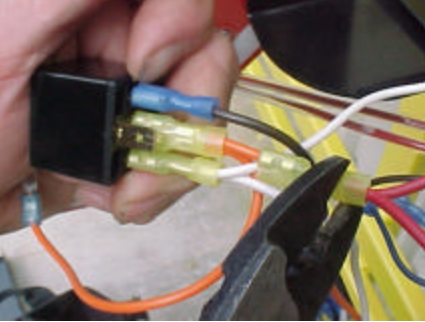
<p>9. Using a flat blade screwdriver, carefully pry the micro switch plate upwards. CAUTION-bushing may break and snap ring will make a loud noise when released. Discard the snap ring and bushing.</p>	<p>10. Remove all wires from micro switch assembly. Black heater wire remains with assy.</p>

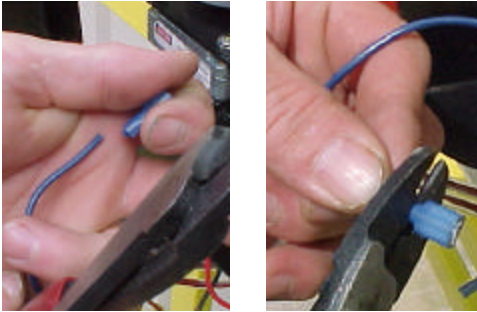
<p>11. Remove the 11/32" nuts on both relays.</p>	<p>12. Disconnect wires from the relays. Discard relays, micro switch assembly & jumper wires – double orange, double black/green, brown & yellow.</p>

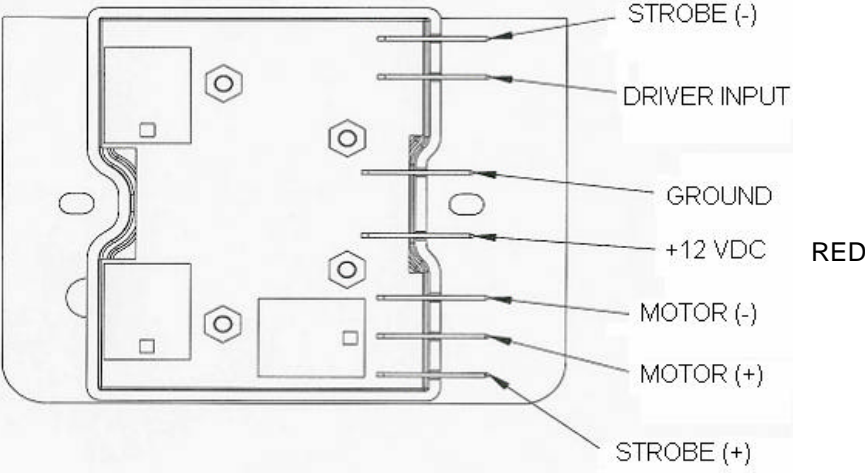
<p>13. Cut smaller (shorter) wire from the double red & double white pigtail sets.</p>	<p>14. Cut Fast-On end off of BLUE wire, strip end approximately 1/4" & crimp new 1/4" fast-on blade, 004024, included with kit.</p>

<p>15. Connect leads to new 005150 module as shown on schematic above. Leave two center tabs, +12VDC & GROUND, disconnected until module is fastened down in next steps. The yellow wire is no longer needed and can be tied back.</p>

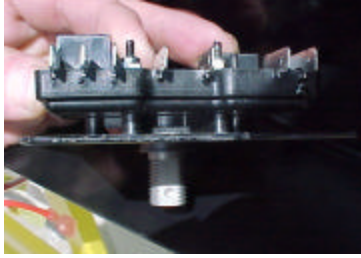
16. Install new 005150 module into position as shown above. Timing mark **MUST** be facing toward the direction of the blade. (Ex. If blade is fully extended, timing mark must be turned to front of unit). Push module shaft through lower hinge hole. Fasten with (2) 11/32" hex nuts from original micro switch assy.

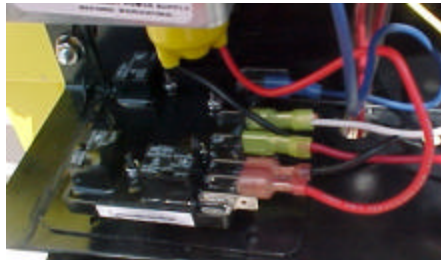
17. Connect +12VDC & GROUND per schematic.

18. Secure with 3/4" nut.

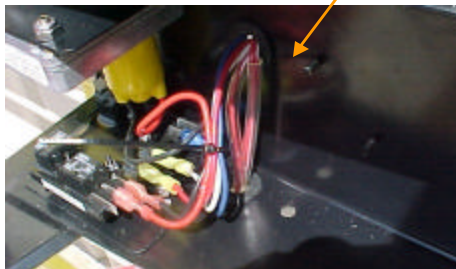
Drain Hole

19. Tie wires. If unit does not have drain hole, add one.

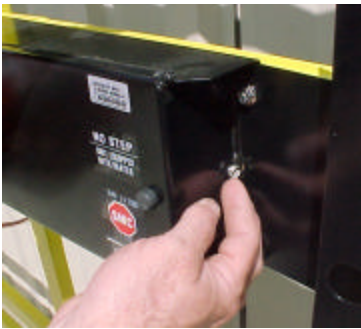
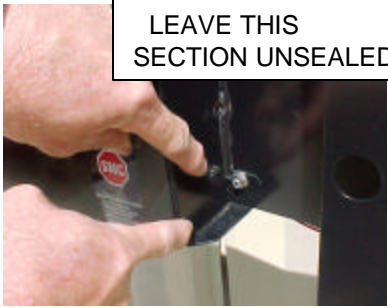
<p>20. Replace cover. Secure with (2) screws. Reseal both ends of the crossing arm cover with RTV. IMPORTANT! – DO NOT seal approximately 1” of the lower right side of the box. This provides an additional drainage location.</p>	<p>21. Test the stop arm assembly to make sure it functions correctly.</p>
<p align="center">If further help is needed, contact the engineering department at Specialty Manufacturing</p>
