**NATIONAL TRANSPORTATION SAFETY BOARD
OFFICE OF HIGHWAY SAFETY
WASHINGTON, D.C.**

**VEHICLE FACTORS GROUP CHAIRMAN'S
FACTUAL REPORT**

Vehicle: 2017 Volvo XC90, being operated by Uber ATG in autonomous mode

NTSB #: **HWY18MH010**

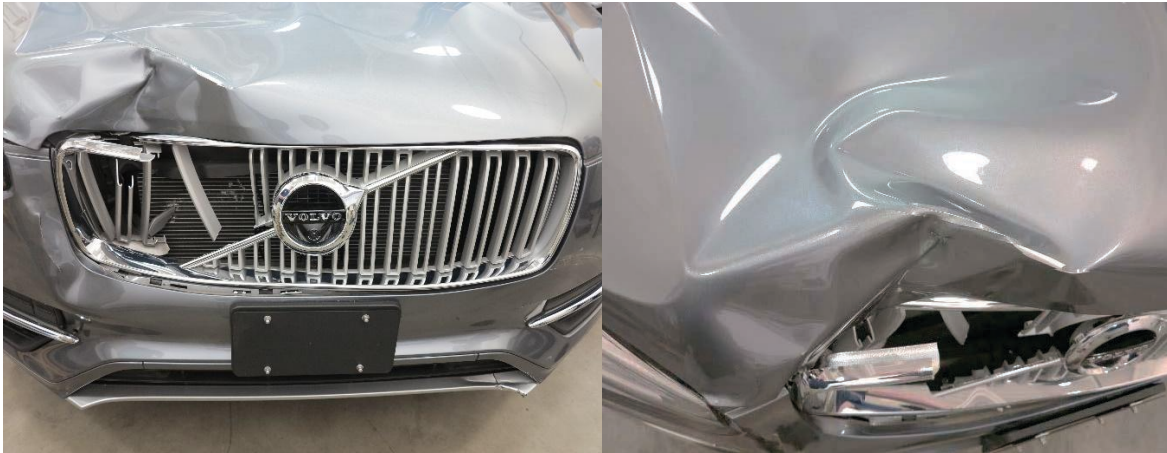
The vehicle sustained collision damage, to the front end, not affecting any major mechanical systems, as shown in **Figure 1**. Damage specific to any of the vehicle components will be described in greater detail in the -applicable sections of this report.

Contact damage to the front of the vehicle was concentrated in an area slightly offset from the vehicle’s centerline toward the passenger side. Contact damage was noted on the vehicle’s front bumper, grille, and hood. The most significant contact damage was concentrated on the hood.

Figure 1 - Front end damage to the 2017 Volvo XC90

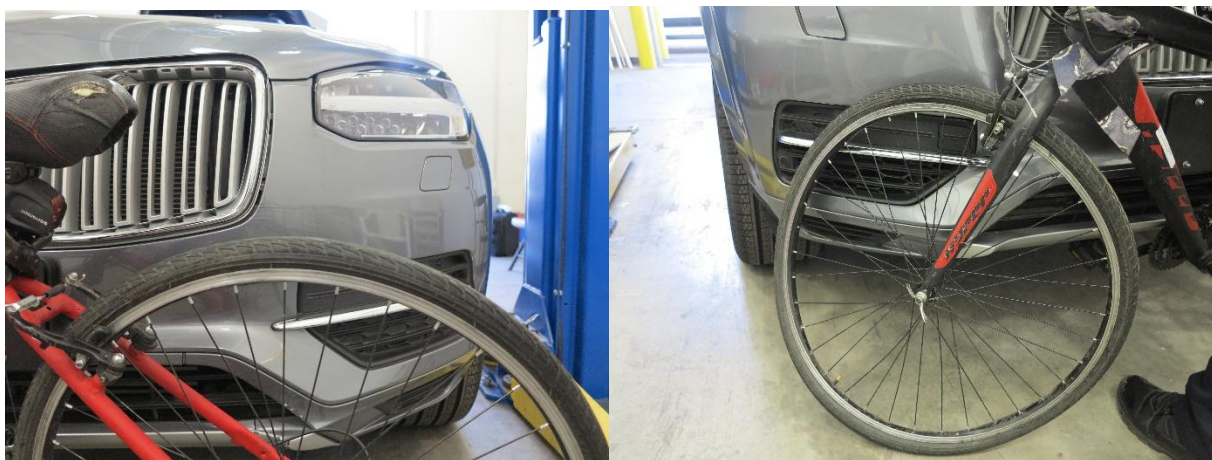
The rear bicycle tire presented a transfer print, visible on the left edge of the front bumper cover and a front tire print to the right edge of the front bumper cover. Gouging and scrape marks were visible to the lower left corner of the front spoiler that was caused by the rear sprocket assembly on the bicycle. As shown in **Figure 2**.

Figure 2– Rear and front bicycle tire transfer print on front bumper cover

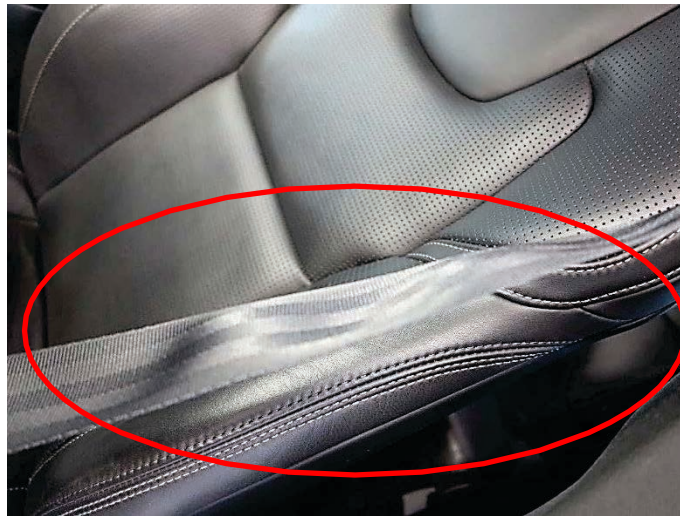
The driver's seat was not damaged. The seat was fully adjustable, ergonomically designed, with ventilation. The driver's seatbelt was found unbuckled and attached at its anchor points, drivers' seatbelt webbing shows cupping with abrasions and load mark, indicating that it was worn at the time of impact, as shown in **Figure 3**.

Figure 3 – Drivers seatbelt of the 2017 Volvo XC90 showing cupping, circled in red

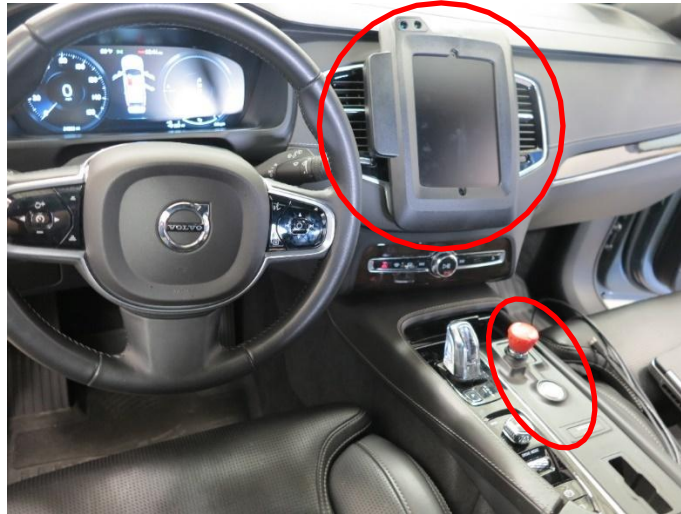
Additional equipment added by ATG to the vehicle operators' compartment are an LCD tablet (Front Seat Control App) mounted above the center console that is hinged for access to factory installed information center. Located on the center console to the right of the shift lever, a red knob has been added to for the vehicle operator (VO) to enable/disable the self-driving mode and a silver momentary push-button to engage the self-driving mode, as shown in **Figure 4**. The VO can also take manual control of the vehicle with inputs to steering, brake or accelerator.

Figure 4 – Additional equipment added to the driver's compartment by Uber ATG, circled in red

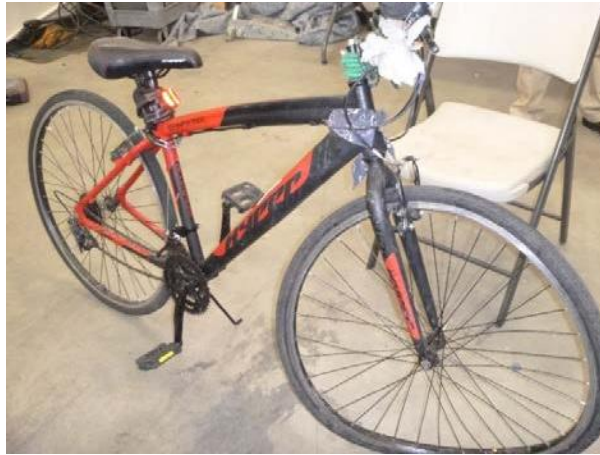
The bicycle had damage to the front rim, and front fork was not aligned with handle bars as shown in **Figure 5**. The bicycle was missing the side reflectors from the spokes on the front and rear wheels as shown in **Figure 6**. The rear reflector on seat post was turned facing forward. White

Figure 5 - Hyper 700c SpinFit Hybrid Bike

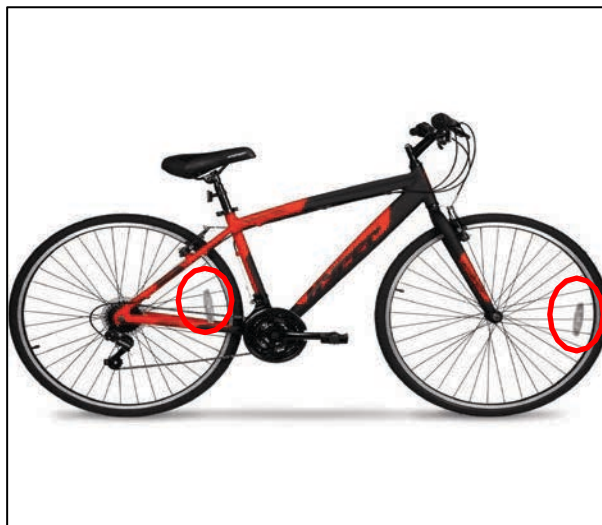
reflector mounted on stem was correctly facing forward, both pedals had front and rear facing reflectors.²²

Figure 6 – Photo of exemplar Hyper 700c SpinFit Hybrid Bike showing reflectors mounted on front and rear wheels circled in red
