## **NTSB Vehicle Photos**

**Houston, Texas**

**HWY15FH010**

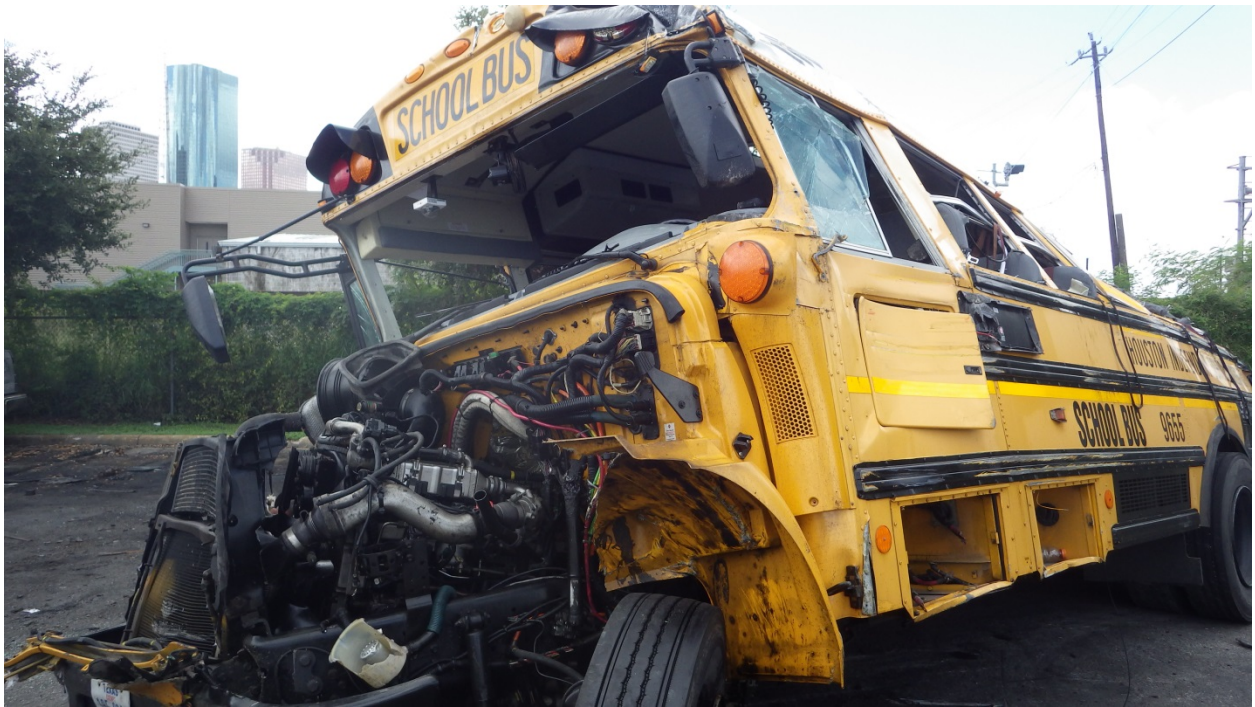
Vehicle Photo 1 – Overall view of the damage to the left side of the HISD school bus from the left front corner. Damage to the engine compartment, windshield and side windows can be seen.

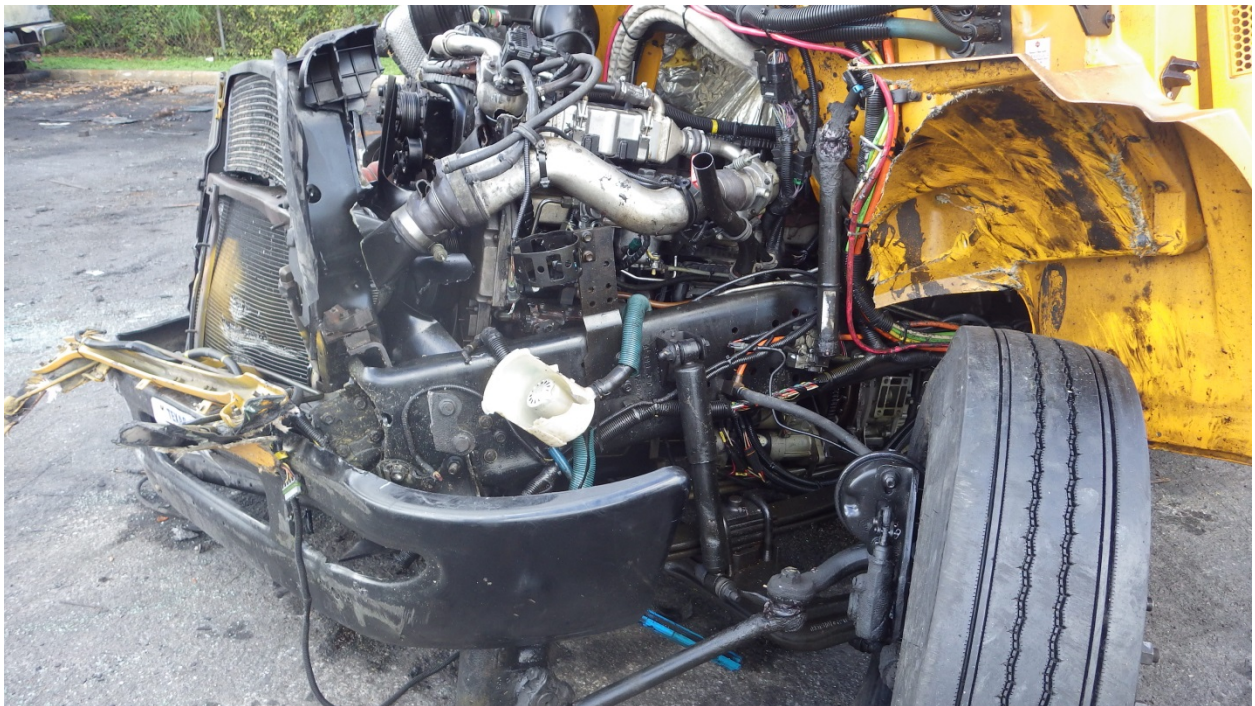
Vehicle Photo 2 – View showing damaged HISD school bus steering components.

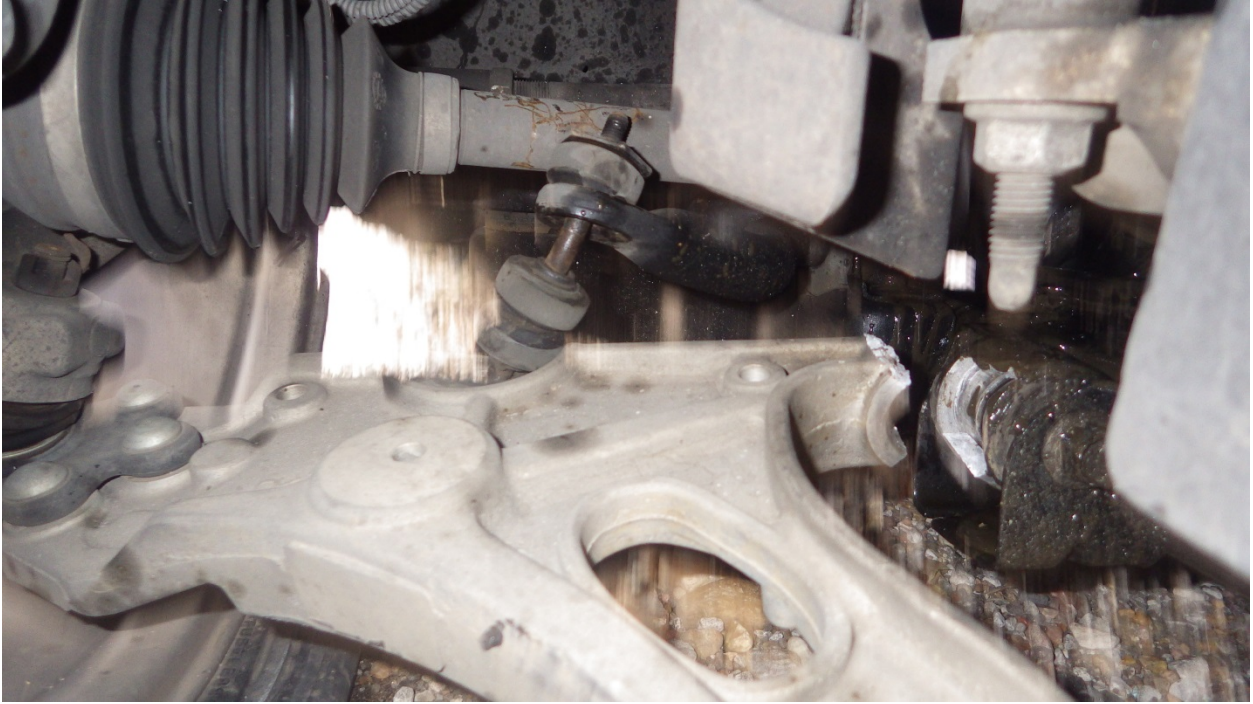
Vehicle Photo 3 – View showing the fractured Buick LeSabre passenger side control arm.
