NATIONAL TRANSPORTATION SAFETY BOARD

17 - Video Study Report

**Specialist's Study Report
by Bill Tuccio**

Location: Scottsdale, Arizona
Date: July 9, 2012
Aircraft: Mooney M20L
Registration: N137MP
Operator: Private
NTSB Number: WPR12FA297

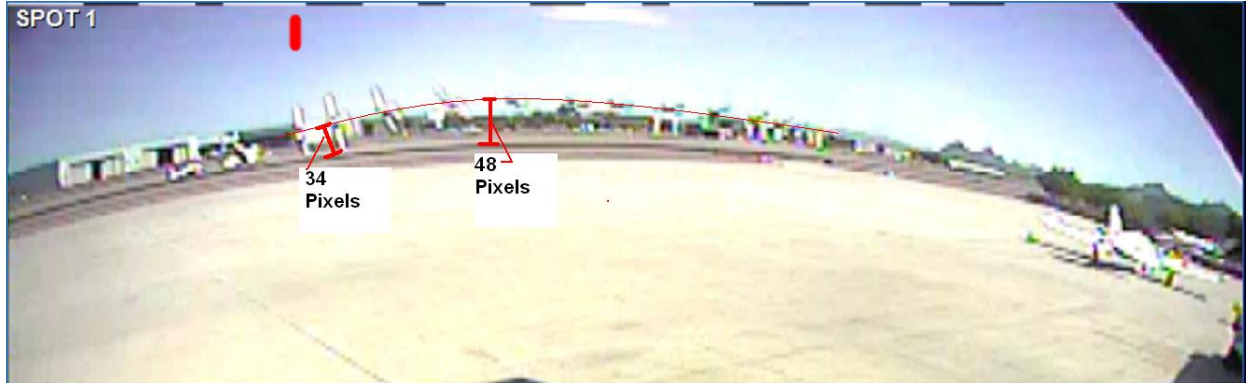
flight path. The known wingspan of the aircraft supplied by the investigator-in-charge (IIC) of 36 feet was combined with a photographic pixel measurement of the aircraft wingspan of 34 pixels from the time-lapse representation of the video. The flight path and pixel measurements are shown in figure 1.

Figure 1. FBO security video time-lapse representation with annotations of curved path and vertical measures.

The location of maximum height is shown in figure 1. This location was measured to be 48 pixels. Applying the relationship of equation 2,

$$48 \text{ pixels} / (1.89 \text{ pixels/feet}) = 25.4 \text{ feet}$$

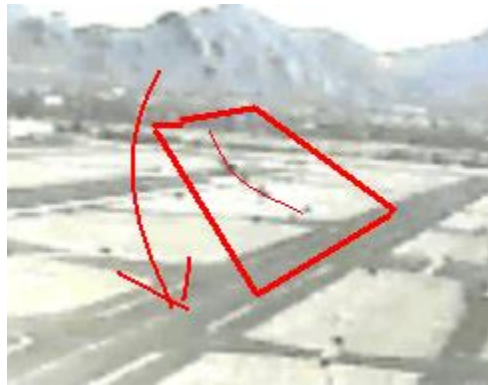
- The three dimensional nature of the flight path, which in fact curves towards the camera as shown in annotated figure 2. The annotated square in figure 2 highlights the aircraft location; the curved arrow line the directionality of the flight path; and the line within the rectangle the path of the aircraft;
- The uncertainties of barrel distortion and flight path make the flight path representation of figure 1 uncertain; further, the location of maximum height derived from the uncertain flight path may not be the proper location.

Figure 2. Tower video time-lapse representation annotated with approximate flight path.
