NATIONAL TRANSPORTATION SAFETY BOARD

Video Factual Report

DCA07MA003

Location: Manhattan, NY
Date: October 11, 2006
Time: 14:42 Eastern Daylight Time
Aircraft: Cirrus Design SR30, N929CD

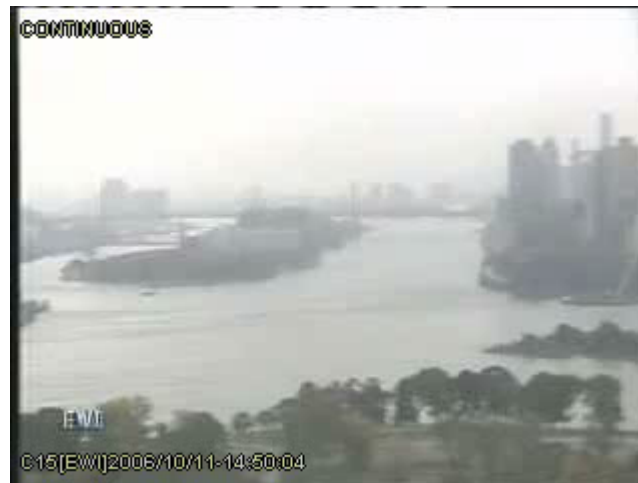
Figure 2 - First Image

The camera view looks down the west channel of the East River, along Roosevelt Island. The Queensboro Bridge can be seen in the distance on the horizon. Figure 2 is the first image of the recording.

According to the time of day clock seen in the lower left corner of the view, this recording began at 14:50:04 and ended at 14:51:43 on October 11, 2006.

The airplane is not visible during any portion of this recording. This is likely due to the relatively small size of the airplane, given the recorded image size and field of view. It is also possible that the recording's compression method did not maintain sufficient detail to discern the airplane. According to the USCG, this is the best copy of the recording available and no other formats exist.

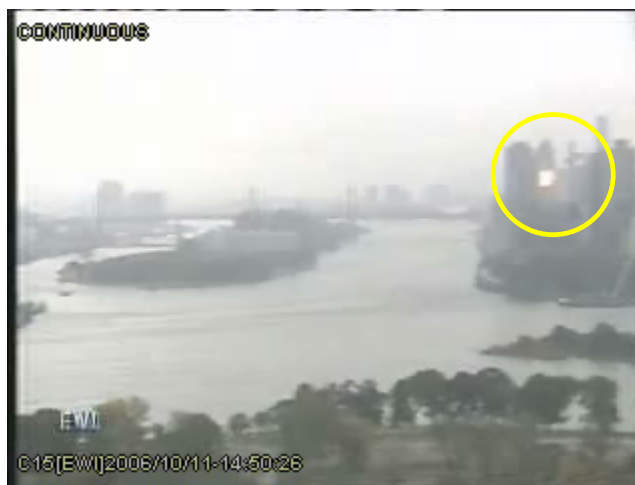
Figure 3 - Explosion

At an indicated time of 14:50:26, an explosion/fire can be seen near the buildings on the right side of the image.
