NATIONAL TRANSPORTATION SAFETY BOARD

Video Study

**NTSB Case Number:
HWY15MH009**

Location: Chattanooga, Tennessee
Date: June 25, 2015
Time: 7:10 PM
Vehicle: 2011 Peterbilt truck tractor and 2005 Great Dane refrigerated semitrailer combination

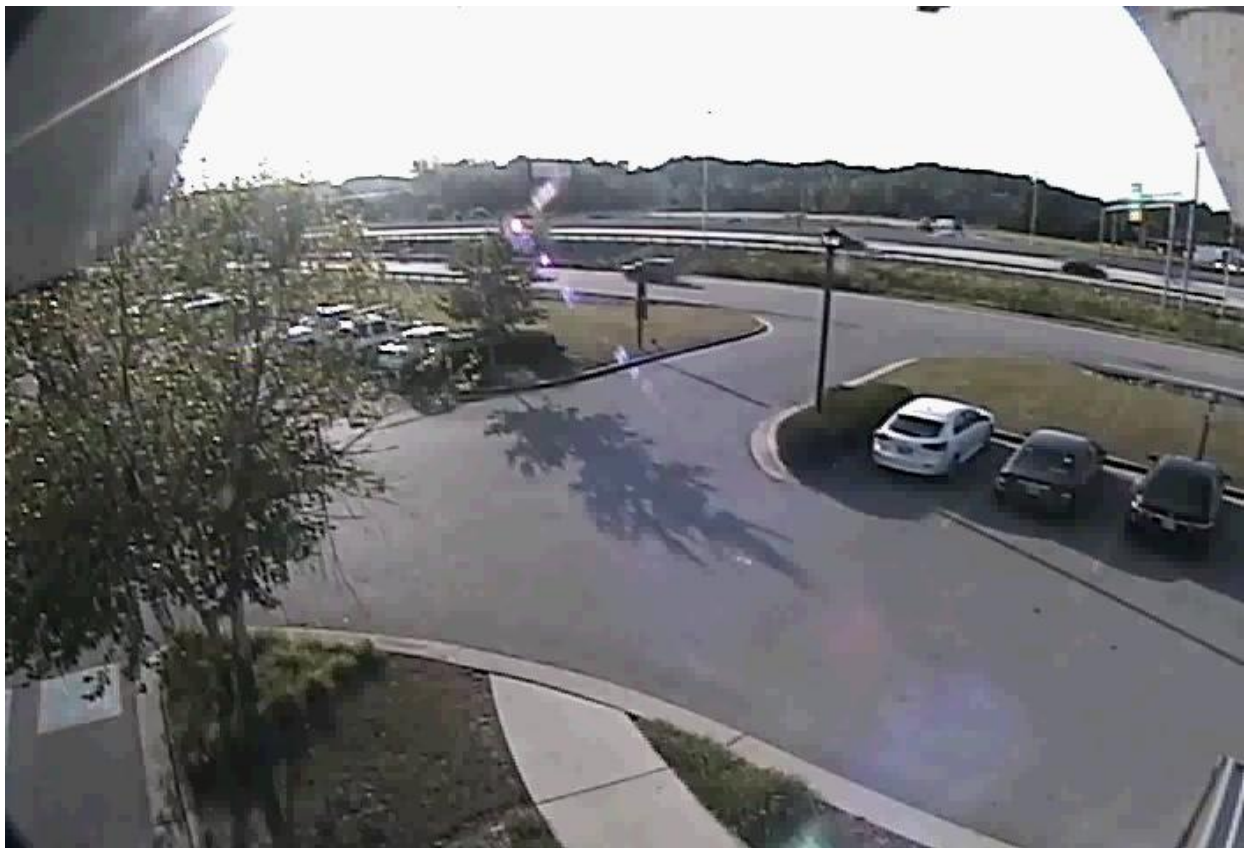
Figure 1 shows a frame from the Camera 1 video before removal of barrel distortion. The I-75 segment in which vehicles can be seen is approximately 300 feet long. The accident truck was moving from left to right. Nine evenly-spaced locations of the accident truck were estimated using video frames in which the truck was at markers superimposed on the frames with the camera model. The markers were spaced by 10

Figure 1. Frame from Camera 1 Video (not showing the accident truck)

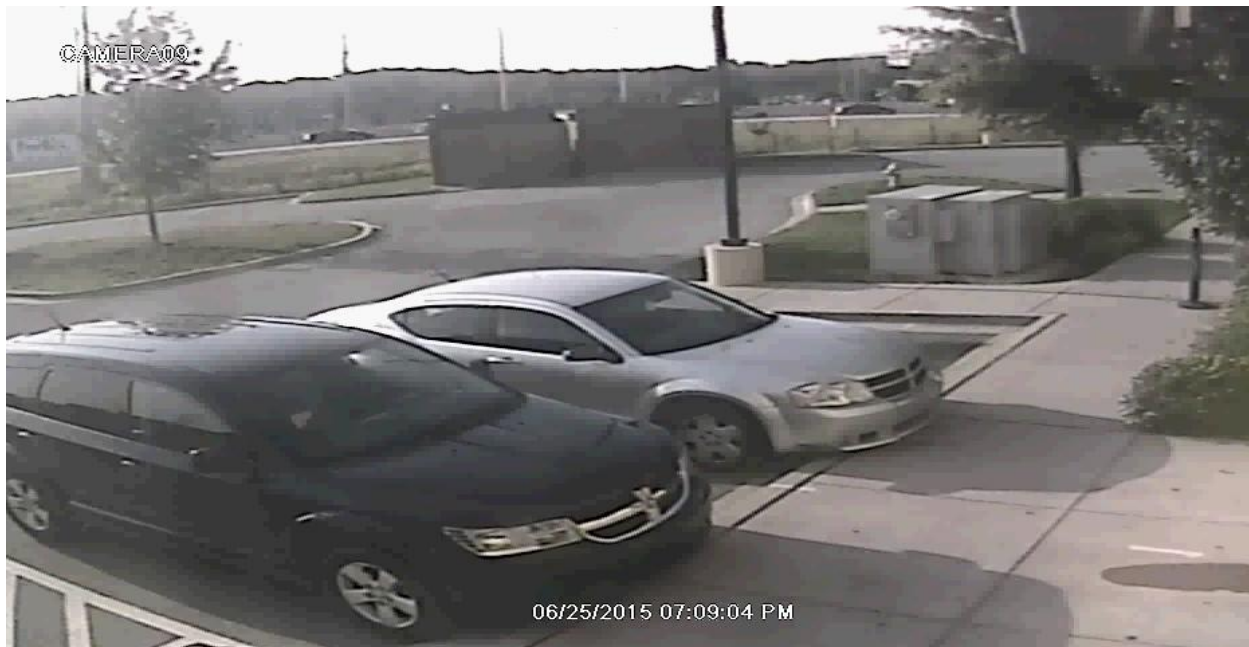
Figure 3 shows a frame from the Camera 2 video before removal of barrel distortion. The I-75 segment in which vehicles can be seen is approximately 260 feet long but the accident truck stops moving approximately 130 feet after entering the camera field of view from left. Seven locations of the accident truck were estimated using video frames in which the truck was at markers superimposed on the frames with the camera model. The markers were spaced by 5 meters. Since the time when each frame was acquired was known, it was possible to plot traveled distance vs. time. The plot in Figure 4, where time was set to zero at the first point, shows that the truck was decelerating. The blue markers and the solid blue line are the raw data. The truck stopped moving approximately 1.5 seconds and 15 feet past the last data point shown in Figure 4.

Figure 3. Frame from Camera 2 Video (not showing the accident truck)
