**NATIONAL TRANSPORTATION SAFETY BOARD**  
Office of Research and Engineering  
Washington, D.C. 20594

## **Video Study**

**NTSB Case Number:  
HWY17MH007**

Location: Baltimore, Maryland  
Date: November 1, 2016  
Time: 6:30 a.m.  
Vehicle No. 1: School Bus operated by AAAfordable Transportation LLC ('school bus')  
Vehicle No. 2: Maryland Transit Administration Bus No. 10 ('MTA bus')  
Vehicle No. 3: Ford Mustang ('car')

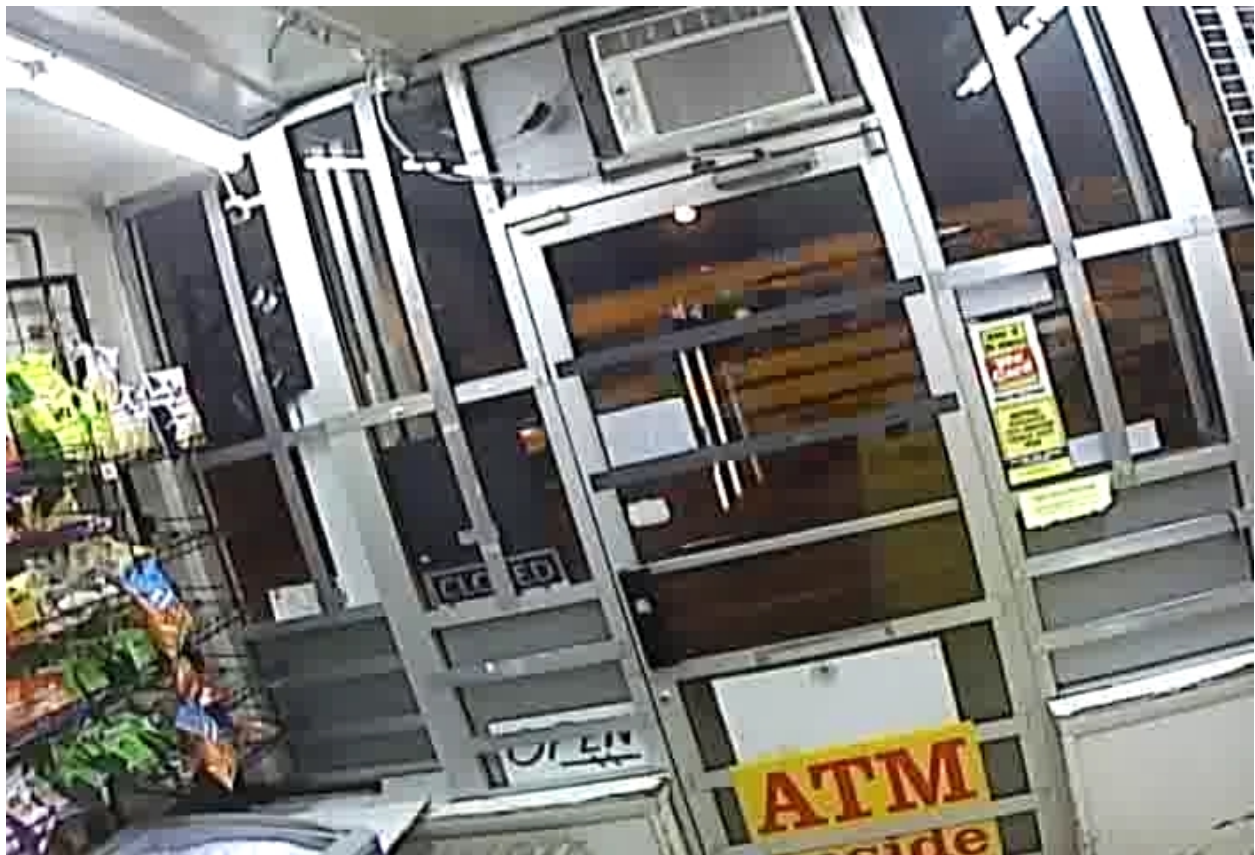
**Figure 2. Frame from the Store Camera Video**

This camera was located inside a store on the northern side of Frederick Avenue. Its resolution was 704x480 and its frame rate was a constant 10 fps. The school bus was visible in the video for about one second. A frame from the video, showing the school bus, is shown in Figure 2. Speed was estimated by measuring the number of frames needed for the school bus to move its bumper-to-bumper length of 35.75 feet. That number was 4.8 frames which resulted in a nominal estimated speed of 74.5 ft/s. When converted to mph and accounting for measurement uncertainties, the estimated speed is  $51 \pm 1$  mph.

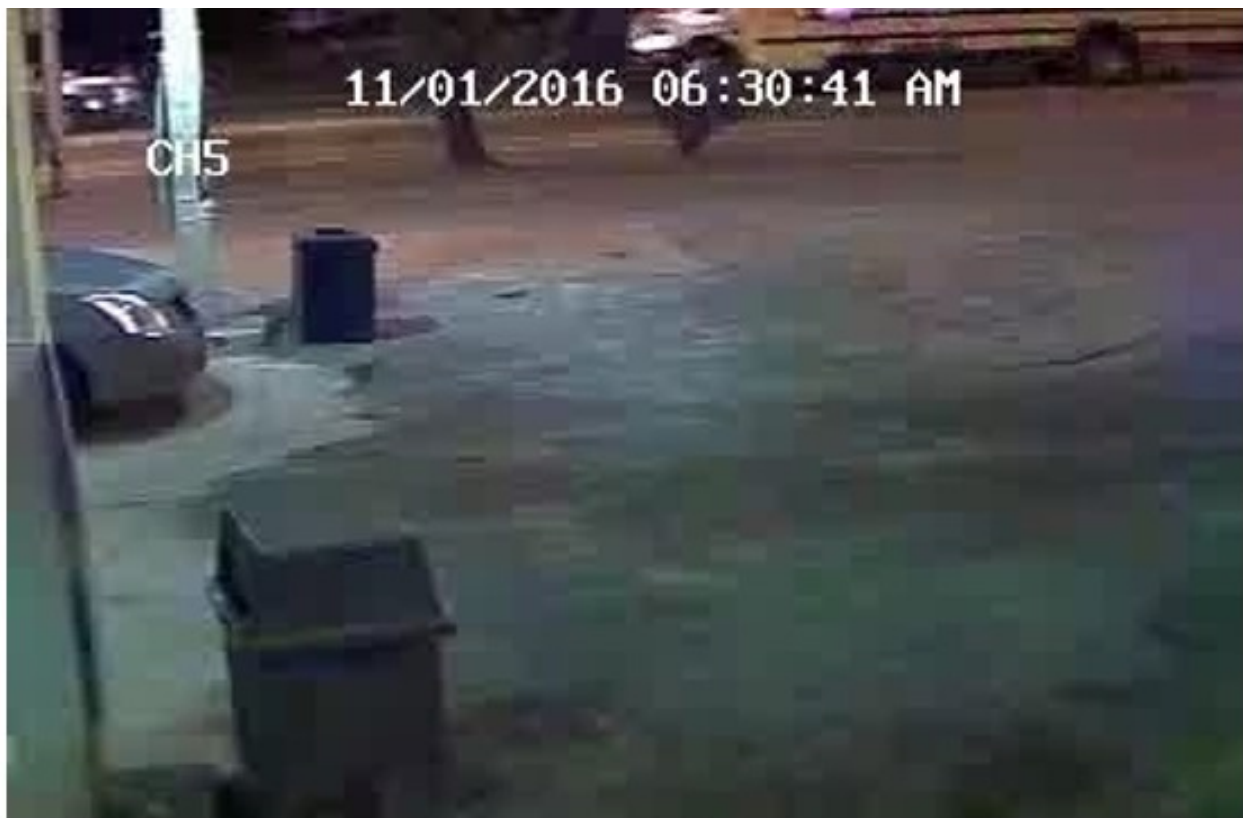
**Figure 3. Frame from Gas Station Camera Video**

This camera was located on a gas station building on the northern side of Frederick Avenue. Its resolution was 352x240 and its frame rate was a constant 30 fps. The school

bus was visible in the video for about 1.2 seconds. A frame from the video is shown in Figure 3. Speed was estimated by measuring the number of frames needed for the school bus to move its bumper-to-bumper length of 35.75 feet. That number was 12.8 frames which resulted in a nominal estimated speed of 83.8 ft/s. When converted to mph and accounting for measurement uncertainties, the estimated speed is  $57 \pm 1$  mph.

This camera also captured a car that was moving east ahead of the school bus. Its estimated speed was 22 mph. It can be seen in the upper left corner in Figure 3. It was assumed that this was the car impacted by the school bus. When the car was impacted, it was out of the field of view of the camera but most of the school bus was still in the camera field of view. Because of the large mass of the bus compared to the mass of the car and limited video resolution, the video does not show any bus speed change or motion indicative of impact. Impact is assumed based on the large speed difference of the two vehicles and the short distance between them.

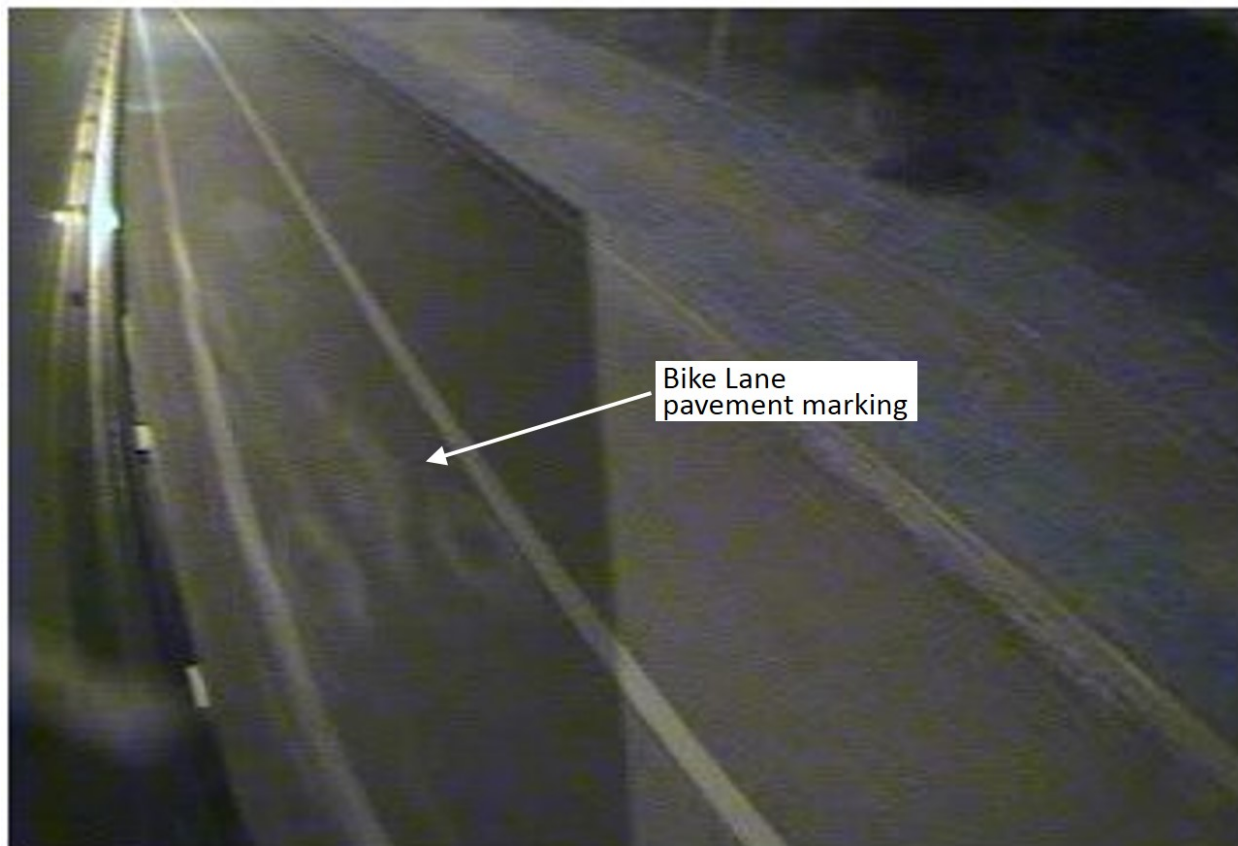
**Figure 5. Frame from MTA Bus Camera 8 Video**

Figure 5 shows a frame from the MTA bus Camera 8 video. The frame shows a Bike Lane pavement marking that is located less than 200 feet east of the final location of the MTA bus. An identical Bike Lane pavement marking is located 482 feet east of the marking seen in Figure 5. The MTA bus traveled this distance in 8 seconds, resulting in an estimated speed of  $482/8=60.3$  ft/s. When converted to mph and accounting for measurement uncertainties, the estimated speed is  $41\pm 1$  mph.

A similar process was used to estimate the speed of the MTA bus on shorter road segments that ended west of the Bike Lane pavement marking seen in Figure 5. One estimate was based on Camera 7 – Rear View over a 135 ft. long road segment. A second estimate was based on Camera 10 – Street Side View over a 220 ft. long road segment. Both speed estimates were  $43\pm 1$  mph.

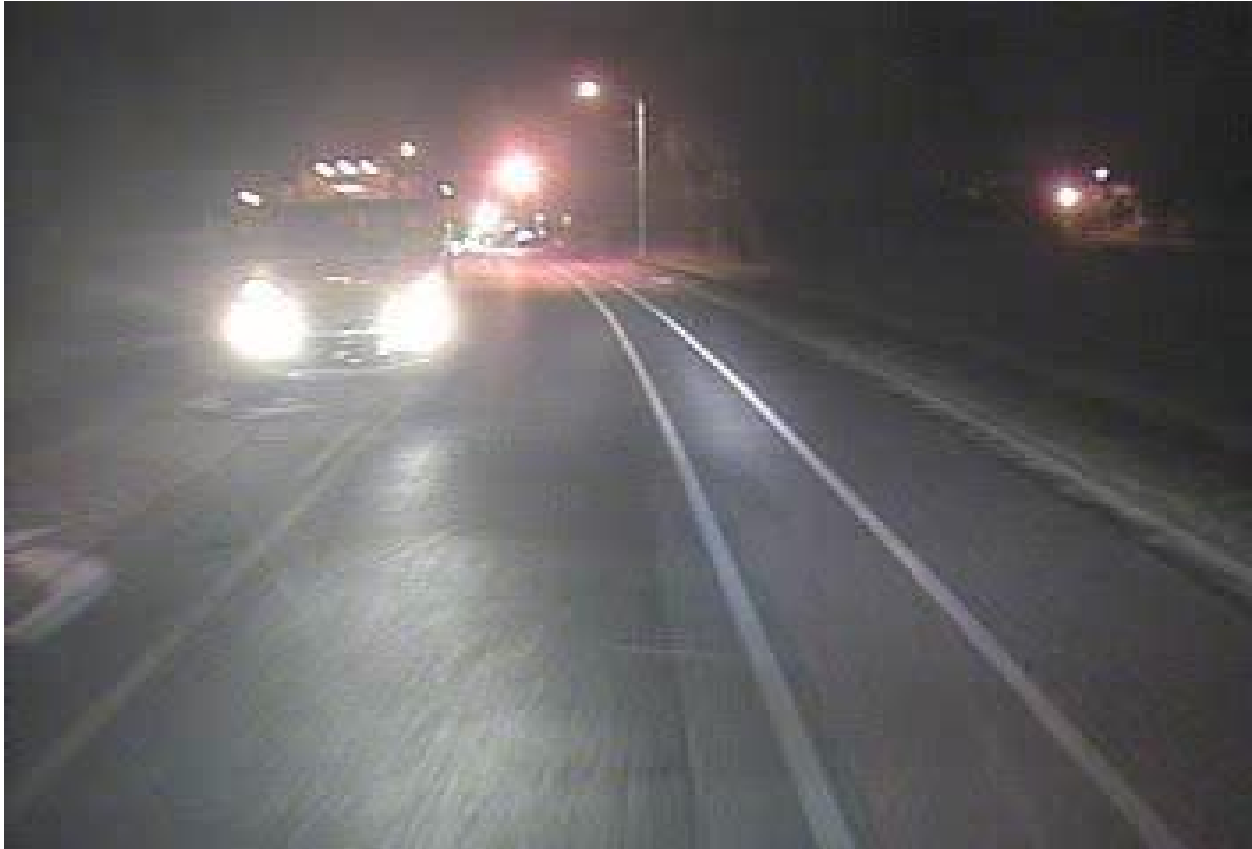
**Figure 6. Frame from MTA Bus Camera 9 Video**

half second before impact. The video ended at time of impact. Figure 6 shows a frame from Camera 9 video that was acquired about 0.3 seconds before impact.

As seen in Figure 6, Camera 9 video captured details of lane lines, arrow road markings in the two-way center turn lane and a lamp post. These details, all visible in Google Earth, were used as reference points for camera optics calibration.

With a calibrated Camera 9 model and estimated locations of the MTA bus, it was possible to estimate the locations and speed of the school bus. As Figure 6 shows, the approaching school bus is visible in frames from the video. To estimate school bus location based on a video frame such as the one in Figure 6, the MTA bus was positioned and oriented in the analysis program at its previously estimated location. A wireframe model of the front of the school bus was constructed that included details of its roof, windshield, headlights and bumper. That wireframe model was then iteratively moved and oriented in an analysis program until the model details optimally coincided with their images in the video frame. The optimal location of the wireframe model was the optimal estimate of the location of the school bus at the time the analyzed video frame was acquired.

It is evident from the video frame in Figure 6 and from other Camera 9 video frames that the school bus impacted the MTA bus because it did not follow the curve of the roadway. The school bus is seen in the figure entering the MTA bus lane from the two-way center turn lane in which it was shortly before impact. There is no video-based information on when the school bus moved into the two-way center turn lane.

The speed of the school bus shortly before impact was estimated as  $45\pm 2$  mph. This estimate was based on the MTA bus Front View camera video. The school bus impacted the MTA bus because it did not follow the curving two-way center turn lane in which it was shortly before impact.
