**National Transportation Safety Board
Office of Aviation Safety – Central Region**

Video Summary – CEN15IA337

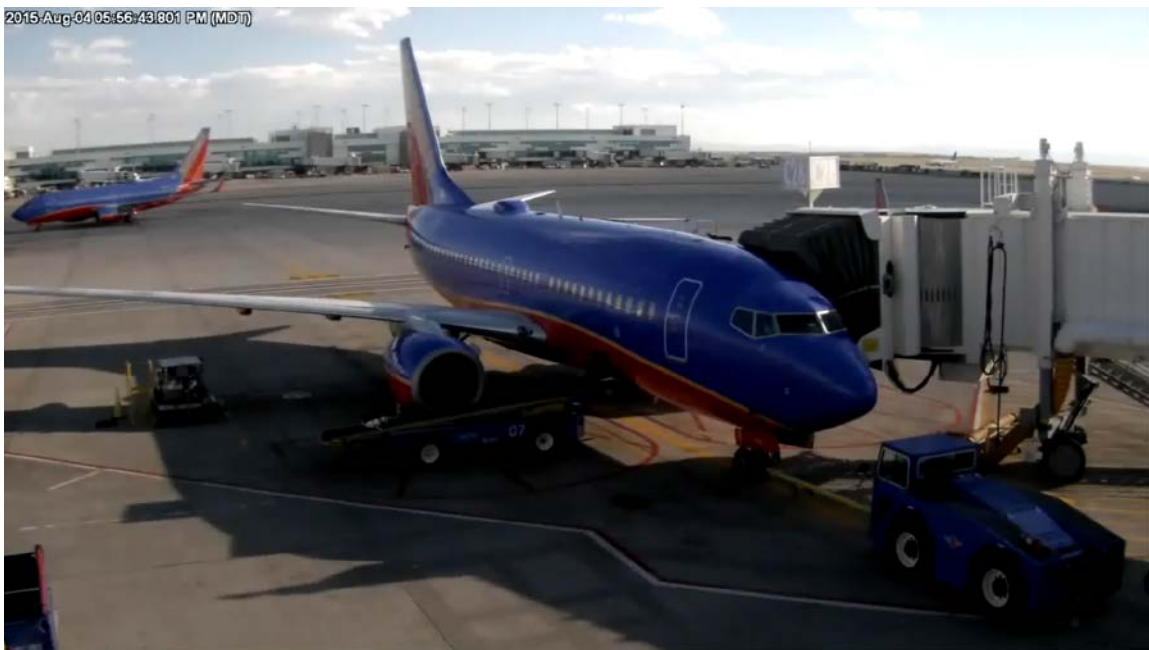
Photograph 1 - Southwest Airlines airplane and provisioning truck.

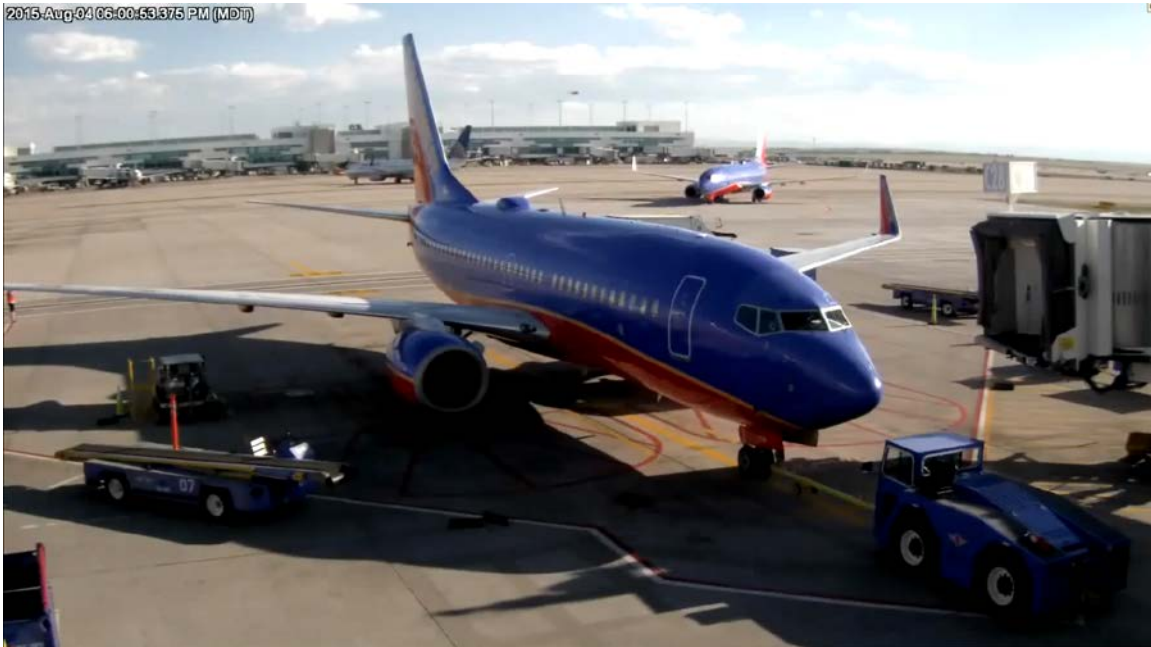
Photograph 2 - Southwest Airlines airplane arriving at Gate 26

- 06:00:53 – The Southwest Airlines (SA) airplane scheduled for gate 26 arrives and starts to turn towards the gate
- 06:01:02 – The tug driver starts to push the SA airplane at gate 28 back as the SA airplane at gate 26 continues to pull in

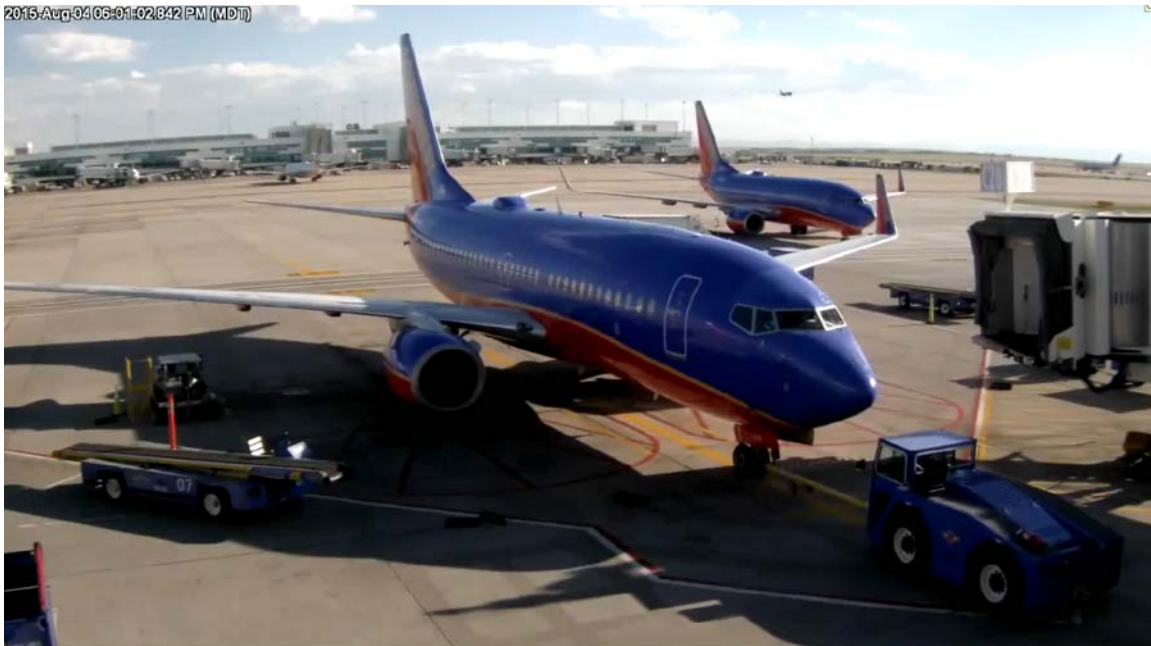
Photograph 3 - Tug starts pushback

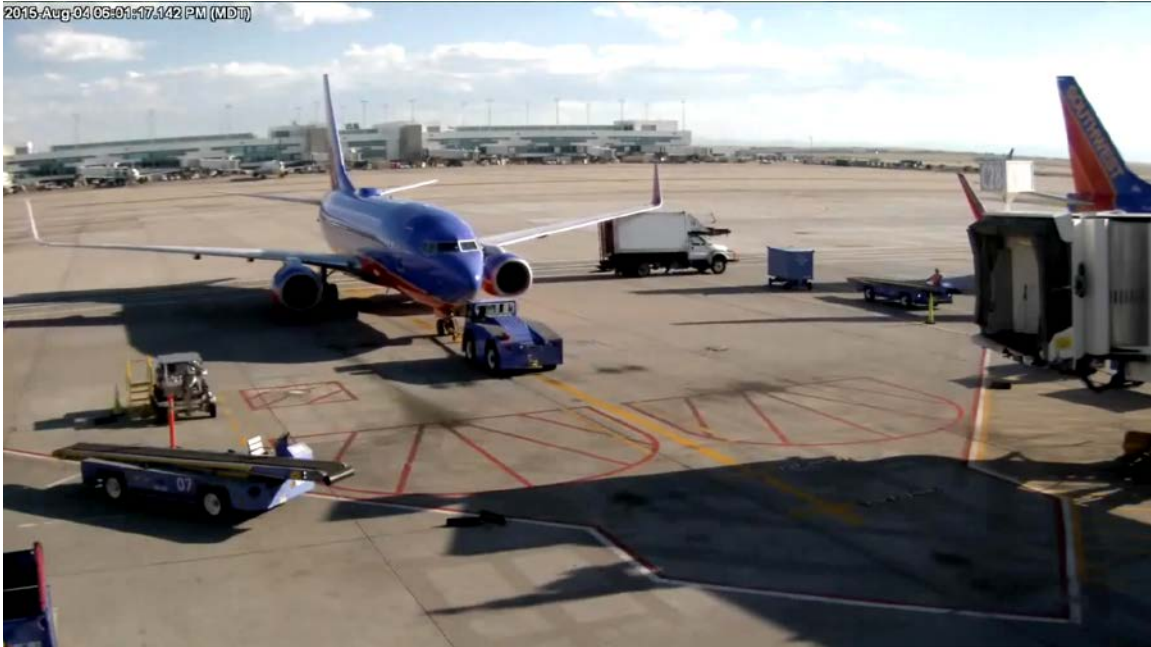
Photograph 4 - Collision between the left wing and the provisioning truck

- 06:01:17 – The collision between the airplane's left wing and the provisioning truck starts
- 06:01:24 – The airplane stops moving backwards and the truck stops its roll
