NATIONAL TRANSPORTATION SAFETY BOARD

Factual Report

METEOROLOGY

CEN19FA072

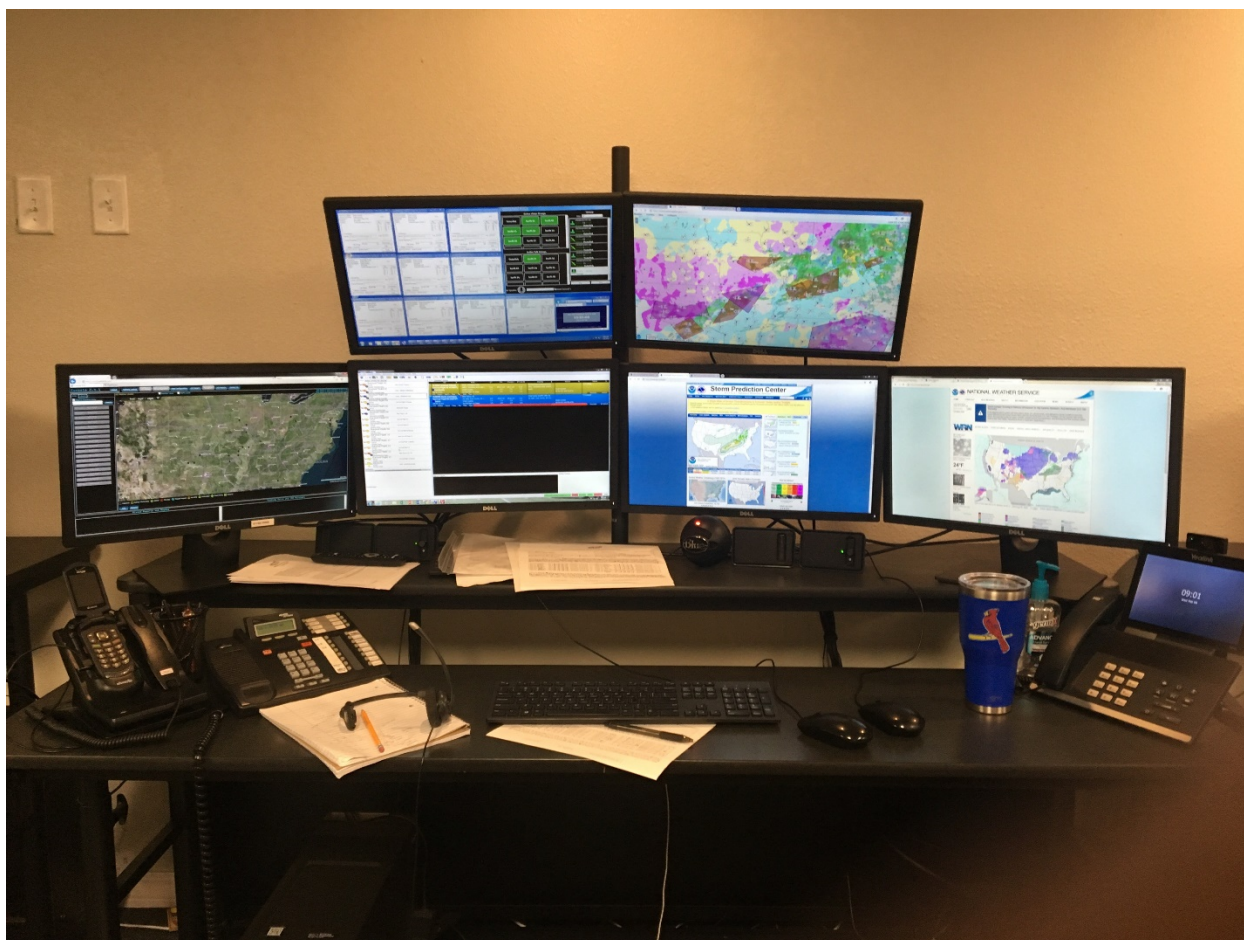
Figure 28 – SF OCC exemplar workstation setup

The SF OCC room was setup with 2 computer workstations with several computer monitors. Figure 28 shows an exemplar image of a typical SF OCC computer workstation setup.
