NATIONAL TRANSPORTATION SAFETY BOARD

Weather Study

WPR17LA084

Location: Brinnon, Washington
Date: April 2, 2017
Time: 1529 Pacific daylight time
2229 coordinated universal time (UTC)
Airplane: Cirrus SR22; Registration: N167CB

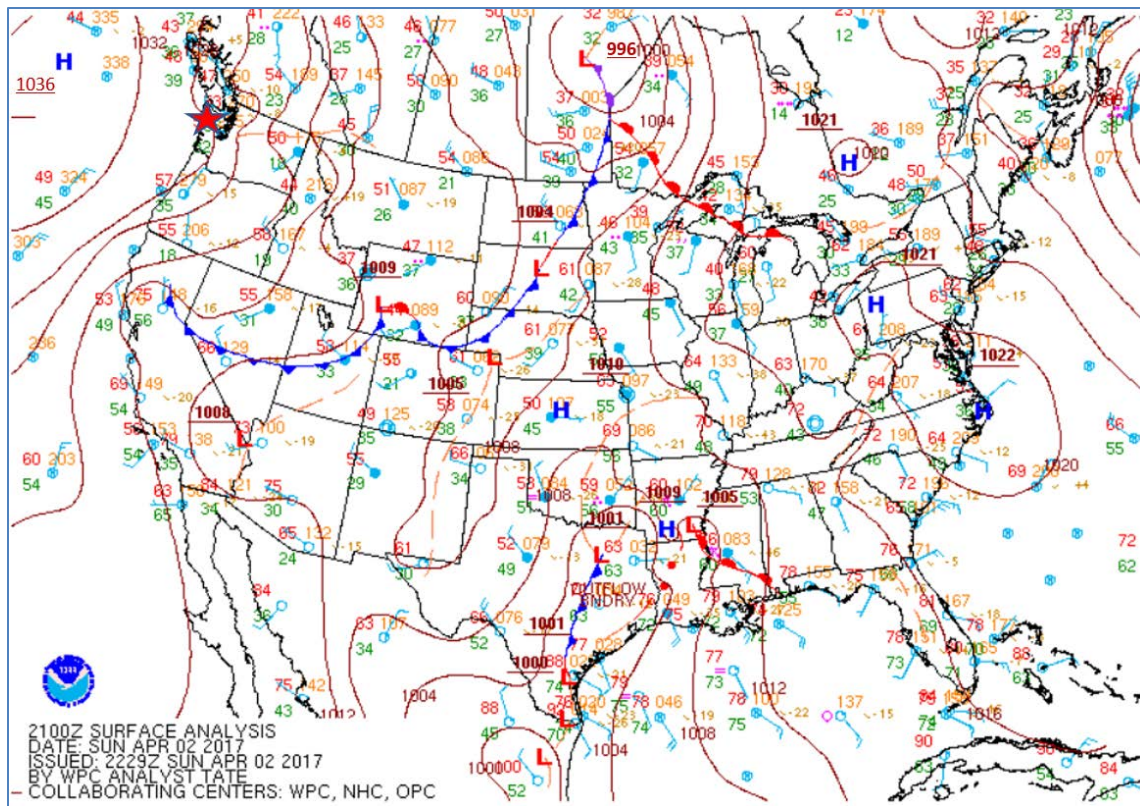
Figure 1 - NWS Surface Analysis for 1400 PDT

The NWS Surface Analysis Chart for the continental United States at 1400 PDT is included as figure 1 with the approximate accident site marked by a red star. The chart depicted a high pressure system at 1036-hectopascals (hPa)¹ off the northwest Pacific coast with the isobars or lines of equal pressure indicating a ridge of high pressure extending eastward over southern Washington and northern Oregon. Further east-northeast, a deep low pressure system at 996-hPa associated with an occluded front was located over Manitoba, Canada, with a cold front extending southwestward across extreme northwest Minnesota, the Dakota’s, into Nebraska, and became stationary extending westward into Wyoming. Another low pressure system at 1009-hPa was located over western Wyoming with another frontal wave, with the cold front extending southwestward into Utah, and then westward into Nevada, and northern California. A weak trough of low pressure was depicted immediately east of the accident site extending across Washington into northern Idaho, and southern British Columbia and Alberta, Canada.

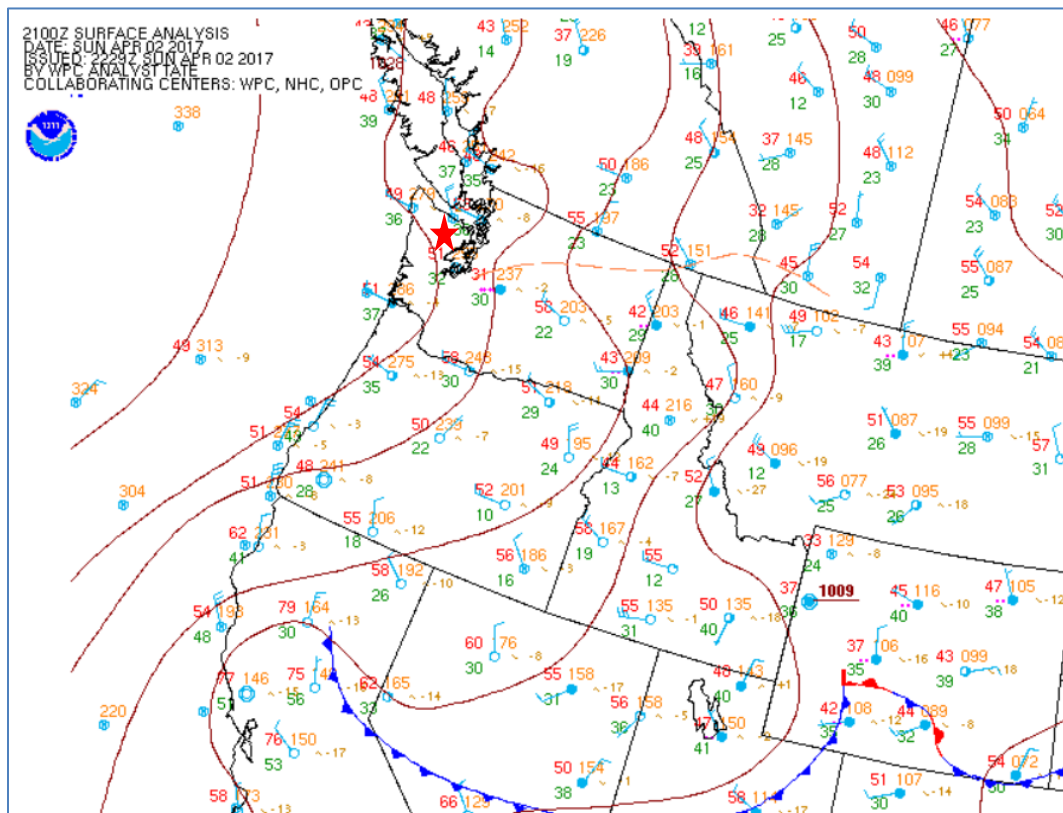
Figure 2 - Northwest section of the Surface Analysis Chart for 1400 PDT

Figure 2 is the northwest section of the NWS Surface Analysis Chart for the same period at 1400 PDT showing more detail with the station models and shows a slightly stronger localized pressure gradient over western Washington by the isobars, or lines of equal pressure at 4-hPa intervals. The closest reporting station model to the accident site in figure 2 was Port Angeles, immediately north, which depicted a northwesterly wind at 15 to 20 knots, overcast clouds, with temperature of 50° Fahrenheit (F), dew point 36° F, with a sea level pressure of 1026.5-hPa. A station to the east of the accident believed to be Stampede Pass, which was located near the trough reported overcast clouds with precipitation in the form of light snow with a temperature of 31° F, a dew point of 30° F, and a sea level pressure 1023.1-hPa.

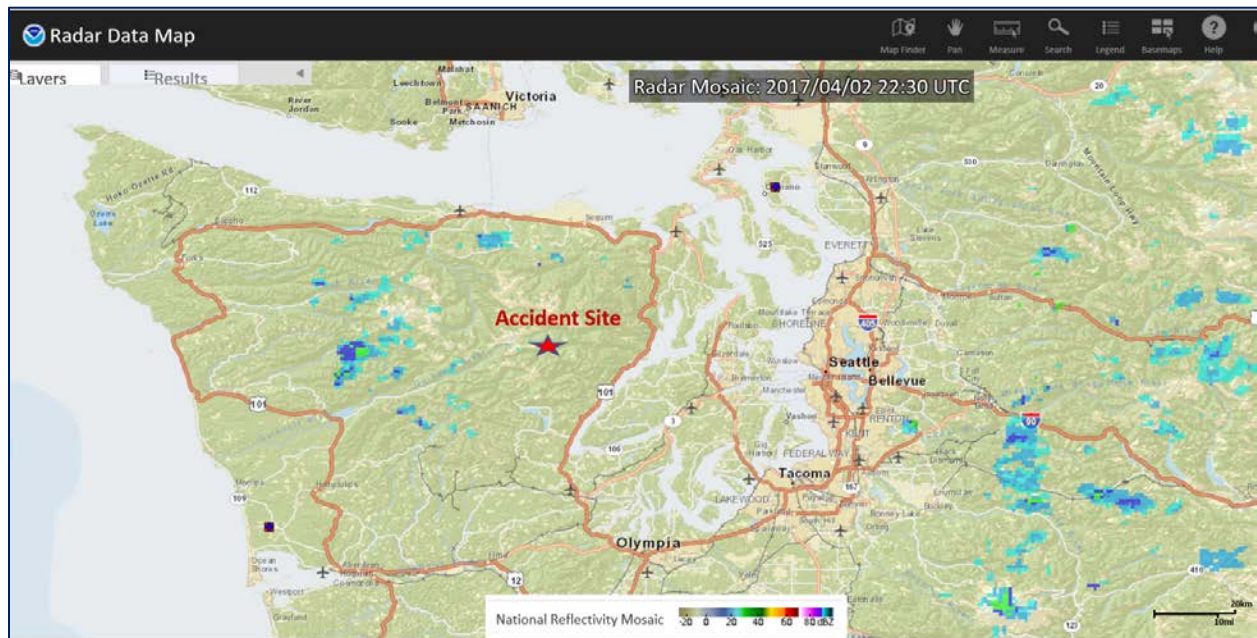
Figure 3 - National Composite Radar Mosaic for 1530 PDT

Figure 3 is the National Composite Radar Mosaic for 1530 PDT obtained through the NCEI archive data, with the approximate accident site marked by the red star. The image depicted scattered very light intensity echoes over Washington during the period, with several small areas of echoes immediately west and north of the accident site. The echoes confirmed scattered light rain showers over the region during the period and confirmed the report of light snow further east at higher elevations. No significant echoes were identified over the accident site during the hour immediately prior to the time of the accident.

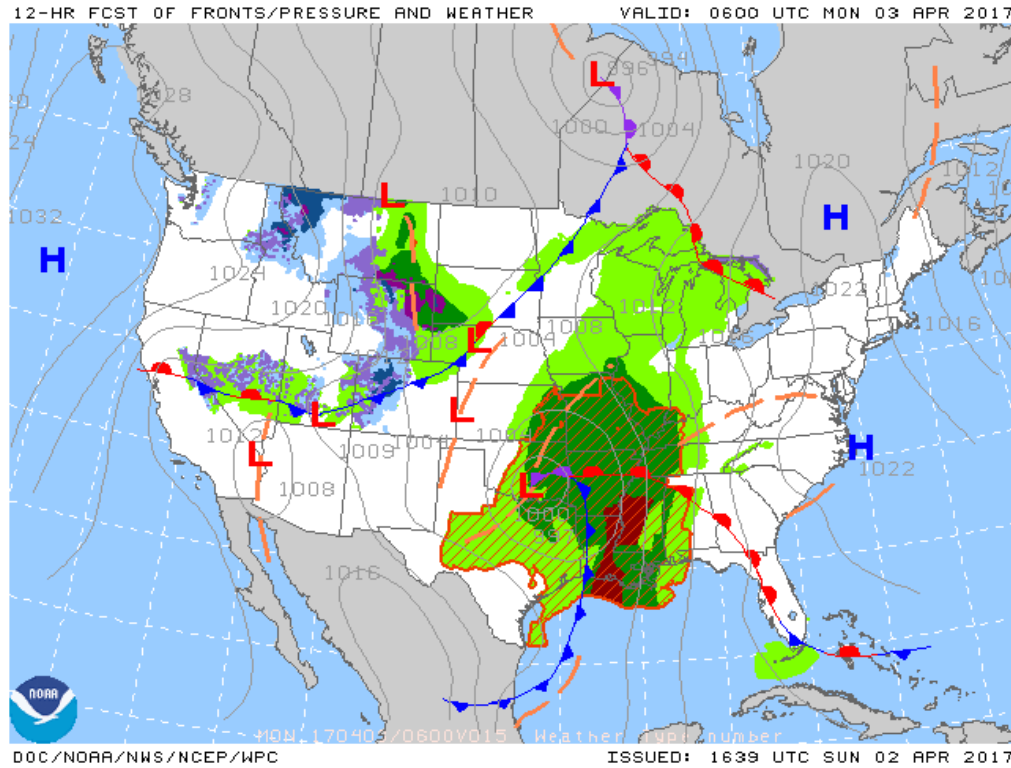
Figure 4 - 12-hour Surface Prognostic Chart for 2300 PDT

A review of the 12-hour Surface Prognostic Chart provided the expected conditions during the evening hours and any precipitation, with the valid time of the chart at 2300 PDT. Figure 4 is the 12-hour Prognostic Chart which depicted no significant boundaries over the region at that time, with several small areas of expected light precipitation mainly in the form of light snow (light blue) and mixed precipitation (purple) in the Olympic area immediately south of the accident site and along the higher terrain immediately east of the Seattle area. Further east over northern Idaho and western Montana a large area of mixed precipitation and snow was expected with a greater than 50% probability or likely snow (dark blue).

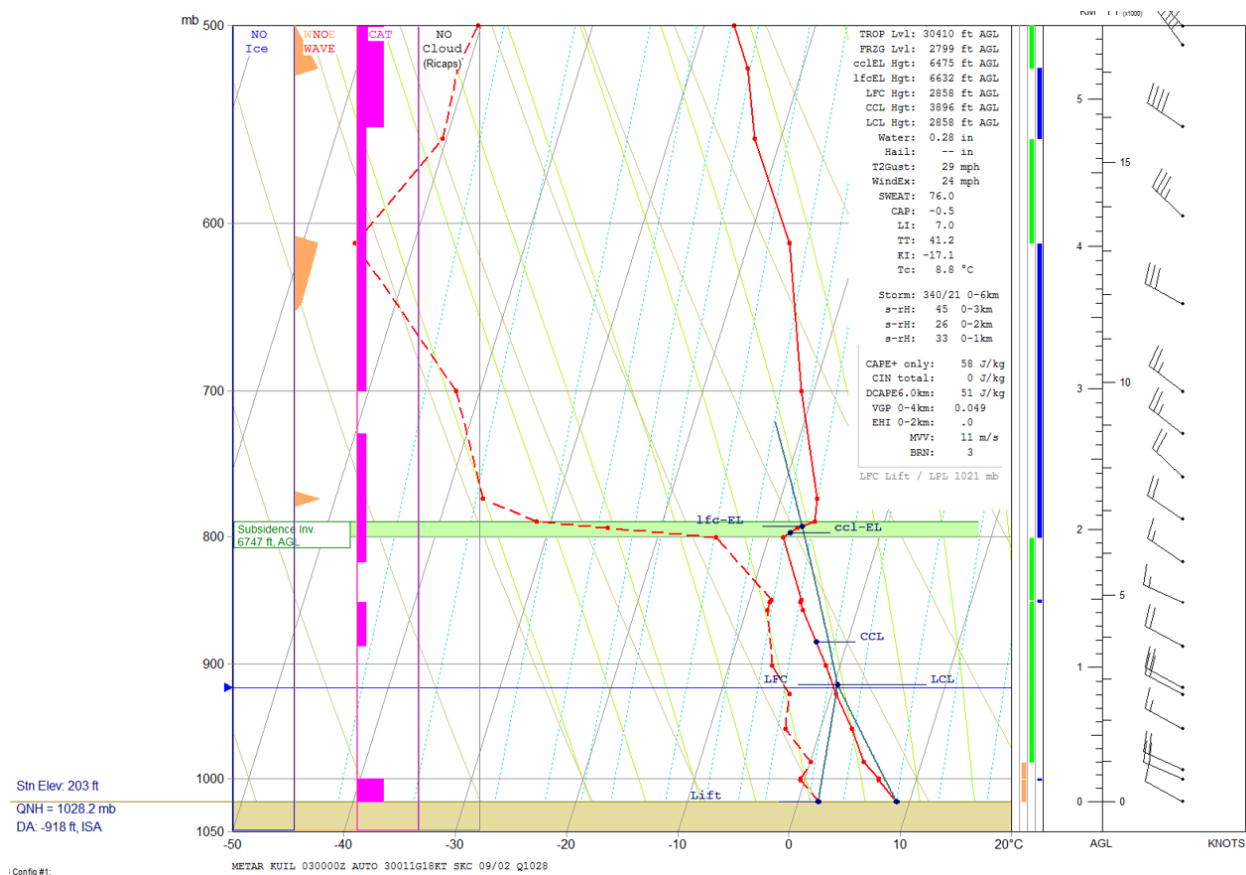
Figure 5 - Quillayute 1700 PDT sounding

The closest sounding to the accident site was from Quillayute (KUIL), Washington, site number 72797, located miles west-northwest from the accident site, at an elevation of 203 ft. The 1700 PDT sounding (0000Z on April 3, 2017) was plotted on a Skew-T log P diagram³ from the surface to 500-hPa or 18,000 ft utilizing RAOB software⁴, and is included as figure 5. The sounding depicted a freezing level (indicated by a blue line) at 3,000 ft with a lifted condensation level (LCL) and level of free convection immediately above it at 3,060 ft (2,858 ft agl), and a (CCL) at 4,099 ft (3,896 ft agl). A shallow temperature inversion due to subsidence was identified at 6,750 ft, where temperature increased with height and acted as a cap to any cloud formation. The atmosphere was characterized as stable with a lifted index of +7.0, while the lowest layer from the surface to the inversion was conditionally unstable and supported fair weather stratocumulus type clouds, with little vertical development. The precipitable water content was low at 0.28 inches, with a surface relative humidity of 60%.

The wind profile indicated a surface wind from northwest or 300° at 11 knots with little directional variation with height, with winds speeds increasing with height. The mean 0 to 6 kilometer or 18,000 ft wind was identified from 310° at 28 knots. The maximum wind was identified at 30,000 ft from 290° at 52 knots, with the tropopause at 30,600 ft. At 6,300 ft or at the approximate height of Mount Christie located 13 mile west of the accident site was from 305° at 16 knots, and would have resulted in a downslope wind over the accident site at about 5,350 ft.

The RAOB turbulence algorithm indicated immediately above the surface at approximately 700 ft there was a strong vertical shear of 8.1 knots per 1,000 ft and indicated a probability of 97% of moderate turbulence at and immediately below this level.

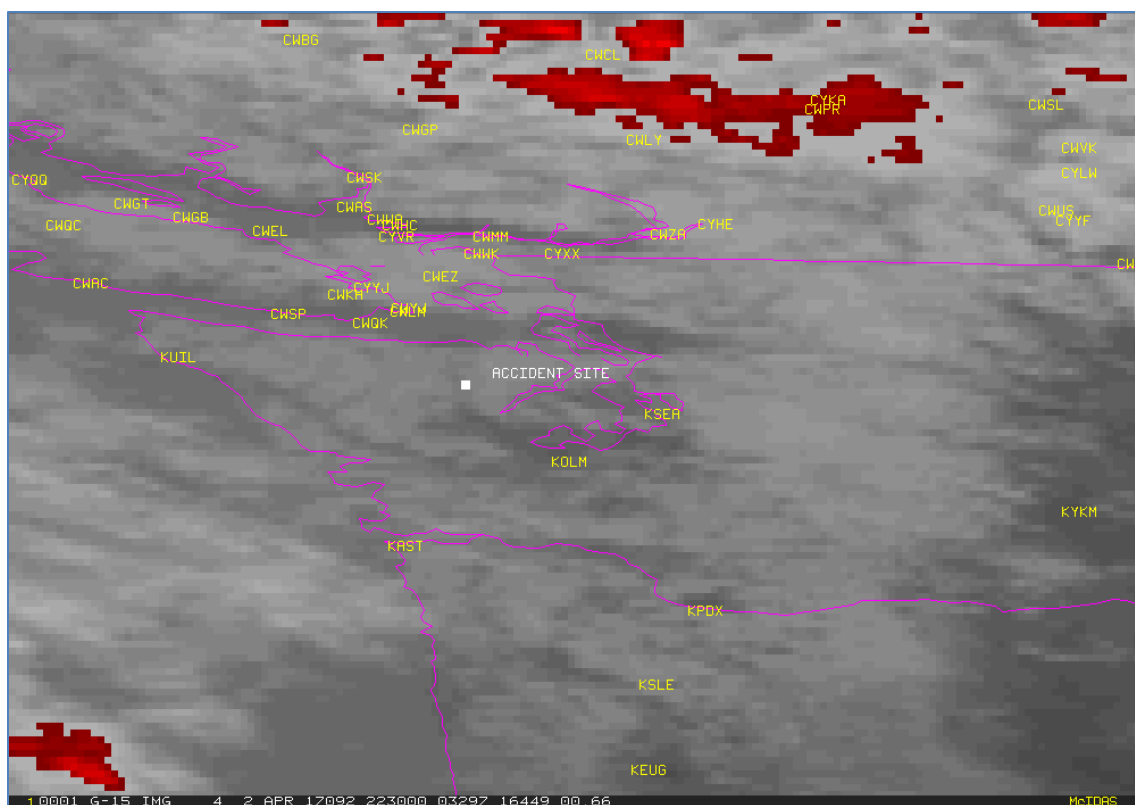
Figure 7 is the GOES-15 infrared image at 6X magnification with a standard MB temperature enhancement curve applied to highlight the higher and colder cloud tops associated with deep convection at 1530 PDT. The accident site is marked by a white square. The image depicted several layers of low to mid-level clouds over the region. The radiative cloud top temperature over the accident site was 271° Kelvin or -2.16° C, which corresponded to cloud tops near 4,000 ft based on the KUIL sounding.

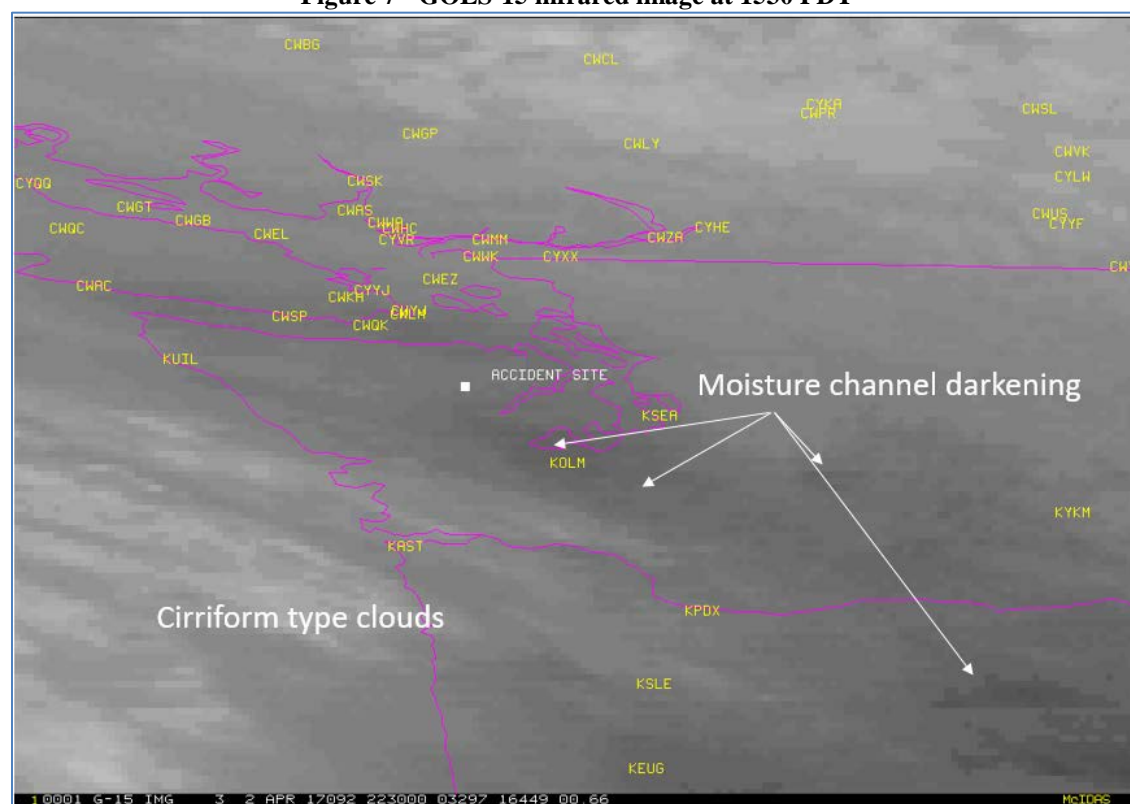
Figure 8 is the GOES-15 water vapor channel image for the same period at 1530 PDT at 6X magnification. The image depicted some moisture channel darkening immediately southwest of the accident site over Washington and Oregon, which indicated descending motion and drying of the mid-level moisture, typically observed during turbulent conditions.

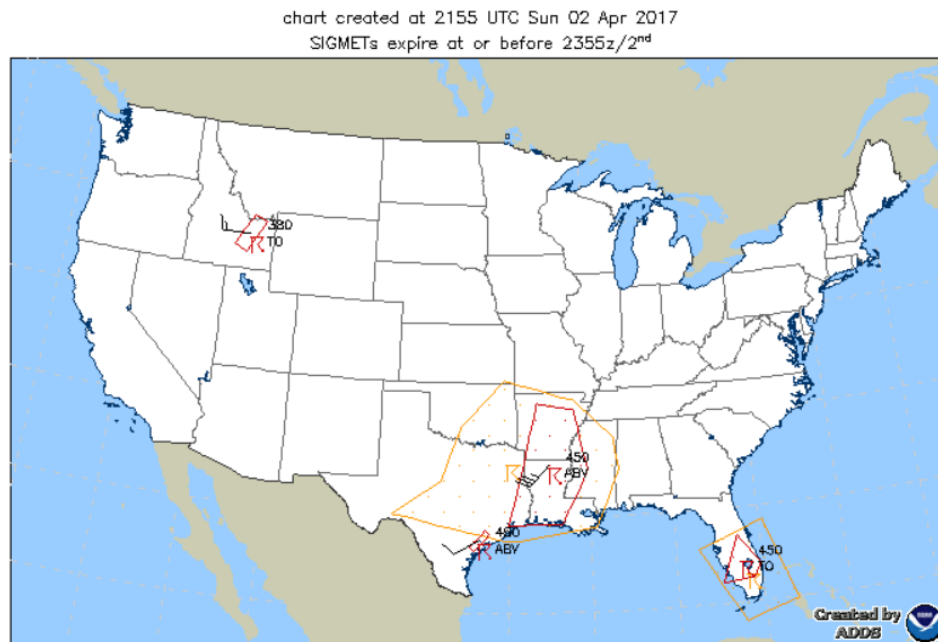
Figure 10 - Convective SIGMETs valid at 1455 PDT

The following inflight weather advisories were current during the period. Figure 10 is the current Convective SIGMETs, no advisories current for Washington were in effect during the period, and none required by NWS criteria. A review of non-convective SIGMETs and Center Weather Advisories indicated no advisories issued during the period.

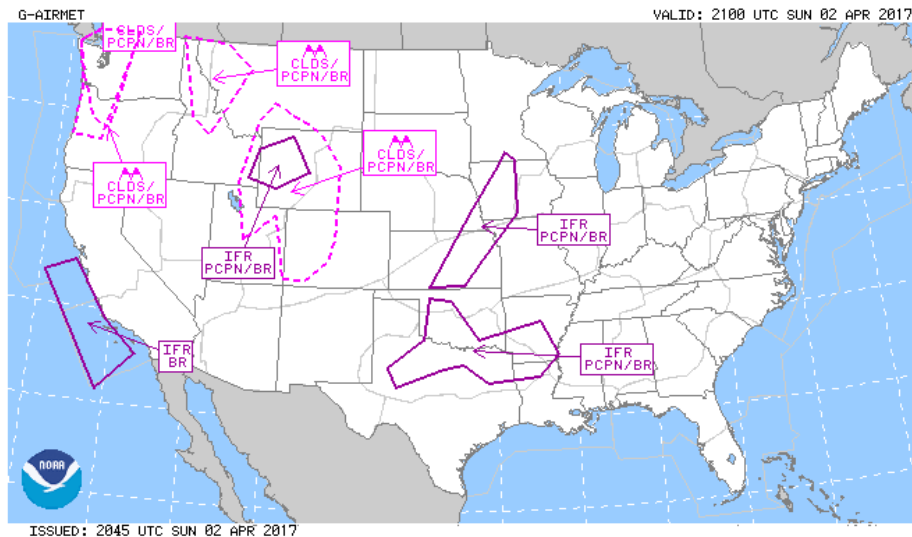
Figure 11 - AIRMET Sierra for IFR and mountain obscuration conditions

The NWS Aviation Weather Center (AWC) in Kansas City, Missouri, issued the following AIRMETS during the period at 1345 PDT. An AIRMET for mountain obscuration, occasional moderate turbulence below 15,000 ft, and icing conditions between 2,000 ft and 12,000 ft in clouds and precipitation were current over the region during the period and are depicted in figures 11 through 13. The advisories were as follows:

MTNS OBSC BY CLDS/PCPN/BR. CONDS CONTG BYD 03Z THRU 09Z.

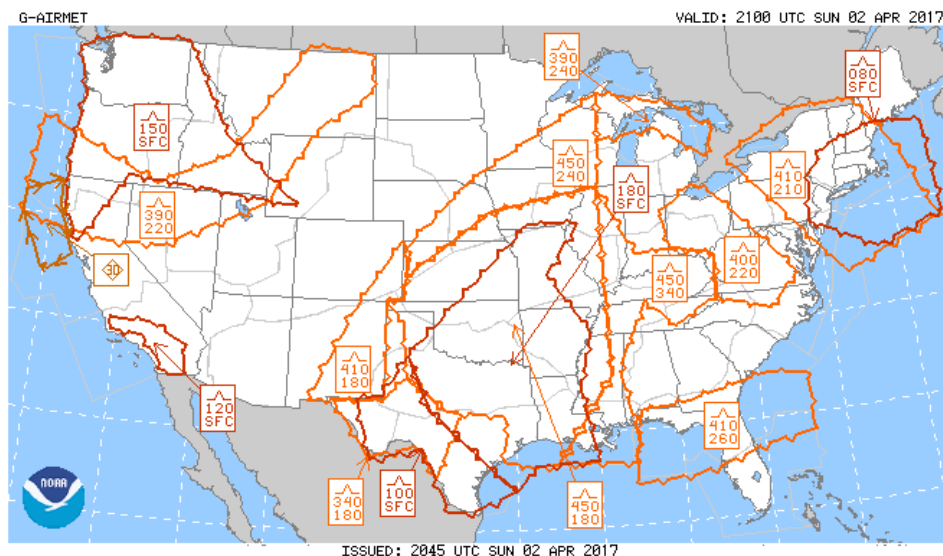
Figure 12 - AIRMET Tango current for turbulence

.
AIRMET TURB...WA OR CA ID WY UT AND CSTL WTRS
FROM 20W HUH TO 60SW YXC TO 20SSE LKT TO 20SE OCS TO LKV TO
20SSE ENI TO 20SSW FOT TO 70SW EUG TO 40S HQM TO TOU TO 20W HUH
MOD TURB BLW 150. CONDS CONTG BYD 03Z THRU 09Z.

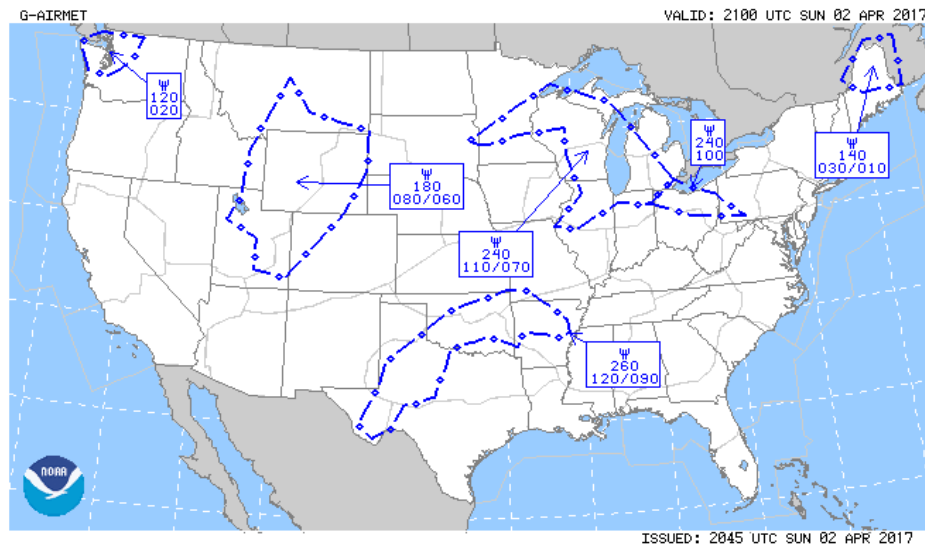
Figure 13 - AIRMET Zulu current for icing conditions

MOD ICE BTN 020 AND 120. CONDS CONTG BYD 03Z THRU 09Z.

FRZLVL...RANGING FROM SFC-140 ACRS AREA

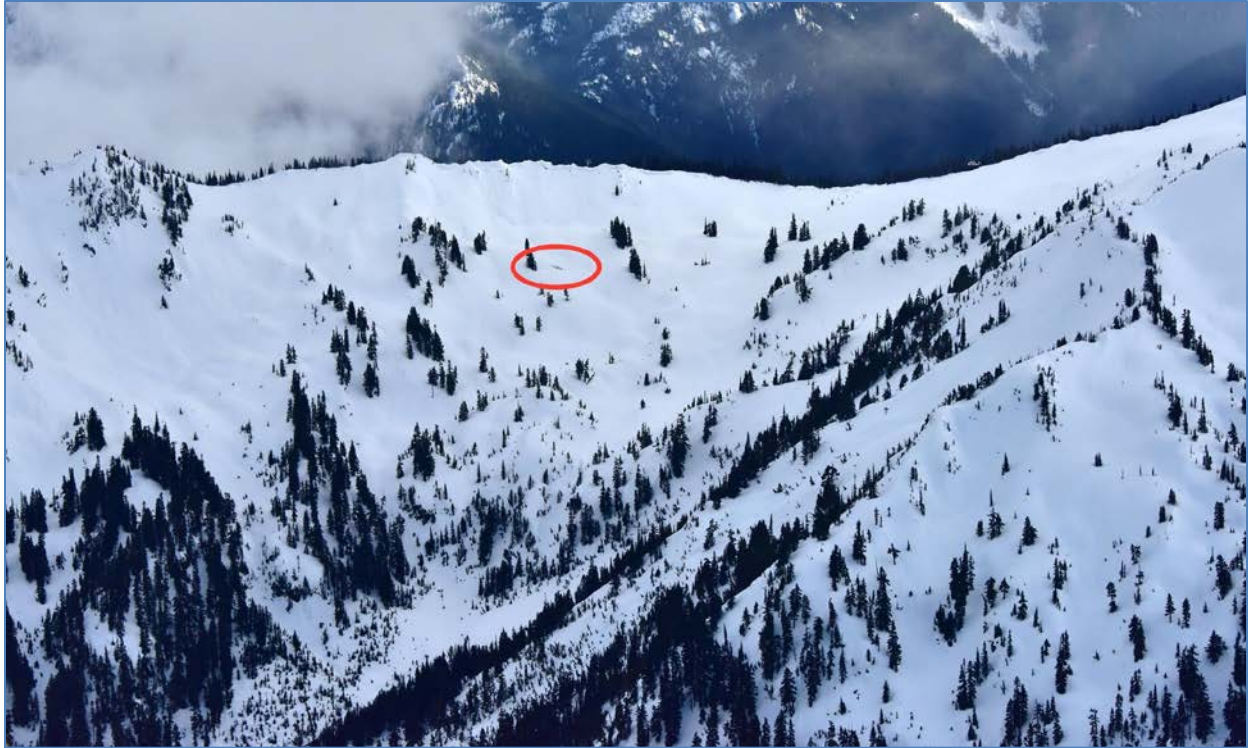
Several images were available of the accident site, showing the snow covered area and the local topography, which is important with regards to upslope and downslope wind conditions. Figures 14 through 16 are the images of the scene with the initial photo showing the accident site within the red circle.

Figure 14 - Accident site below ridge crest

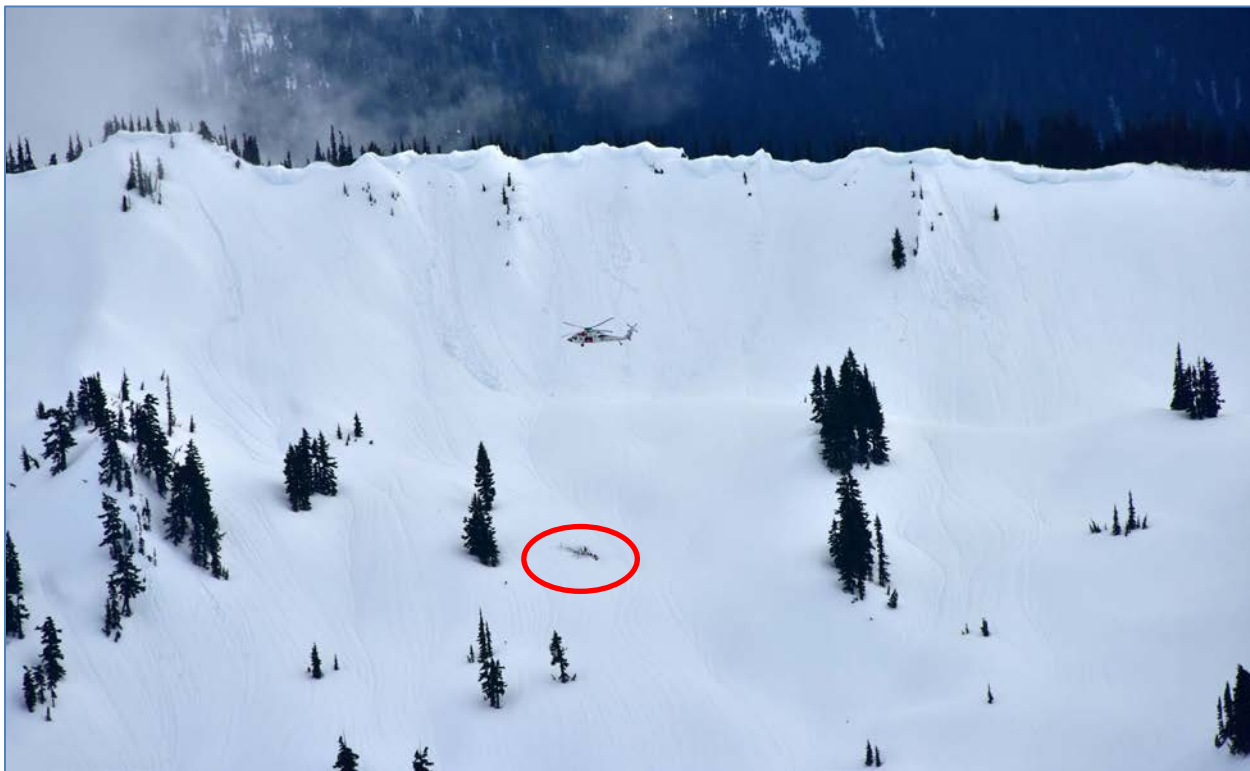
Figure 15 - Accident site closeup

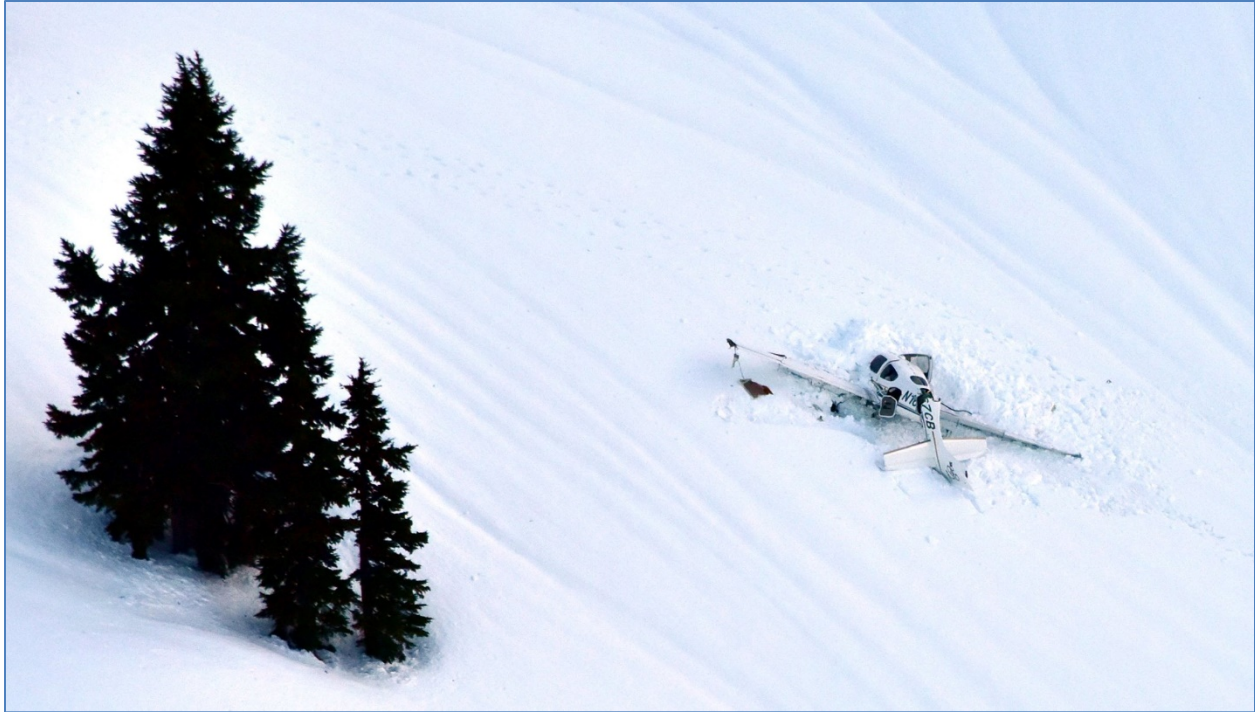
Figure 16 - closeup of the accident airplane
