NATIONAL TRANSPORTATION SAFETY BOARD

Group Chairman's Factual Report

METEOROLOGY

DCA16SH002

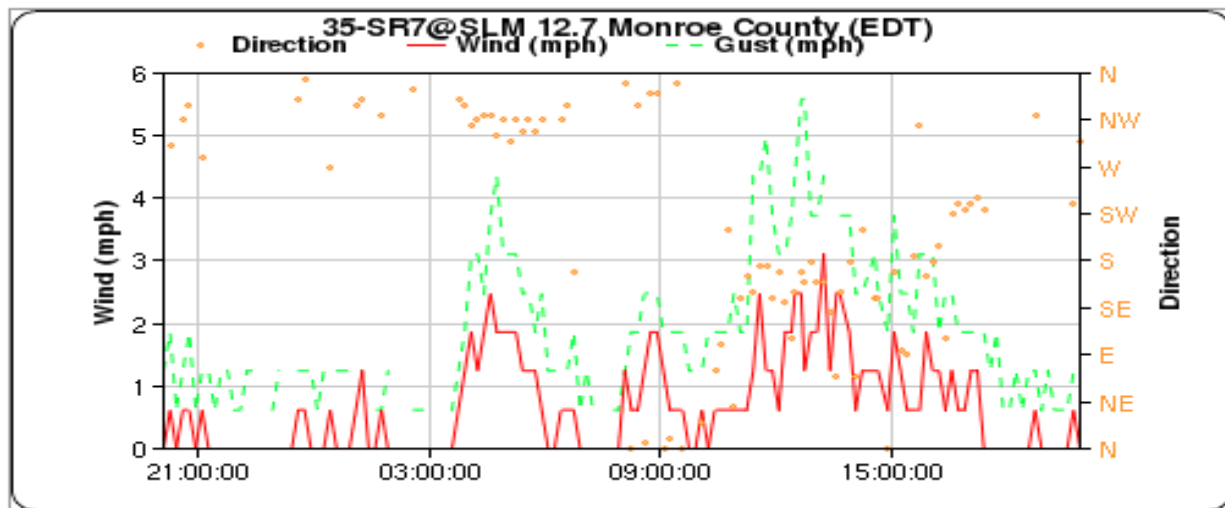
A 24-hour plot of wind speed and direction from 2100 EDT on August 26 through 2100 EDT on August 27, 2016 is included as figure 2. The plot shows winds were generally less than 3 mph with a maximum wind gust of 6 mph from the northwest during the period after the Chlorine leak.

Figure 2 – OH35 Hannibal plot of wind

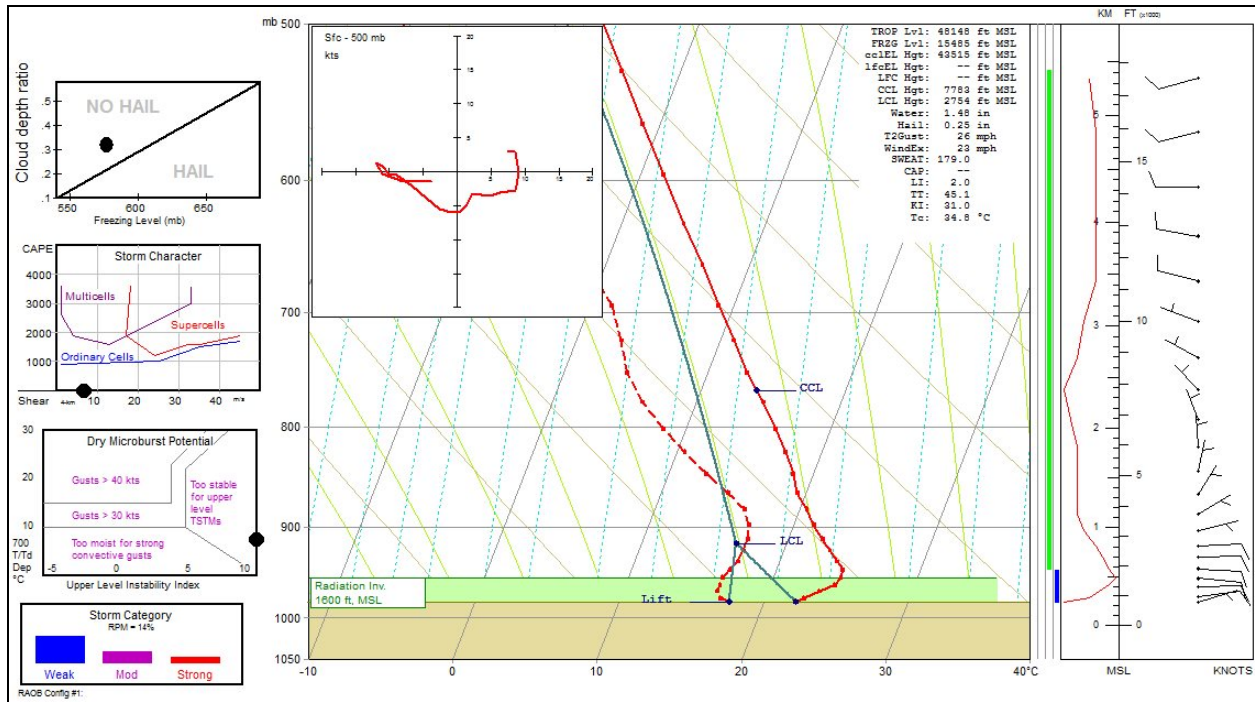
The NOAA Air Resource Laboratory (ARL) archive data was accessed and the Global Data Assimilation System (GDAS) global numerical mesoscale model plotted over the accident site for the same period at 0800 EDT (1200Z). The GDAS model had a resolution of 0.5° and is included as figure 5 utilizing the RAOB software. While not an observation, it provided the best estimate of the winds and temperature structure over the accident site.

Figure 5 - GDAS numerical model sounding over the accident site at 0800 EDT

The GDAS model depicted similar conditions as the Pittsburgh sounding with a light surface wind from the east or from 070° at 4 knots, with a temperature of 72 F, a dew point of 63 F, and a relative humidity of 75%. A surface based temperature inversion was also indicated to 803 feet agl (1,600 feet msl). The LCL was identified immediately above the inversion at 1,957 feet agl,

with the LCL at 6,986 feet agl. The wind profile depicted easterly winds at low altitudes backing to the west with height through 10,000 feet.

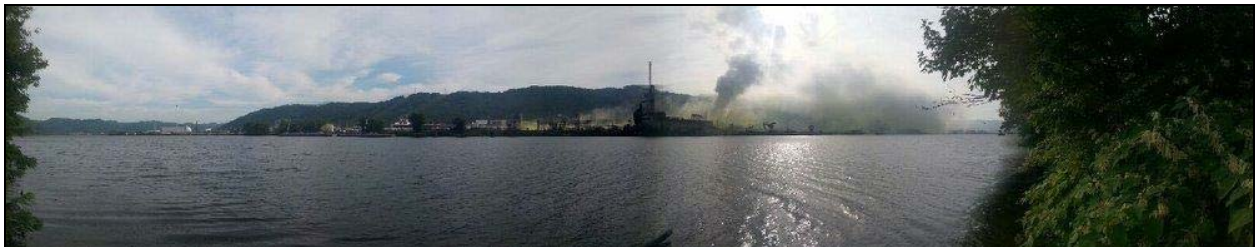
Several pictures were taken after the Chlorine gas leak from the Ohio side of the river looking towards the northeast, at a distance of slightly over 1/4 mile or approximately 1,720 feet. Figure 9 and 10 are two of those images which shows the water vapor from one of the cooling tower going upwards nearly vertical with a slight tilt to the south, although not related to the accident. The green to yellowish low cloud was the visible indication of the Chlorine gas leak, which remains close to the ground and slowly propagates to the south. Chlorine has a specific gravity of 2.67, which indicates that is more than 2.5 time heavier than air, and as a result will sink and spread downhill or pool in low lying areas. The stronger the concentration of the chlorine gas the deeper green in appearance the cloud will have. In figure 10, the greenish yellow chlorine gas appears in front of and below the water vapor cloud, which rises and is observed dissipating to the south, with the chlorine remaining at low levels.

Figure 9 - Panoramic view looking northeast from the Ohio side of the river

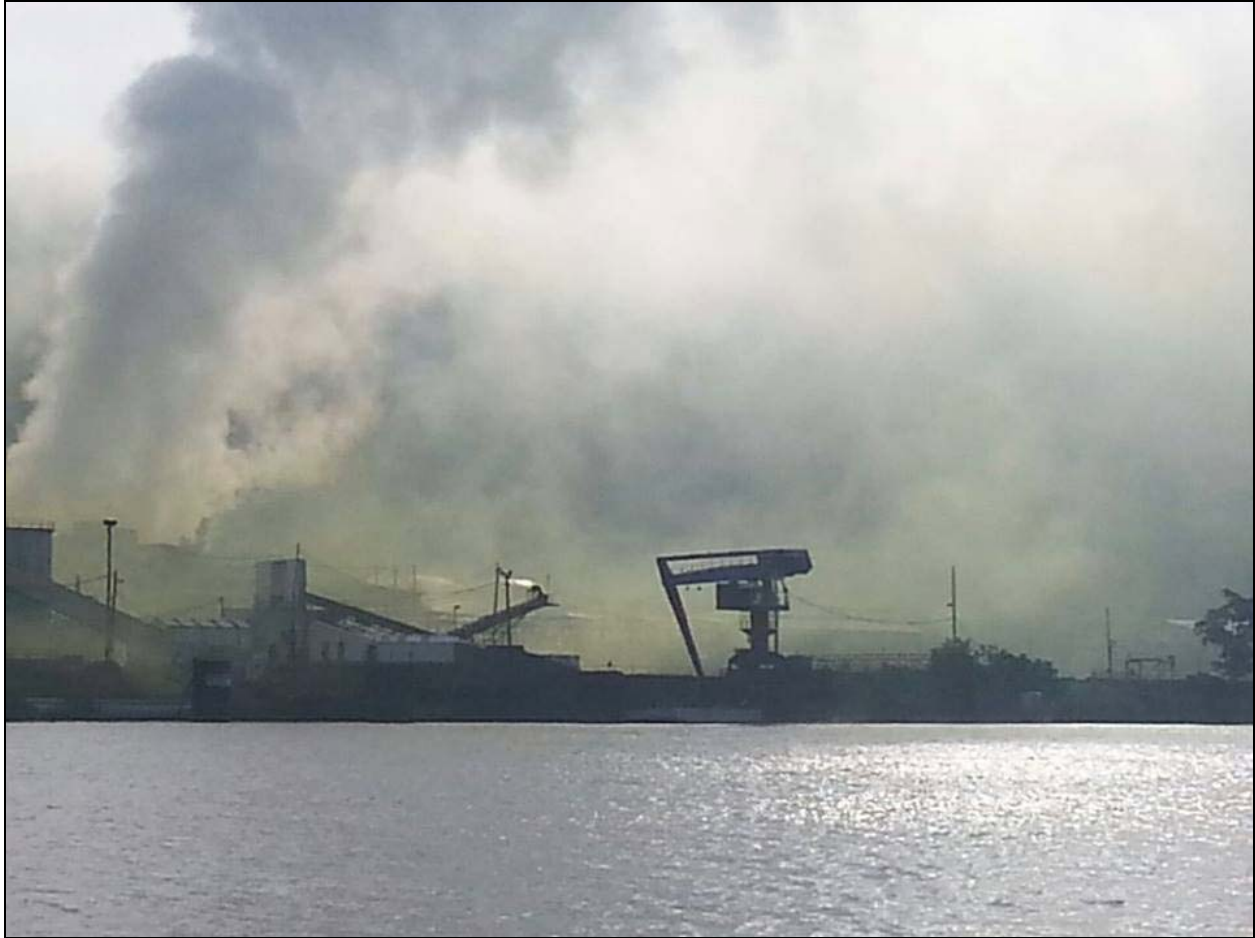
Figure 10 - Close up of the gas leak from the Ohio side of the river
