NATIONAL TRANSPORTATION SAFETY BOARD

Group Chairman's Factual Report

METEOROLOGY

WPR16FA130

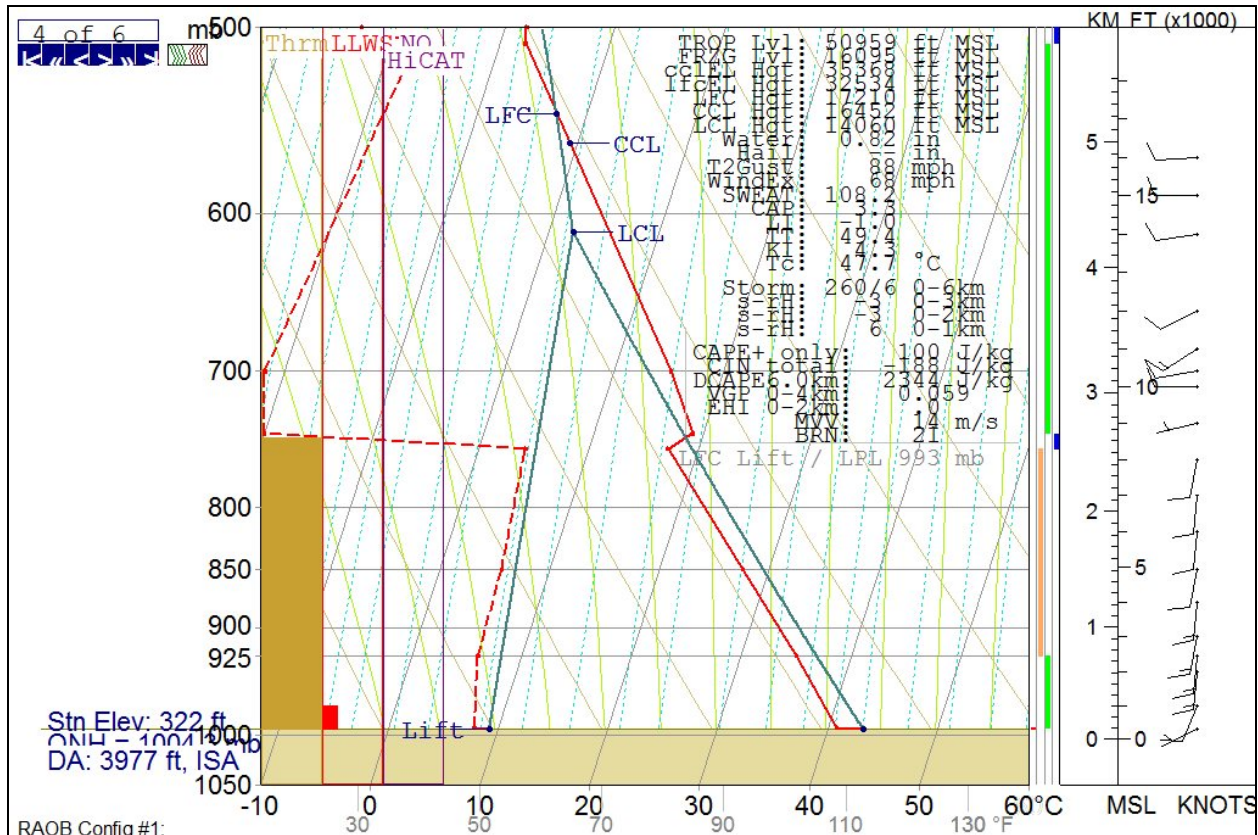
Figure 3 - Yuma Providing Grounds sounding at 1500 MST

The closest upper air sounding to the accident was from U.S. Army Yuma Proving Grounds, Arizona, site number #74004, located approximately 90 miles south from the accident site. A 1500 MST (2200Z) sounding on June 23, 2016 was available and plotted on a standard Skew-T log P diagram⁶ from the surface to 500-hPa or 18,000 feet utilizing RAOB software⁷ and is included as figure 3.

The Yuma sounding depicted a warm and dry low level environment with a surface temperature of 43.2° C (109.8° F), a dew point temperature of 9.2° C (48.6° F), with a relative humidity of 13%. Based on the station elevation of 322 feet and the temperature and dew point provided a density altitude of 3,980 feet. The thermal profile supported strong thermals through 8,500 feet (which are depicted on the left hand side of the diagram in tan). The lifted condensation level (LCL)⁸ was identified at approximately 13,700 feet agl, the convective condensation level (CCL)⁹, and the level of free convection (LFC)¹⁰ at approximately 16,100 feet agl. The sounding did not indicate any specific cloud layers and no level below 18,000 feet had a relative humidity greater than 30%. The freezing level was identified at 16,100 feet and the sounding analysis did not support any icing conditions below 18,000 feet.

The Lifted Index¹¹ was -1.0, and K-index¹² of 4.3, which indicated a weak or low risk of thunderstorm development over the region. The thermal structure indicated an unstable low-level environment below 8,000 feet agl, where the temperature decreased at a rate of 3° C per 1,000 feet. With the first layer below 50 feet indicating a super-adiabatic lapse rate which exceeded the 3° rate, this often occurs with intense surface heating and can produce significant updrafts or thermals of rising air and dust devils.

The sounding wind profile indicated a surface wind from 240° at 5 knots with wind direction backing to the south (counterclockwise with height) with a slight increase in wind speed to 14 knots at 2,600 feet agl. The wind shifted to the west immediately above 8,000 feet where a slight temperature inversion was noted, where temperature increased in height and the lapse rate became closer to the dry-adiabatic rate. The mean 0 to 6 kilometer or 18,000 feet wind was from 230° at 8 knots, and the level of maximum wind was identified at 32,000 feet with the wind from

180° at 32 knots. In the lowest 1,000 feet a light low-level wind shear (LLWS) was indicated due to the change in wind direction and speed; however, no other strong vertical shears were noted to indicate any significant turbulence. Figure 4 below provides the observed height, pressure (Pres), temperature (T), dew point temperature (Td), relative humidity (RH), wind direction and speed, clear air turbulence (CAT), LLWS, and icing potential through 10,000 feet.

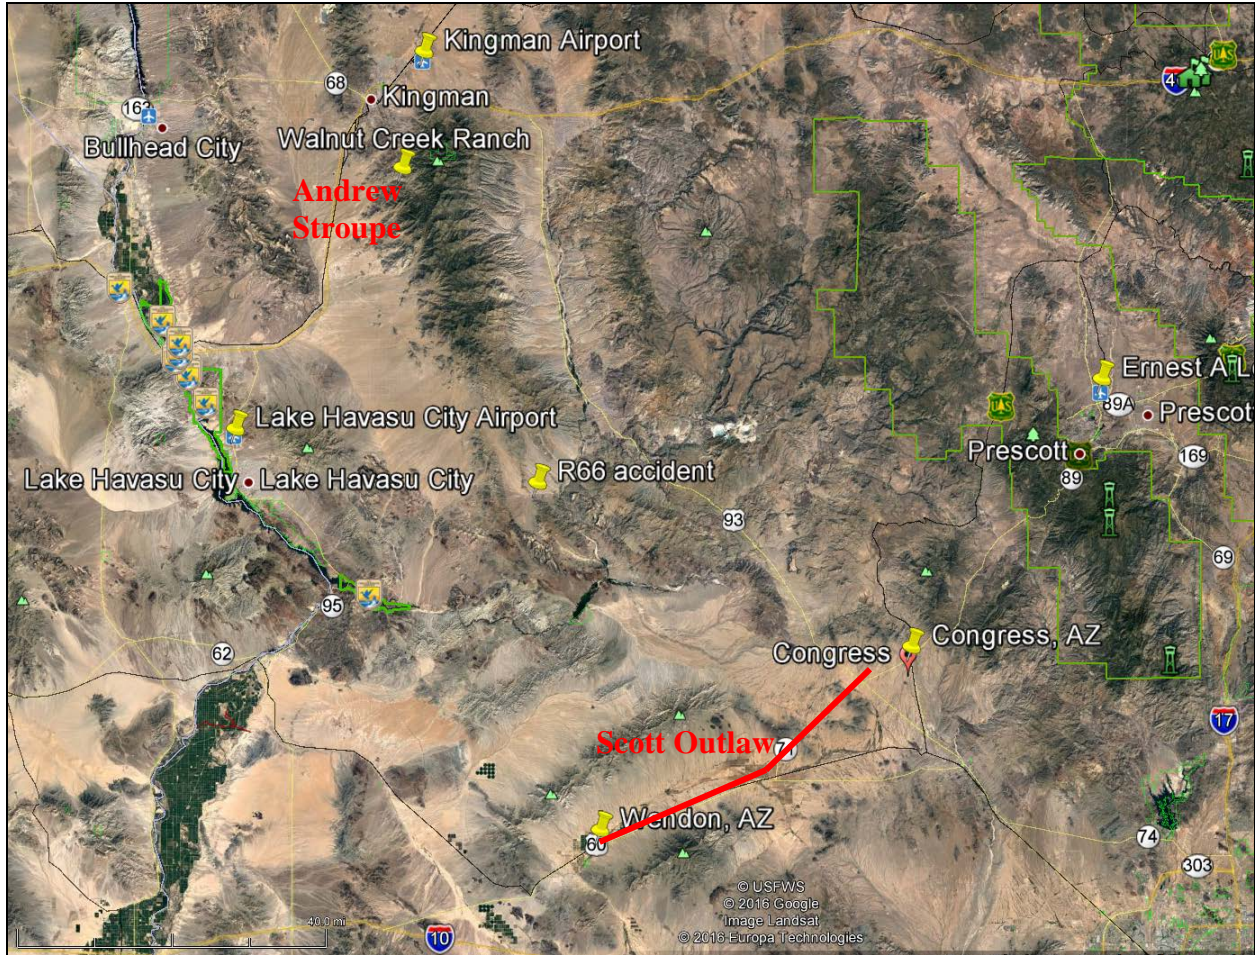
Figure 11 - Google map of witness and related airport locations

There were two aviation professionals who provided statements regarding the weather conditions they encountered on June 23, 2016 over southwestern Arizona. Both of the individuals were familiar with the operation of Robinson helicopters and considered reliable witnesses of the environmental conditions. The general locations of their observations are included in the map in figure 11.

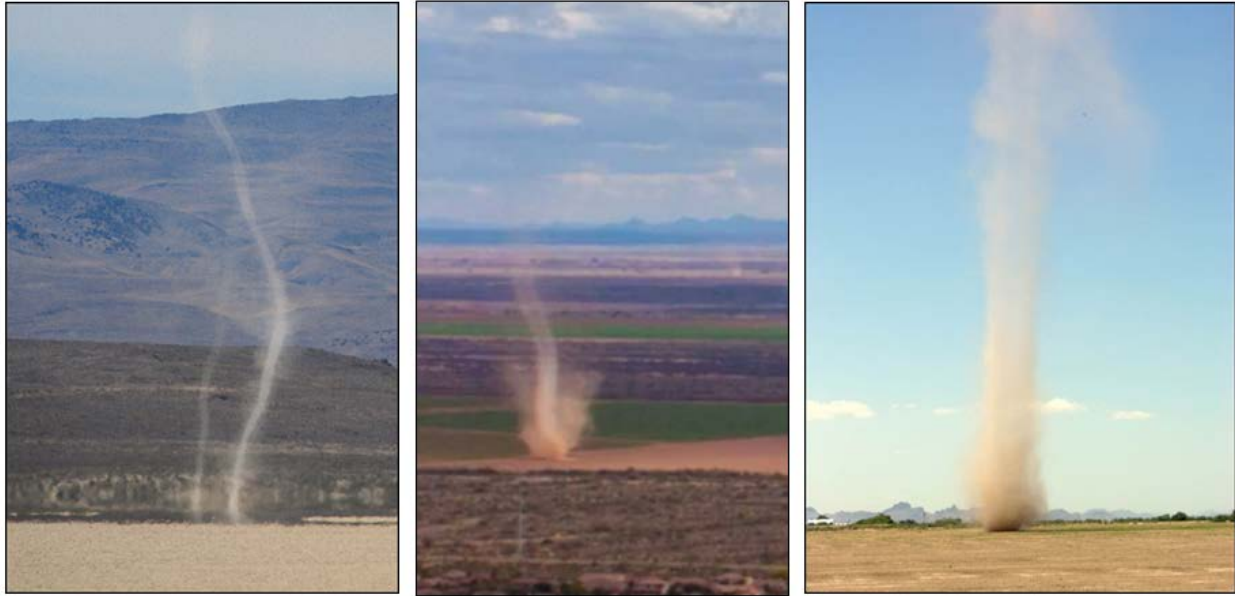
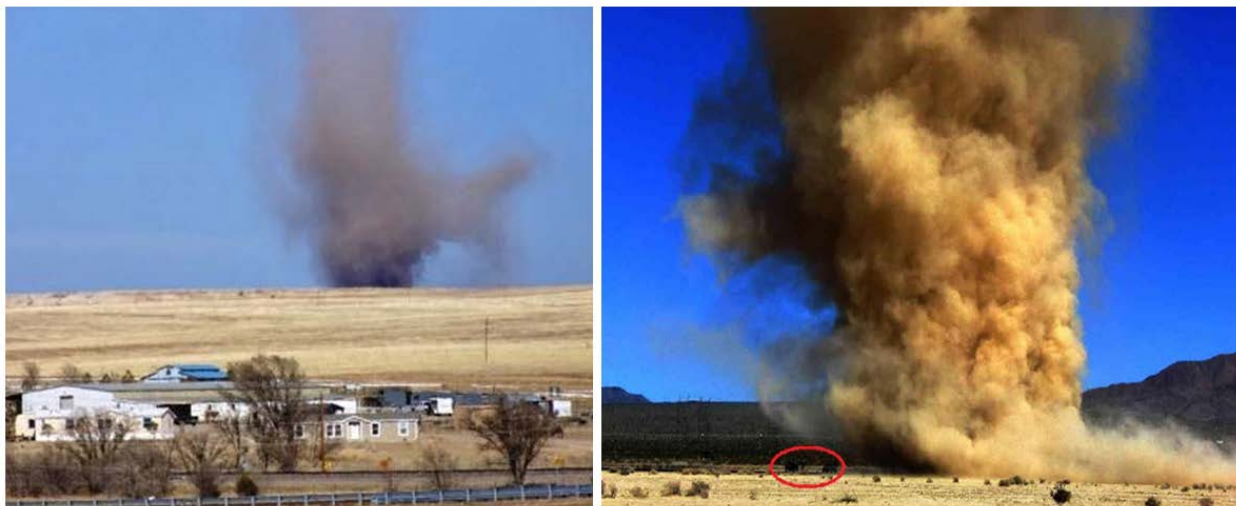
Several photographs of dust devils are included as figures 12 and 13, showing their various size diameters, vertical extent, and circulation with dirt debris. The images show vertical columns with a diameter ranging from several feet to several hundred feet, dwarfing houses, telephone and power poles in the bottom examples.

Figure 12 - Dust Devils from small barely visible tubes to well defined vortices

Figure 13 - Large Dust Devils
