# National Transportation Safety Board

**WEATHER STUDY**  
**ANC16FA023**

Location: Skagway, Alaska

Aircraft: Airbus AS350B2; N94TH

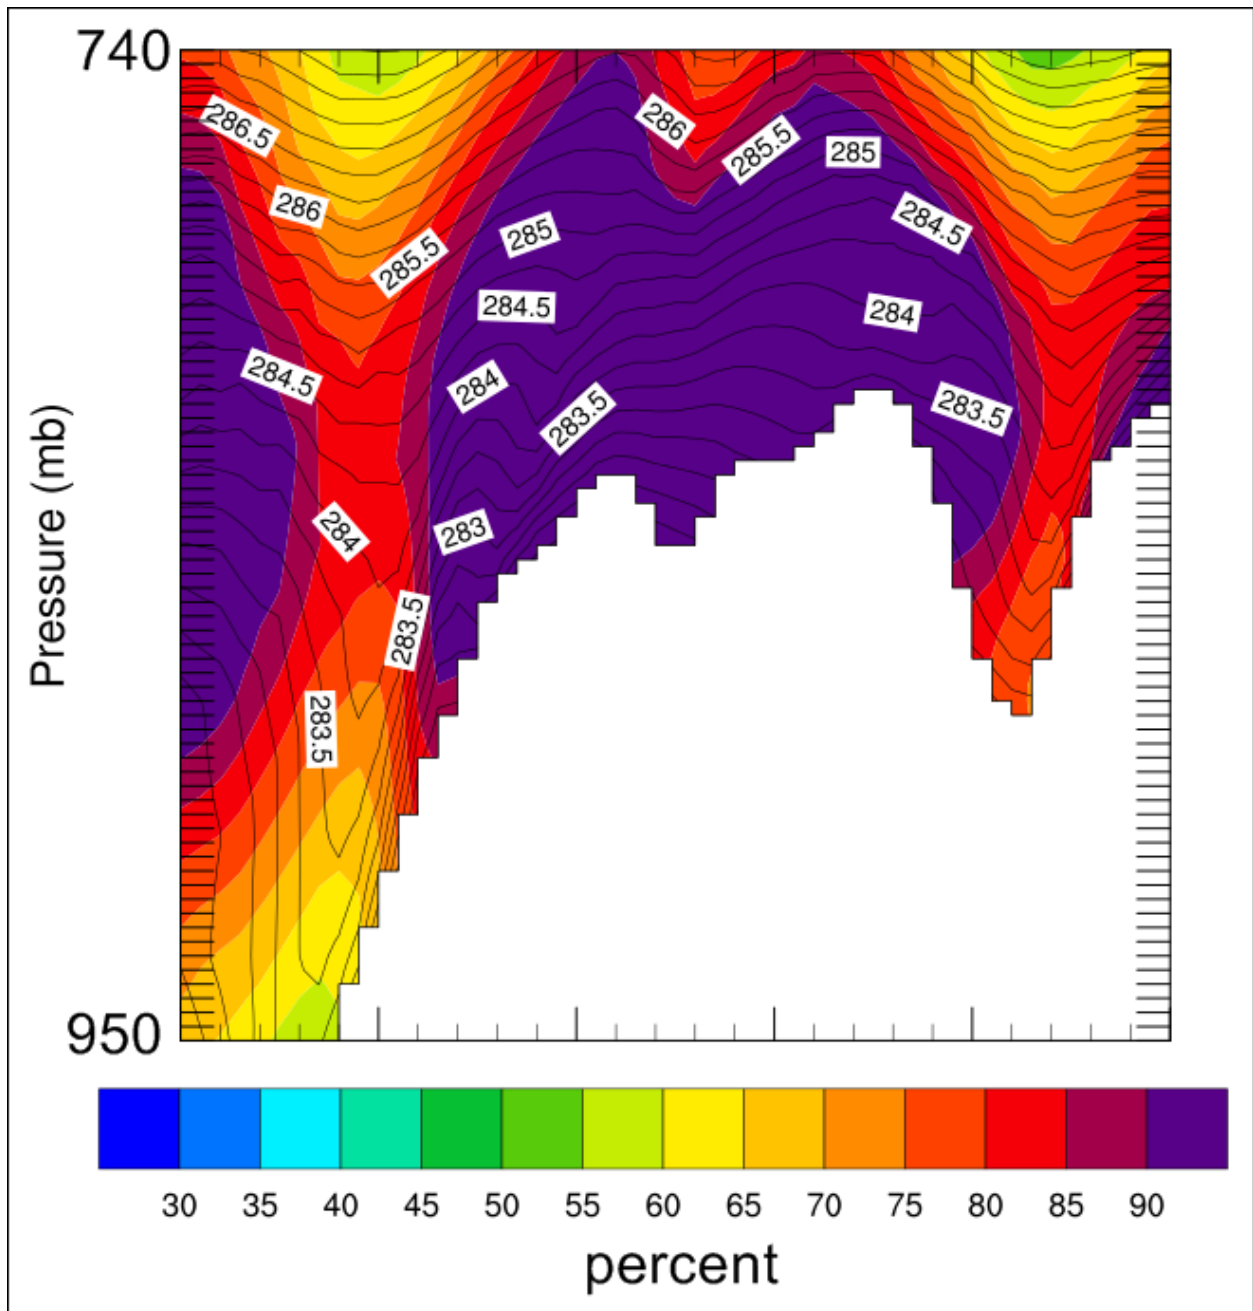
**Figure 7** – WRF simulation of relative humidity around the accident location (west-to-east cross-section along the latitude 59.450278°N). Black contours are lines of constant potential temperature (degrees Kelvin)..

The WRF run also provided information pertaining to horizontal wind, relative humidity and vertical velocity for the accident location. Figures 4-9 present these data in graphical form. For all WRF images, the center of the horizontal axis is the accident location (59.450278°N, 135.20556°W). These data depict horizontal wind magnitudes greater than 30 knots, relative humidity greater than 90 percent, and maximum vertical velocities in the area around +/-800 feet per minute.

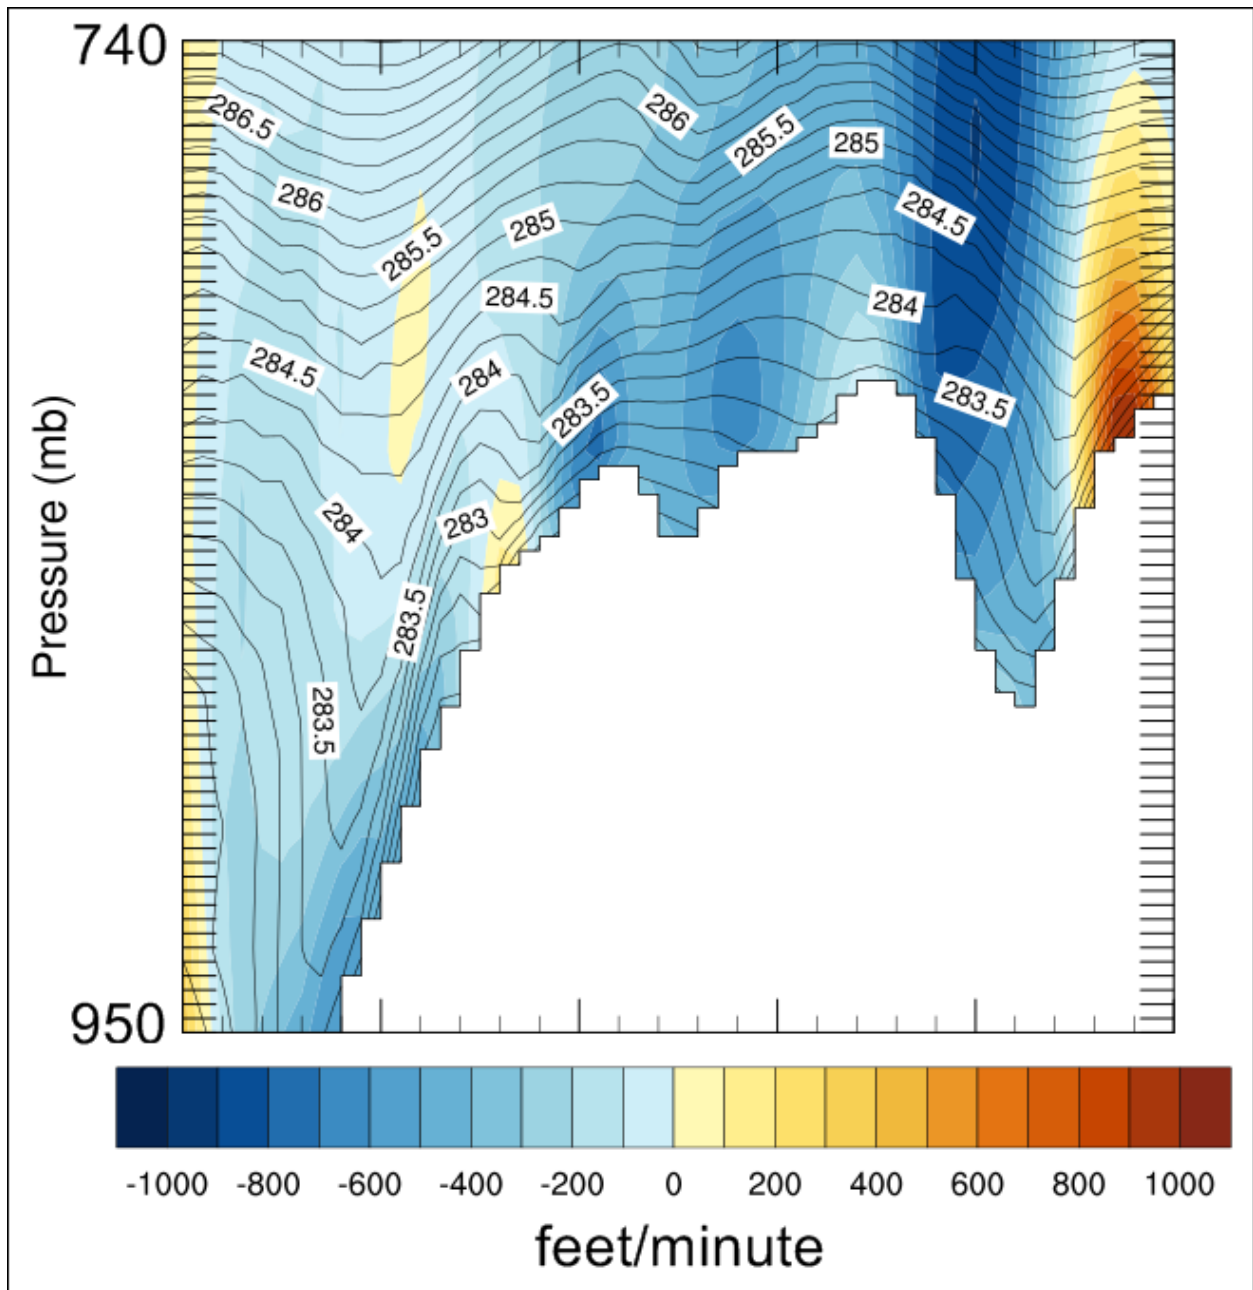
**Figure 9** – WRF simulation of vertical velocities around the accident location (west-to-east cross-section along the latitude  $59.450278^{\circ}\text{N}$ ). Black contours are lines of constant potential temperature (degrees Kelvin).

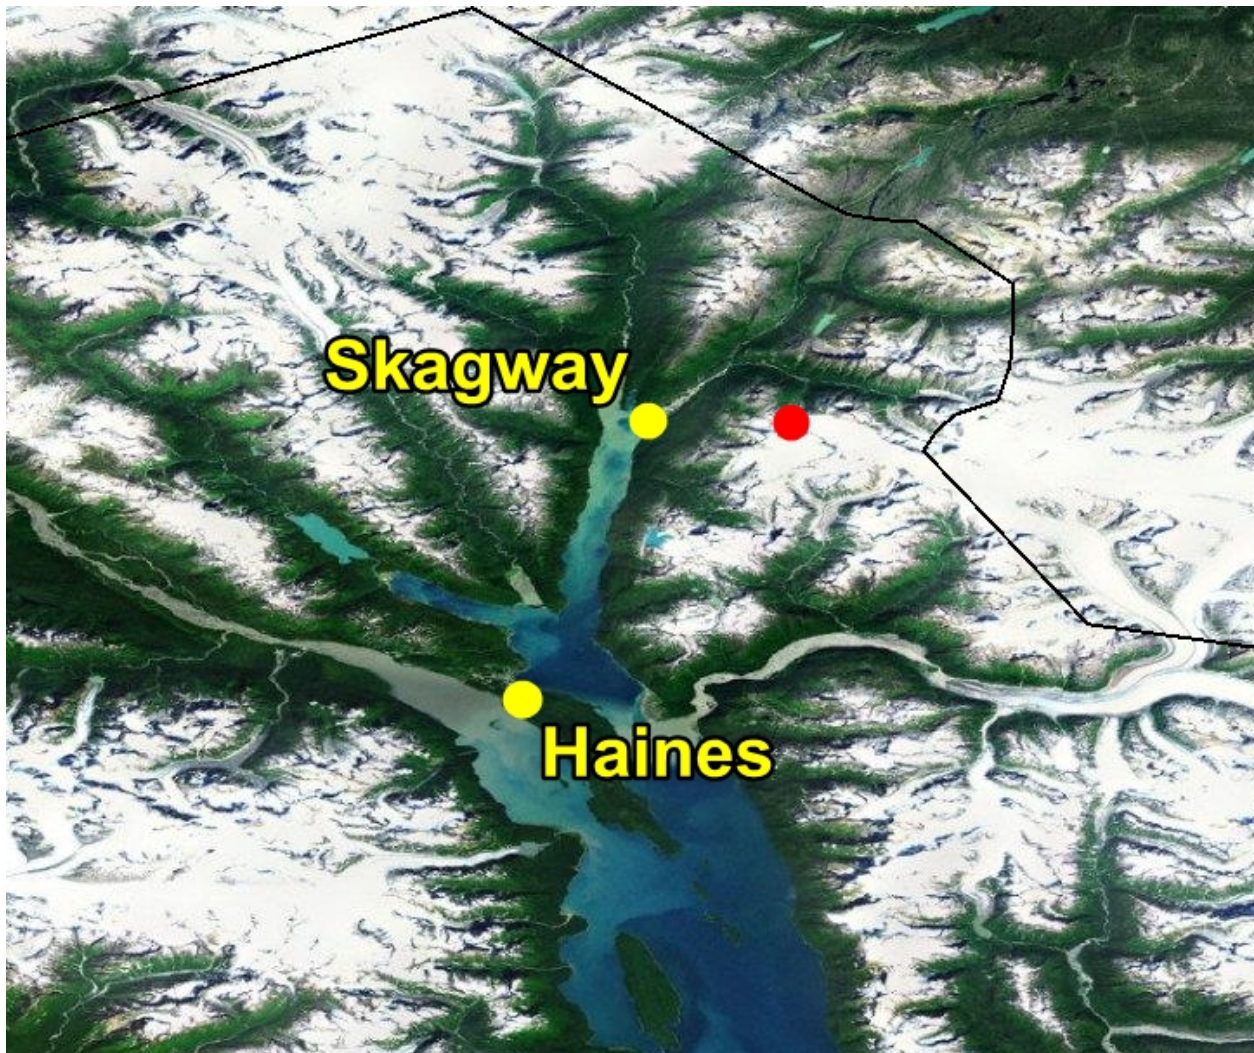
**Figure 12** – Map of the FAA Haines and Skagway weather cameras. Accident location is denoted by red dot.

Images from the Skagway and Haines FAA weather cameras were retrieved for times surrounding the accident time. The Skagway northeast-facing camera did not have a view in the direction of the accident location and captured imagery farther north. Figure 14 identifies cloudy conditions north of the accident location at about 1855 AKDT. The Haines north-facing camera did have a view in the direction of the accident location and between 1850 AKDT (figure 16) and 1900 AKDT (figure 17) identified cloudy conditions in that direction.

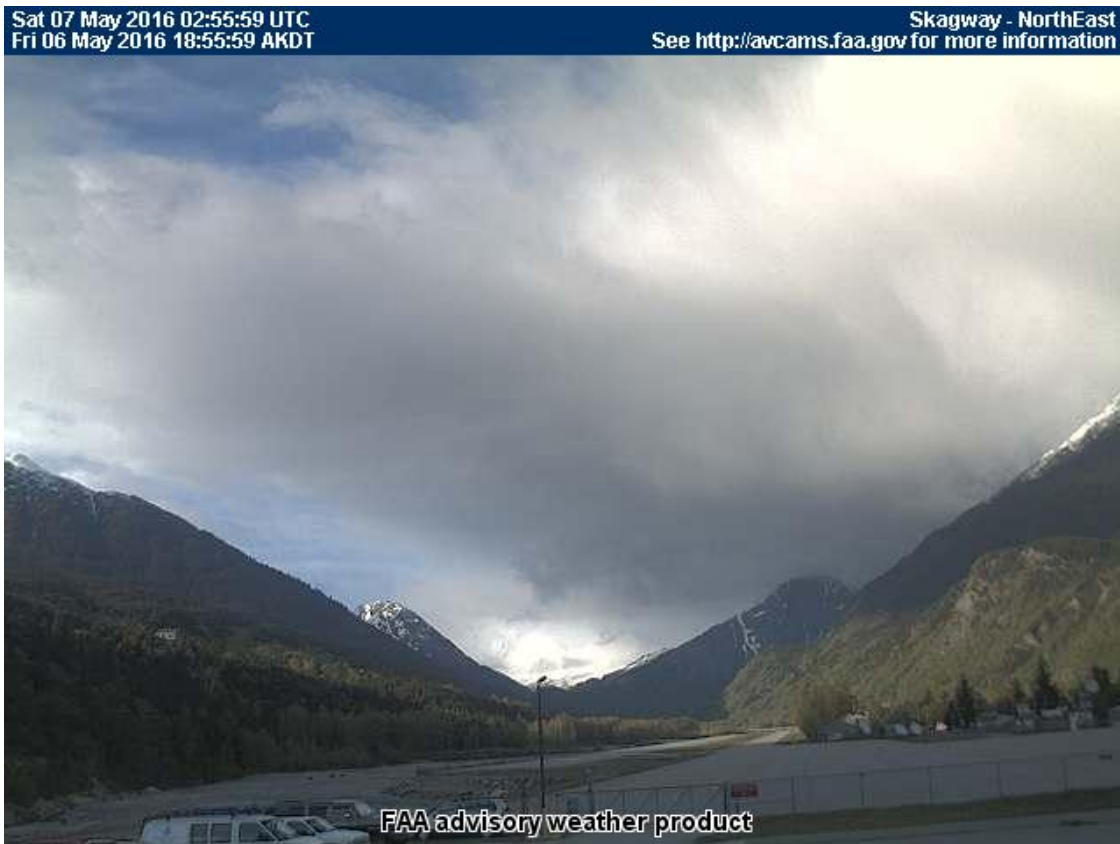
Figure 14 – Northeast-facing Skagway camera image at about 1855 AKDT.

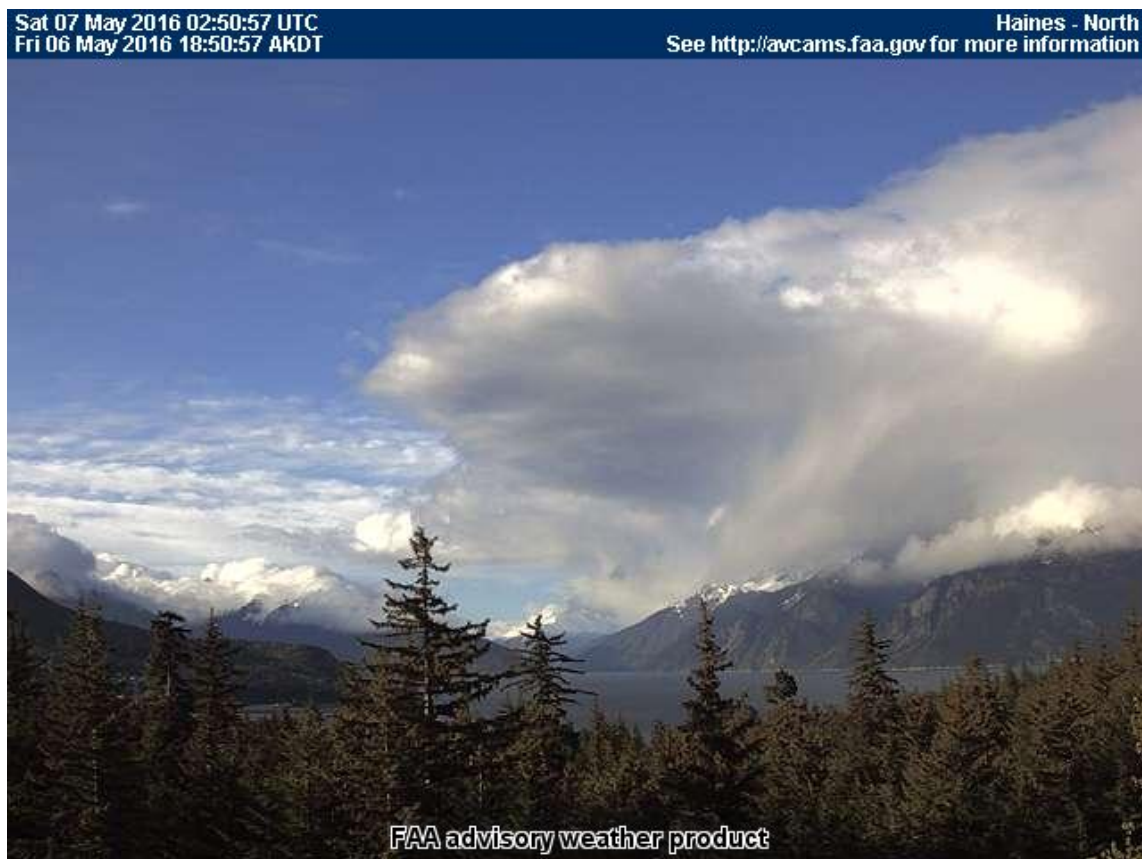
Figure 16 – North-facing Haines camera image at about 1850 AKDT.

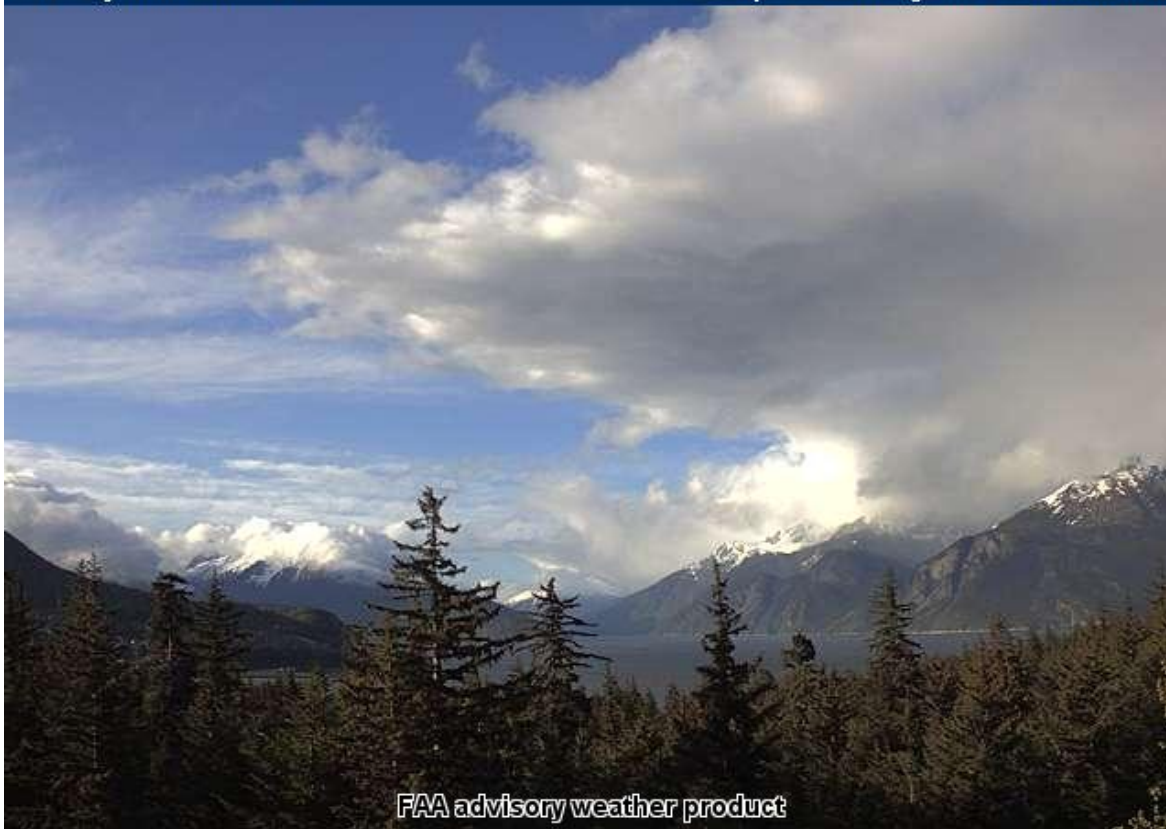
**Figure 17** – North-facing Haines camera image at about 1900 AKDT.
