NATIONAL TRANSPORTATION SAFETY BOARD
Vehicle Recorder Division
Washington, DC 20594

Witness Video and Audio

Specialist's Factual Report
By Bill Tuccio, Ph.D.

Location: Panhandle, Texas
Date: June 28, 2016
Trains: BNSF, Eastbound Train, S-LACLPC1-26K
BNSF, Westbound Train, Q-CHISBD6-27L
NTSB Number: DCA16FR008

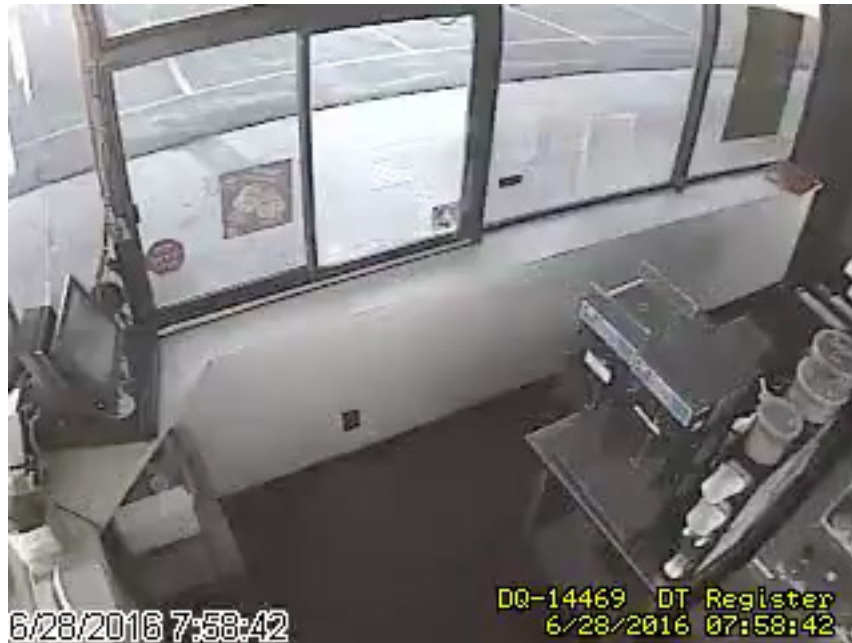
Figure 1. Dairy Queen security camera field of view.

The National Transportation Safety Board (NTSB) Vehicle Recorder Division received two witness videos from a security camera installed in a Dairy Queen retail store. The camera's field of view is shown in figure 1. Figure 2 shows the position of the Dairy Queen relative to the accident and grade crossing. The grade crossing shown in figure 2 was about 1,825 feet from the Dairy Queen and the point of collision of the two trains was about 4,540 feet from the Dairy Queen. Recorded video was not pertinent to the investigation; as such, only the recorded audio was considered by this report.

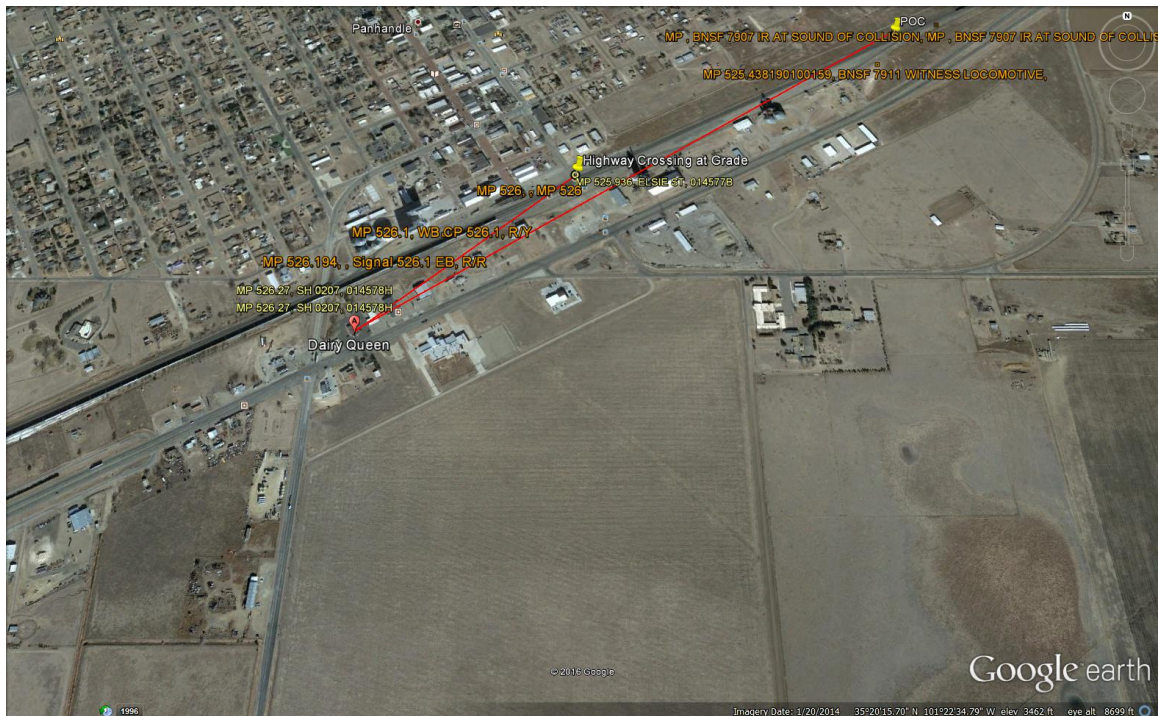
Figure 2. Location of Dairy Queen relative to accident-relevant points.
