**NATIONAL TRANSPORTATION SAFETY  
BOARD  
WASHINGTON, D.C**

**WITNESSES 4 - VIEWING ANGLES STUDY  
FOR WITNESS #32**

- A. ACCIDENT: DCA-96-MA-070
- Location: East Moriches, New York  
Date: July 17, 1996  
Time: 2031 Eastern Daylight Time  
Airplane: Boeing 747-131, N93119

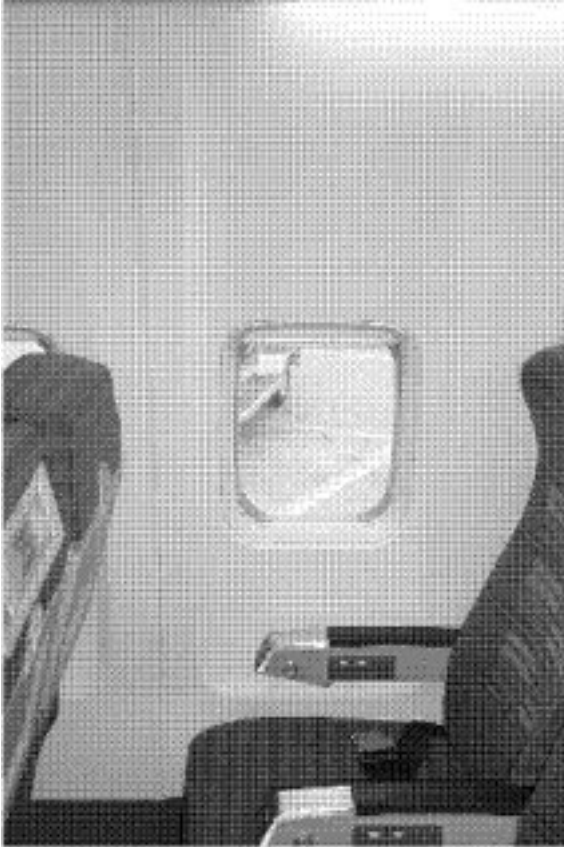
Figure 1: A digital photograph showing seat 5F and the associated window

On June 9, 2000, a US Airways Boeing 737-400 series airplane was used to determine the viewing angles from the window next to seat 5F. This 737-400 series airplane was equipped with three rows of first class seats. Row 5 was the second row in the coach class.<sup>1</sup> The window for seat 5F was directly aligned with the seat and therefore was not obstructed by the seat back in front or behind. (See Figure 1) This window was the ninth window counting from the front of the airplane. When looking at the window adjacent to seat 5F, the engine was visible in the window behind. (See Figure 2) A photograph showing the view straight out the window adjacent to seat 5F is shown in Figure 3.

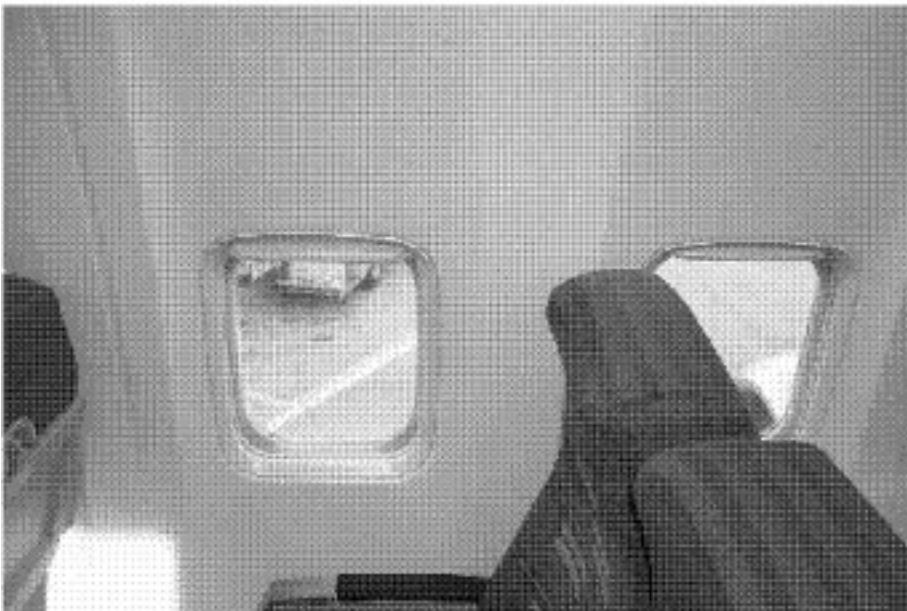
Figure 2: A digital photograph showing the window adjacent to seat 5F and the engine visible in the window behind.

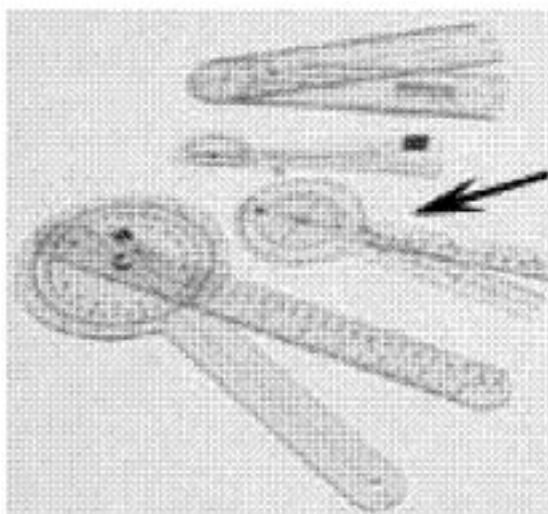
Figure 4: A picture of a plastic hand-held goniometer.

An Abney hand level and a hand-held goniometer' (See Figure 4) were the tools used to measure the vertical and horizontal viewing angles, respectively.

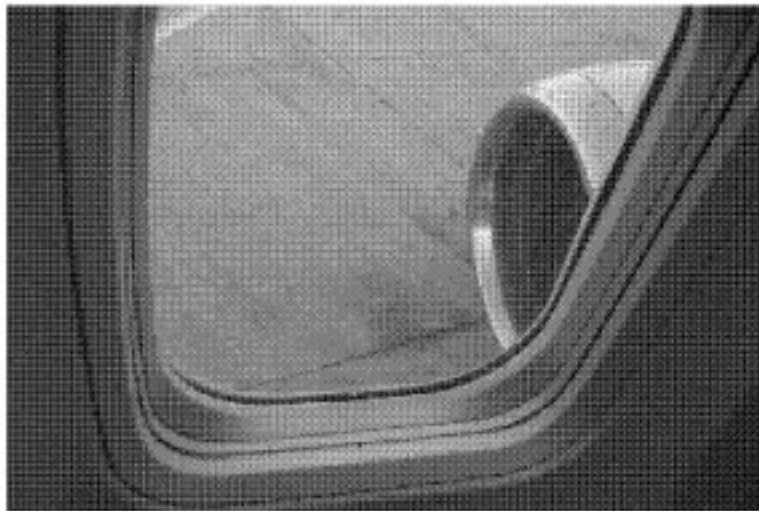
Figure 7: Another digital photograph showing the engine looking downward and backward from the window in seat 5F.

The viewing angle to the bottom edge of the engine was approximately 45 degrees down (from horizontal) while the viewing angle to the bottom edge of the window was approximately 60-65 degrees down. The higher the point of reference (viewing position), the greater the viewing angle downward to the edge of the window. Therefore, the most downward view from this window was approximately 60-65 degrees (from horizontal). The engine was not obstructing the view from 45 degrees downward to approximately 60-65 degrees downward. Although a photograph showing the spacing between the engine and the airplane body was not possible, Figure 5 through Figure 7 do illustrate the location of the engine in reference to seat 5F.
