## 1.0 Wreckage Diagram

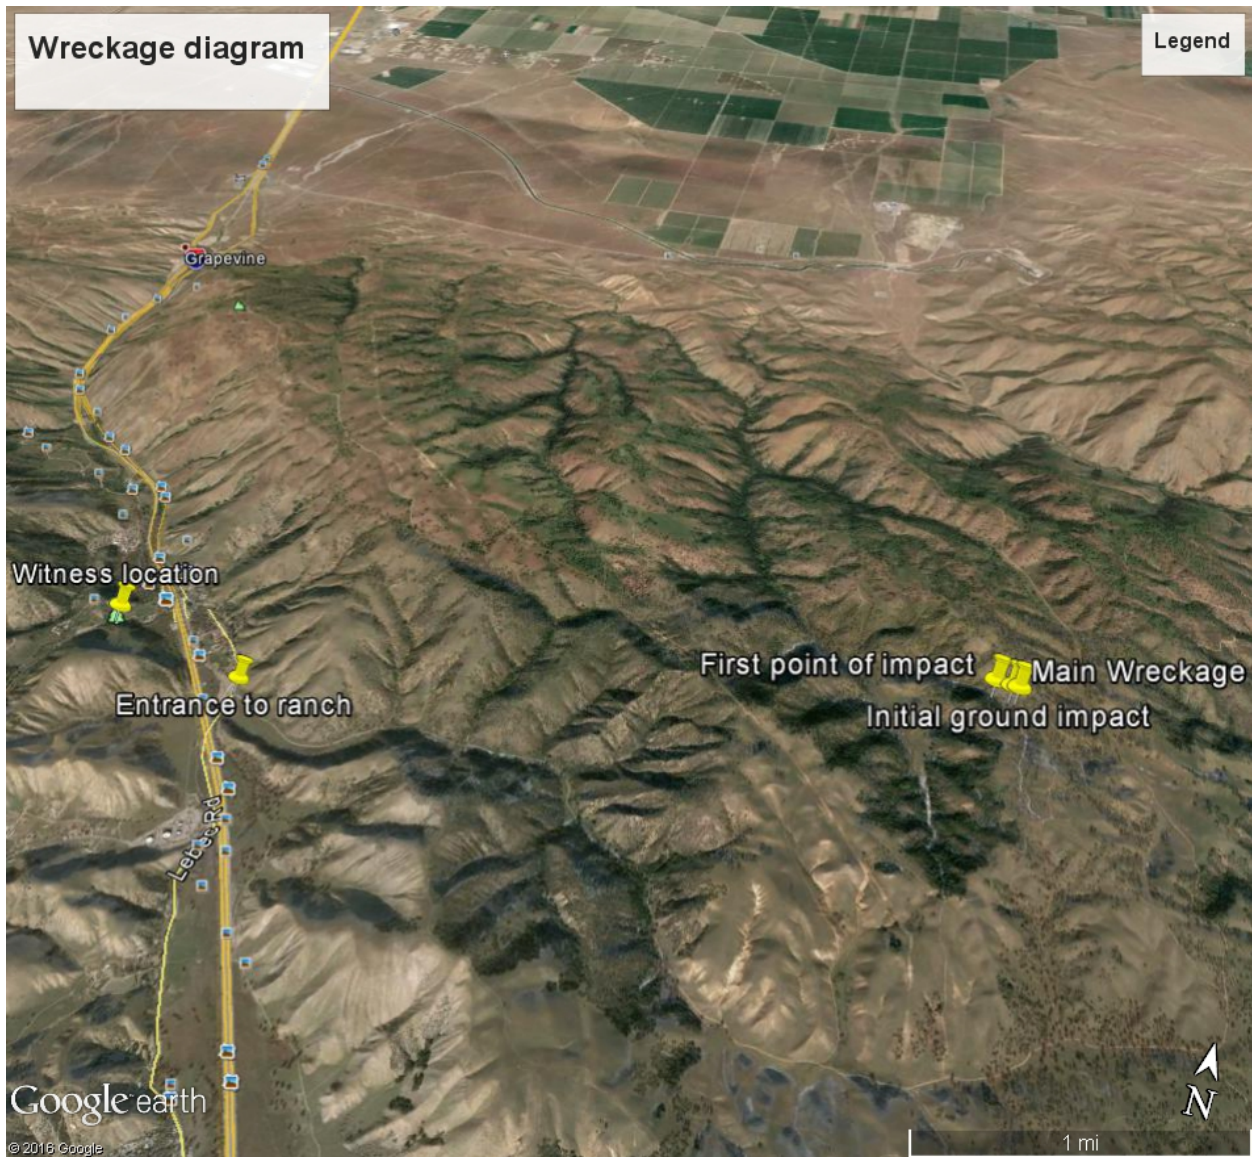
Witnesses report seeing a low flying aircraft flying over the interstate, about 4 miles from the accident site. The airplane impacted tree covered terrain on a 090 heading at about 4,000 mean sea level (msl).

Figure 1: Google Earth view of the witness locations and accident site
