lssued: 3/17/2022 Preliminary Report HWY22FH004

## Multivehicle Collision at Signalized Intersection

North Las Vegas, Nevada January 29, 2022

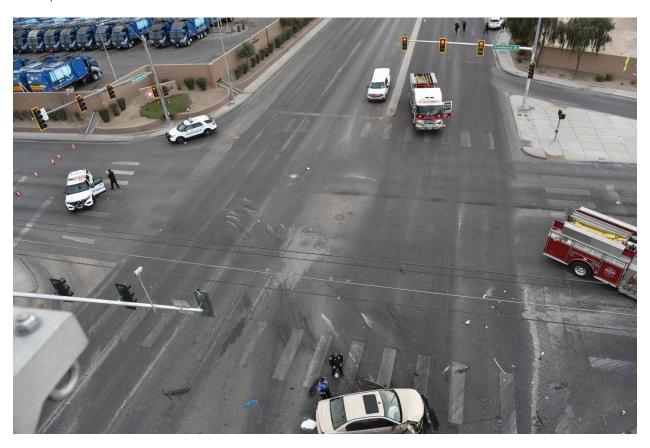
**Figure 1.** Intersection of North Commerce Street and West Cheyenne Avenue, looking west. (Source: North Las Vegas Police Department)

North Commerce Street is a two-lane asphalt road with one southbound lane, one northbound lane, and a center turn lane, traveling through an industrial area. At the crash location, the roadway is straight with a slight upgrade as it approaches the intersection. Two 35-mph speed limit signs are posted on North Commerce Street in the crash area. West Cheyenne Avenue is a six-lane asphalt road with three westbound

lanes, three eastbound lanes, and center turn lanes that allow for turns onto North Commerce Street in the north or southbound directions. At the crash location, the roadway is straight and level. The speed limit on West Cheyenne Avenue in this area is 50 mph.

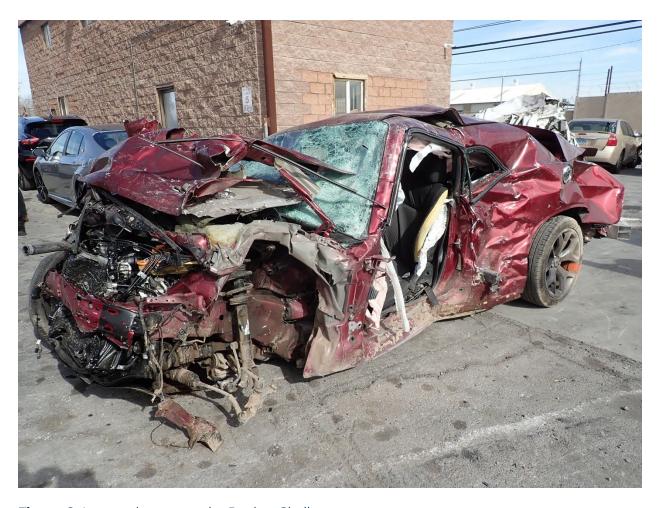
**Figure 2.** Impact damage to the Dodge Challenger.

On Saturday, January 29, 2022, about 3:12 p.m. Pacific standard time, a 2018 Dodge Challenger passenger car, occupied by a 59-year-old driver and a 46-year-old passenger, was traveling north on North Commerce Street in North Las Vegas, Clark County, Nevada. The Dodge was approaching the intersection with West Cheyenne Avenue at a recorded speed of 103 mph. The intersection is controlled by a traffic signal light, and the approach for both roadways include multiple lanes for throughtraffic and for vehicles making turning maneuvers (figure 1). The Dodge entered the intersection against a red traffic signal, causing a multivehicle collision. Impact damage to the Dodge is shown in figure 2.
