SURVIVAL FACTORS ATTACHMENT

Alabama Uniform Traffic Crash Report 1681939

HWY21MH009

ALABAMA UNIFORM TRAFFIC CRASH REPORT

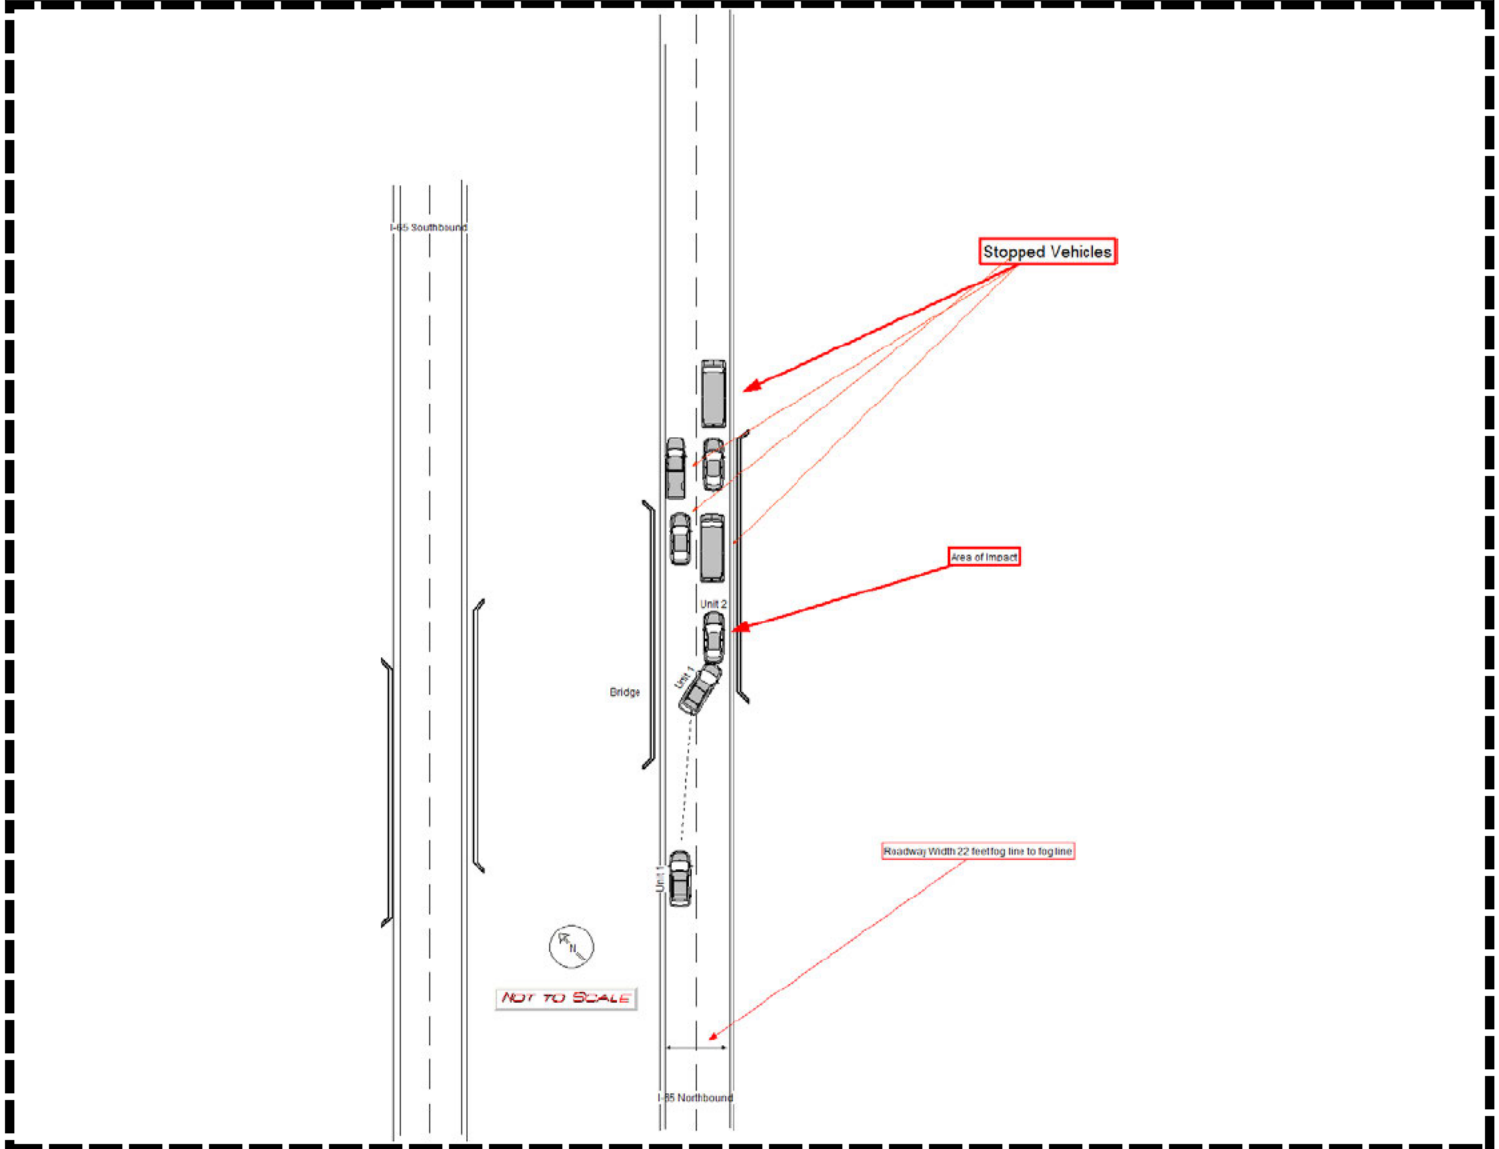
DIAGRAM

Unit 1 was northbound on I-65 in the left lane. Unit 2 was northbound on I-65 in the right lane. Traffic ahead of unit 2 came to a stop because of crashes ahead. Unit 1 took evasive action as she was crossing the bridge moving from the left lane to the right lane and colliding into the rear of unit 2. It was raining at the time of the crash and there was reduced visibility. The blood draw was taken as a result of a crash that happened following this crash.
