**HIGHWAY FACTORS GROUP CHAIRMAN'S
FACTUAL REPORT**

**Highway Attachment – Fatal Traffic Collision Report and CHP MAIT
Supplemental Report for Motorcoach Crash on
I-15 S/B on December 19, 2013**

Pala Mesa, California

HWY20FH003

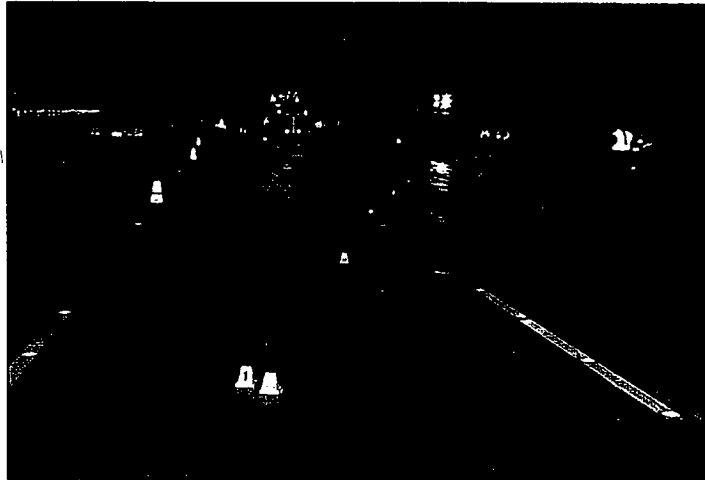
Figure 1. Physical evidence item #1.

Item	Physical Evidence Origin
1	A tire friction mark deposited by the left-front tire of the Van Hool bus

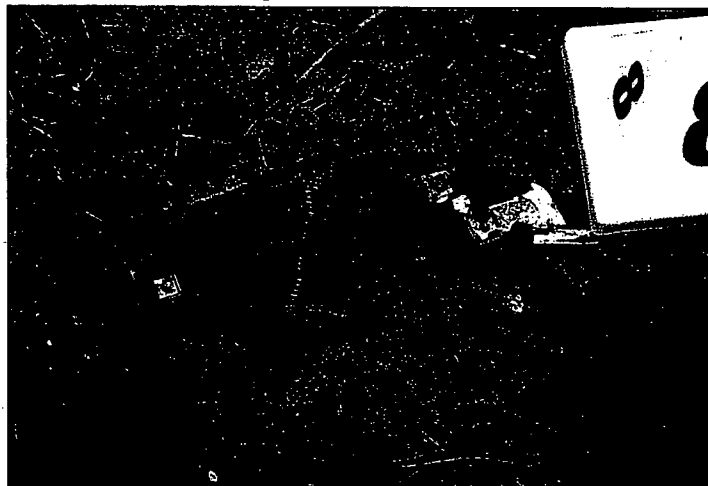
Figure 8. Physical evidence item #8.

8 The amber lens from the rear turn signal on the left side of the Van Hool bus

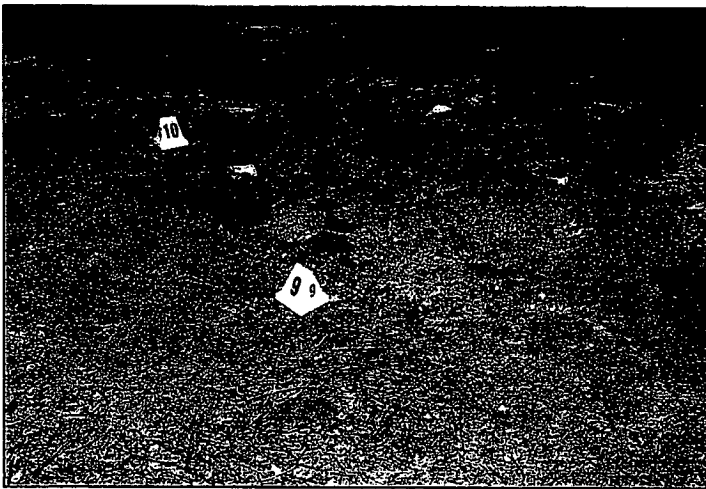
Figure 9. Physical evidence item #9.

9 Fragments of glass from the broken window on the left side of the Van Hool bus
