National Transportation Safety Board

HWY24MH005

VEHICLE RECORDERS

Group Chair's Factual Report

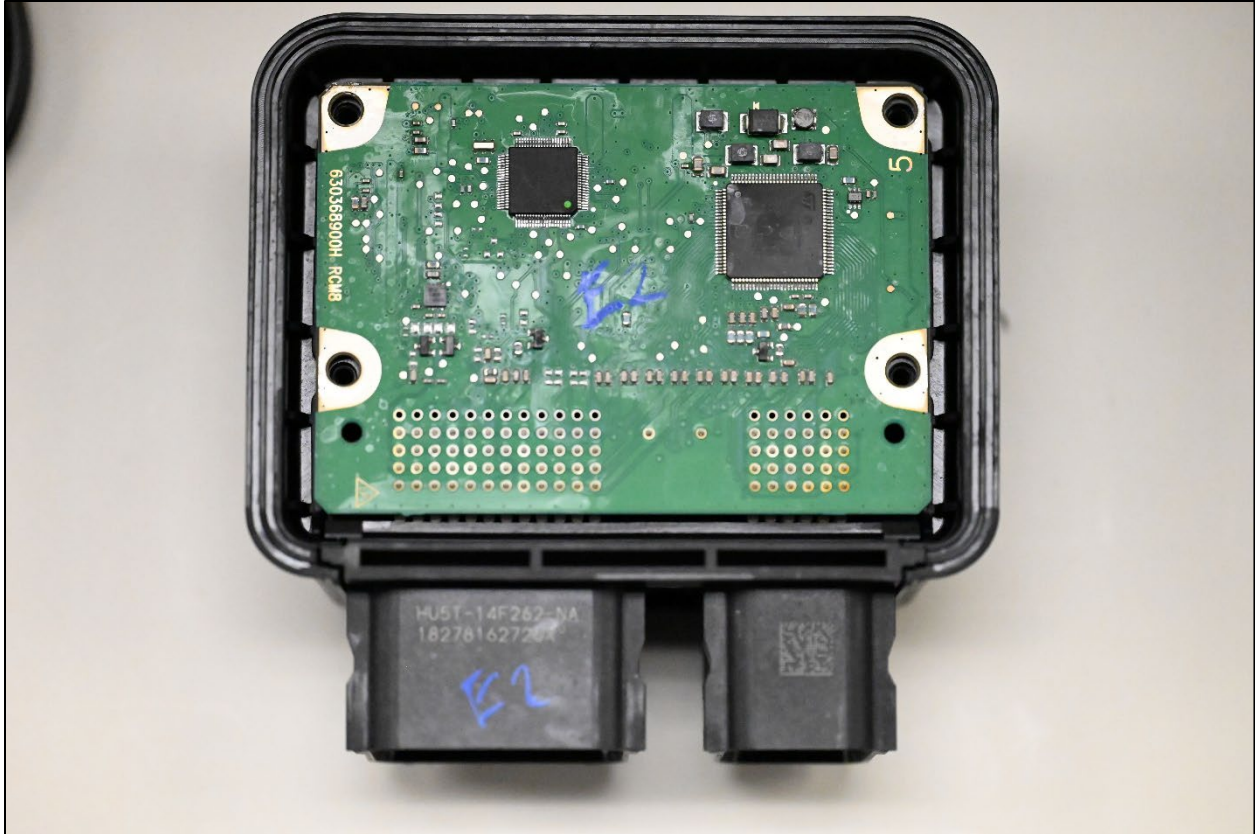
Figure 2: Exemplar 3's MCU installed into Exemplar 2

Validating chip-level component swaps across modules of identical part numbers is a topic that has been validated in previous SAE literature and extensive cases.ⁱ The topic of component transfers across modules of slightly varying part numbers has been explored successfully in various lectures and during the initial research for the previously cited SAE technical paper.ⁱ Due to extensive thermal damage, the exact subject Micro Bird ACM was unknown. To validate the successful transfer of data across these slightly varying non-identical part numbers, further testing was required. The MCU belonging to E3 was installed into E2. The final product of E3's MCU installed into the non-identical E2 module can be observed in Figure 2.

Utilizing a benchtop download methodology, E2 containing the MCU belonging to E3 was imaged successfully. To validate the successful transfer of data across the non-identical modules, the data from the original download of E3 was compared to the data obtained from the download of E2 containing E3's MCU. It was expected that certain information contained in the CDR download reports would be different; date/time, user inputted description, DTCs at time of retrieval, key cycles, and the associated hexadecimal data. However, the overall data related to the stored crash events was expected to remain unchanged; System Status, Deployment Command Data, Pre-Crash Data -5 to 0 sec, and change in velocity (Delta-V) plots.¹

When comparing the pre-crash data downloaded from E3 to the downloaded pre-crash data from E2 containing E3's MCU, the crash data was identical. This testing, along with prior literature and lectures, showed that data could be successfully transferred between ACM of slightly varying part numbers.

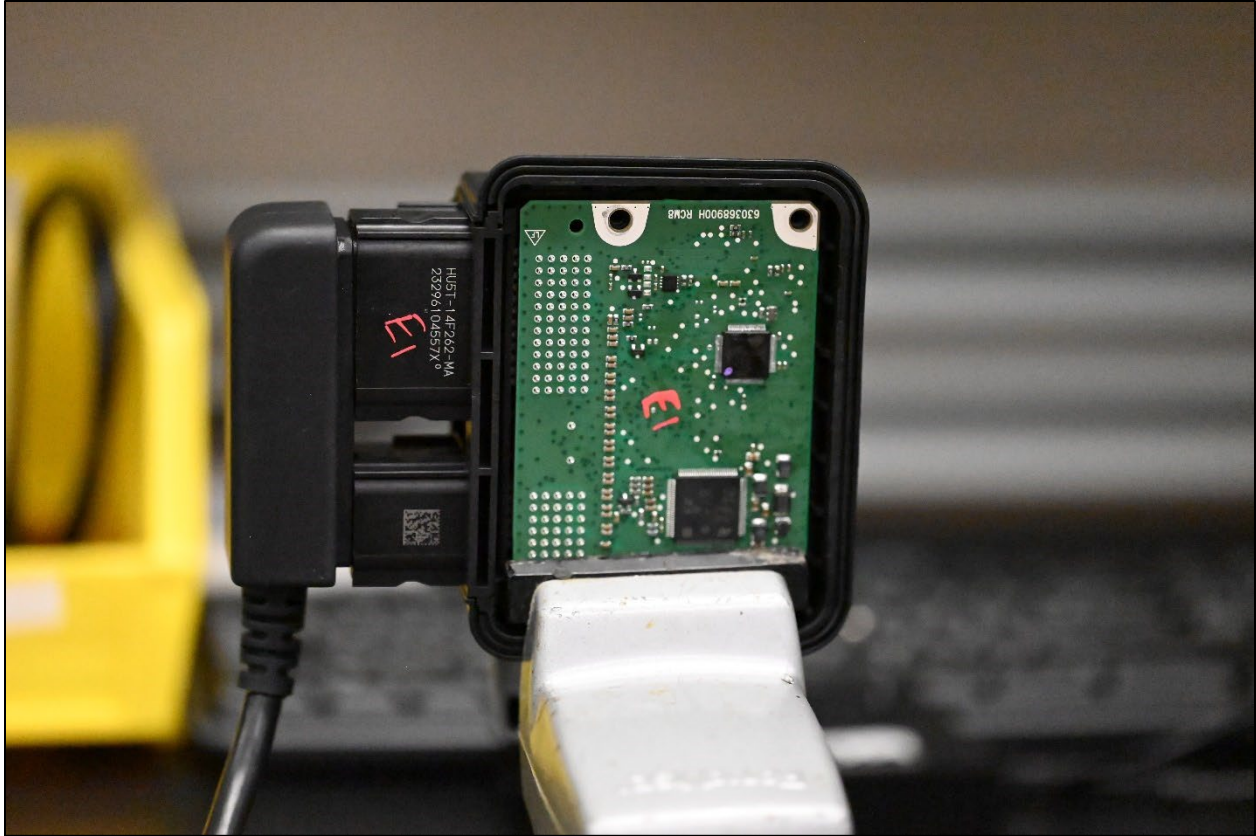
Figure 7: Exemplar 1 containing subject MCU

The Micro Bird's MCU was installed into E1 utilizing heat, flux paste, solder, solder wick, and isopropyl alcohol. A Bosch CANPlus CDR interface with a serial to USB plug and power source, a clamp, a laptop, a direct-to-module cable 823 (1699200428), and an ACM adapter (F-00K-108-387) were utilized. The clamped E1 containing the subject MCU can be observed in Figure 7.

The subject vehicle information and notes were entered into the Bosch CDR software and attempts were made to image the ACM. Due to the various cracks that were determined to have penetrated beyond the layers of the MCU casing, no data was able to be retrieved from the subject MCU.
