NATIONAL TRANSPORTATION SAFETY BOARD

MATERIALS LABORATORY FACTUAL REPORT

Report No. 18-082

Place : Miami, Florida
Date : March 15, 2018
Vehicle : Florida International University UniversityCity Pedestrian Bridge
NTSB No. : HWY18MH009
Investigator : Robert Accetta (HS-20)

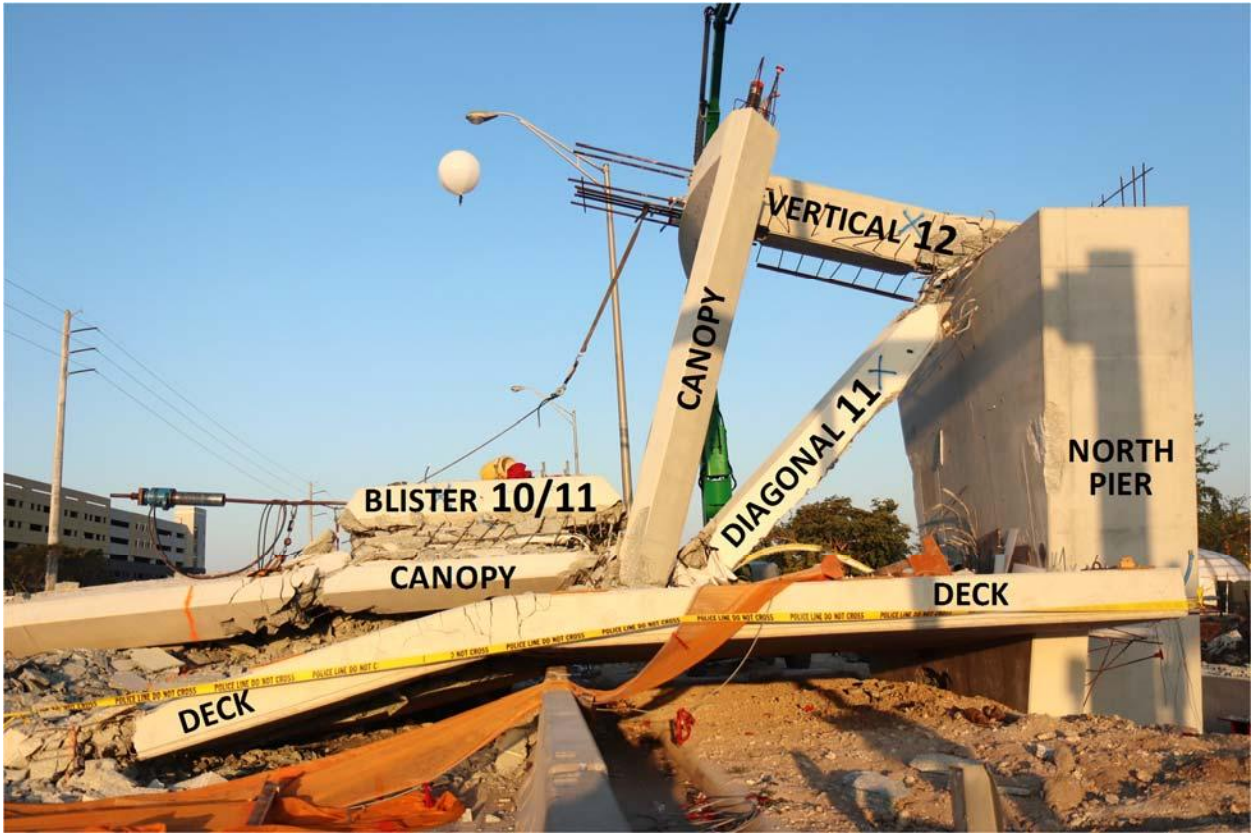
Figure 1: Photo looking west showing the north end of the bridge after collapse.

After the collapse, numerous samples of concrete and steel from the bridge were collected on-site for future materials testing. As shown in Figure 1, the north end of the bridge had sizeable portions of structure largely intact, and the majority of samples came from this area. In this area, the northmost portion of the bridge containing Diagonal 11, Vertical 12, and the canopy between those two members had rotated 90 degrees counterclockwise, as viewed looking west, from the original intact bridge position.

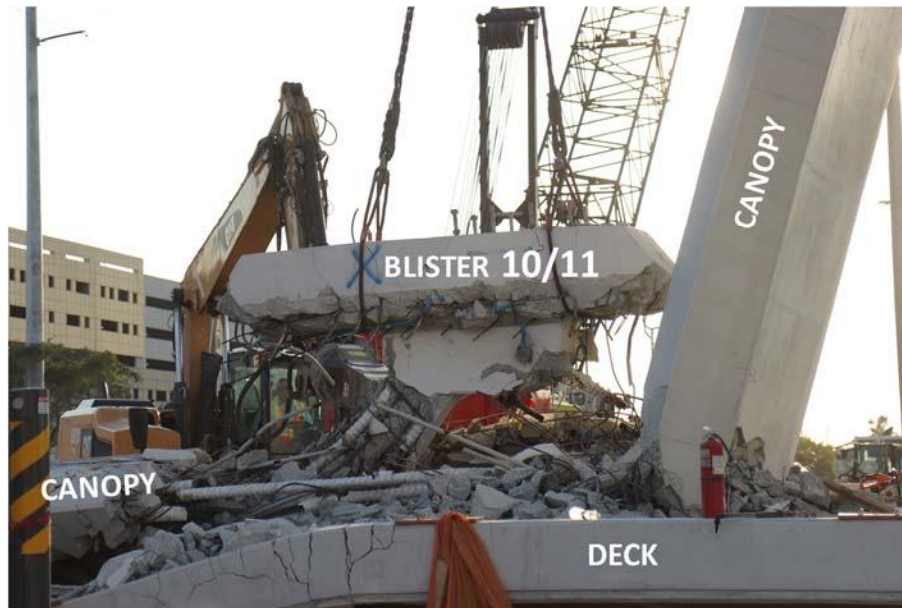
Figure 2: Photos looking west showing the removal via crane of Diagonal 11 (top) and Blister 10/11 (bottom).

- Diagonal 11 (top image, Figure 2)
- Blister 10/11 (bottom image, Figure 2)
- Vertical 12 (Figure 3)
- The northmost portion of the deck that included the nodal region where Diagonal 11 and Vertical 12 met the deck (Figures 4-7)

Diagonal 11 was obtained by torch cutting the PT rods at the top end of the member, then lifting it via crane. Blister 10/11 was obtained by jackhammering the concrete along the bottom edge to separate it from the top of the mating canopy, torch cutting the PT rods and reinforcing bars along the bottom of the blister, then lifting it via crane.

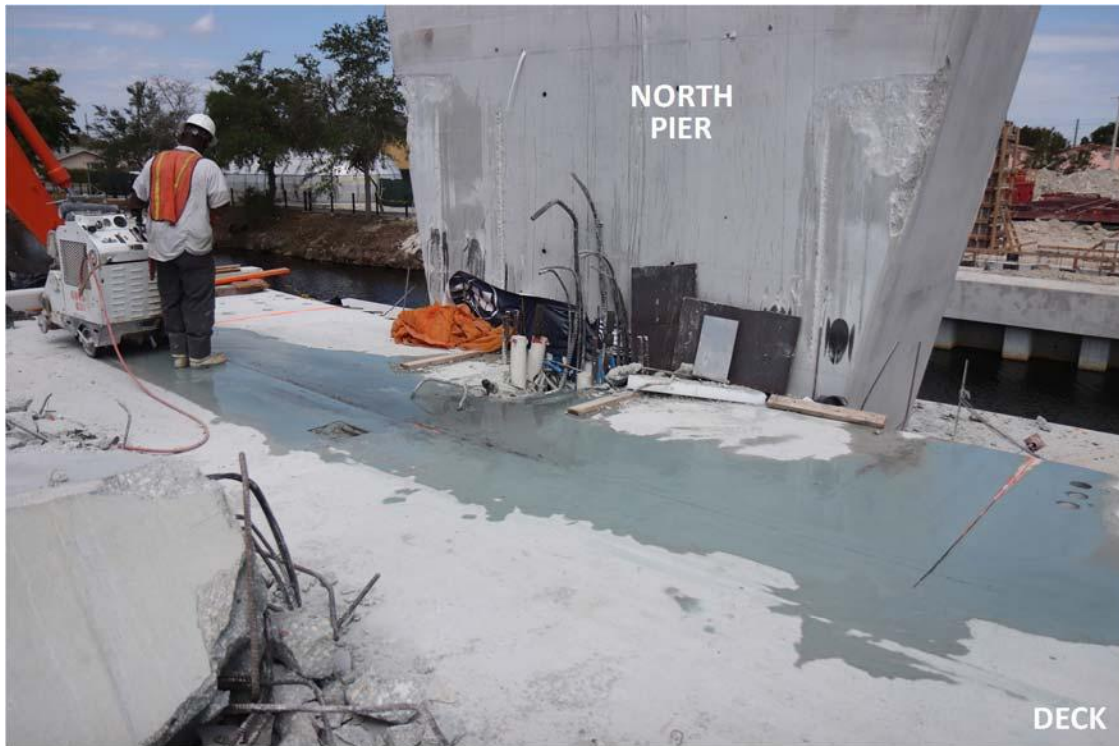
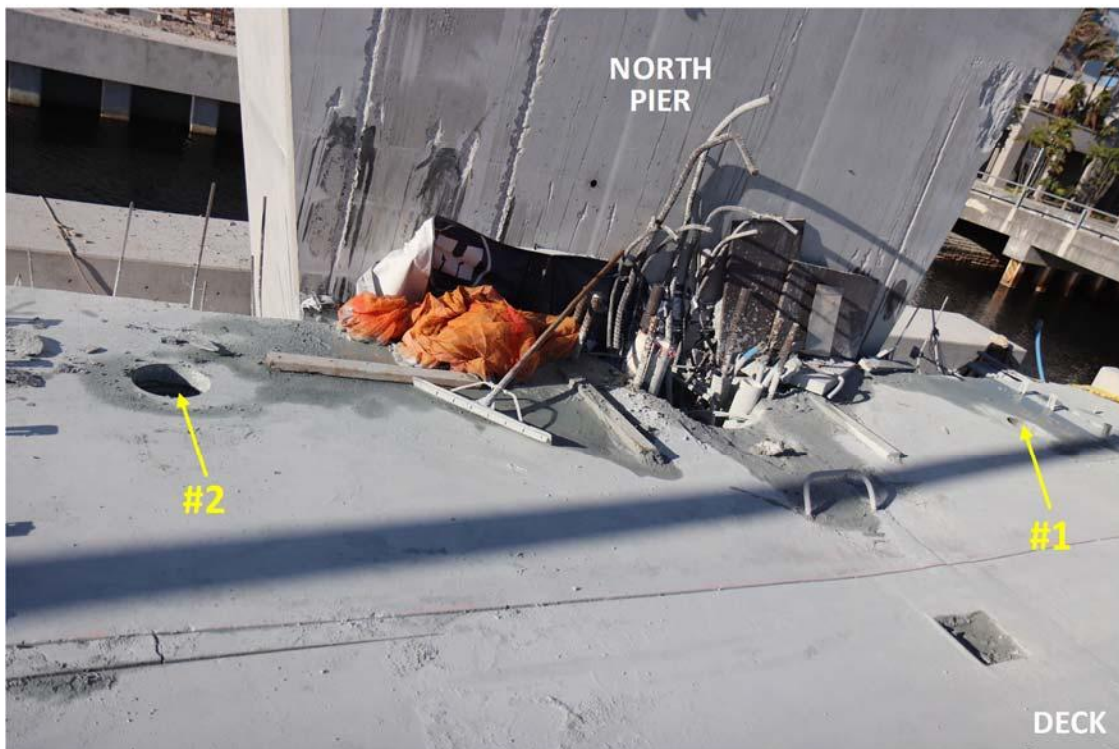
Figure 4: Photos showing the saw cut of the center two-thirds of the northmost portion of the deck. The two large-diameter cores taken to provide pick points for lifting the piece are indicated.

The center two-thirds of the northmost portion of the deck was wet saw cut from the remainder of the structure, as shown in Figure 4. This area was where Diagonal 11 and Vertical 12 met the deck. Two large-diameter cores were sectioned from the concrete (bottom image of Figure 4) to provide “pick points” for lifting the piece, and to allow a crane to act as a stabilizing force during final cutting (Figure 5). Once the cuts were complete, the concrete of the deck surrounding the cuts was removed via jackhammer to facilitate removal of the piece. When clearance was obtained, the deck piece was removed via crane using the pick points (Figures 6-7).

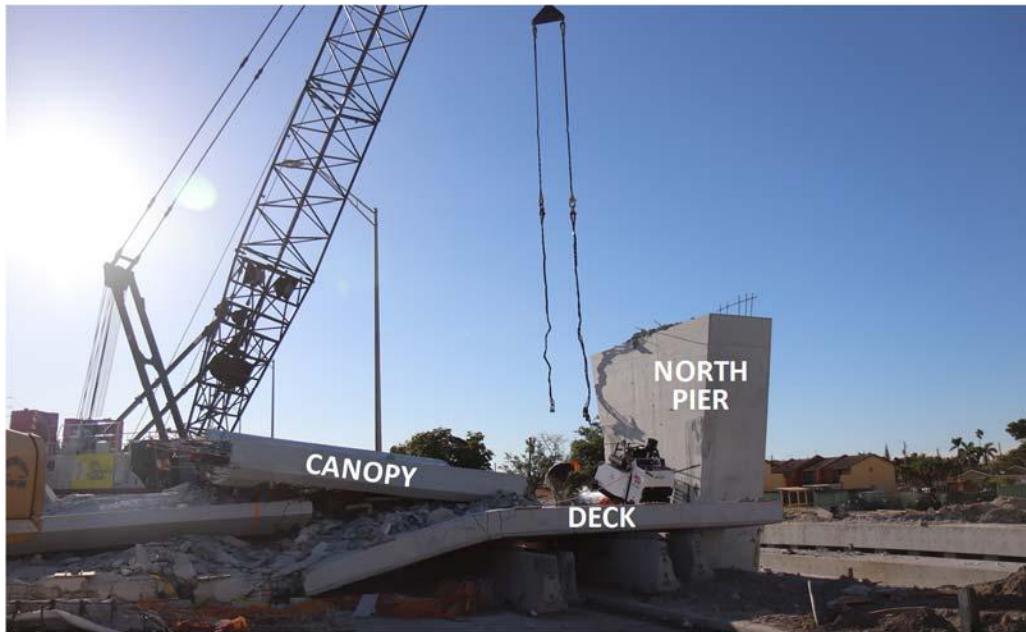
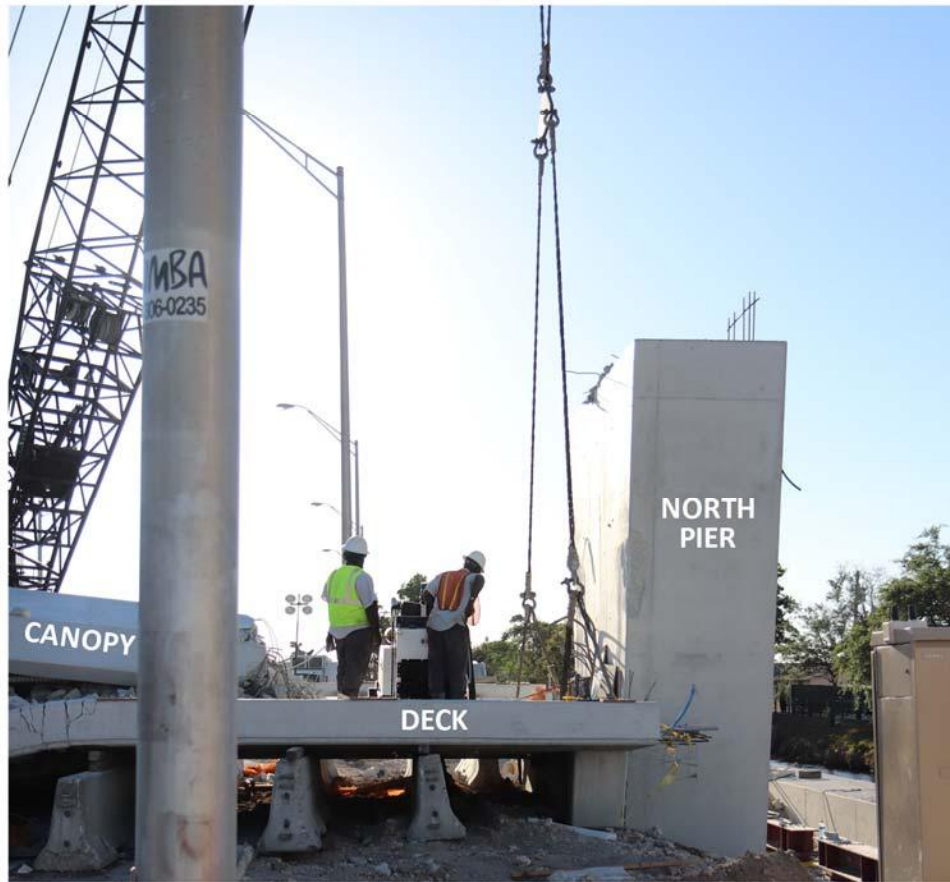
Figure 5: Photos looking west showing positioning of the crane for support and eventual removal of the large deck piece.

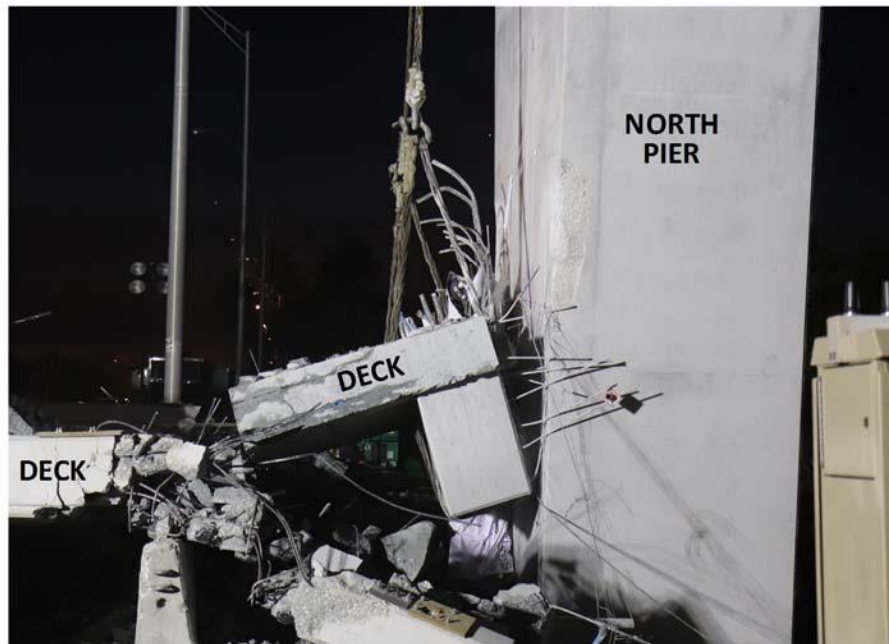
Figure 6: Photos looking west showing jackhammering and removal via crane of the large deck piece.

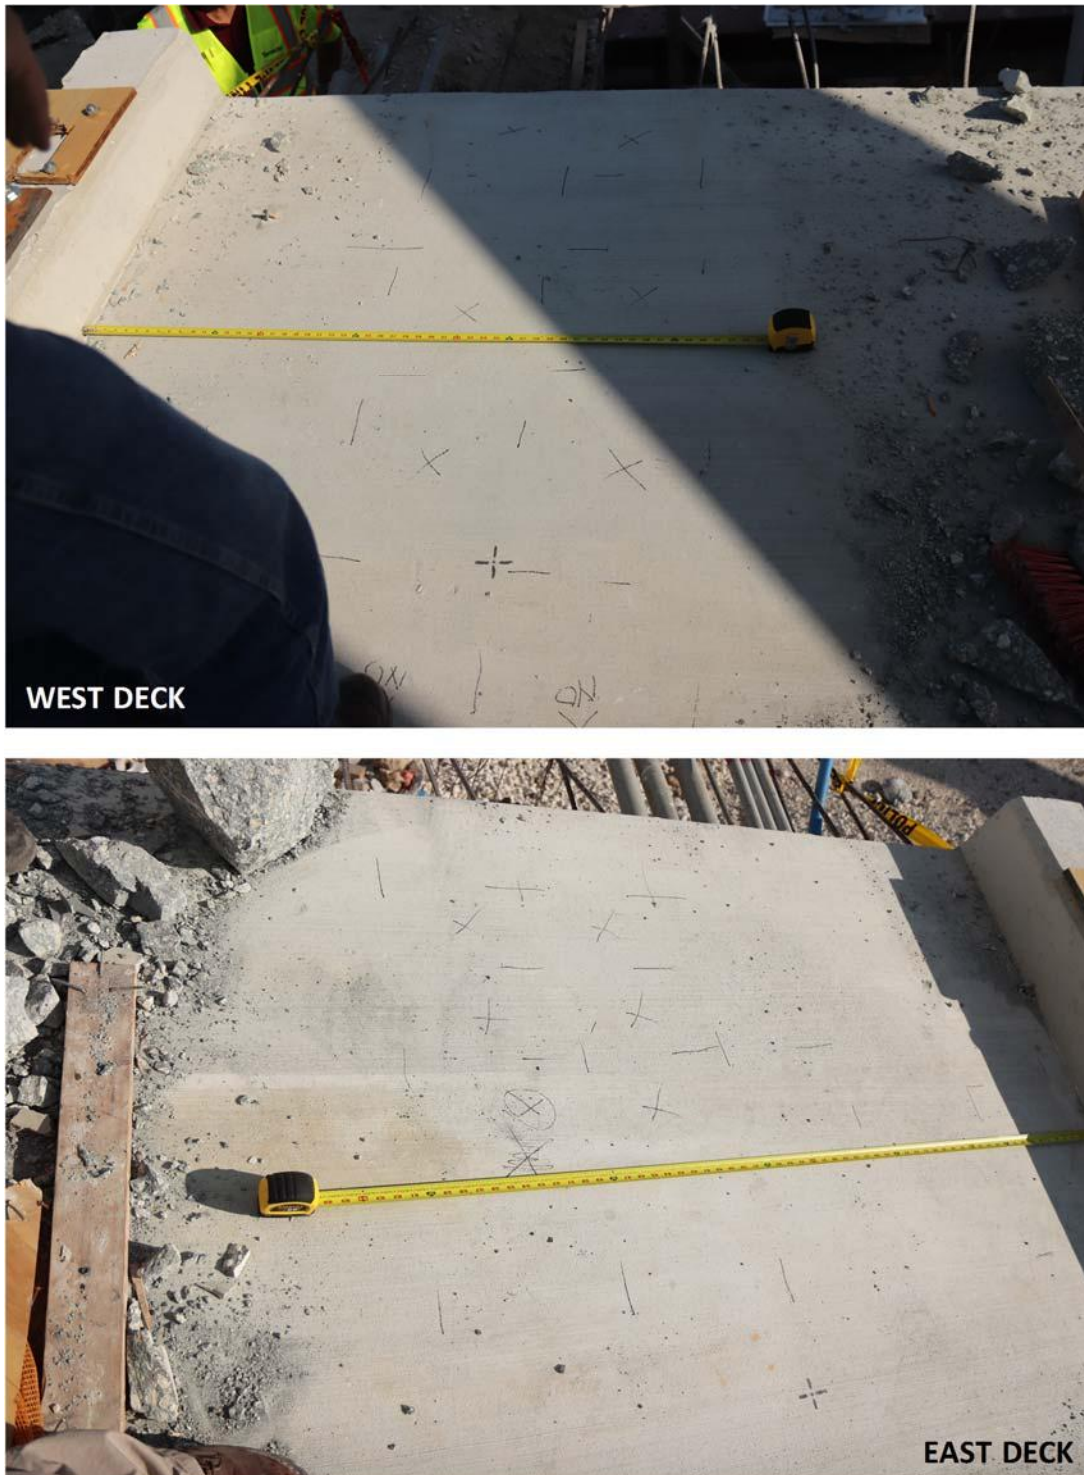
Figure 8: Photos showing the marked locations where concrete core samples for materials testing were taken from the east and west side of the deck. Per the design plans and ultrasonic inspection, the indicated areas were clear of underlying steel and plastic conduit internal to the deck.

Concrete core samples for materials testing were taken from the east and west side of the bridge deck in the areas shown in Figures 8 and 9. A mix of eight partial and full samples were obtained. Four partial and full concrete core samples for materials testing were taken from the canopy in the areas shown in Figure 10.

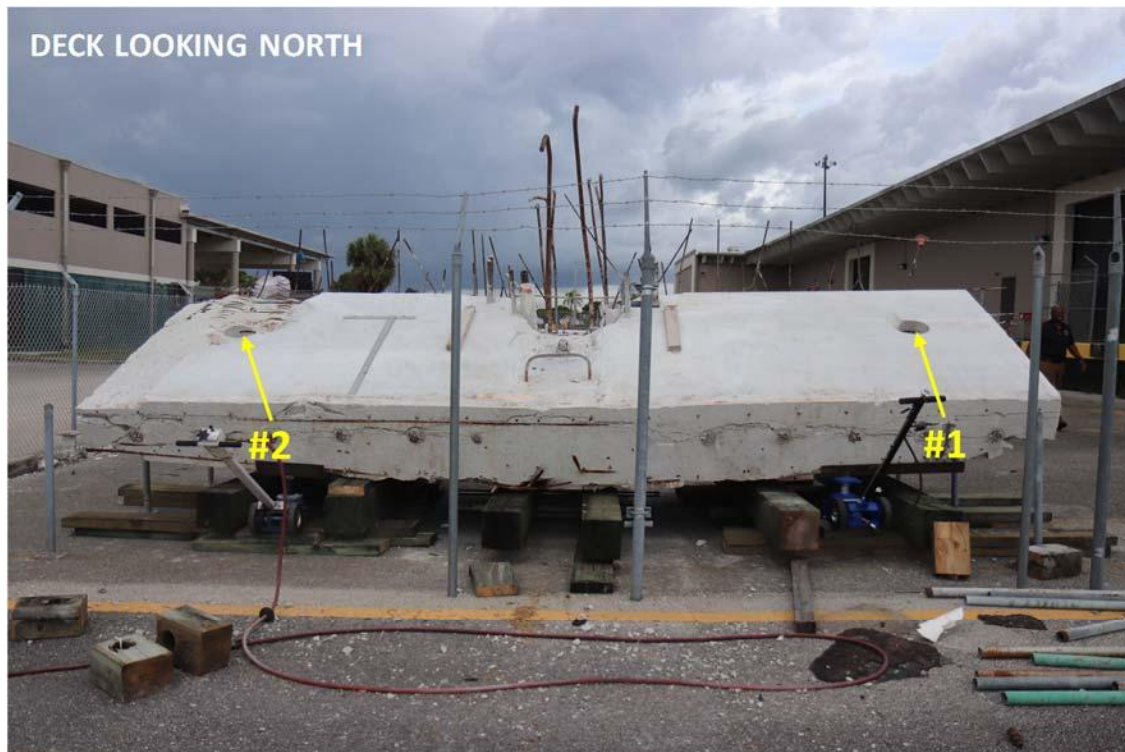
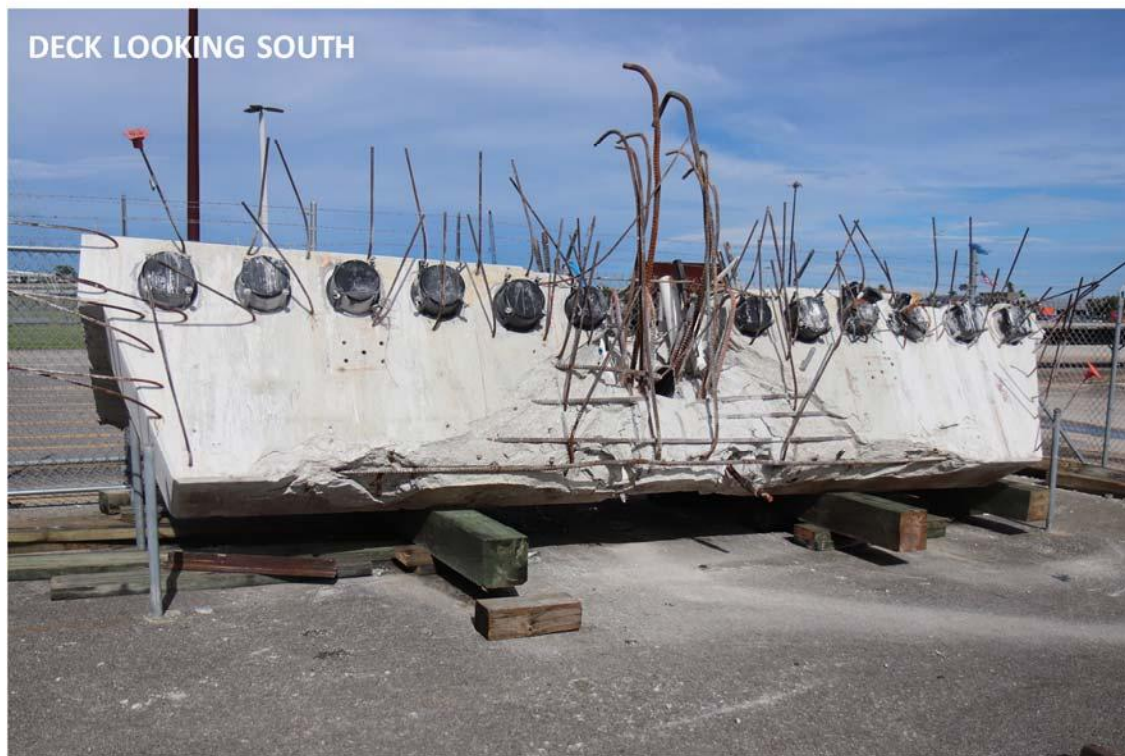
Figure 11: Photos showing the large deck piece after placement in the FDOT yard. Damage is visible on the north face of the deck. The locations of the large-diameter concrete cores that served as pick points for moving the piece are indicated.

The large-diameter concrete cores taken from the pick points of the deck are shown in Figures 11 and 12. These samples were retained in case further analysis was warranted.

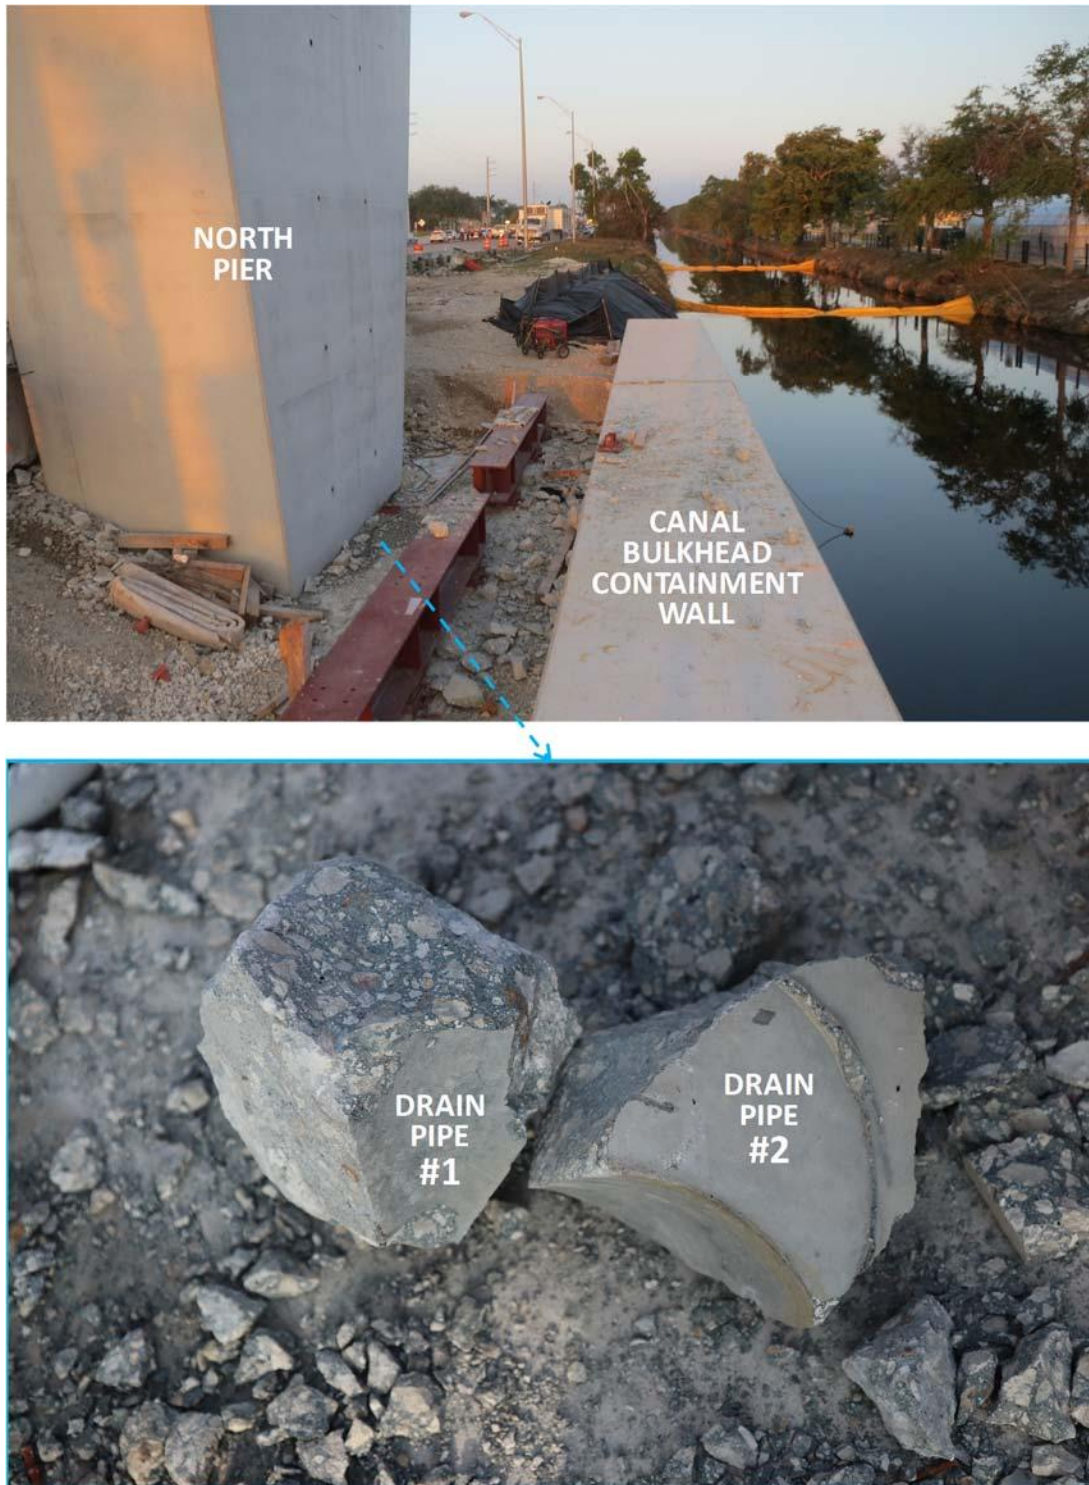
Figure 13: (Top) Photo showing the general location where two pieces of concrete with smooth geometrical features were found on the north side of the collapse site, between the north pier and the canal bulkhead containment wall. (Bottom) Photo showing the two pieces of concrete after handling and visual inspection.

Two pieces of concrete with smooth geometrical features were found on the north side of the collapse site, between the north pier and the canal bulkhead containment wall. Figure 13 shows the general vicinity on-scene where the pieces were found. The smooth features were consistent with concrete that had formed against a rounded internal component such as a drain pipe. The pieces were thus labeled Drain Pipe #1 and Drain Pipe #2 and were retained as evidence.

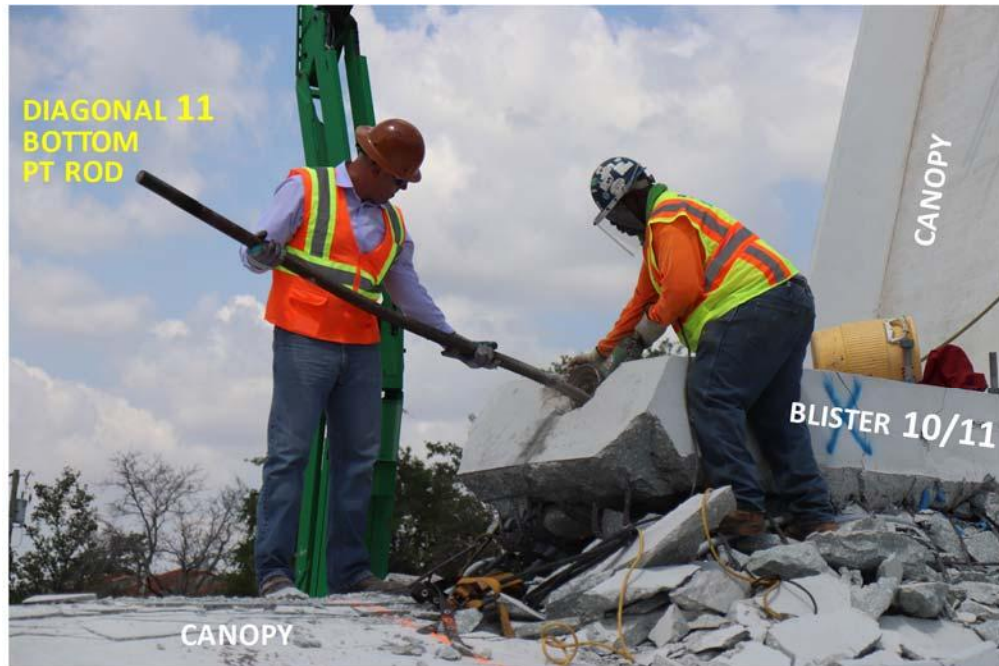
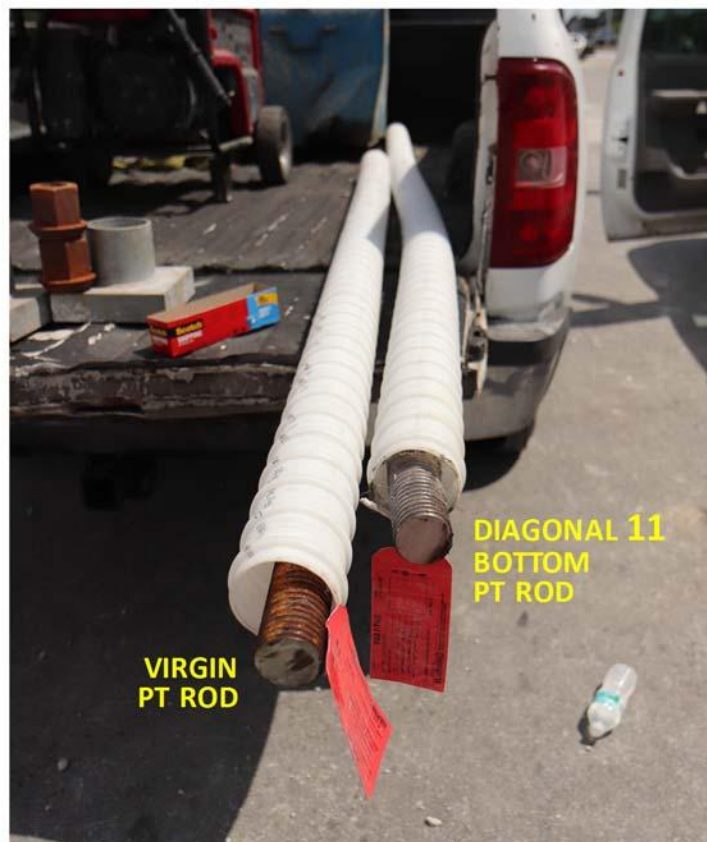
Figure 14: Photos showing the on-scene removal of the bottom PT rod from Diagonal 11 (top) and the two PT rods shipped to TFHRC for testing (bottom).

In addition to the concrete samples, numerous steel samples were also collected for materials testing. While on-scene, the top portion of the bottom PT rod from Diagonal 11 was saw cut and retained. This length of PT rod had the hydraulic jack from the post-

tensioning operation still assembled to it after the collapse¹. A length of virgin PT rod was collected from a stockpile of unused building materials being stored on the build site near the south end of the bridge. The stockpile was undisturbed by the collapse of the bridge. Both PT rods collected are shown in Figure 14.

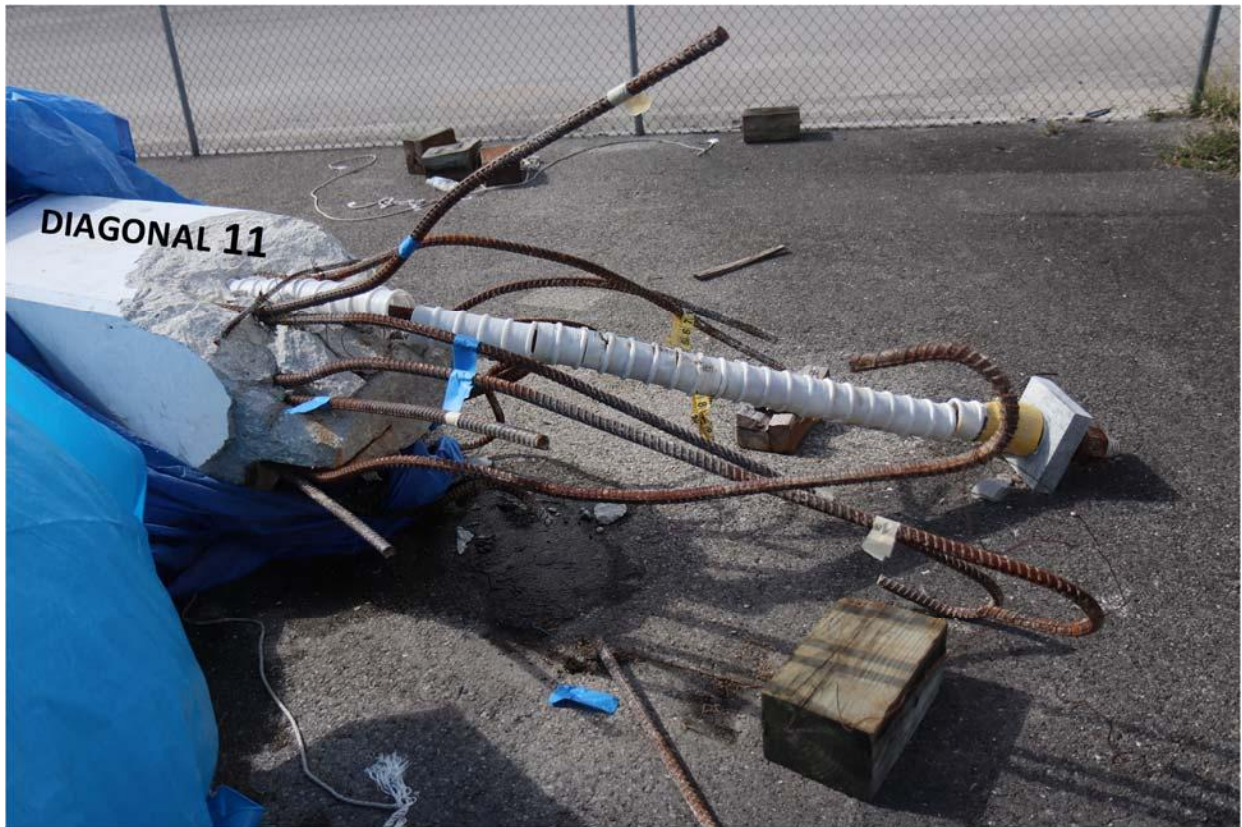
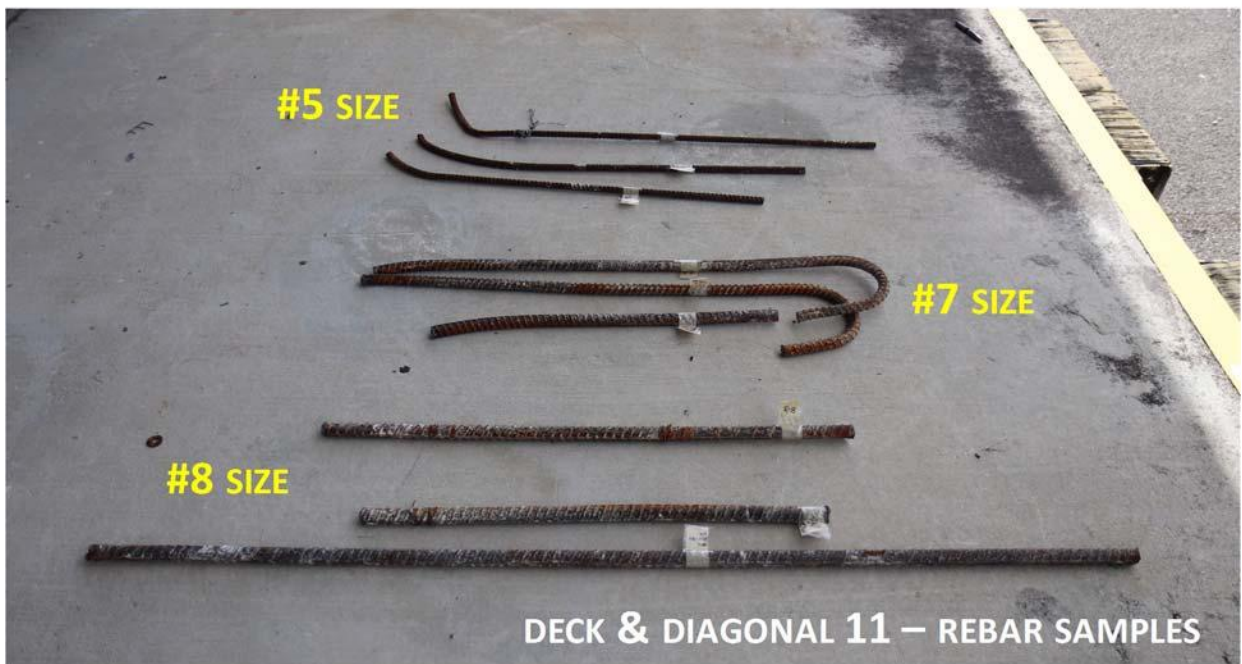
Figure 15: (Top) Photo showing some of the reinforcing bars collected from Diagonal 11 while at the FDOT yard prior to sectioning. (Bottom) Photo showing some of the reinforcing bars collected from the pieces stored at the FDOT yard and sent to TFHRC for testing.

After moving the large-scale specimens to the FDOT yard, steel reinforcing bars of various sizes were collected. Reinforcing bars of sizes #5, #7, and #8 were collected via torch cutting from either the deck piece or the bottom end of Diagonal 11. Reinforcing bars of size #11 were extracted from Vertical 12 by removing the concrete surrounding the bars via jackhammer, then saw cutting them. The bars collected from Diagonal 11 and Vertical 12 are marked with blue painter's tape and beige masking tape in Figures 15 and 16, respectively.

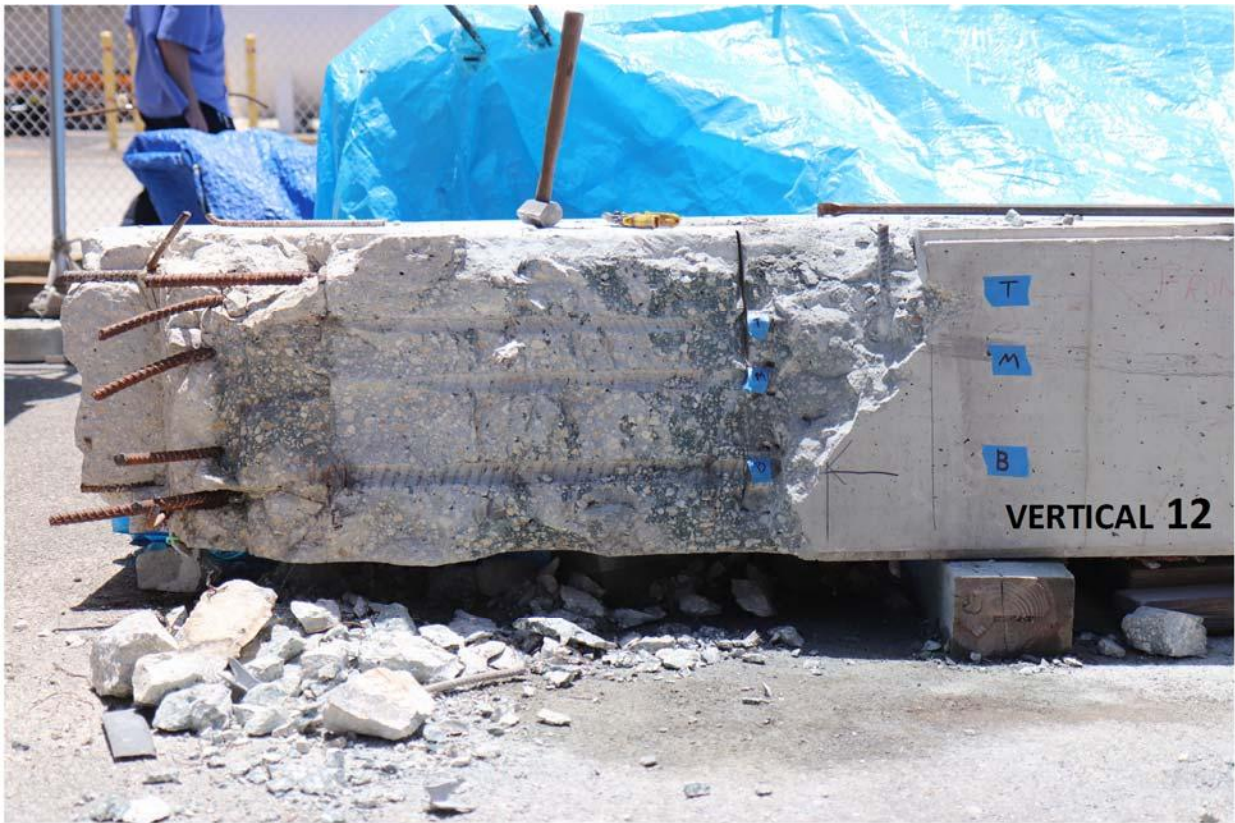
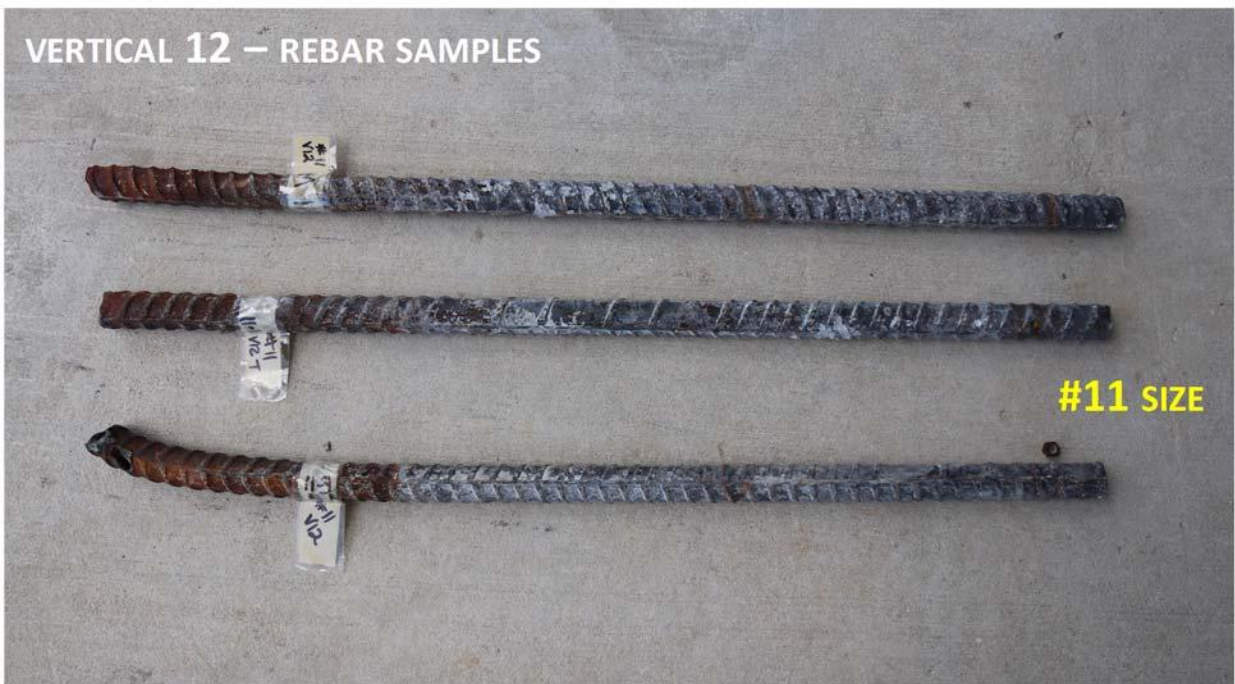
Figure 16: The top photo shows the location in Vertical 12 where the bars shown in the bottom photo were removed at the FDOT yard. The bars were sent to TFHRC for testing.

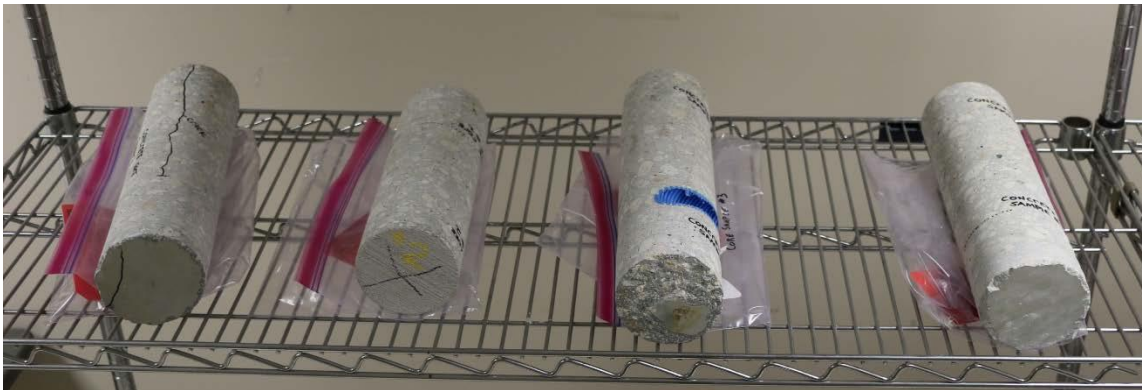
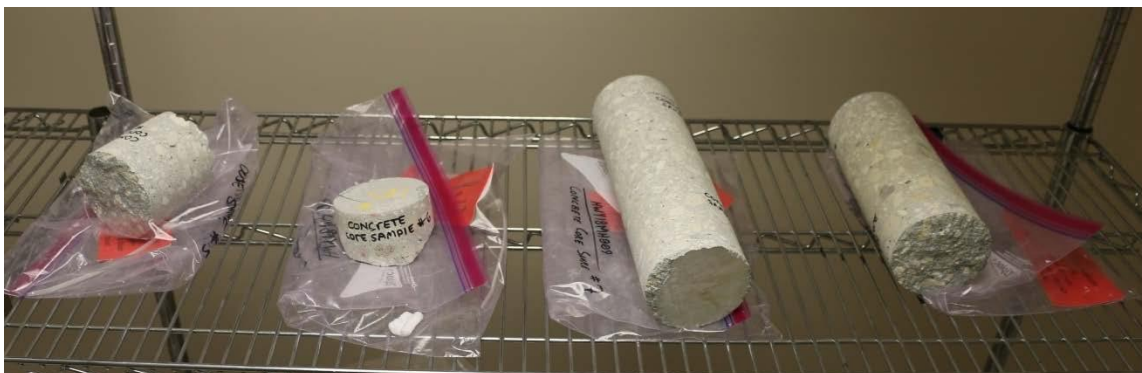
Figure 3 shows the concrete core samples extracted from the bridge deck. A total of eight full or partial core segments were received. Table 1 lists the length for each specimen and relevant notes.

(a) Appearing left-to-right, Core #1 – Deck through Core #4 – Deck

(b) Appearing left-to-right, Core #5 – Deck through Core #8 – Deck

Figure 3. Concrete core samples extracted from the bridge deck

ID	Diameter (in)	Length (in)	Usable Length [†] (in)	Notes
Core #1 – Deck	3.75	14.25	0.0	Sample had a full-depth crack along its length
Core #2 – Deck	3.75	11.0	7.12	Sample had shape deformities from coring that made a portion of the sample unusable
Core #3 – Deck	3.75	14.125	9.25	Sample had a blue, corrugated plastic tube embedded approximately 4-inch from one end running transversely
Core #4 – Deck	3.75	14.0	10.25	Sample had shape deformities from coring that made a portion of the sample unusable
Core #5 – Deck	3.75	4.25	3.0	Sample had shape deformities from coring that made a portion of the sample unusable
Core #6 – Deck	3.75	1.50	1.50	None
Core #7 – Deck	3.75	12.75	8.50	Sample had shape deformities from coring that made a portion of the sample unusable
Core #8 – Deck	3.75	9.50	8.50	Sample had shape deformities from coring that made a portion of the sample unusable

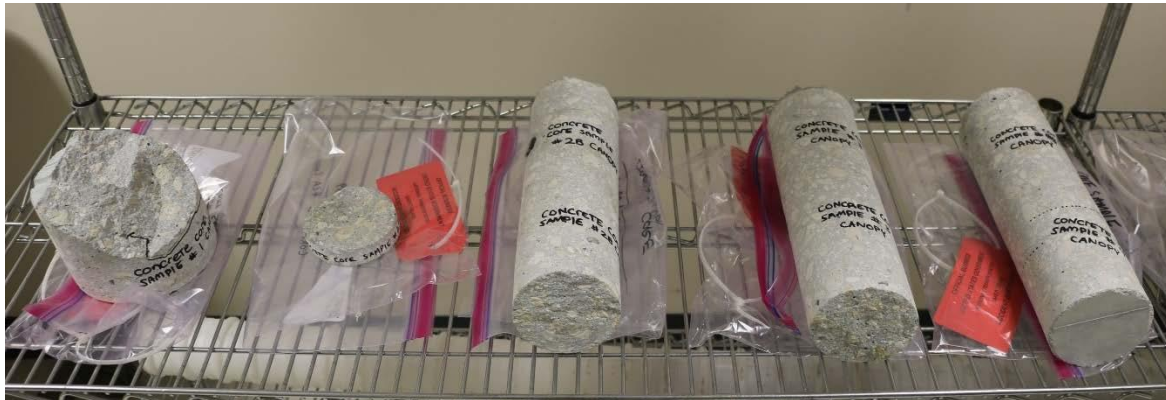
Figure 4 shows the concrete core samples recovered from the canopy of the bridge. A total of five full cores or partial core segments were received. Table 2 lists the length of each specimen and relevant notes.

Figure 4. Concrete core samples extracted from the canopy of the bridge, from left-to-right, Core #1 – Canopy, #2A – Canopy, #2B – Canopy, #3 – Canopy, and #4 – Canopy

ID	Diameter (in)	Length (in)	Usable Length [†] (in)	Notes
Core #1 – Canopy	5.5	2.25	2.25	Small crack in the sample
Core #2A – Canopy	3.75	1.0	1.0	None
Core #2B – Canopy	3.75	11.5	7.125	Sample has a plastic conduit running through it in the transverse direction
Core #3 – Canopy	3.75	11.75	11.0	Sample had shape deformities from coring that made a portion of the sample unusable
Core #4 – Canopy	3.75	12.5	8.0	Sample had shape deformities from coring that made a portion of the sample unusable

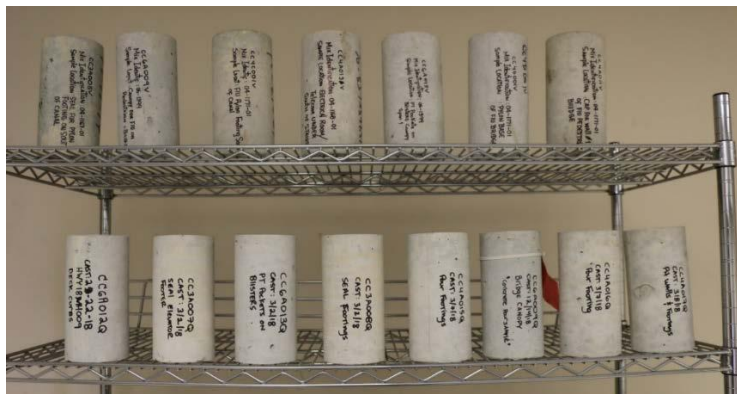
Figure 5. Concrete cylinder samples received from Professional Service Industries, Inc. (top) and Universal Engineering Sciences (bottom)

Figure 5 shows the concrete cylinder samples recovered from two engineering firms^a hired to conduct quality control testing on the concrete used in the bridge structure. All 15 cylinder samples shown were mold-cast with nominal dimensions of 4 inches in diameter and 8 inches in length. These samples were taken from different concrete mixtures used in different portions of the bridge structure including the deck, canopy, post-tensioning (PT) blister pockets, footings, and stairs. Three to five different concrete mixtures are represented here with specified compressive strengths between 3,000 psi and 8,500 psi. FHWA-TFHRC was provided documentation for each cylinder sample. These documents were provided by the respective engineering firms.

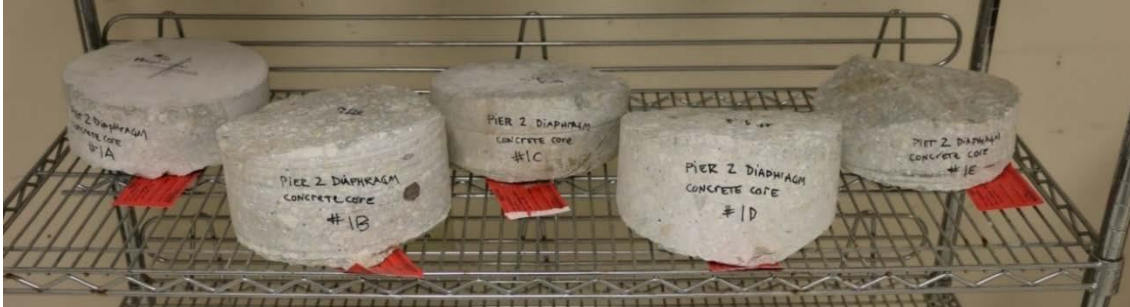
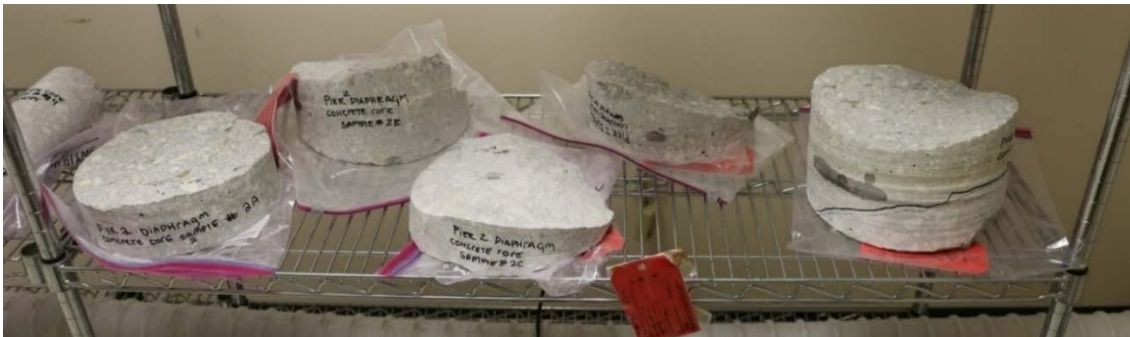
Figure 6. Pier 2 diaphragm concrete core samples

Figure 6 (a) and (b) show the concrete core samples recovered from what the evidence tag refers to as the “pier 2 diaphragm”. These core segments each measured 9.5 inches in diameter and varied in length. The voids left by these two core locations were used as the “pick points” during removal of a portion of the collapsed bridge structure from the roadway.

(a) Appearing left-to-right, Sample #1A through #1E

(a) Appearing left-to-right, Sample #2A through #2E

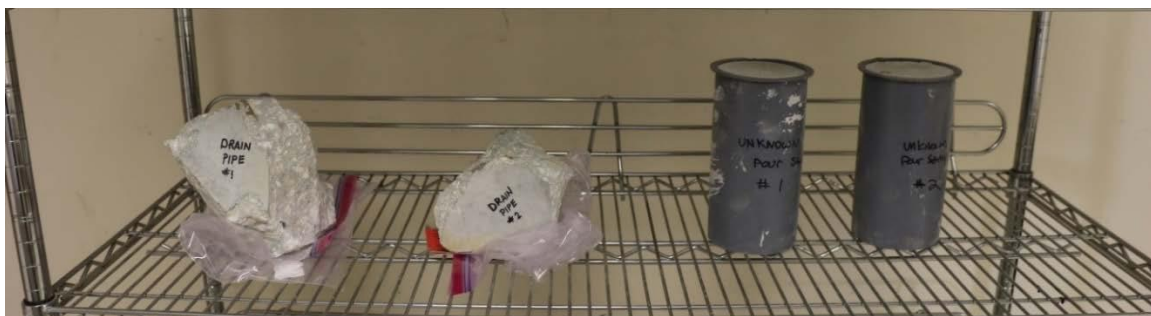
Figure 7 shows two concrete samples (left side of the figure) that were recovered at the collapse site and appear to have originally resided in the structure adjacent to the drain pipe that passed through the north diaphragm immediately under Member 12. The two samples shown on the right side of Figure 7 are associated with an evidence tag that reads “unknown pre-poured specimens.” The unknown concrete cylinder samples were delivered to FHWA-TFHRC in their molds and these molds were not removed. These samples measure 4 inches in diameter and 8 inches in height.

Figure 7. Concrete samples recovered from drain pipe region (left) and unknown concrete cylinder samples (right)

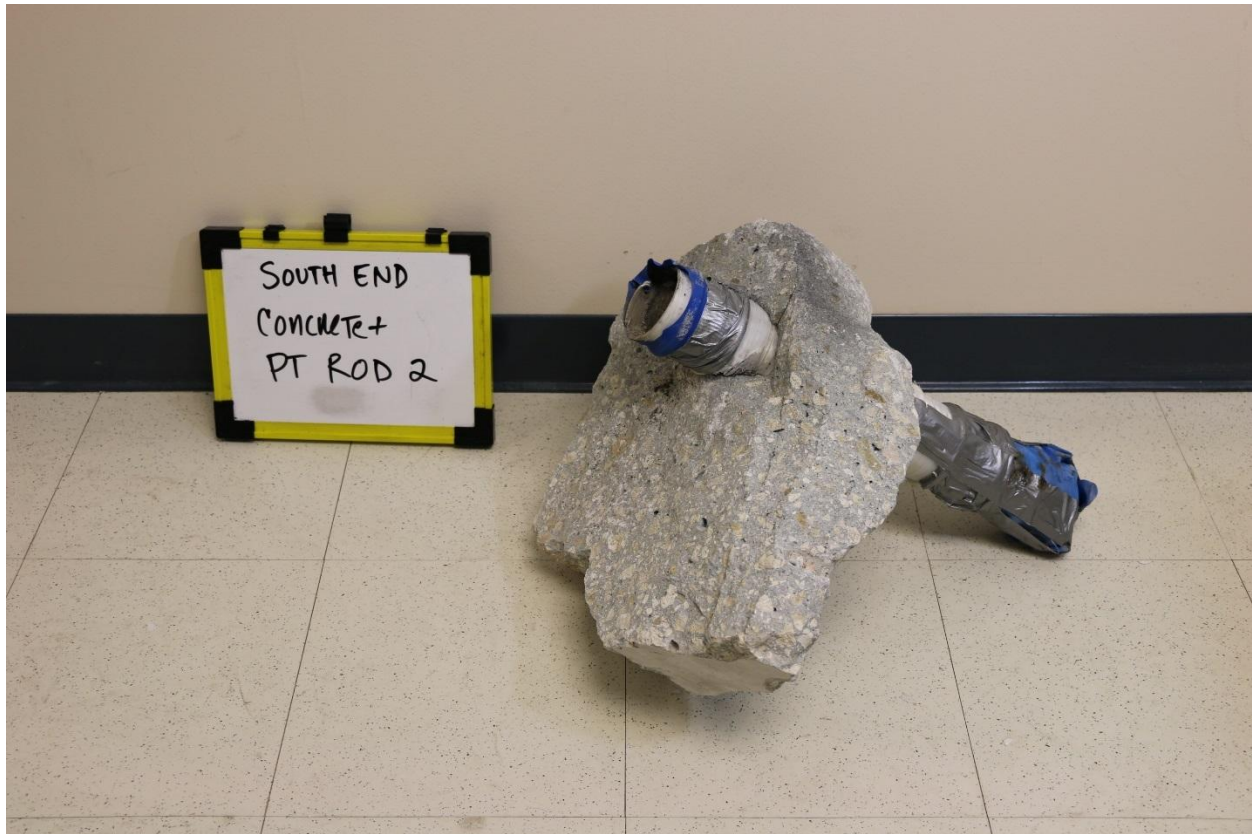
Lastly, Figure 8 shows a piece of concrete with an embedded PT duct that was recovered from the south end of the bridge structure after the collapse.

Figure 8. Concrete segment with embedded PT duct recovered from south end of bridge

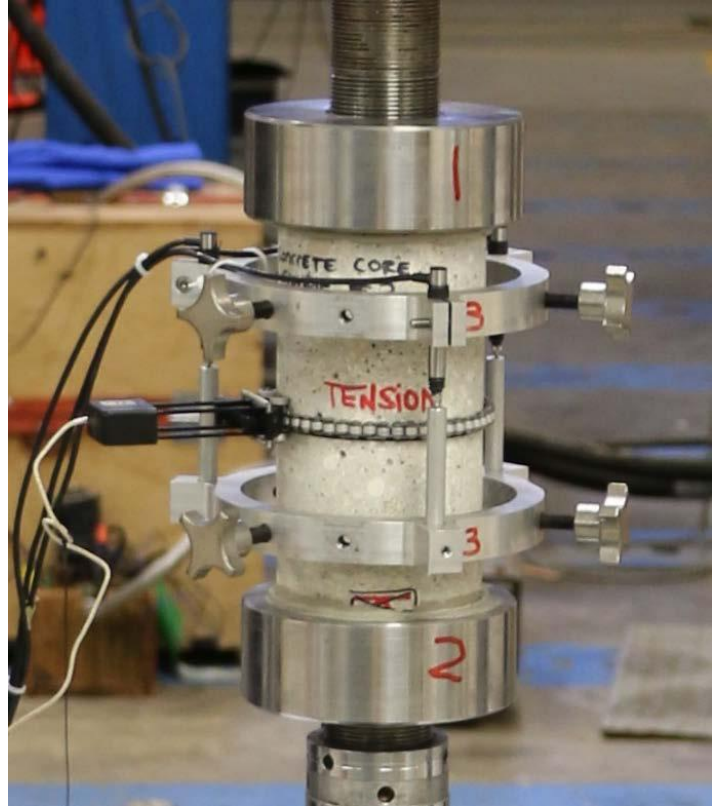
Figure 11. Close-up view of concrete tension test sample in the test machine
