NATIONAL TRANSPORTATION SAFETY BOARD

MATERIALS LABORATORY FACTUAL REPORT

Report No. 18-082

Place : Miami, Florida
Date : March 15, 2018
Vehicle : Florida International University UniversityCity Pedestrian Bridge
NTSB No. : HWY18MH009
Investigator : Robert Accetta (HS-20)

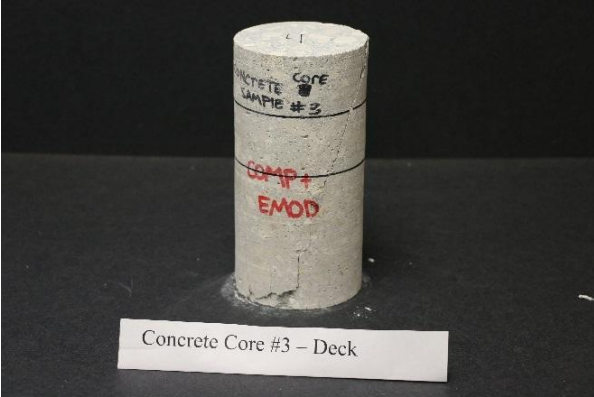
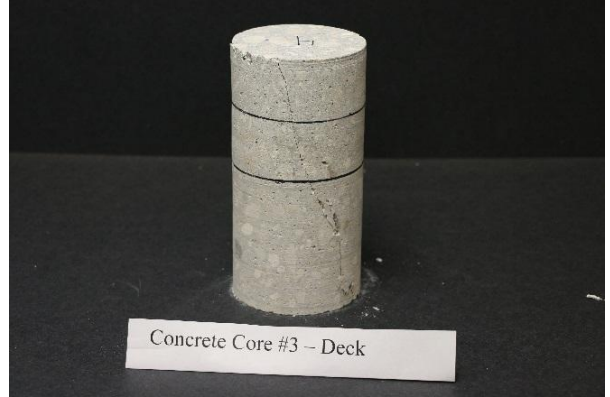
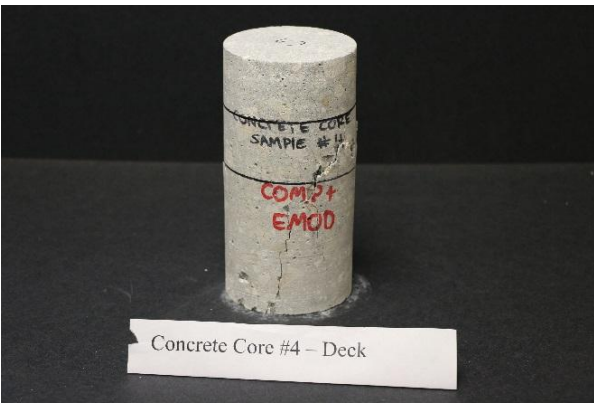
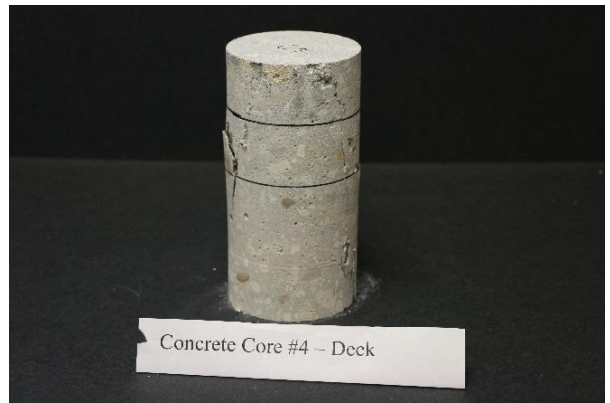
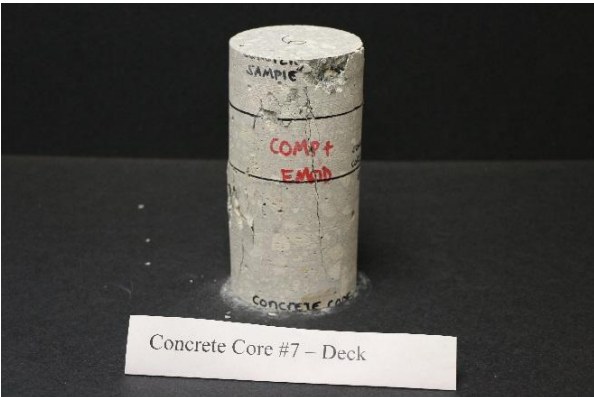
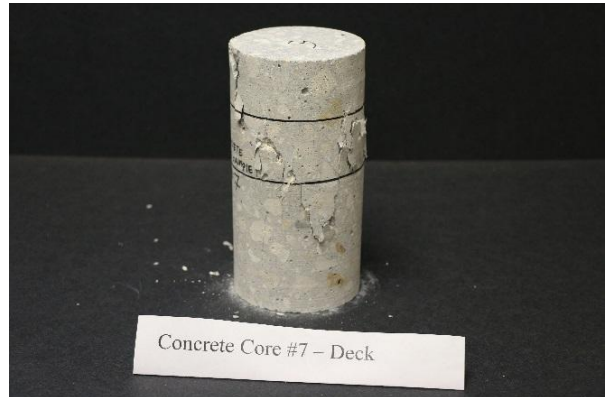
Figure 14. Photographs of bridge deck core samples after compression testing

Figure 14 presents representative images of bridge deck core samples after compression testing. All three samples exhibited compression failure, and the failure type according to ASTM C39 is listed in Table 6.

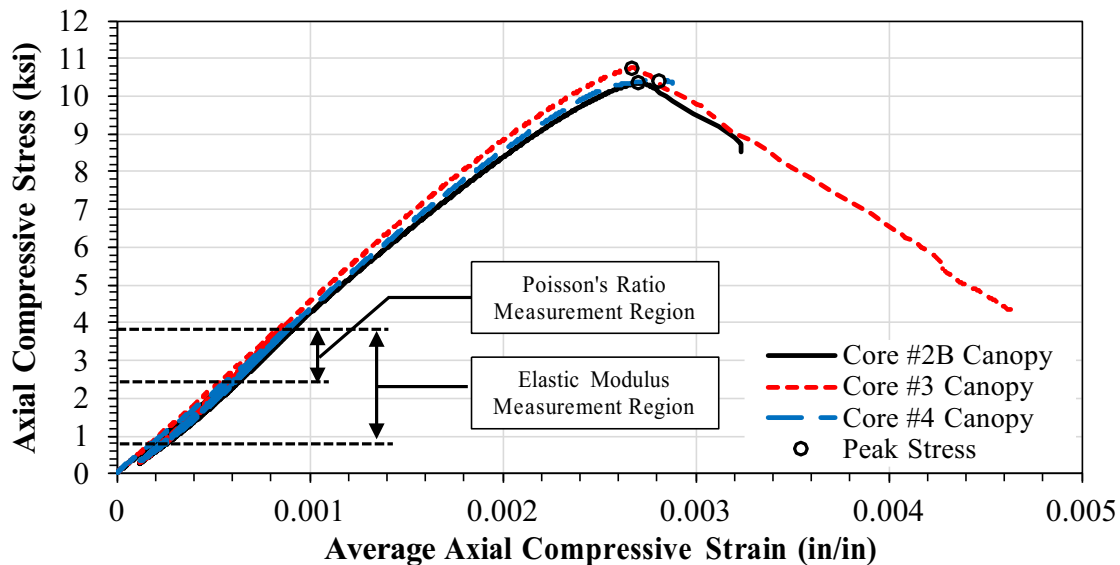
Figure 15. Compressive stress-strain relationships for bridge canopy core samples

Sample ID	Core #2B - Canopy	Core #3 - Canopy	Core #4 - Canopy
Average Diameter (in)	3.71	3.71	3.71
Average Length (in)	6.61	6.74	6.64
Unit Weight (lb/ft ³)	139.0	139.9	138.8
Compressive Strength (ksi)	10.34	10.74	10.42
Axial Strain at Peak Compressive Stress	0.0027	0.0027	0.0028
Elastic Modulus (Average of 3 Cycles) (ksi)	4430	4784	4536
Poisson's Ratio (Average of 3 Cycles)	0.126	0.112	0.130
Failure Type per ASTM C39	Type 3	Type 1	Type 3

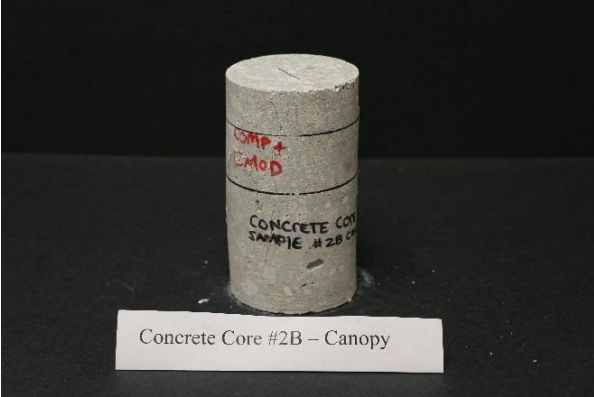
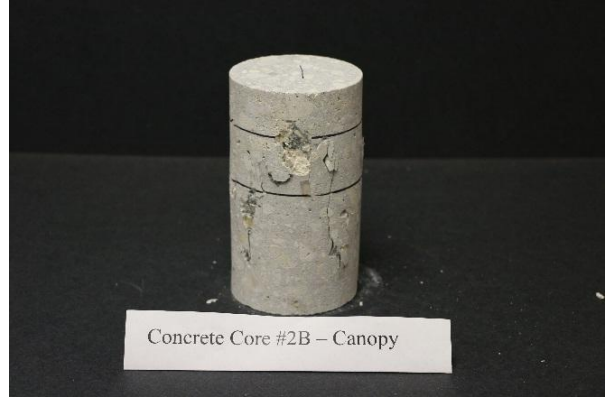
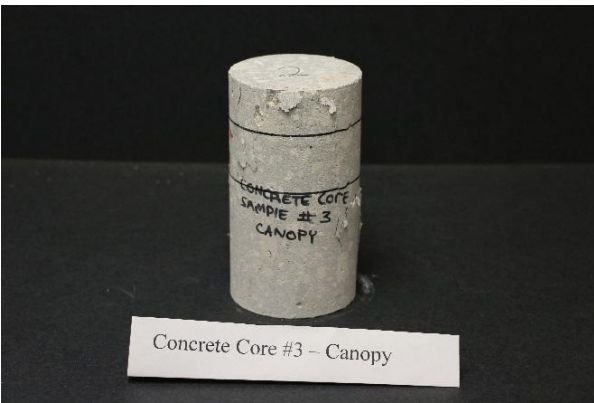
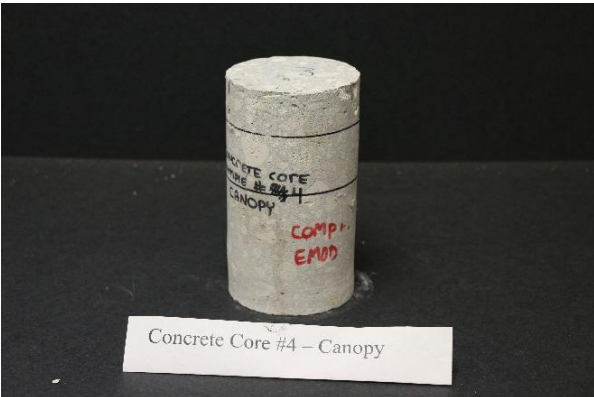
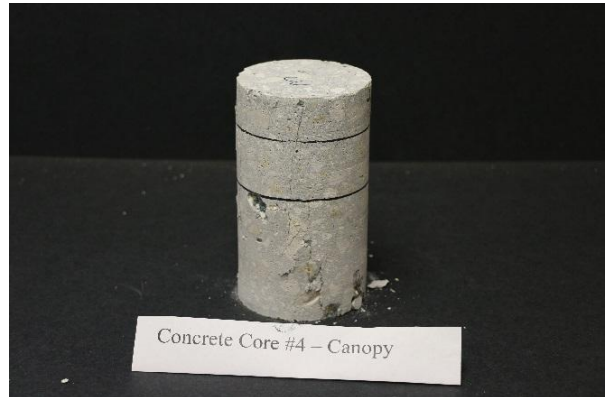
Figure 16. Photographs of bridge canopy core samples after compression testing

Figure 16 presents representative images of bridge canopy core samples after compression testing. All three samples exhibited compression failure, and the failure type according to ASTM C39 is listed in Table 7.

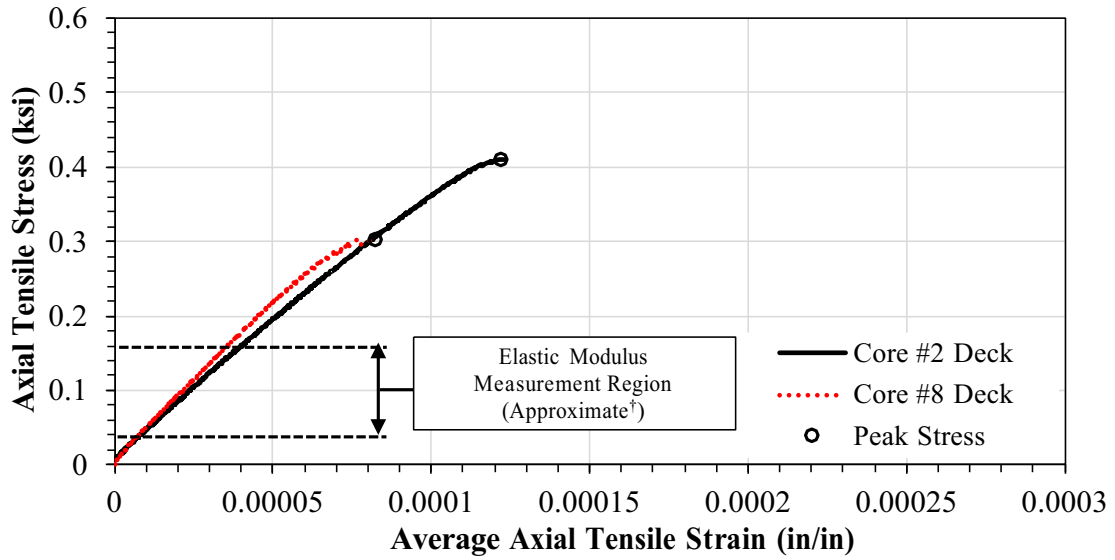
Figure 17 depicts the tensile stress-strain response of the two bridge deck core samples tested in tension. A circular marker has been added to each curve to identify the peak tensile stress. The curves were truncated immediately prior to abrupt loss of load carrying capacity due to tensile rupture of concrete.

† The elastic modulus was determined by calculating the slope of the tensile stress-strain curve between 10% and 40% of the measured tensile strength, thus the displayed range is approximate.

Figure 17. Tensile stress-strain relationships for bridge deck core samples

Sample ID	Core #3 - Deck	Core #4 - Deck
Average Diameter (in)	3.72	3.72
Average Length (in)	6.89	6.89
Unit Weight (lb/ft ³)	138.0	139.3
Tensile Strength (ksi)	0.41	0.30
Axial Strain at Peak Tensile Stress	0.00012	0.00008
Elastic Modulus (ksi)	3758	4285

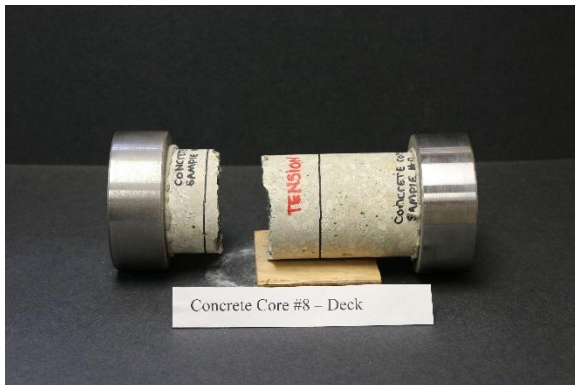
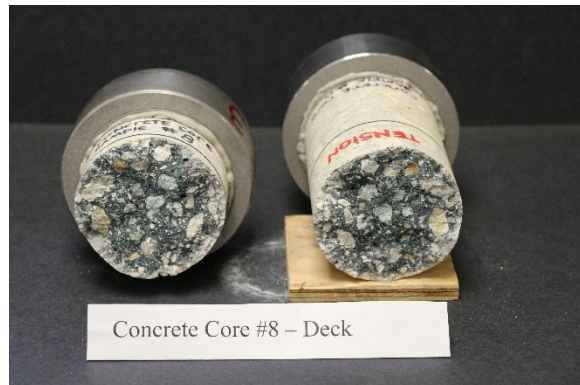
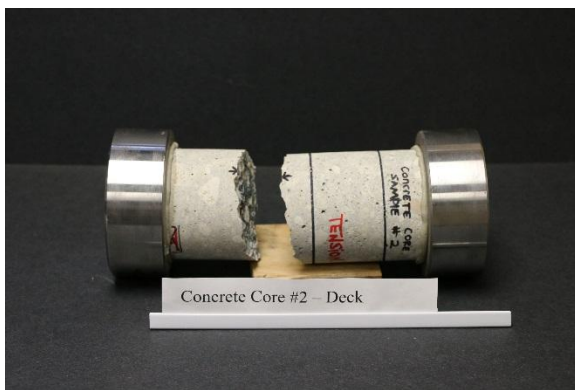
Figure 18 presents representative images of bridge deck core samples after tension testing. Both samples failed by tensile rupture of concrete within the 4-inch extensometer gauge length. The fracture surface was normal to the direction of loading, which is expected for a brittle material that fails in principal tension.

Figure 18. Photographs of bridge deck core samples after tension testing

There were no specifications for tensile strength of the concrete. However, the post-failure fracture surfaces of the tension specimens were all perpendicular to the direction of loading, which is typical of brittle materials like concrete that fail in tension.

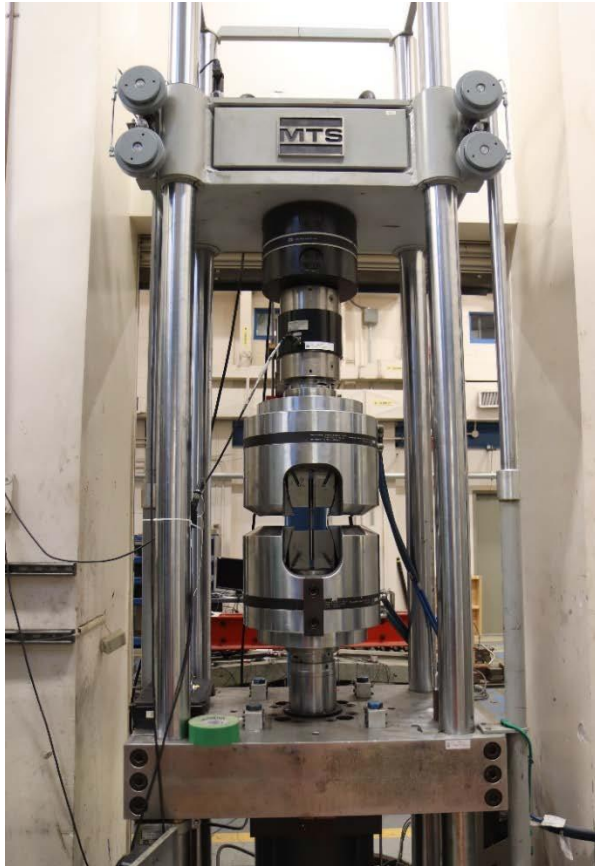
The tension testing was conducted in a 220-kip and a 550-kip servovalve controlled hydraulic test frame, respectively shown in Figure 29 and Figure 30. Each frame was fitted with side-loading hydraulic wedge grips for gripping onto specimens. Each frame was controlled by a dedicated controller and computer that also collected data throughout the testing.

Figure 29. 220-kip test frame

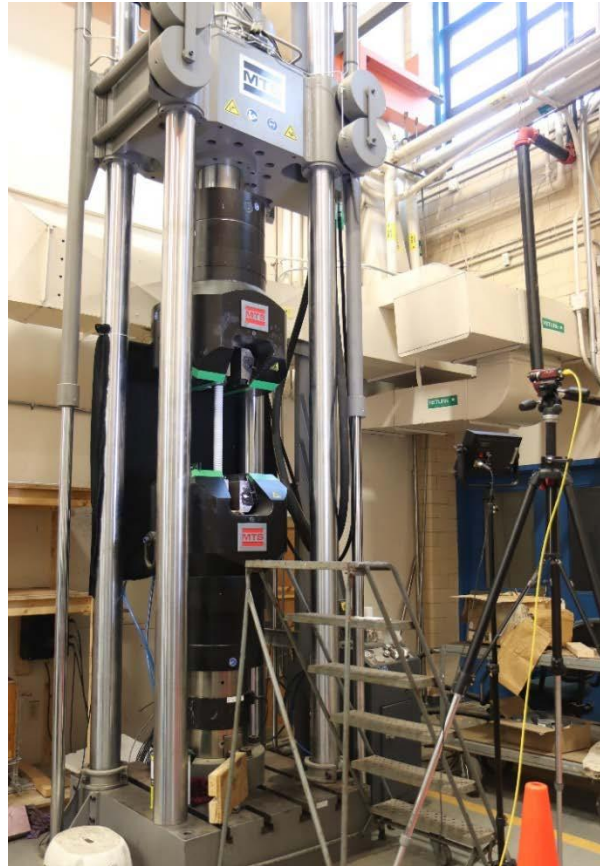
Figure 30. 550-kip test frame

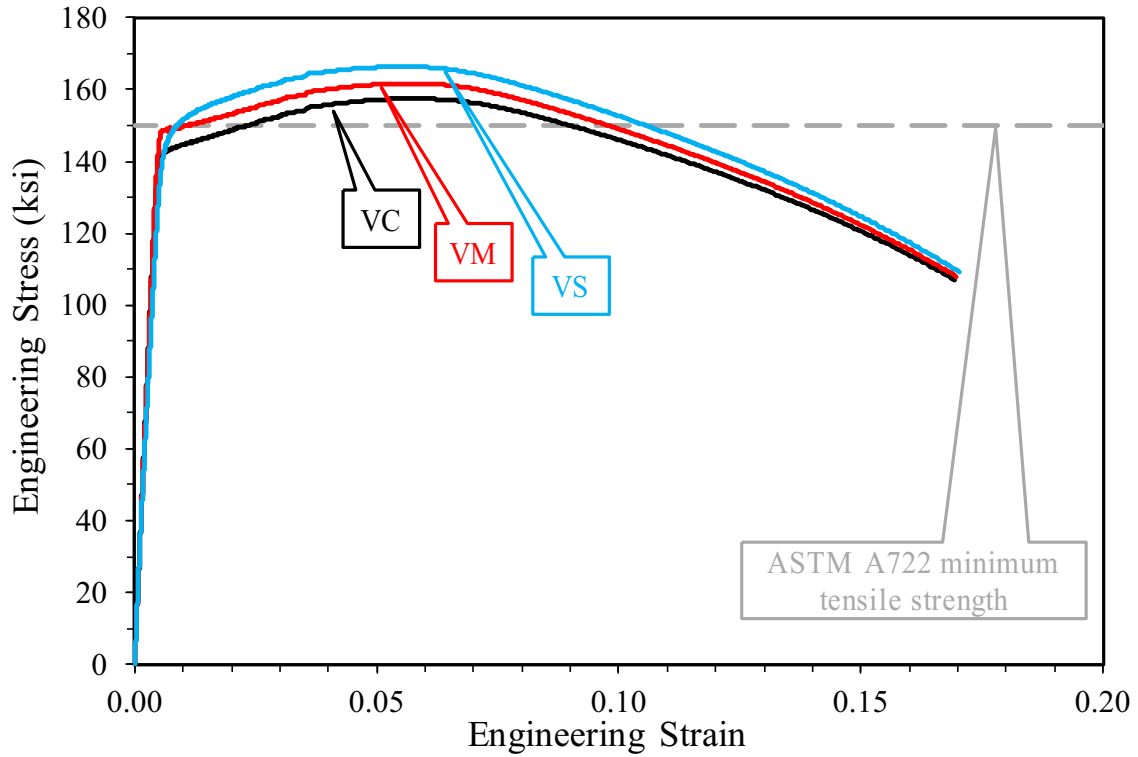
The plots of the stress versus strain results for the machined round bar specimens are shown in Figure 31 and Figure 32, respectively for the three specimens from the virgin bar and the Diagonal 11 bar. The specimen labels start with “V” if it came from the virgin bar, or “11” if it came from the diagonal 11 bar. The second letter determines the radial location the specimen was machined from; “C” for the bar core, “M” from the mid-radius, and “S” from the surface. The reportable quantities for each of the machined round bar specimens are reported in Table 11. Yield strength was determined from the 0.2% offset method outlined in ASTM A370, the tensile strength is the maximum stress attained in the test, the elongation at fracture is last strain measured before significant load drop, and the reduction in area is based on the final measured diameter at the fracture.

Figure 31. Stress versus strain results for virgin bar machined round specimens

Specimen	Yield Strength (ksi)	Tensile Strength (ksi)	Elongation at Fracture (percent)	Reduction in Area (percent)
VC	142.8	157.5	16.9	34
VM	148.9	161.7	17.0	33
VS	147.0	166.4	17.0	34
11C	144.0	159.1	16.6	34
11M	148.3	161.8	17.1	34
11S	143.7	165.2	16.8	33
ASTM A722	≥ 120	≥ 150	≥ 7	—

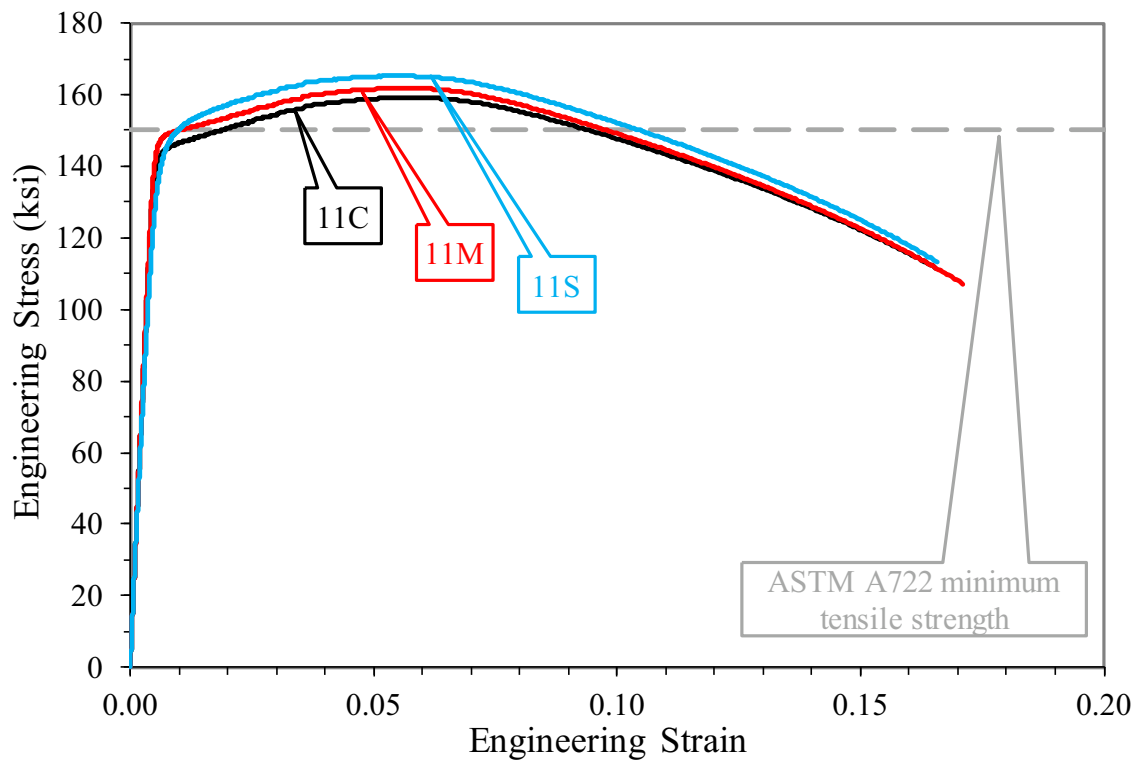
Figure 32. Stress versus strain results for diagonal 11 bar machined round specimens

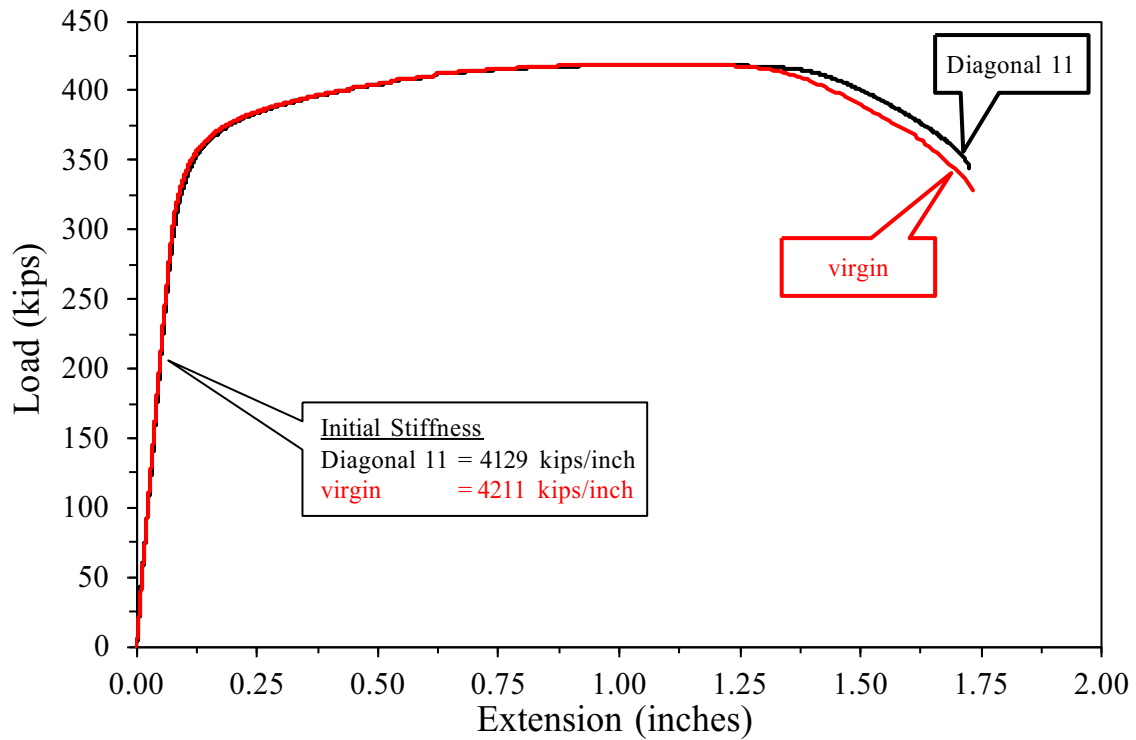
Figure 34. Load versus extension of the full-size bars

Specimen	Yield Strength (ksi)	Tensile Strength (ksi)	Elongation at Fracture (percent)
Diagonal 11	135.0	161.1	9.86
Virgin	136.0	161.2	9.91
ASTM A722	≥ 120	≥ 150	≥ 7

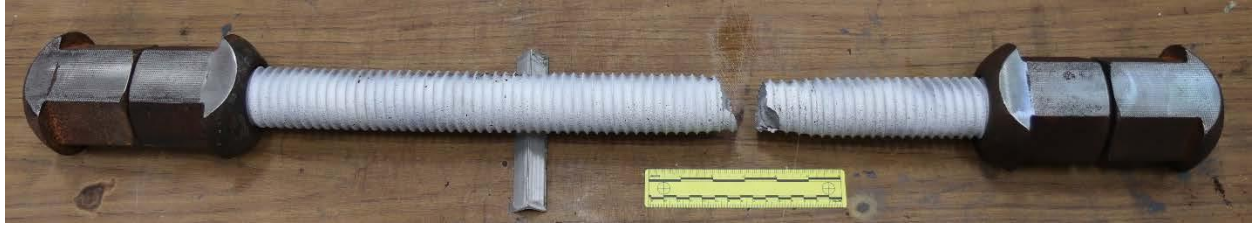
Figure 35. Photo of fractured Diagonal 11 bar

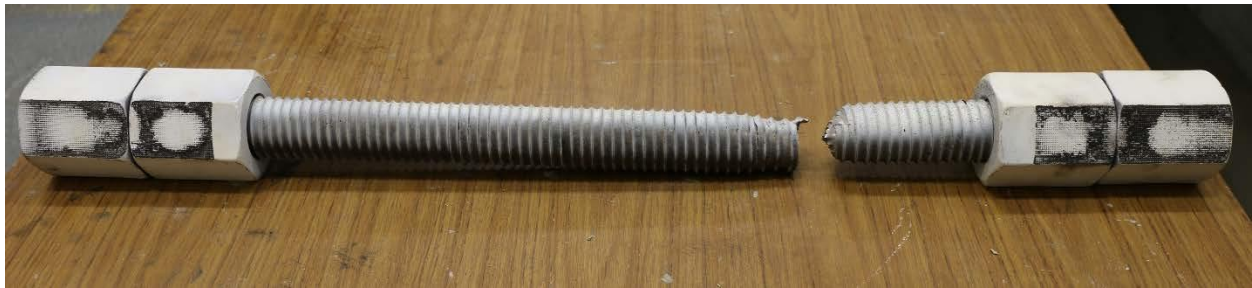
Figure 36. Photo of fractured virgin bar

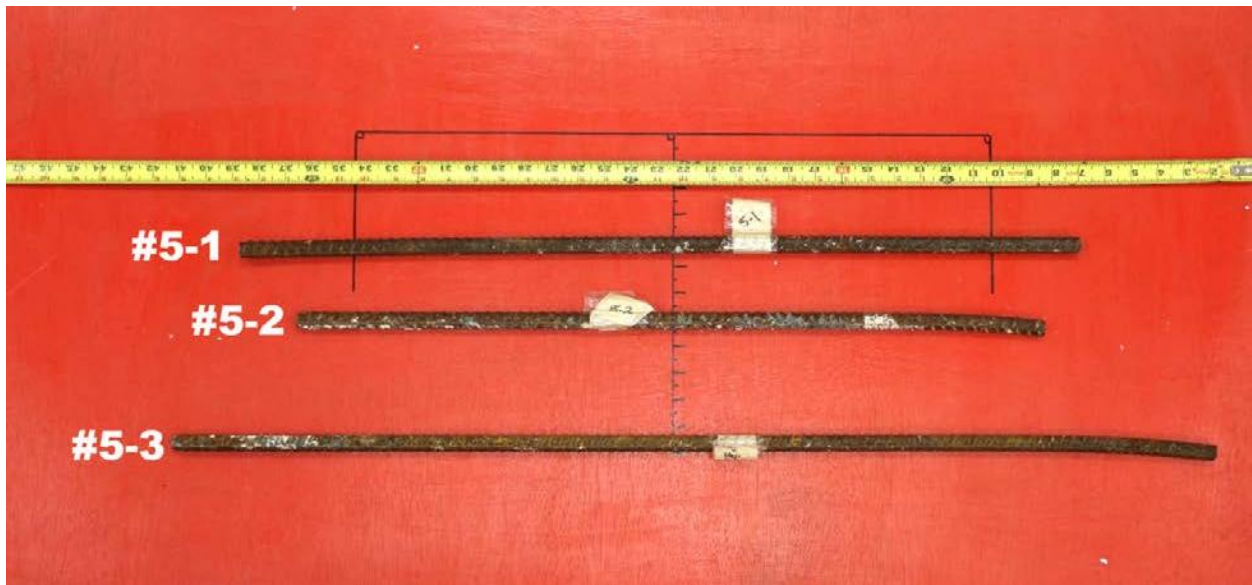
Figure 38. #5 bars received

Each bar sample was inspected to determine its suitability for tensile testing. Specifically, bars were inspected to determine their geometric linearity or straightness. It was determined that no portions of the #7 bar samples or sample #8-2 were suitable for testing due to the out-of-straightness of these bars. The remaining bar samples were all determined to have regions sufficiently straight to be suitable for uniaxial tension testing.

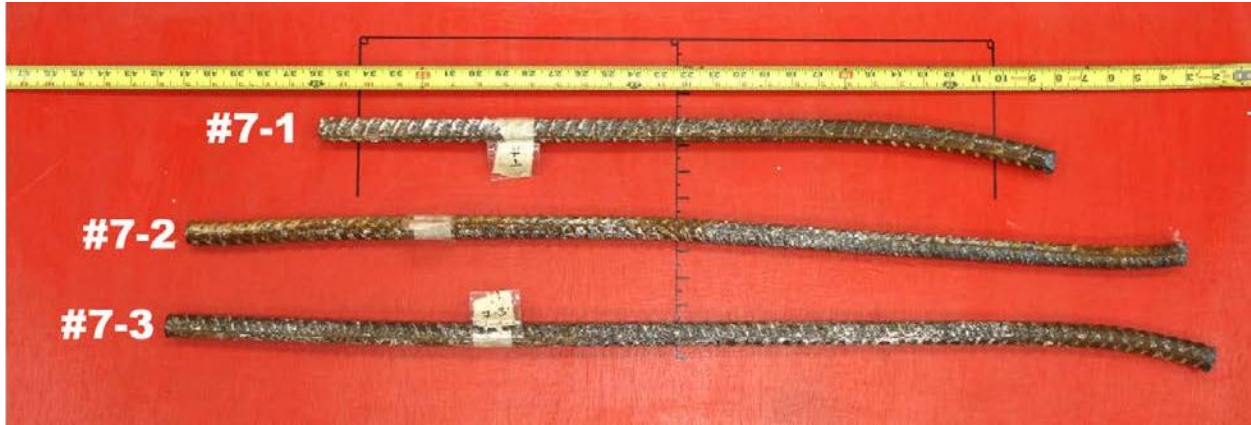
Figure 39. #7 bars received

The reinforcing bars were specified to be steel per ASTM A615⁴, Grade 60. Collapse-induced deformation of the size #7 bars collected precluded testing of them. Tension test results of the remaining size #5, #8, and #11 bars all met the minimum yield strength, tensile strength, and percent elongation at fracture for their respective sizes.

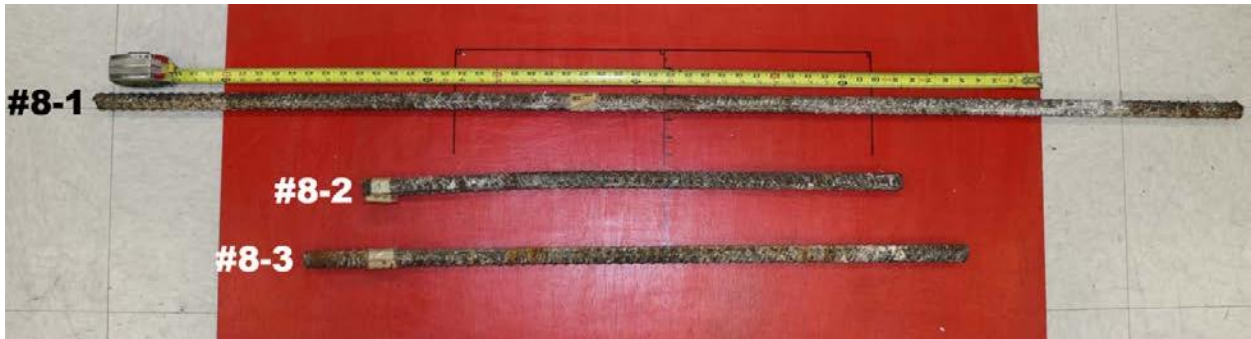
Figure 40. #8 bars received

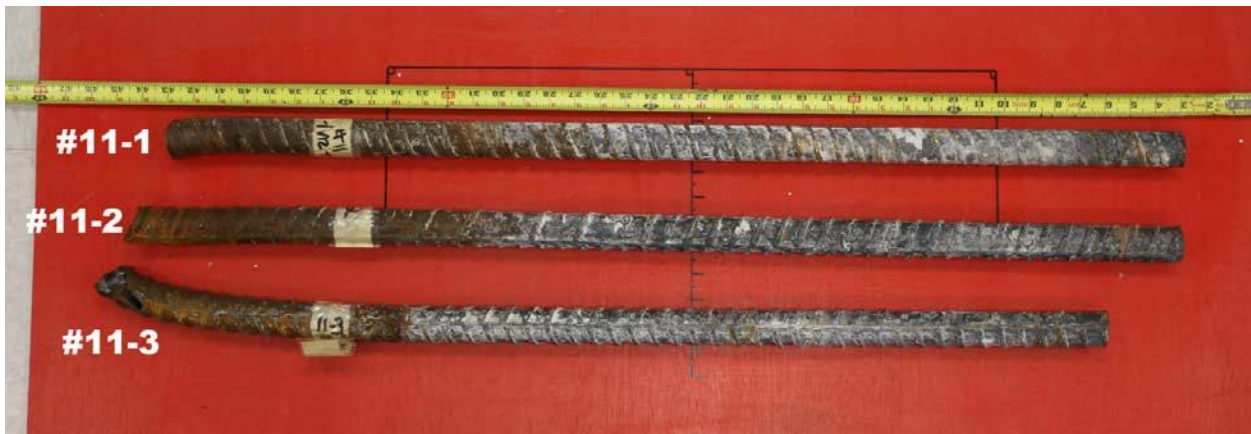
Figure 41. #11 bars received

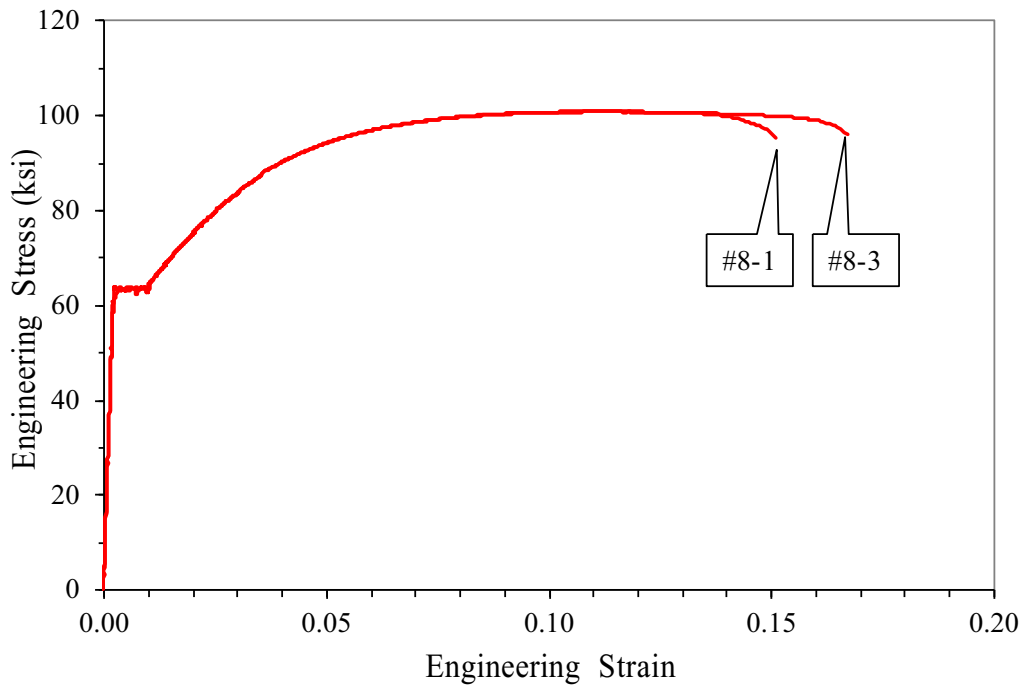
Figures 42, 43, and 44 show the stress versus strain results, respectively, for the #5, #8, and #11 bars. The pertinent data for each of the specimens is reported in Table 16. Yield strength was determined by the 0.2% offset method defined in ASTM A370, tensile strength was based on the maximum stress achieved, and elongation at fracture was the final strain measured before significant load drop from fracture.

Figure 43. Stress versus strain results for #8 reinforcing bars

Specimen	Yield Strength (ksi)	Tensile Strength (ksi)	Elongation at Fracture (percent)
#5-1	64.7	108.5	15.25
#5-2	63.2	107.3	16.52
#5-3	63.7	108.2	16.19
#8-1	63.4	100.9	15.08
#8-3	63.4	100.8	16.71
#11-1	73.1	112.6	14.09
#11-2	73.6	113.2	11.23 ^b
#11-3	72.8	112.6	9.81 ^b
ASTM A615	≥ 60	≥ 90	^a

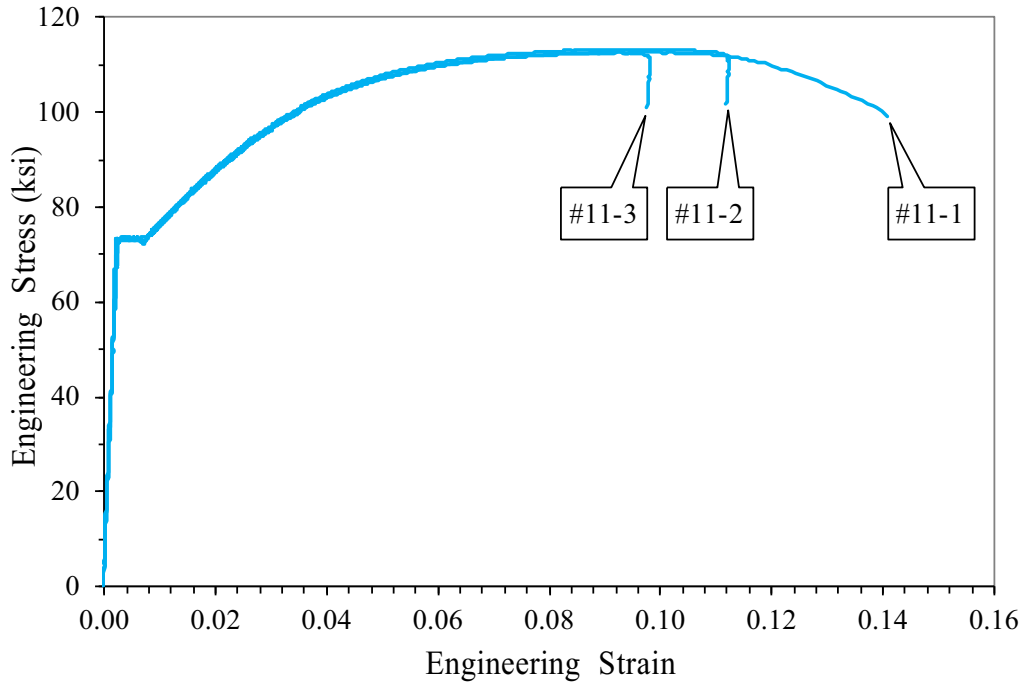
Figure 44. Stress versus strain results for #11 reinforcing bars

Specimens #11-2 and #11-3 fractured near the grips and thus outside the 8-inch gauge length. For these two specimens, the reported elongation is not fully representative of the material since it does not capture the necking of the specimen prior to fracture. This also explains the final load drop for these two specimens in Figure 44 because load was dropping as necking occurred outside the gauge length, thus keeping the strain nearly constant within the gauge length. Additional post-processing of the video extensometer data could be possible with an increased gauge length; however, since the measured elongation within the 8.000-inch gauge length was greater than the ASTM A615 requirement, this additional processing was not completed.

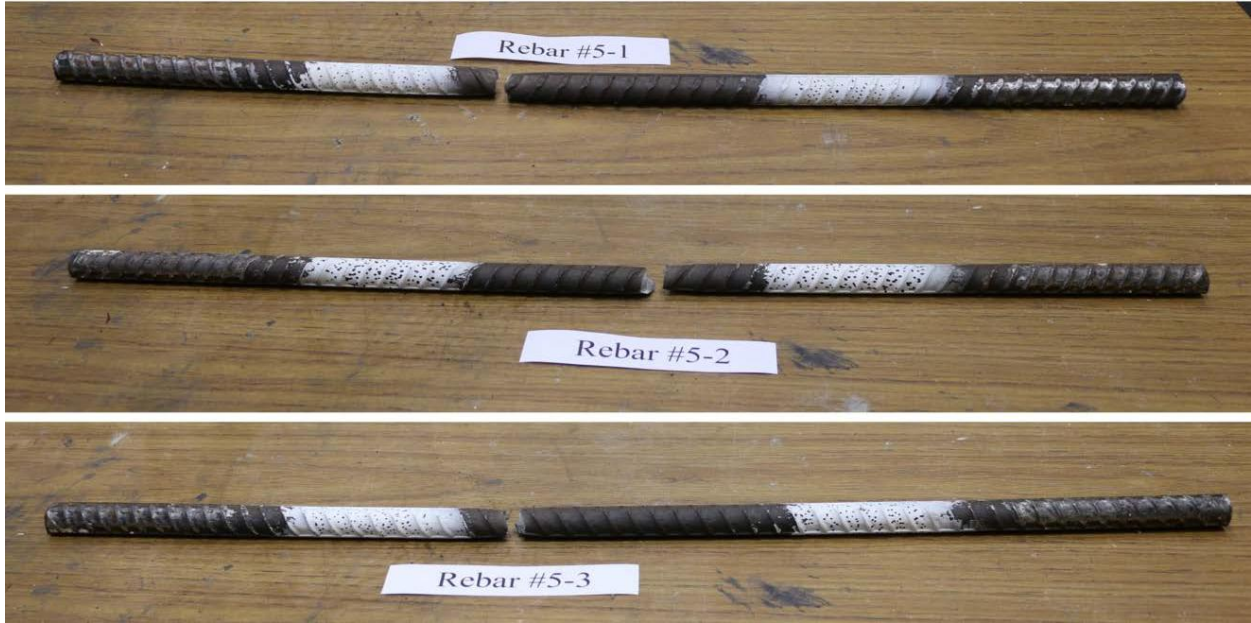
Photographs of the failed #5, #8, and #11 specimens are shown in Figure 45, Figure 46, and Figure 47, respectively.

Figure 45. Photographs of fractured #5 bar specimens

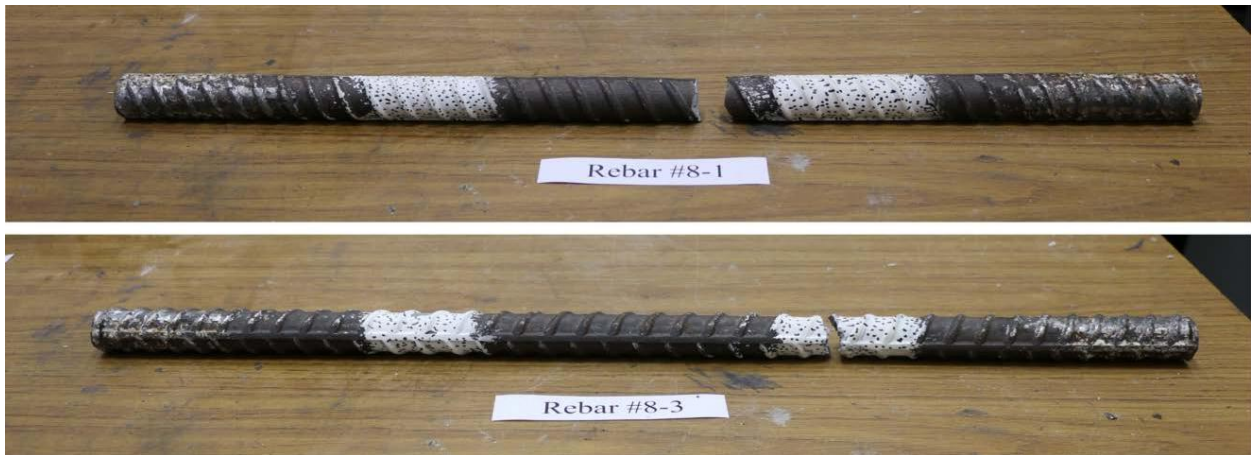
Figure 46. Photographs of fractured #8 bar specimens

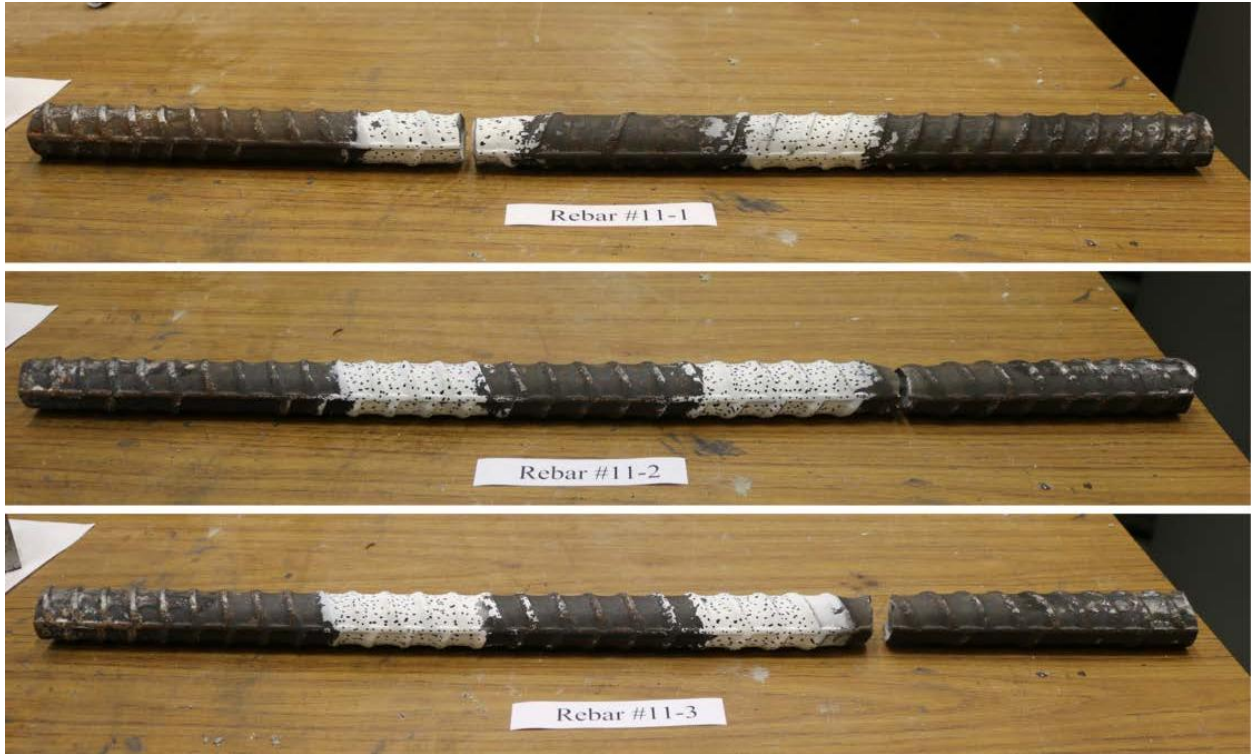
Figure 47. Photographs of fractured #11 bar specimens
