National Transportation Safety Board

Office of Research and Engineering

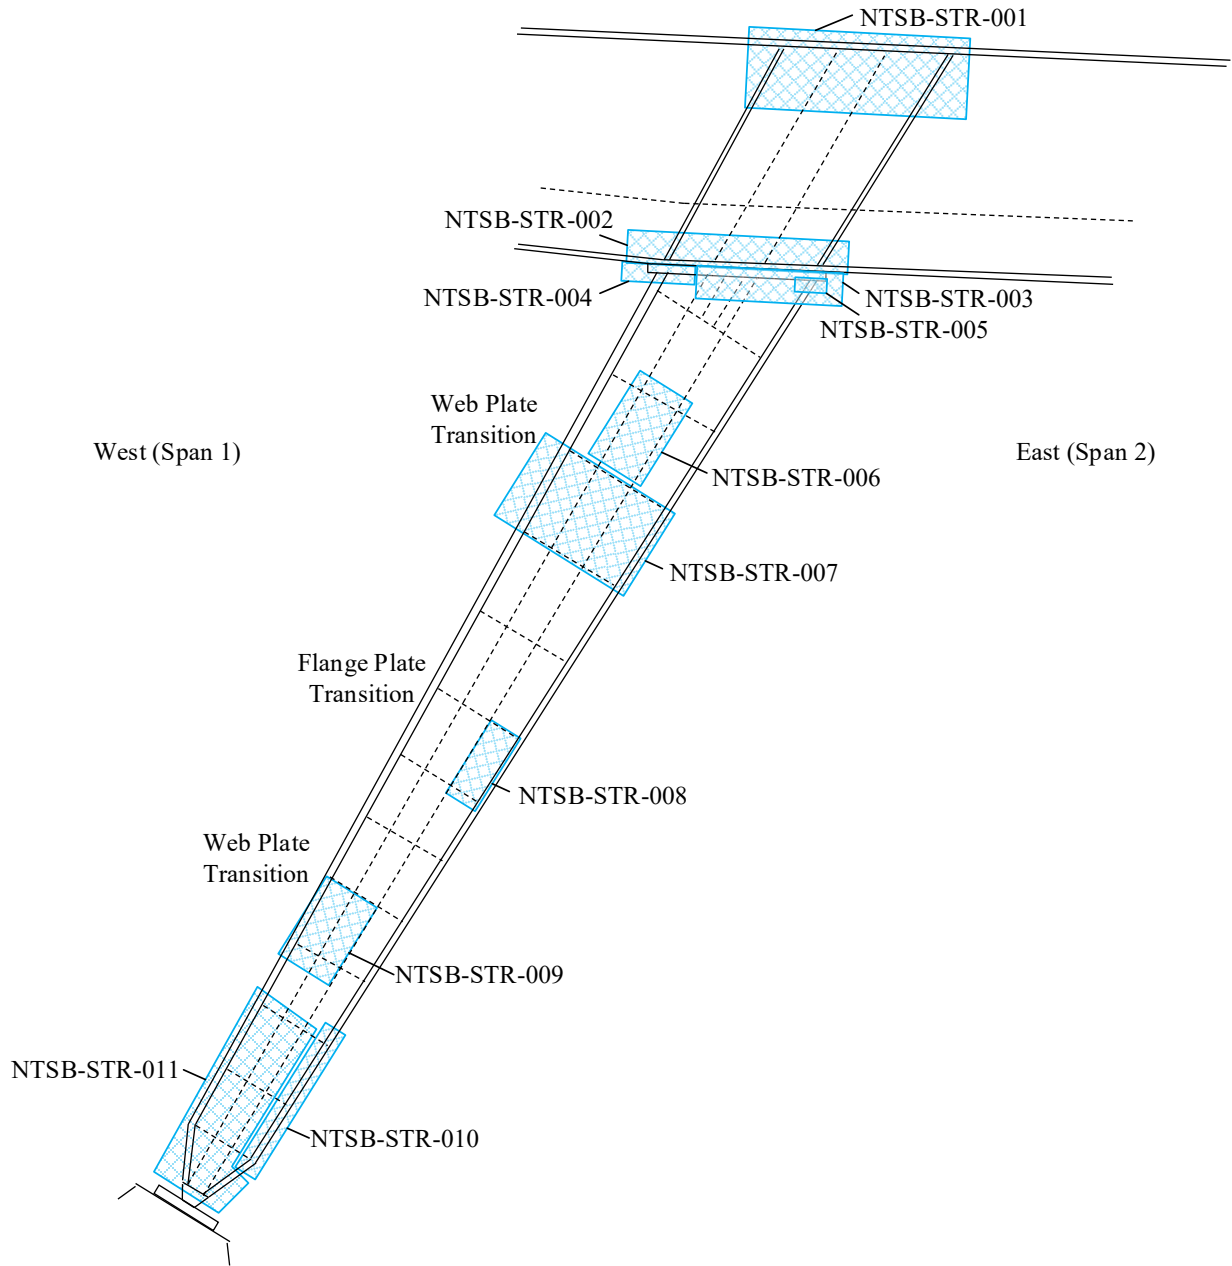
Figure 3. B1R – South-West Leg.

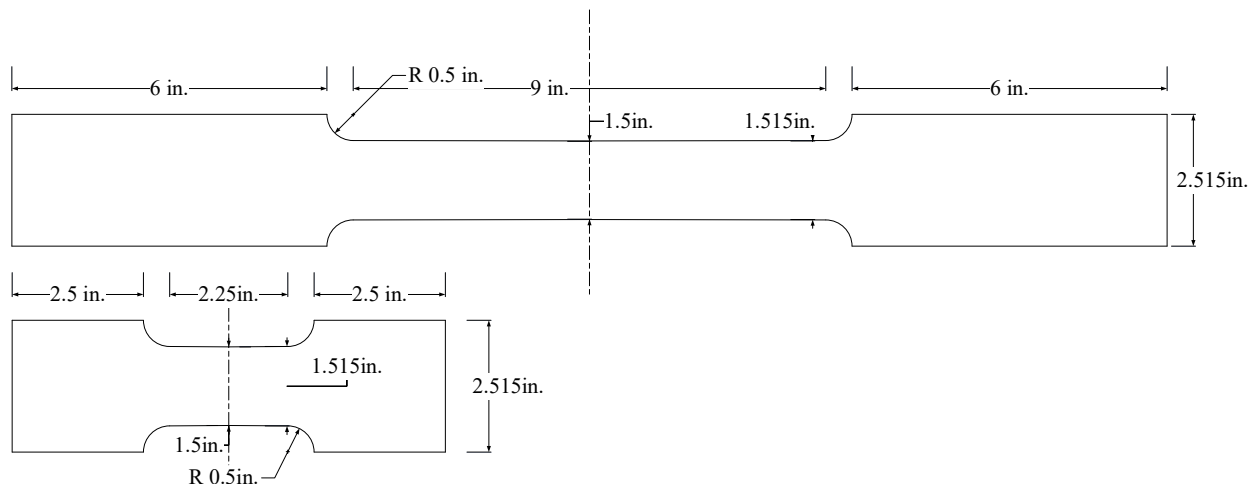
Figure 7. Tensile coupon dimensions.

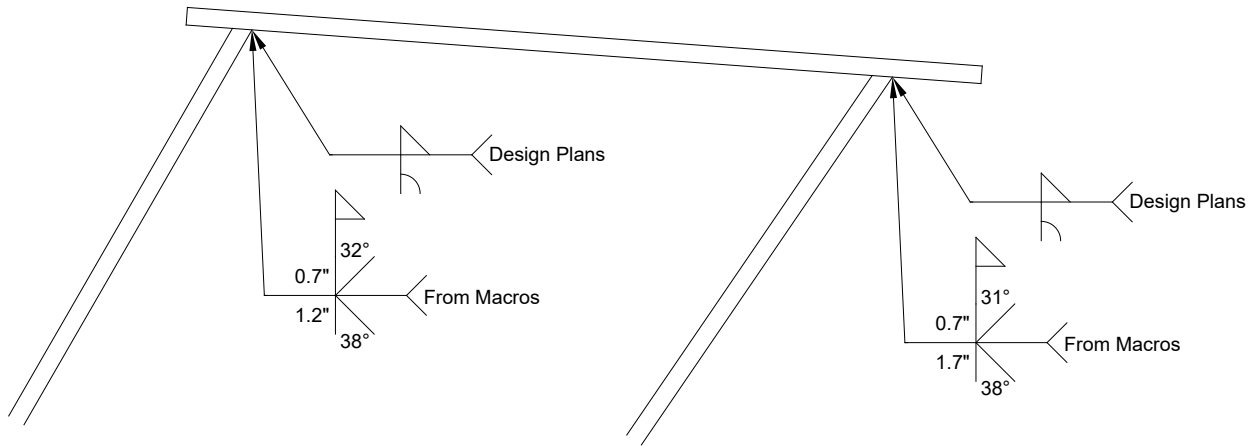
Figure 8. Design weld profile versus the observed profile for B1R.

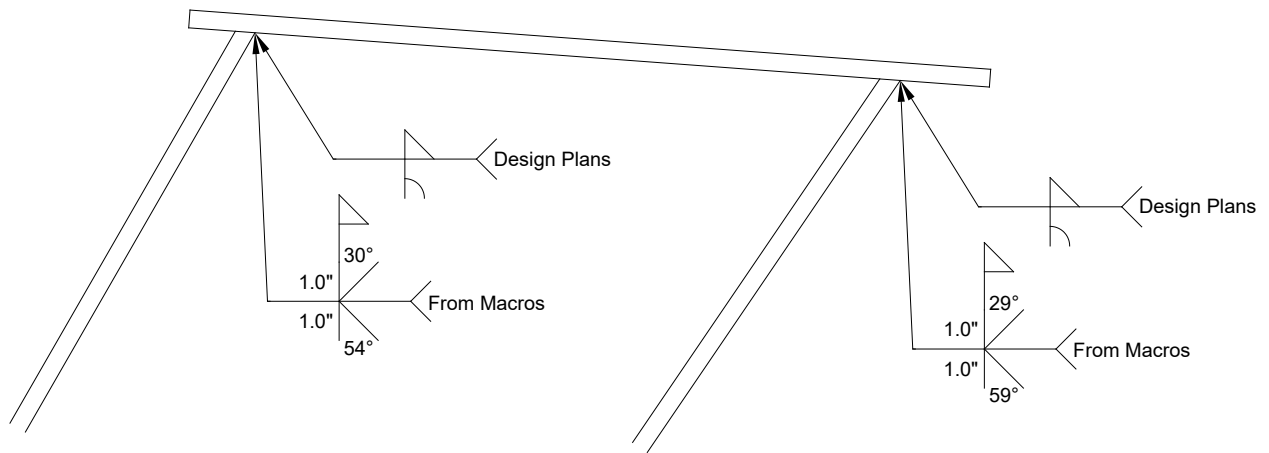
Figure 10. Design weld profile versus the observed profile for B2R.

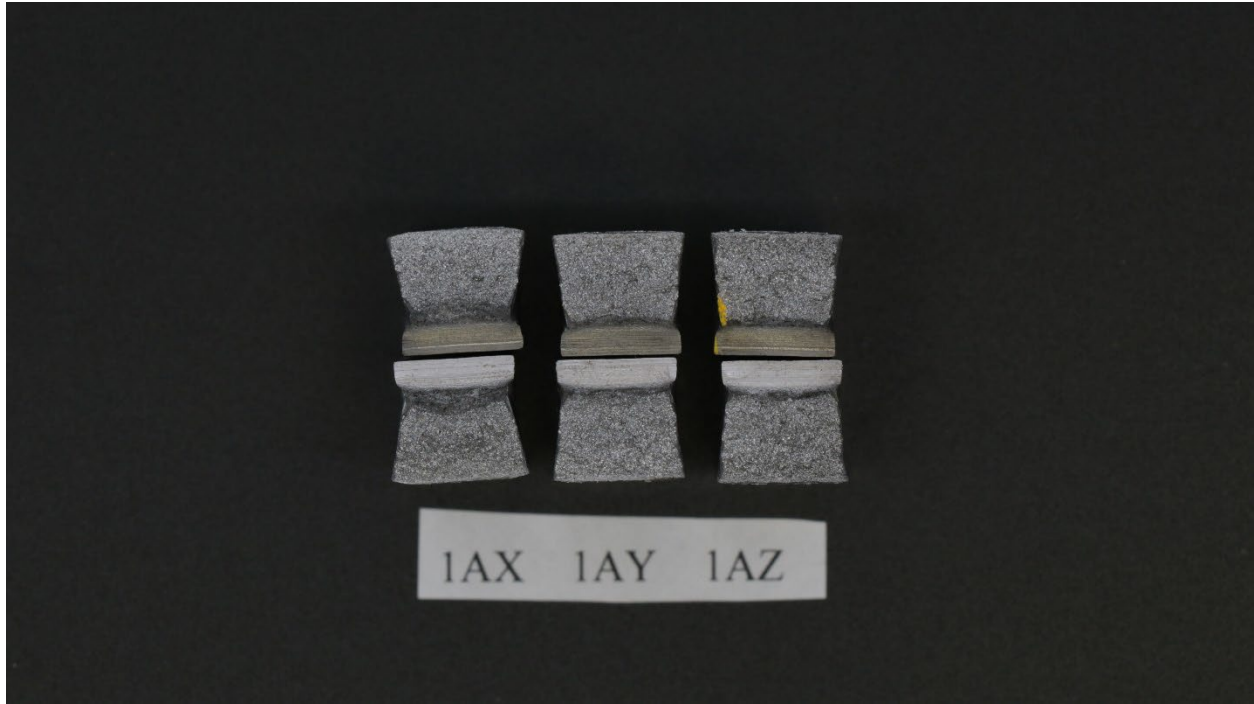
Figure E.1. Shear fracture surfaces for plate 1A.

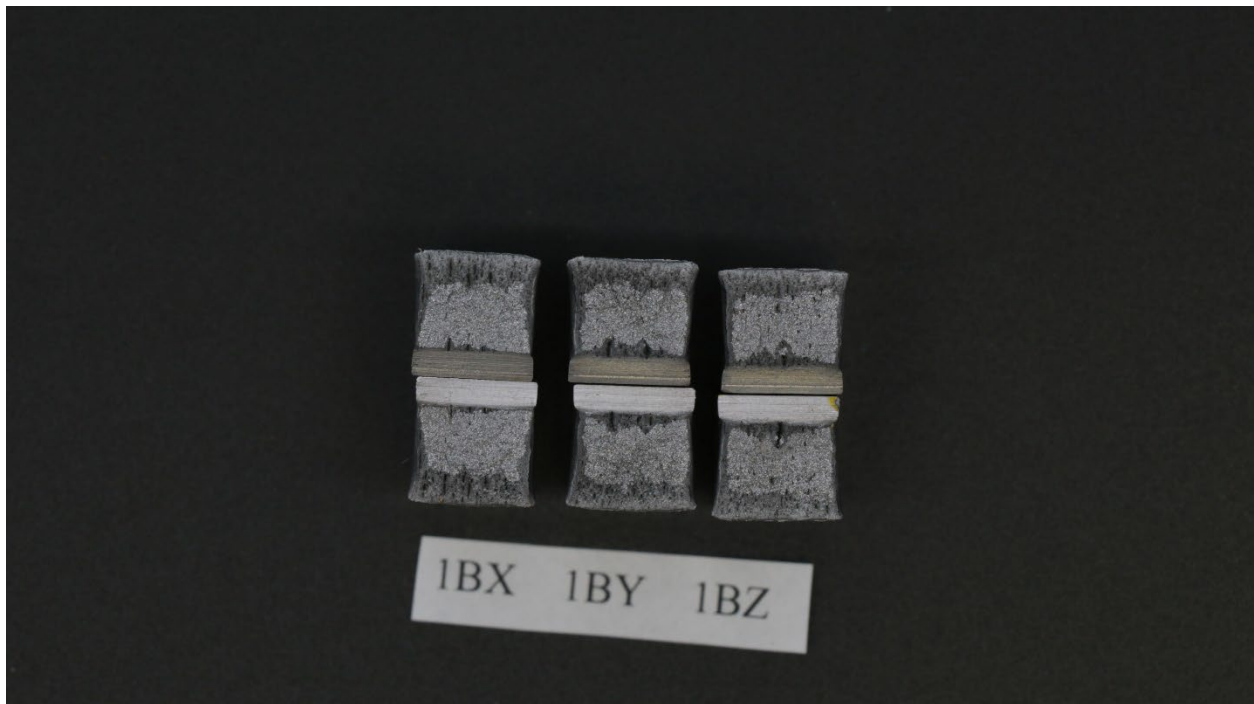
Figure E.2. Shear fracture surfaces for plate 1B.

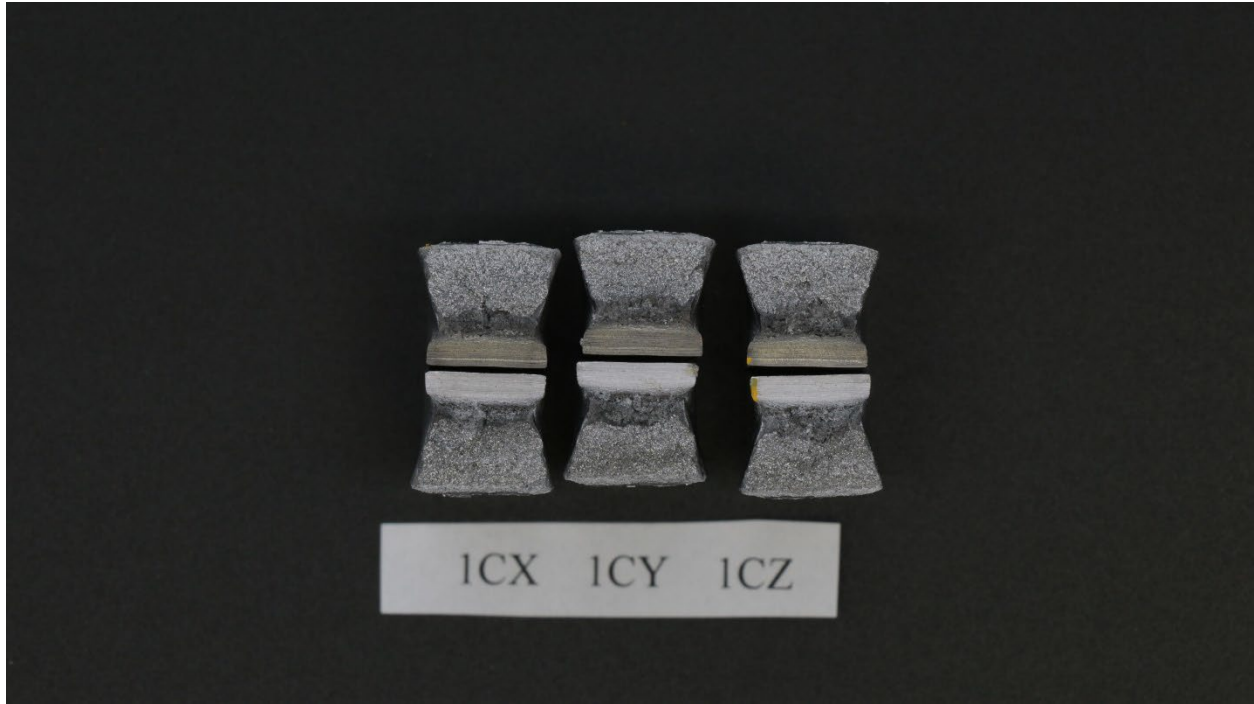
Figure E.3. Shear fracture surfaces for plate 1C.

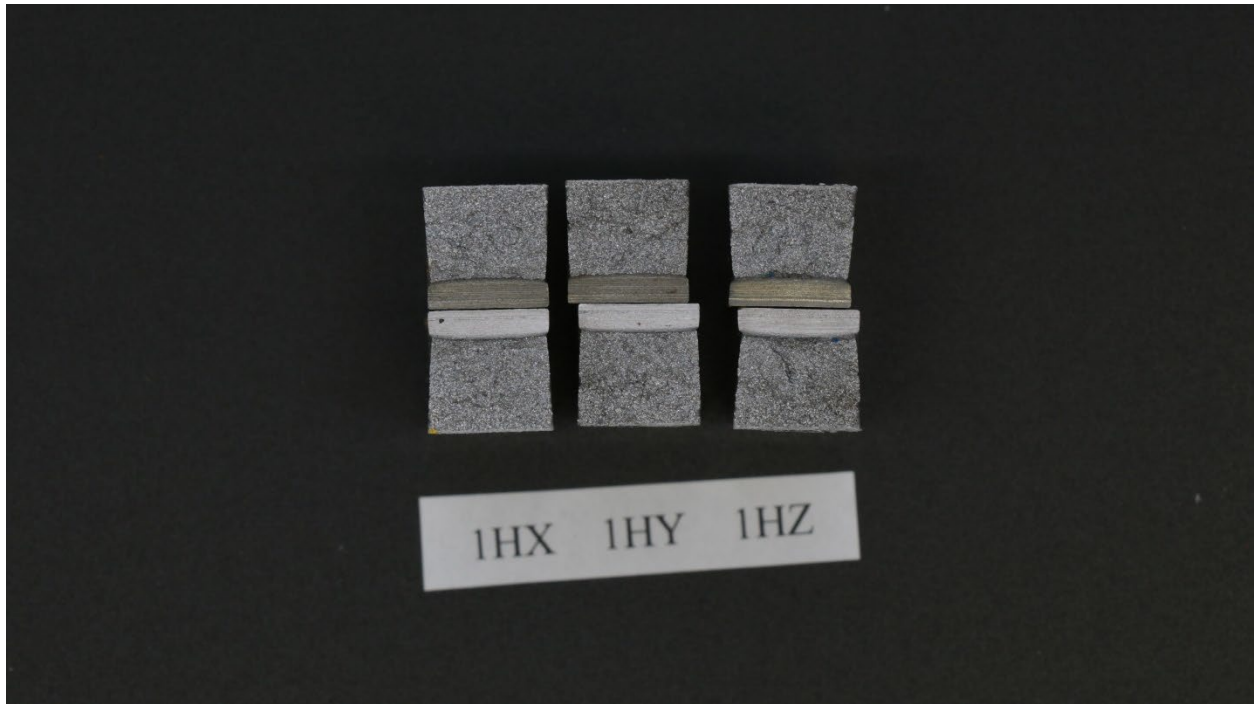
Figure E.4. Shear fracture surfaces for plate 1H.

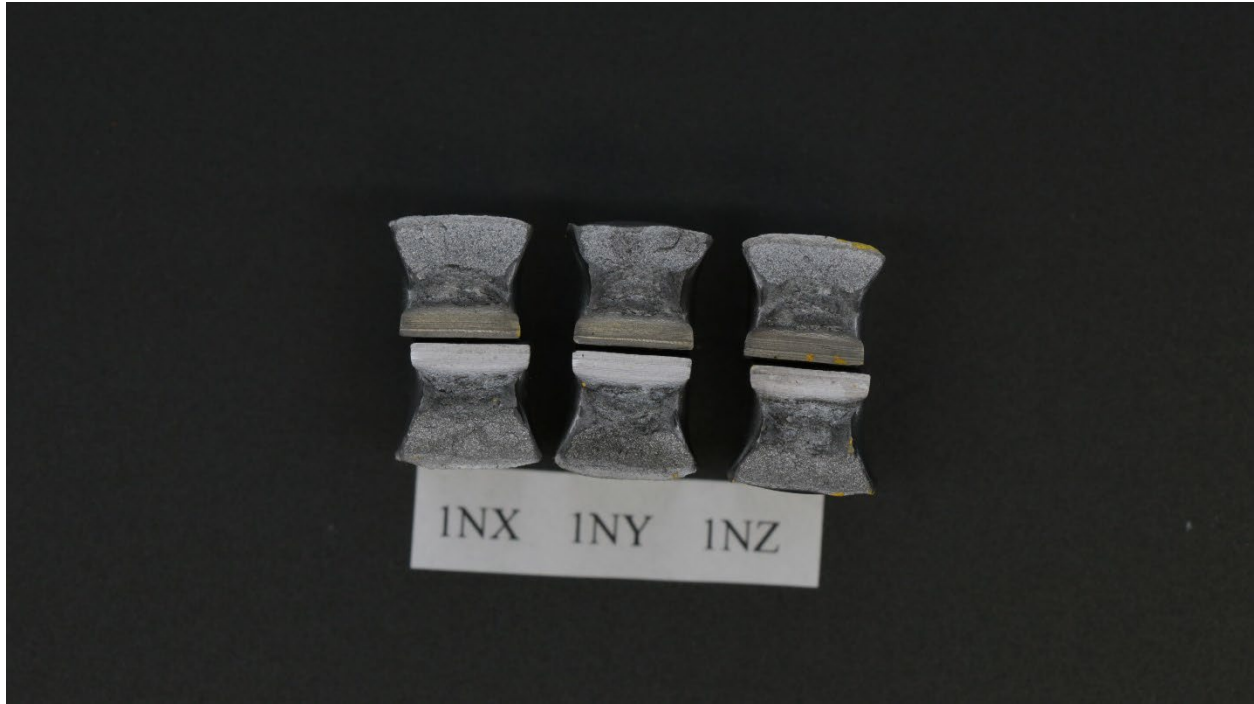
Figure E.5. Shear fracture surfaces for plate 1N.

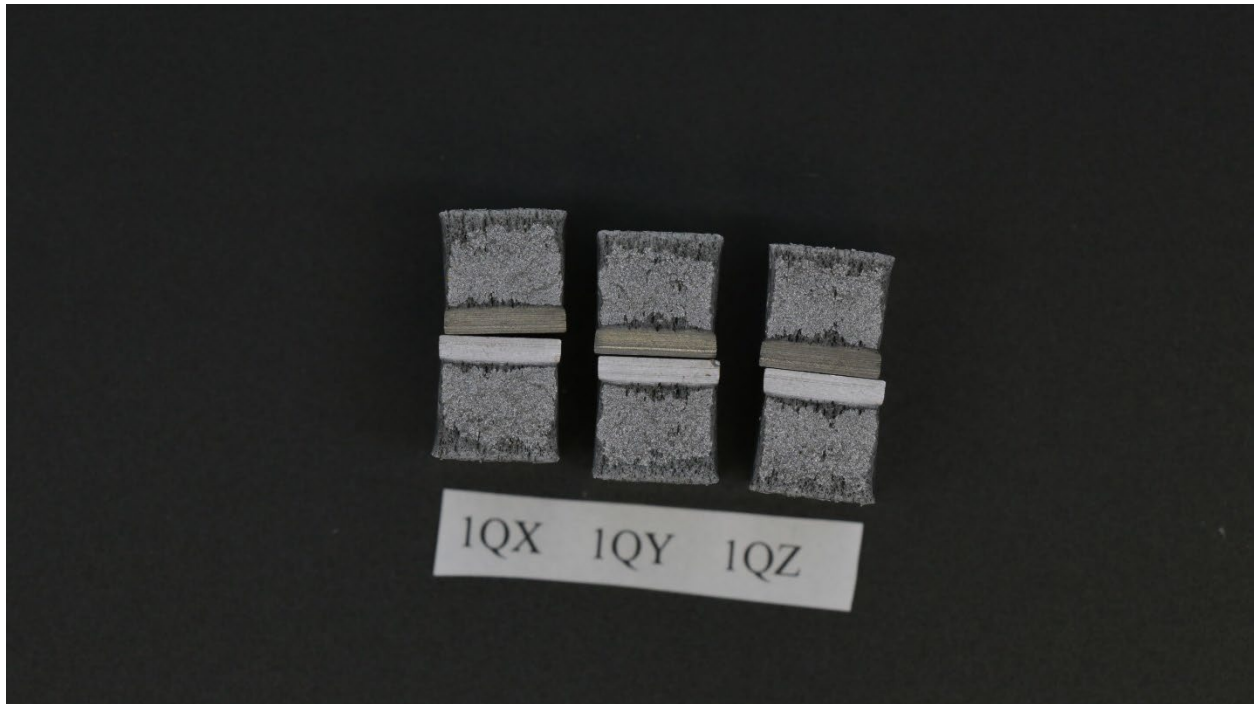
Figure E.6. Shear fracture surfaces for plate 1Q.

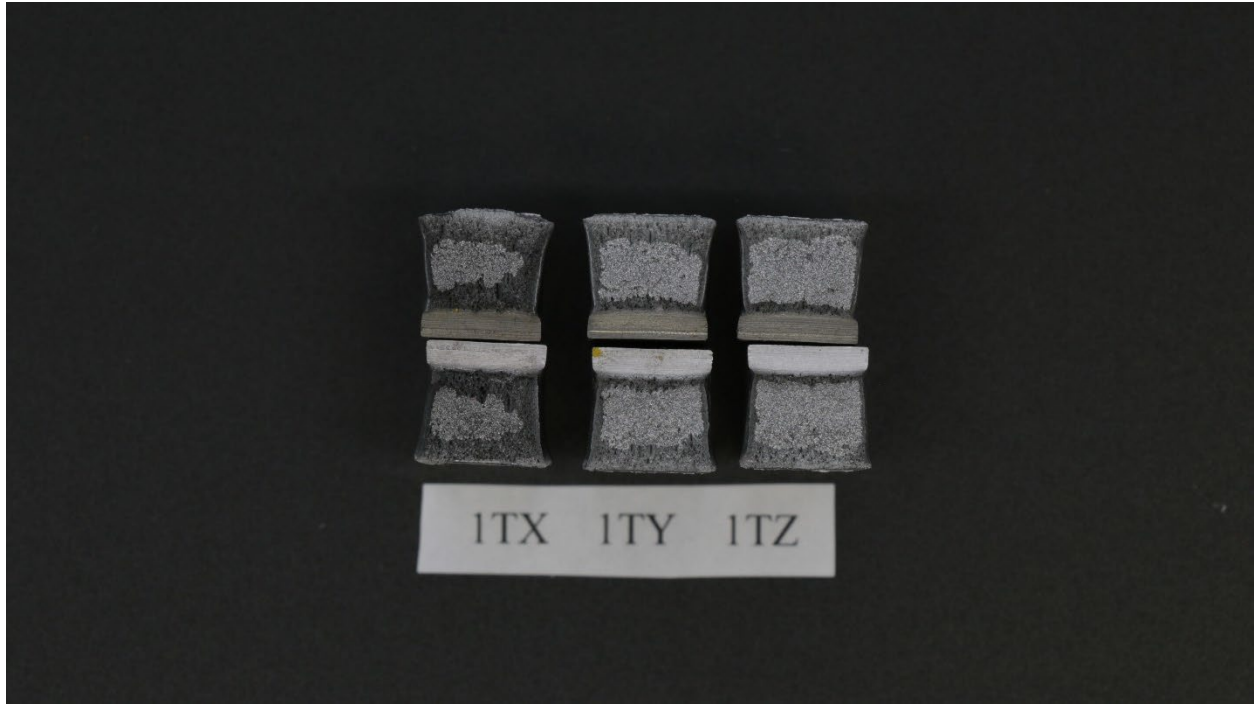
Figure E.7. Shear fracture surfaces for plate 1T.

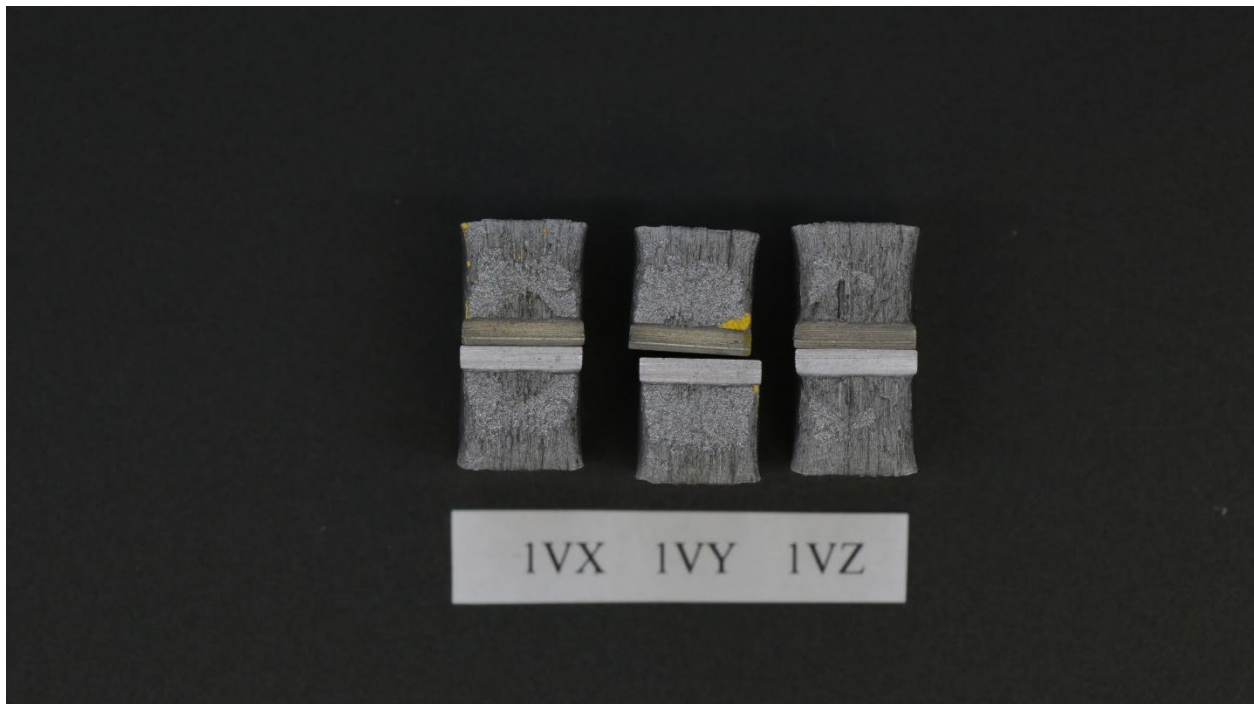
Figure E.8. Shear fracture surfaces for plate 1V.

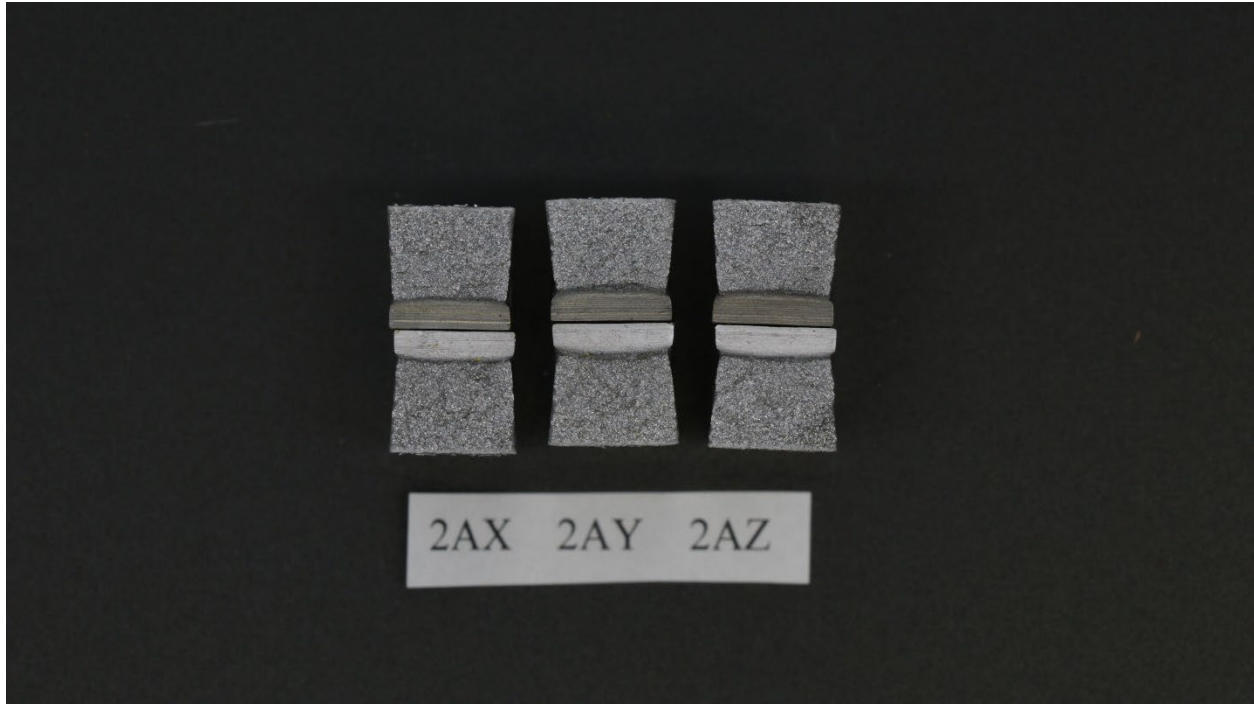
Figure E.9. Shear fracture surfaces for plate 2A.

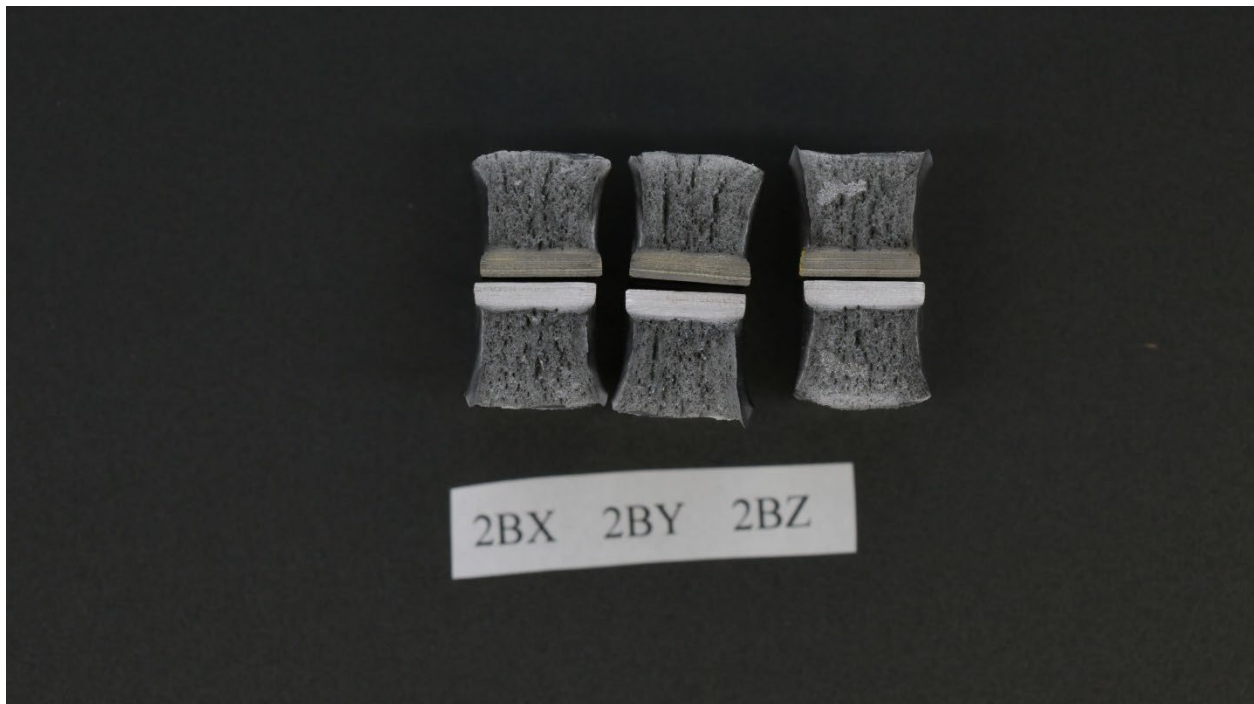
Figure E.10. Shear fracture surfaces for plate 2B.

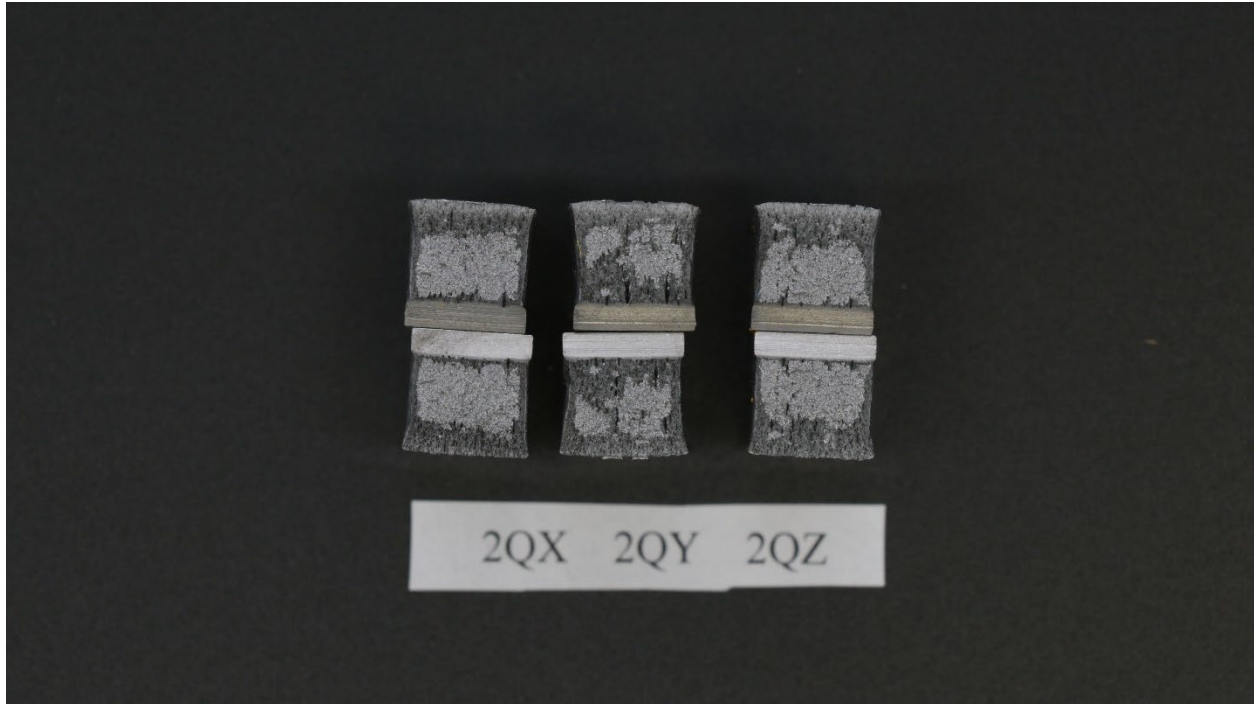
Figure E.11. Shear fracture surfaces for plate 2Q.

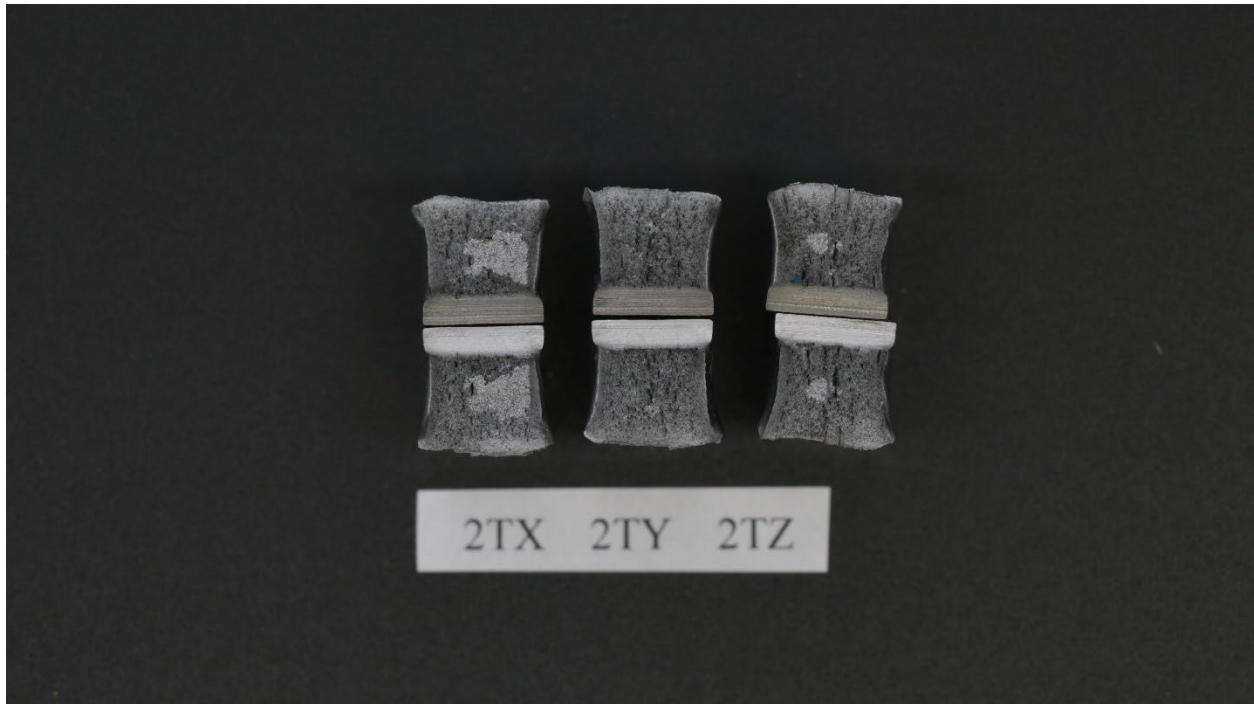
Figure E.12. Shear fracture surfaces for plate 2T.

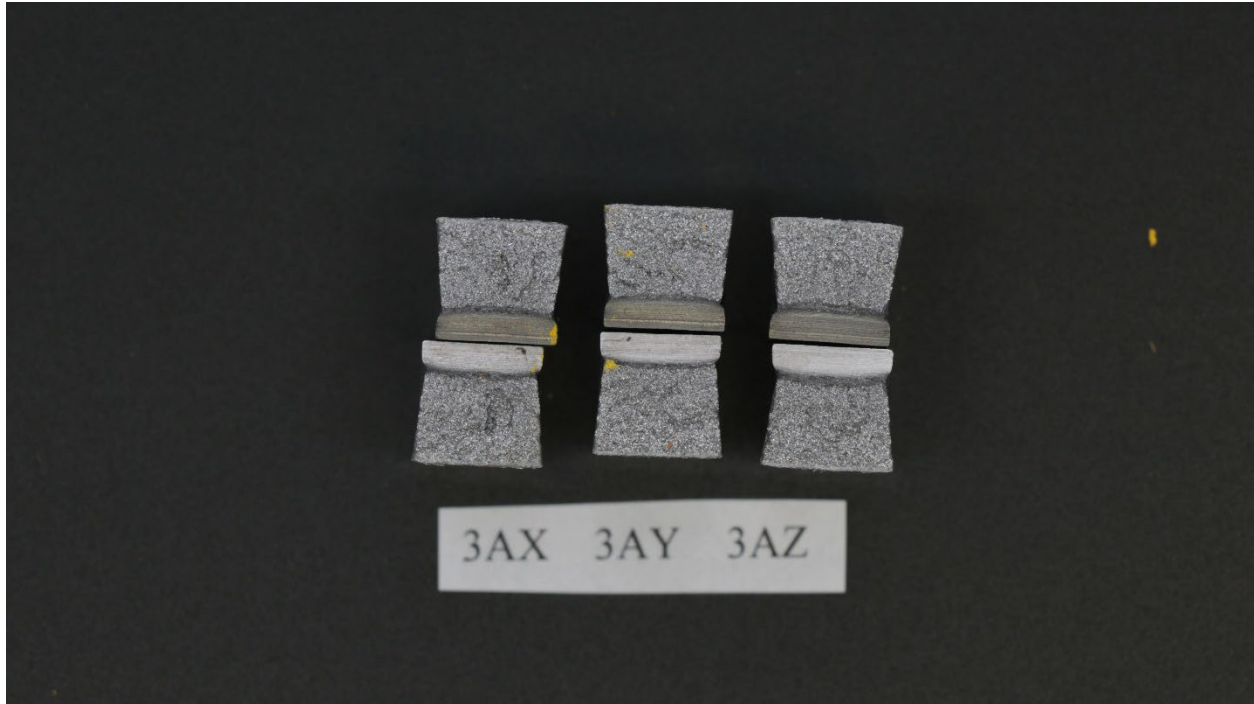
Figure E.13. Shear fracture surfaces for plate 3A.

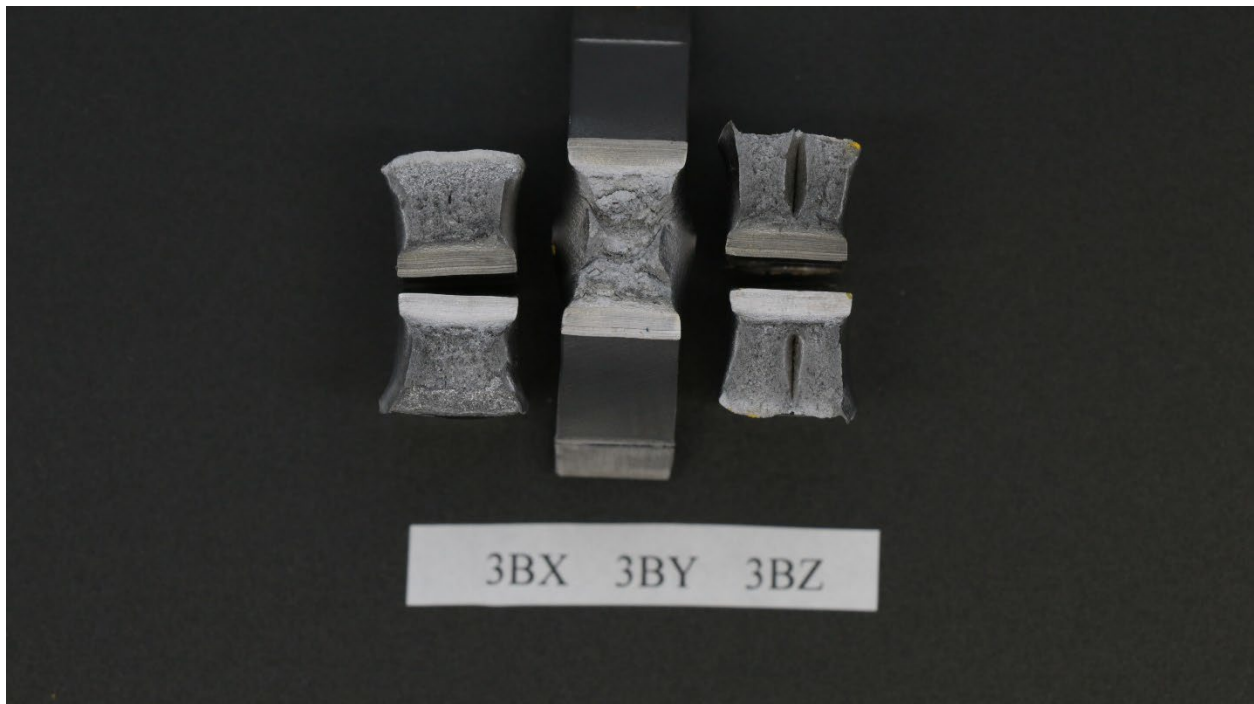
Figure E.14. Shear fracture surfaces for plate 3B.

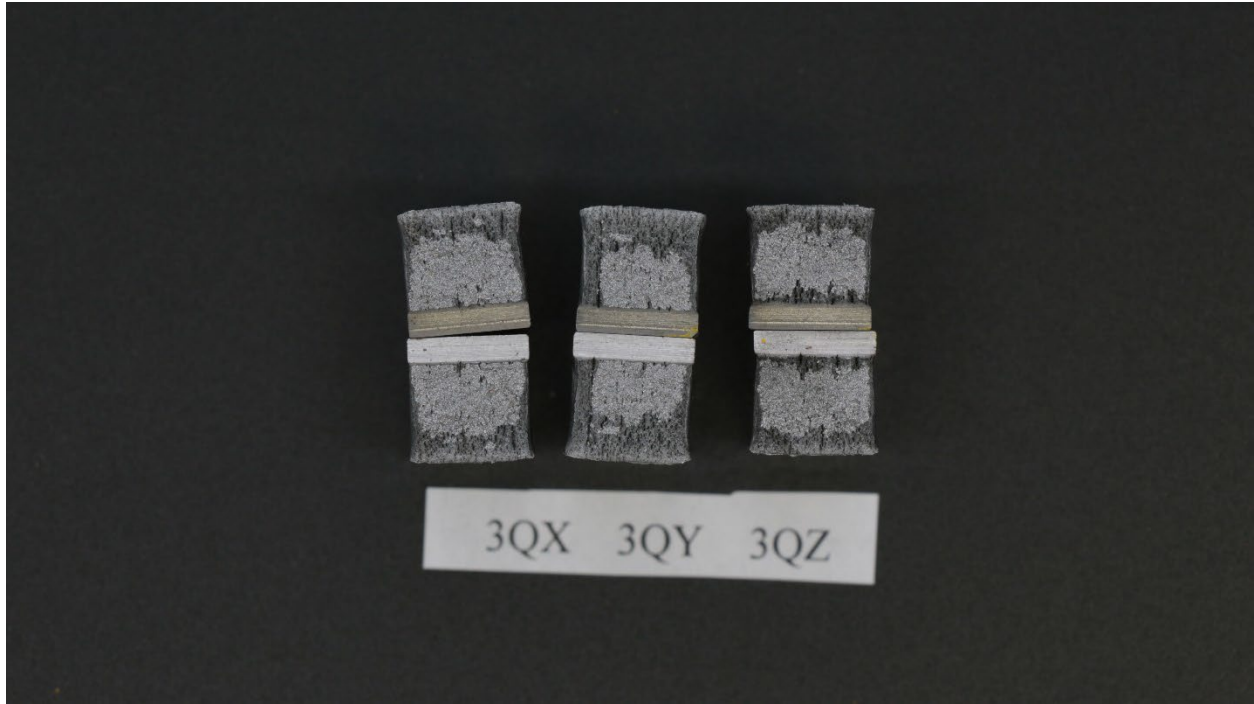
Figure E.15. Shear fracture surfaces for plate 3Q.

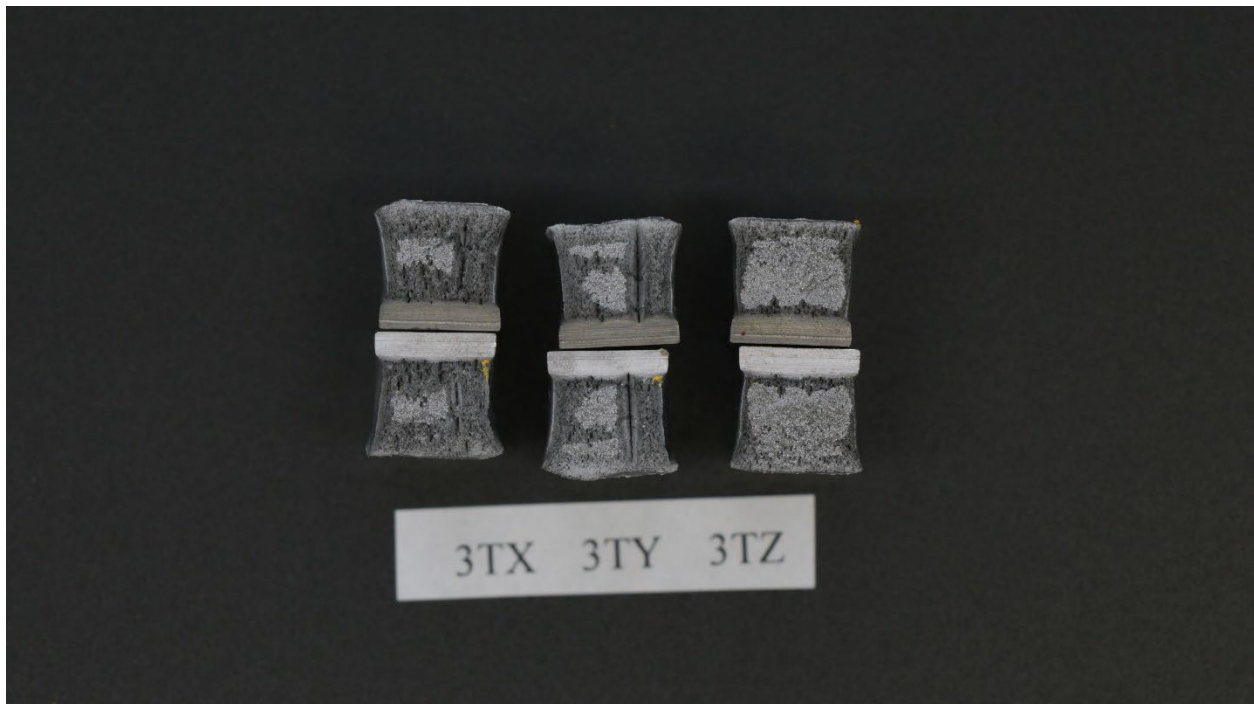
Figure E.16. Shear fracture surfaces for plate 3T.

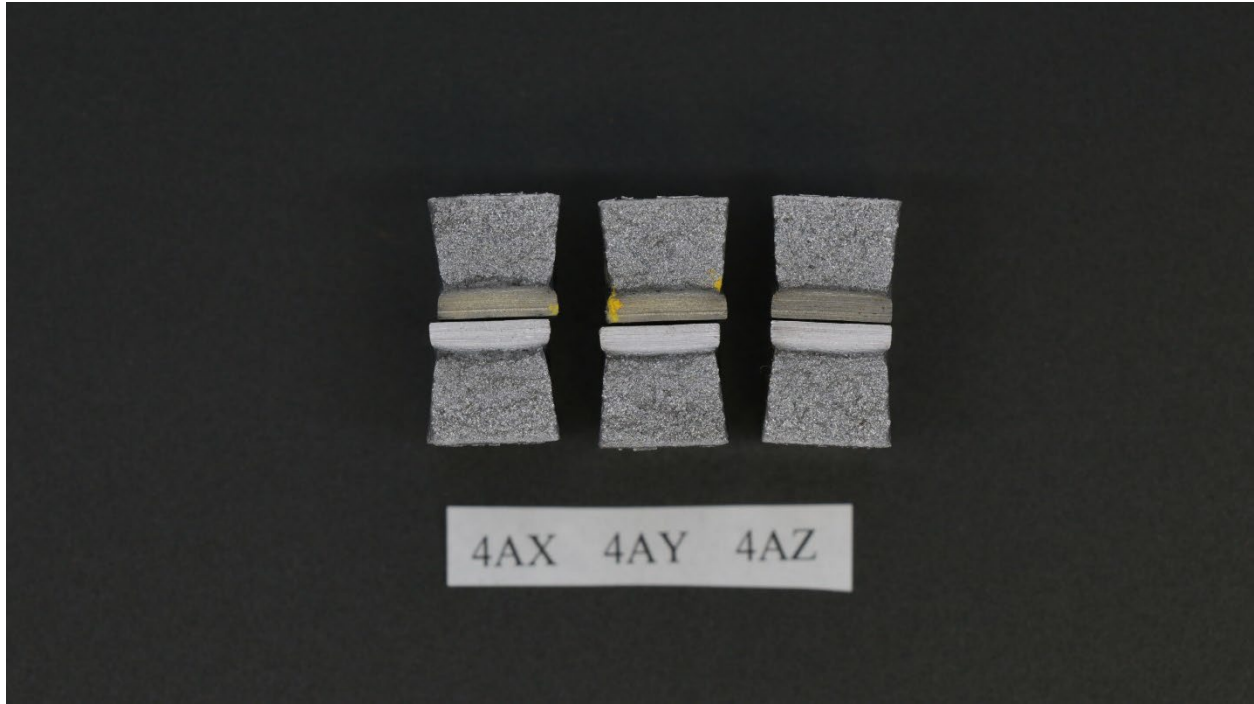
Figure E.17. Shear fracture surfaces for plate 4A.

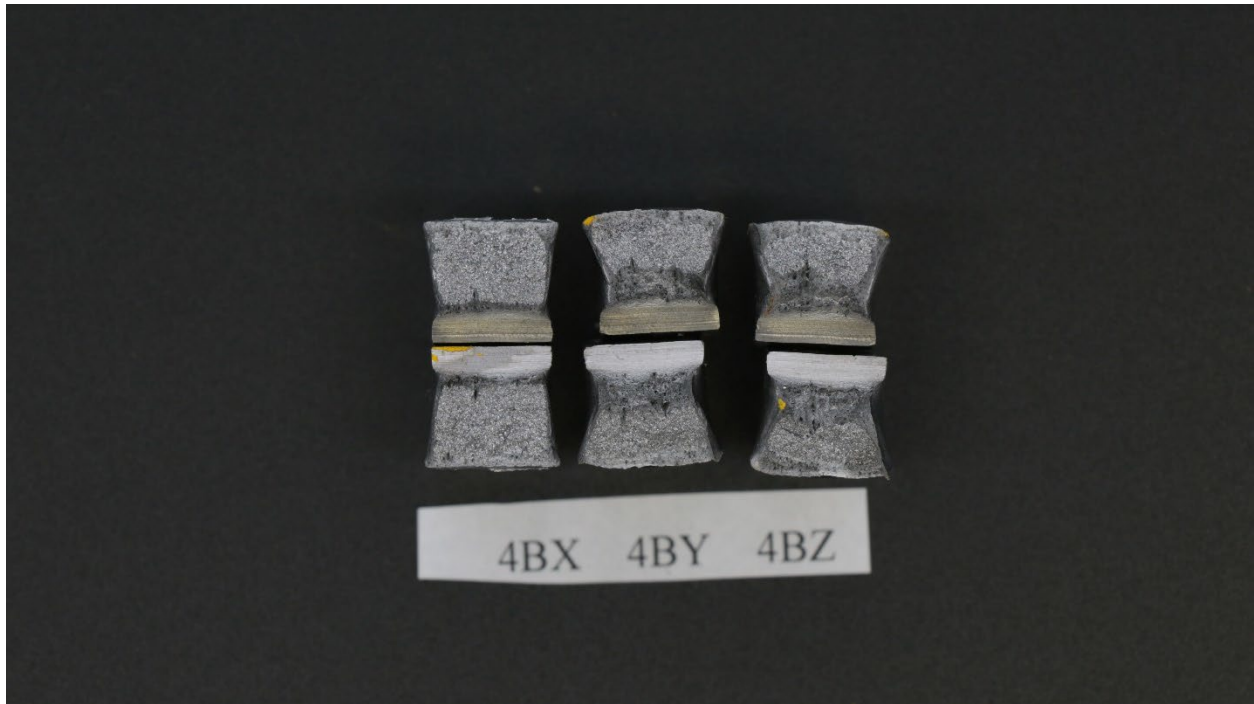
Figure E.18. Shear fracture surfaces for plate 4B.

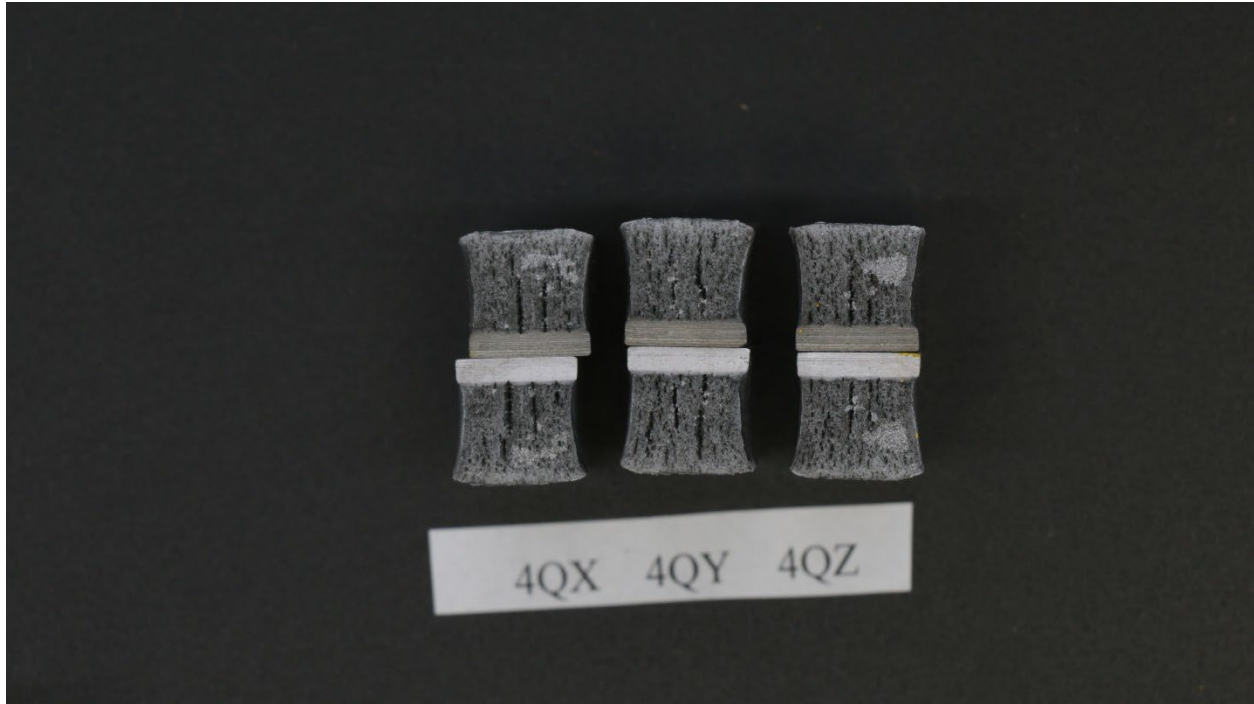
Figure E.19. Shear fracture surfaces for plate 4Q.

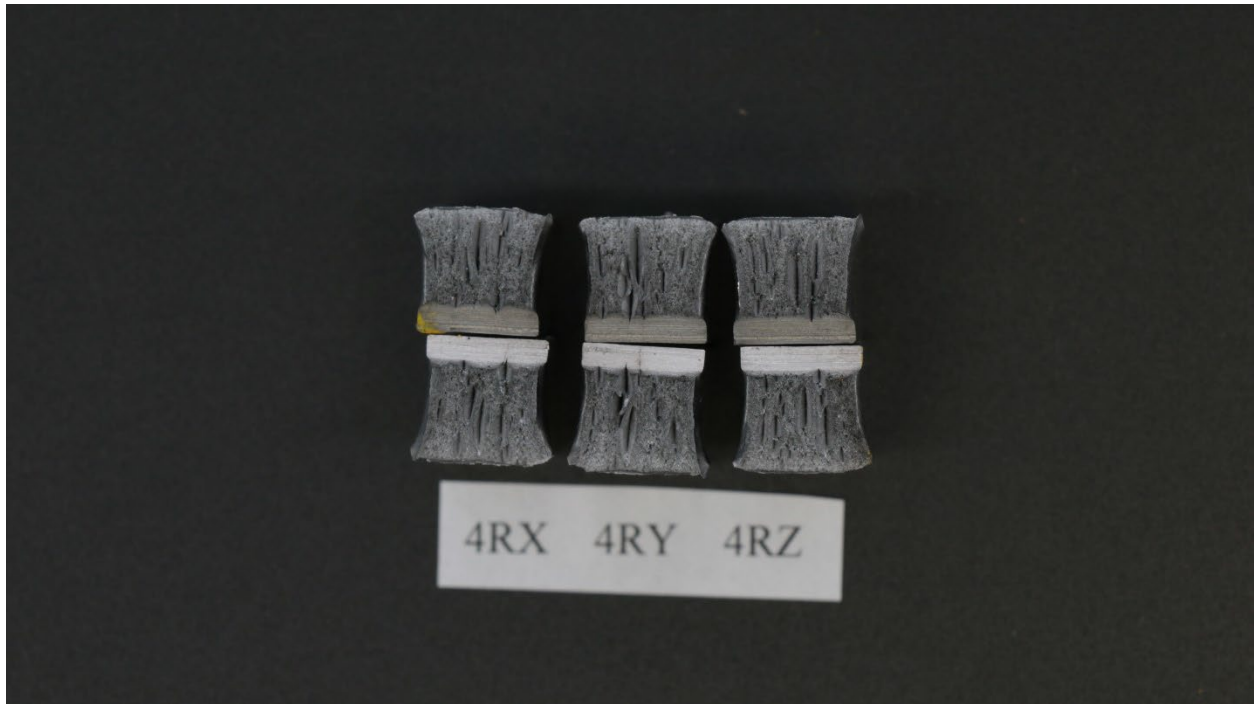
Figure E.20. Shear fracture surfaces for plate 4R.

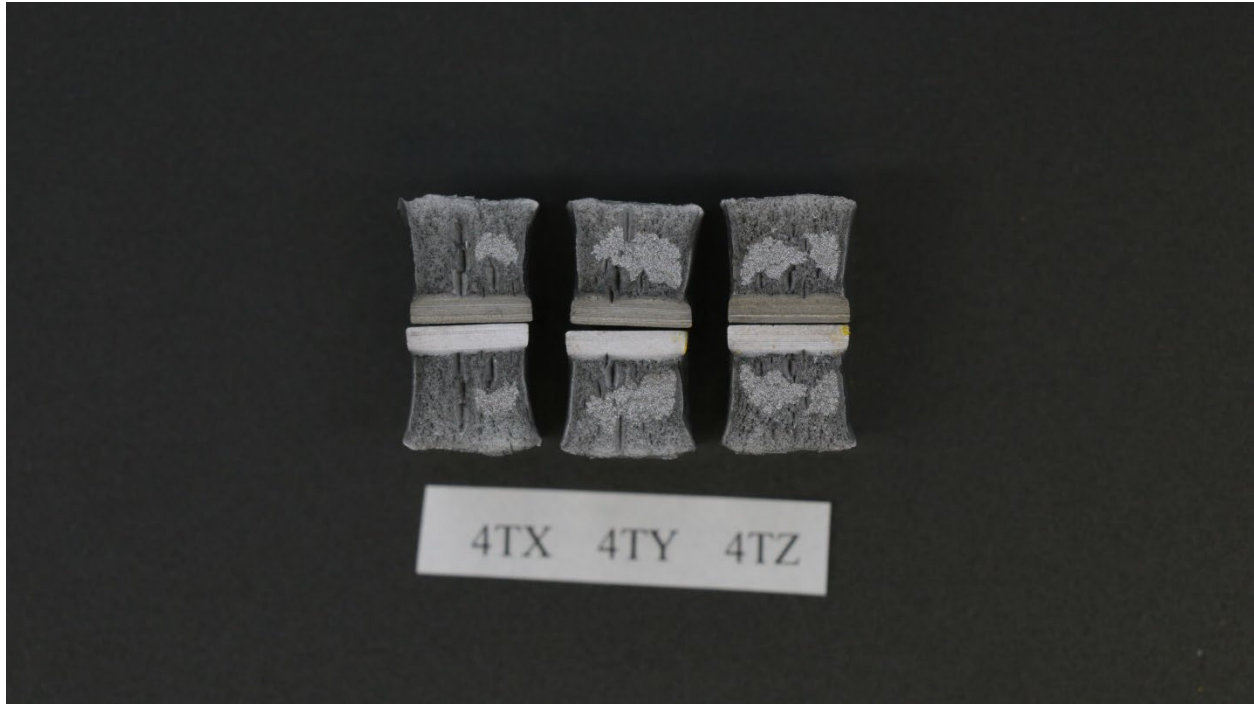
Figure E.21. Shear fracture surfaces for plate 4T.

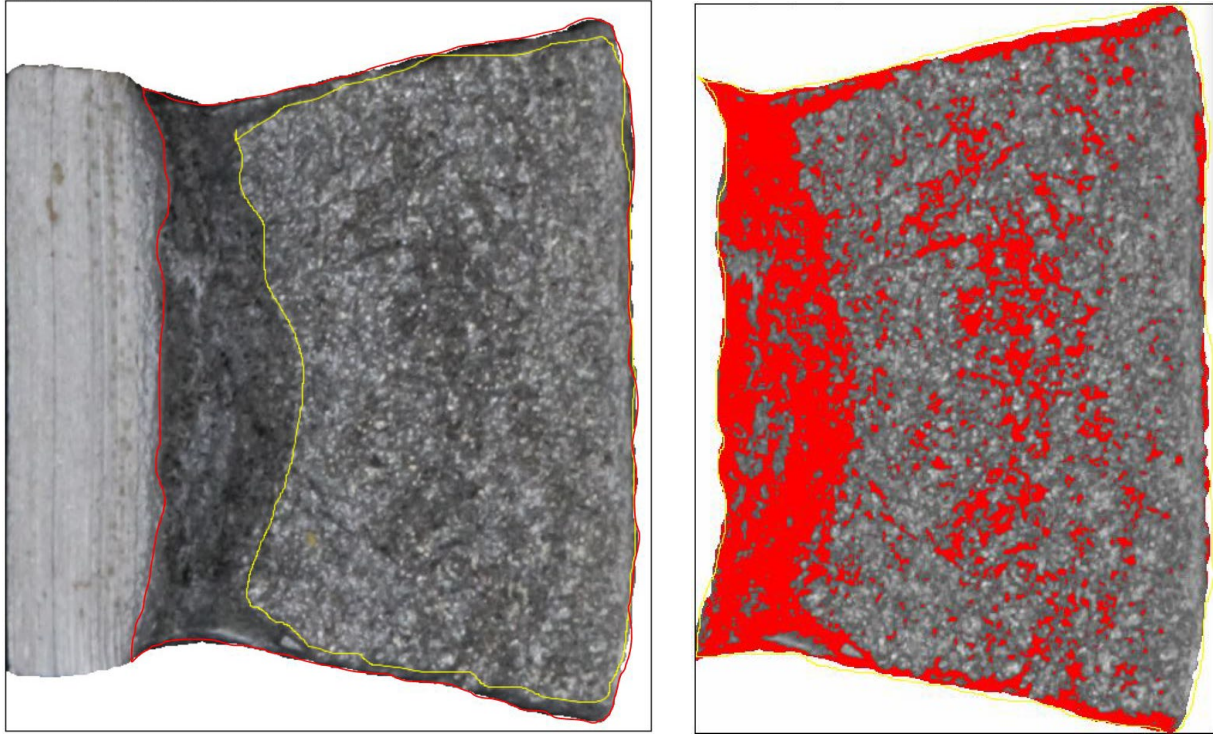
Figure E.22. Shear fracture areas for specimen 1AX using a Mask Area Method (left) and a Pixel Intensity Method (right).
