National Transportation Safety Board

Office of Research and Engineering

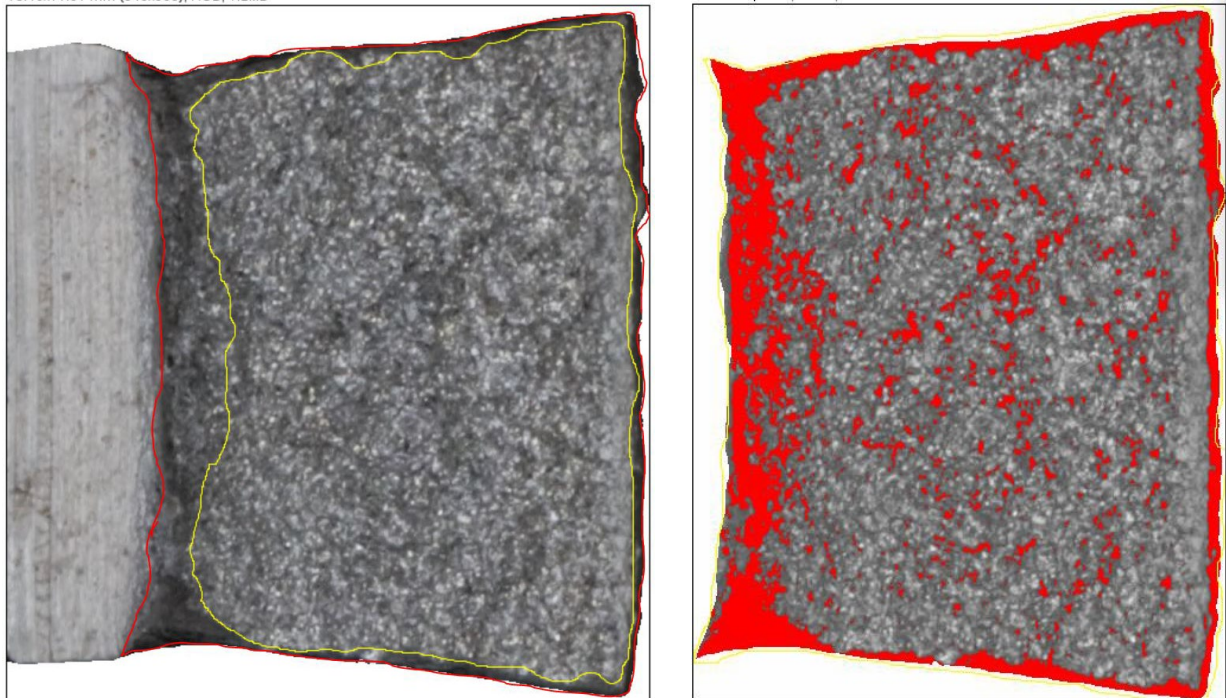
Figure E.23. Shear fracture areas for specimen 1AY using a Mask Area Method (left) and a Pixel Intensity Method (right).

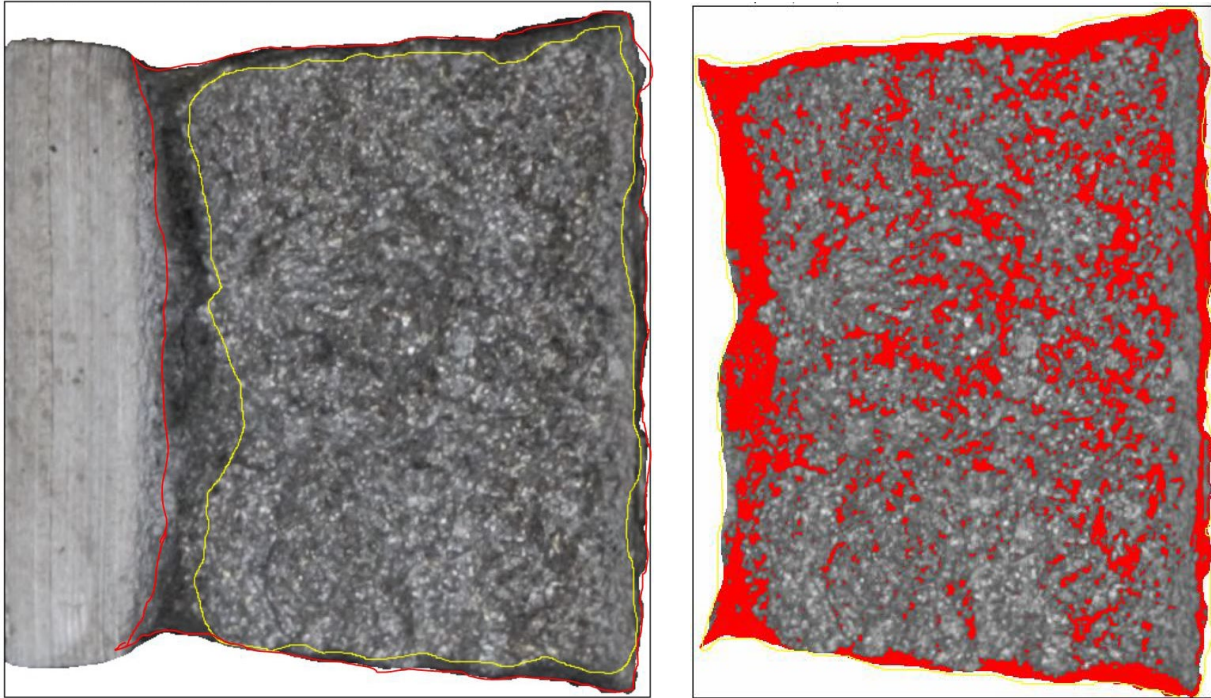
Figure E.24. Shear fracture areas for specimen 1AZ using a Mask Area Method (left) and a Pixel Intensity Method (right).

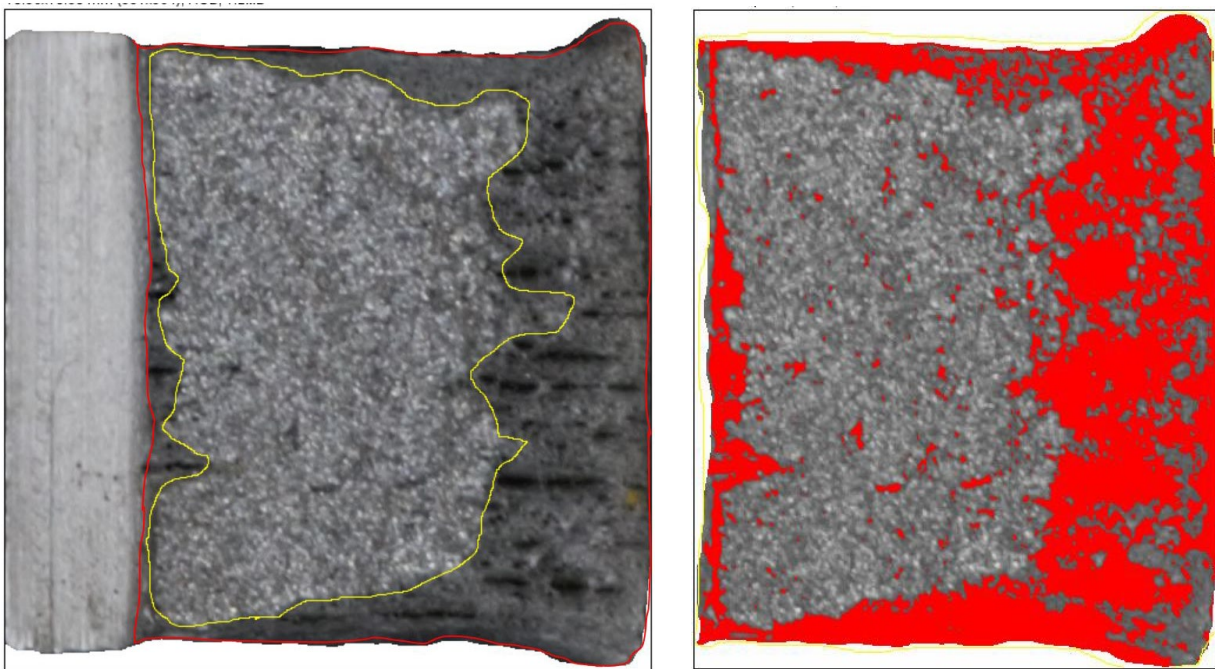
Figure E.25. Shear fracture areas for specimen 1BX using a Mask Area Method (left) and a Pixel Intensity Method (right).

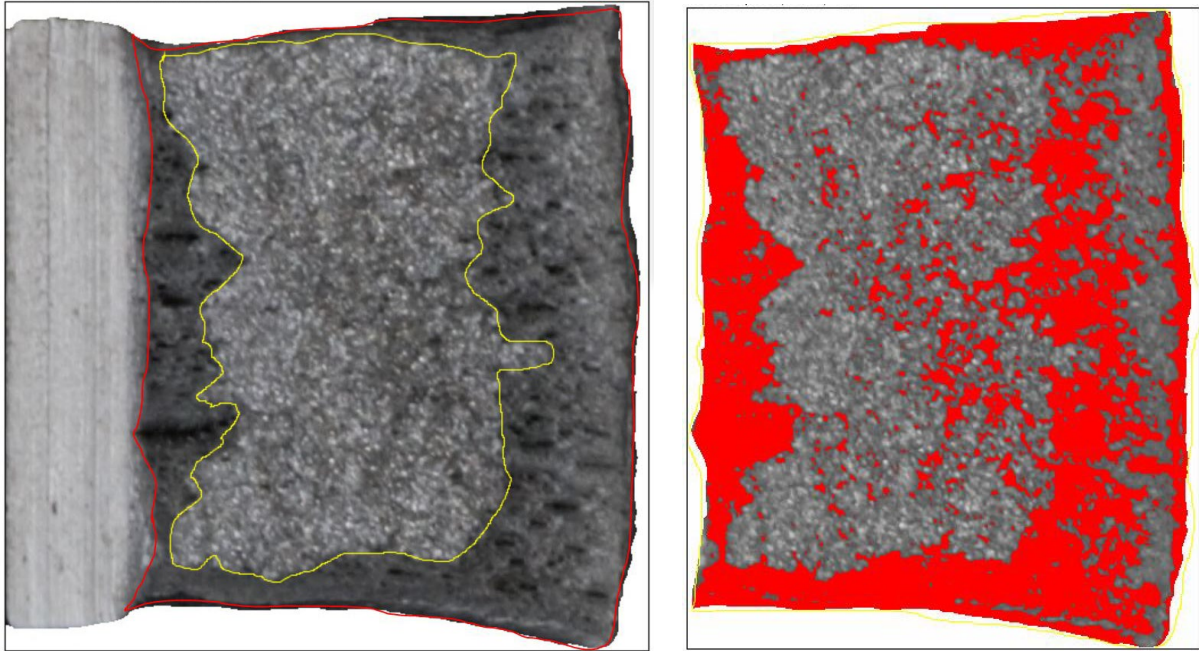
Figure E.26. Shear fracture areas for specimen 1BY using a Mask Area Method (left) and a Pixel Intensity Method (right).

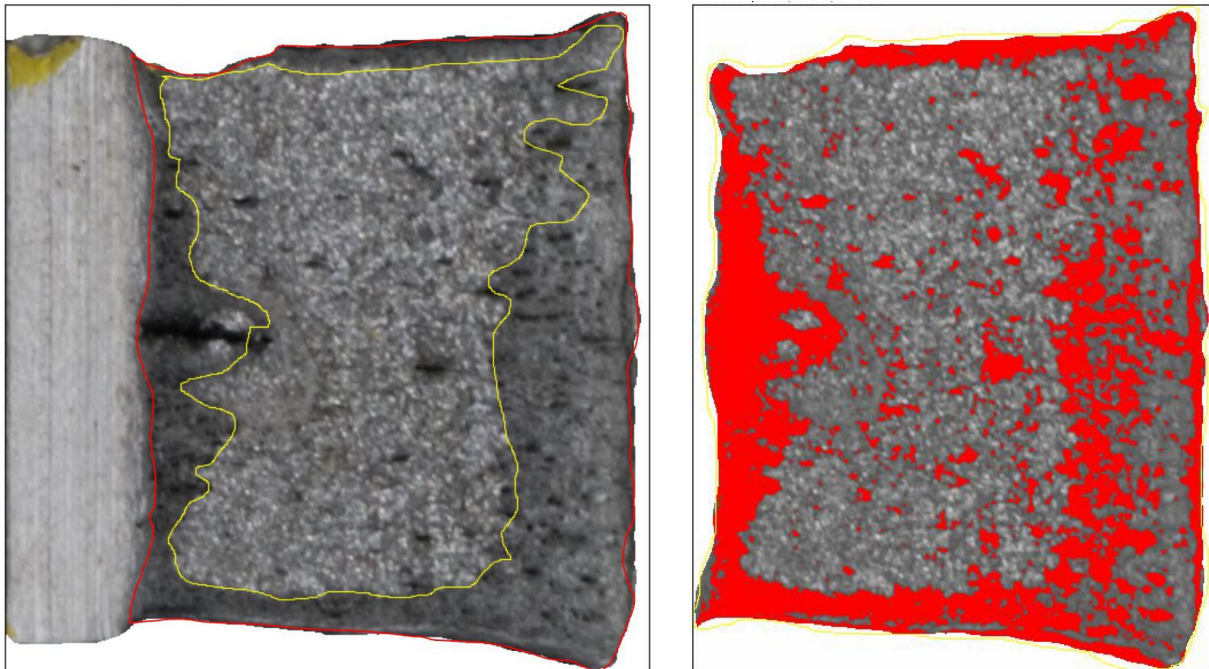
Figure E.27. Shear fracture areas for specimen 1BZ using a Mask Area Method (left) and a Pixel Intensity Method (right).

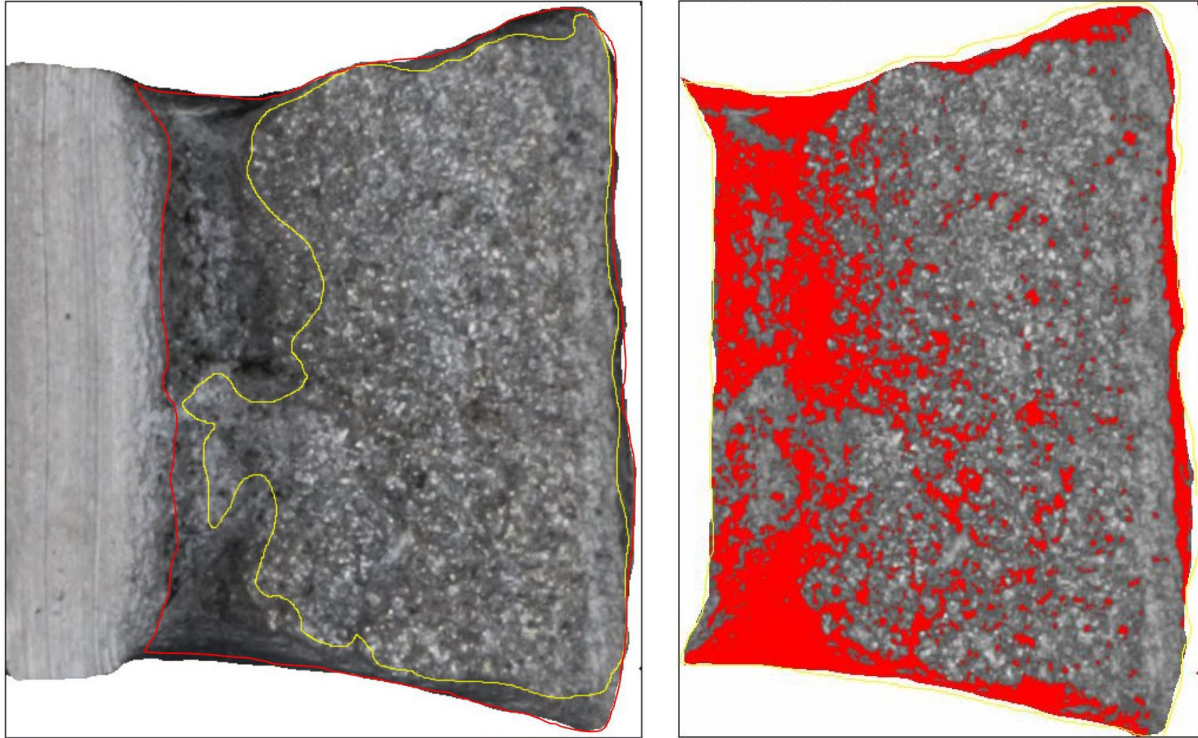
Figure E.28. Shear fracture areas for specimen 1CX using a Mask Area Method (left) and a Pixel Intensity Method (right).

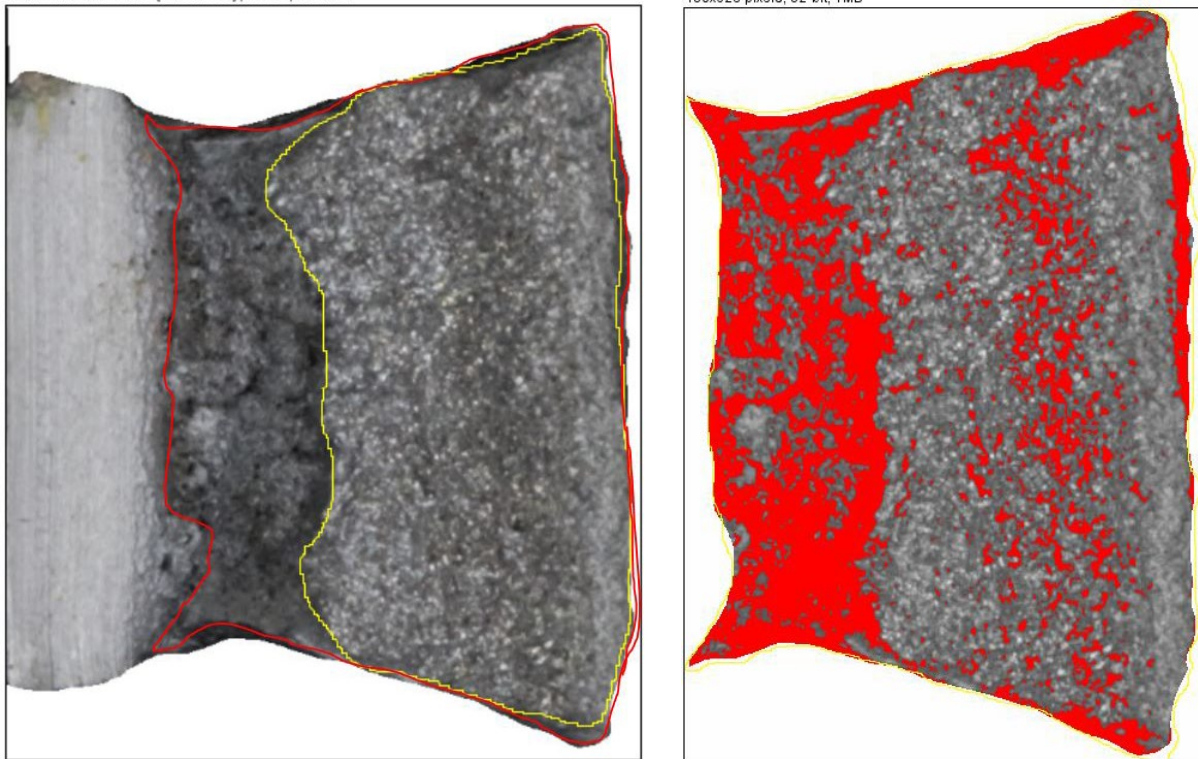
Figure E.29. Shear fracture areas for specimen 1CY using a Mask Area Method (left) and a Pixel Intensity Method (right).

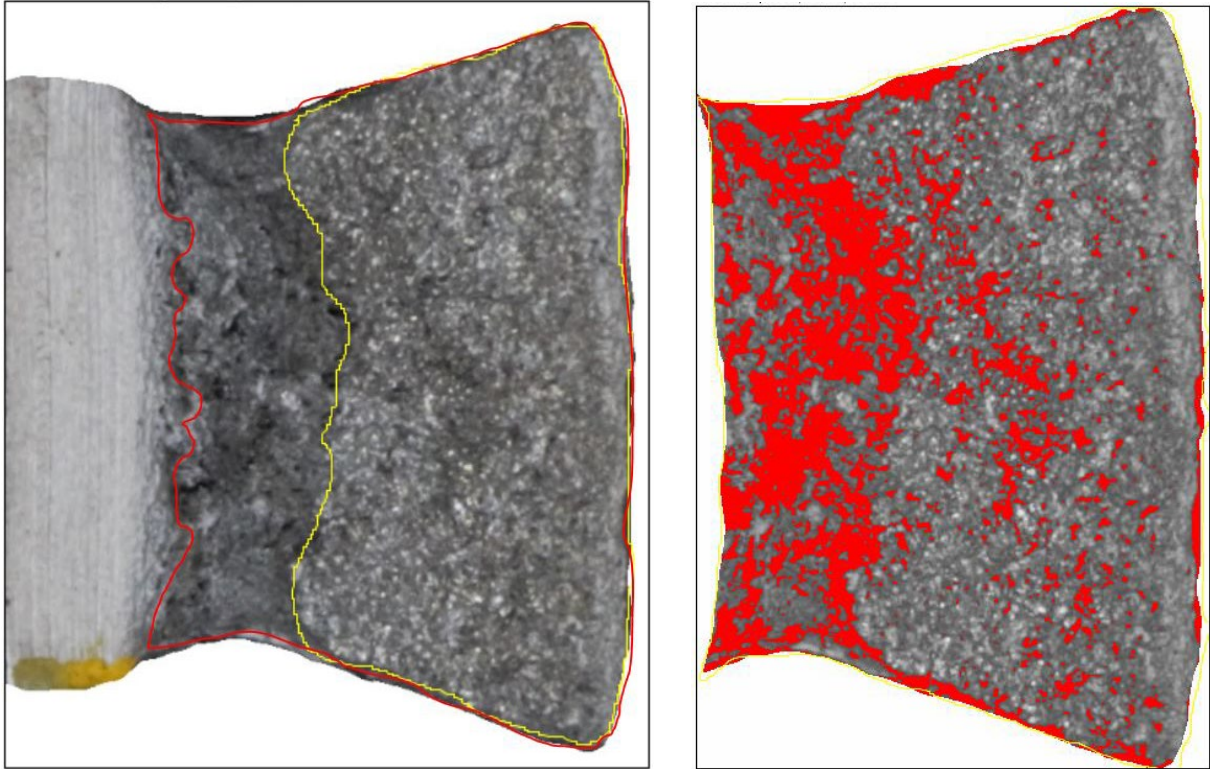
Figure E.30. Shear fracture areas for specimen 1CZ using a Mask Area Method (left) and a Pixel Intensity Method (right).

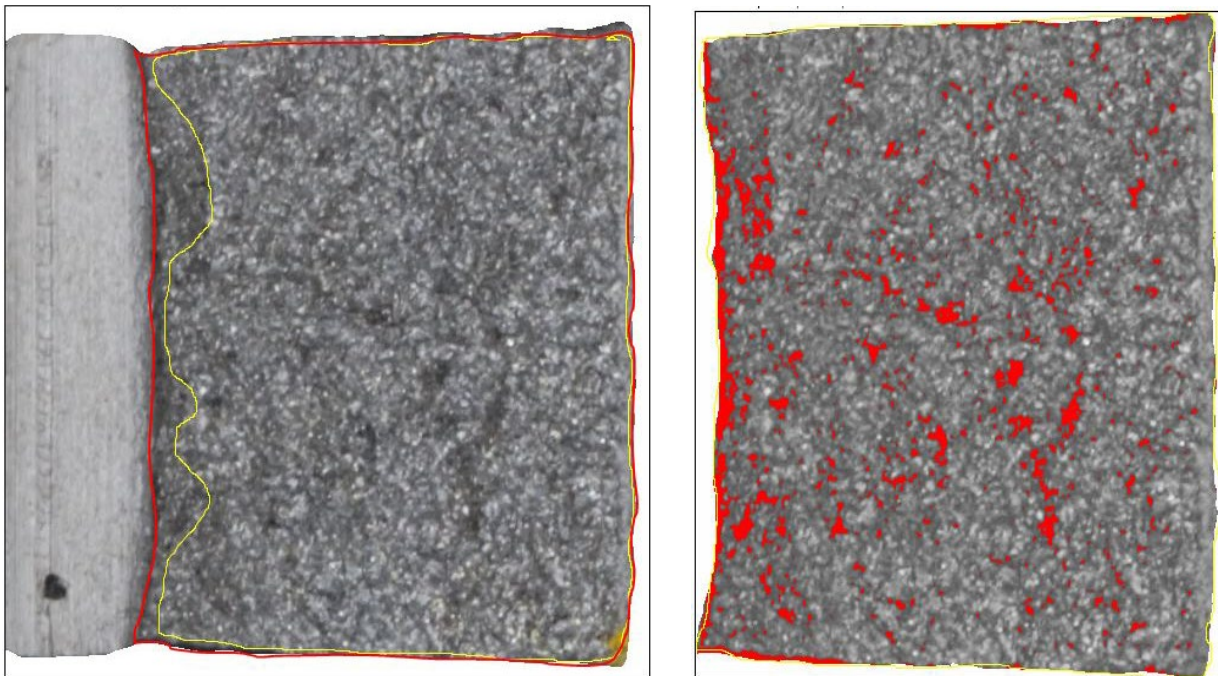
Figure E.31. Shear fracture areas for specimen 1HX using a Mask Area Method (left) and a Pixel Intensity Method (right).

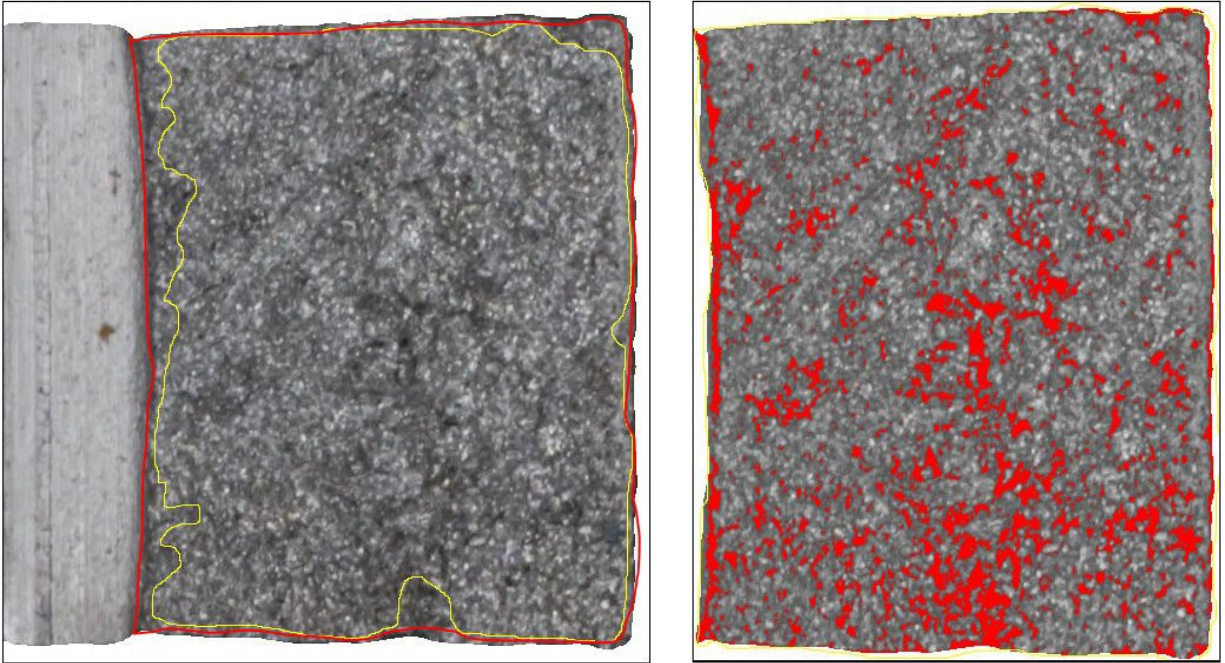
Figure E.32. Shear fracture areas for specimen 1HY using a Mask Area Method (left) and a Pixel Intensity Method (right).

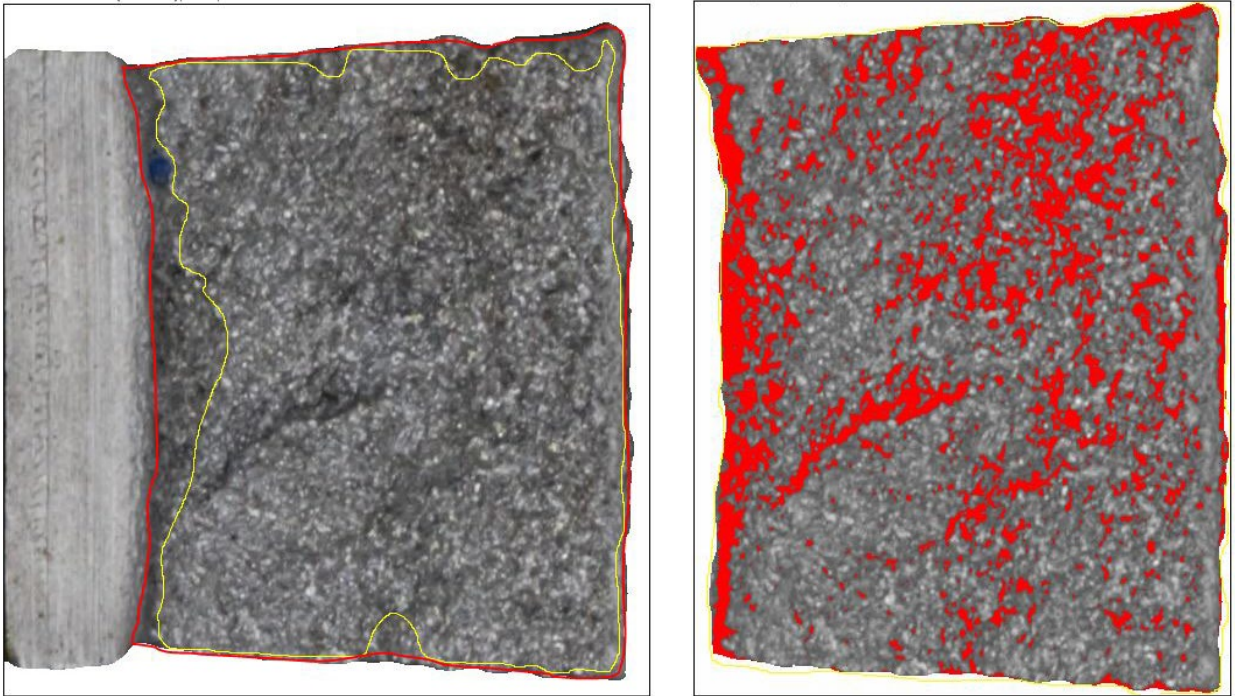
Figure E.33. Shear fracture areas for specimen 1HZ using a Mask Area Method (left) and a Pixel Intensity Method (right).

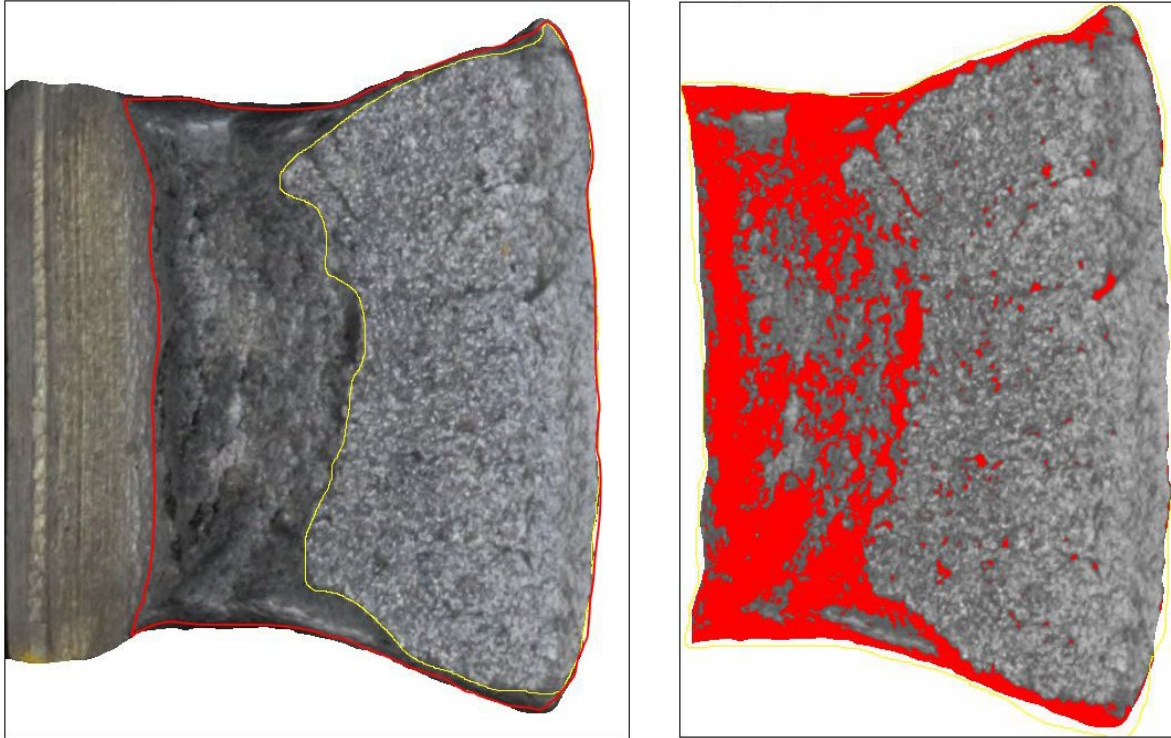
Figure E.34. Shear fracture areas for specimen 1NX using a Mask Area Method (left) and a Pixel Intensity Method (right).

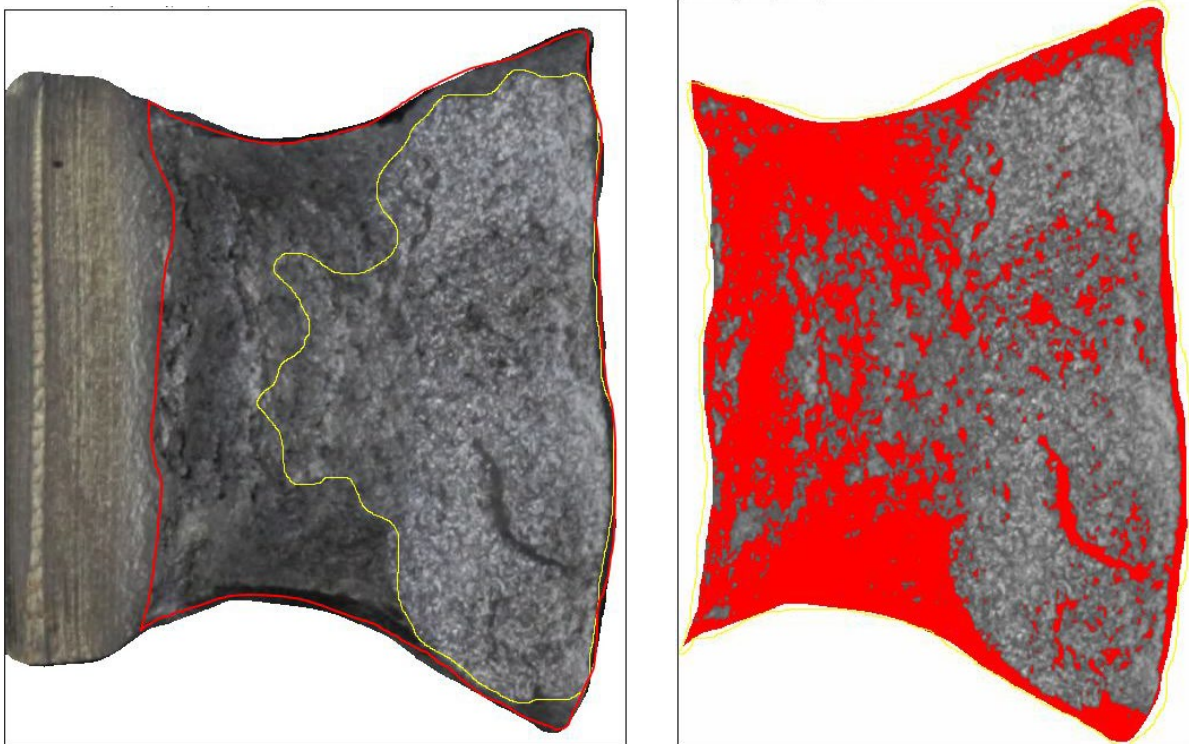
Figure E.35. Shear fracture areas for specimen 1NY using a Mask Area Method (left) and a Pixel Intensity Method (right).

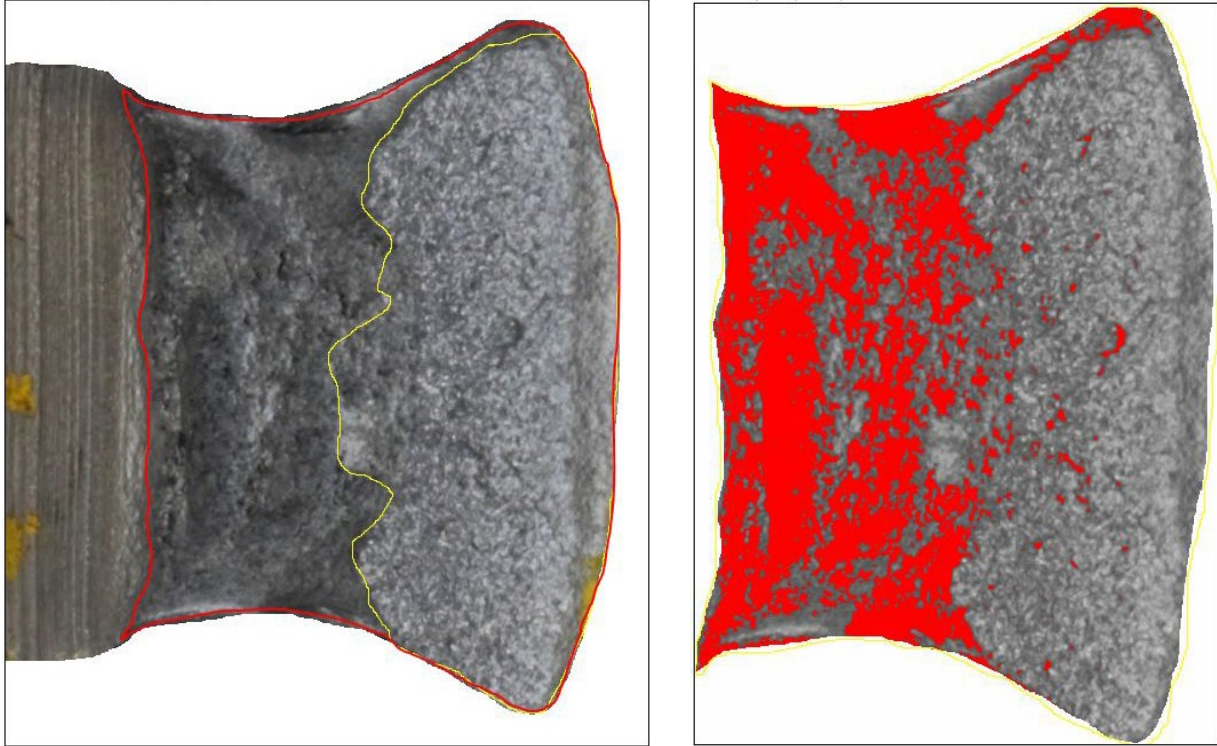
Figure E.36. Shear fracture areas for specimen 1NZ using a Mask Area Method (left) and a Pixel Intensity Method (right).

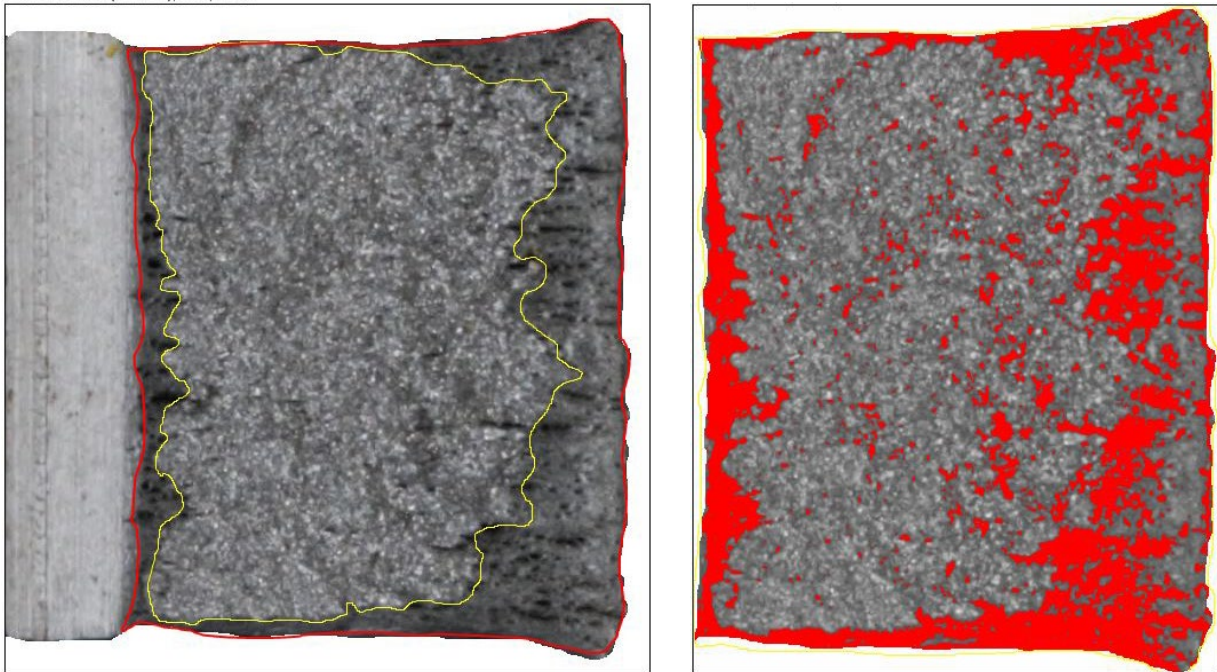
Figure E.37. Shear fracture areas for specimen 1QX using a Mask Area Method (left) and a Pixel Intensity Method (right).

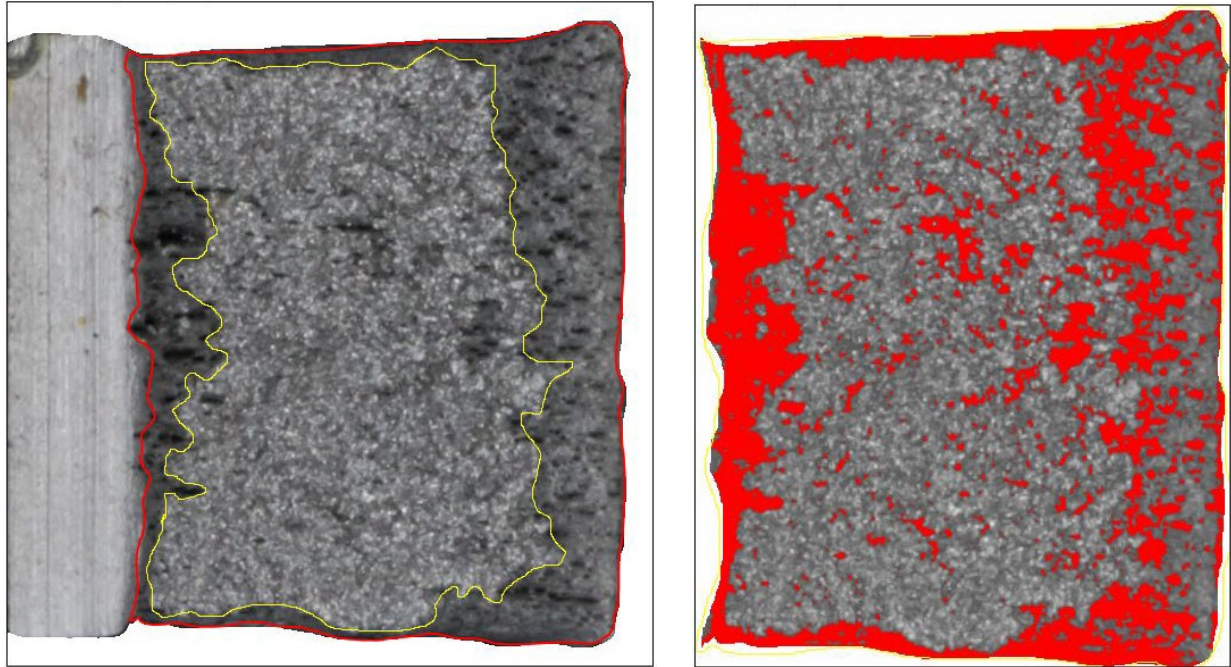
Figure E.38. Shear fracture areas for specimen 1QY using a Mask Area Method (left) and a Pixel Intensity Method (right).

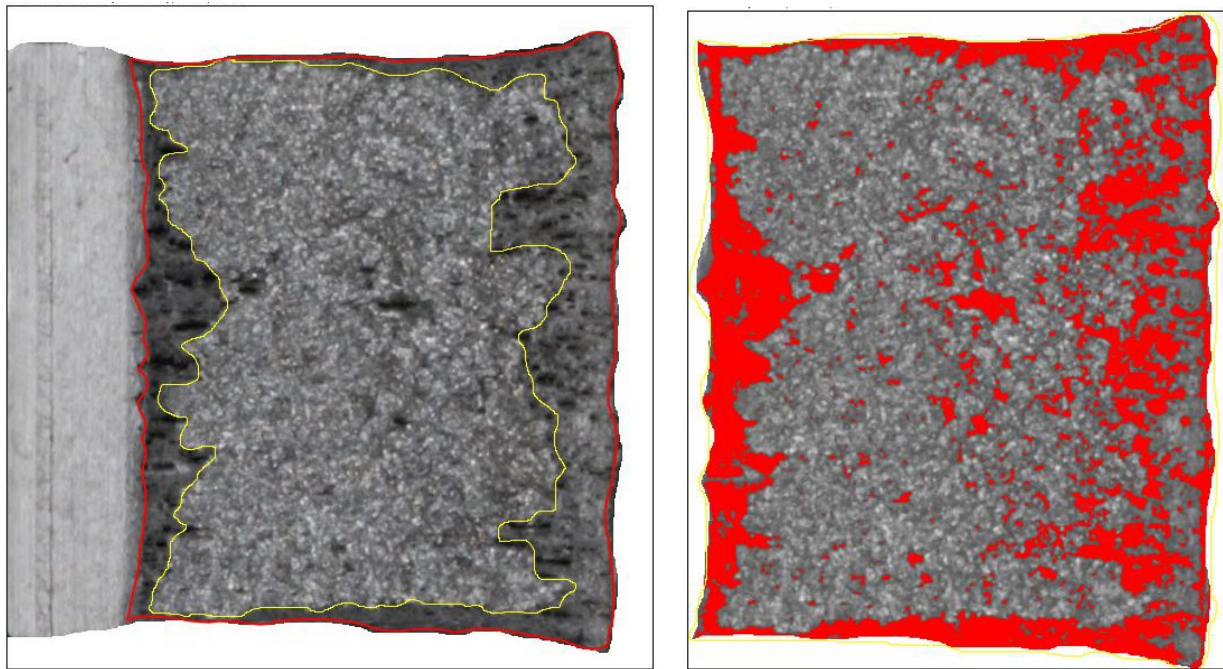
Figure E.39. Shear fracture areas for specimen 1QZ using a Mask Area Method (left) and a Pixel Intensity Method (right).

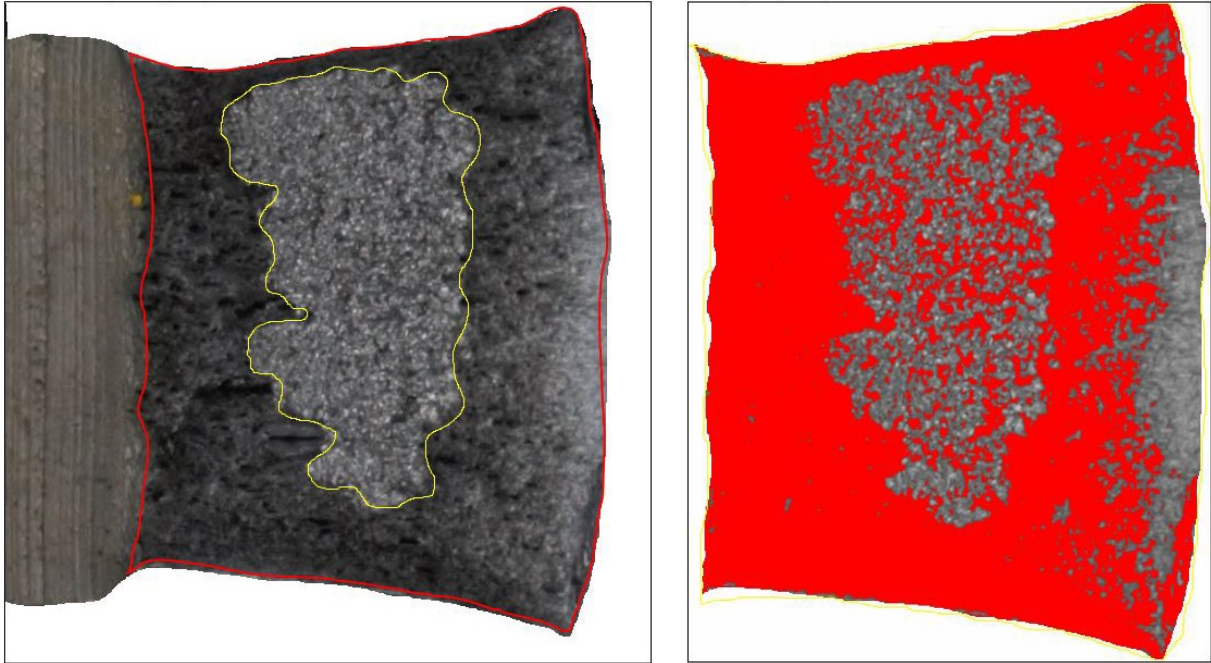
Figure E.40. Shear fracture areas for specimen 1TX using a Mask Area Method (left) and a Pixel Intensity Method (right).

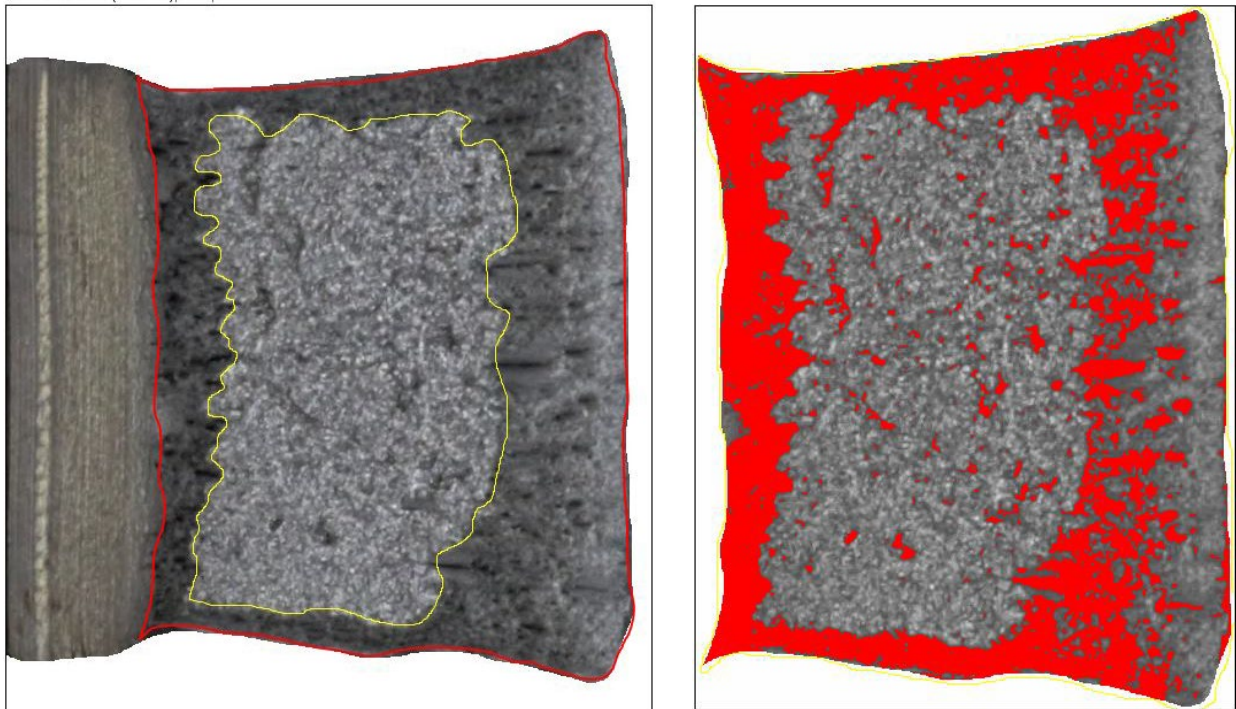
Figure E.41. Shear fracture areas for specimen 1TY using a Mask Area Method (left) and a Pixel Intensity Method (right).

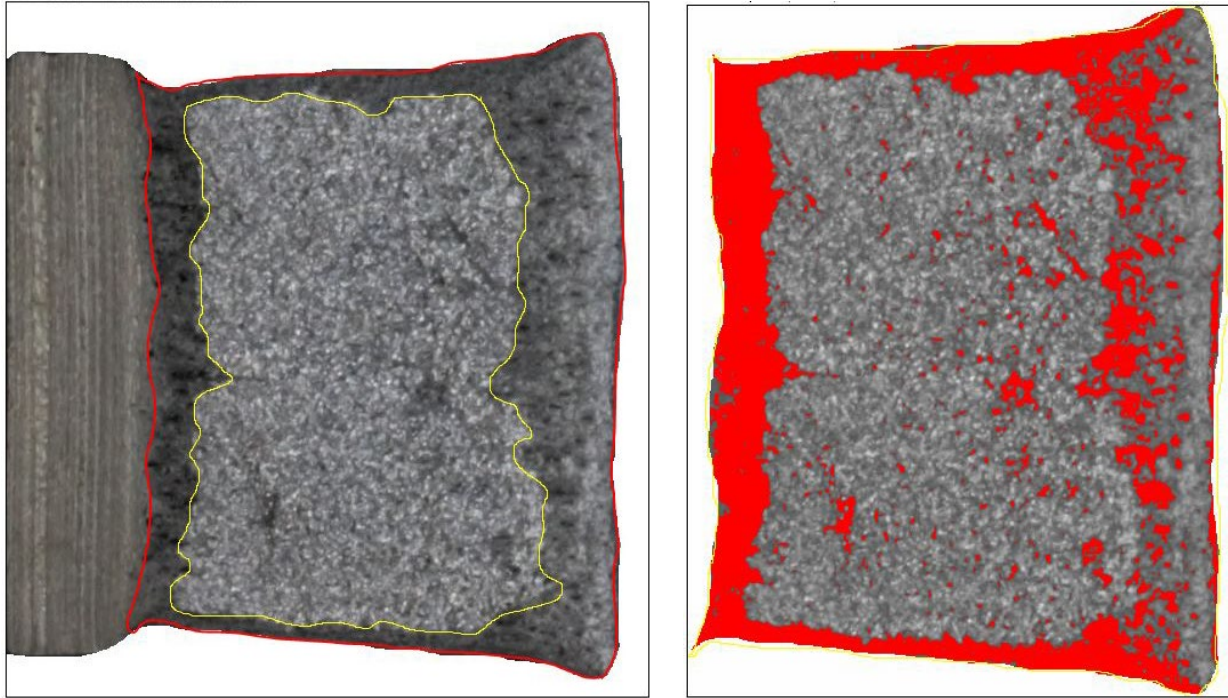
Figure E.42. Shear fracture areas for specimen 1TZ using a Mask Area Method (left) and a Pixel Intensity Method (right).

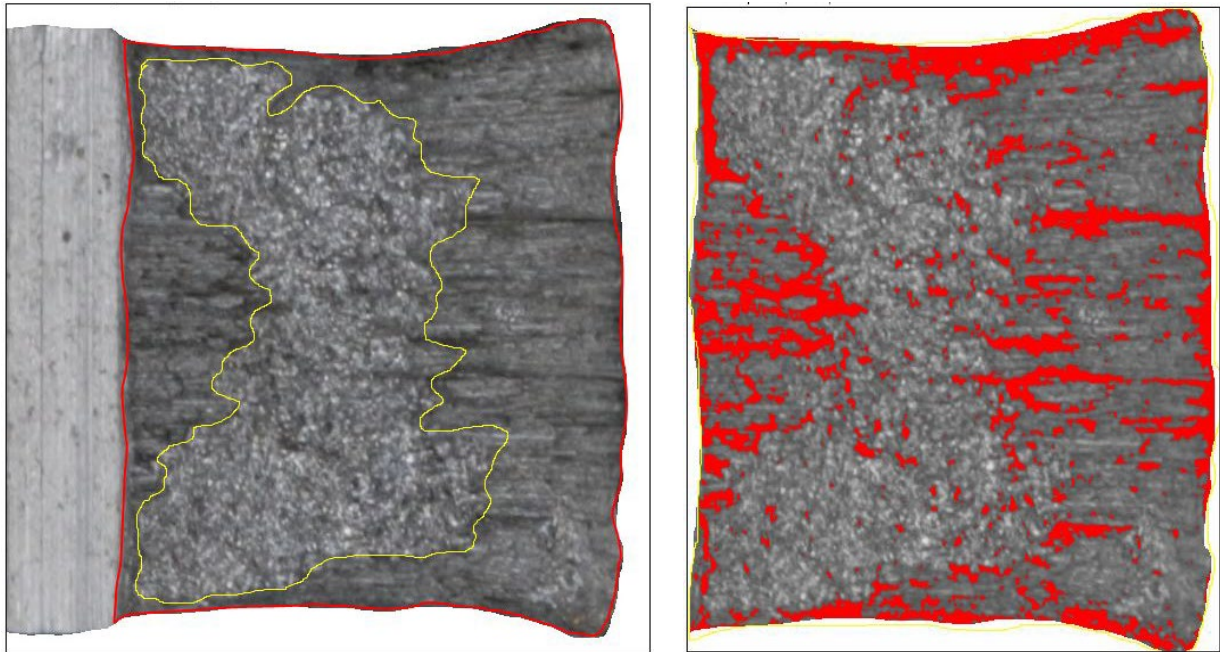
Figure E.43. Shear fracture areas for specimen 1VX using a Mask Area Method (left) and a Pixel Intensity Method (right).

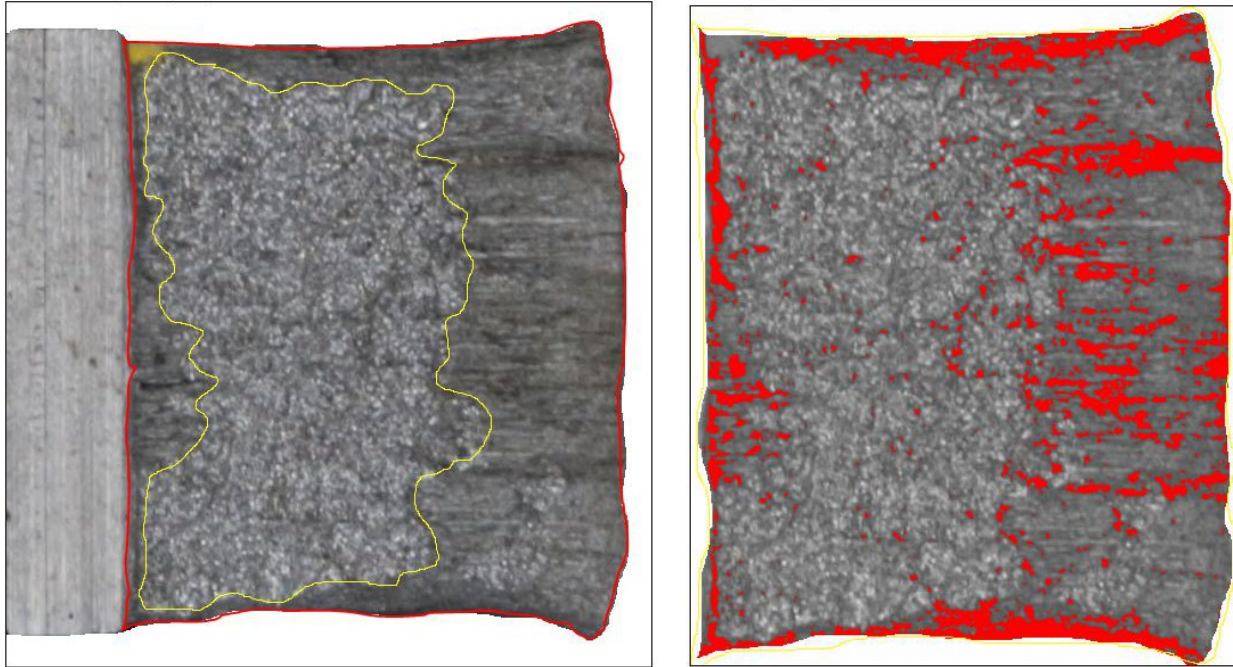
Figure E.44. Shear fracture areas for specimen 1VY using a Mask Area Method (left) and a Pixel Intensity Method (right).

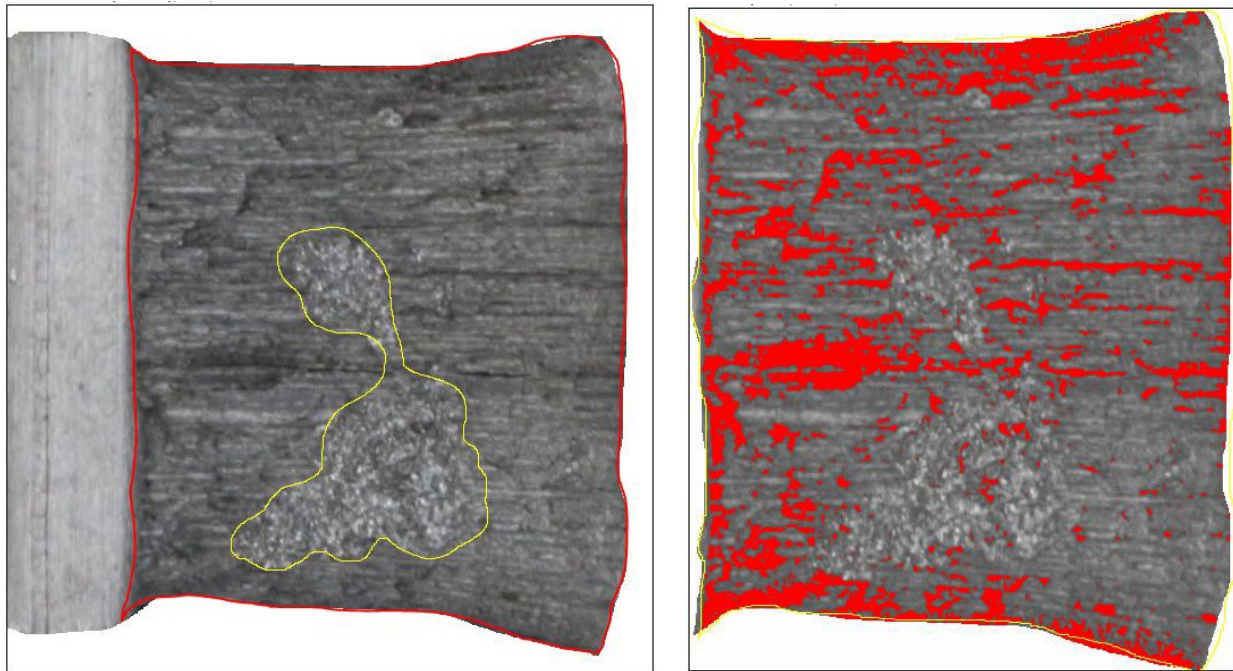
Figure E.45. Shear fracture areas for specimen 1VZ using a Mask Area Method (left) and a Pixel Intensity Method (right).

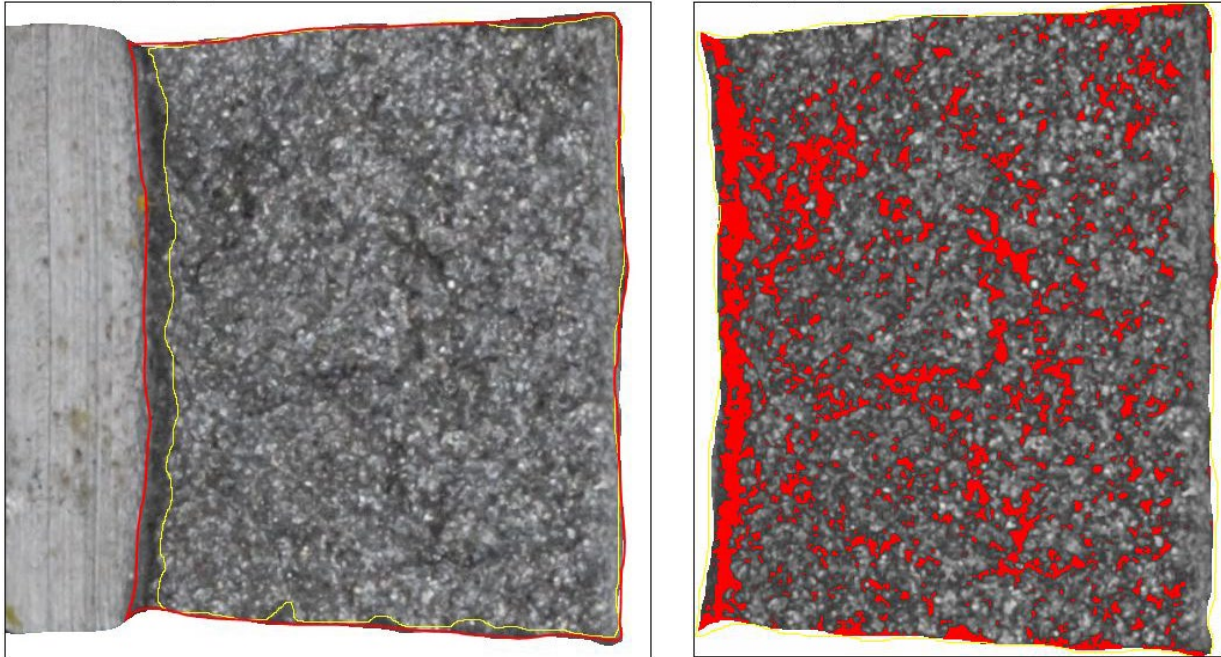
Figure E.46. Shear fracture areas for specimen 2AX using a Mask Area Method (left) and a Pixel Intensity Method (right).

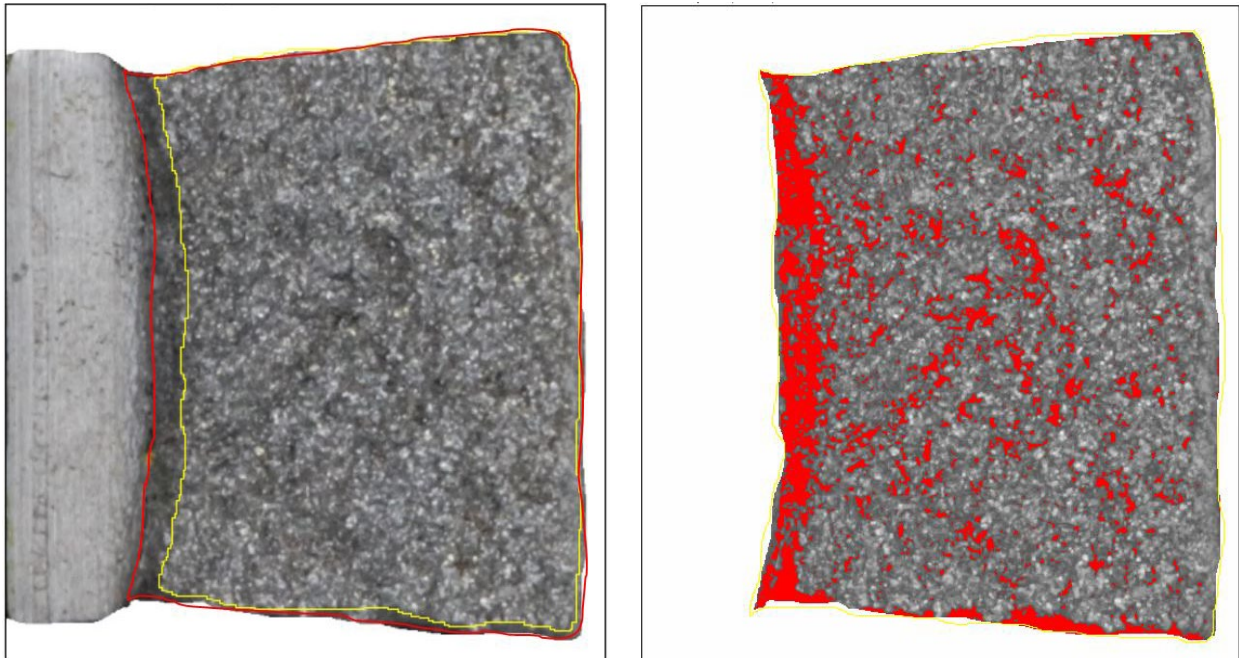
Figure E.47. Shear fracture areas for specimen 2AY using a Mask Area Method (left) and a Pixel Intensity Method (right).

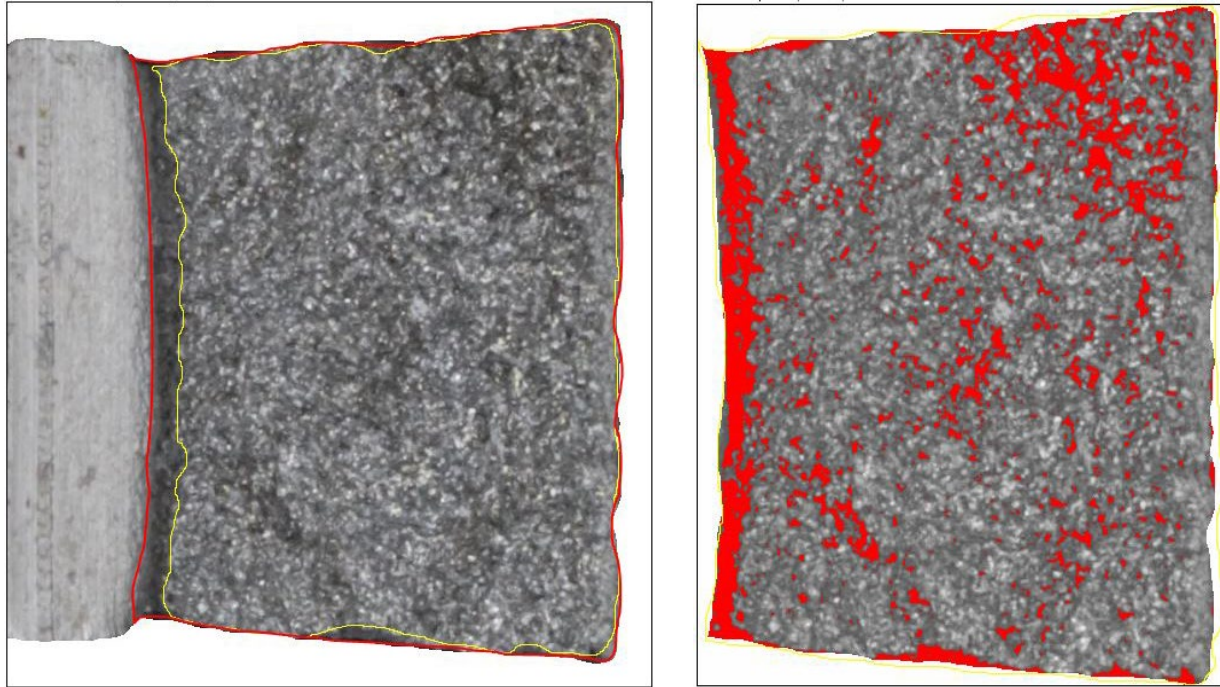
Figure E.48. Shear fracture areas for specimen 2AZ using a Mask Area Method (left) and a Pixel Intensity Method (right).
