National Transportation Safety Board

Office of Research and Engineering

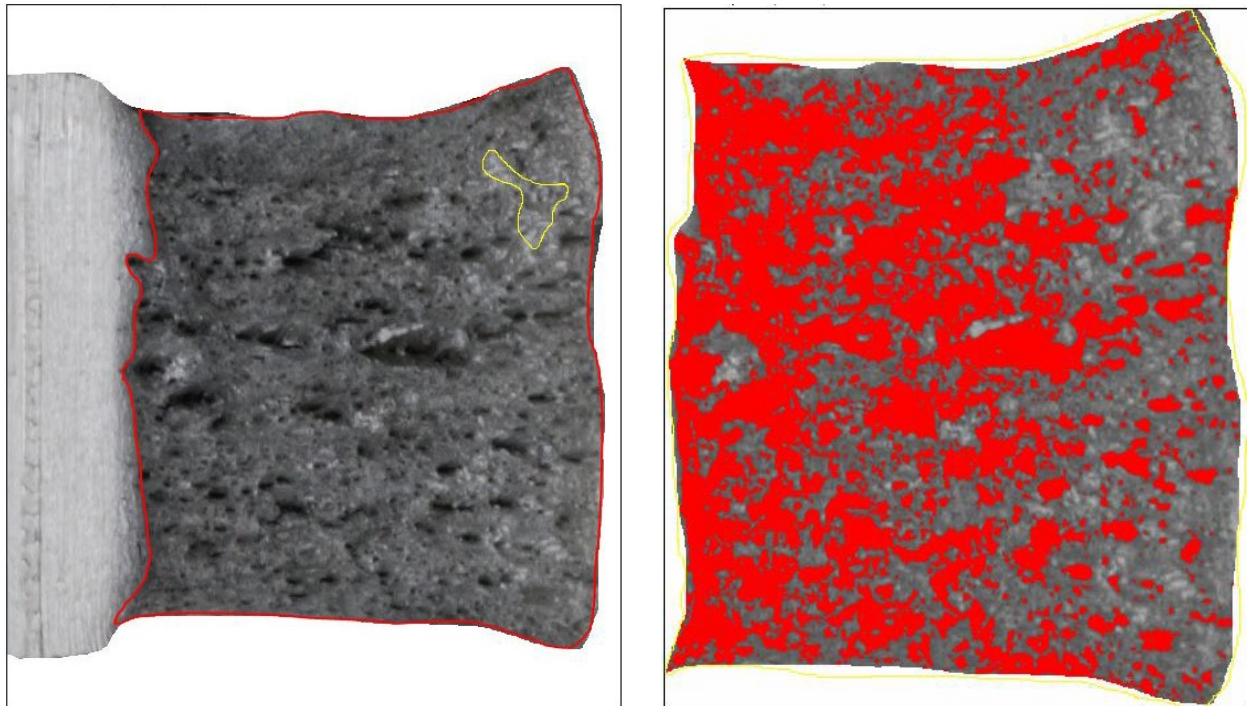
Figure E.49. Shear fracture areas for specimen 2BX using a Mask Area Method (left) and a Pixel Intensity Method (right).

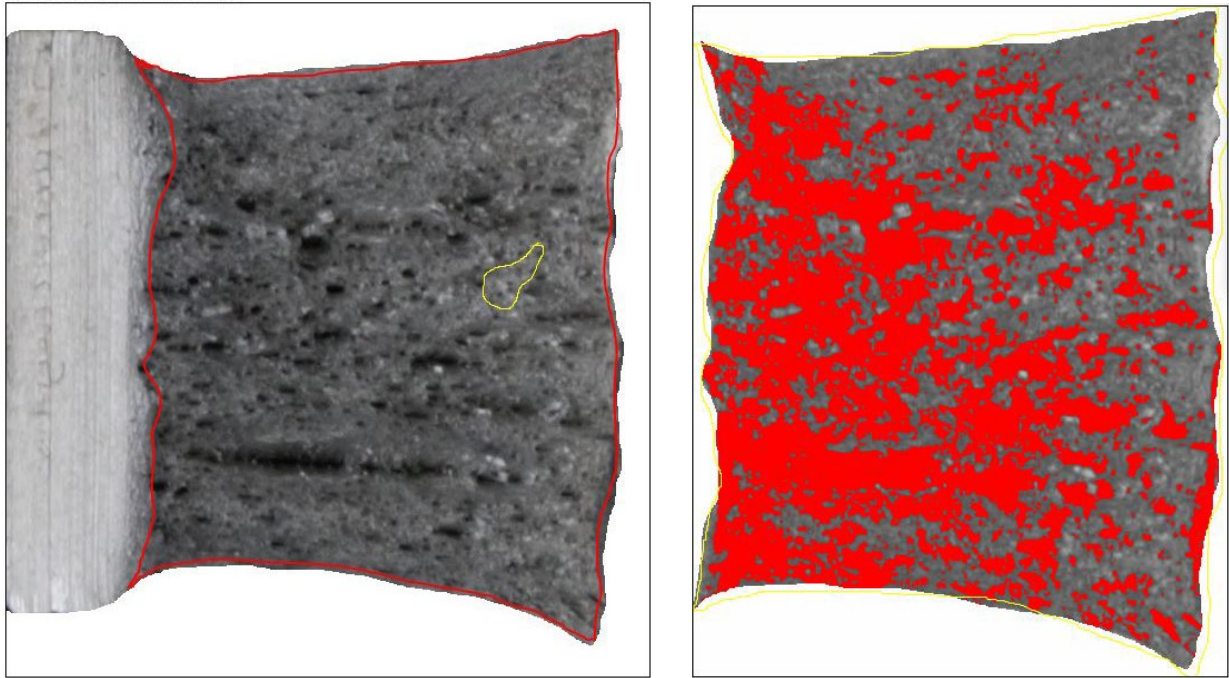
Figure E.50. Shear fracture areas for specimen 2BY using a Mask Area Method (left) and a Pixel Intensity Method (right).

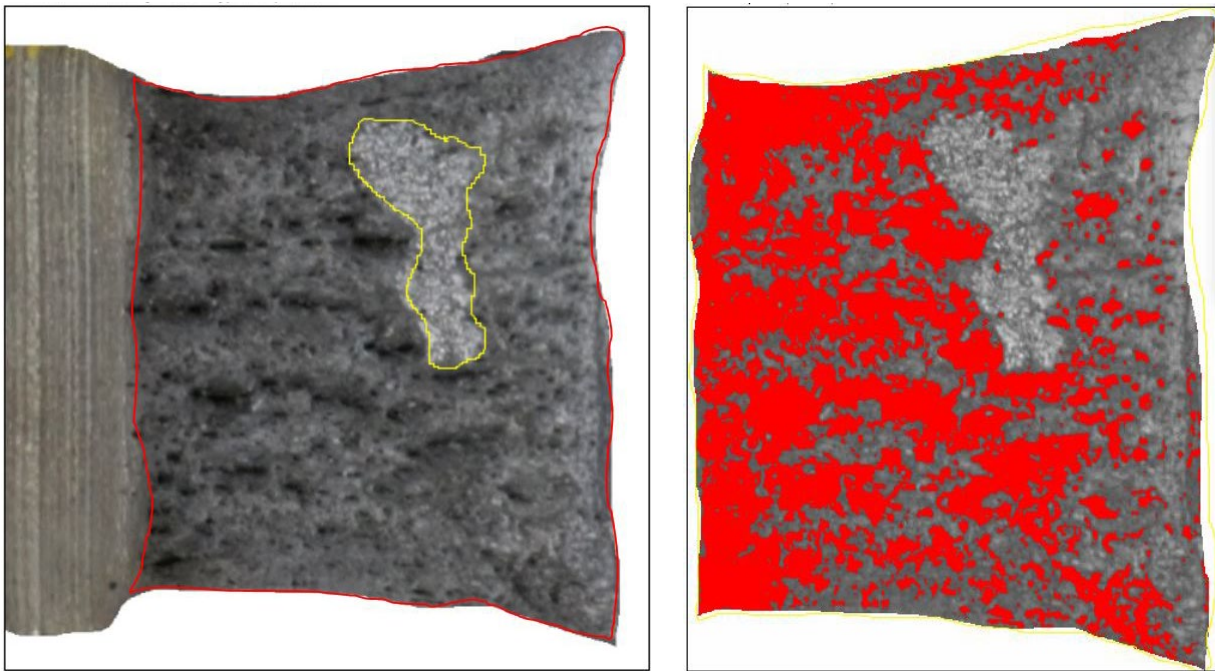
Figure E.51. Shear fracture areas for specimen 2BZ using a Mask Area Method (left) and a Pixel Intensity Method (right).

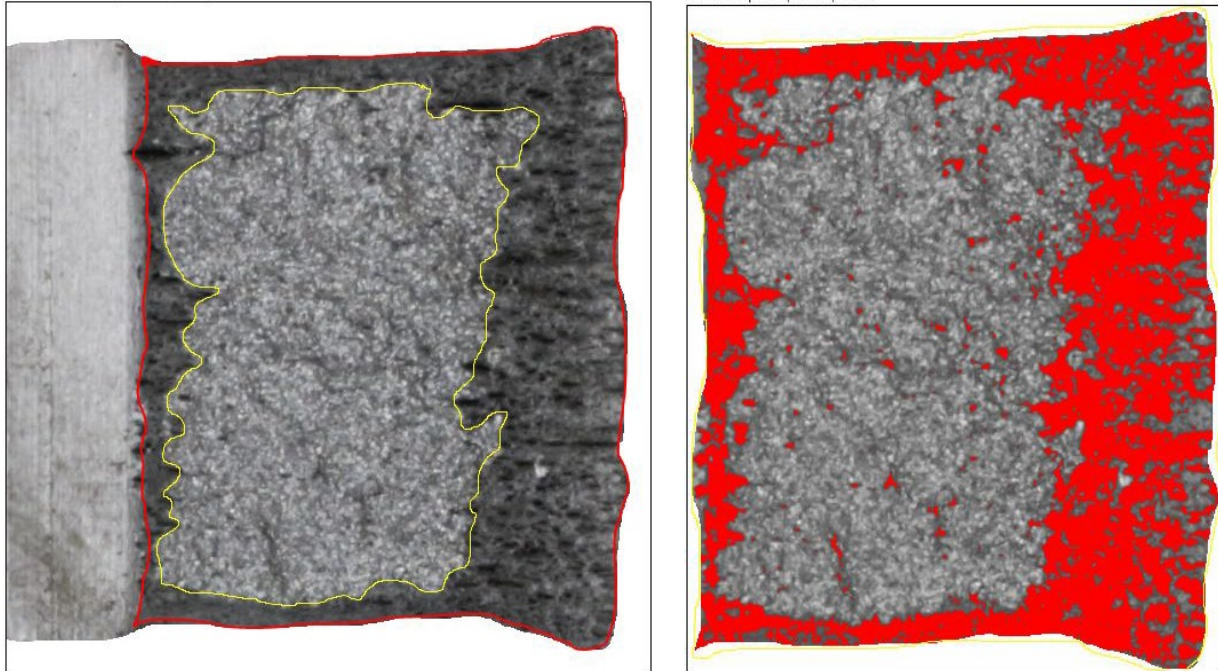
Figure E.52. Shear fracture areas for specimen 2QX using a Mask Area Method (left) and a Pixel Intensity Method (right).

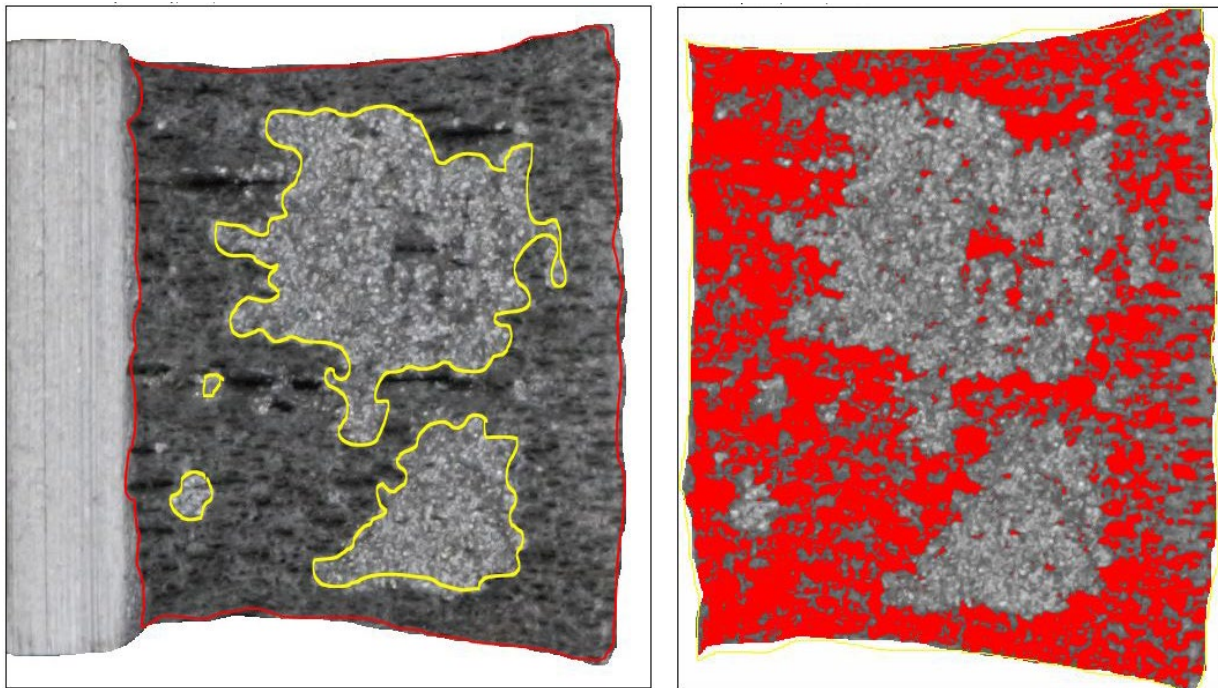
Figure E.53. Shear fracture areas for specimen 2QY using a Mask Area Method (left) and a Pixel Intensity Method (right).

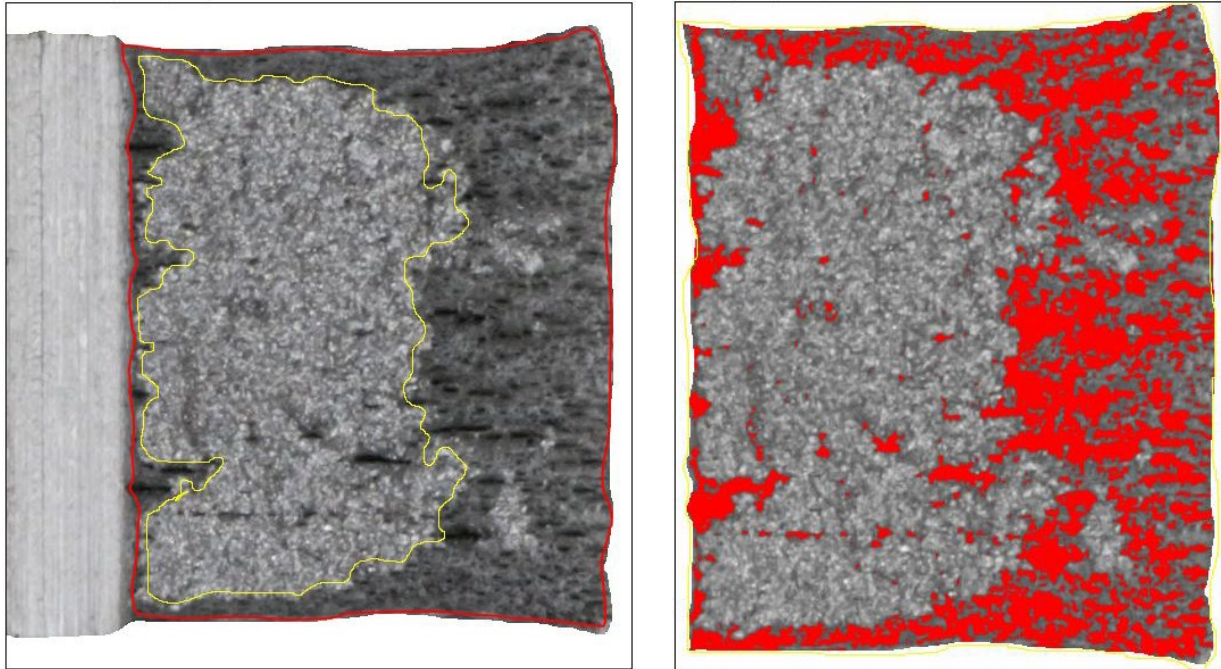
Figure E.54. Shear fracture areas for specimen 2QZ using a Mask Area Method (left) and a Pixel Intensity Method (right).

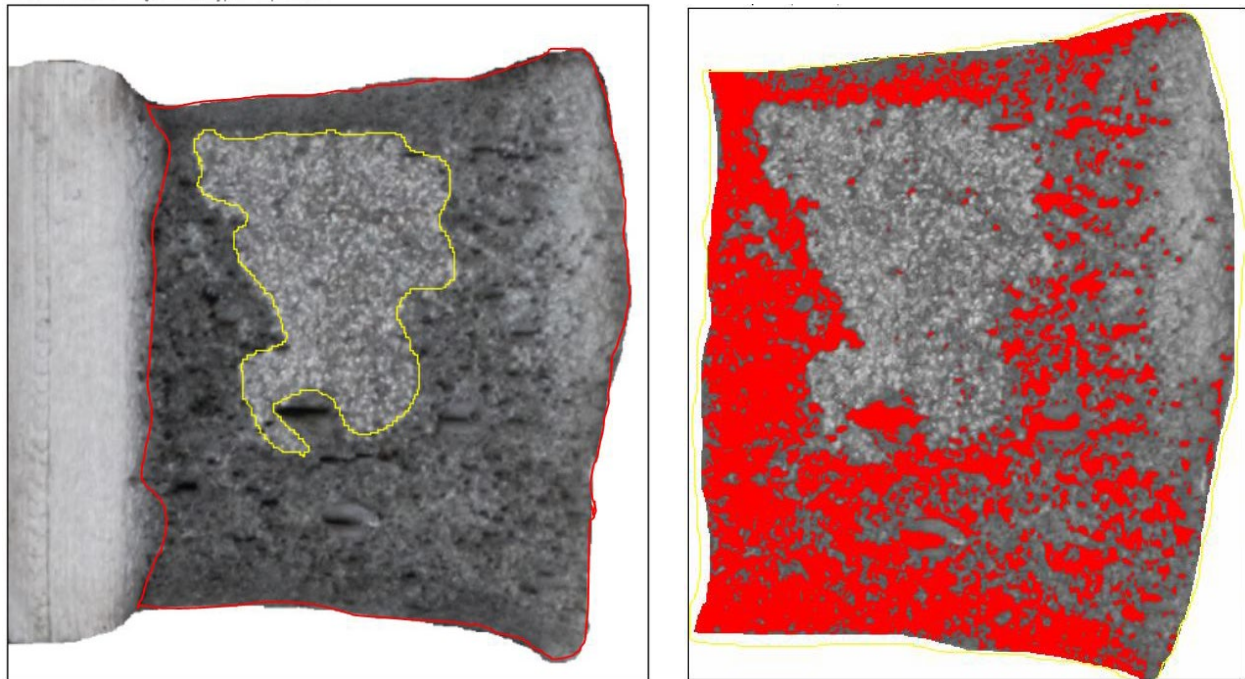
Figure E.55. Shear fracture areas for specimen 2TX using a Mask Area Method (left) and a Pixel Intensity Method (right).

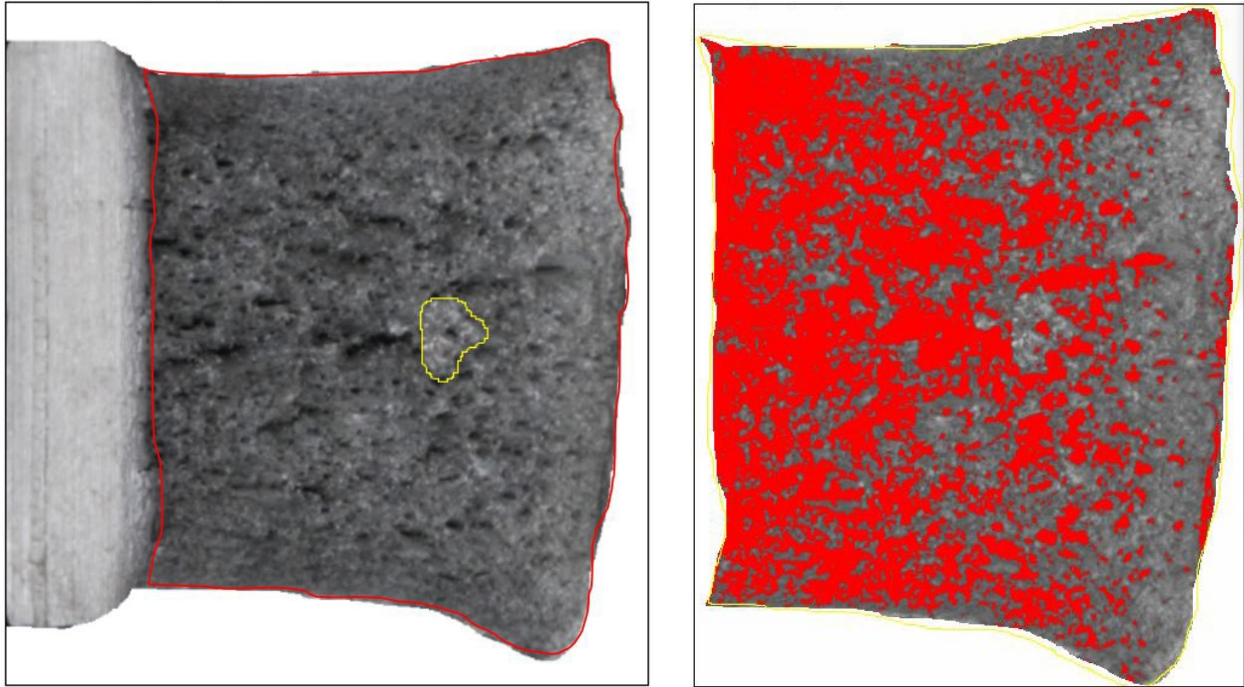
Figure E.56. Shear fracture areas for specimen 2TY using a Mask Area Method (left) and a Pixel Intensity Method (right).

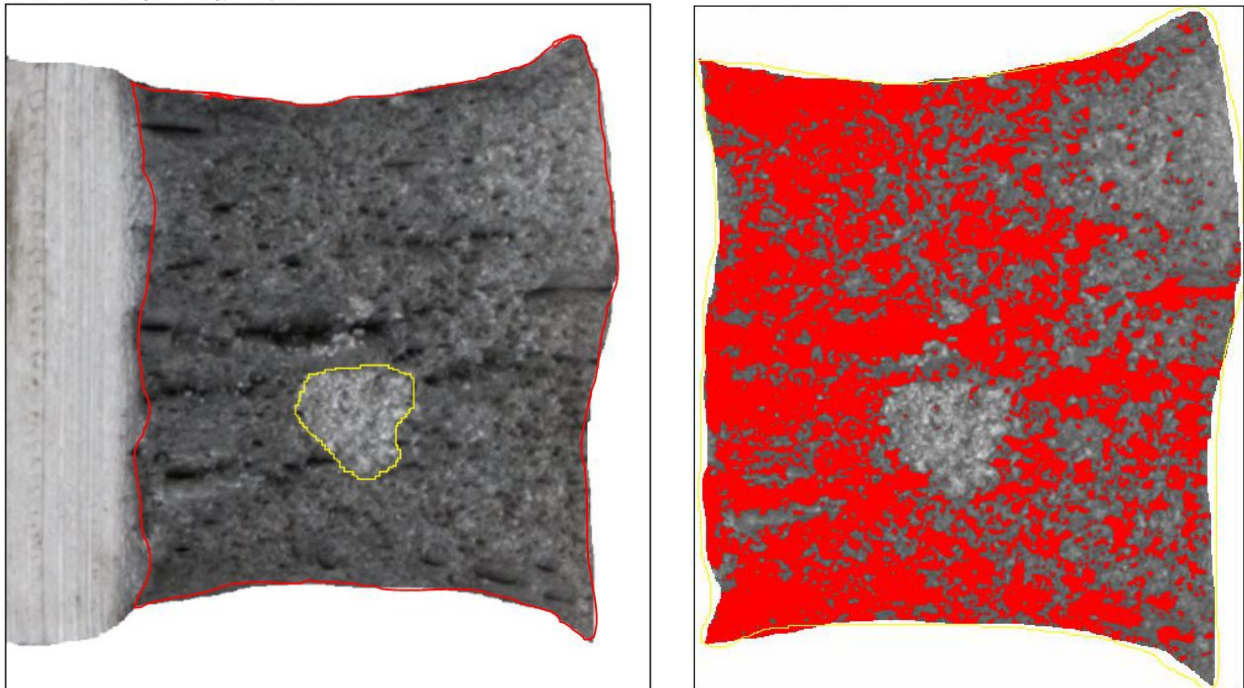
Figure E.57. Shear fracture areas for specimen 2TZ using a Mask Area Method (left) and a Pixel Intensity Method (right).

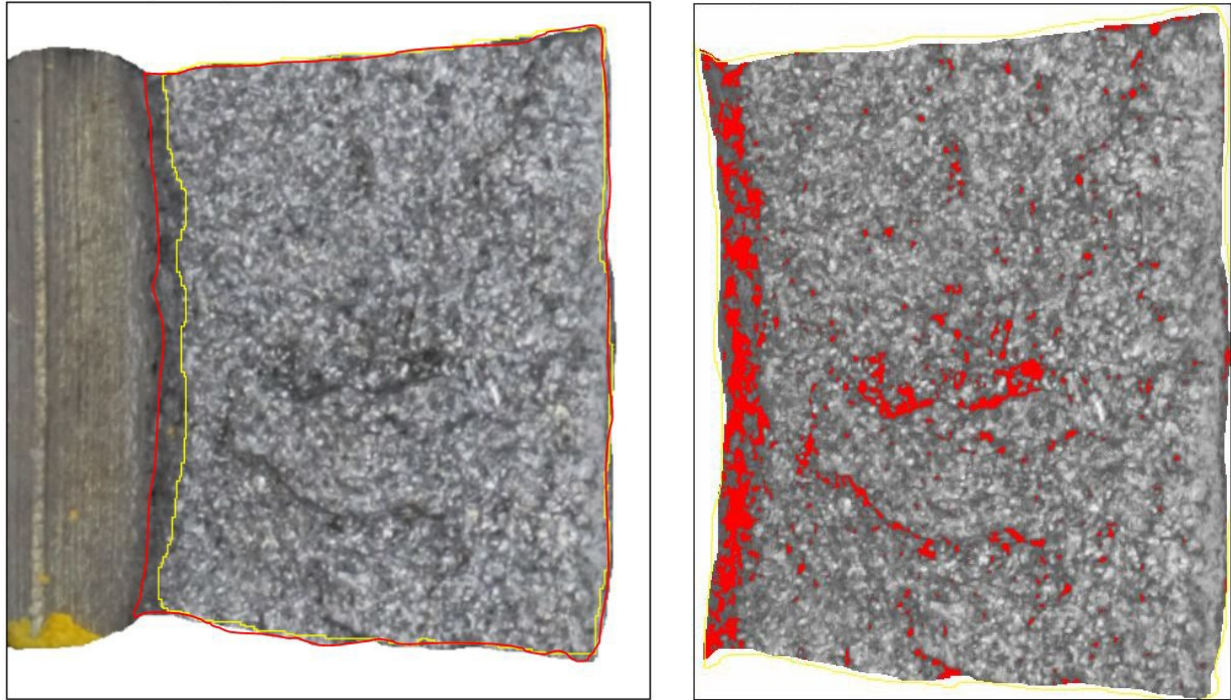
Figure E.58. Shear fracture areas for specimen 3AX using a Mask Area Method (left) and a Pixel Intensity Method (right).

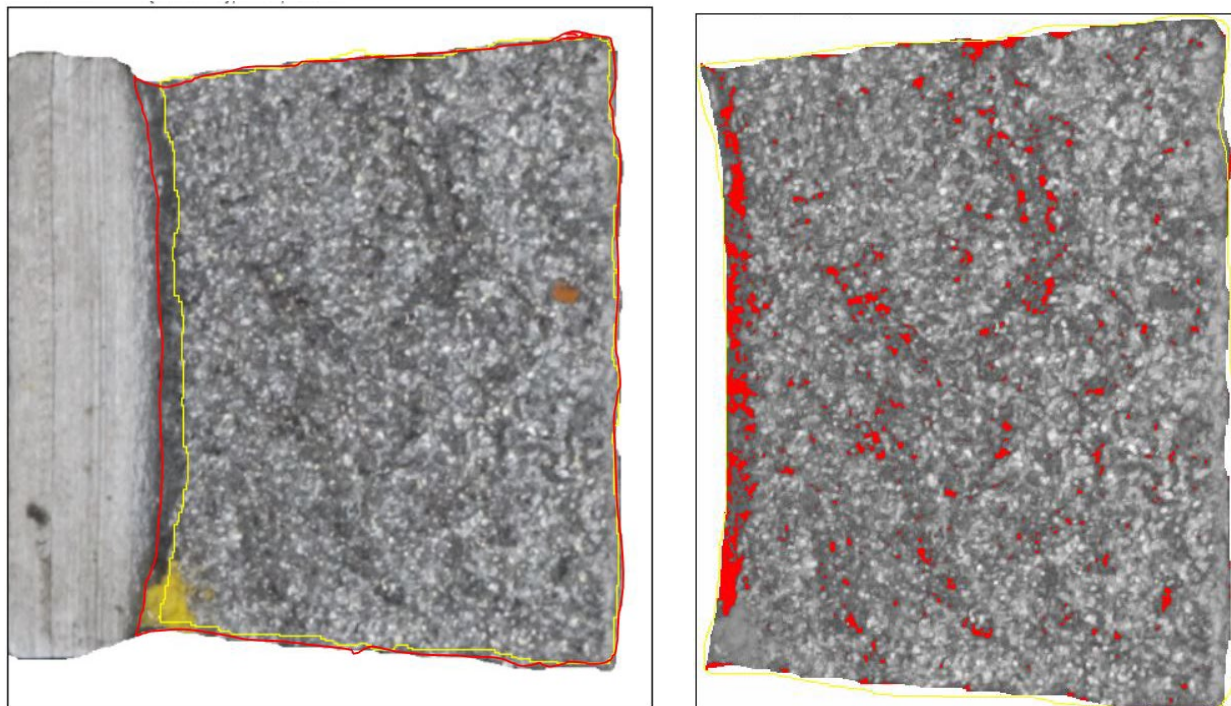
Figure E.59. Shear fracture areas for specimen 3AY using a Mask Area Method (left) and a Pixel Intensity Method (right).

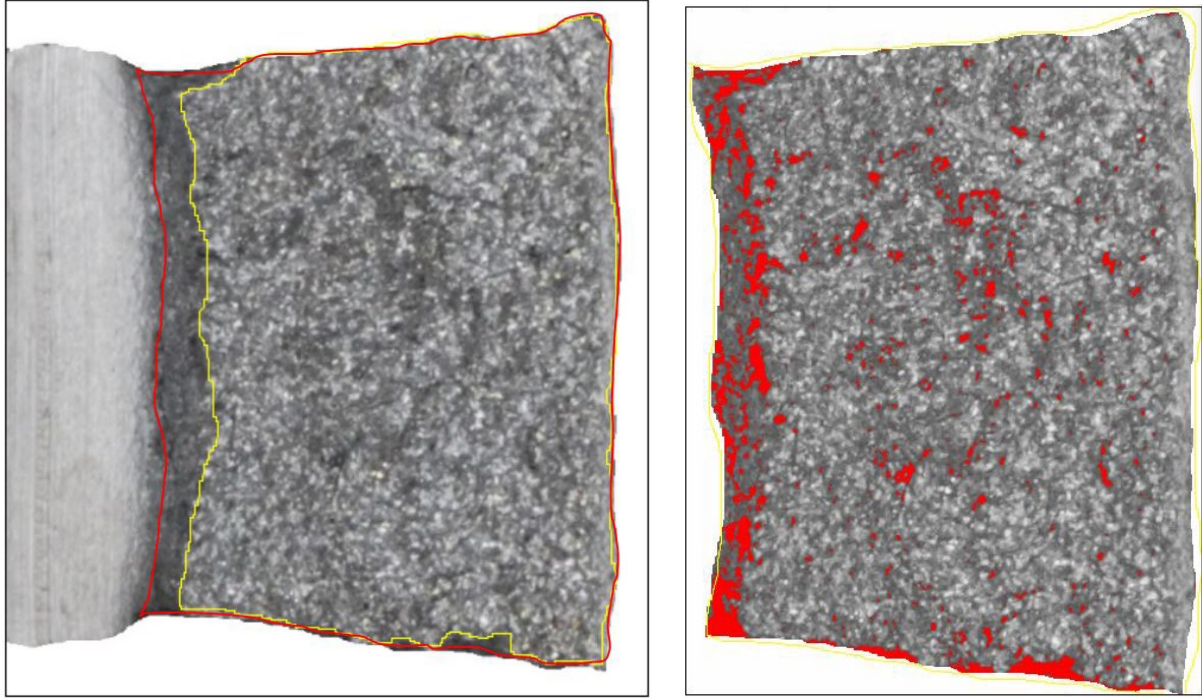
Figure E.60. Shear fracture areas for specimen 3AZ using a Mask Area Method (left) and a Pixel Intensity Method (right).

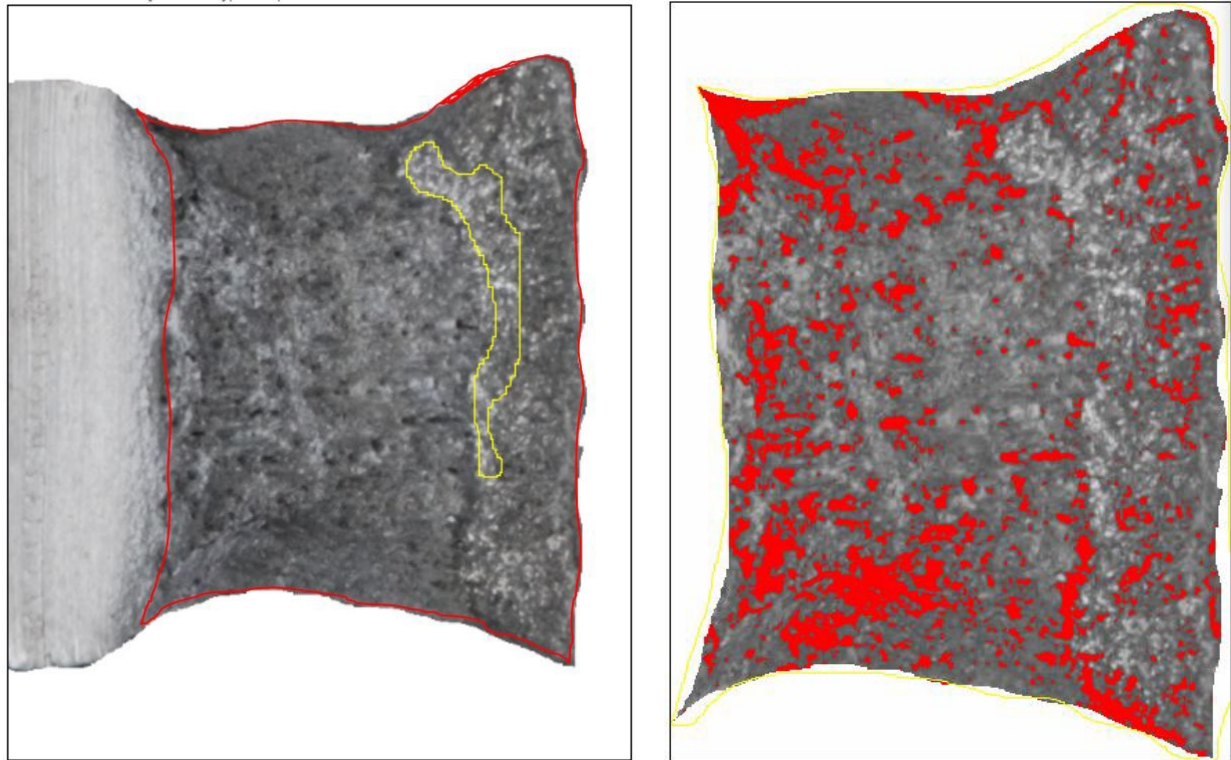
Figure E.61. Shear fracture areas for specimen 3BX using a Mask Area Method (left) and a Pixel Intensity Method (right).

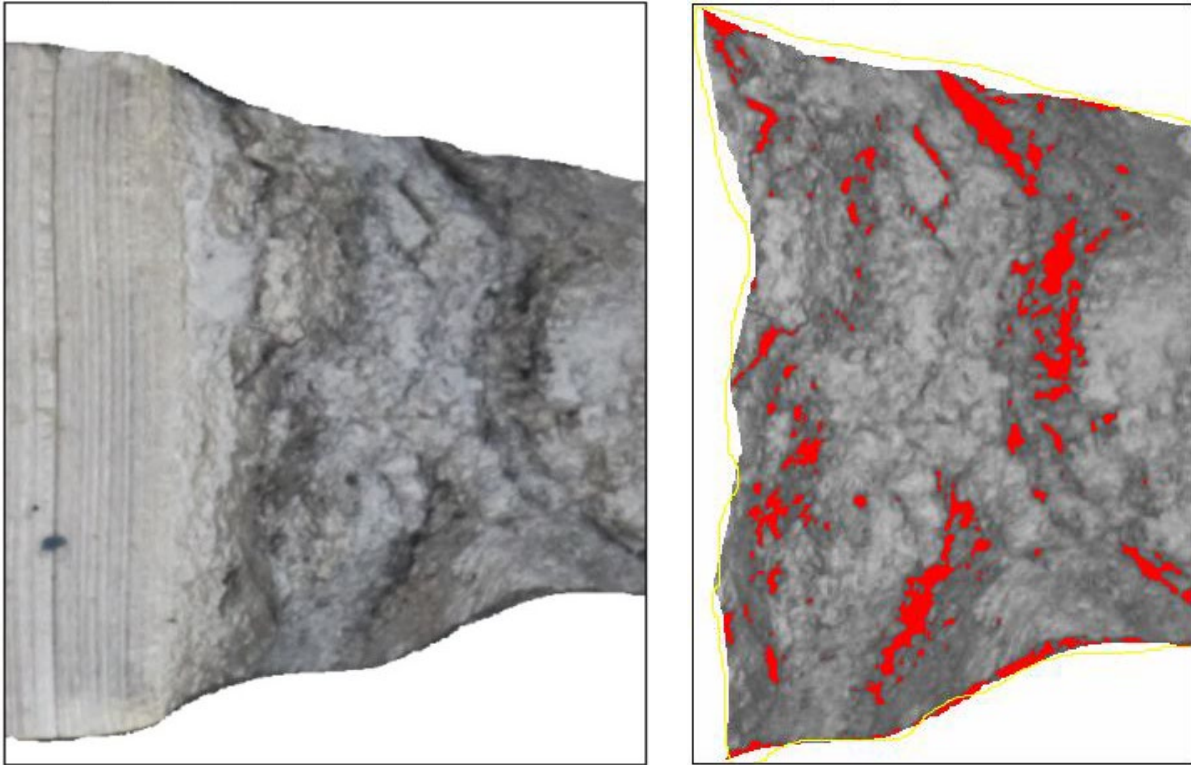
Figure E.62. Shear fracture areas for specimen 3BY using a Mask Area Method (left) and a Pixel Intensity Method (right). Note this specimen did not separate in two pieces.

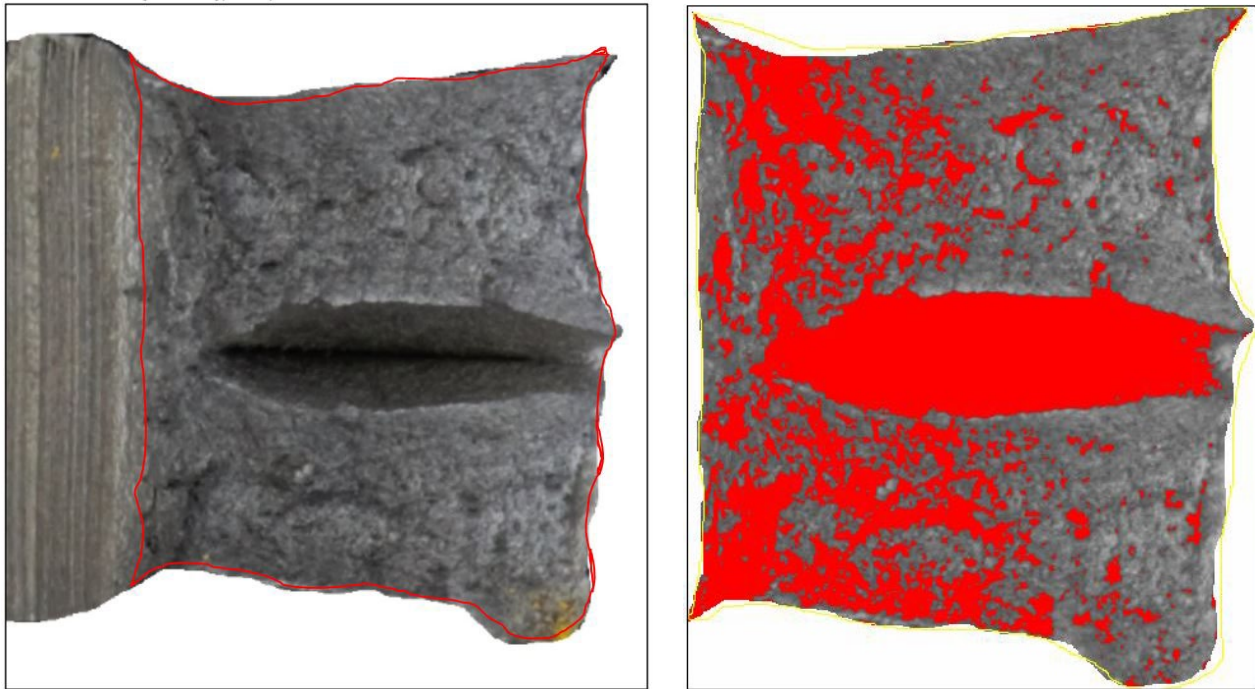
Figure E.63. Shear fracture areas for specimen 3BZ using a Mask Area Method (left) and a Pixel Intensity Method (right).

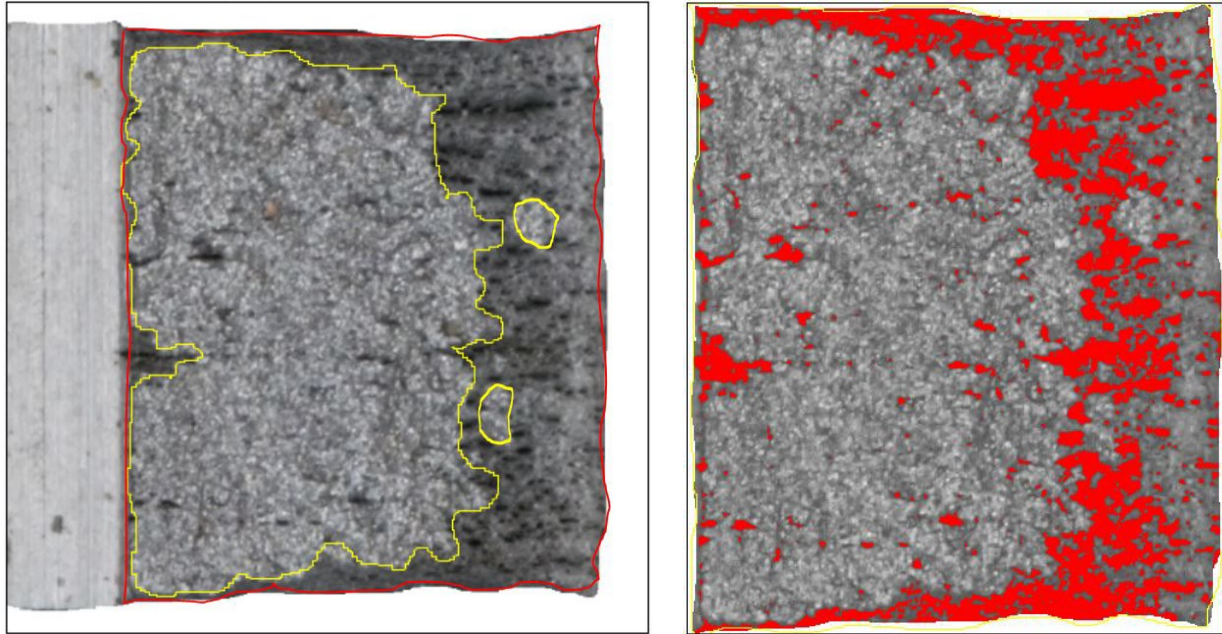
Figure E.64. Shear fracture areas for specimen 3QX using a Mask Area Method (left) and a Pixel Intensity Method (right).

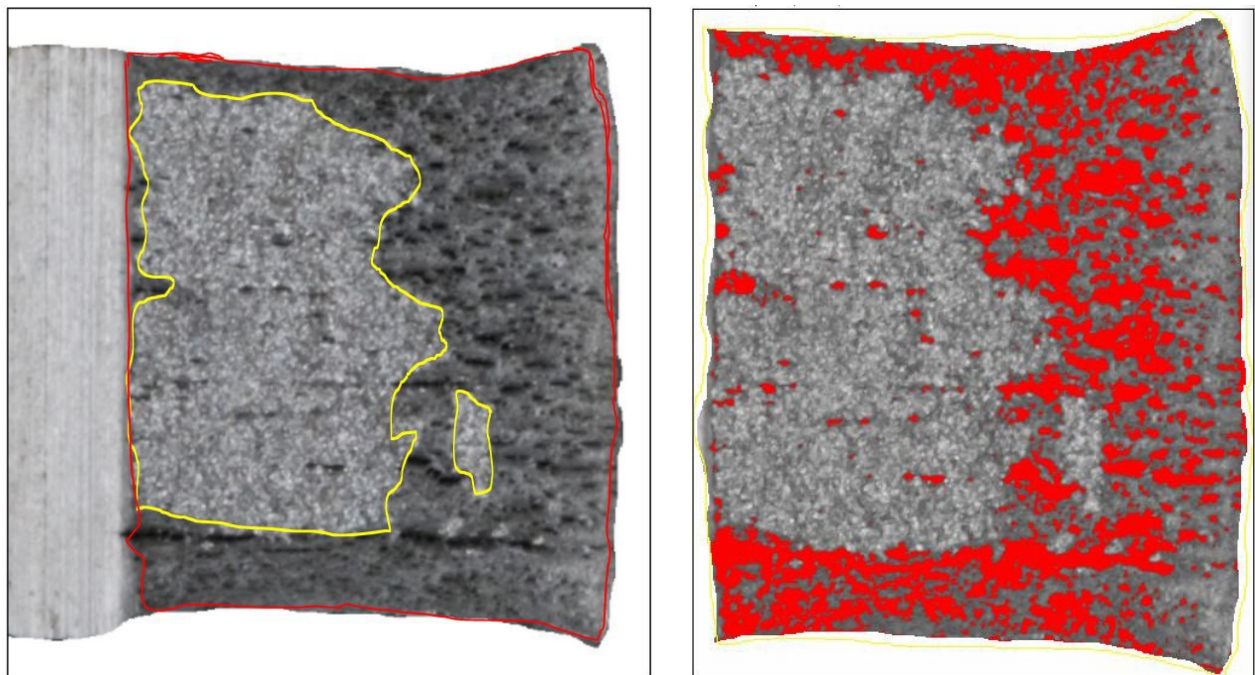
Figure E.65. Shear fracture areas for specimen 3QY using a Mask Area Method (left) and a Pixel Intensity Method (right).

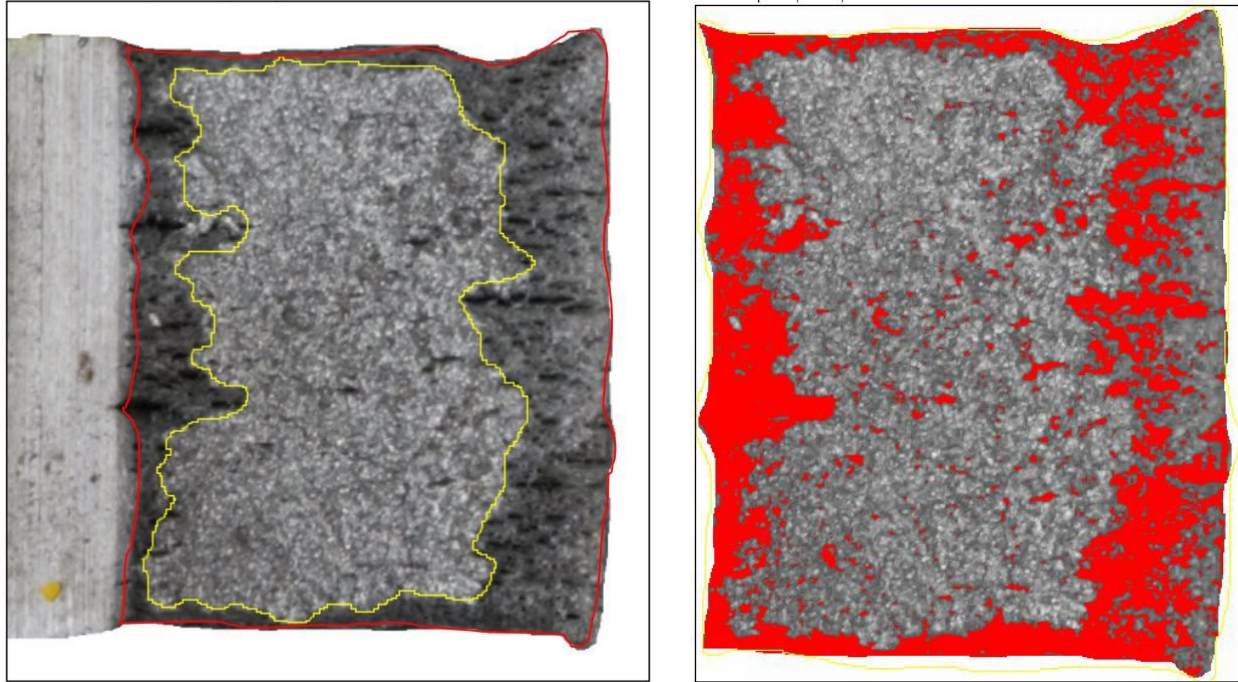
Figure E.66. Shear fracture areas for specimen 3QZ using a Mask Area Method (left) and a Pixel Intensity Method (right).

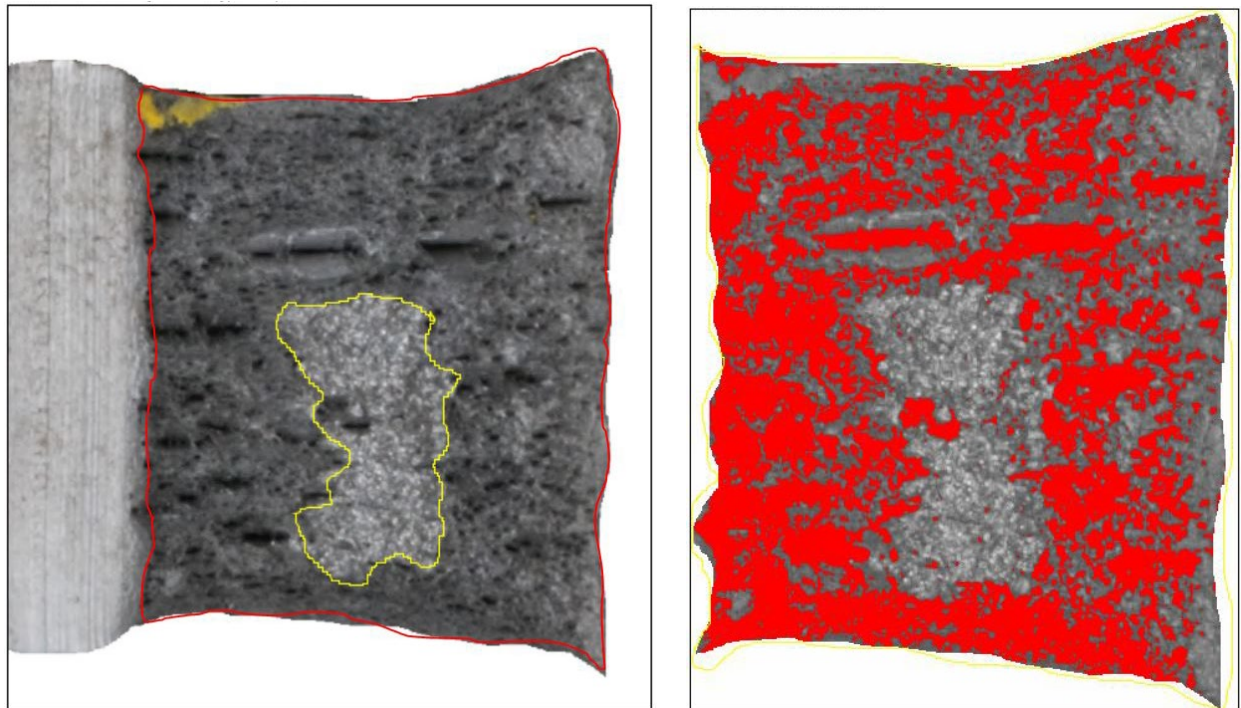
Figure E.67. Shear fracture areas for specimen 3TX using a Mask Area Method (left) and a Pixel Intensity Method (right).

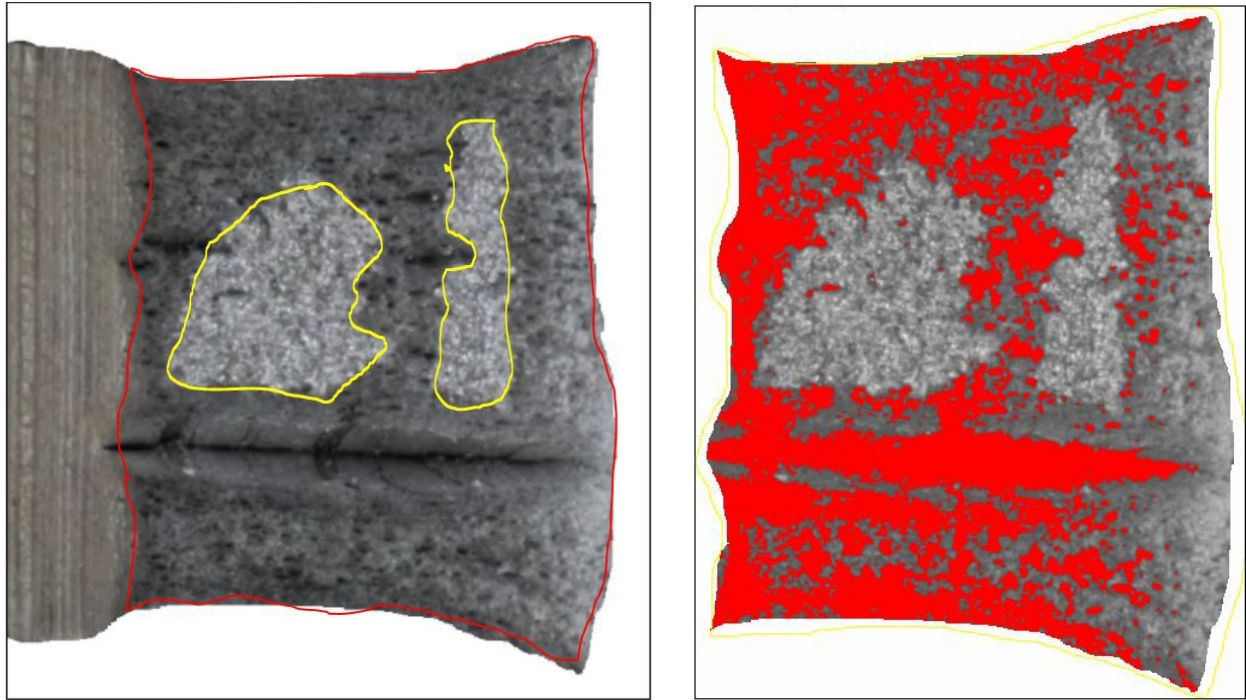
Figure E.68. Shear fracture areas for specimen 3TY using a Mask Area Method (left) and a Pixel Intensity Method (right).

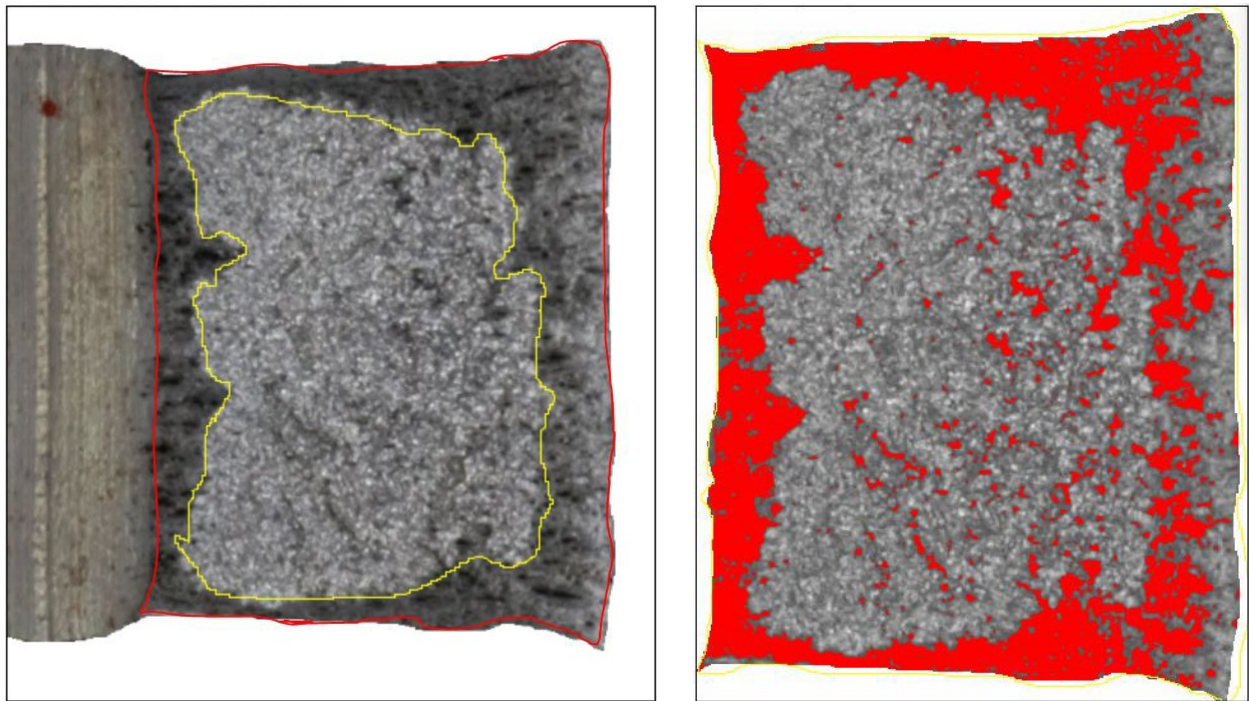
Figure E.69. Shear fracture areas for specimen 3TZ using a Mask Area Method (left) and a Pixel Intensity Method (right).

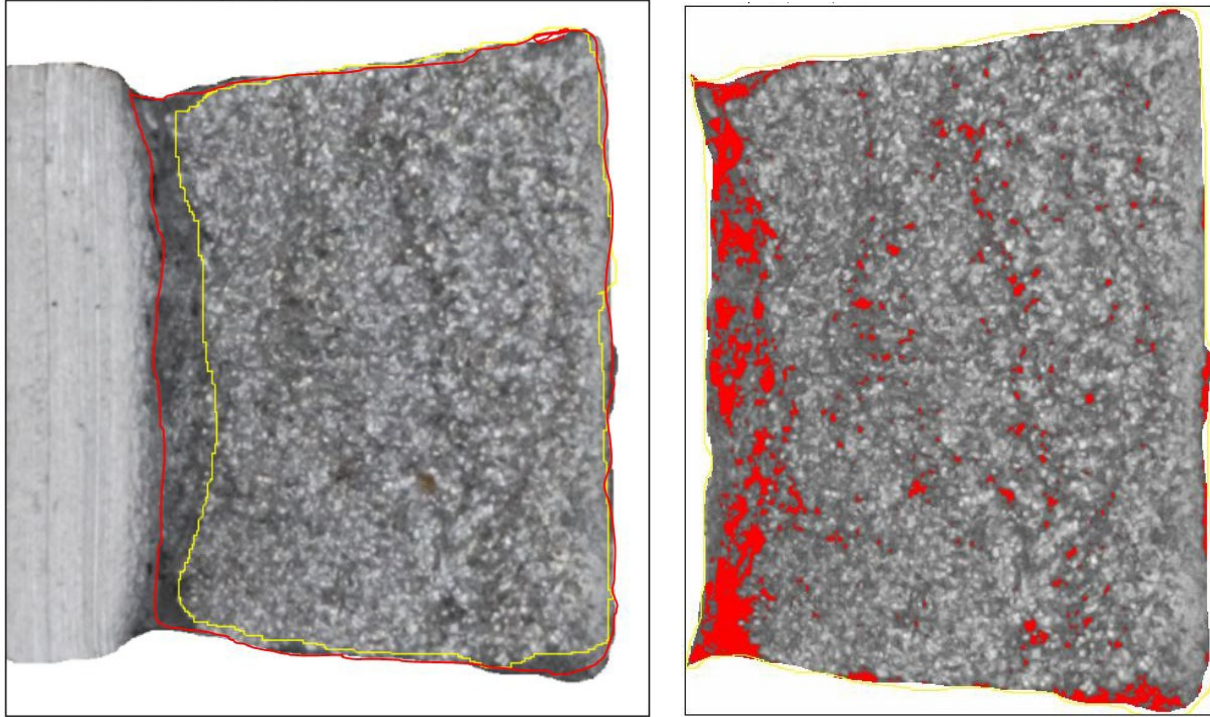
Figure E.70. Shear fracture areas for specimen 4AX using a Mask Area Method (left) and a Pixel Intensity Method (right).

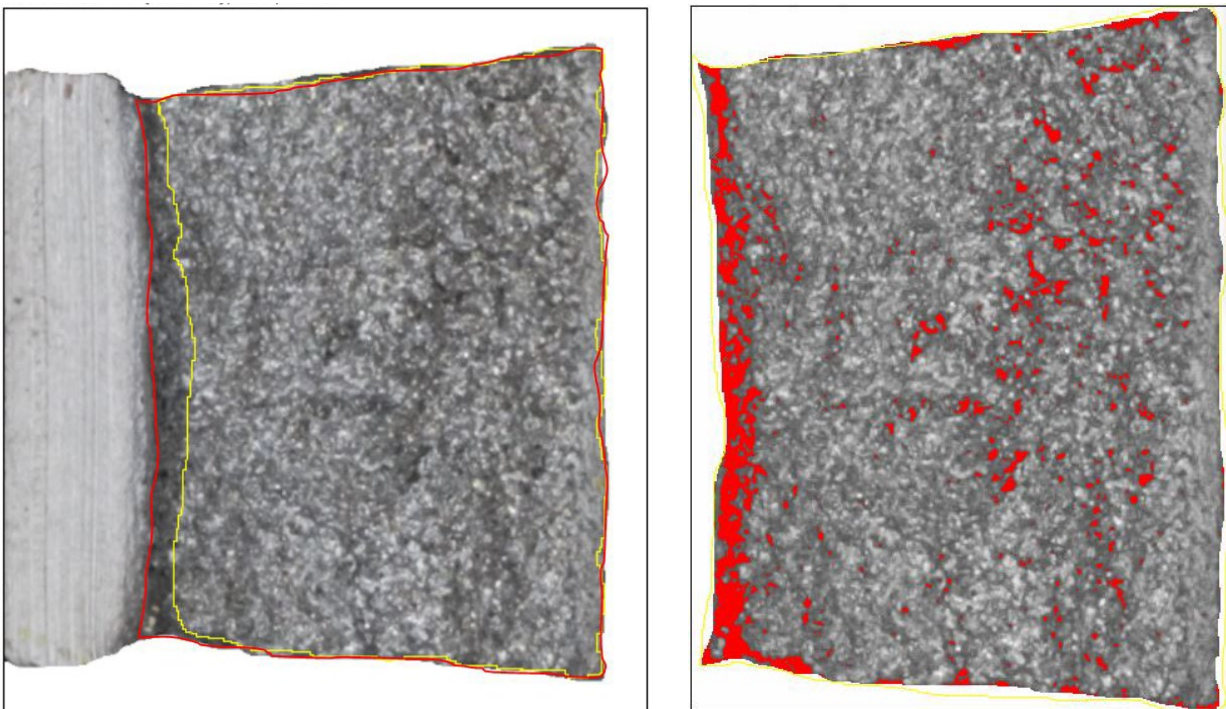
Figure E.71. Shear fracture areas for specimen 4AY using a Mask Area Method (left) and a Pixel Intensity Method (right).

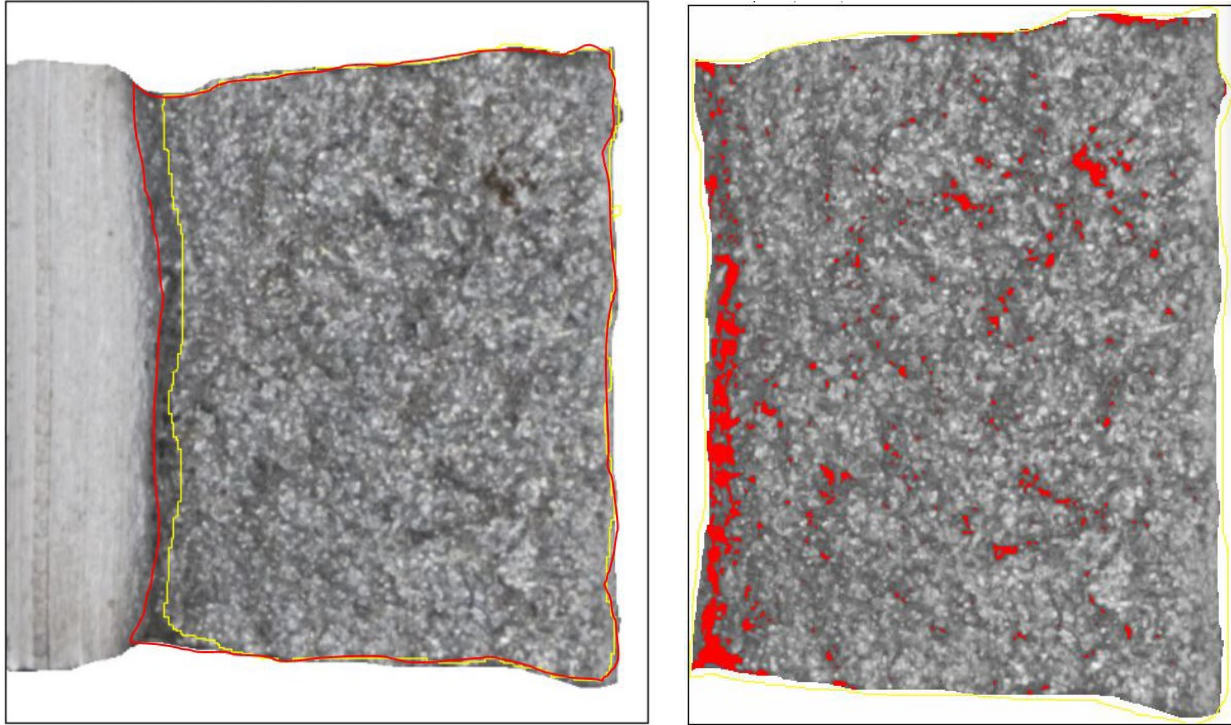
Figure E.72. Shear fracture areas for specimen 4AZ using a Mask Area Method (left) and a Pixel Intensity Method (right).

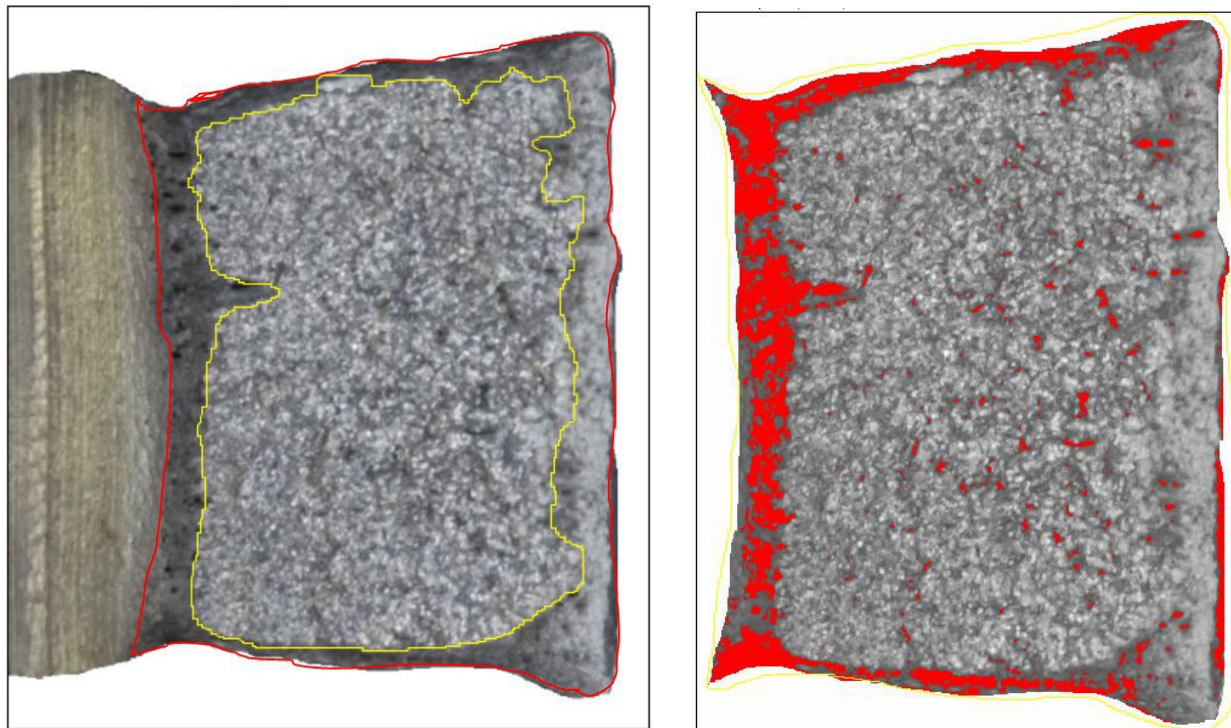
Figure E.73. Shear fracture areas for specimen 4BX using a Mask Area Method (left) and a Pixel Intensity Method (right).

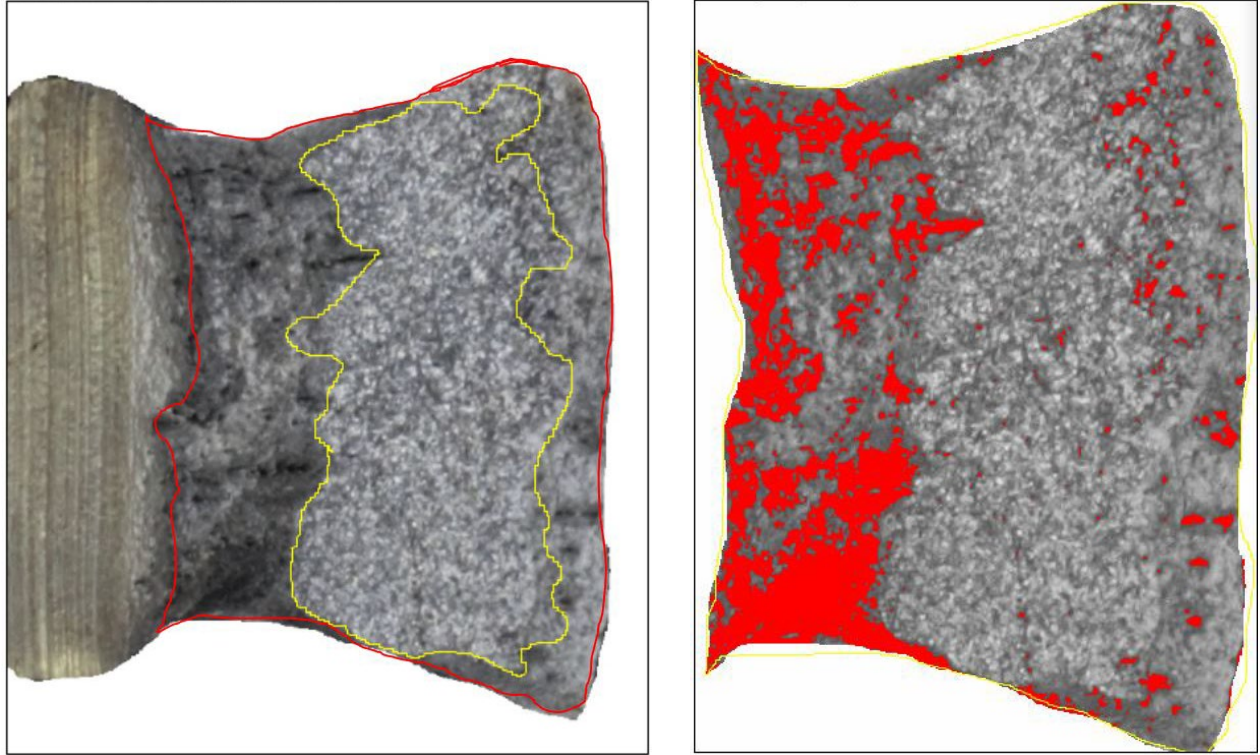
Figure E.74. Shear fracture areas for specimen 4BY using a Mask Area Method (left) and a Pixel Intensity Method (right).
