National Transportation Safety Board

Office of Research and Engineering

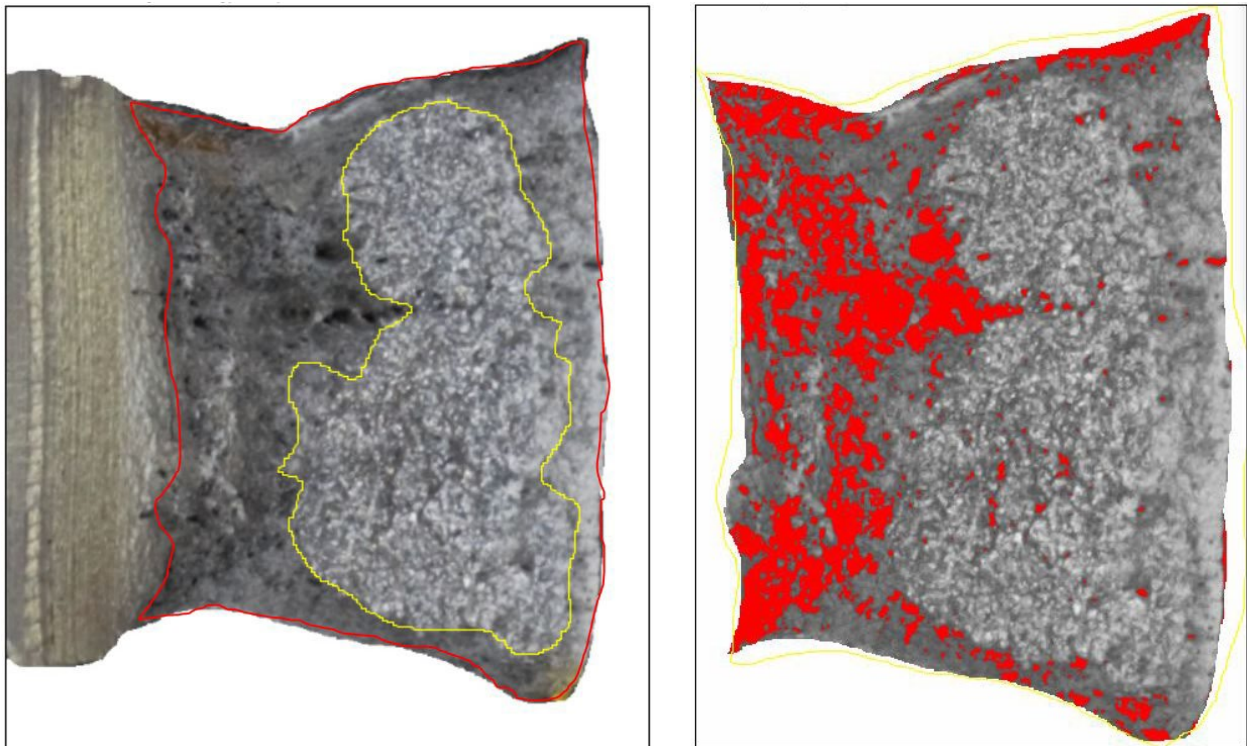
Figure E.75. Shear fracture areas for specimen 4BZ using a Mask Area Method (left) and a Pixel Intensity Method (right).

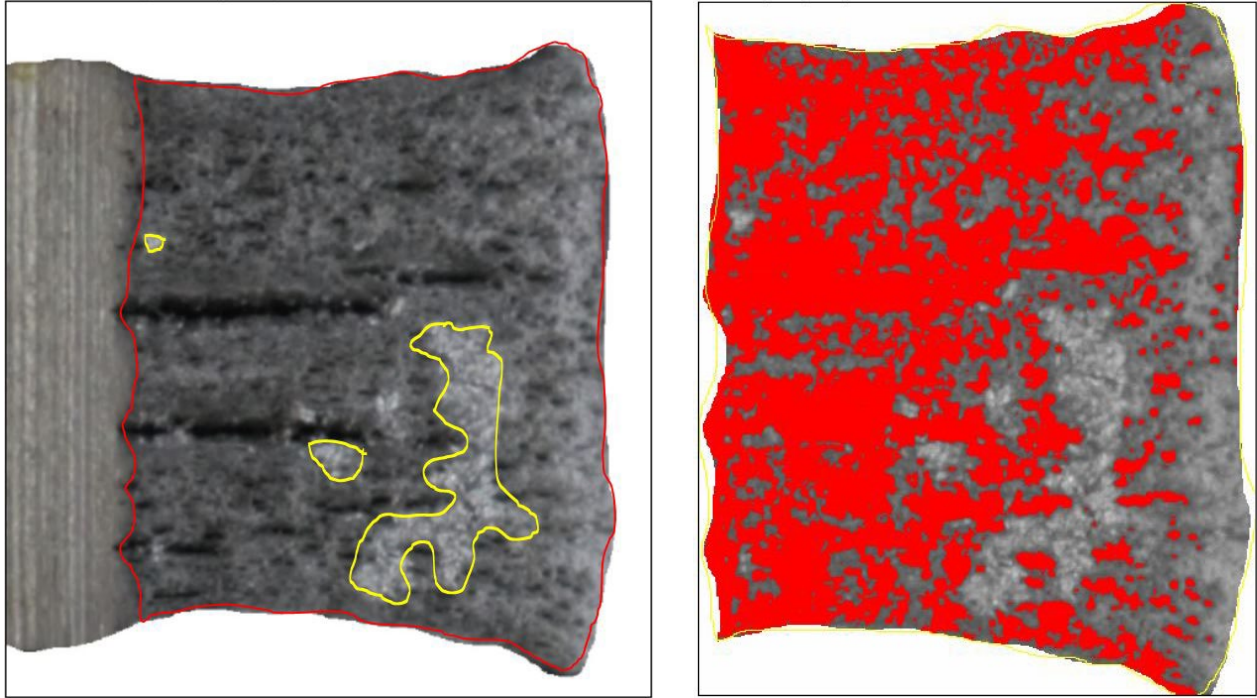
Figure E.76. Shear fracture areas for specimen 4QX using a Mask Area Method (left) and a Pixel Intensity Method (right).

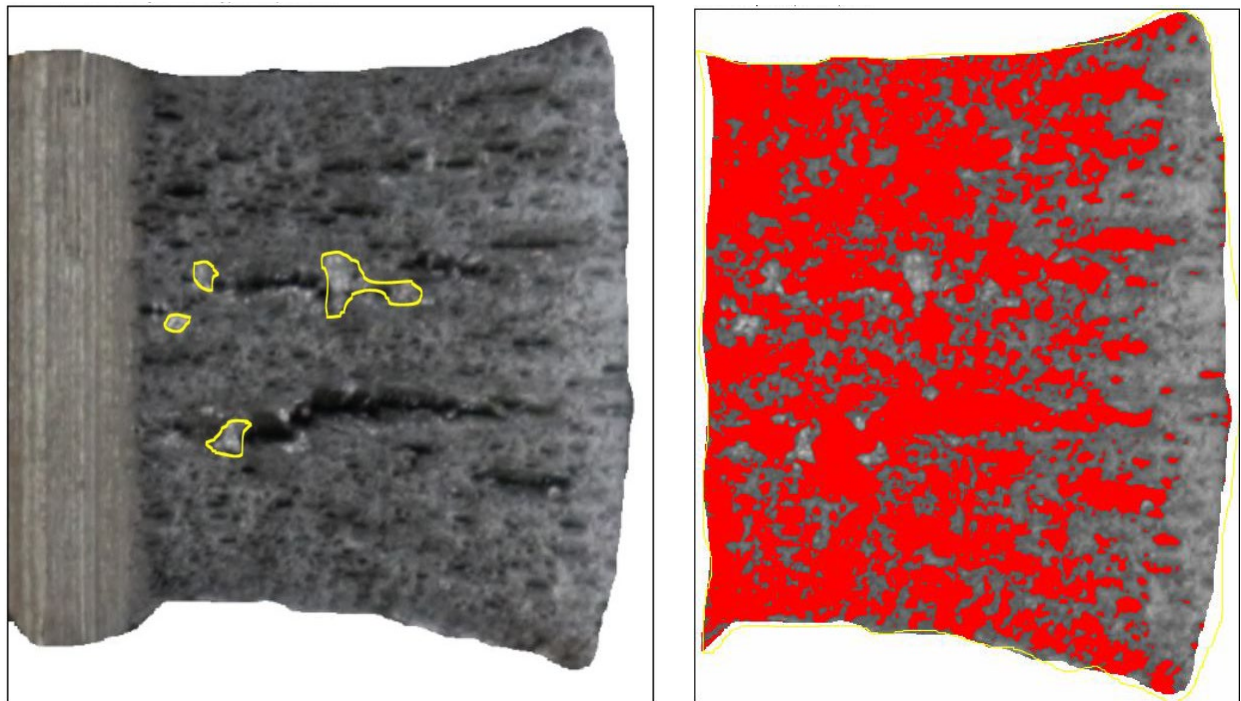
Figure E.77. Shear fracture areas for specimen 4QY using a Mask Area Method (left) and a Pixel Intensity Method (right).

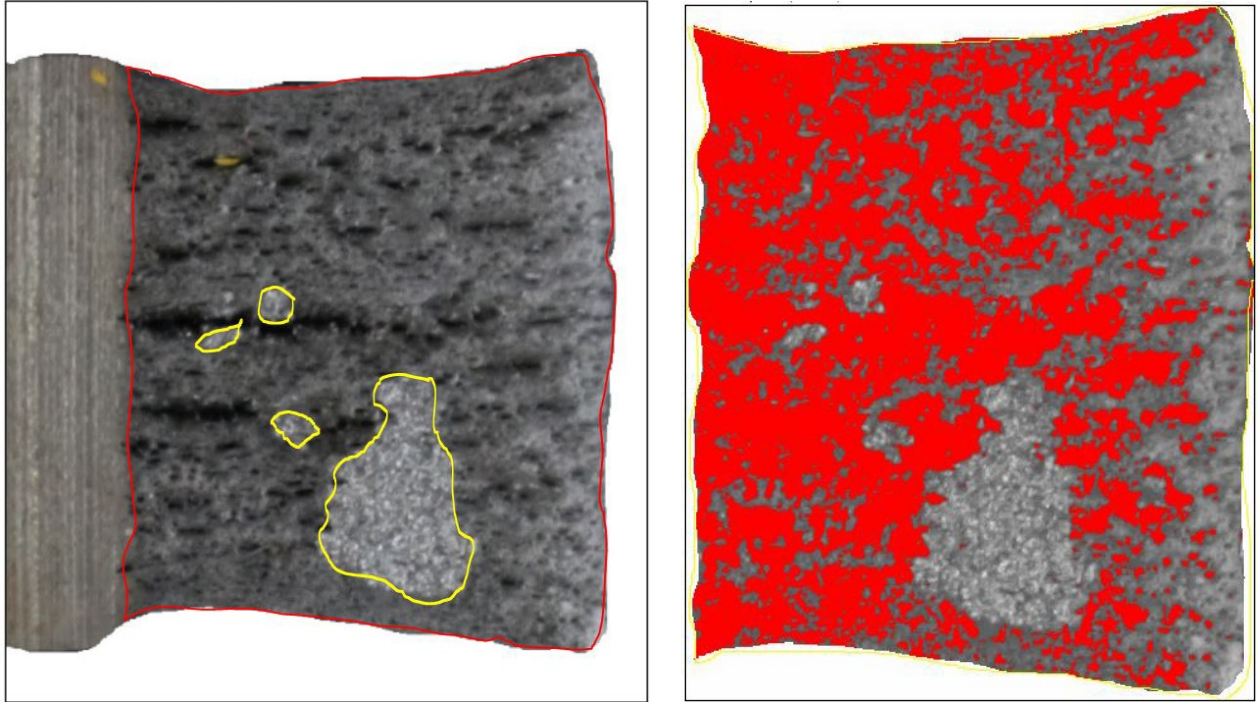
Figure E.78. Shear fracture areas for specimen 4QZ using a Mask Area Method (left) and a Pixel Intensity Method (right).

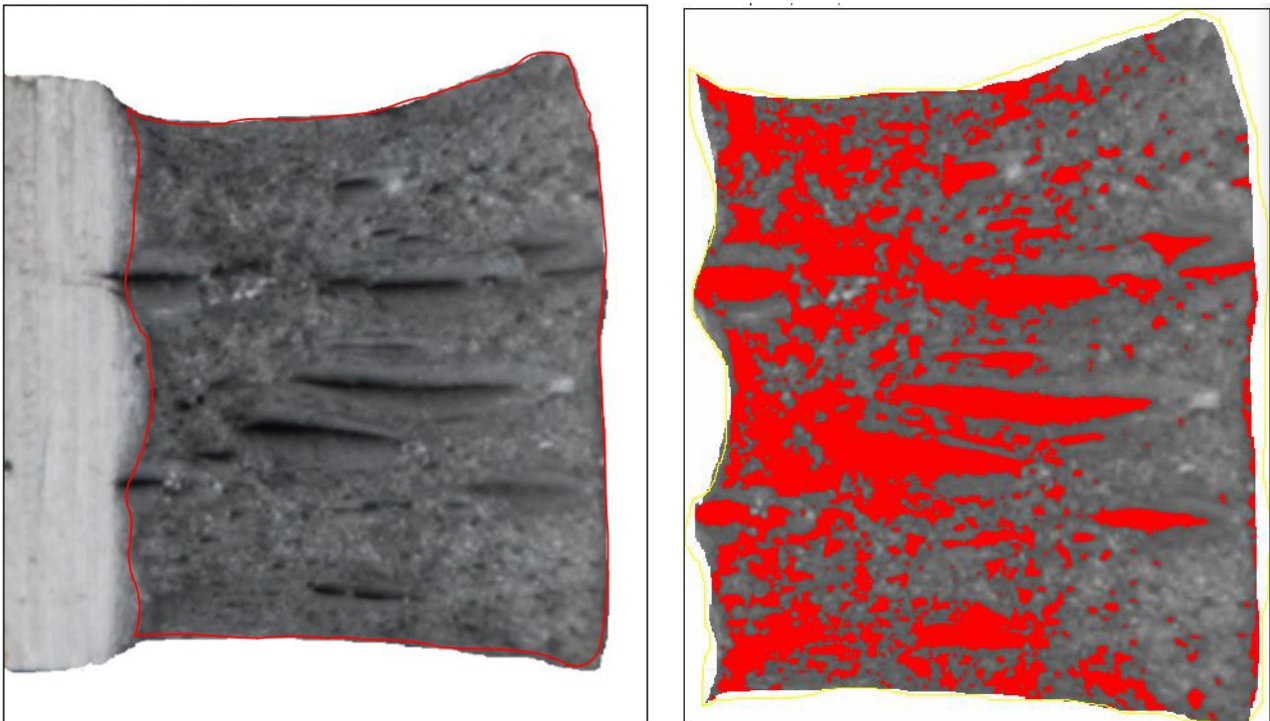
Figure E.79. Shear fracture areas for specimen 4RX using a Mask Area Method (left) and a Pixel Intensity Method (right).

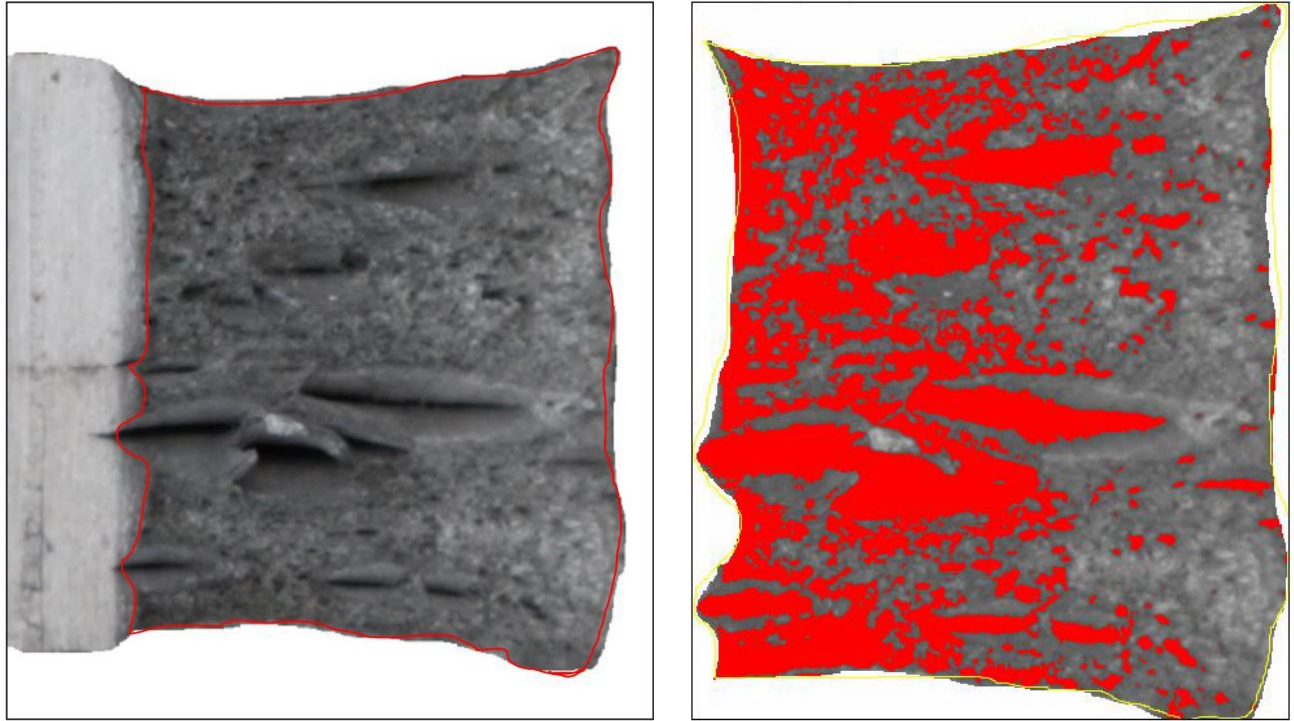
Figure E.80. Shear fracture areas for specimen 4RY using a Mask Area Method (left) and a Pixel Intensity Method (right).

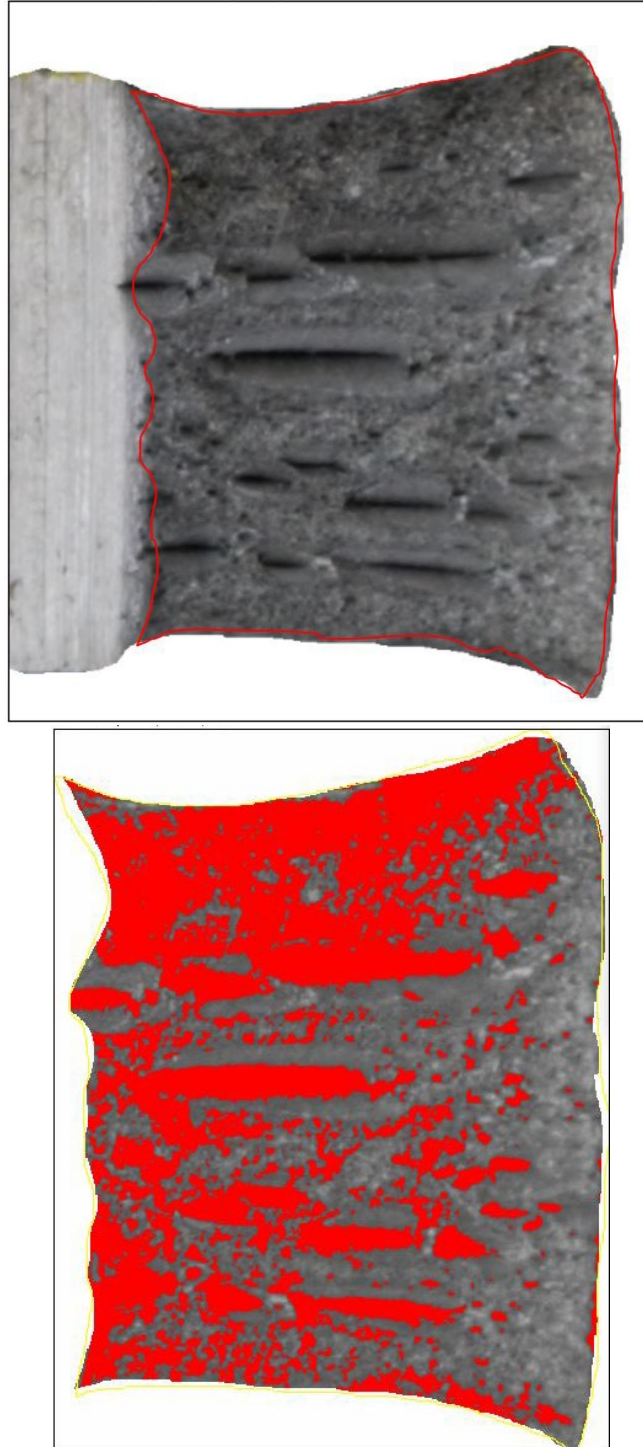
Figure E.81. Shear fracture areas for specimen 4RZ using a Mask Area Method (left) and a Pixel Intensity Method (right).

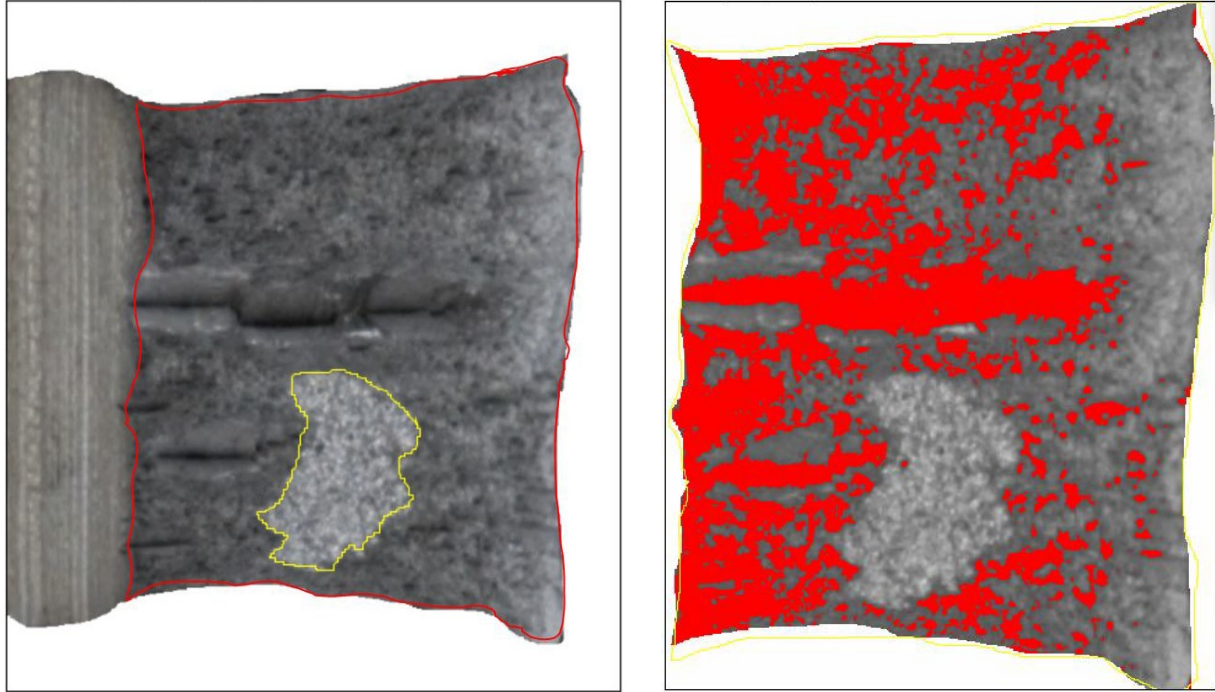
Figure E.82. Shear fracture areas for specimen 4TX using a Mask Area Method (left) and a Pixel Intensity Method (right).

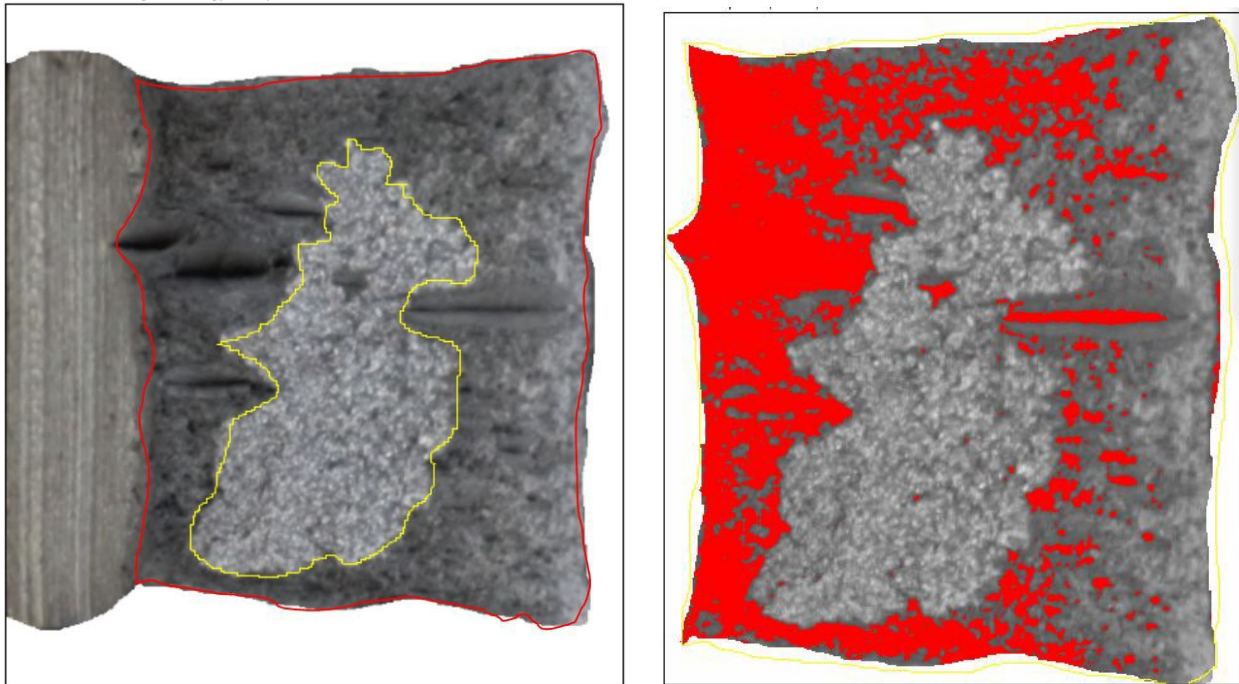
Figure E.83. Shear fracture areas for specimen 4TY using a Mask Area Method (left) and a Pixel Intensity Method (right).

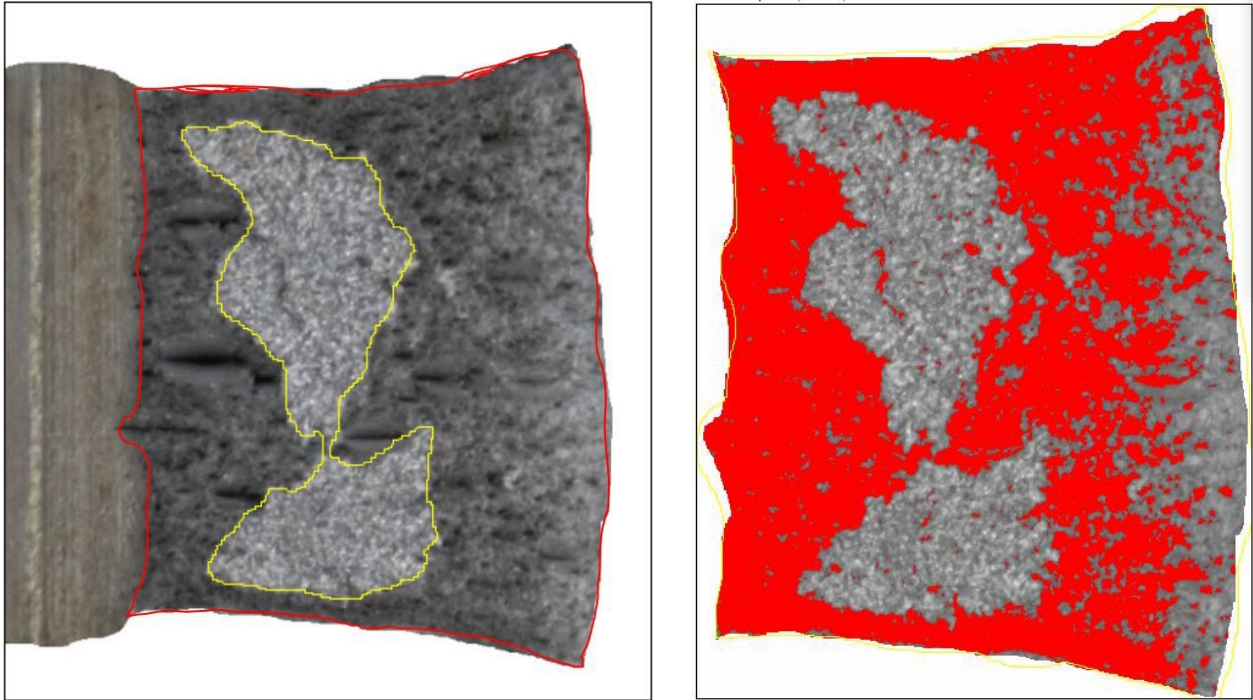
Figure E.84. Shear fracture areas for specimen 4TZ using a Mask Area Method (left) and a Pixel Intensity Method (right).

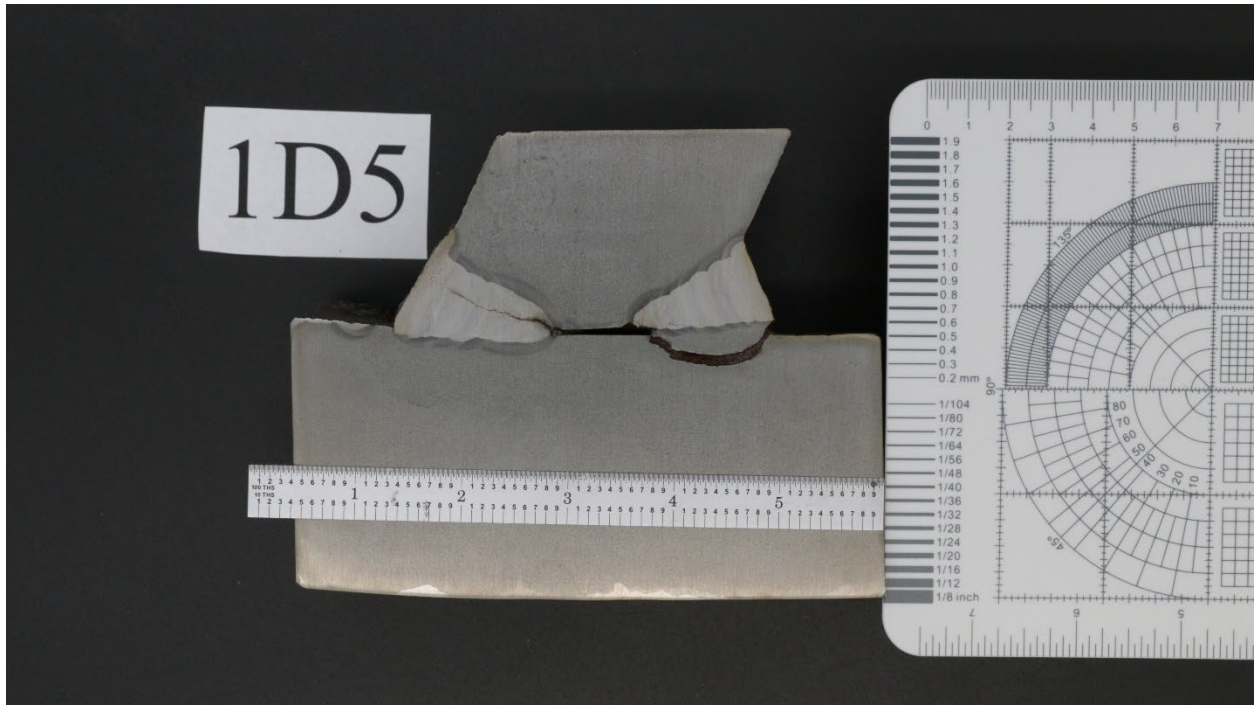
Figure G.1. Macroetch of 1D5 with planar reference scales.

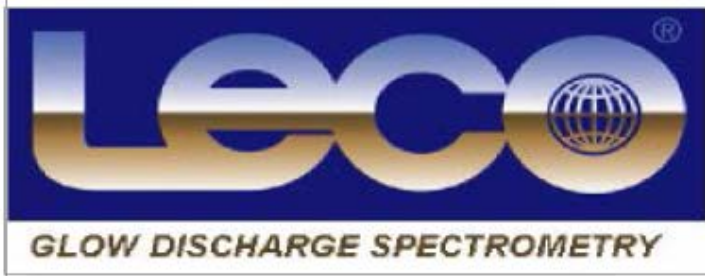
Disclaimer: This document was prepared carefully, using current references. Users of this SRM should ensure that this document and the corresponding Certificate of Analysis in their possession are current. This can be accomplished by contacting the SRM Program: telephone (301) 975-2200; fax (301) 948-3730; e-mail srmmsds@nist.gov; or via the Internet at <http://www.nist.gov/srm>.

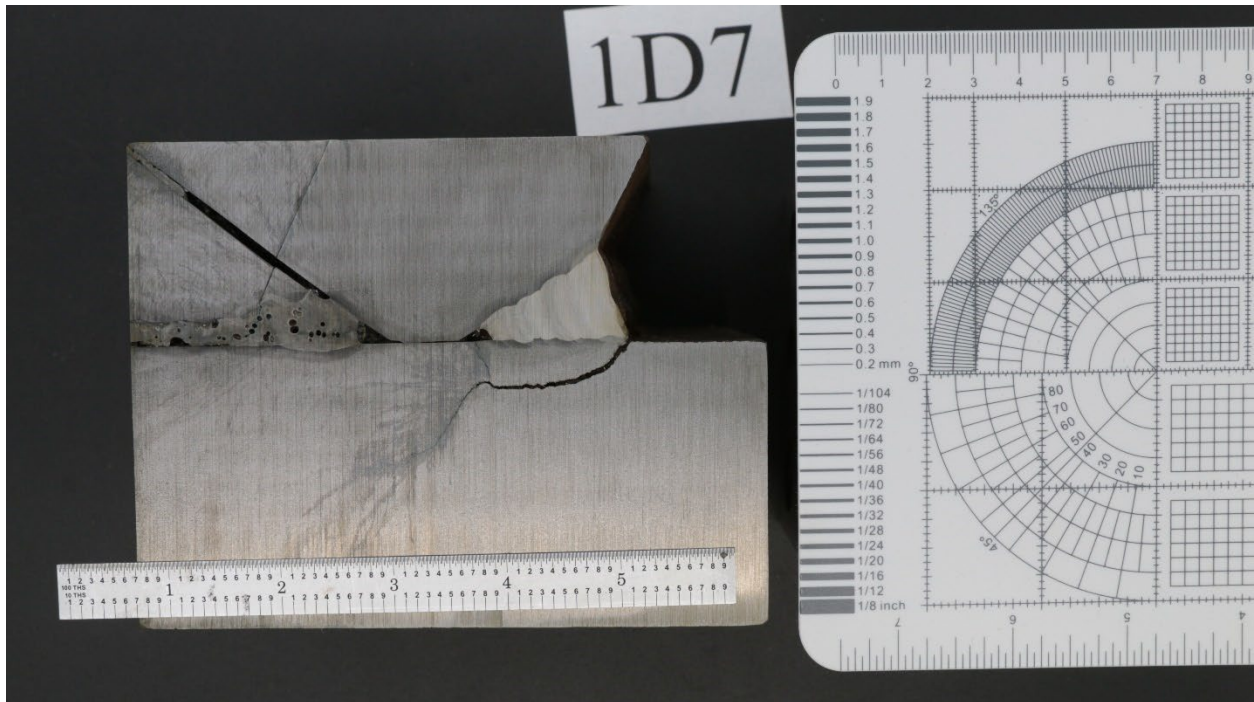
Figure 1. Macroetch of 1D7 with planar reference scales. (Figure G.3 of the FHWA Factual Report).

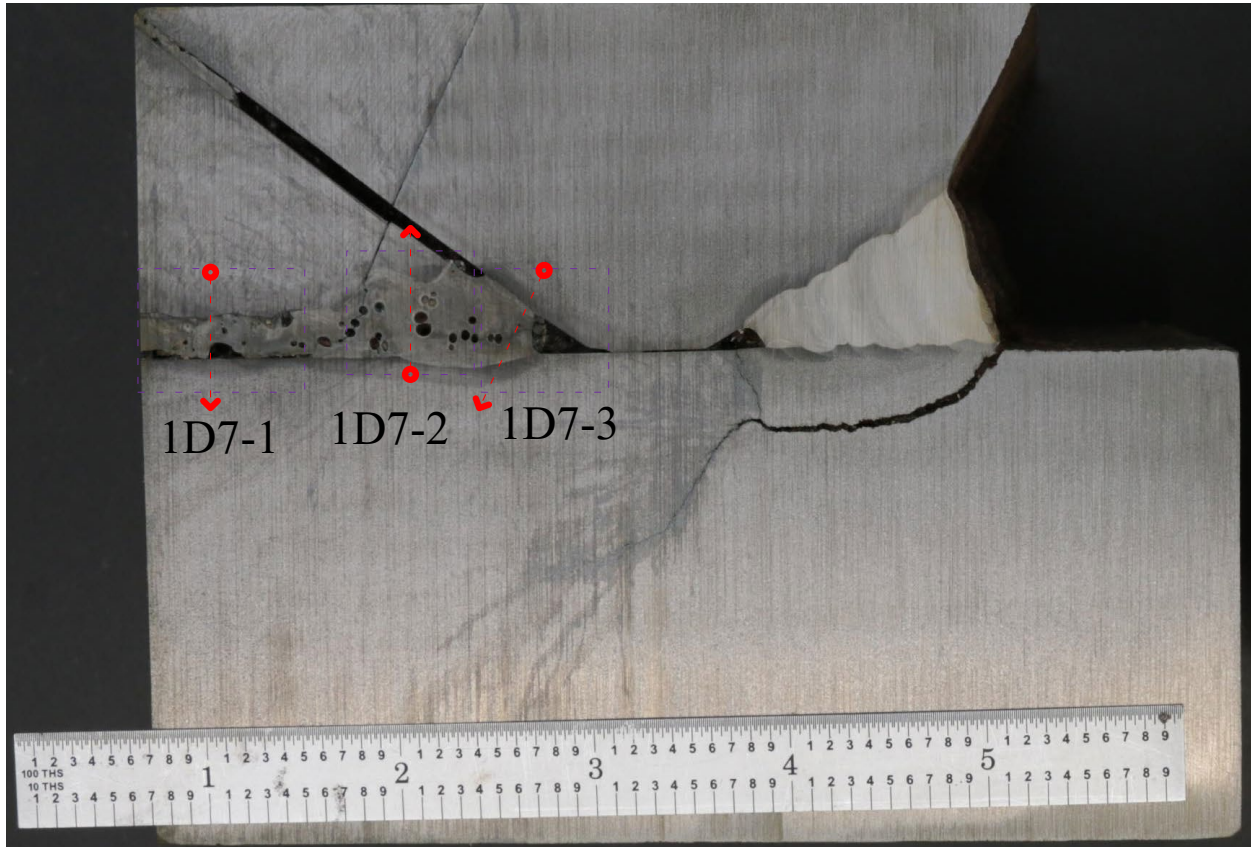
Figure 3. Macroetch of 1D7 with approximate sectioned area and gradient line path.

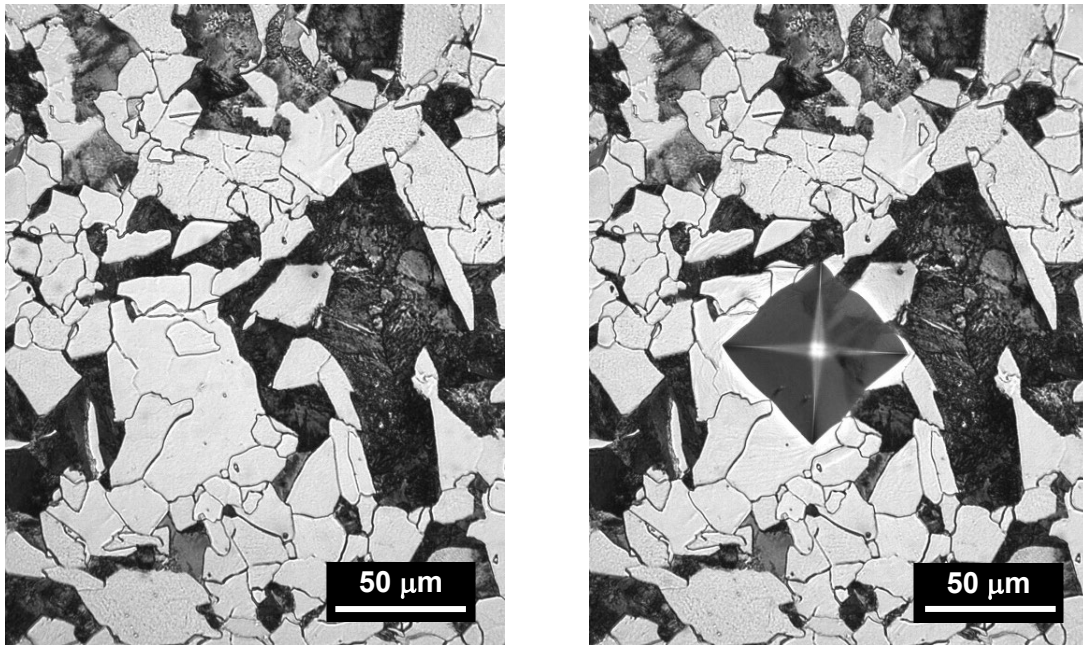
Figure 11. 1D7-1 Sample ID B1 microstructure prior to indentation (left) and with the Vickers microindentation (right). 5% Nital etch. 40x magnification. Ferrite/pearlite dominant.

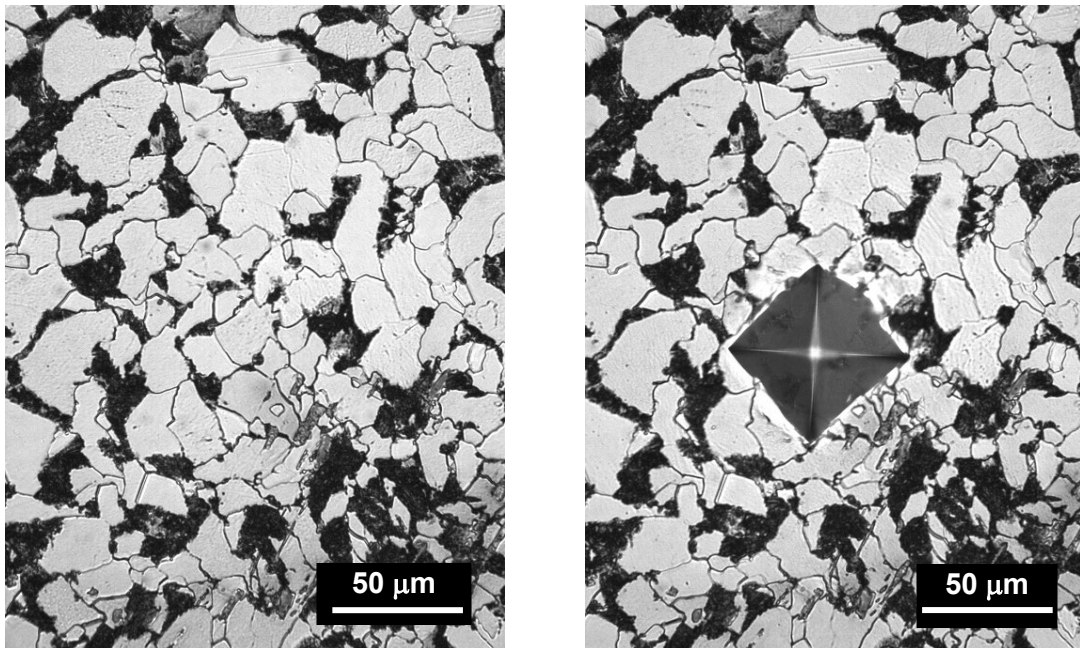
Figure 12. 1D7-1 Sample ID B2 microstructure prior to indentation (left) and with the Vickers microindentation (right). 5% Nital etch. 40x magnification. Ferrite/pearlite dominant.

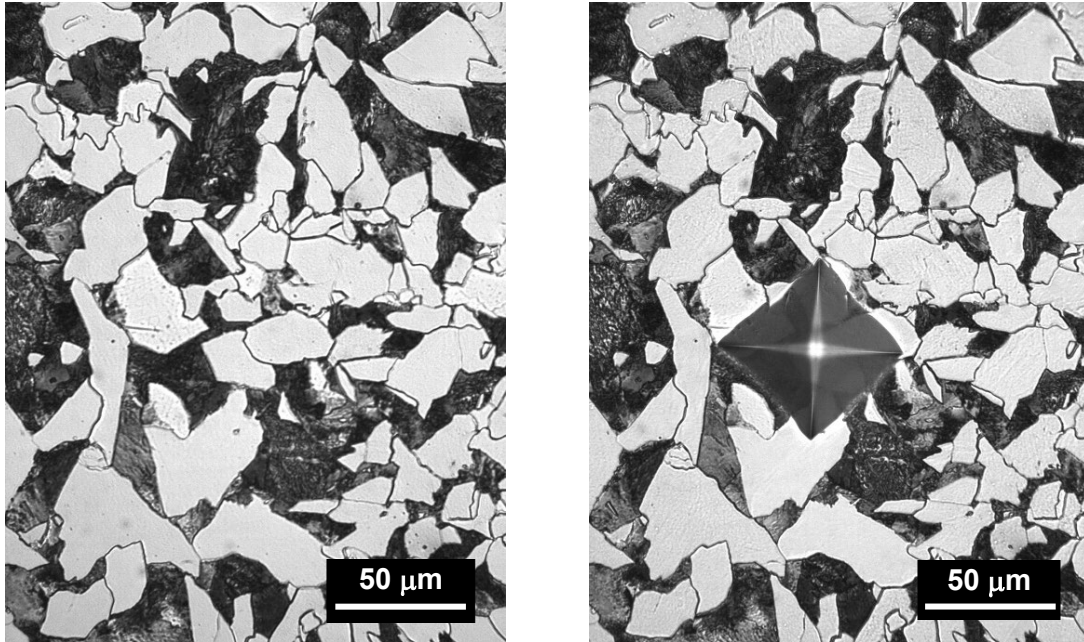
Figure 13. 1D7-1 Sample ID B3 microstructure prior to indentation (left) and with the Vickers microindentation (right). 5% Nital etch. 40x magnification. Ferrite/pearlite dominant.

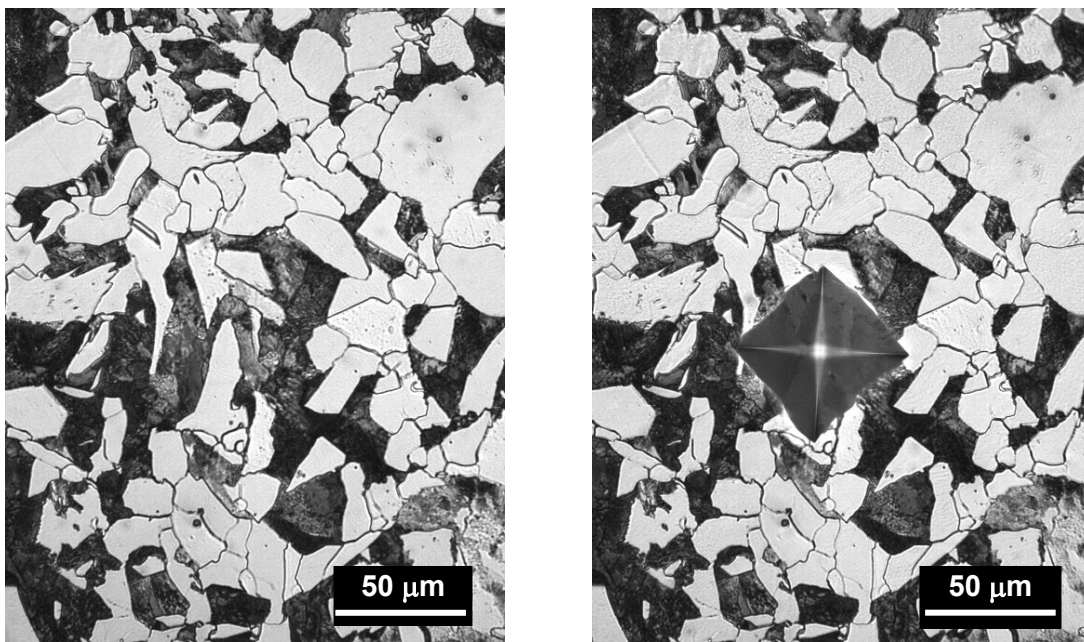
Figure 14. 1D7-1 Sample ID B4 microstructure prior to indentation (left) and with the Vickers microindentation (right). 5% Nital etch. 40x magnification. Ferrite/pearlite dominant.

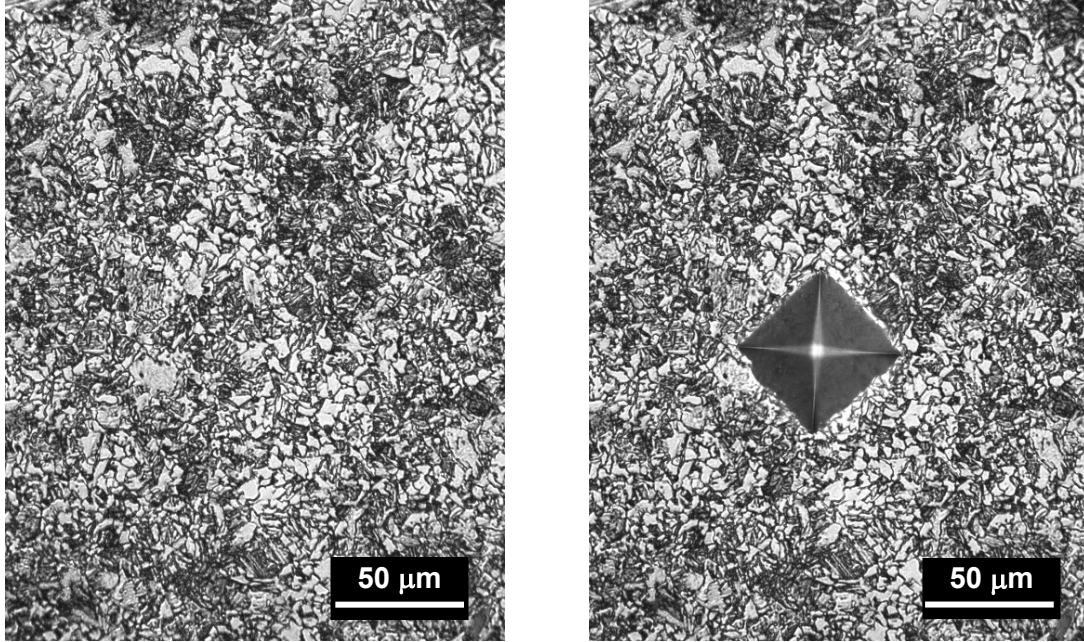
Figure 15. 1D7-1 Sample ID H1 microstructure prior to indentation (left) and with the Vickers microindentation (right). 5% Nital etch. 40x magnification. Refined ferrite/pearlite from the heat cycle.

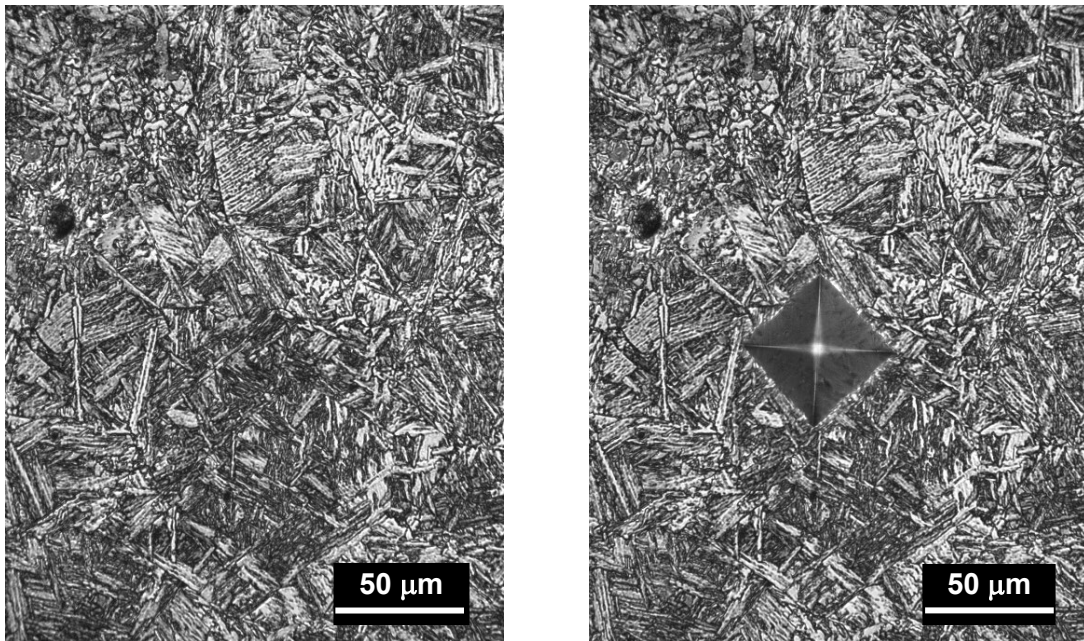
Figure 16. 1D7-1 Sample ID H2 microstructure prior to indentation (left) and with the Vickers microindentation (right). 5% Nital etch. 40x magnification. Martensite dominant.

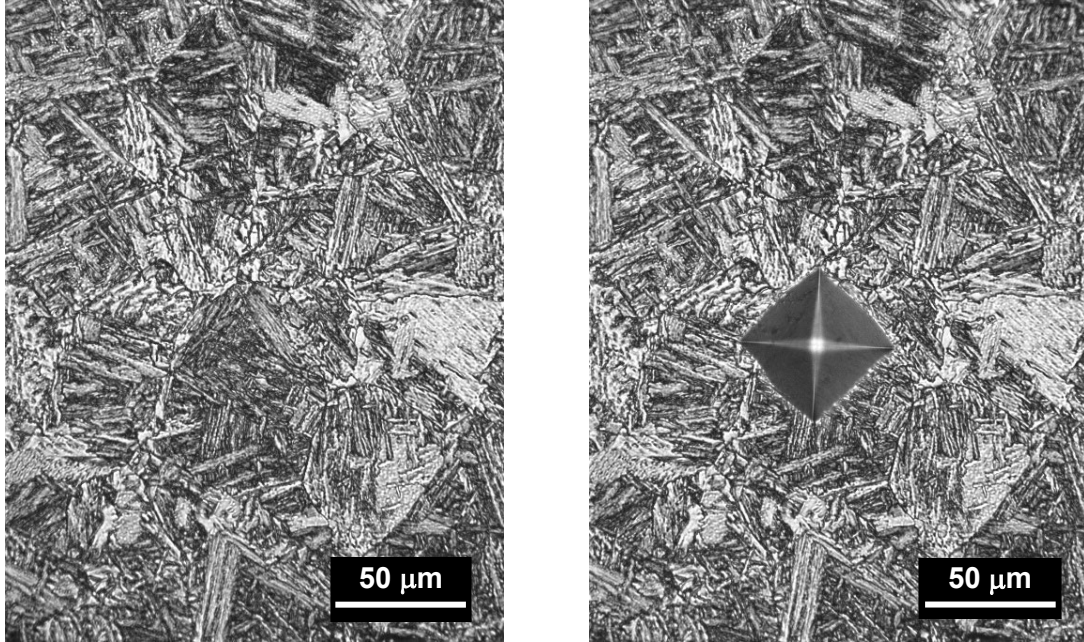
Figure 17. 1D7-1 Sample ID H3 microstructure prior to indentation (left) and with the Vickers microindentation (right). 5% Nital etch. 40x magnification. Martensite dominant.

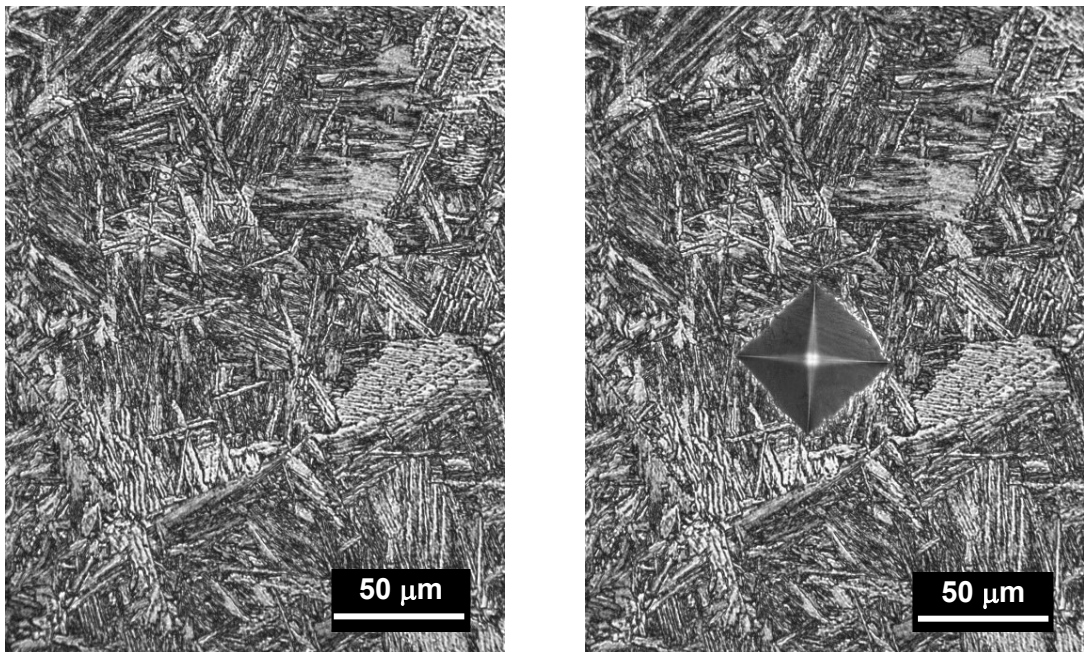
Figure 18. 1D7-1 Sample ID H4 microstructure prior to indentation (left) and with the Vickers microindentation (right). 5% Nital etch. 40x magnification. Martensite dominant.

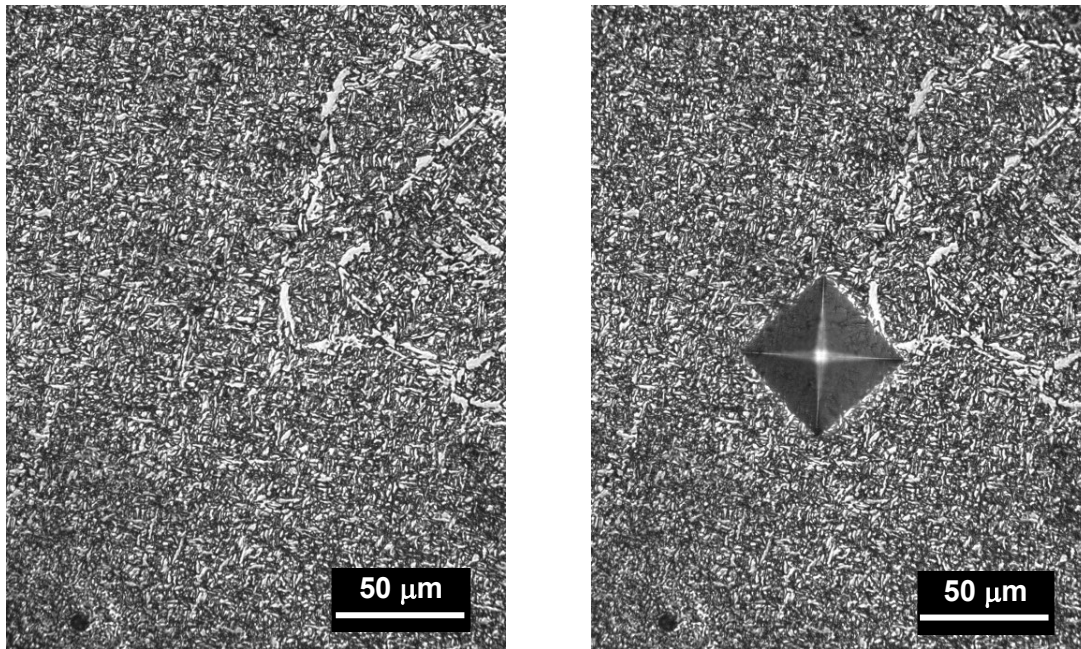
Figure 19. 1D7-1 Sample ID W1 microstructure prior to indentation (left) and with the Vickers microindentation (right). 5% Nital etch. 40x magnification. Acicular ferrite dominant with some proeutectoid ferrite.

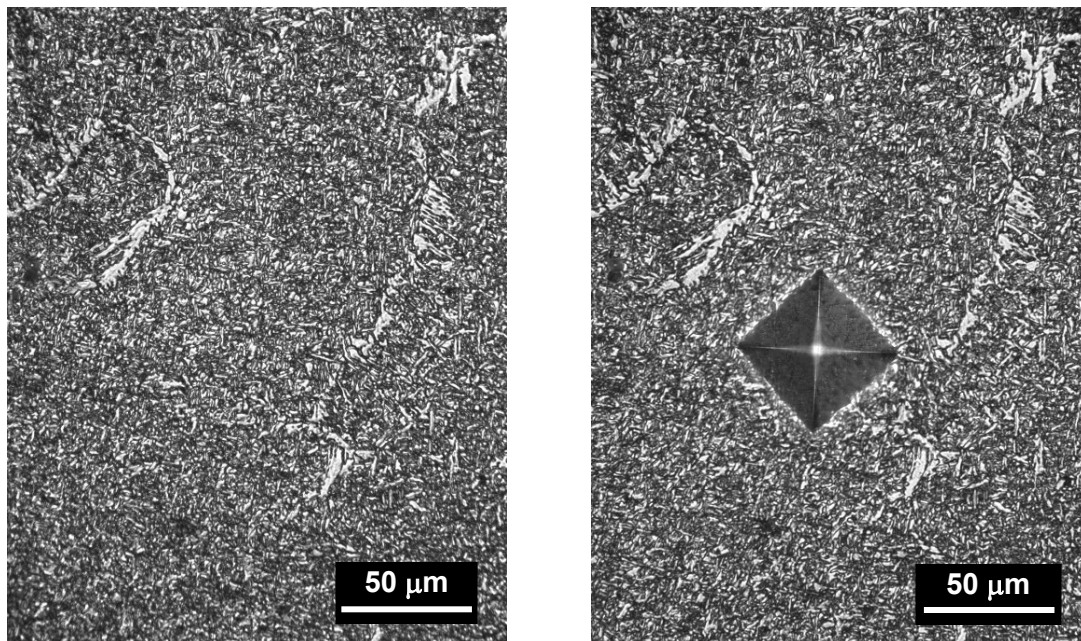
Figure 20. 1D7-1 Sample ID W2 microstructure prior to indentation (left) and with the Vickers microindentation (right). 5% Nital etch. 40x magnification. Acicular ferrite dominant with some proeutectoid ferrite and Widmanstätten ferrite.

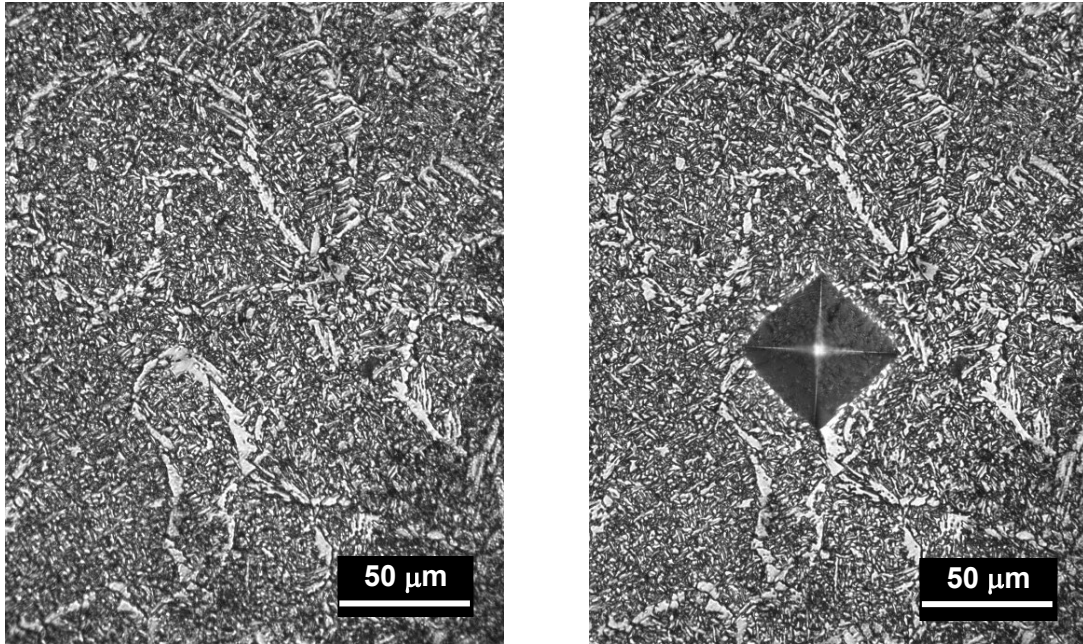
Figure 21. 1D7-1 Sample ID W3 microstructure prior to indentation (left) and with the Vickers microindentation (right). 5% Nital etch. 40x magnification. Acicular ferrite dominant with some proeutectoid ferrite and Widmanstätten ferrite.

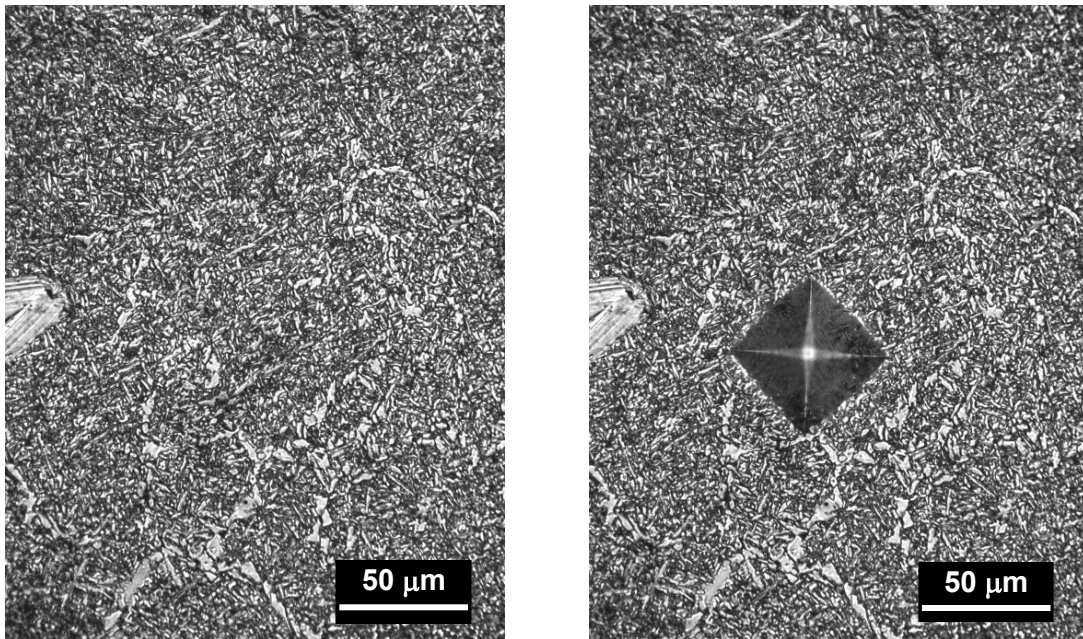
Figure 22. 1D7-1 Sample ID W4 microstructure prior to indentation (left) and with the Vickers microindentation (right). 5% Nital etch. 40x magnification. Acicular ferrite dominant with some proeutectoid ferrite and Widmanstätten ferrite.

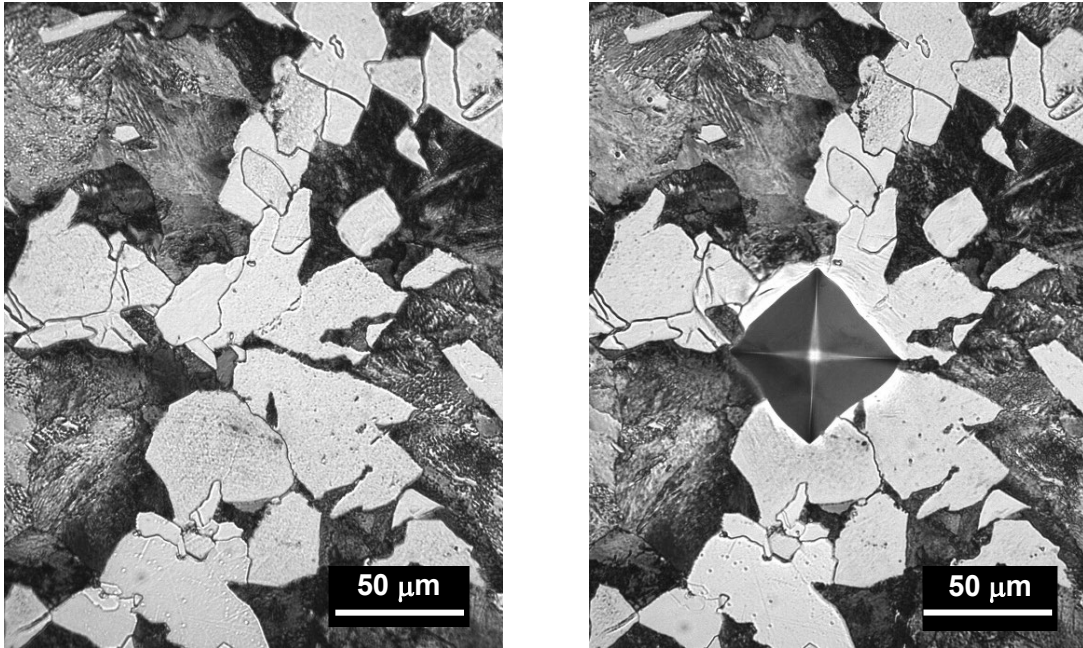
Figure 23. 1D7-2 Sample ID B1 microstructure prior to indentation (left) and with the Vickers microindentation (right). 5% Nital etch. 40x magnification. Ferrite/pearlite dominant.

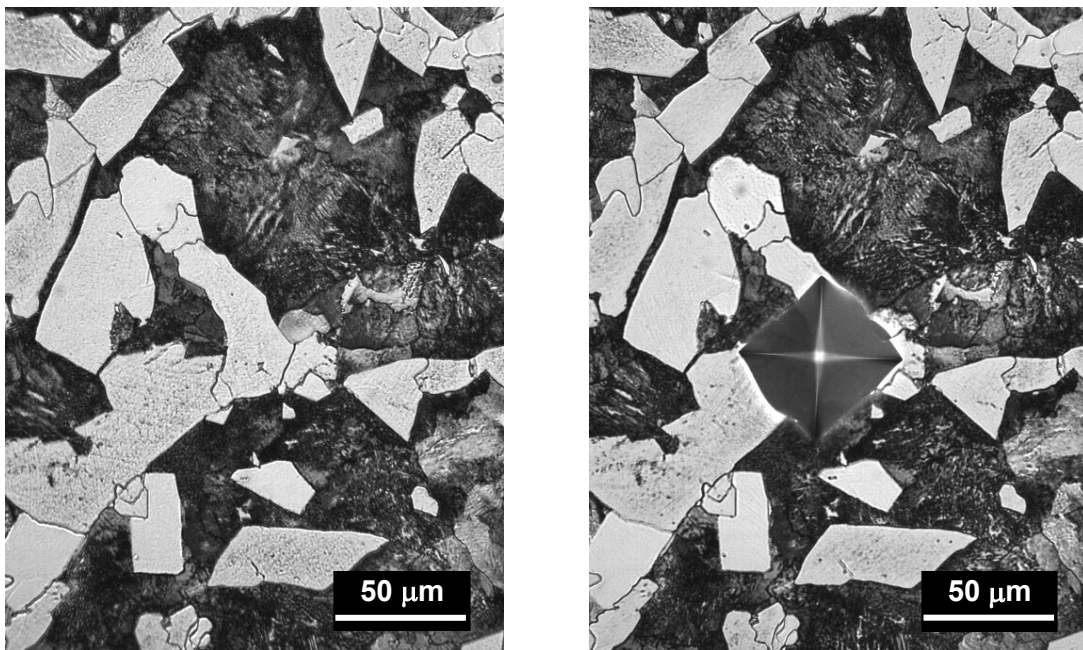
Figure 24. 1D7-2 Sample ID B2 microstructure prior to indentation (left) and with the Vickers microindentation (right). 5% Nital etch. 40x magnification. Ferrite/pearlite dominant.
