National Transportation Safety Board

Office of Research and Engineering

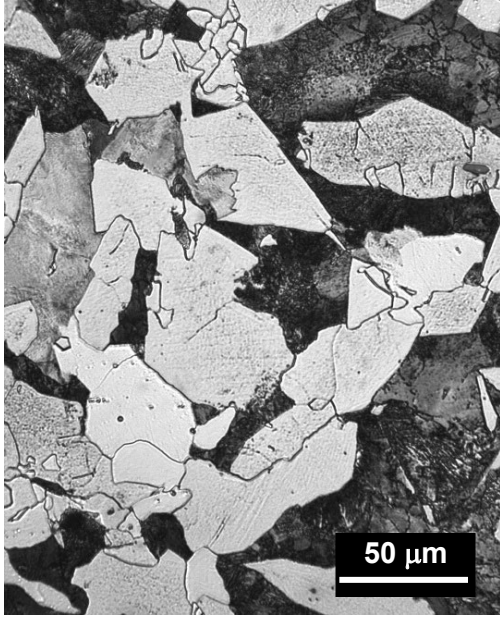
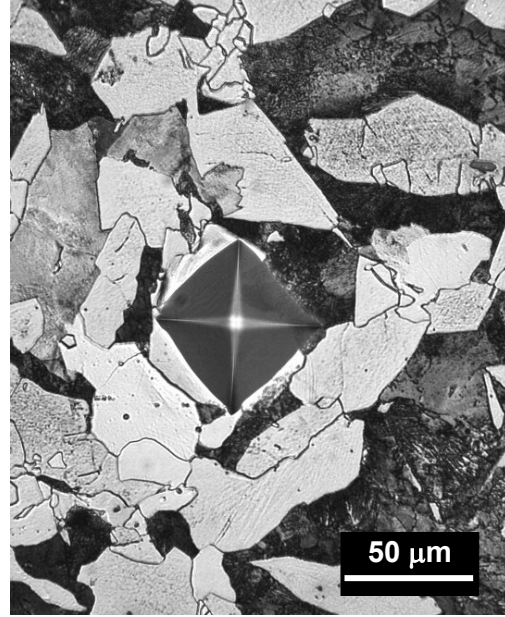
Figure 25. 1D7-2 Sample ID B3 microstructure prior to indentation (left) and with the Vickers microindentation (right). 5% Nital etch. 40x magnification. Ferrite/pearlite dominant.

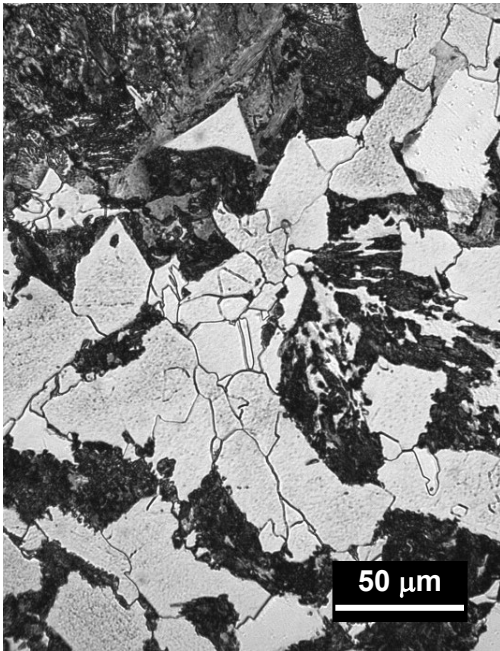
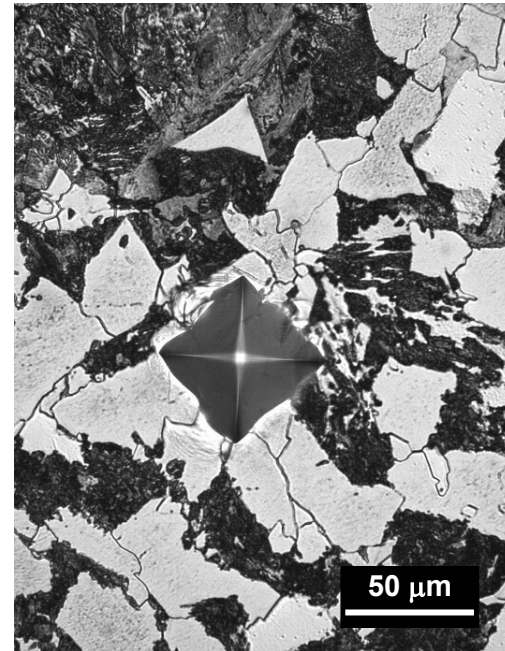
Figure 26. 1D7-2 Sample ID B4 microstructure prior to indentation (left) and with the Vickers microindentation (right). 5% Nital etch. 40x magnification. Ferrite/pearlite dominant.

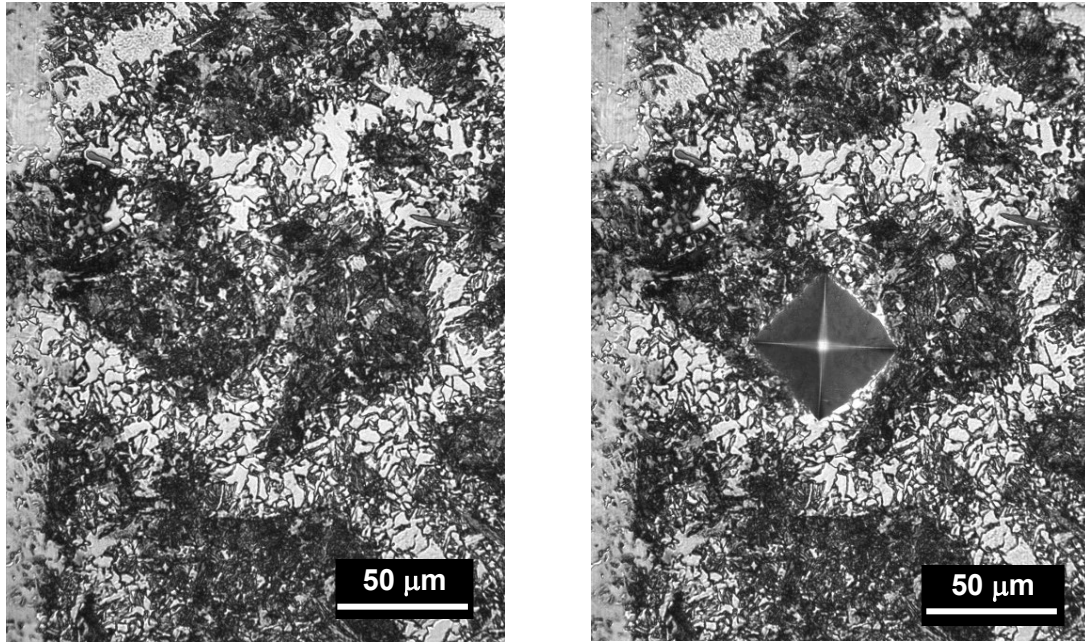
Figure 27. 1D7-2 Sample ID H1 microstructure prior to indentation (left) and with the Vickers microindentation (right). 5% Nital etch. 40x magnification. Refined ferrite/pearlite from the heat cycle.

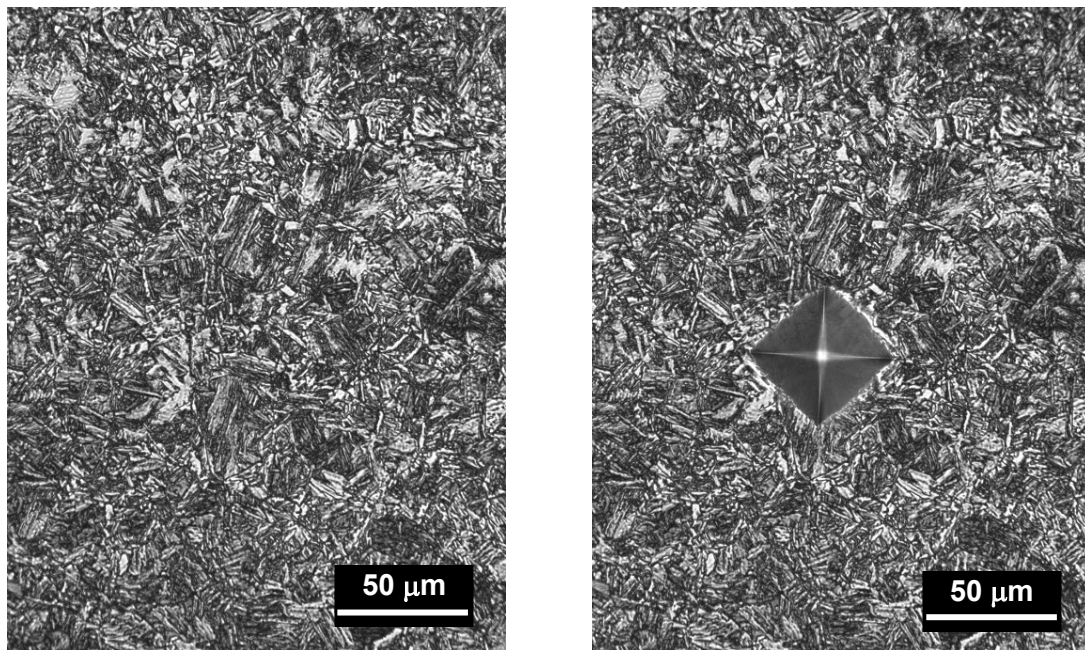
Figure 28. 1D7-2 Sample ID H2 microstructure prior to indentation (left) and with the Vickers microindentation (right). 5% Nital etch. 40x magnification. Refined ferrite/pearlite dominant with some martensite.

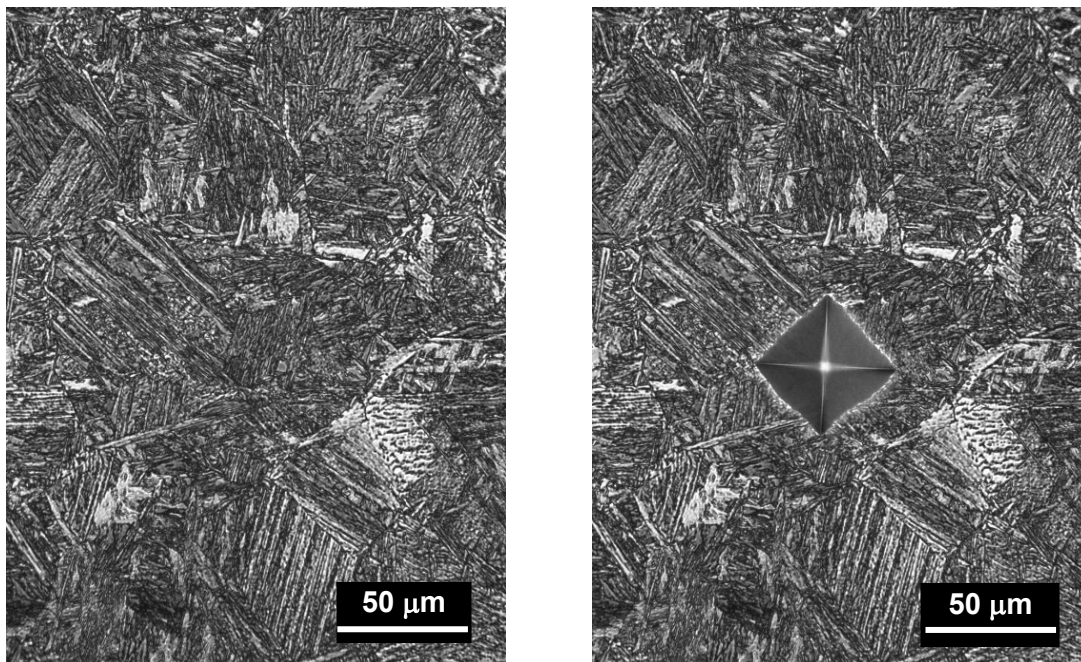
Figure 29. 1D7-2 Sample ID H3 microstructure prior to indentation (left) and with the Vickers microindentation (right). 5% Nital etch. 40x magnification. Martensite dominant.

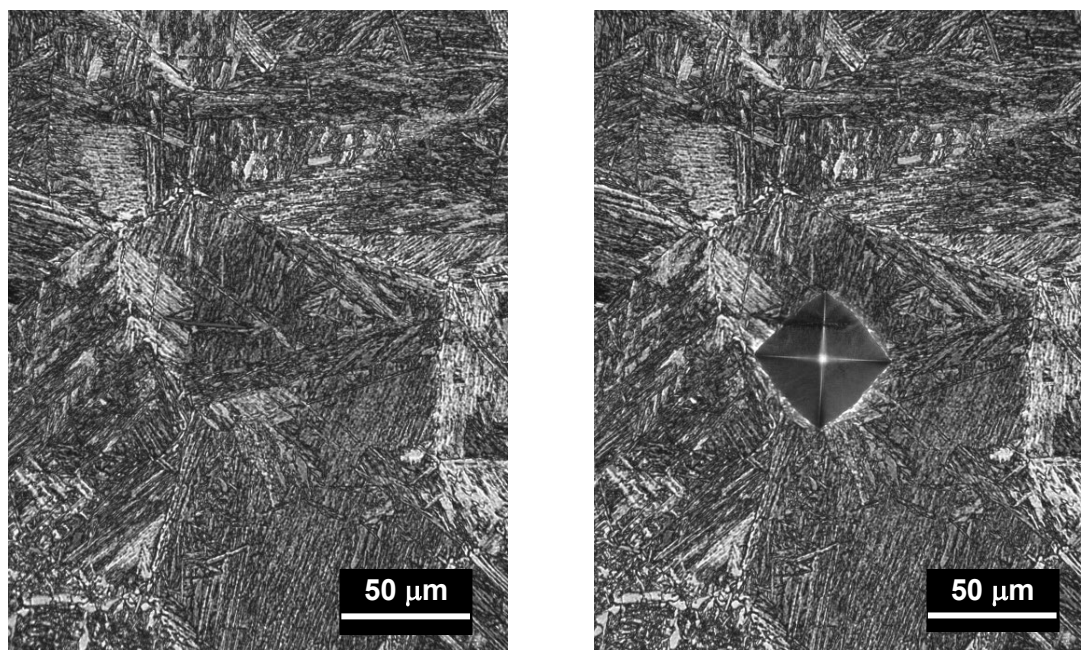
Figure 30. 1D7-2 Sample ID H4 microstructure prior to indentation (left) and with the Vickers microindentation (right). 5% Nital etch. 40x magnification. Martensite dominant.

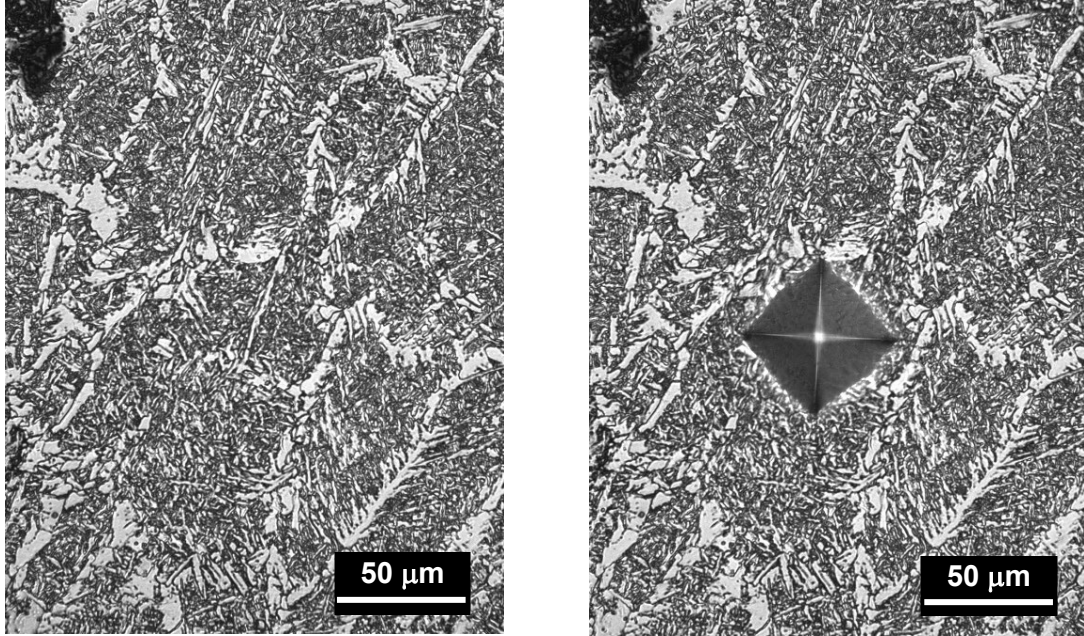
Figure 31. 1D7-2 Sample ID W1 microstructure prior to indentation (left) and with the Vickers microindentation (right). 5% Nital etch. 40x magnification. Note that the upper left corner blotch is marker. Acicular ferrite dominant with some proeutectoid ferrite and Widmanstätten ferrite.

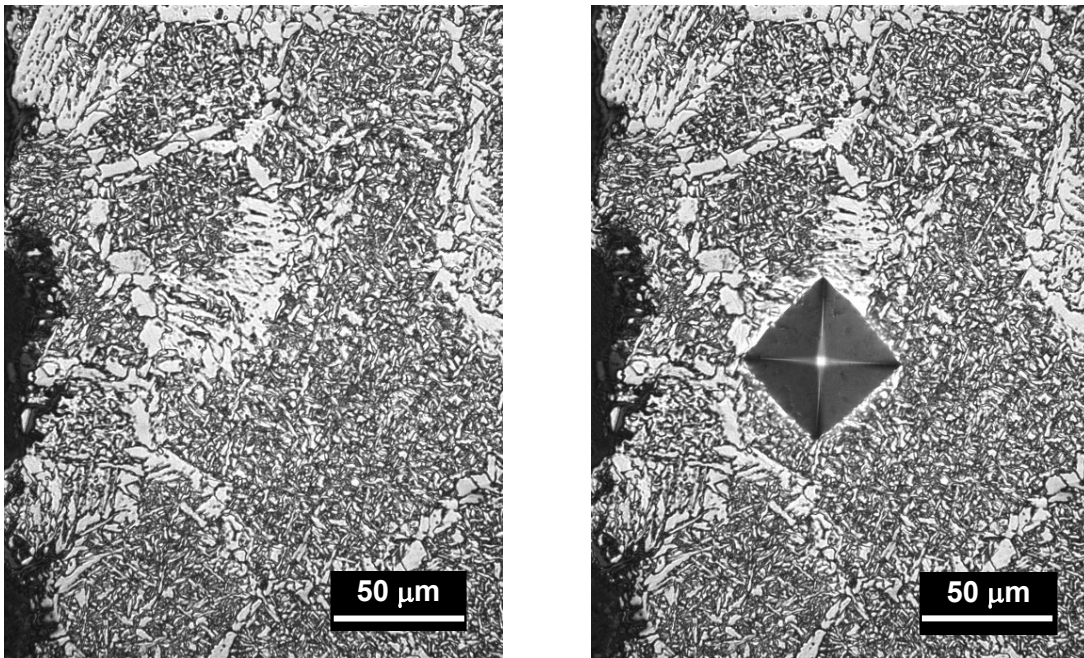
Figure 32. 1D7-2 Sample ID W2 microstructure prior to indentation (left) and with the Vickers microindentation (right). 5% Nital etch. 40x magnification. Note that the blotch about the left edge is marker. Acicular ferrite dominant with some proeutectoid ferrite and Widmanstätten ferrite.

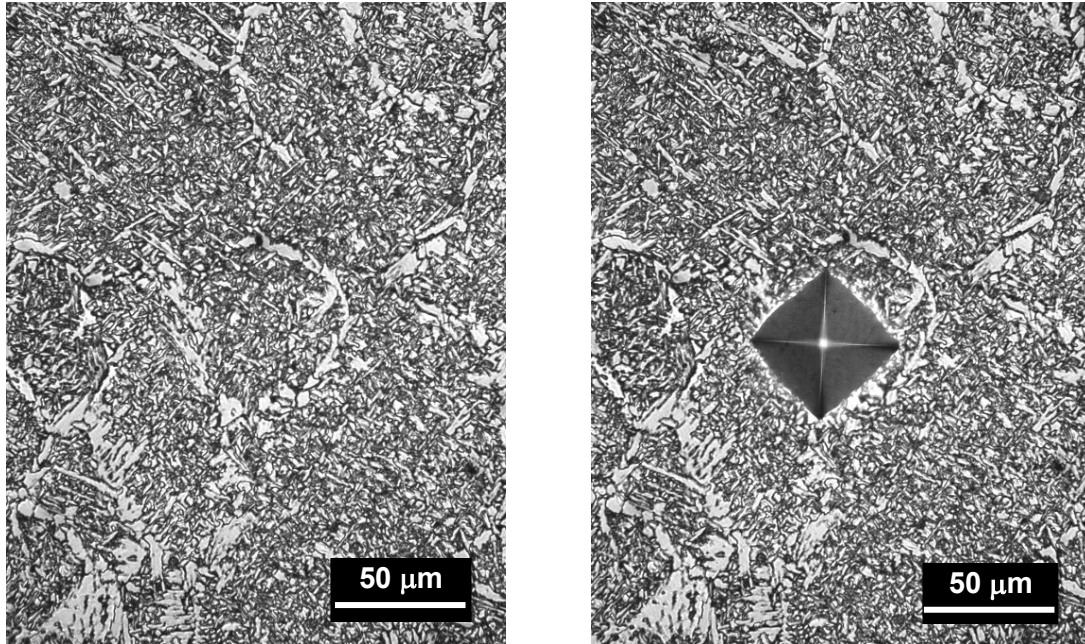
Figure 33. 1D7-2 Sample ID W3 microstructure prior to indentation (left) and with the Vickers microindentation (right). 5% Nital etch. 40x magnification. Acicular ferrite dominant with some proeutectoid ferrite and Widmanstätten ferrite.

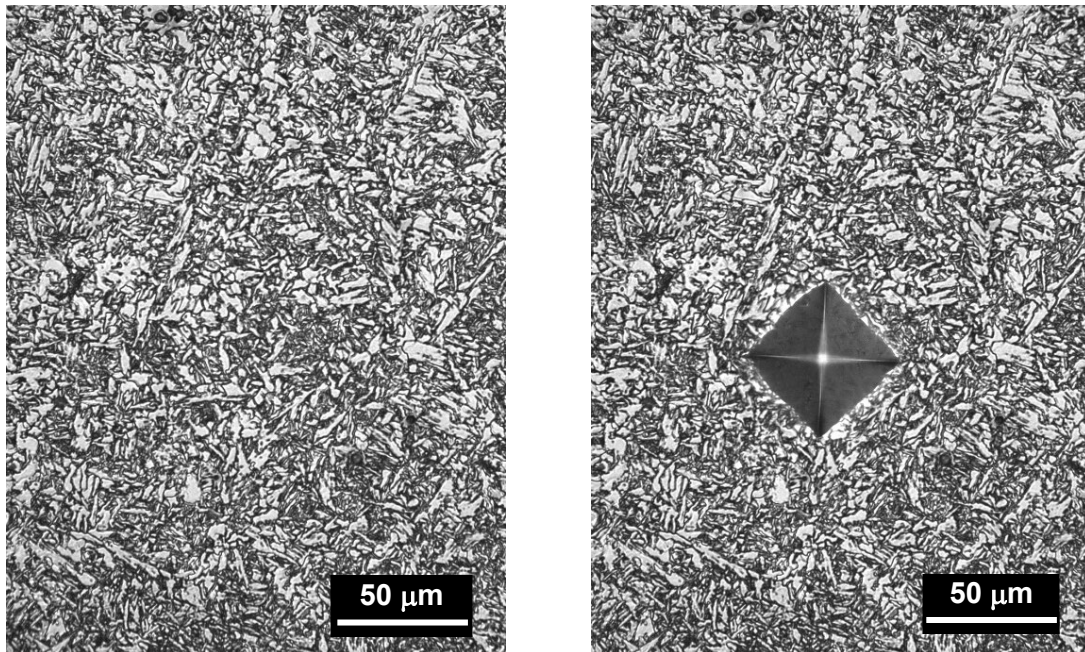
Figure 34. 1D7-2 Sample ID W4 microstructure prior to indentation (left) and with the Vickers microindentation (right). 5% Nital etch. 40x magnification. Acicular ferrite dominant.

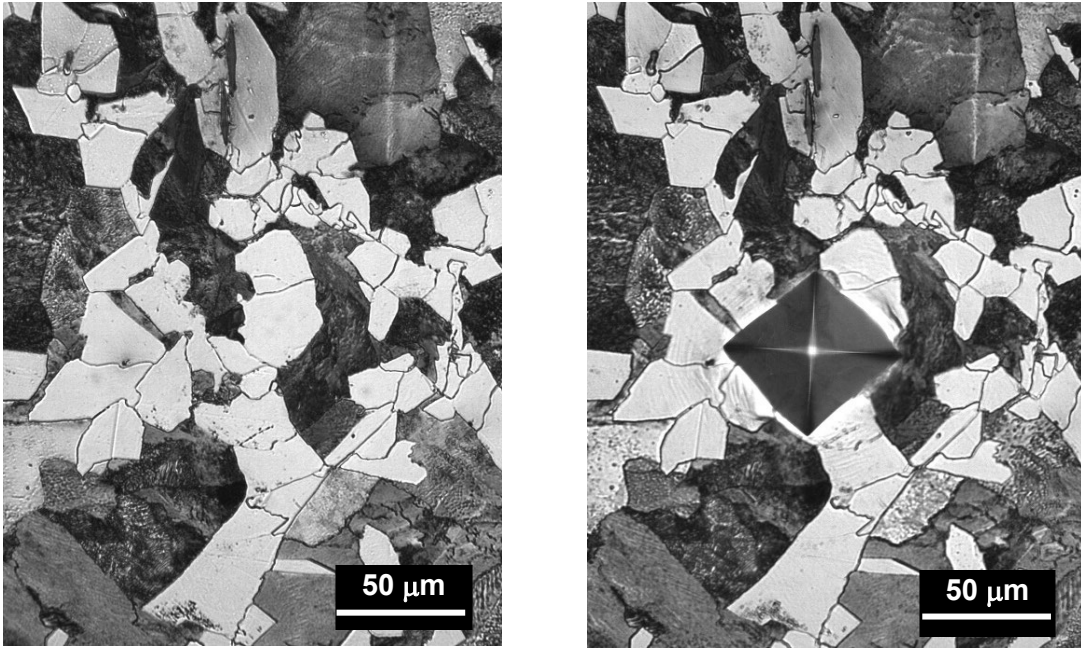
Figure 35. 1D7-3 Sample ID B1 microstructure prior to indentation (left) and with the Vickers microindentation (right). 5% Nital etch. 40x magnification. Ferrite/pearlite dominant.

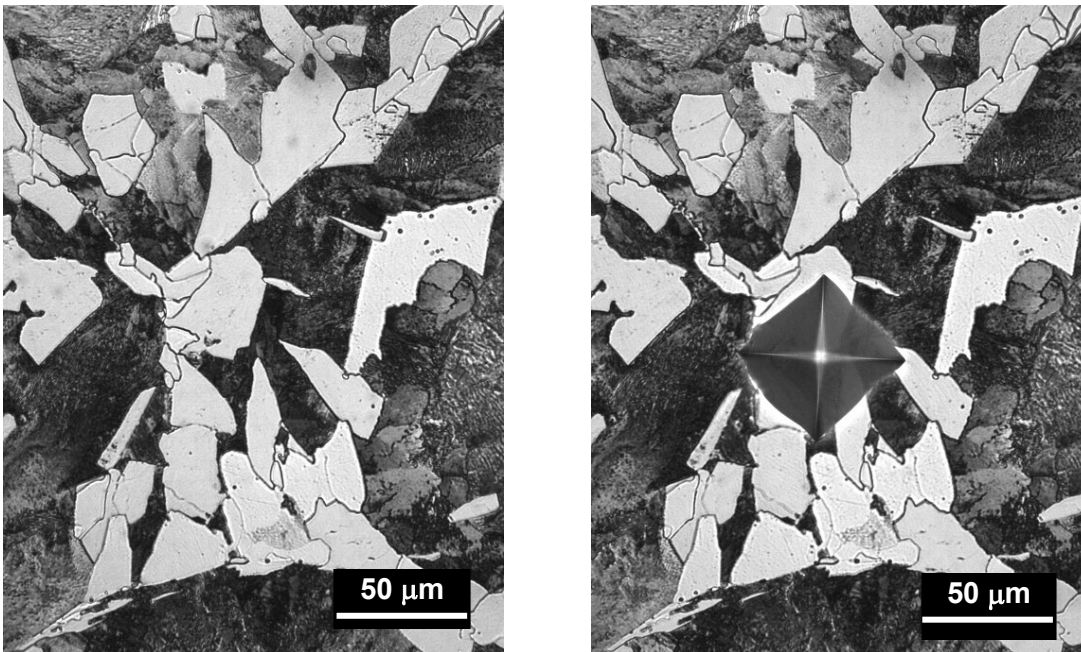
Figure 36. 1D7-3 Sample ID B2 microstructure prior to indentation (left) and with the Vickers microindentation (right). 5% Nital etch. 40x magnification. Ferrite/pearlite dominant.

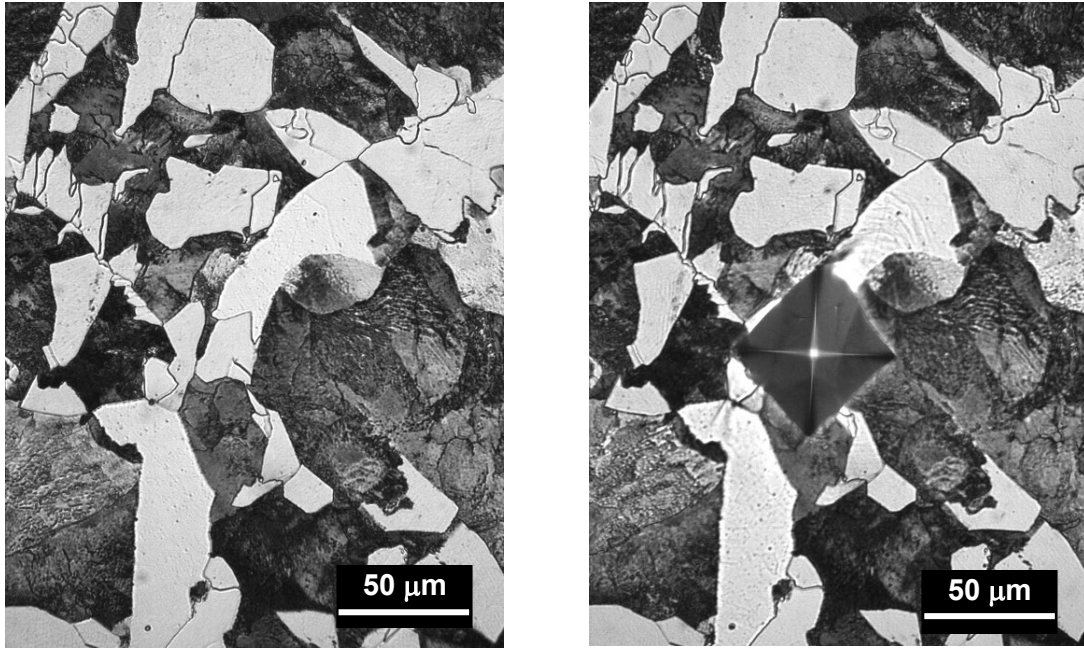
Figure 37. 1D7-3 Sample ID B3 microstructure prior to indentation (left) and with the Vickers microindentation (right). 5% Nital etch. 40x magnification. Ferrite/pearlite dominant.

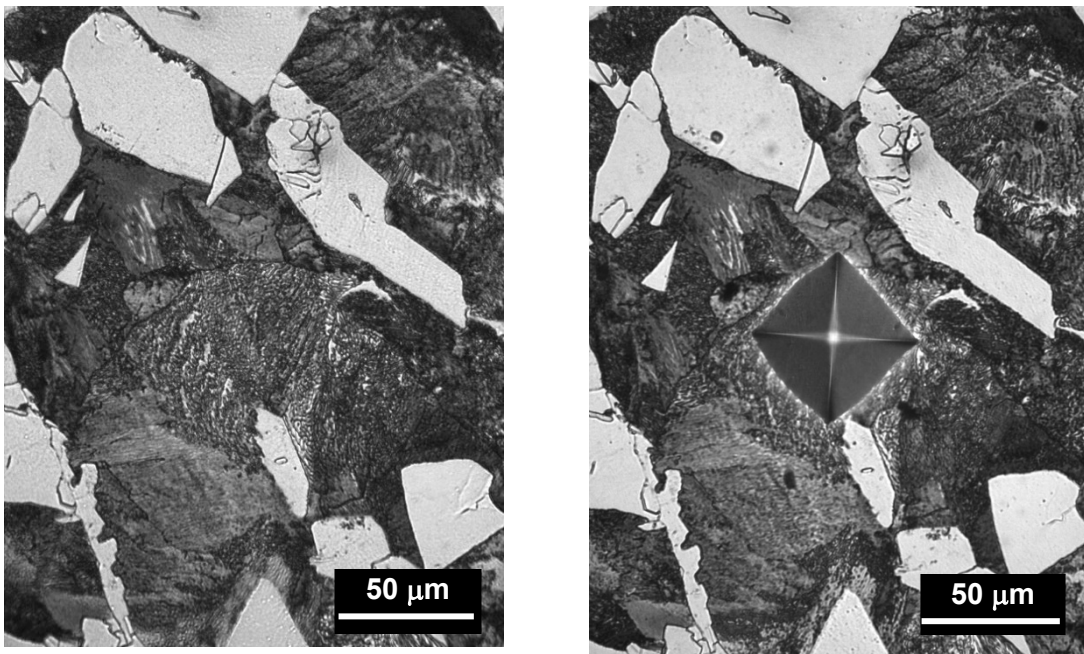
Figure 38. 1D7-3 Sample ID B4 microstructure prior to indentation (left) and with the Vickers microindentation (right). 5% Nital etch. 40x magnification. Ferrite/pearlite dominant.

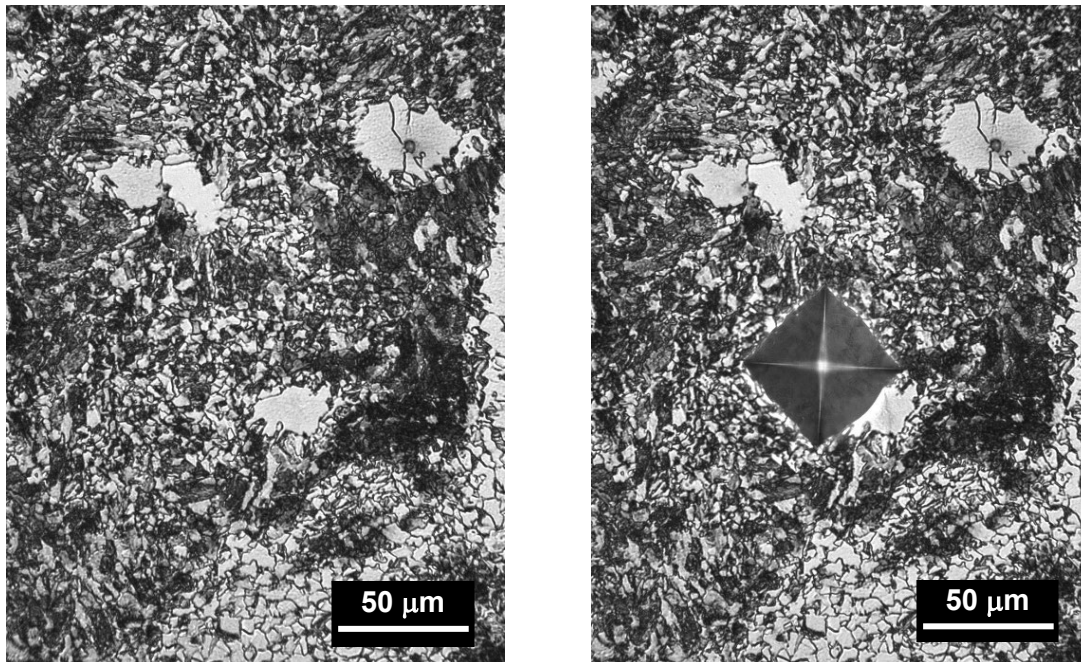
Figure 39. 1D7-3 Sample ID H1 microstructure prior to indentation (left) and with the Vickers microindentation (right). 5% Nital etch. 40x magnification. Refined ferrite/pearlite from the heat cycle.

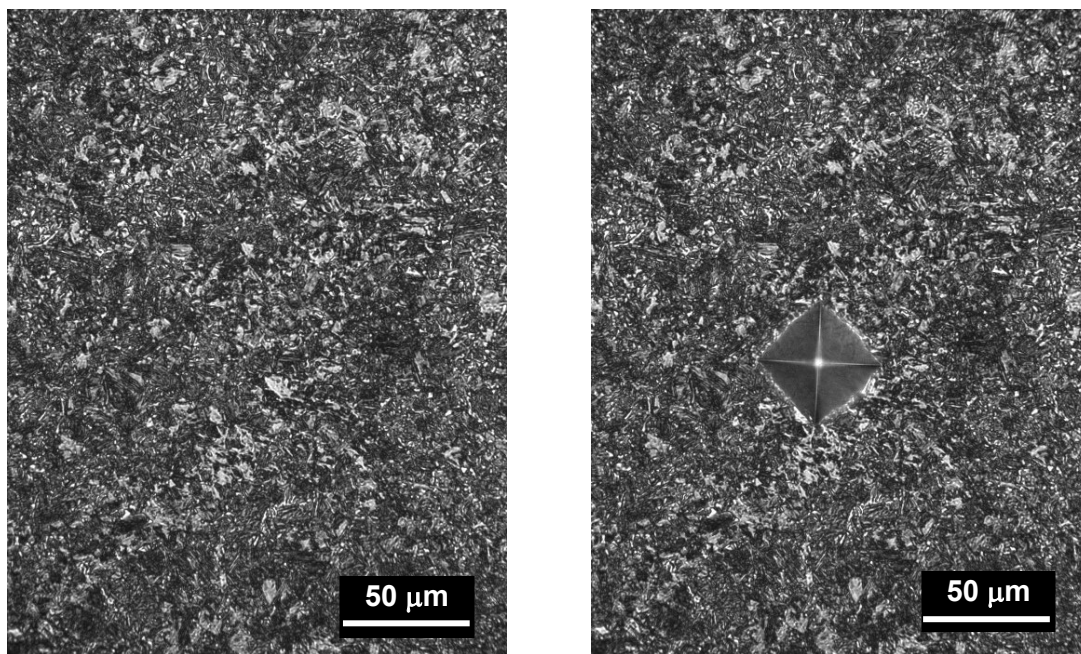
Figure 40. 1D7-3 Sample ID H2 microstructure prior to indentation (left) and with the Vickers microindentation (right). 5% Nital etch. 40x magnification. Martensite dominant.

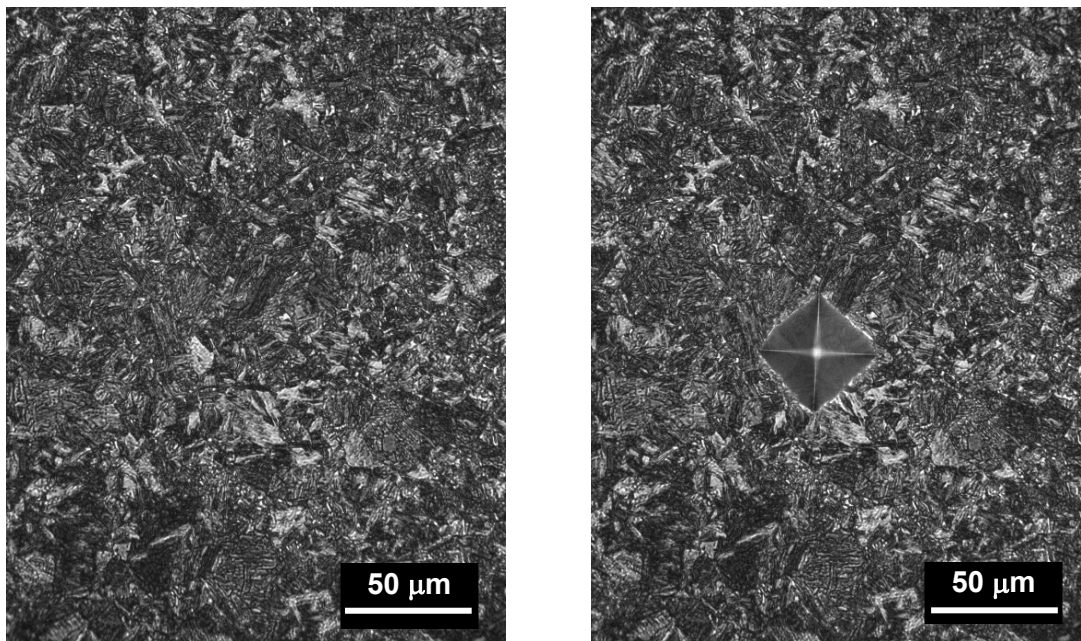
Figure 41. 1D7-3 Sample ID H3 microstructure prior to indentation (left) and with the Vickers microindentation (right). 5% Nital etch. 40x magnification. Martensite dominant.

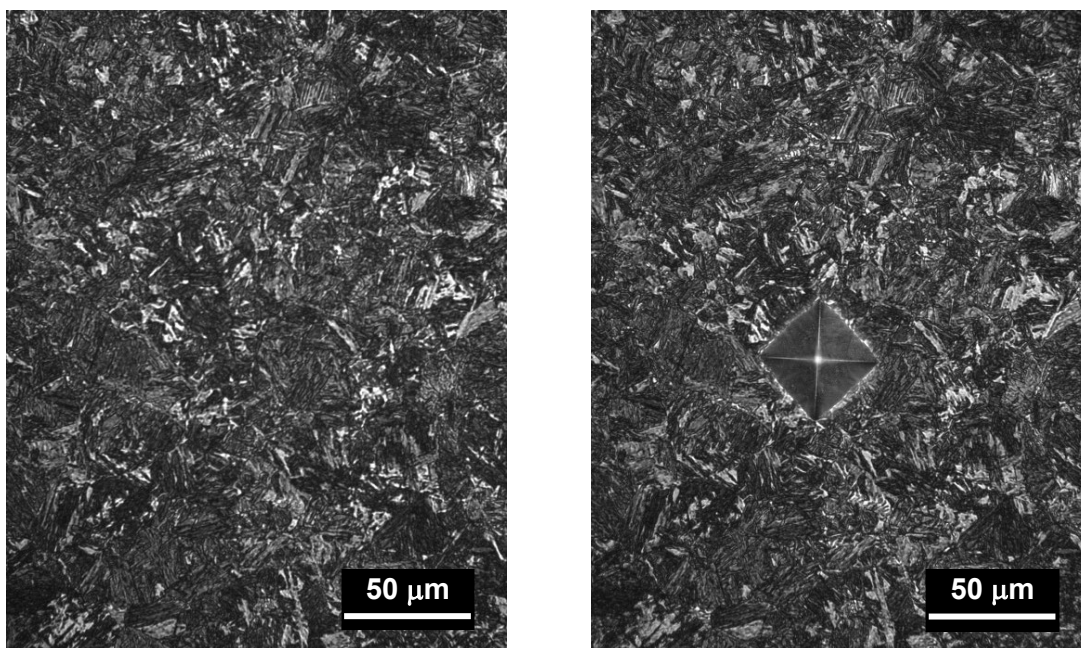
Figure 42. 1D7-3 Sample ID H4 microstructure prior to indentation (left) and with the Vickers microindentation (right). 5% Nital etch. 40x magnification. Martensite dominant.

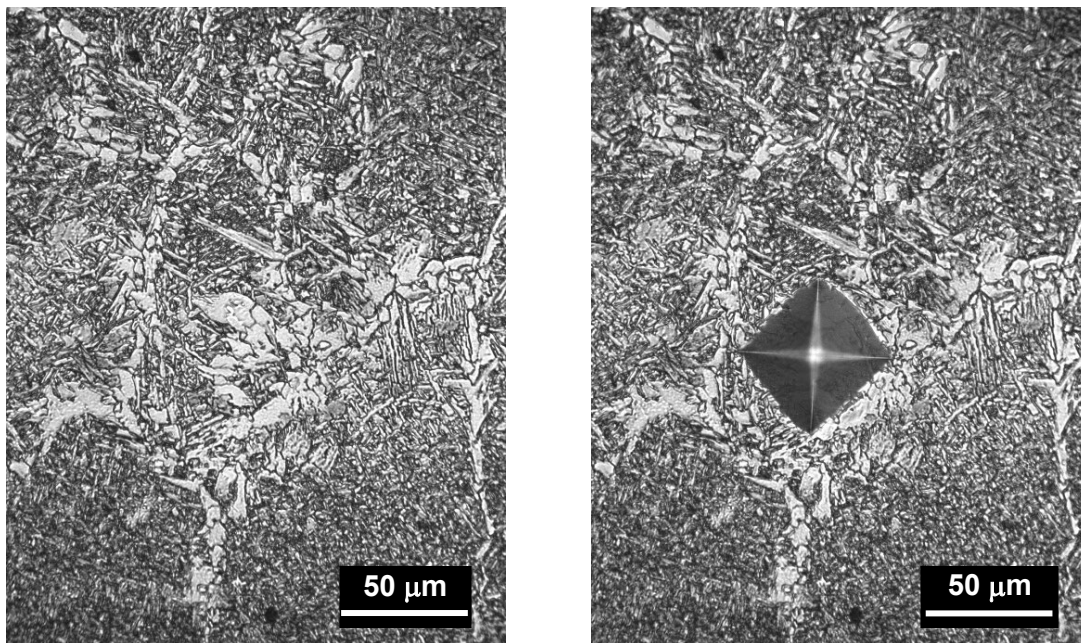
Figure 43. 1D7-3 Sample ID W1 microstructure prior to indentation (left) and with the Vickers microindentation (right). 5% Nital etch. 40x magnification. Acicular ferrite with proeutectoid ferrite and Widmanstätten ferrite.

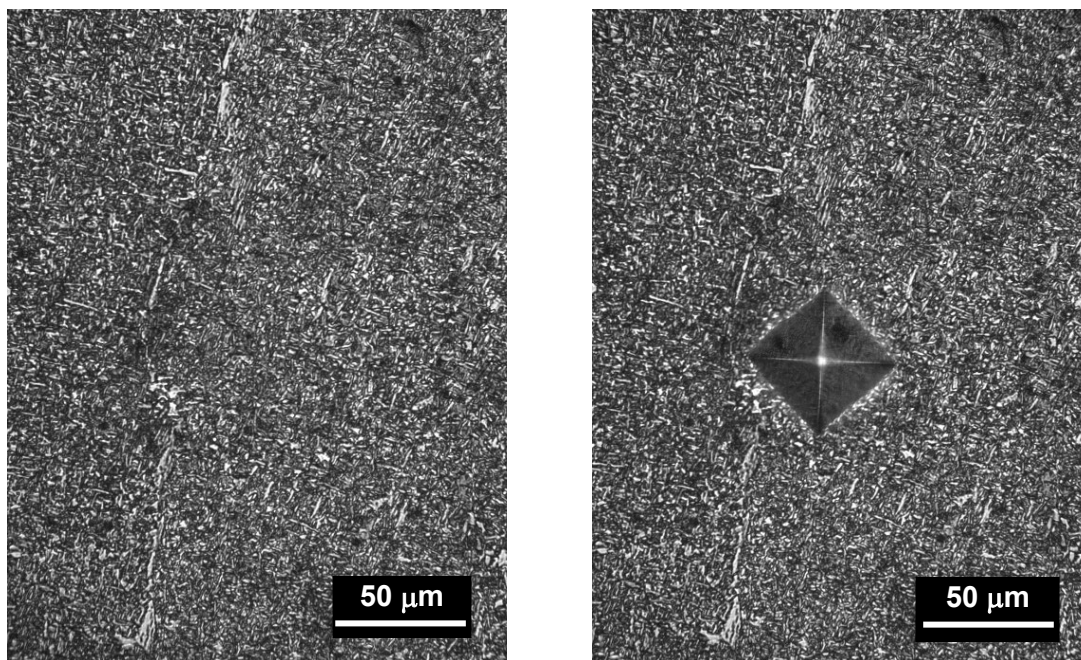
Figure 44. 1D7-3 Sample ID W2 microstructure prior to indentation (left) and with the Vickers microindentation (right). 5% Nital etch. 40x magnification. Acicular ferrite.

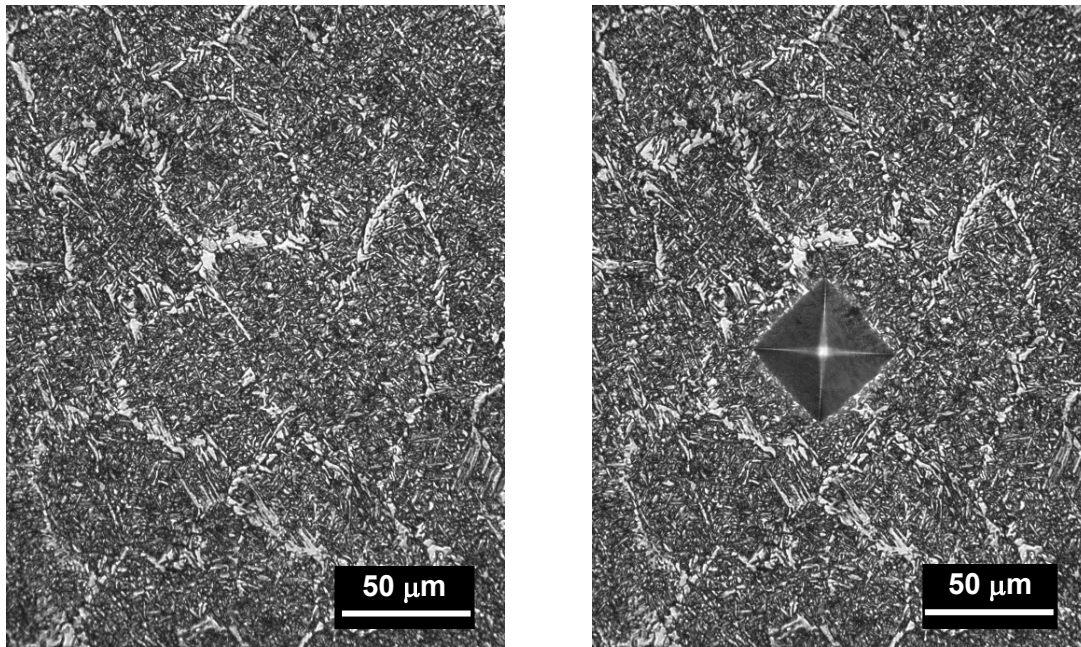
Figure 45. 1D7-3 Sample ID W3 microstructure prior to indentation (left) and with the Vickers microindentation (right). 5% Nital etch. 40x magnification. Acicular ferrite and martensite with some proeutectoid ferrite and Widmanstätten ferrite.

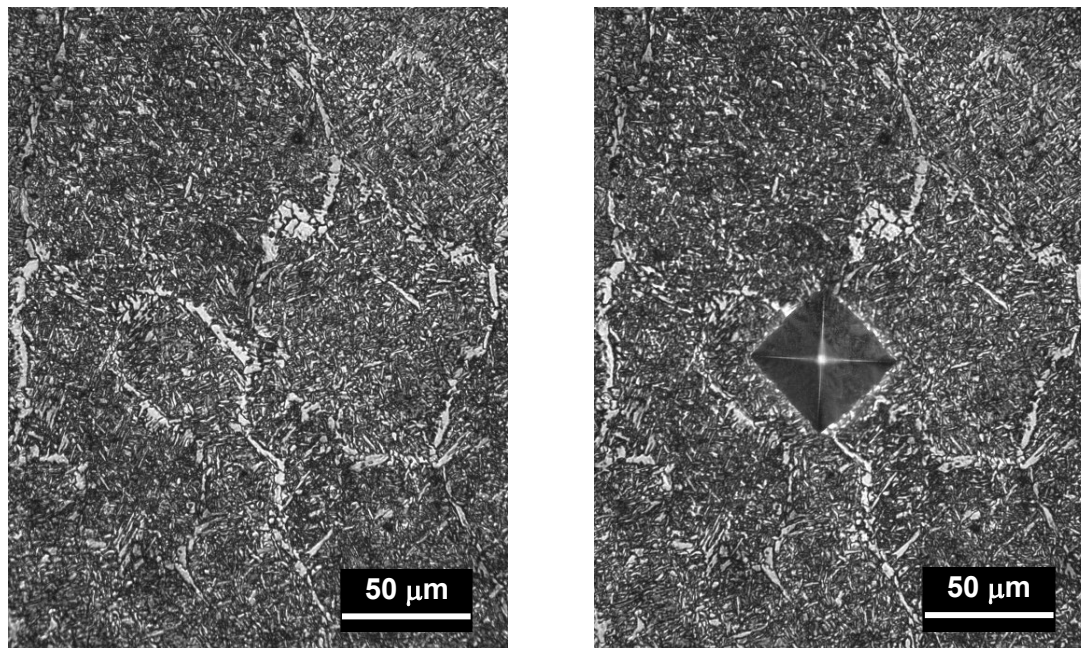
Figure 46. 1D7-3 Sample ID W4 microstructure prior to indentation (left) and with the Vickers microindentation (right). 5% Nital etch. 40x magnification. Acicular ferrite and martensite with some proeutectoid ferrite and Widmanstätten ferrite.

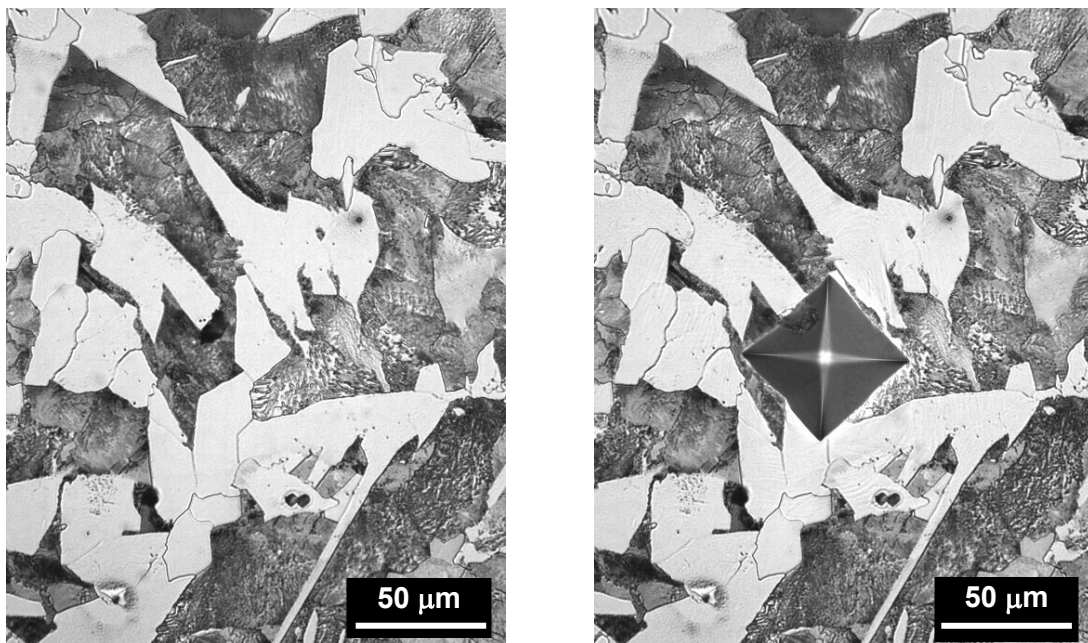
Figure 47. 1E7-1 Sample ID B1 microstructure prior to indentation (left) and with the Vickers microindentation (right). 5% Nital etch. 40x magnification. Ferrite/pearlite dominant.

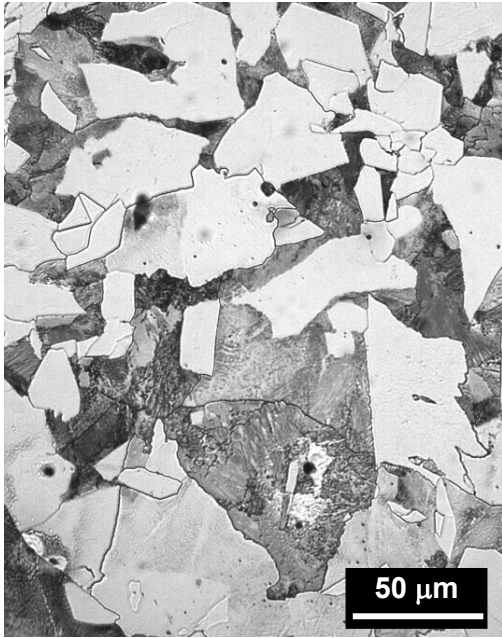
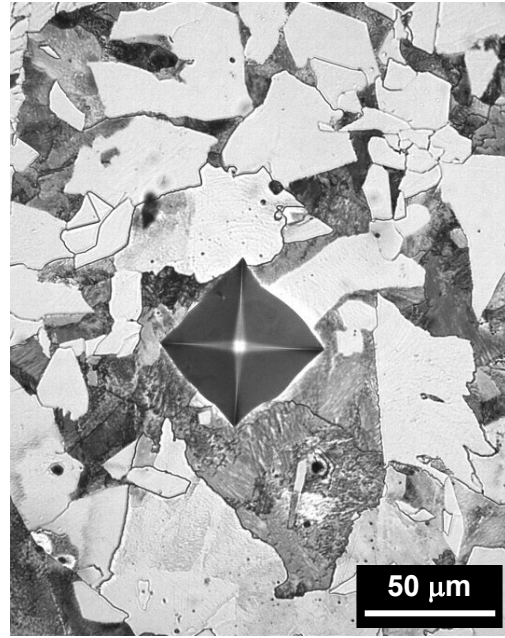
Figure 48. 1E7-1 Sample ID B2 microstructure prior to indentation (left) and with the Vickers microindentation (right). 5% Nital etch. 40x magnification. Ferrite/pearlite dominant.

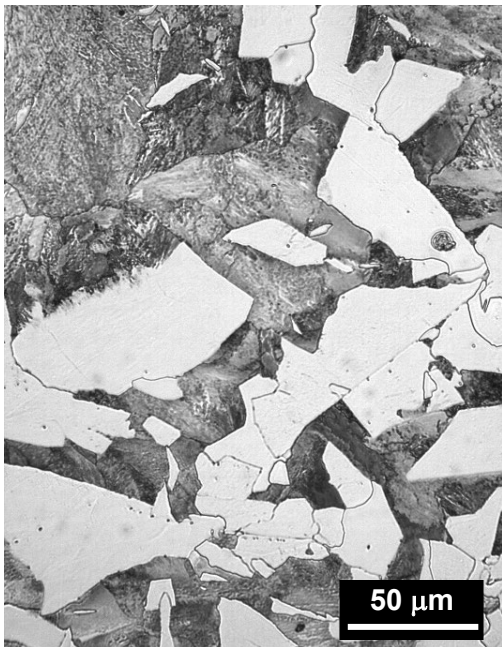
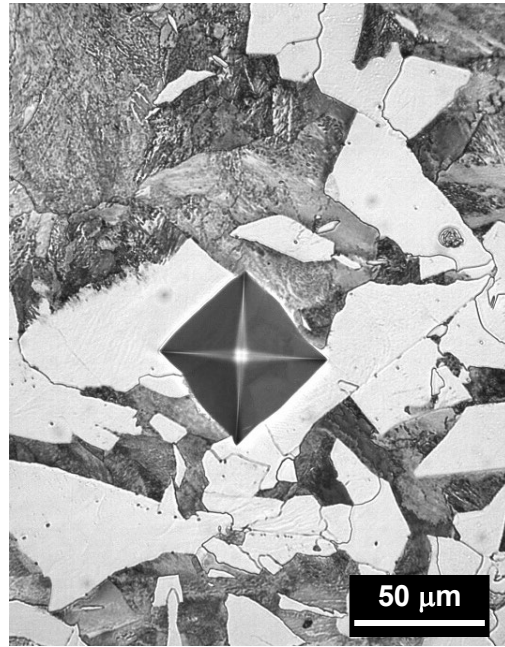
Figure 49. 1E7-1 Sample ID B3 microstructure prior to indentation (left) and with the Vickers microindentation (right). 5% Nital etch. 40x magnification. Ferrite/pearlite dominant.

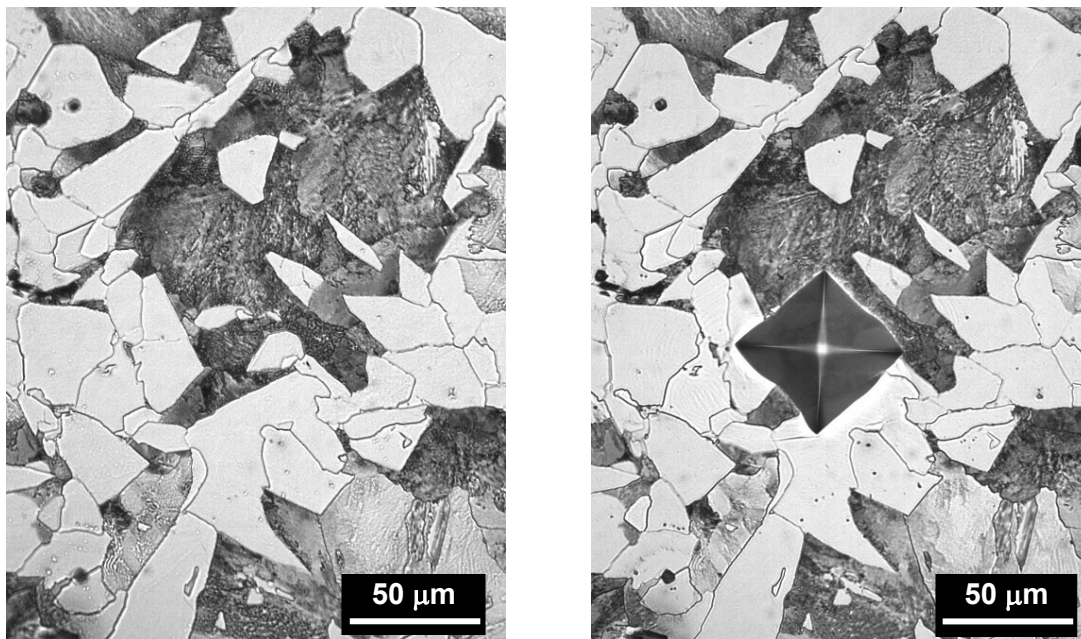
Figure 50. 1E7-1 Sample ID B4 microstructure prior to indentation (left) and with the Vickers microindentation (right). 5% Nital etch. 40x magnification. Ferrite/pearlite dominant.

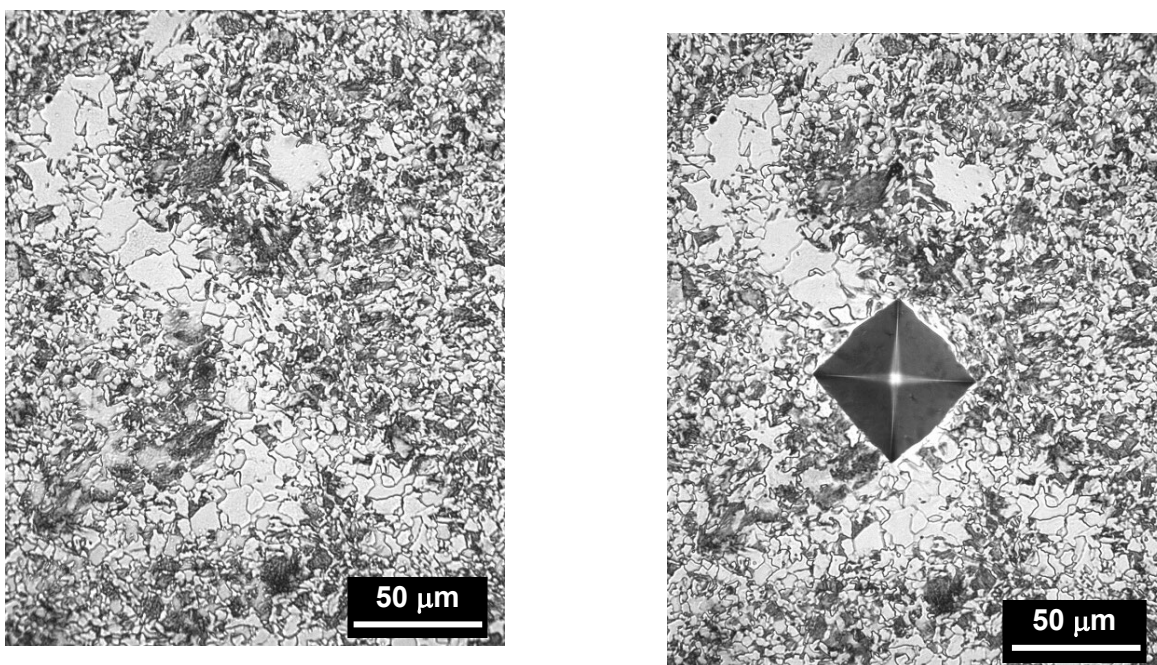
Figure 51. 1E7-1 Sample ID H1 microstructure prior to indentation (left) and with the Vickers microindentation (right). 5% Nital etch. 40x magnification. Refined ferrite/pearlite from the heat cycle.

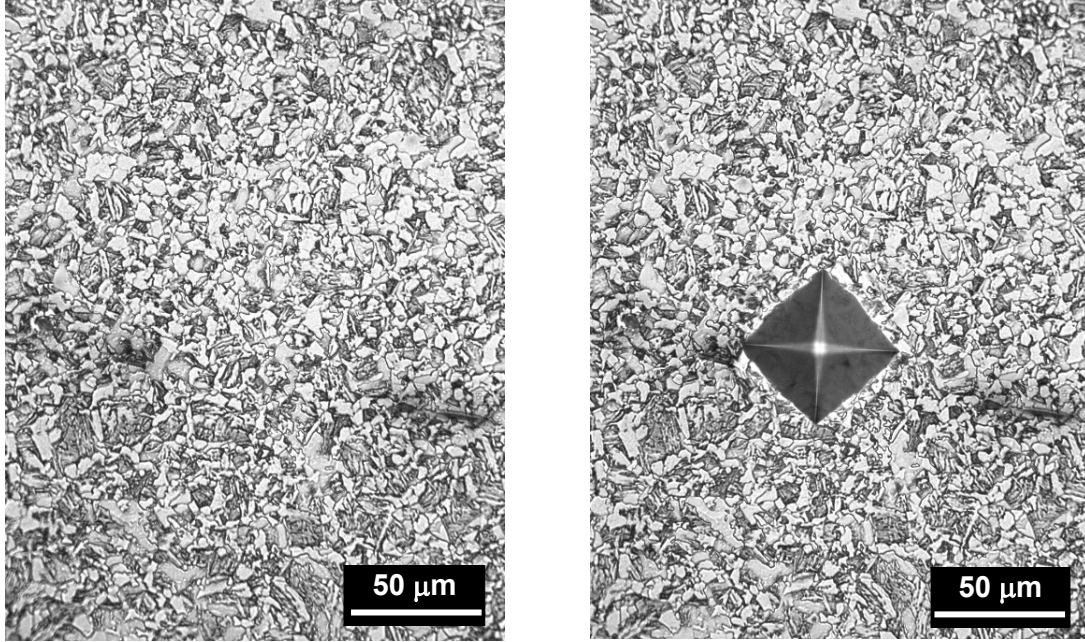
Figure 52. 1E7-1 Sample ID H2 microstructure prior to indentation (left) and with the Vickers microindentation (right). 5% Nital etch. 40x magnification. Refined ferrite/pearlite from the heat cycle.

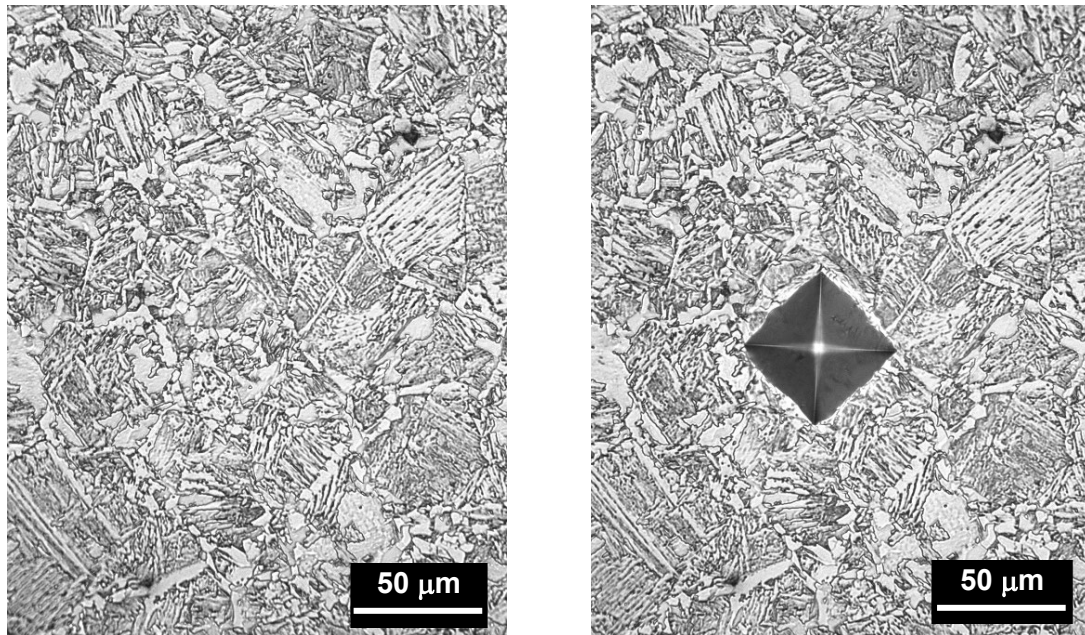
Figure 53. 1E7-1 Sample ID H3 microstructure prior to indentation (left) and with the Vickers microindentation (right). 5% Nital etch. 40x magnification. Ferrite and martensite.

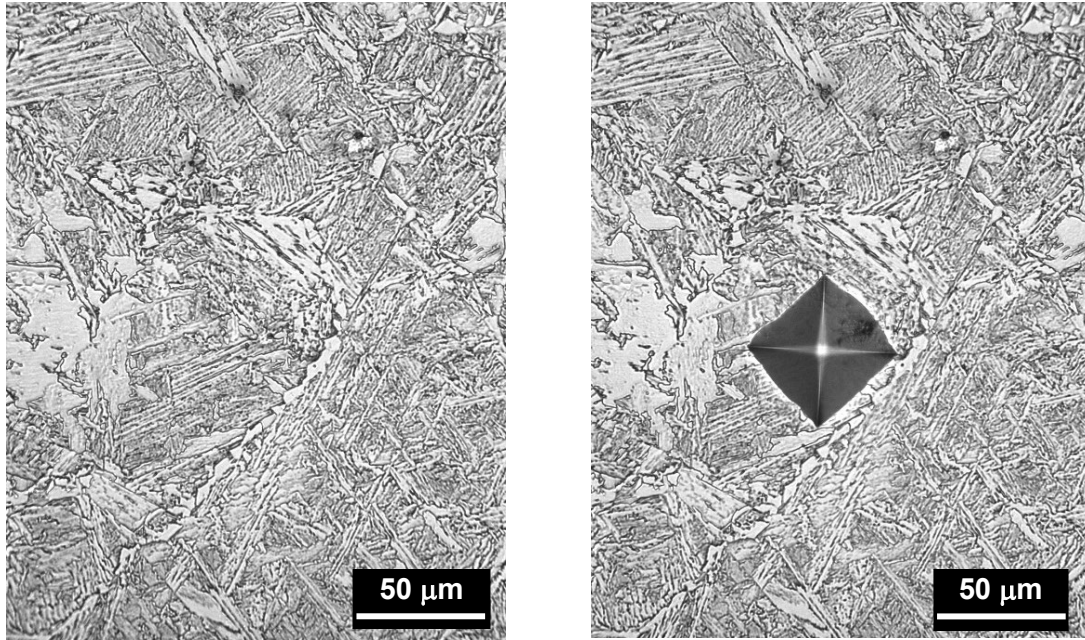
Figure 54. 1E7-1 Sample ID H4 microstructure prior to indentation (left) and with the Vickers microindentation (right). 5% Nital etch. 40x magnification. Ferrite and martensite.
