National Transportation Safety Board

Office of Research and Engineering

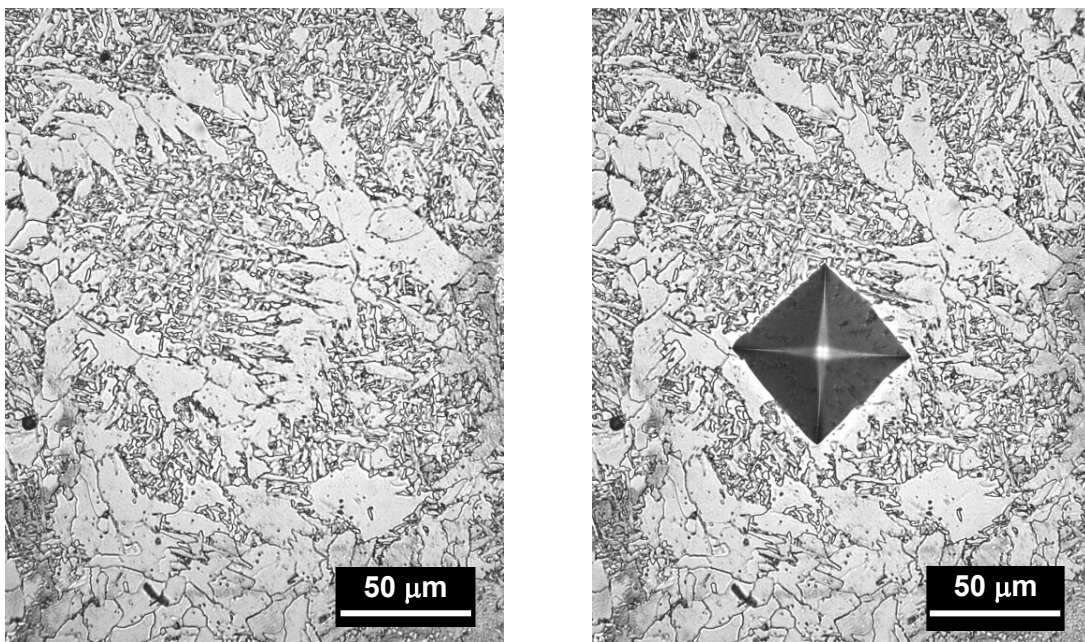
Figure 55. 1E7-1 Sample ID W1 microstructure prior to indentation (left) and with the Vickers microindentation (right). 5% Nital etch. 40x magnification. Proeutectoid and acicular ferrite.

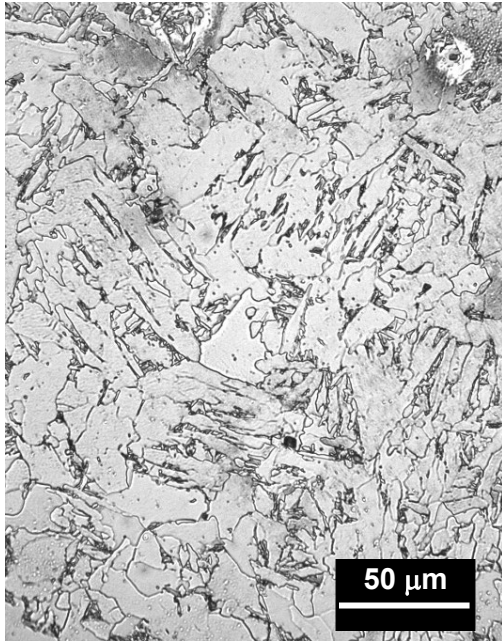
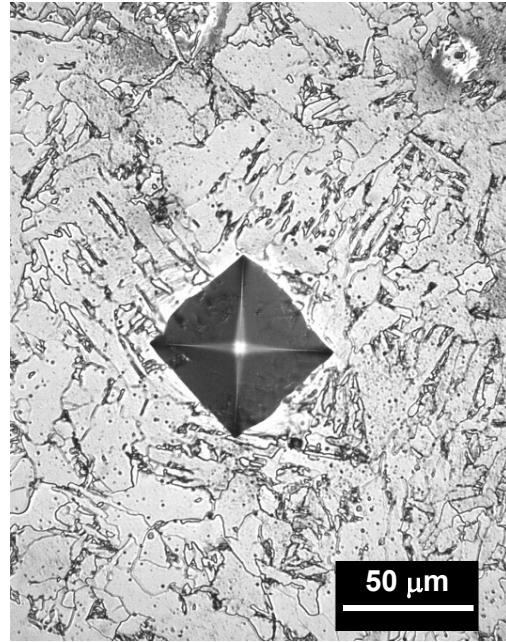
Figure 56. 1E7-1 Sample ID W2 microstructure prior to indentation (left) and with the Vickers microindentation (right). 5% Nital etch. 40x magnification. Refined ferrite dominant.

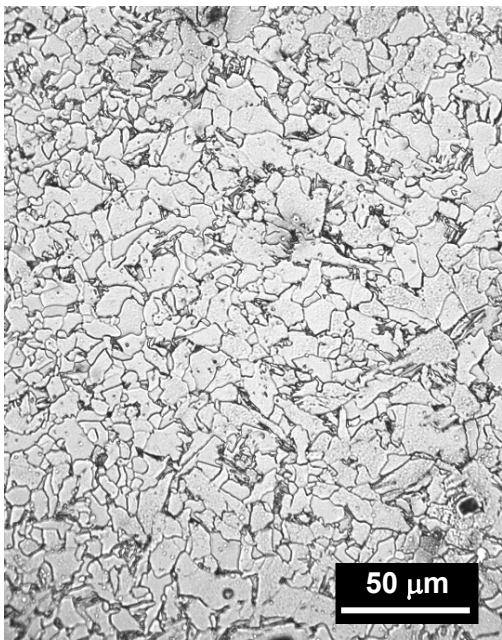
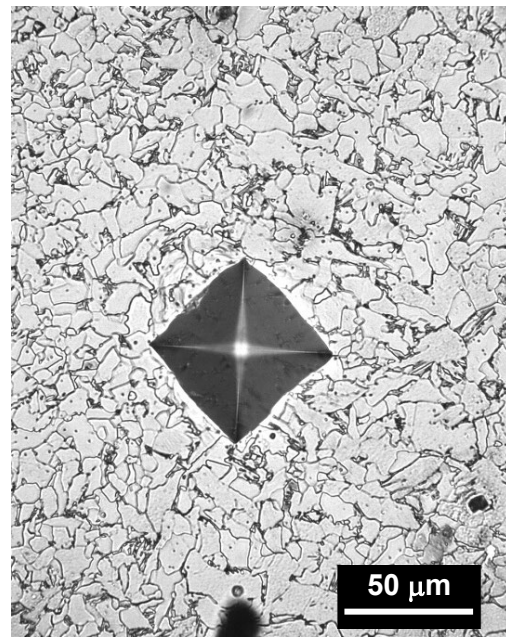
Figure 57. 1E7-1 Sample ID W3 microstructure prior to indentation (left) and with the Vickers microindentation (right). 5% Nital etch. 40x magnification. Refined ferrite dominant.

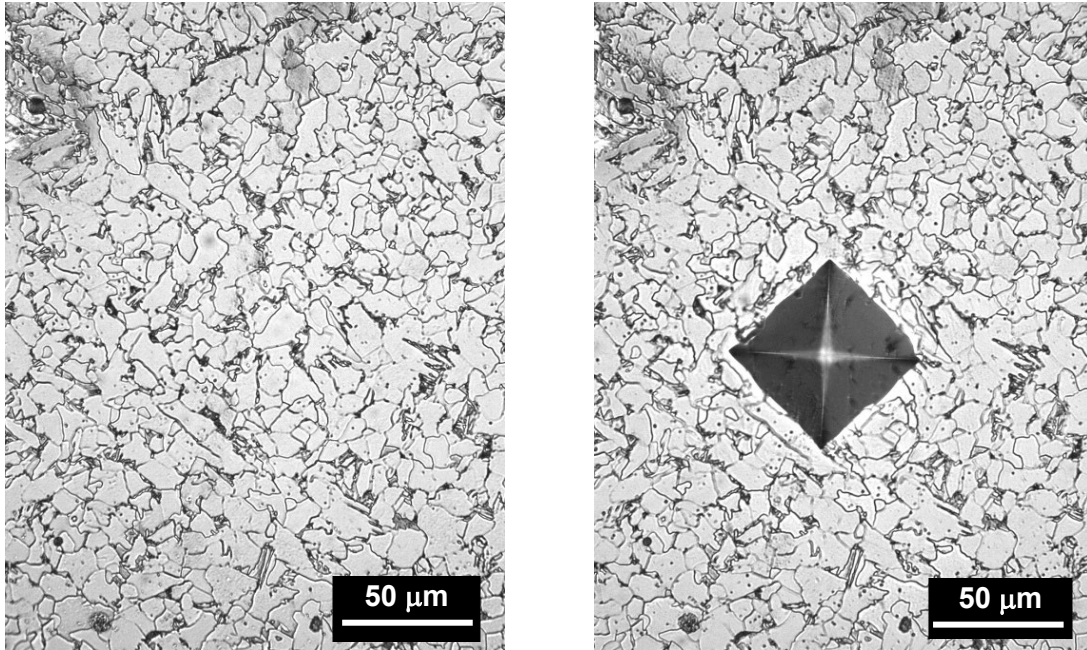
Figure 58. 1E7-1 Sample ID W4 microstructure prior to indentation (left) and with the Vickers microindentation (right). 5% Nital etch. 40x magnification. Refined ferrite dominant.

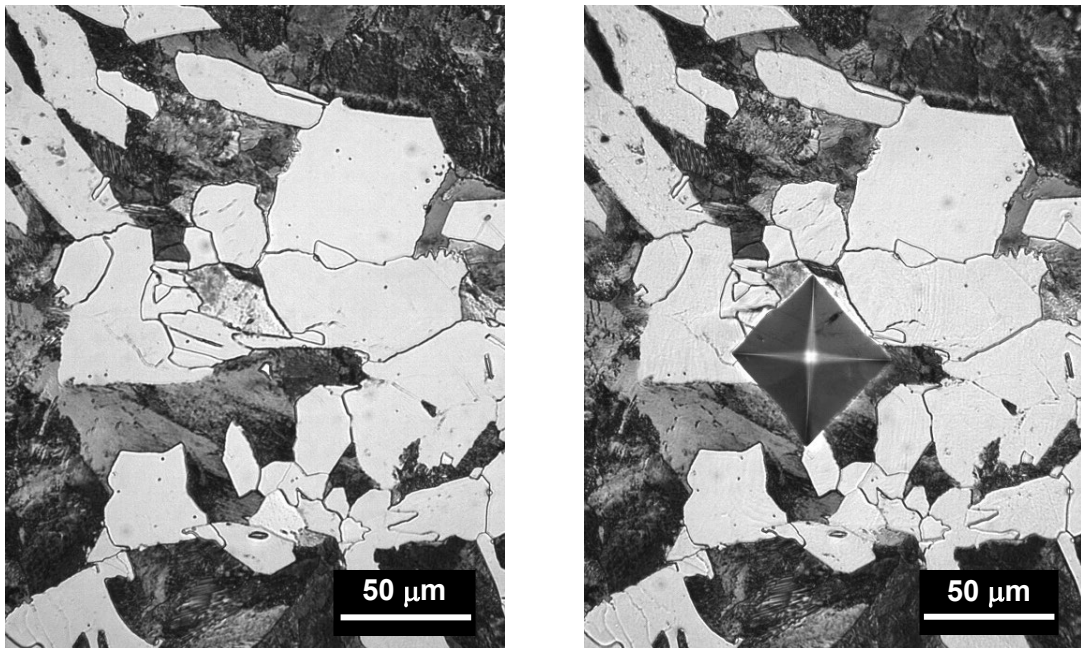
Figure 59. 1E7-2 Sample ID B1 microstructure prior to indentation (left) and with the Vickers microindentation (right). 5% Nital etch. 40x magnification. Ferrite/pearlite dominant.

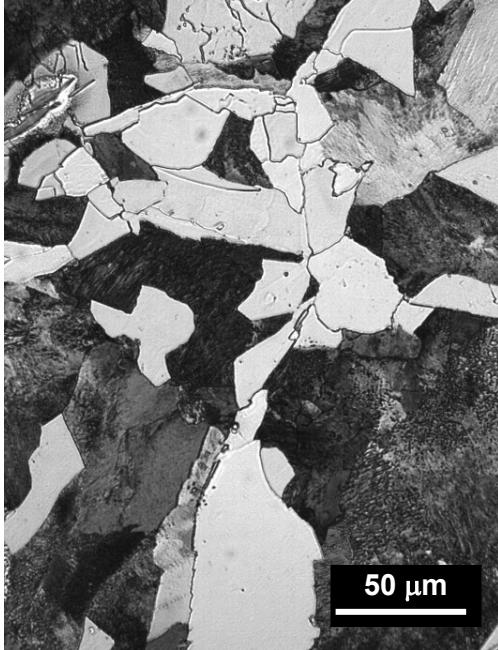
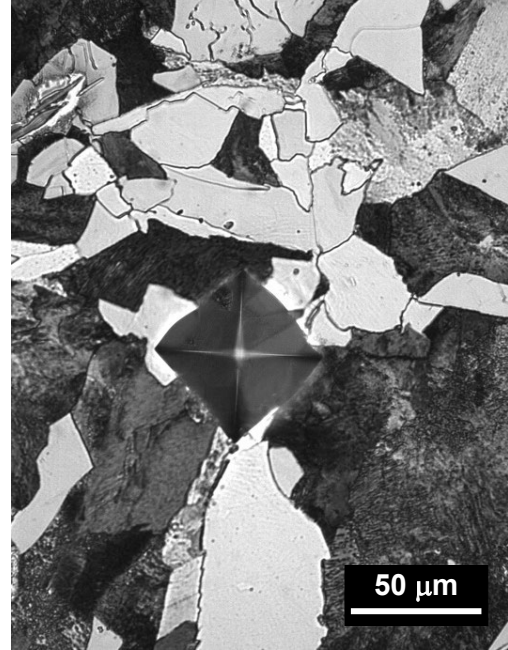
Figure 60. 1E7-2 Sample ID B2 microstructure prior to indentation (left) and with the Vickers microindentation (right). 5% Nital etch. 40x magnification. Ferrite/pearlite dominant.

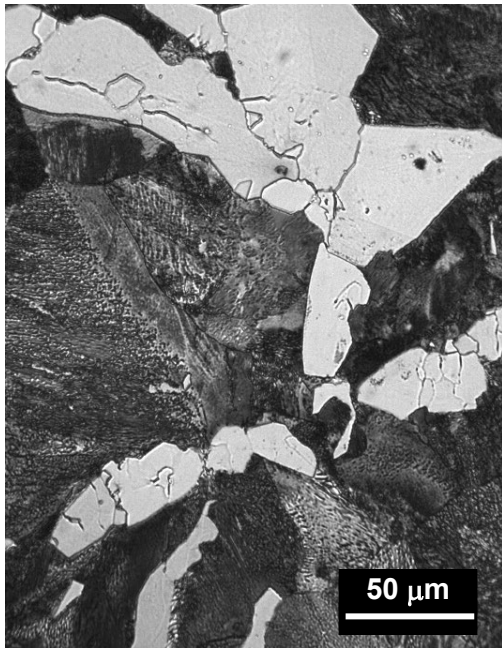
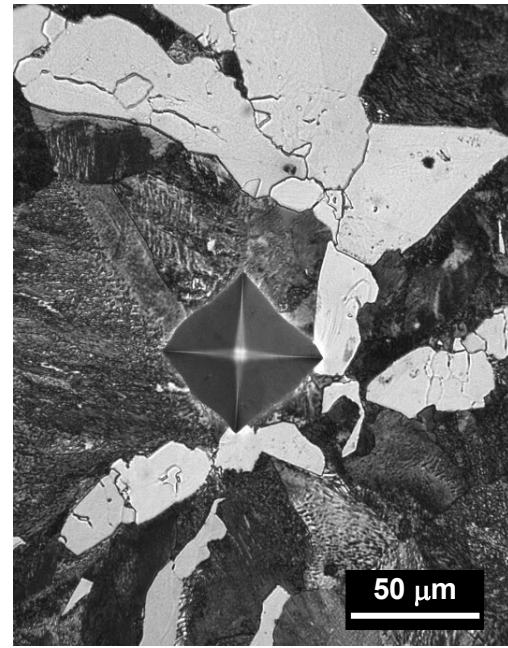
Figure 61. 1E7-2 Sample ID B3 microstructure prior to indentation (left) and with the Vickers microindentation (right). 5% Nital etch. 40x magnification. Ferrite/pearlite dominant.

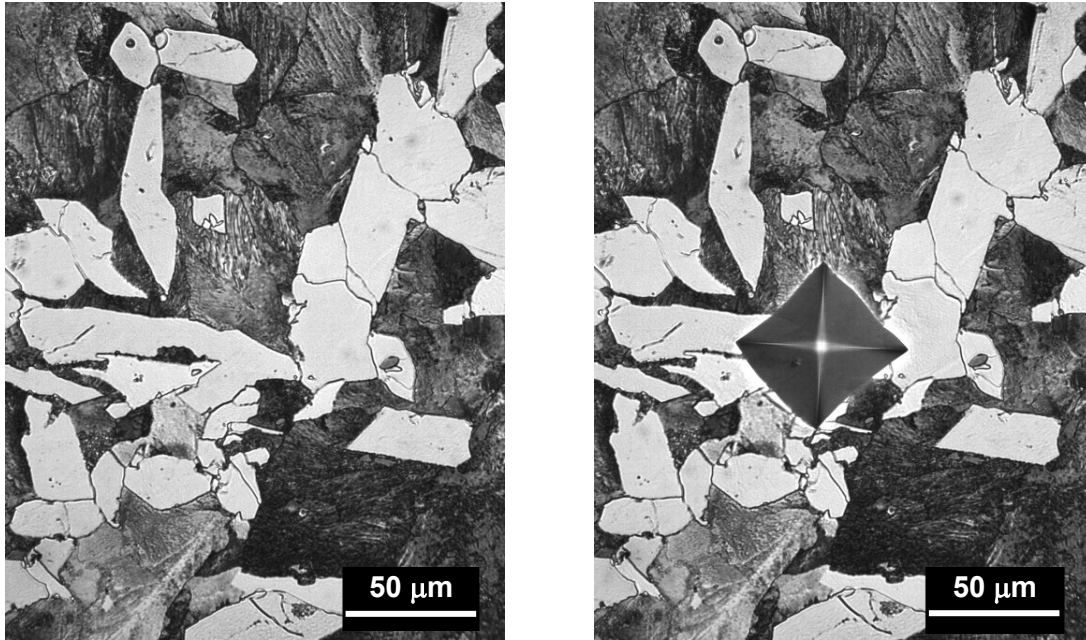
Figure 62. 1E7-2 Sample ID B4 microstructure prior to indentation (left) and with the Vickers microindentation (right). 5% Nital etch. 40x magnification. Ferrite/pearlite dominant.

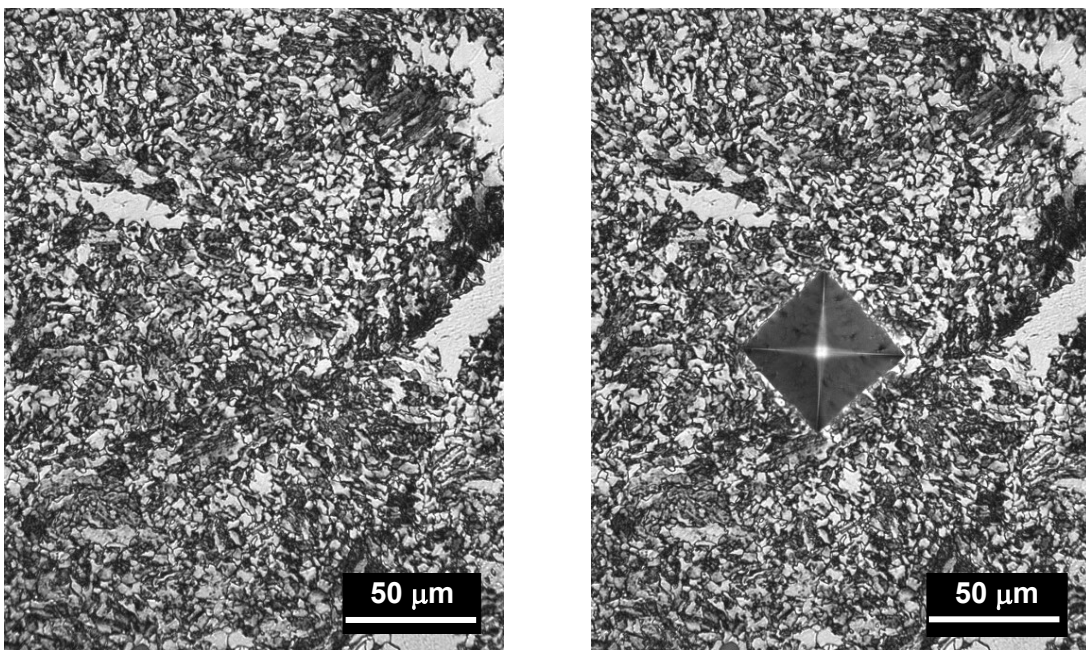
Figure 63. 1E7-2 Sample ID H1 microstructure prior to indentation (left) and with the Vickers microindentation (right). 5% Nital etch. 40x magnification. Refined ferrite/pearlite from the heat cycle.

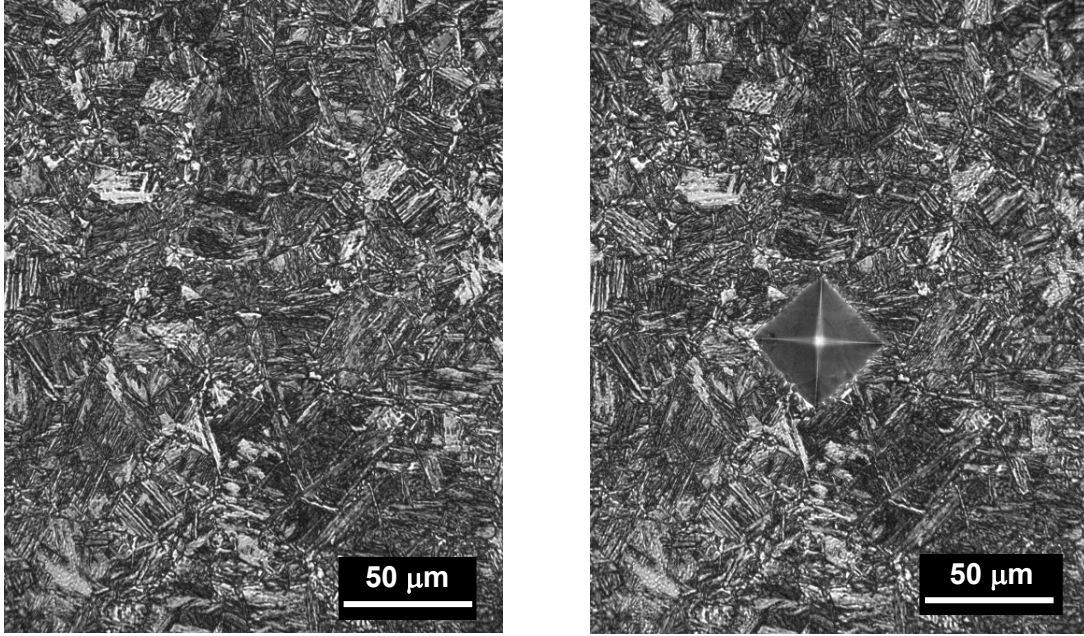
Figure 64. 1E7-2 Sample ID H2 microstructure prior to indentation (left) and with the Vickers microindentation (right). 5% Nital etch. 40x magnification. Martensite dominant.

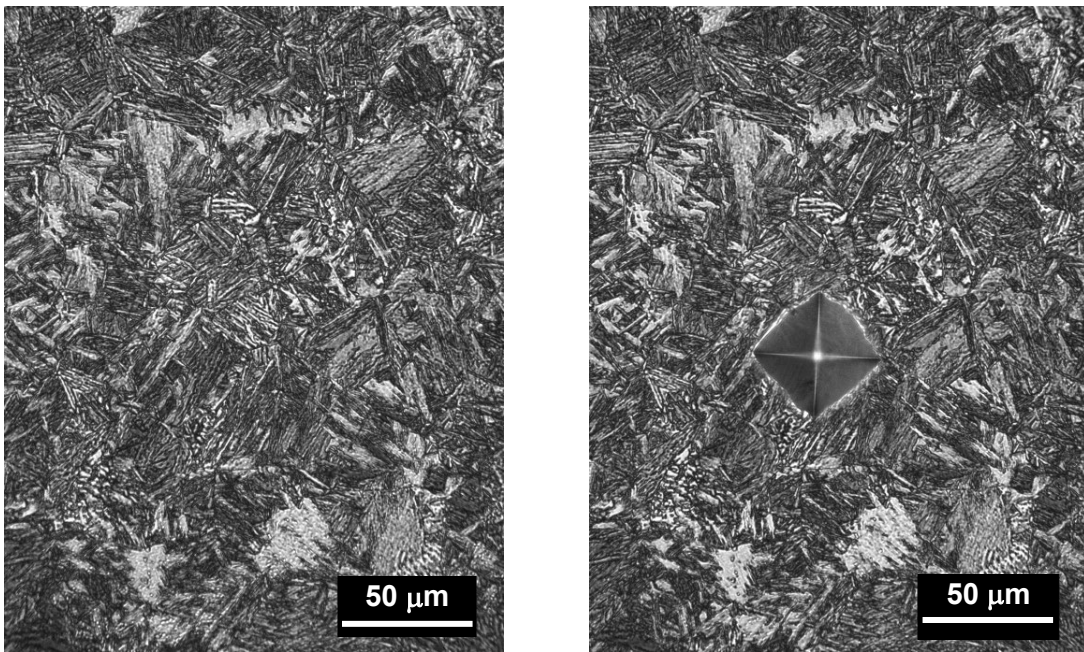
Figure 65. 1E7-2 Sample ID H3 microstructure prior to indentation (left) and with the Vickers microindentation (right). 5% Nital etch. 40x magnification. Martensite dominant.

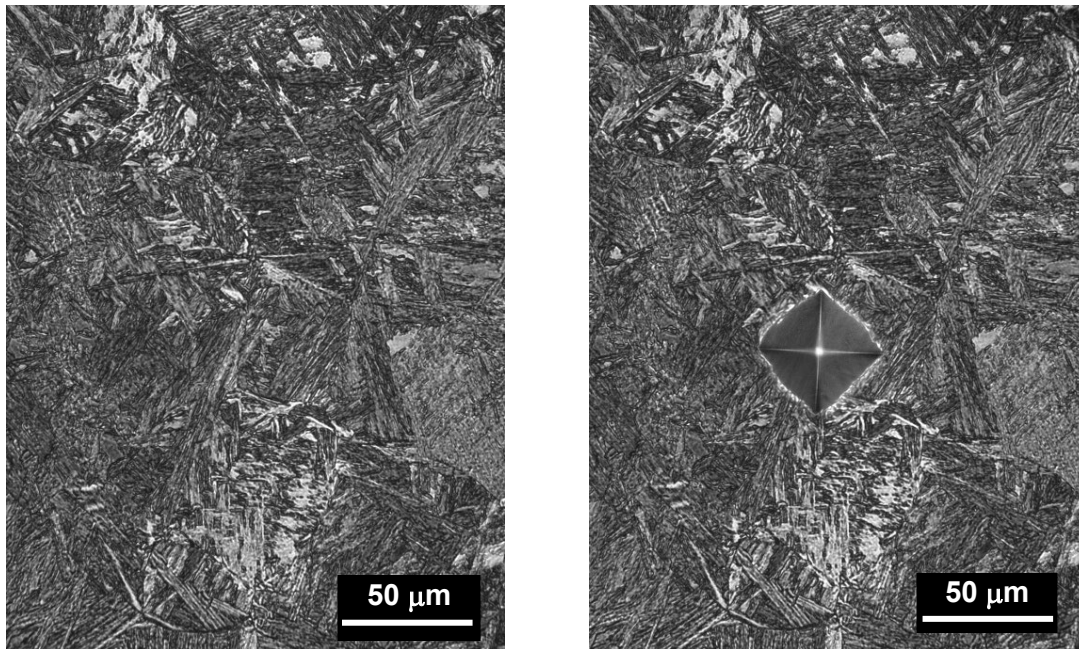
Figure 66. 1E7-2 Sample ID H4 microstructure prior to indentation (left) and with the Vickers microindentation (right). 5% Nital etch. 40x magnification. Martensite dominant.

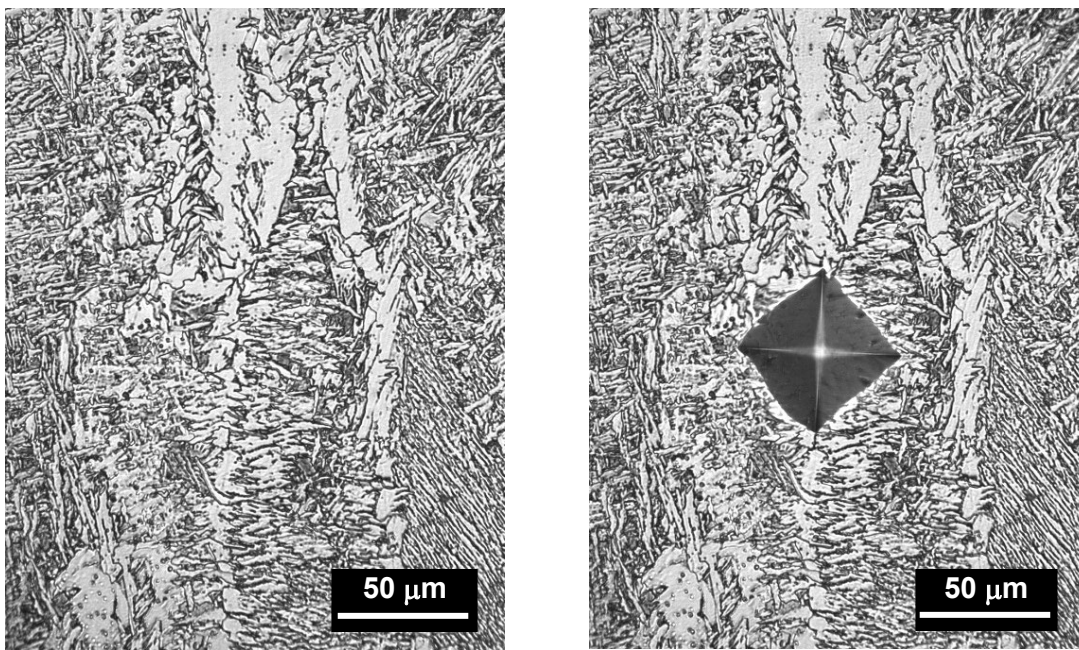
Figure 67. 1E7-2 Sample ID W1 microstructure prior to indentation (left) and with the Vickers microindentation (right). 5% Nital etch. 40x magnification. Acicular ferrite with proeutectoid ferrite and Widmanstätten ferrite.

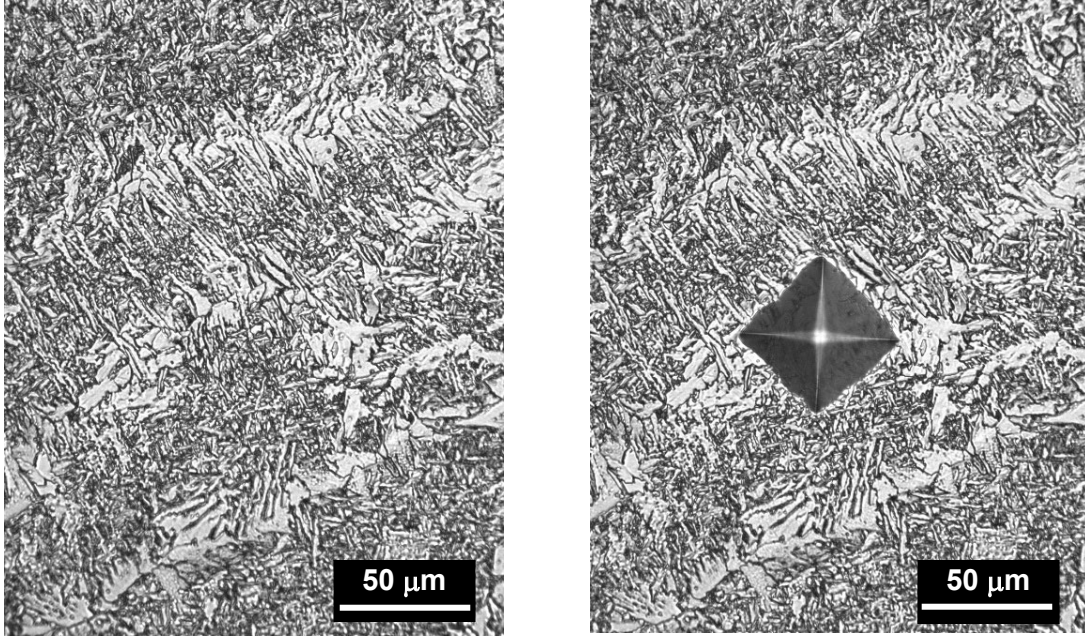
Figure 68. 1E7-2 Sample ID W2 microstructure prior to indentation (left) and with the Vickers microindentation (right). 5% Nital etch. 40x magnification. Acicular ferrite with proeutectoid ferrite and Widmanstätten ferrite.

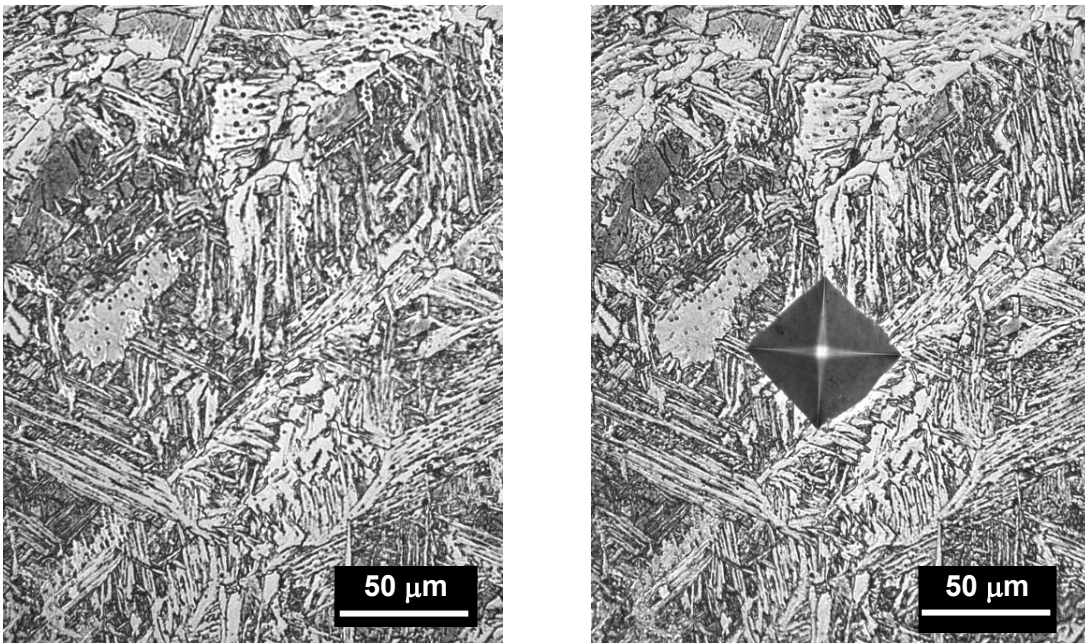
Figure 69. 1E7-2 Sample ID W3 microstructure prior to indentation (left) and with the Vickers microindentation (right). 5% Nital etch. 40x magnification. Acicular ferrite with proeutectoid ferrite and Widmanstätten ferrite.

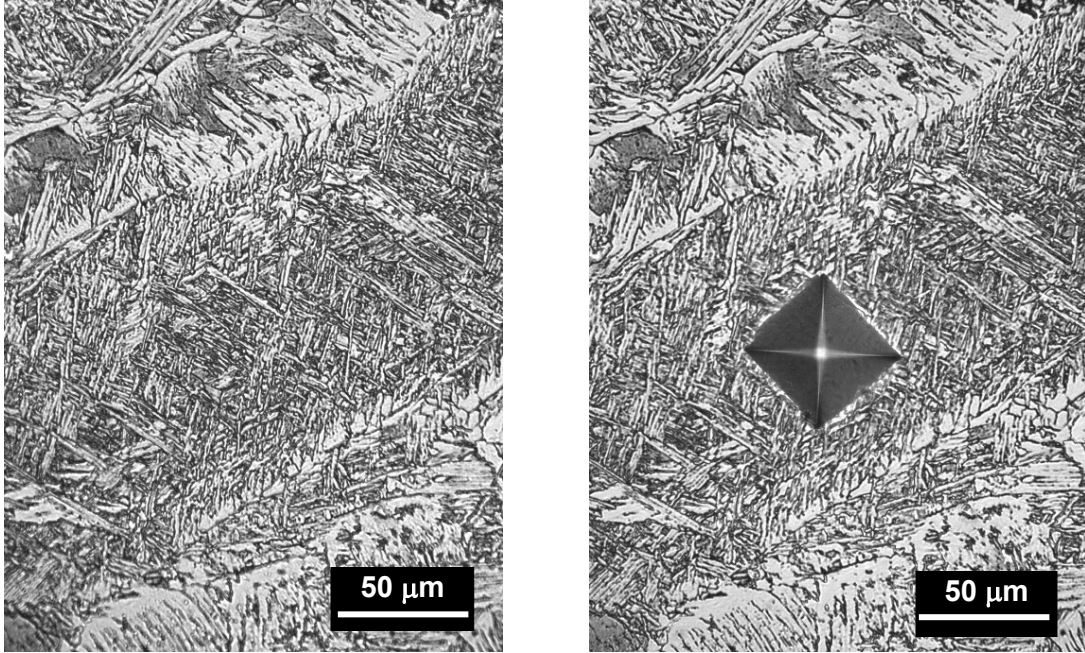
Figure 70. 1E7-2 Sample ID W4 microstructure prior to indentation (left) and with the Vickers microindentation (right). 5% Nital etch. 40x magnification. Acicular ferrite with proeutectoid ferrite and Widmanstätten ferrite.

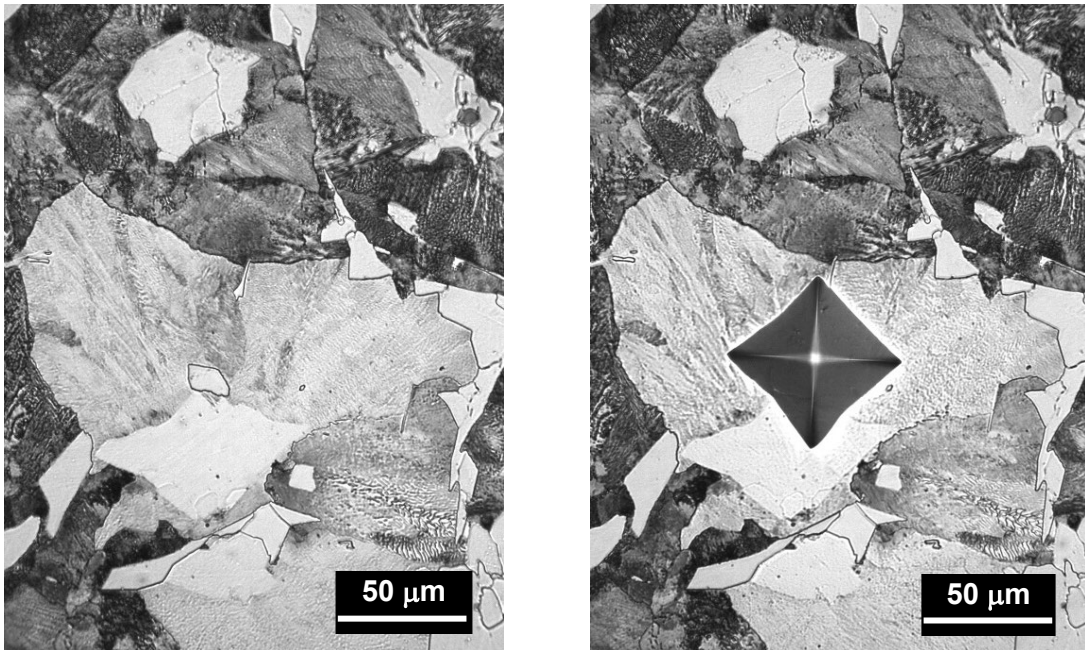
Figure 71. 1E7-3 Sample ID B1 microstructure prior to indentation (left) and with the Vickers microindentation (right). 5% Nital etch. 40x magnification. Ferrite/pearlite dominant.

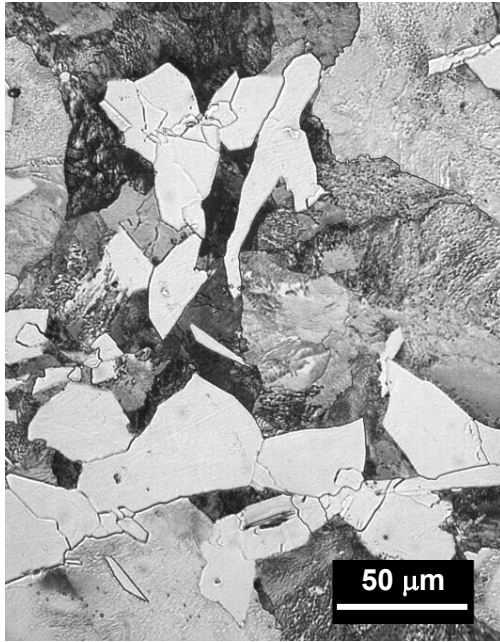
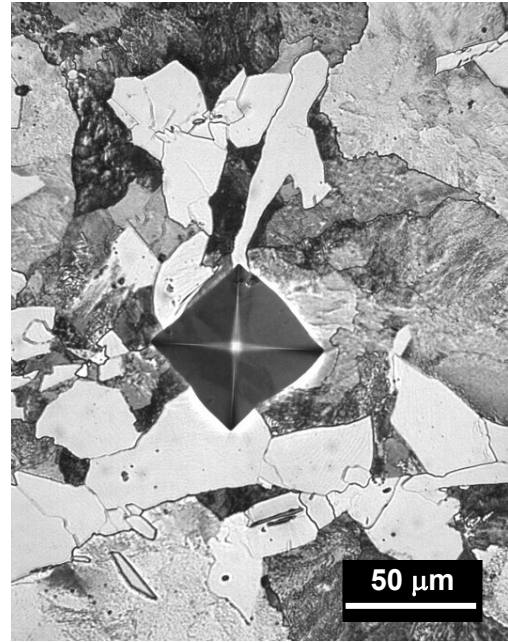
Figure 72. 1E7-3 Sample ID B2 microstructure prior to indentation (left) and with the Vickers microindentation (right). 5% Nital etch. 40x magnification. Ferrite/pearlite dominant.

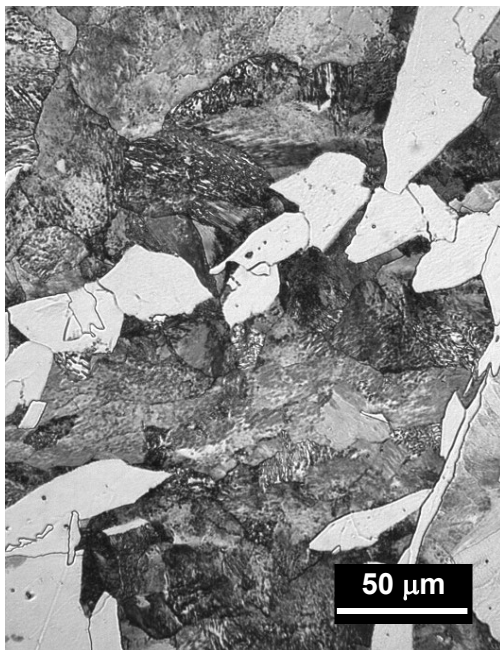
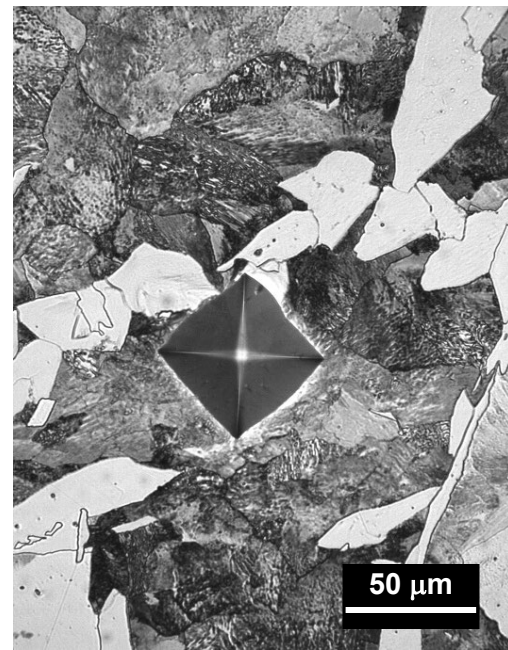
Figure 73. 1E7-3 Sample ID B3 microstructure prior to indentation (left) and with the Vickers microindentation (right). 5% Nital etch. 40x magnification. Ferrite/pearlite dominant.

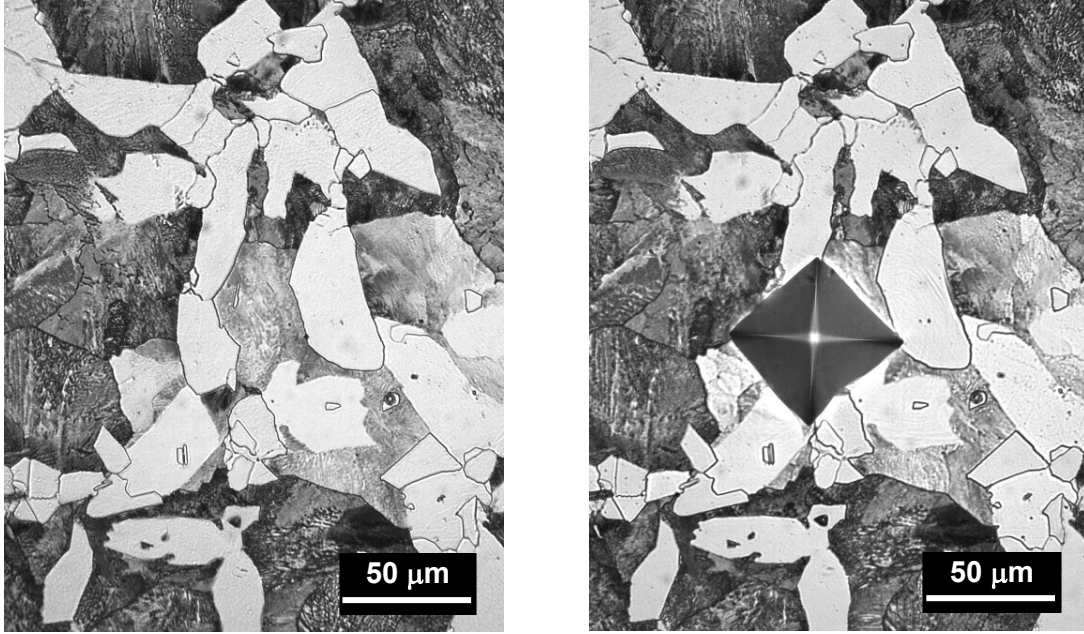
Figure 74. 1E7-3 Sample ID B4 microstructure prior to indentation (left) and with the Vickers microindentation (right). 5% Nital etch. 40x magnification. Ferrite/pearlite dominant.

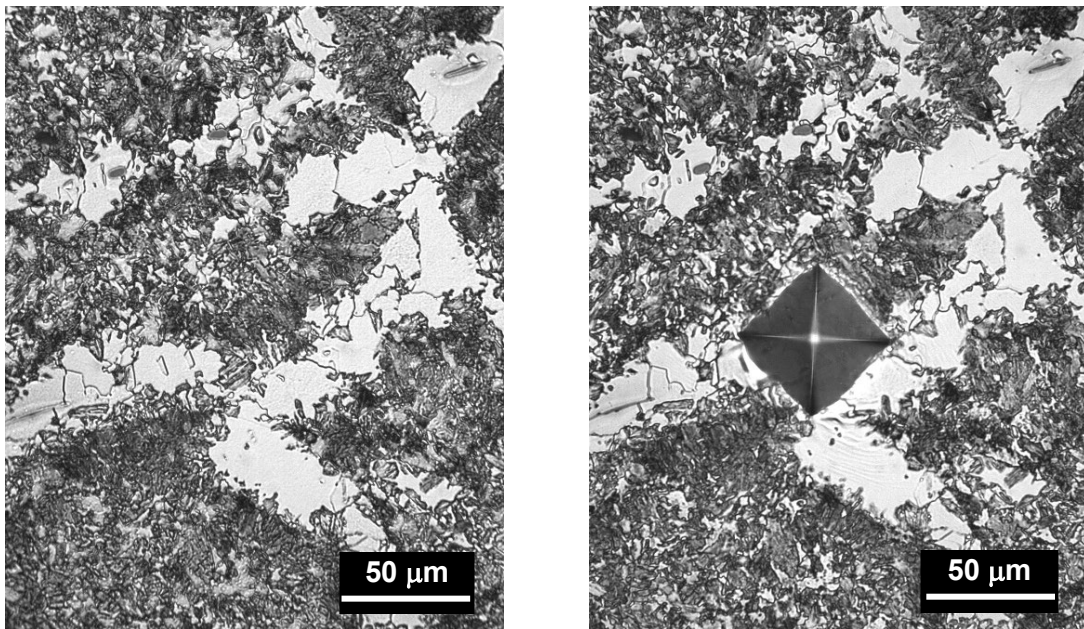
Figure 75. 1E7-3 Sample ID H1 microstructure prior to indentation (left) and with the Vickers microindentation (right). 5% Nital etch. 40x magnification. Refined ferrite/pearlite from the heat cycle.

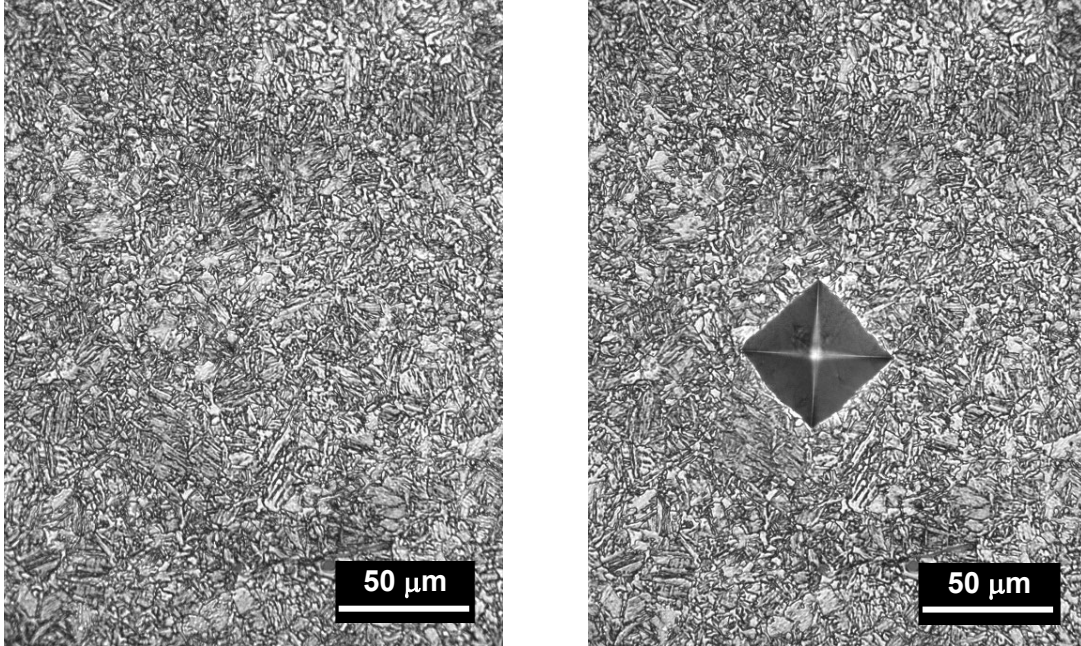
Figure 76. 1E7-3 Sample ID H2 microstructure prior to indentation (left) and with the Vickers microindentation (right). 5% Nital etch. 40x magnification. Ferrite/pearlite and martensite.

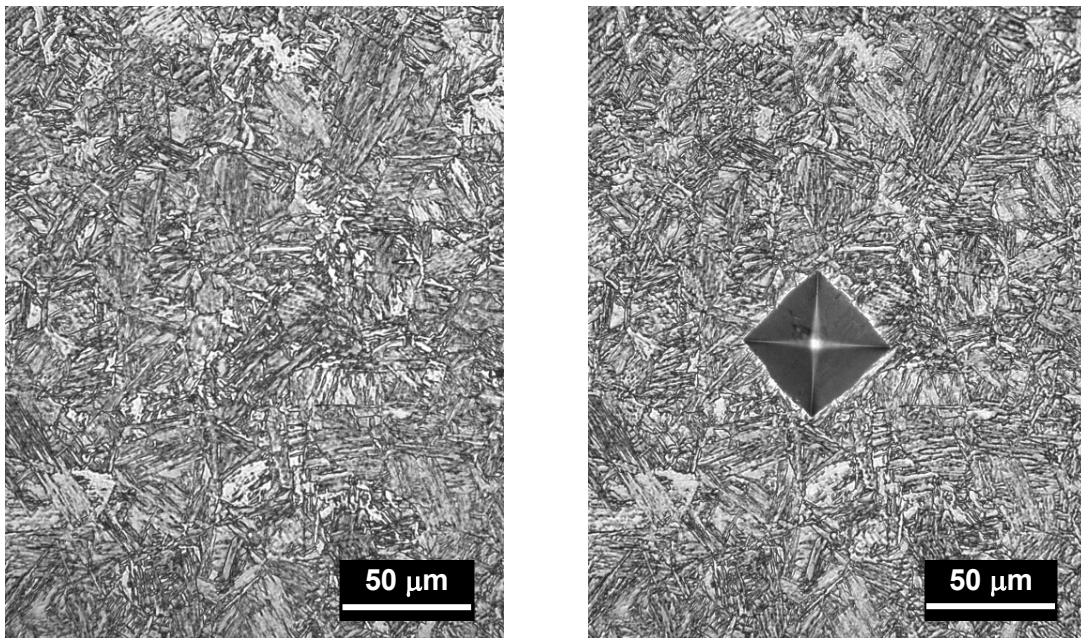
Figure 77. 1E7-3 Sample ID H3 microstructure prior to indentation (left) and with the Vickers microindentation (right). 5% Nital etch. 40x magnification. Ferrite/pearlite and martensite.

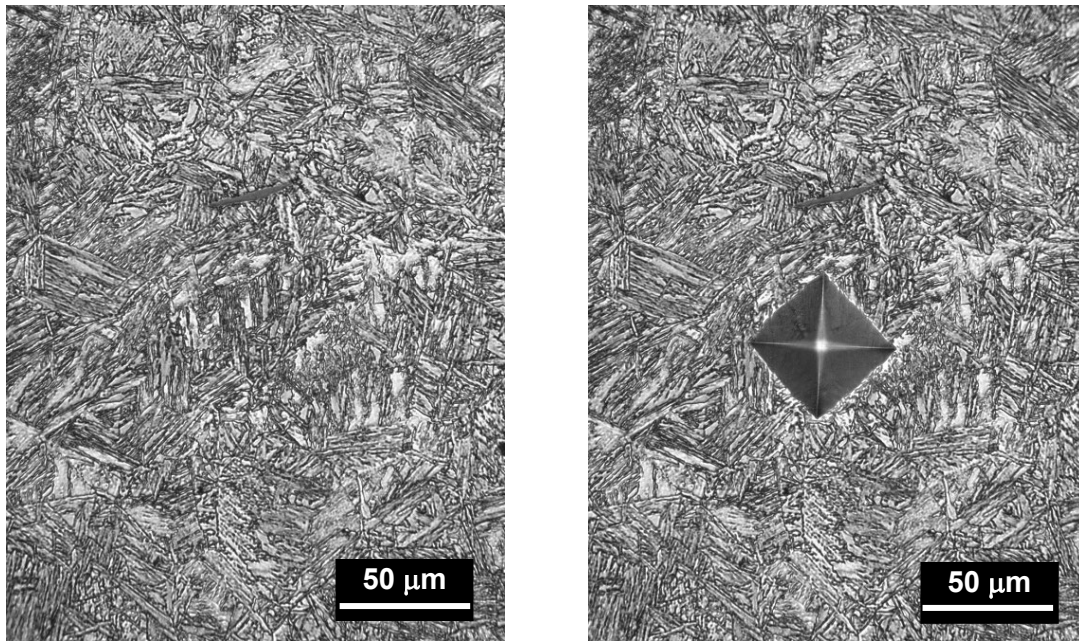
Figure 78. 1E7-3 Sample ID H4 microstructure prior to indentation (left) and with the Vickers microindentation (right). 5% Nital etch. 40x magnification. Ferrite/pearlite and martensite.

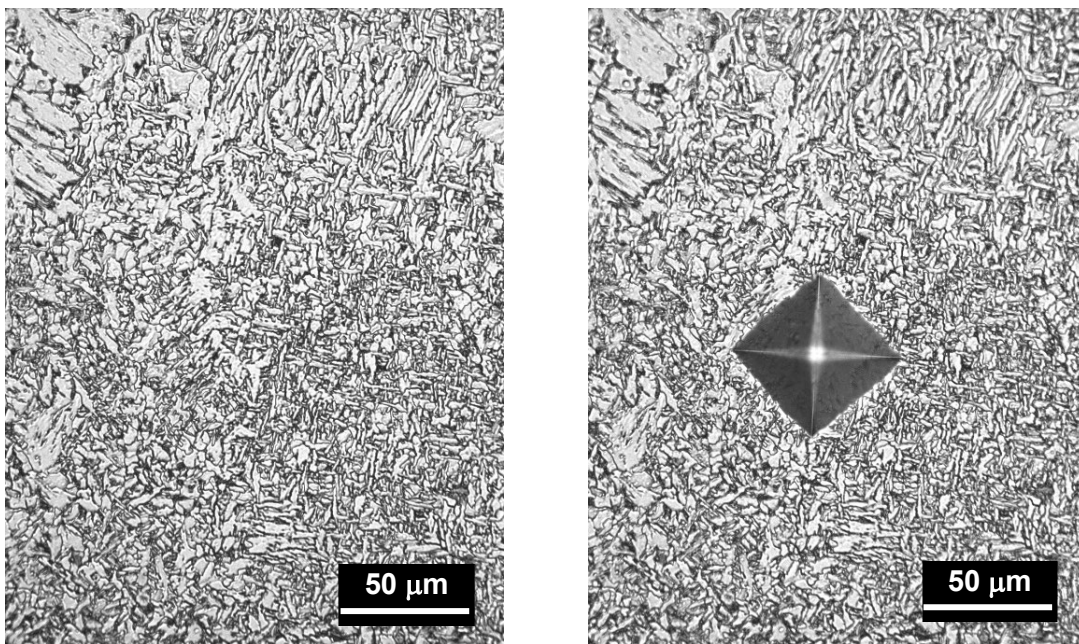
Figure 79. 1E7-3 Sample ID W1 microstructure prior to indentation (left) and with the Vickers microindentation (right). 5% Nital etch. 40x magnification. Acicular ferrite dominant with some proeutectoid ferrite and Widmanstätten ferrite.

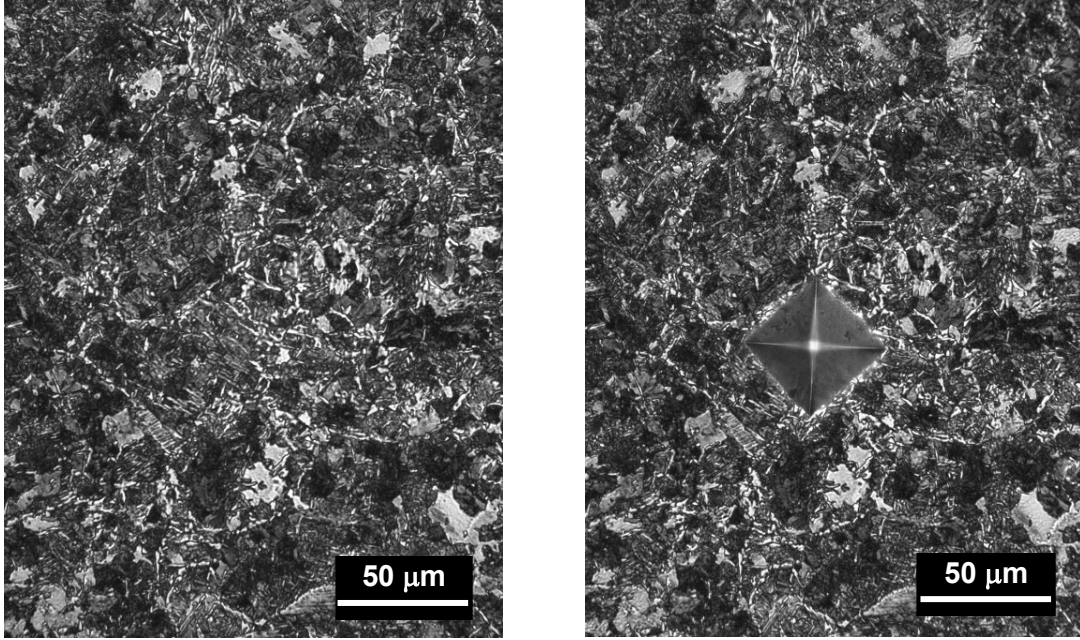
Figure 80. 1E7-3 Sample ID W2 microstructure prior to indentation (left) and with the Vickers microindentation (right). 5% Nital etch. 40x magnification. Martensite with some acicular ferrite proeutectoid ferrite.

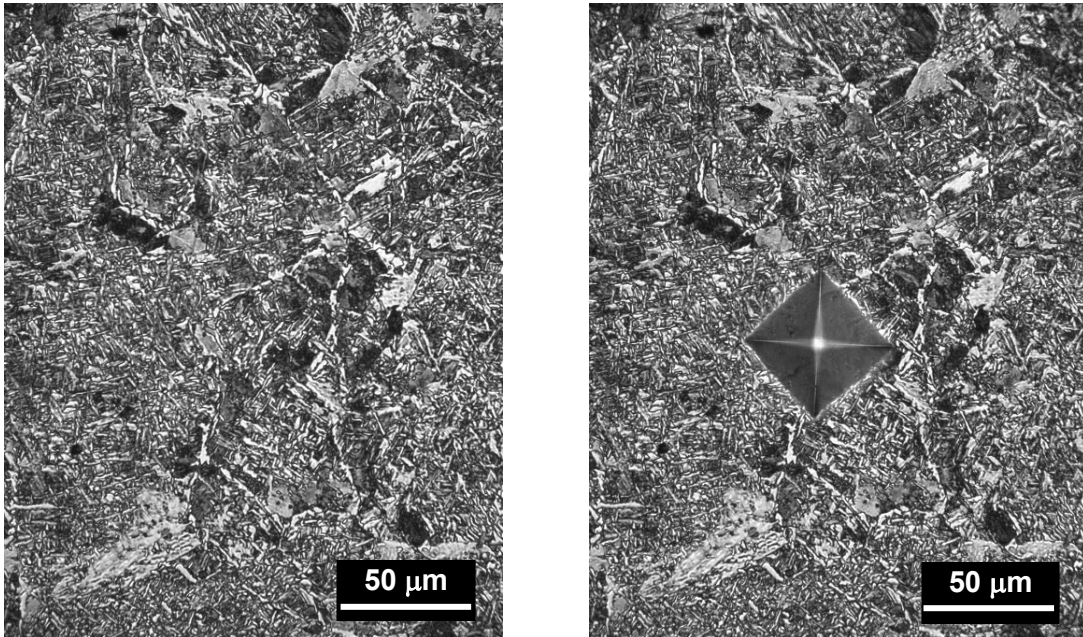
Figure 81. 1E7-3 Sample ID W3 microstructure prior to indentation (left) and with the Vickers microindentation (right). 5% Nital etch. 40x magnification. Acicular ferrite dominant with some proeutectoid ferrite and Widmanstätten ferrite.

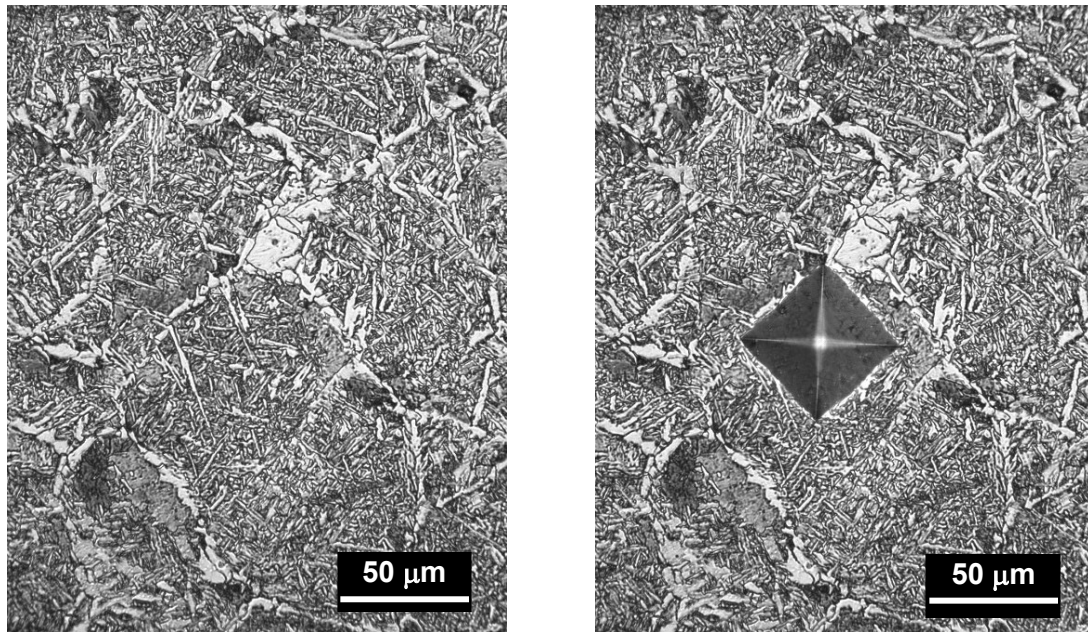
Figure 82. 1E7-3 Sample ID W4 microstructure prior to indentation (left) and with the Vickers microindentation (right). 5% Nital etch. 40x magnification. Acicular ferrite dominant with some proeutectoid ferrite and Widmanstätten ferrite.

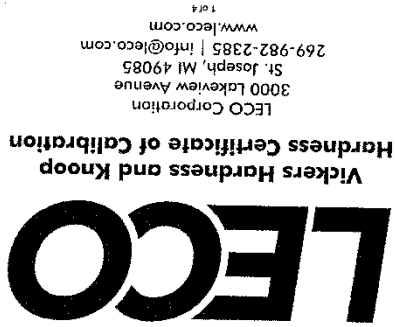
Test Block Information
