NATIONAL TRANSPORTATION SAFETY BOARD

MATERIALS LABORATORY STUDY REPORT

Report No. 19-043

Place : Miami, FL
Date : March 15, 2018
Vehicle : FIU UniversityCity Pedestrian Bridge
NTSB No. : HWY18MH009
Investigator : Robert Accetta (HS-20)

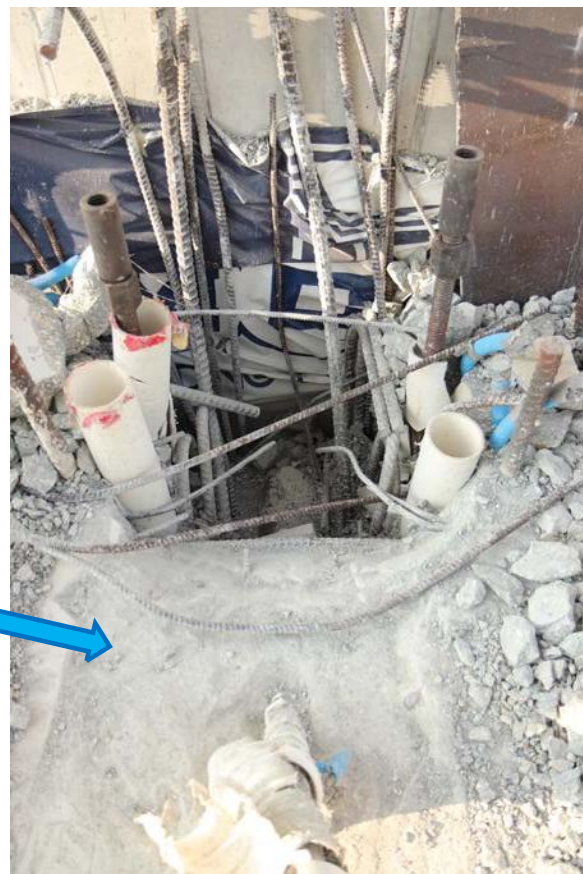
Figure 1: On-scene photos of the deck surface. The red box outlines the flat area on the deck surface under Member 11. The yellow box outlines where Member 12 was located.

The location of the flat area on the deck surface under Member 11 is shown in Figures 1 and 2. Yellow dashed lines indicate a lip on the surface that was consistent with the edge of a cold joint. A portion of this area was sectioned and removed from the deck surface, as shown in Figure 3. The largest pieces separated from the deck were numbered 1, 2, and 3.

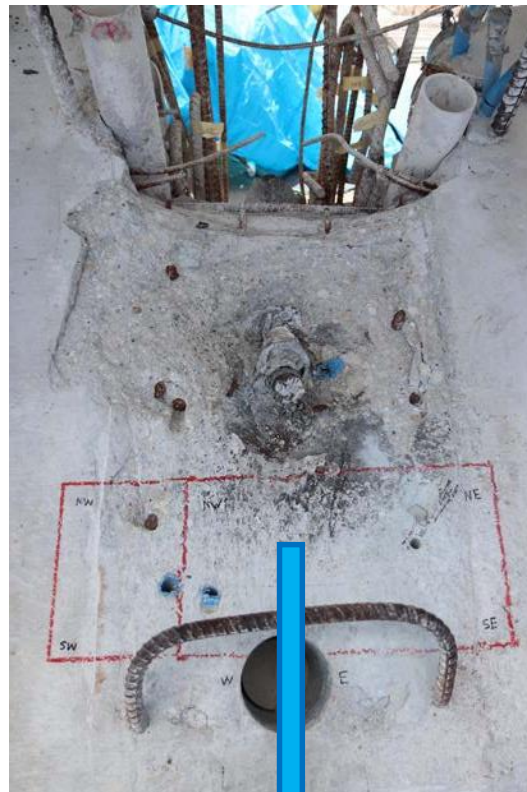
Figure 2: Close-up photos of the deck surface under Member 11. The yellow dotted lines indicate the edges of the cold joint.

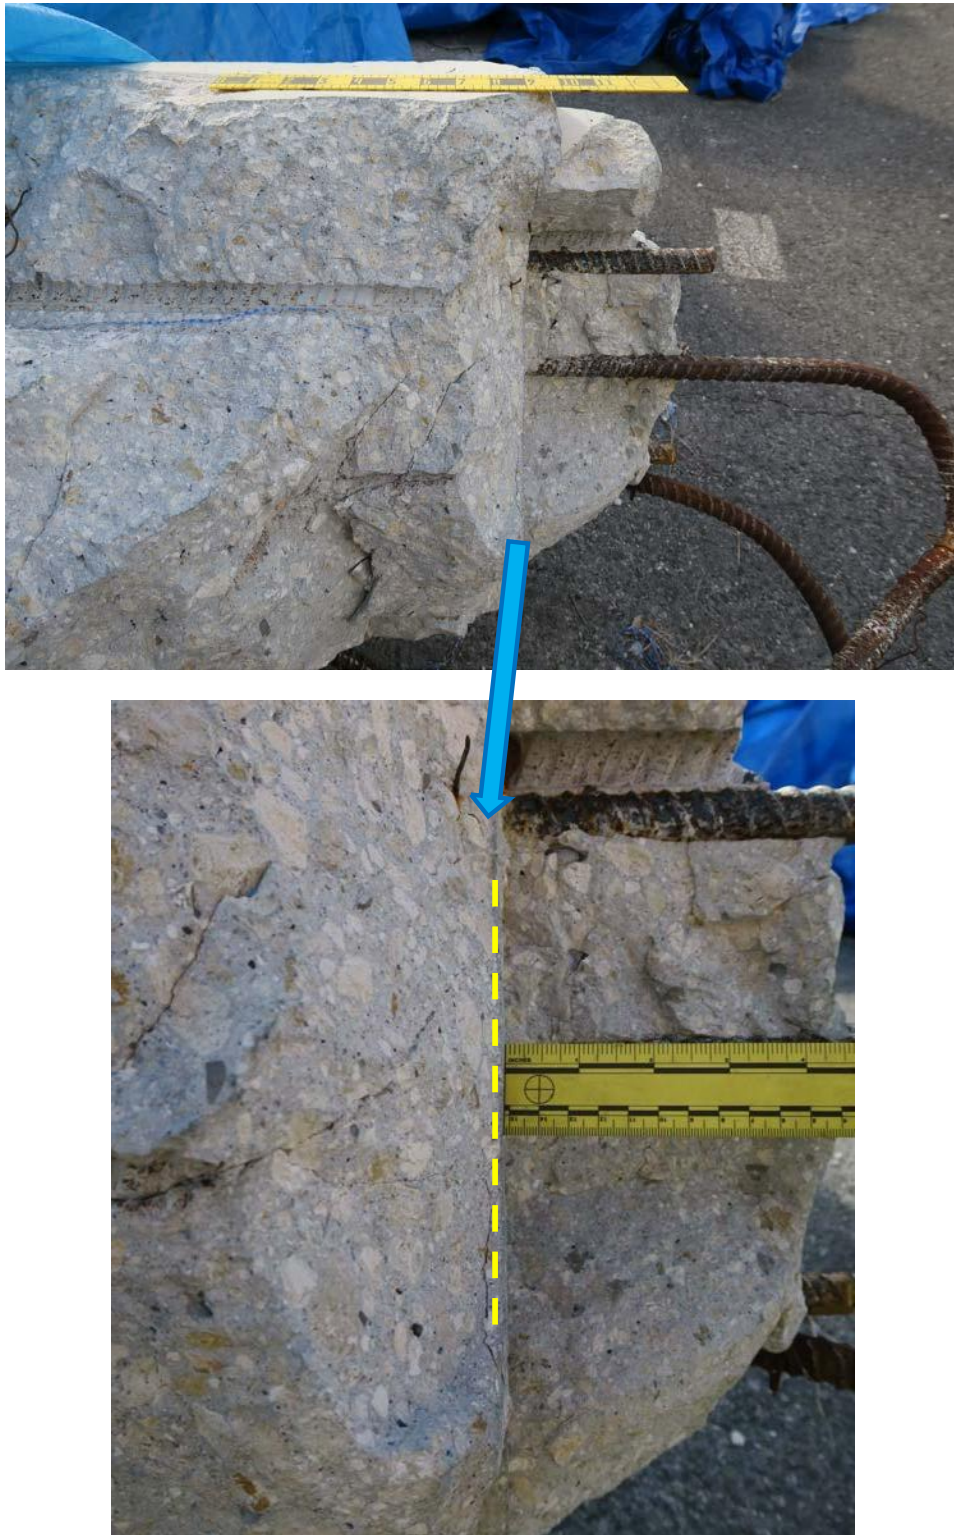
Figure 4: Macro photos of the bottom of Member 12 viewed in profile. The yellow dotted line indicates the straight plane of the flat area observed.

The bottom of Member 12 is shown in profile in Figure 4 and perpendicular in Figure 5. The yellow dashed line in Figure 4 highlights the straight plane of the flat area observed. Figure 5 shows that the flat area on Member 12 was only a portion of the cold joint and was irregular in shape.

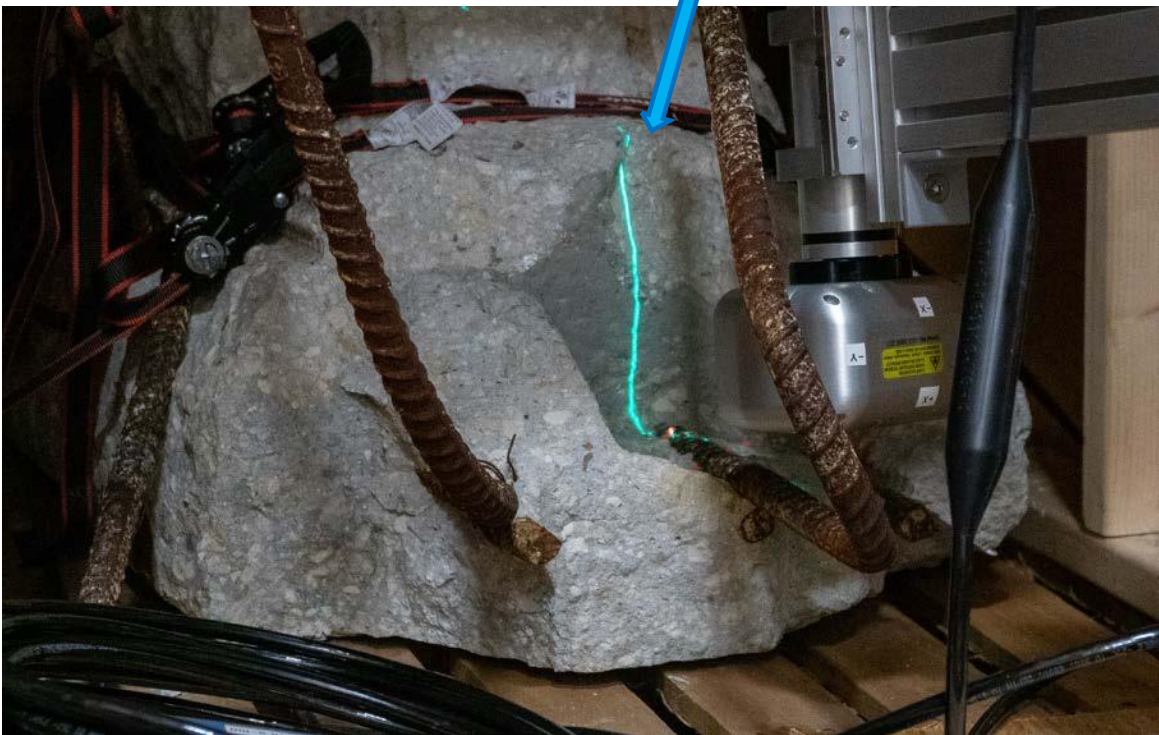
Figure 6: Macro photos of a laser scan of the flat area on the bottom of Member 12. The green line in the bottom image is the laser projected onto the surface.

Pieces 1, 2, and 3 on the deck and all the flat area under Member 12 were scanned using a 2G Robotics ULS-100 short-range laser scanner with a class 3R laser. An exemplar photo of a laser scan of the flat area on the bottom of Member 12 is shown in Figure 6. The laser determined the height of the surface at each positional coordinate on a specified grid.

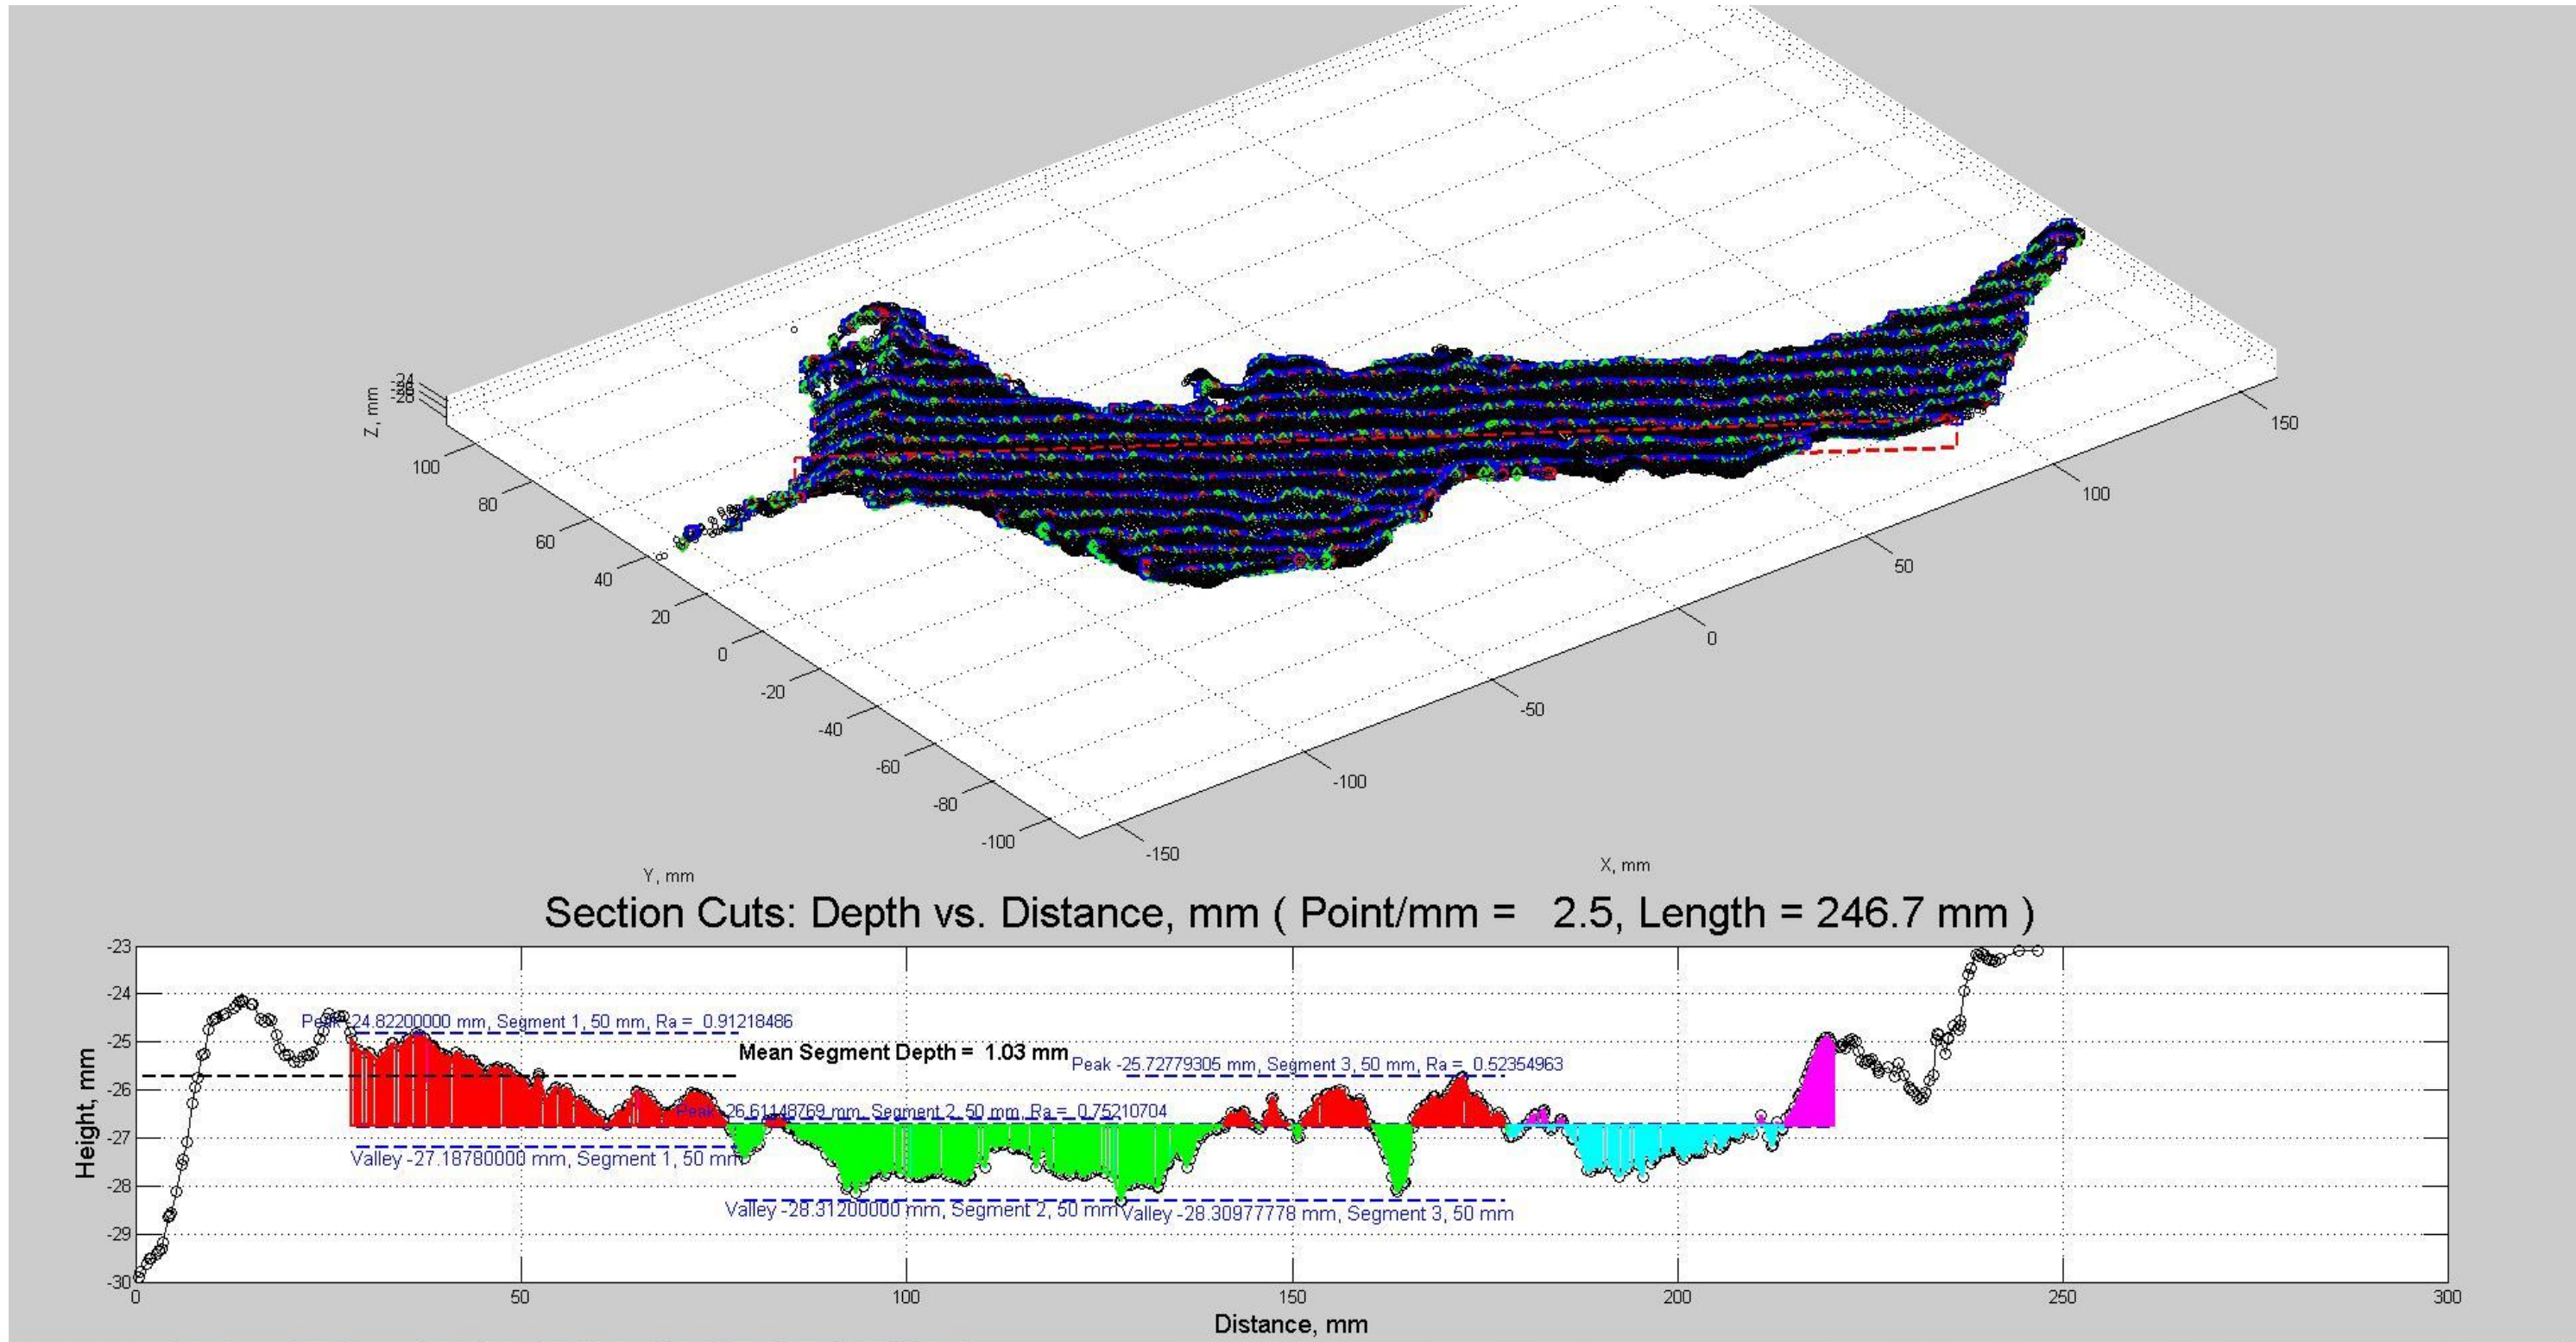
Figure 10: Exemplar section cut and MSD calculation #1 for Member 12.

- Calculate the centerline for each extracted point profile. The centerline is a straight line that divides equal areas above (defined by the centerline to surface peak distance times the incremental distance along the surface) and below (defined by the centerline to surface valley distance times the incremental distance along the surface). (Figure 10)

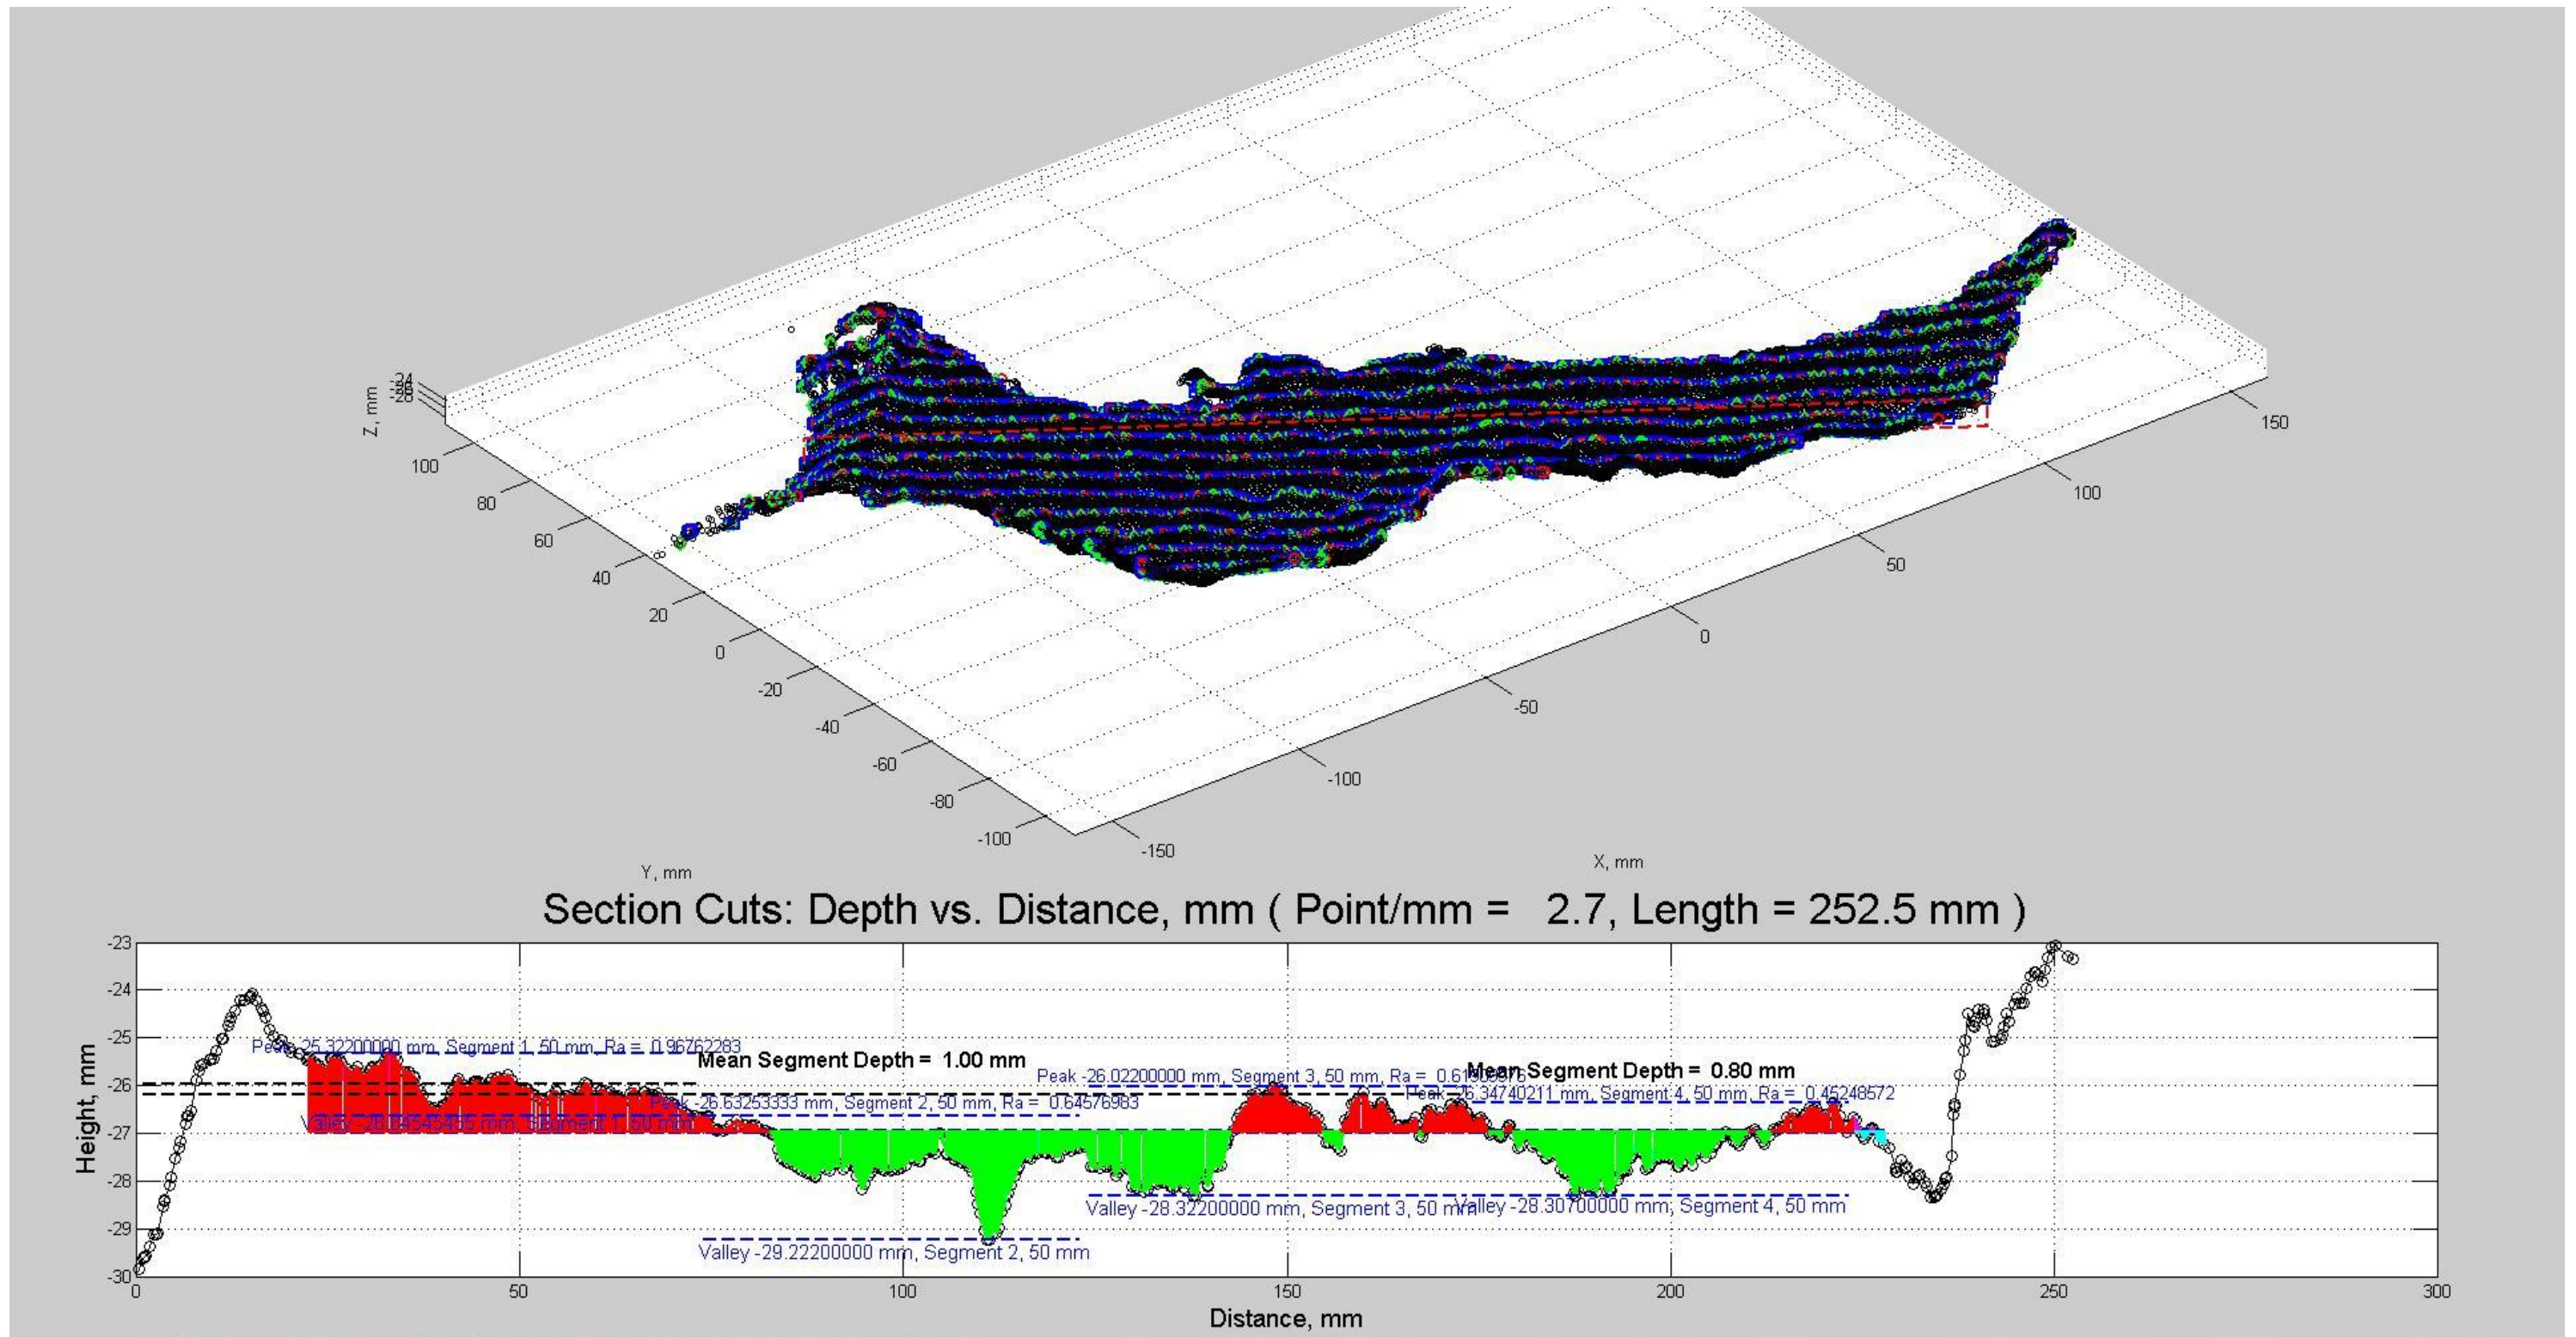
Figure 11: Exemplar section cut and MSD calculation #2 for Member 12.

- Calculate the mean profile depth (MPD) from the centerline in segment lengths of 50 mm (about 2.0 in.) when at least two adjacent 50 mm segment lengths are present.² (Figure 11)

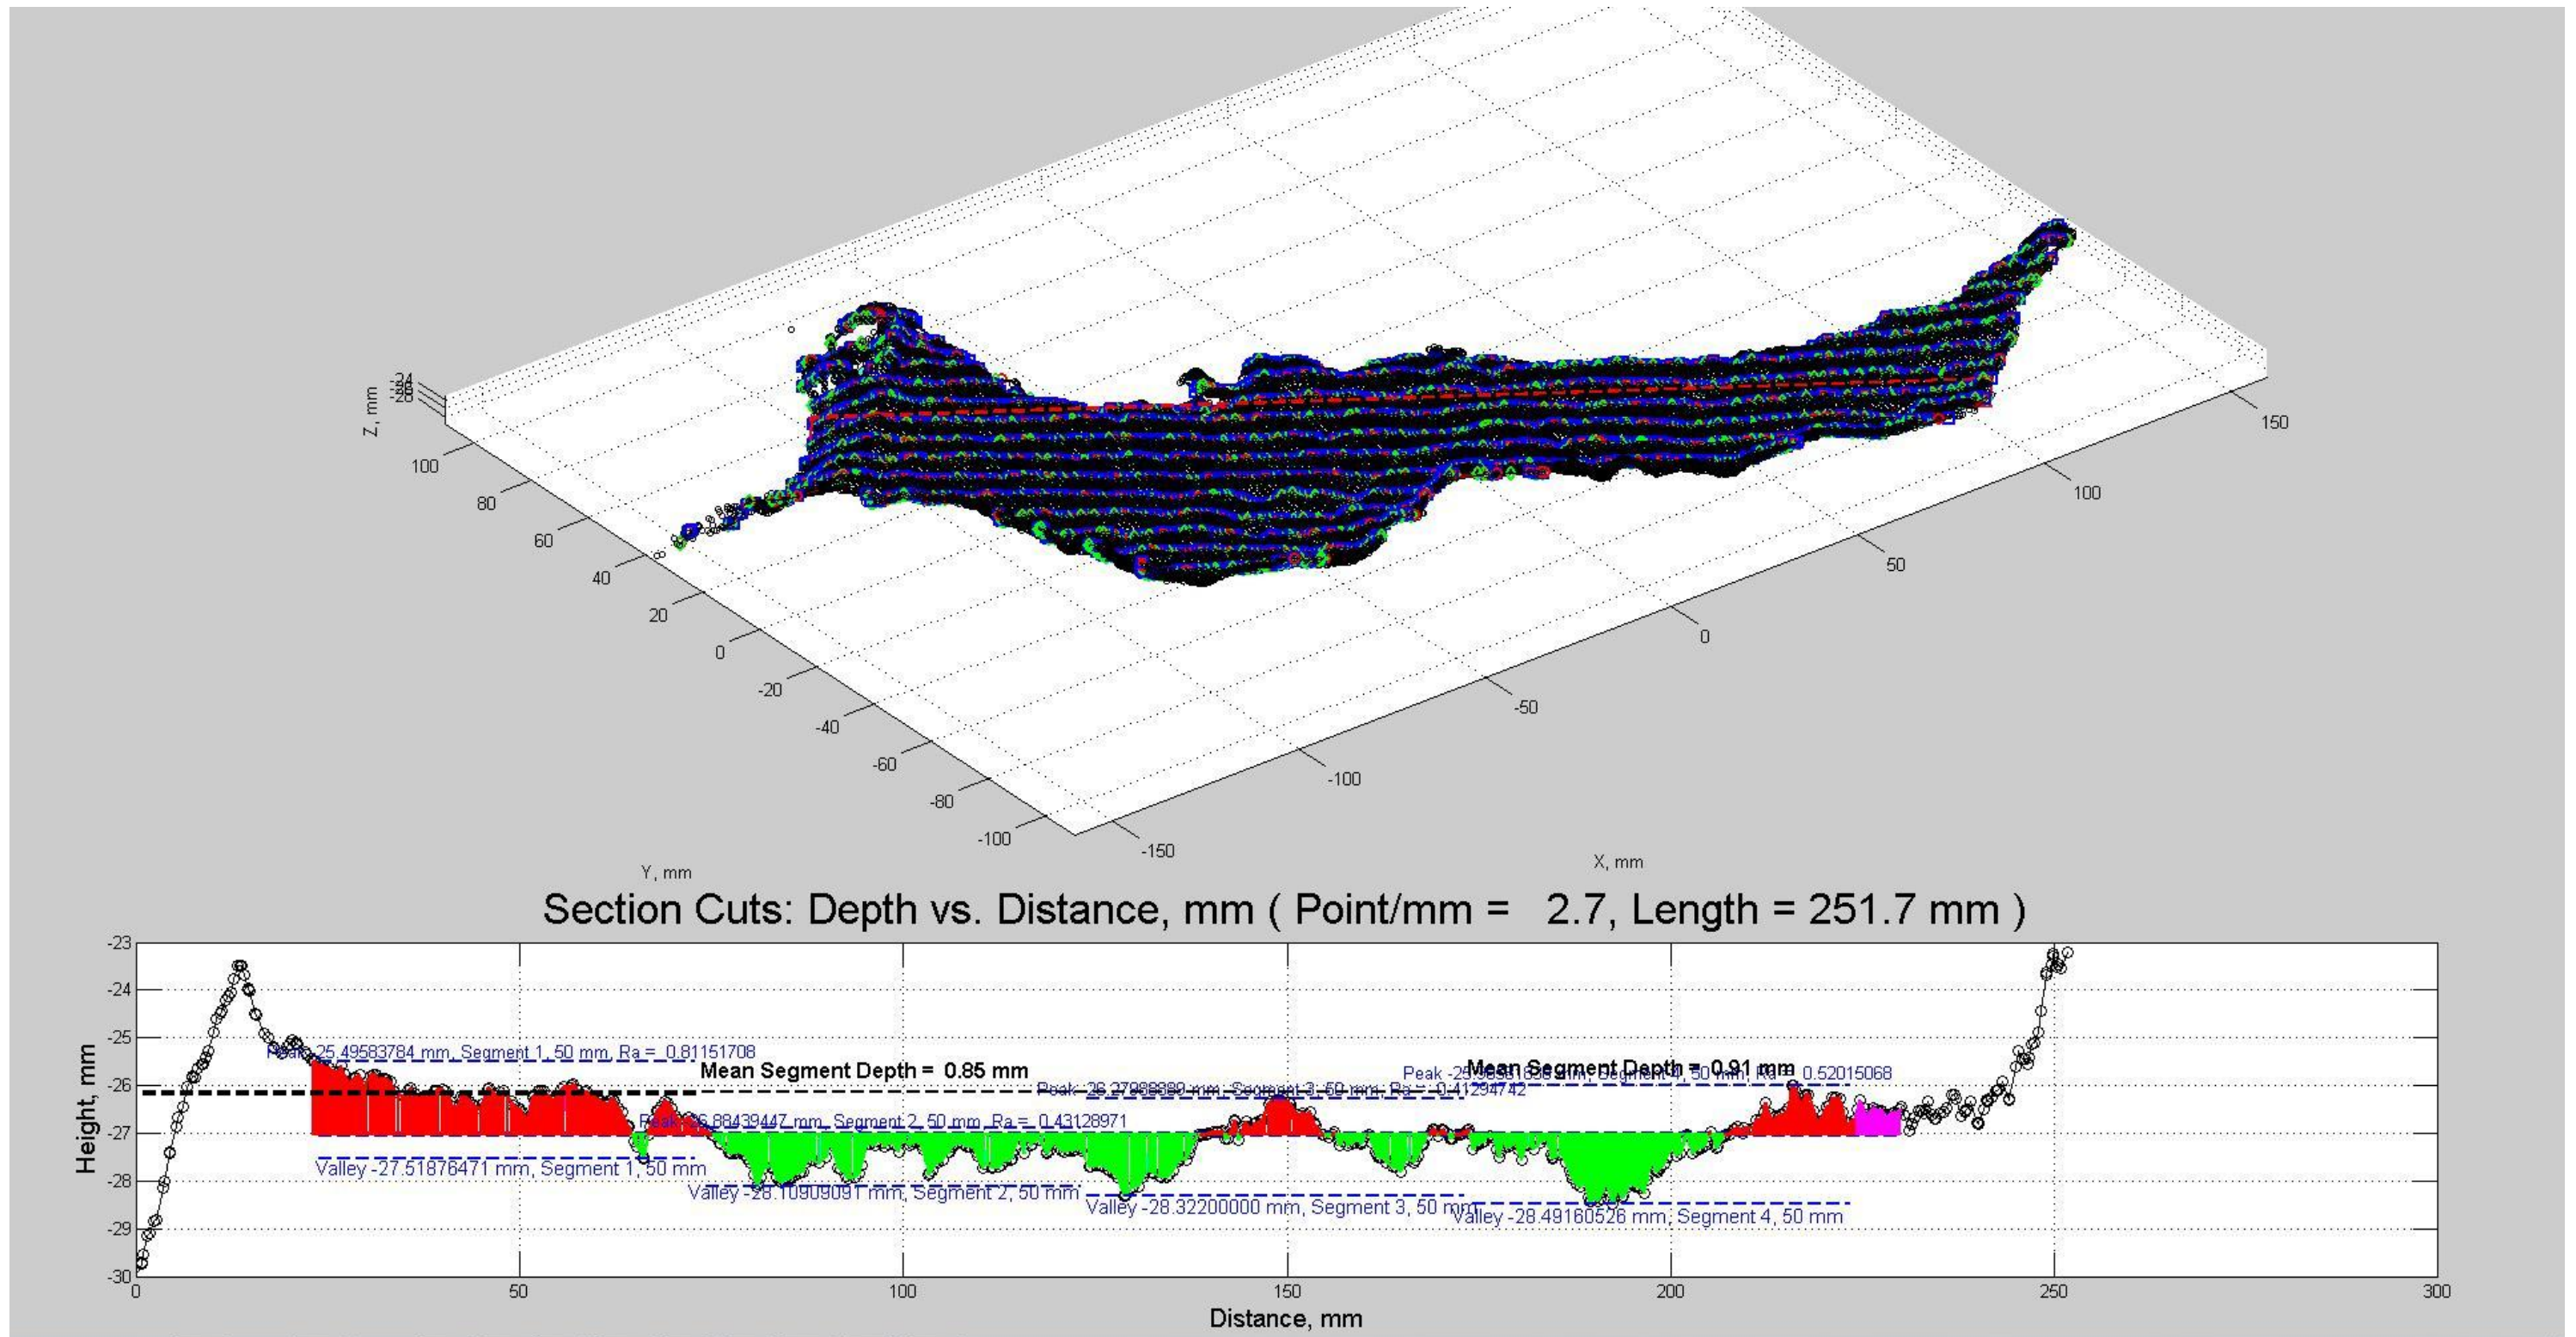
Figure 12: Exemplar section cut and MSD calculation #3 for Member 12.

- Average all MPDs across the scanned surface to calculate the arithmetic mean roughness value (S_a) for the target cold joint areas. (Figure 12)
