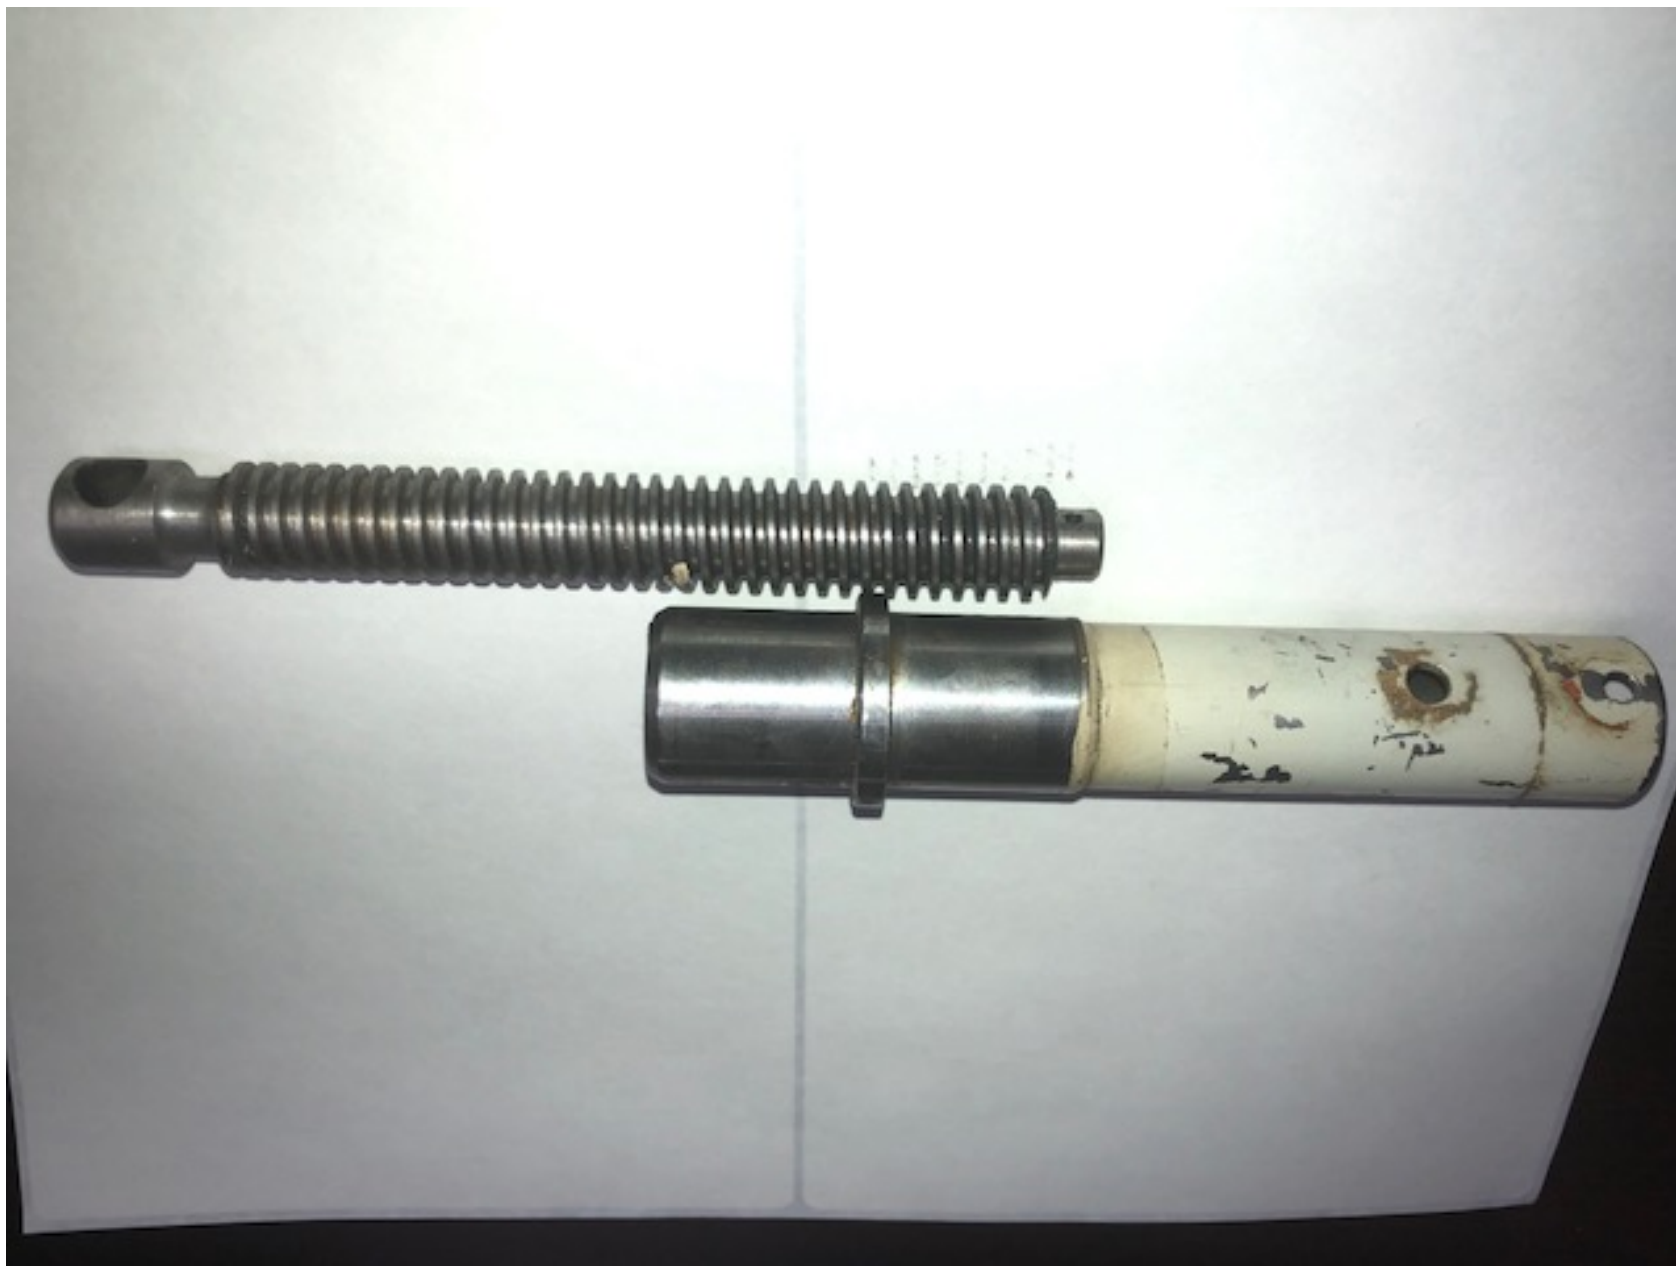
**Photo 1 – Supplied view of the jackscrew in the trim system.**

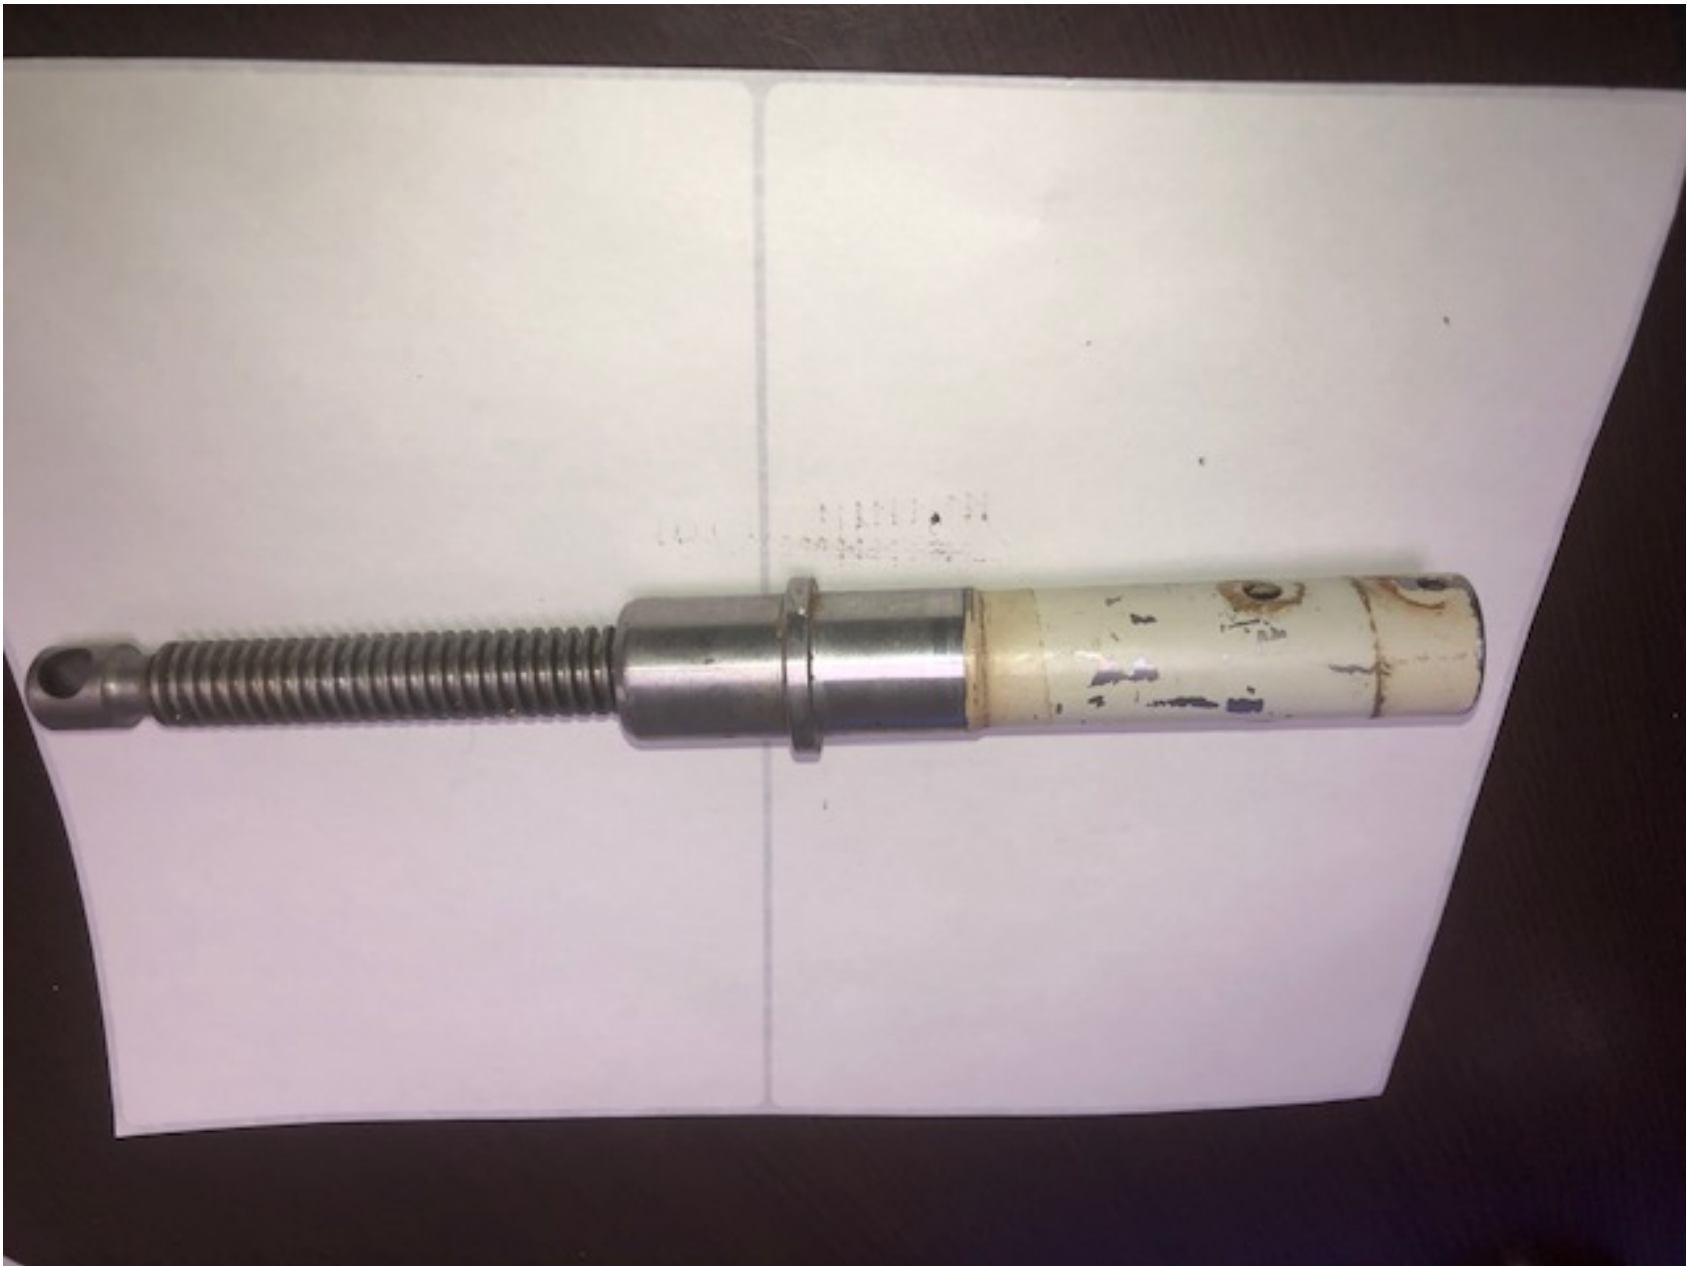
**Photo 2 - Supplied view of the jackscrew in the trim system.**

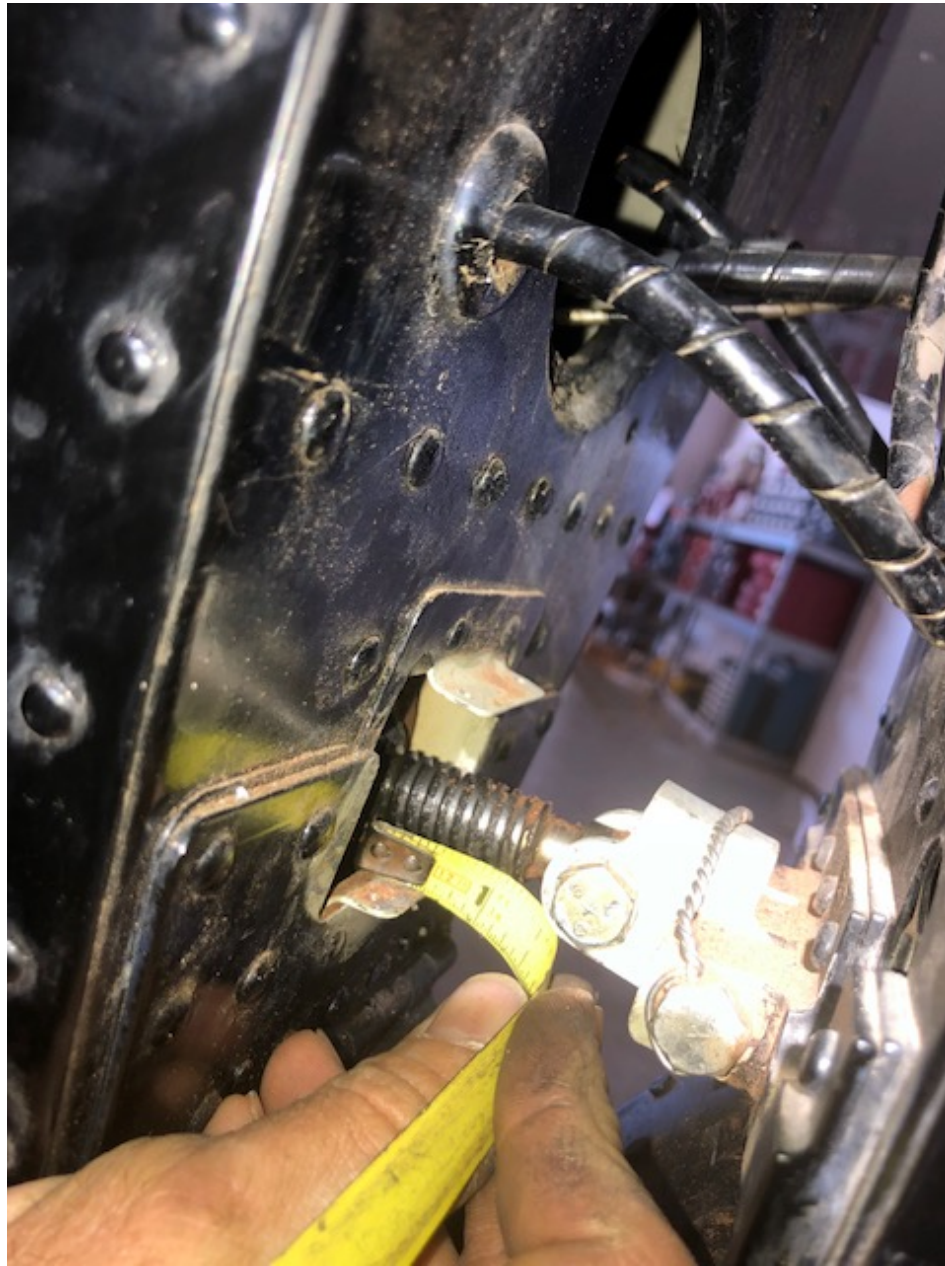
**Photo 3 - Supplied view of the jackscrew with about 8 threads showing. Trim indicator is in the takeoff position.**

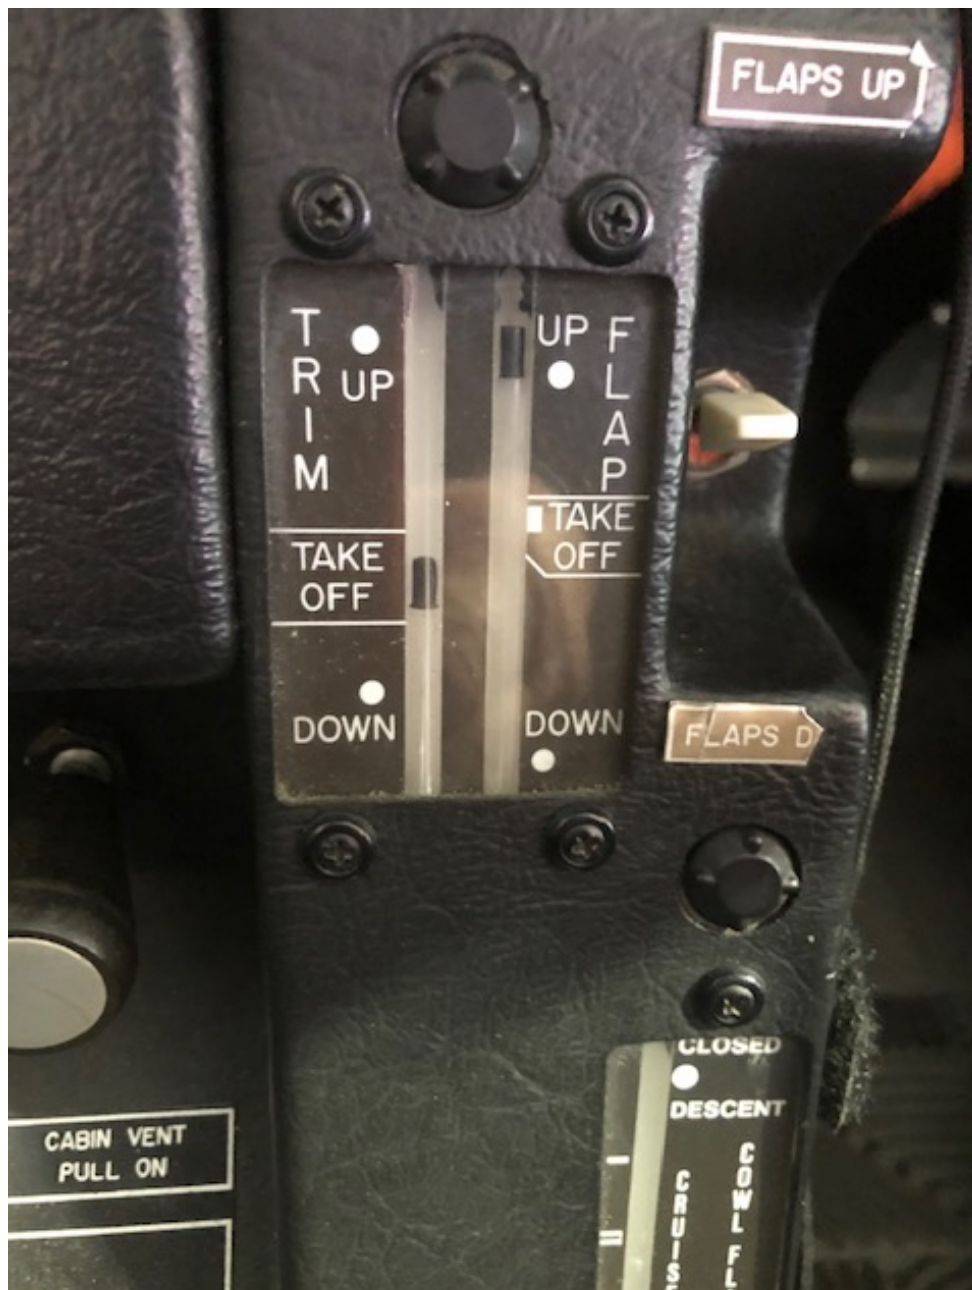
**Photo 4 - Supplied view of the trim indicator in the takeoff position. The jackscrew has about 8 threads showing.**

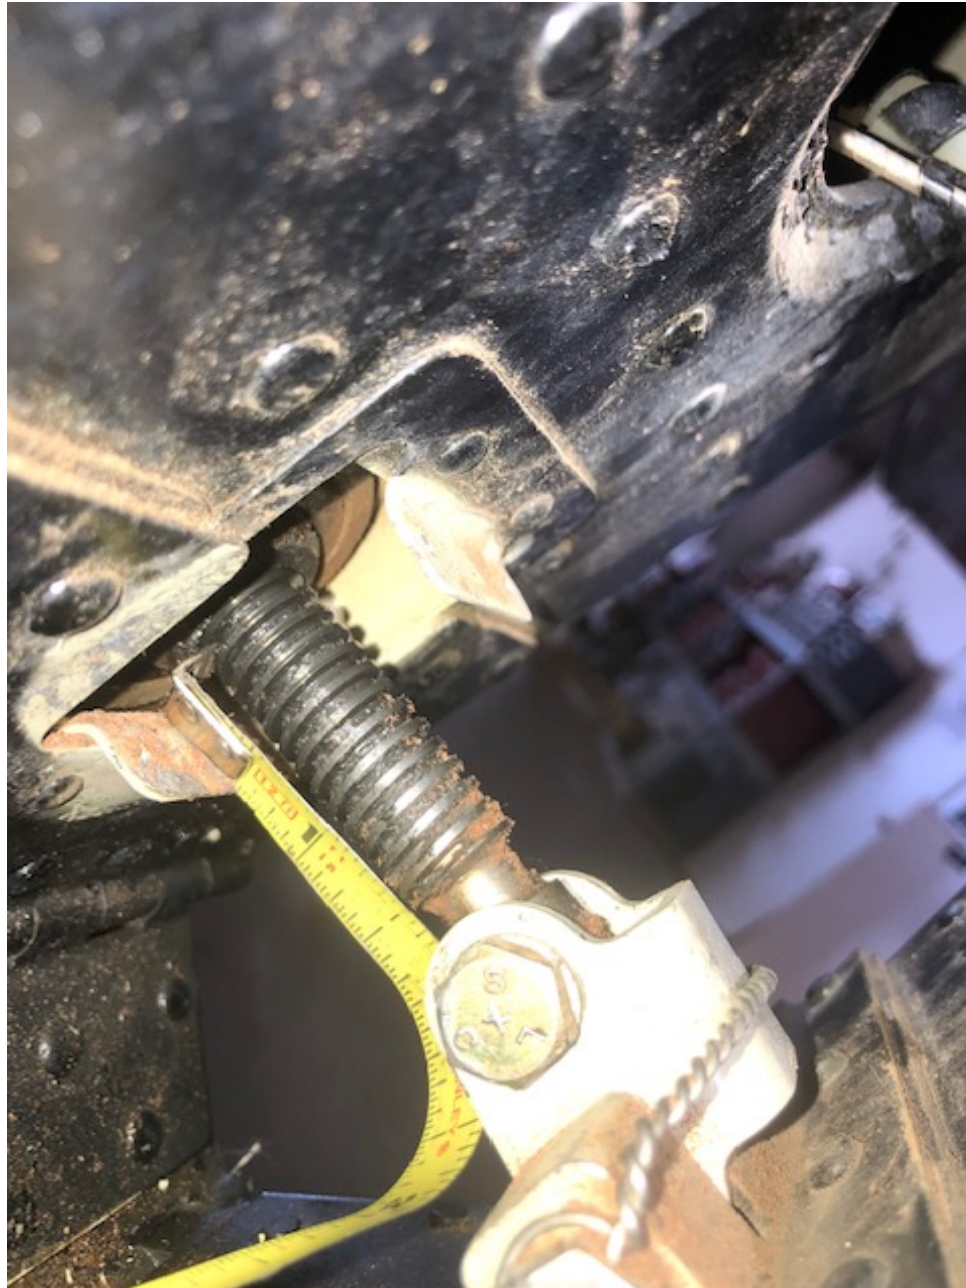
**Photo 5 - Supplied view of the jackscrew with about 13 threads showing.**

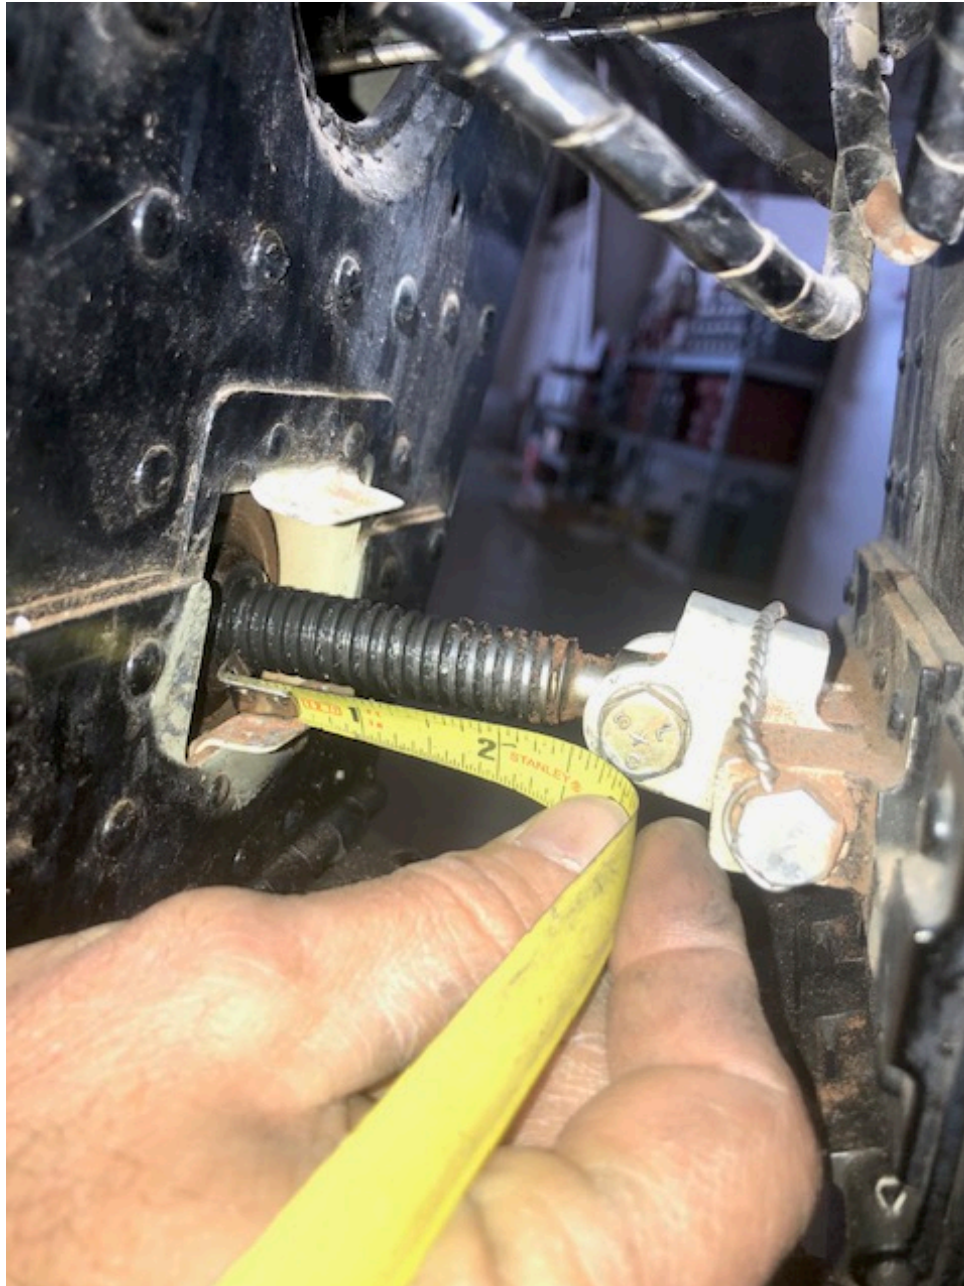
**Photo 6 - Supplied view of the jackscrew at full extension.**

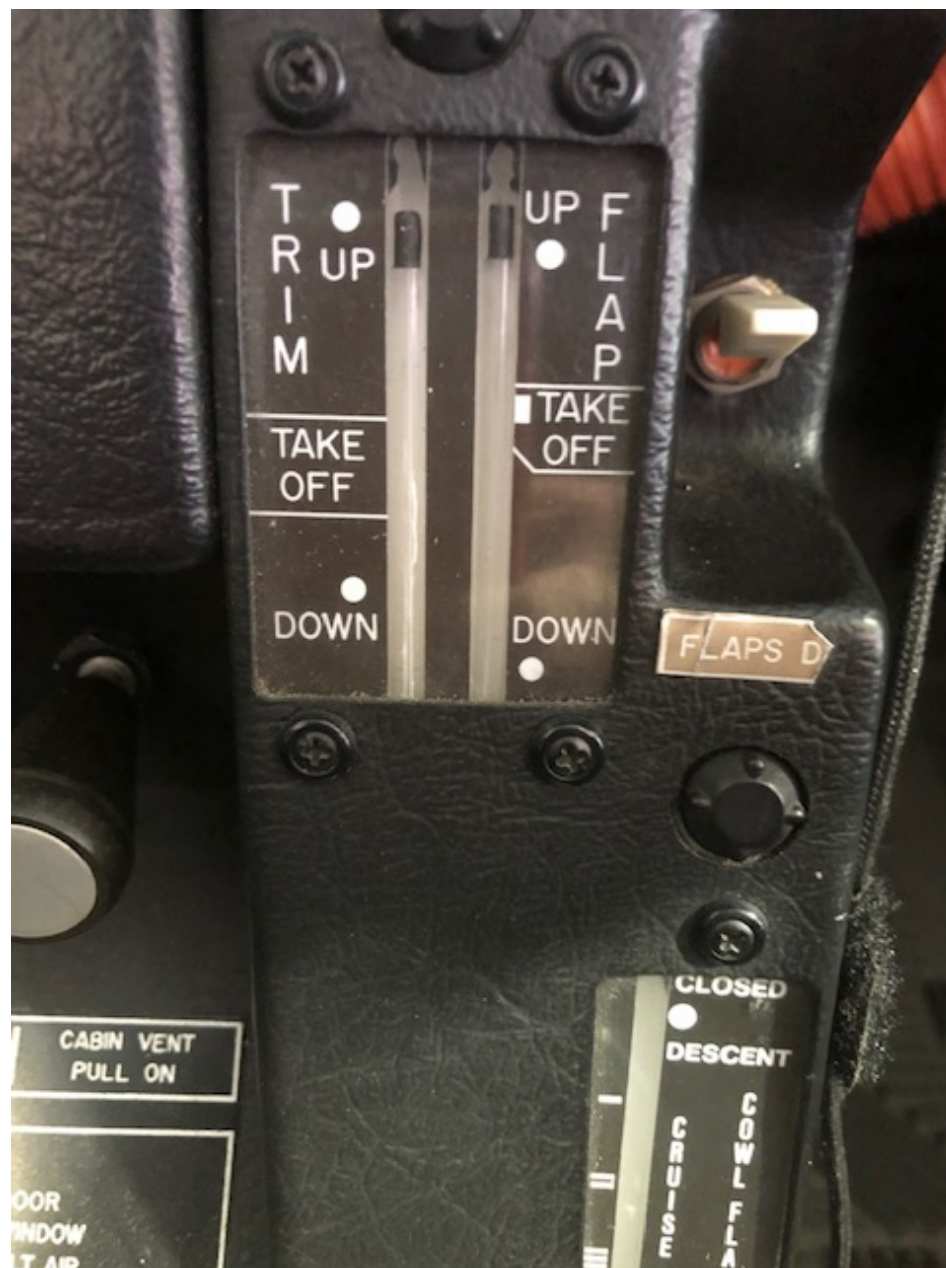
**Photo 7 - Supplied view of the trim indicator in the full up position. The jack screw is at its full extension.**
