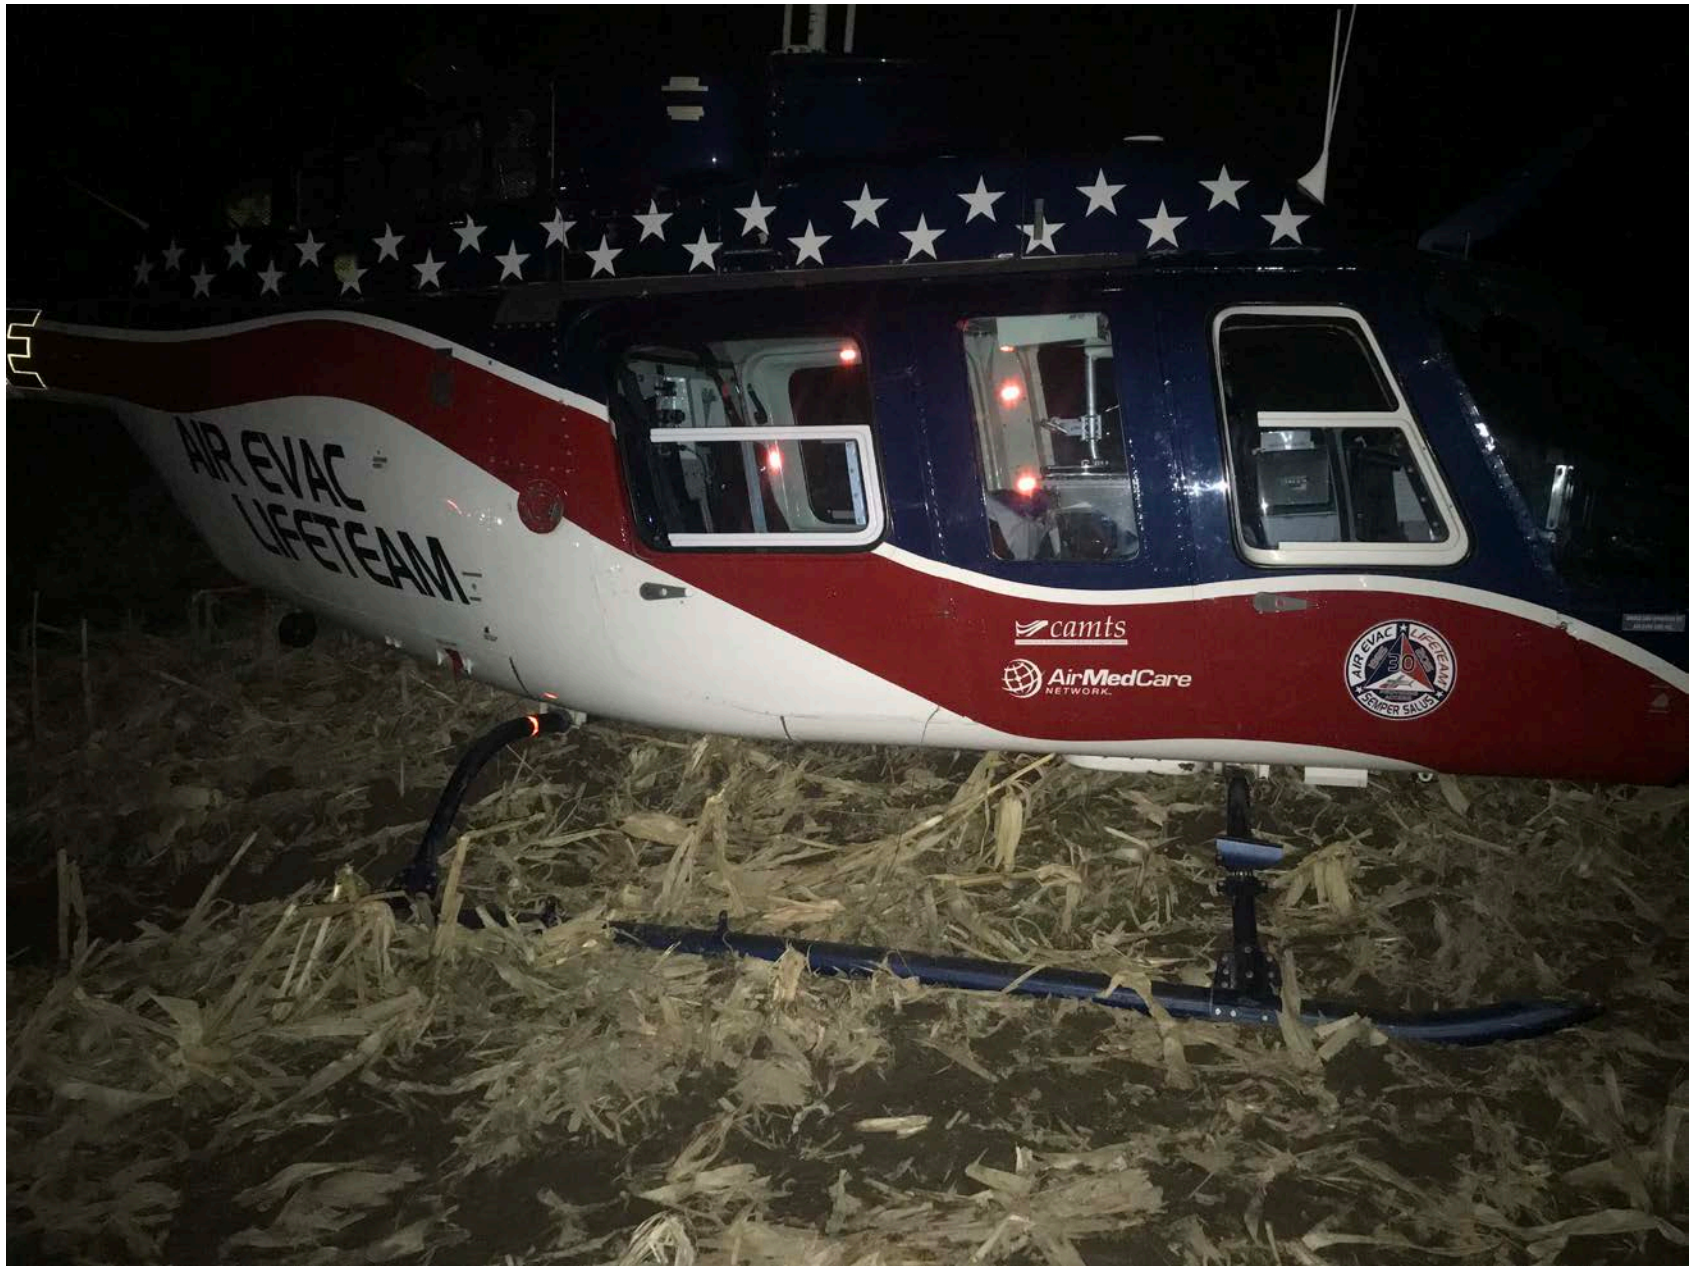
Photo 1 – Supplied photo with a view of the right side of the helicopter.

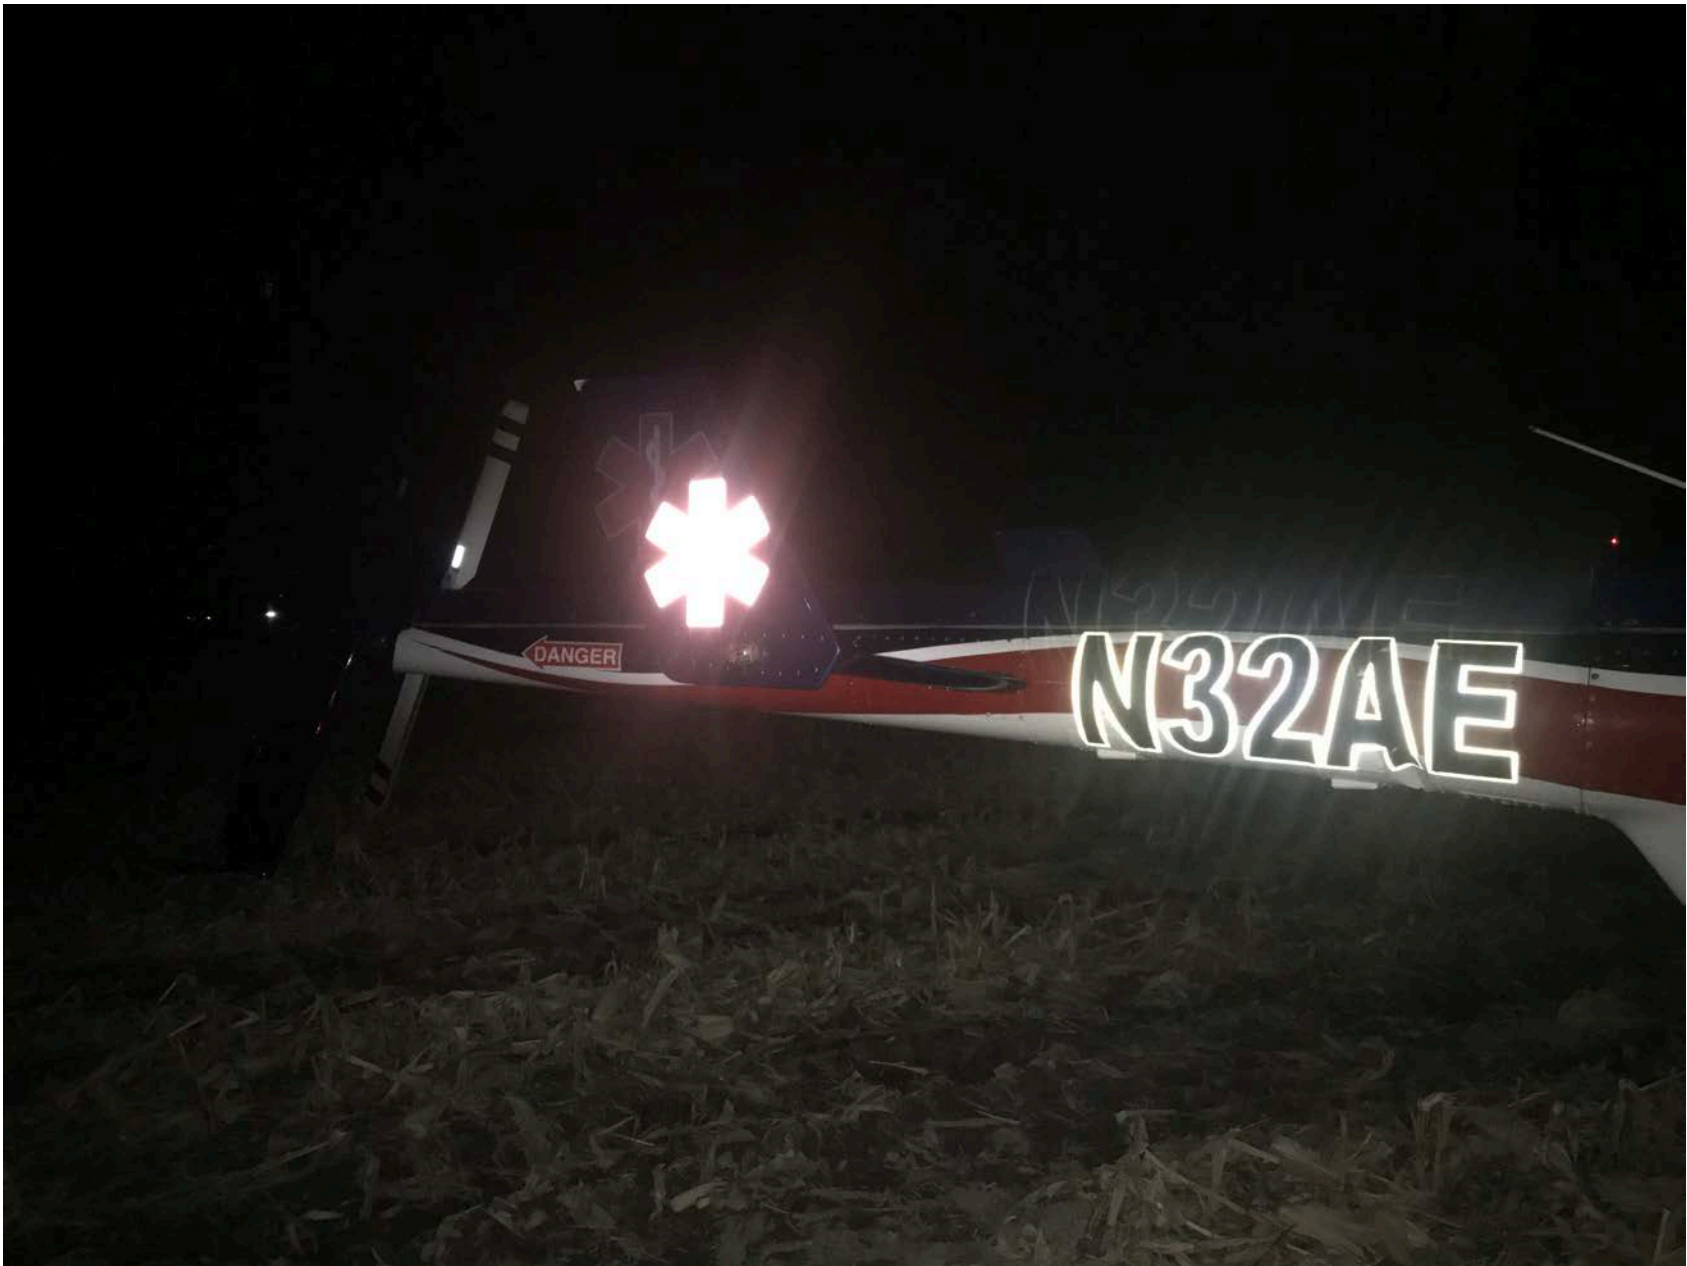
Photo 2 - Supplied photo with a view of the right side of the tailboom.

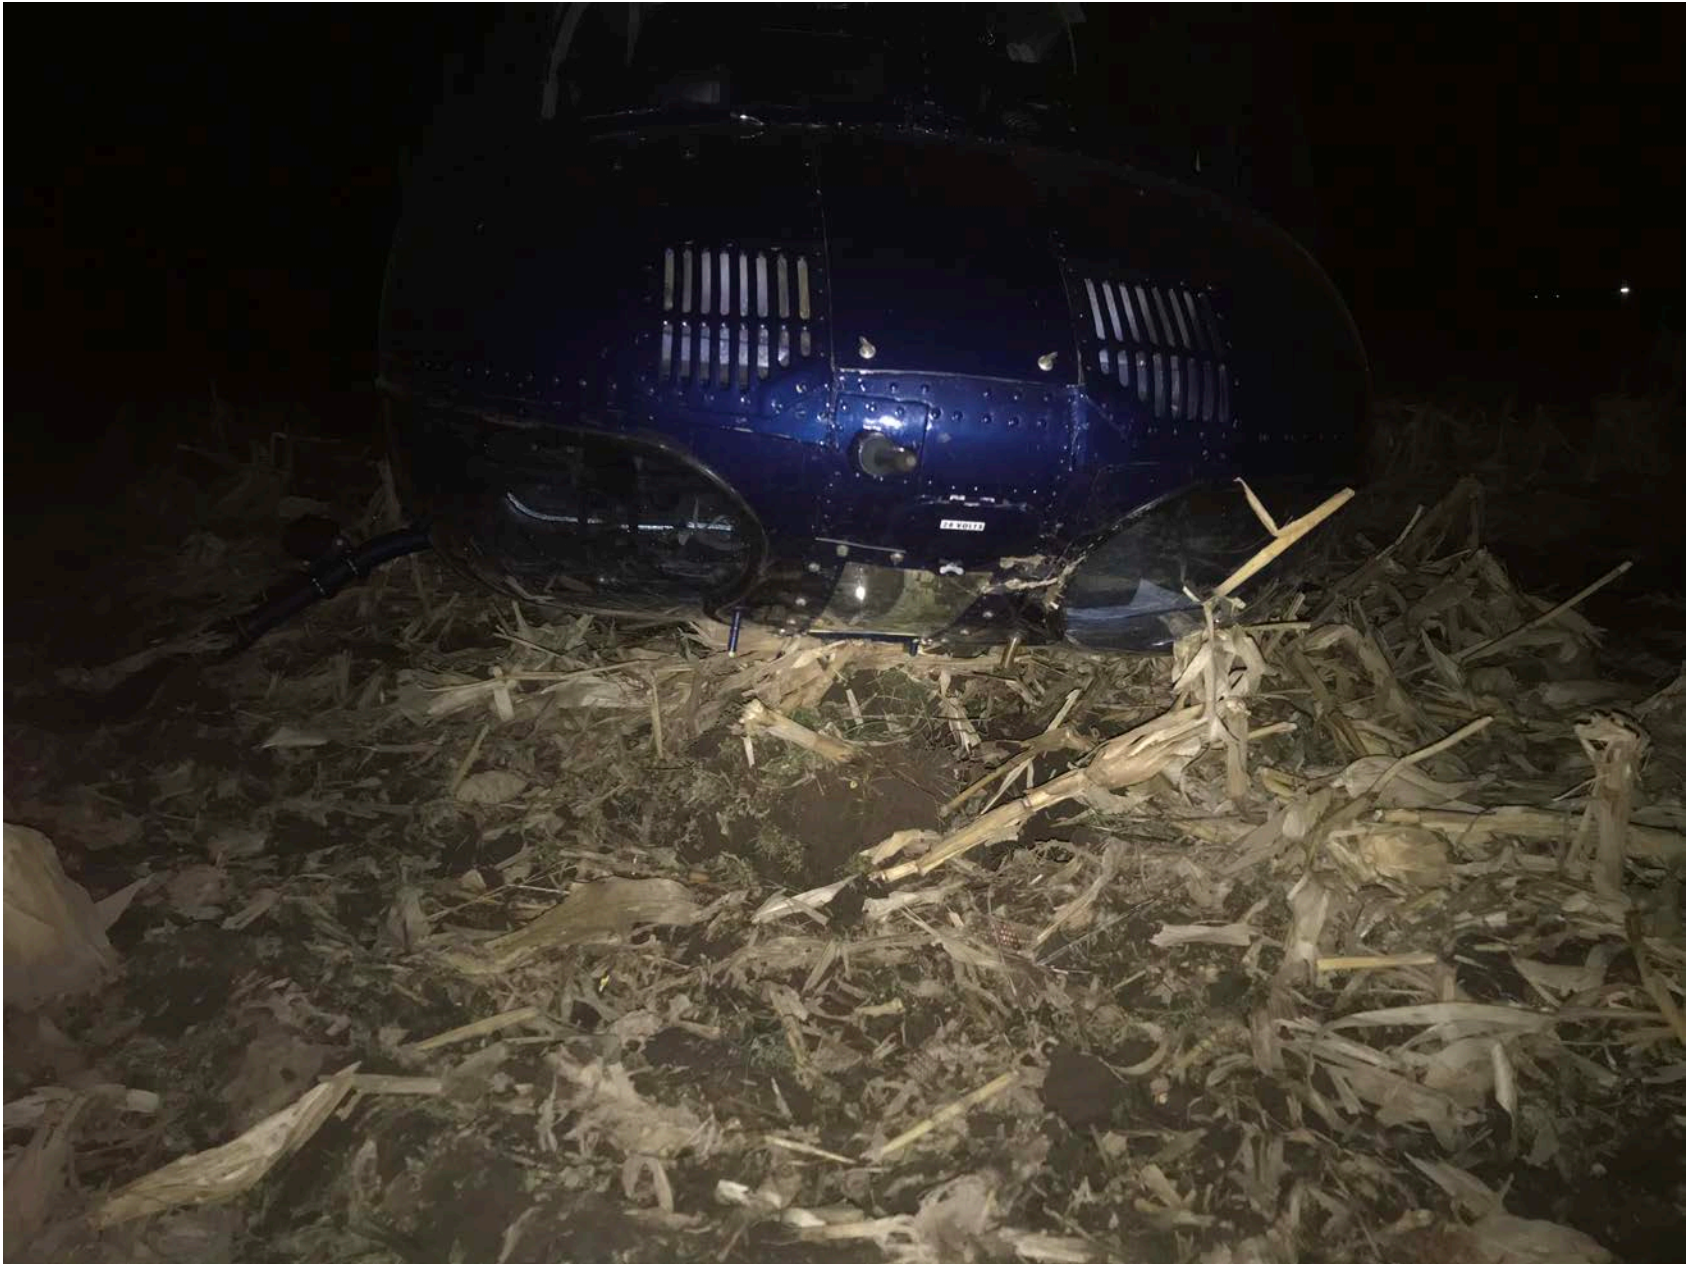
Photo 3 - Supplied photo with a view of the front of the helicopter.

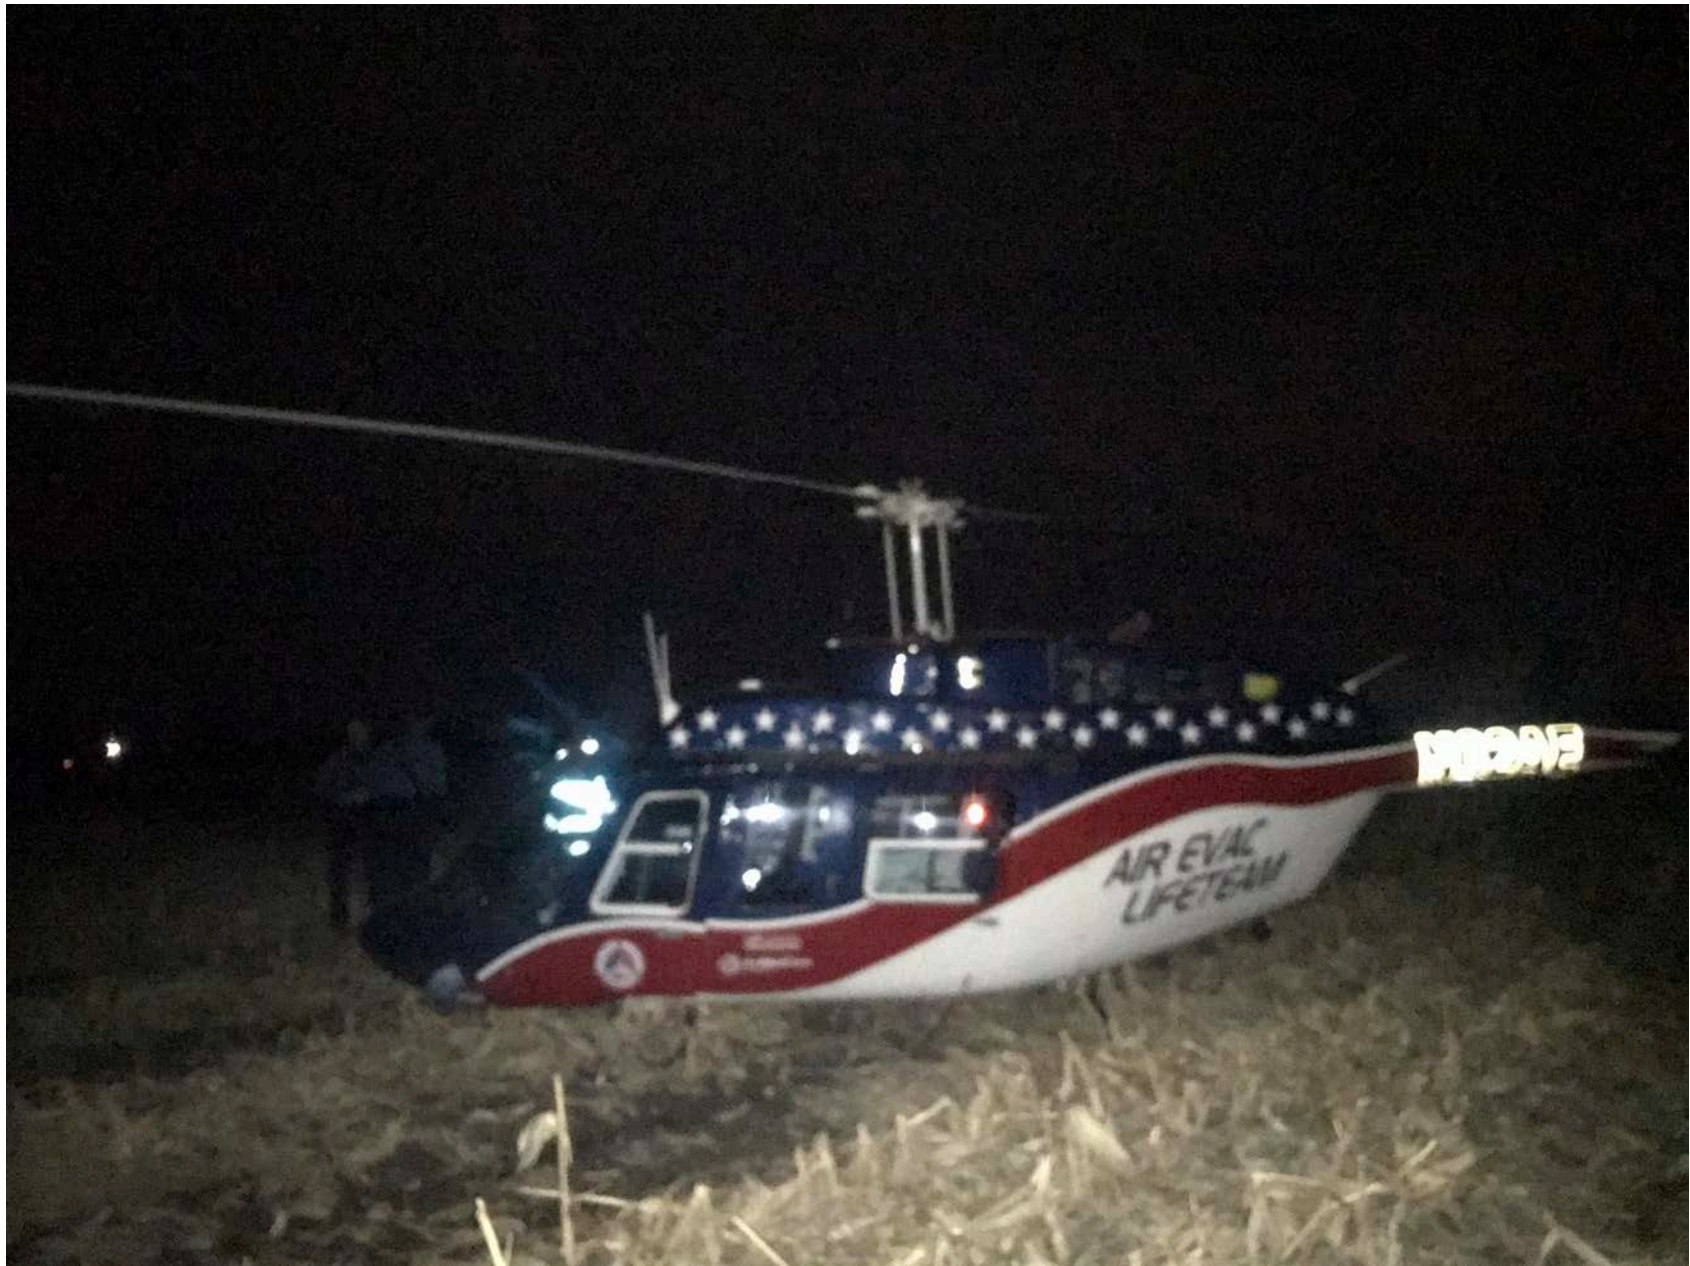
Photo 4 - Supplied photo with a view of the left side of the helicopter.

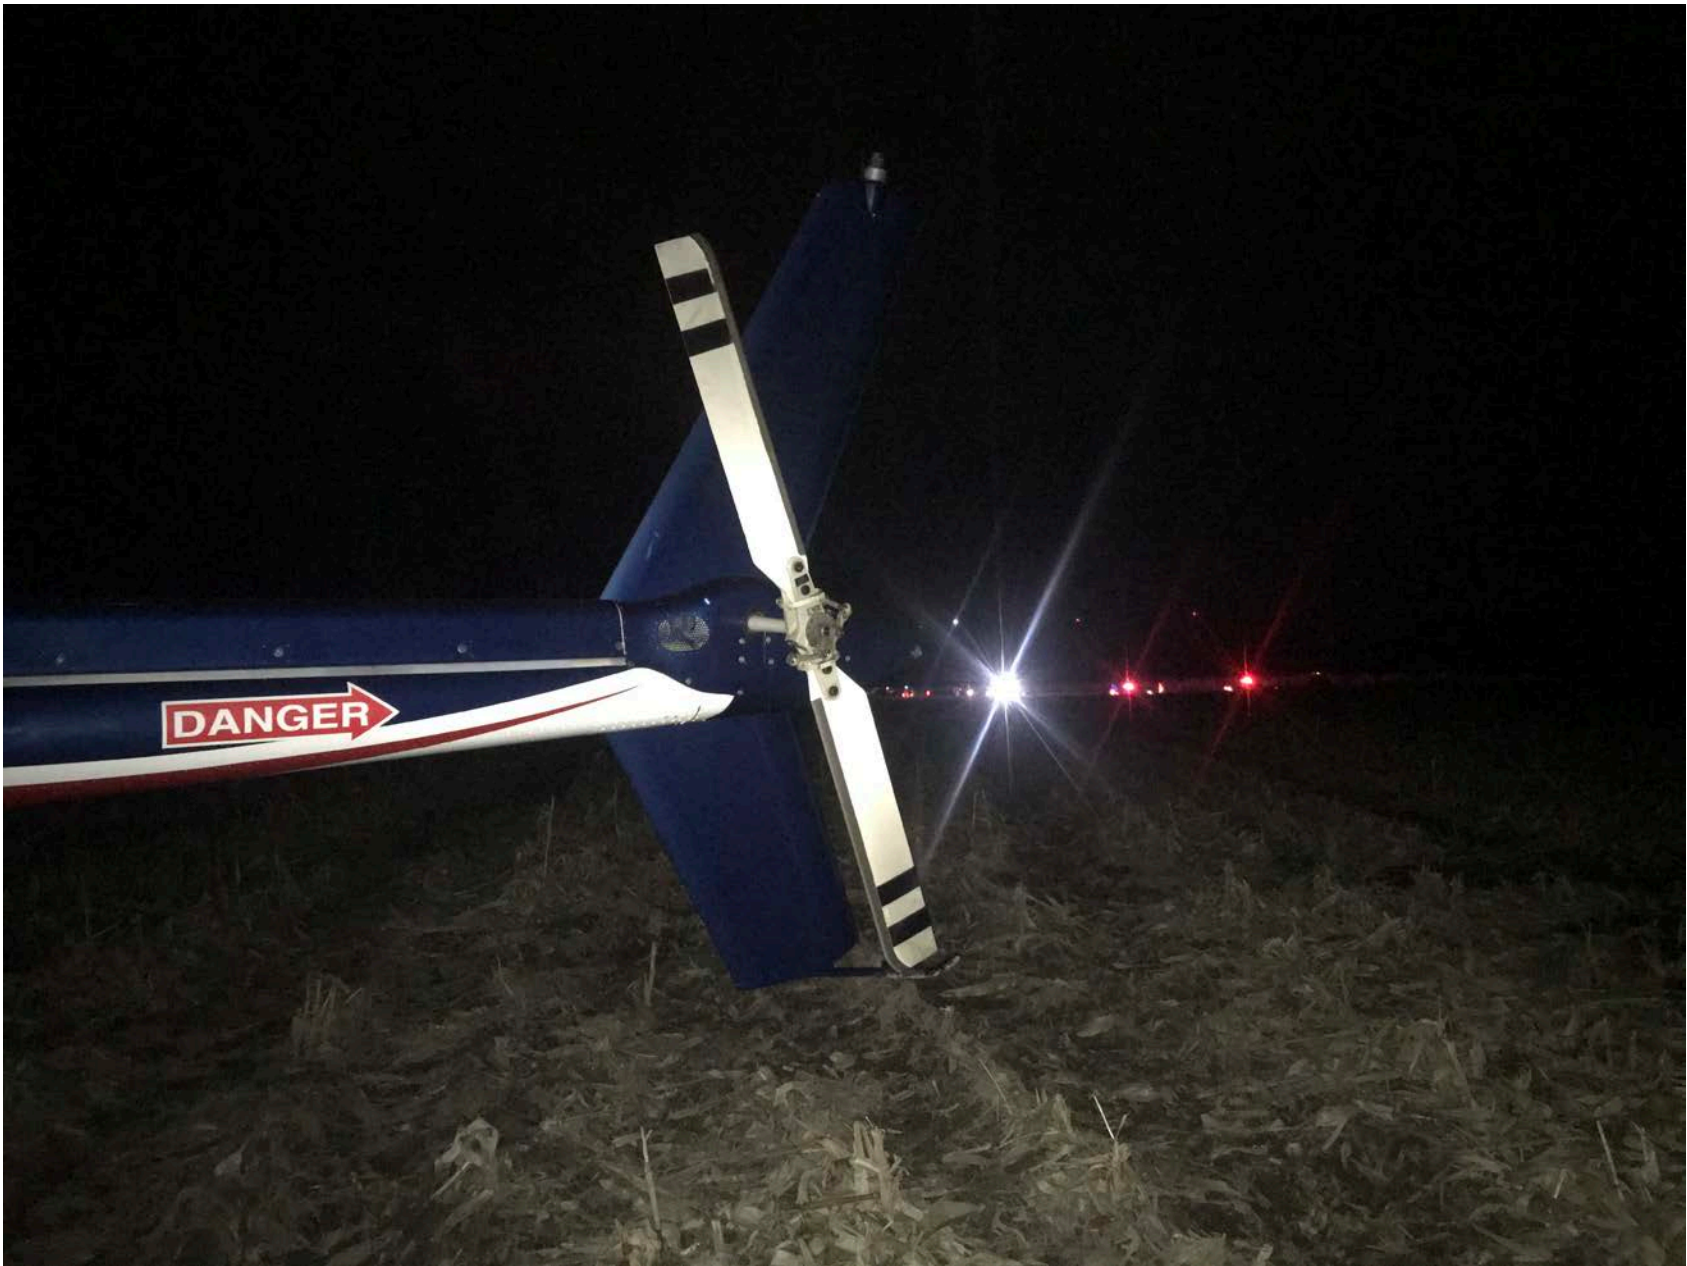
Photo 5 - Supplied photo with a view of the tail rotor.

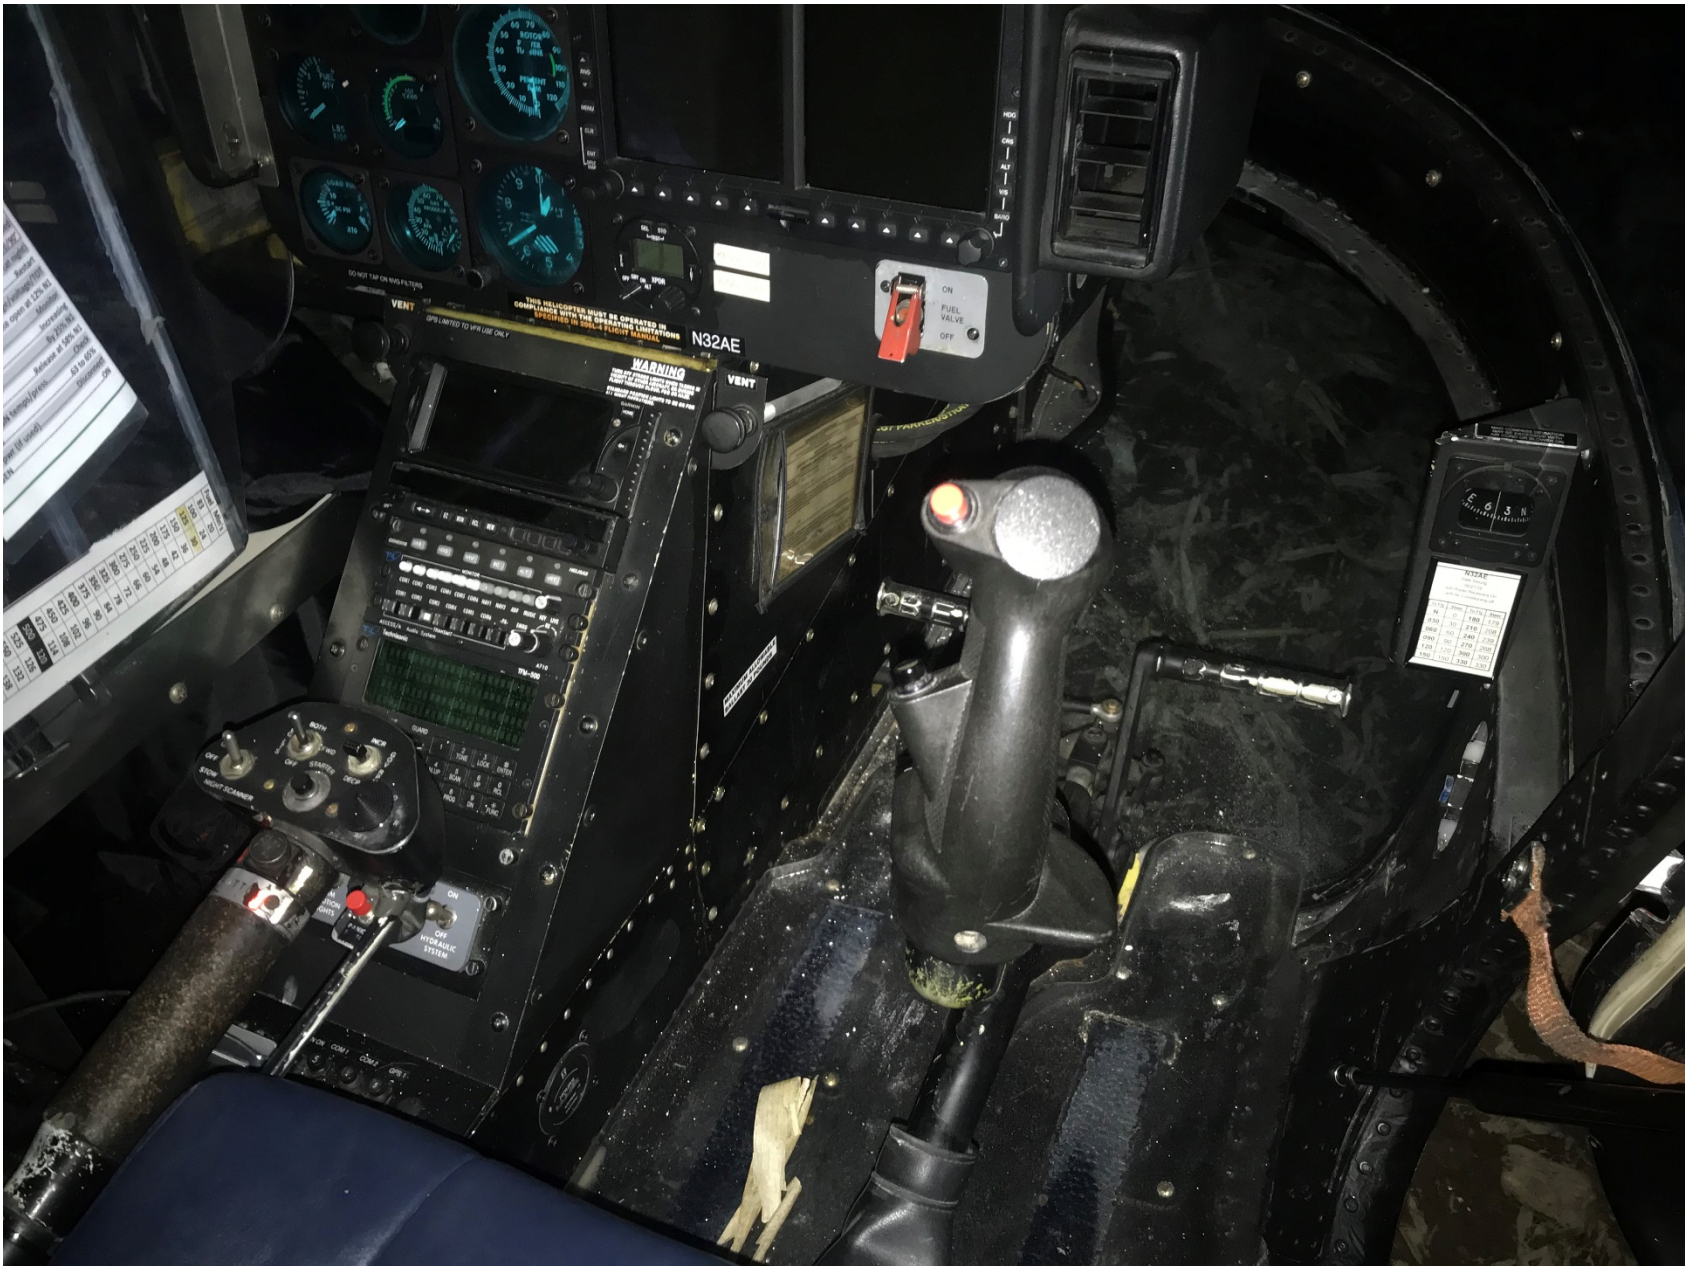
Photo 6 - Supplied photo with a view of the cockpit.

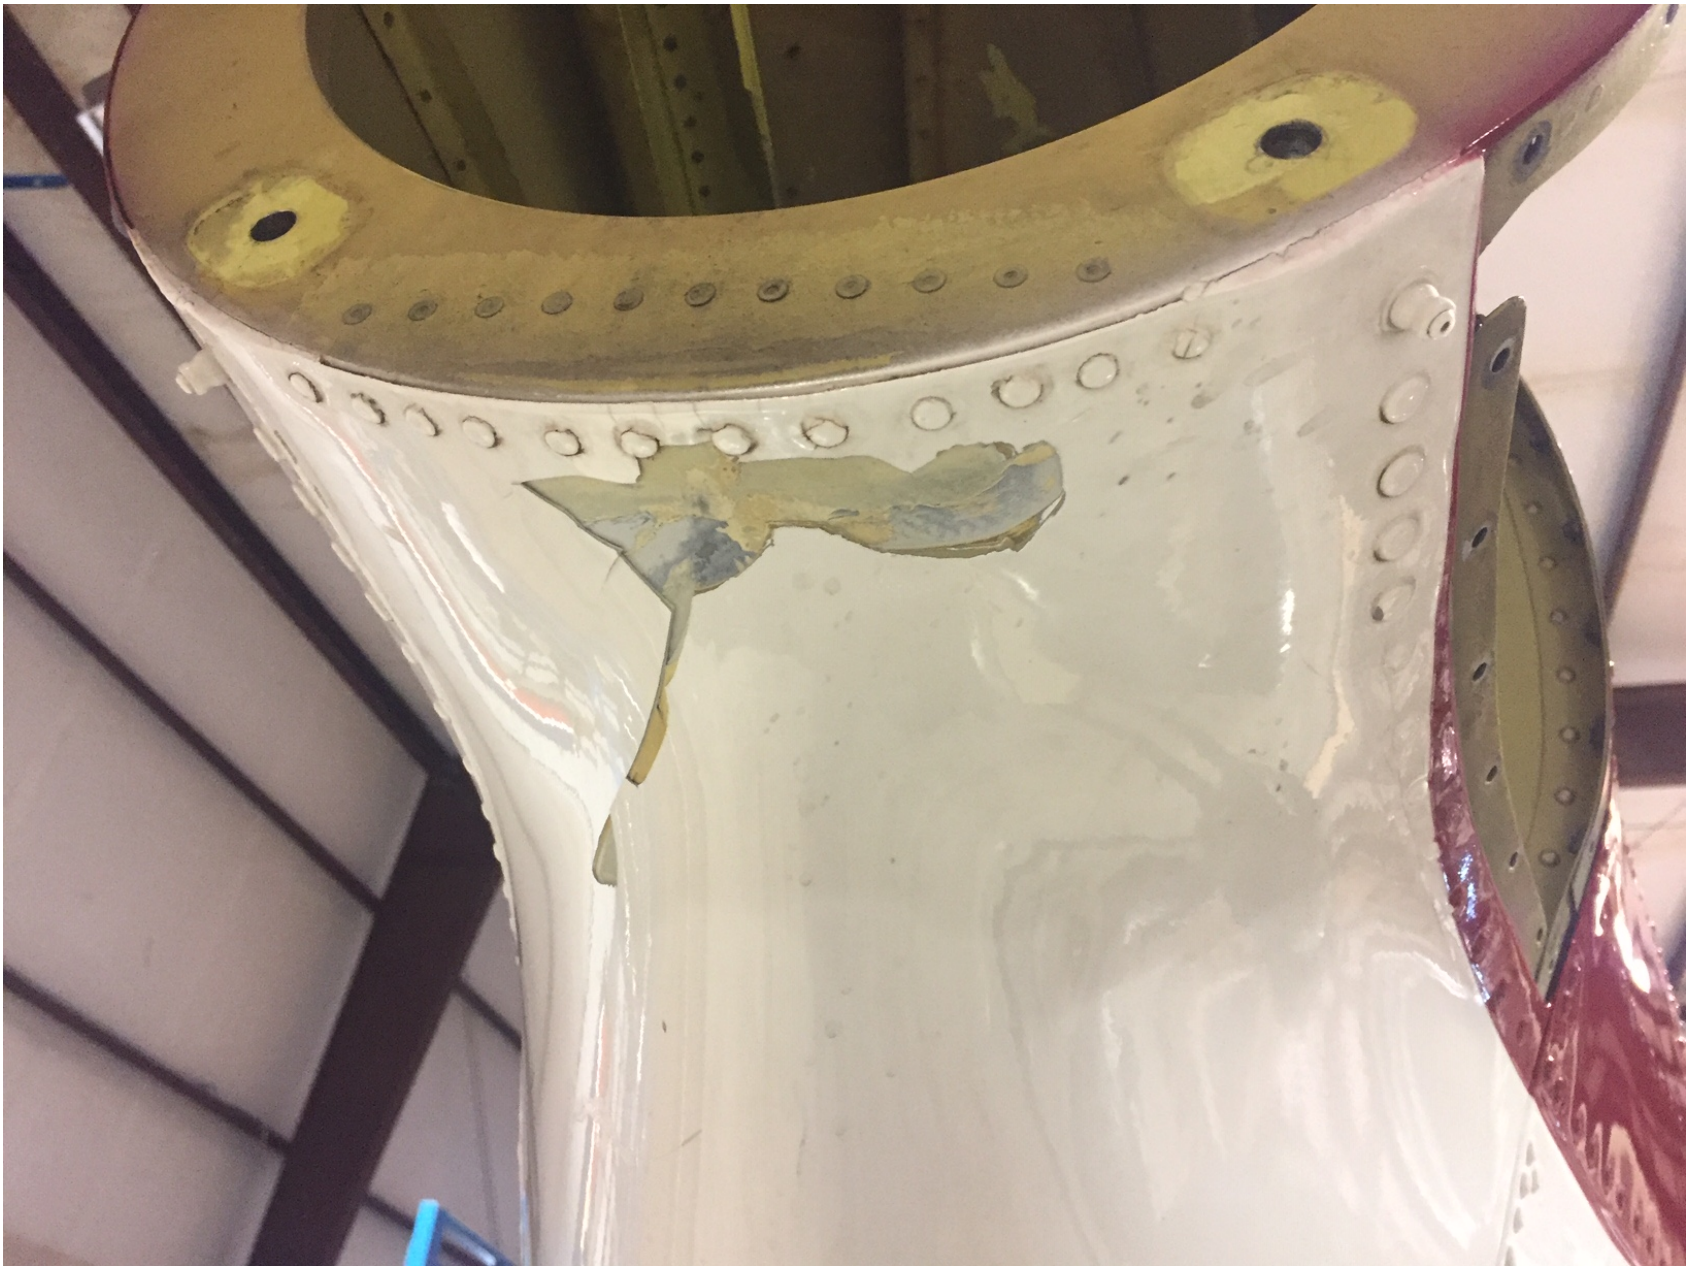
Photo 7 - Supplied photo with a view of deformed skin near the junction of the fuselage and tail boom.

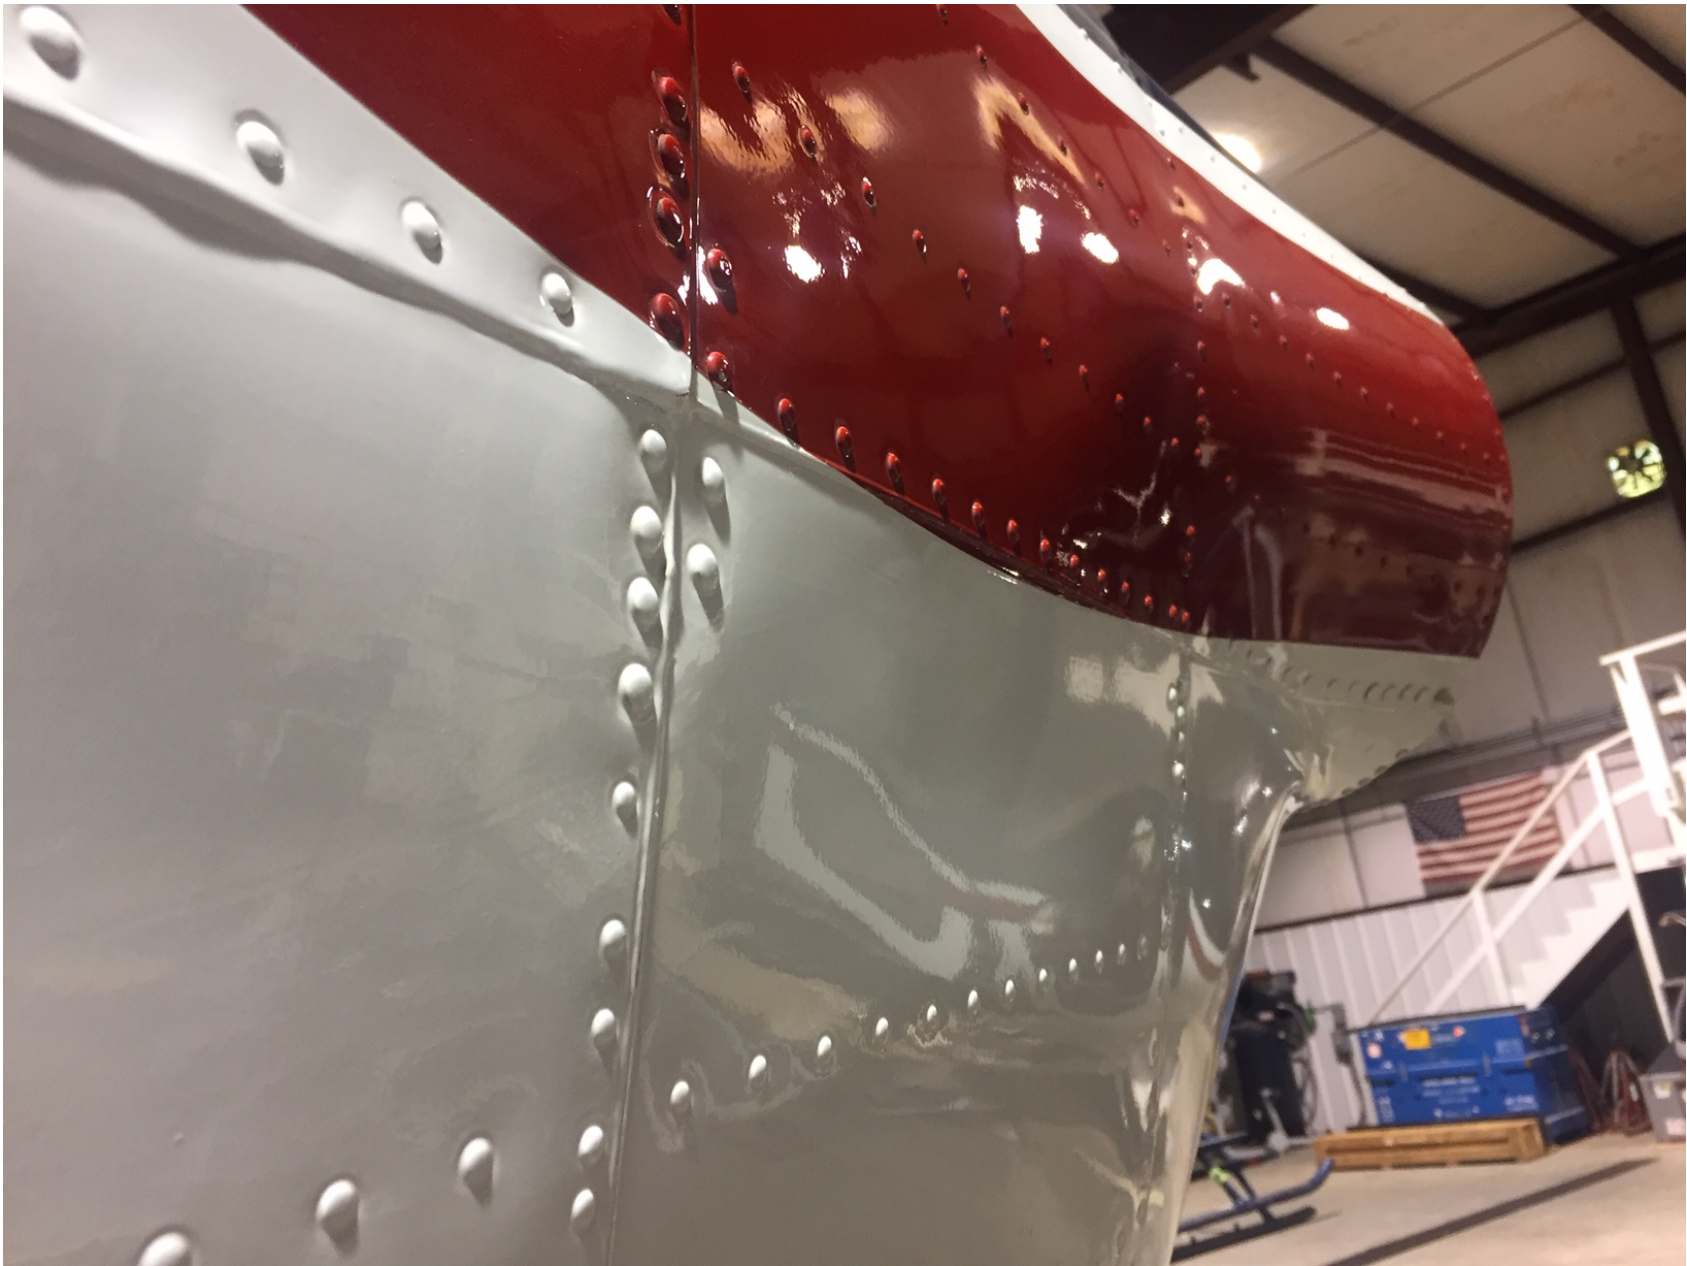
Photo 8 - Supplied photo with a view of deformed skin near the junction of the fuselage and tail boom.

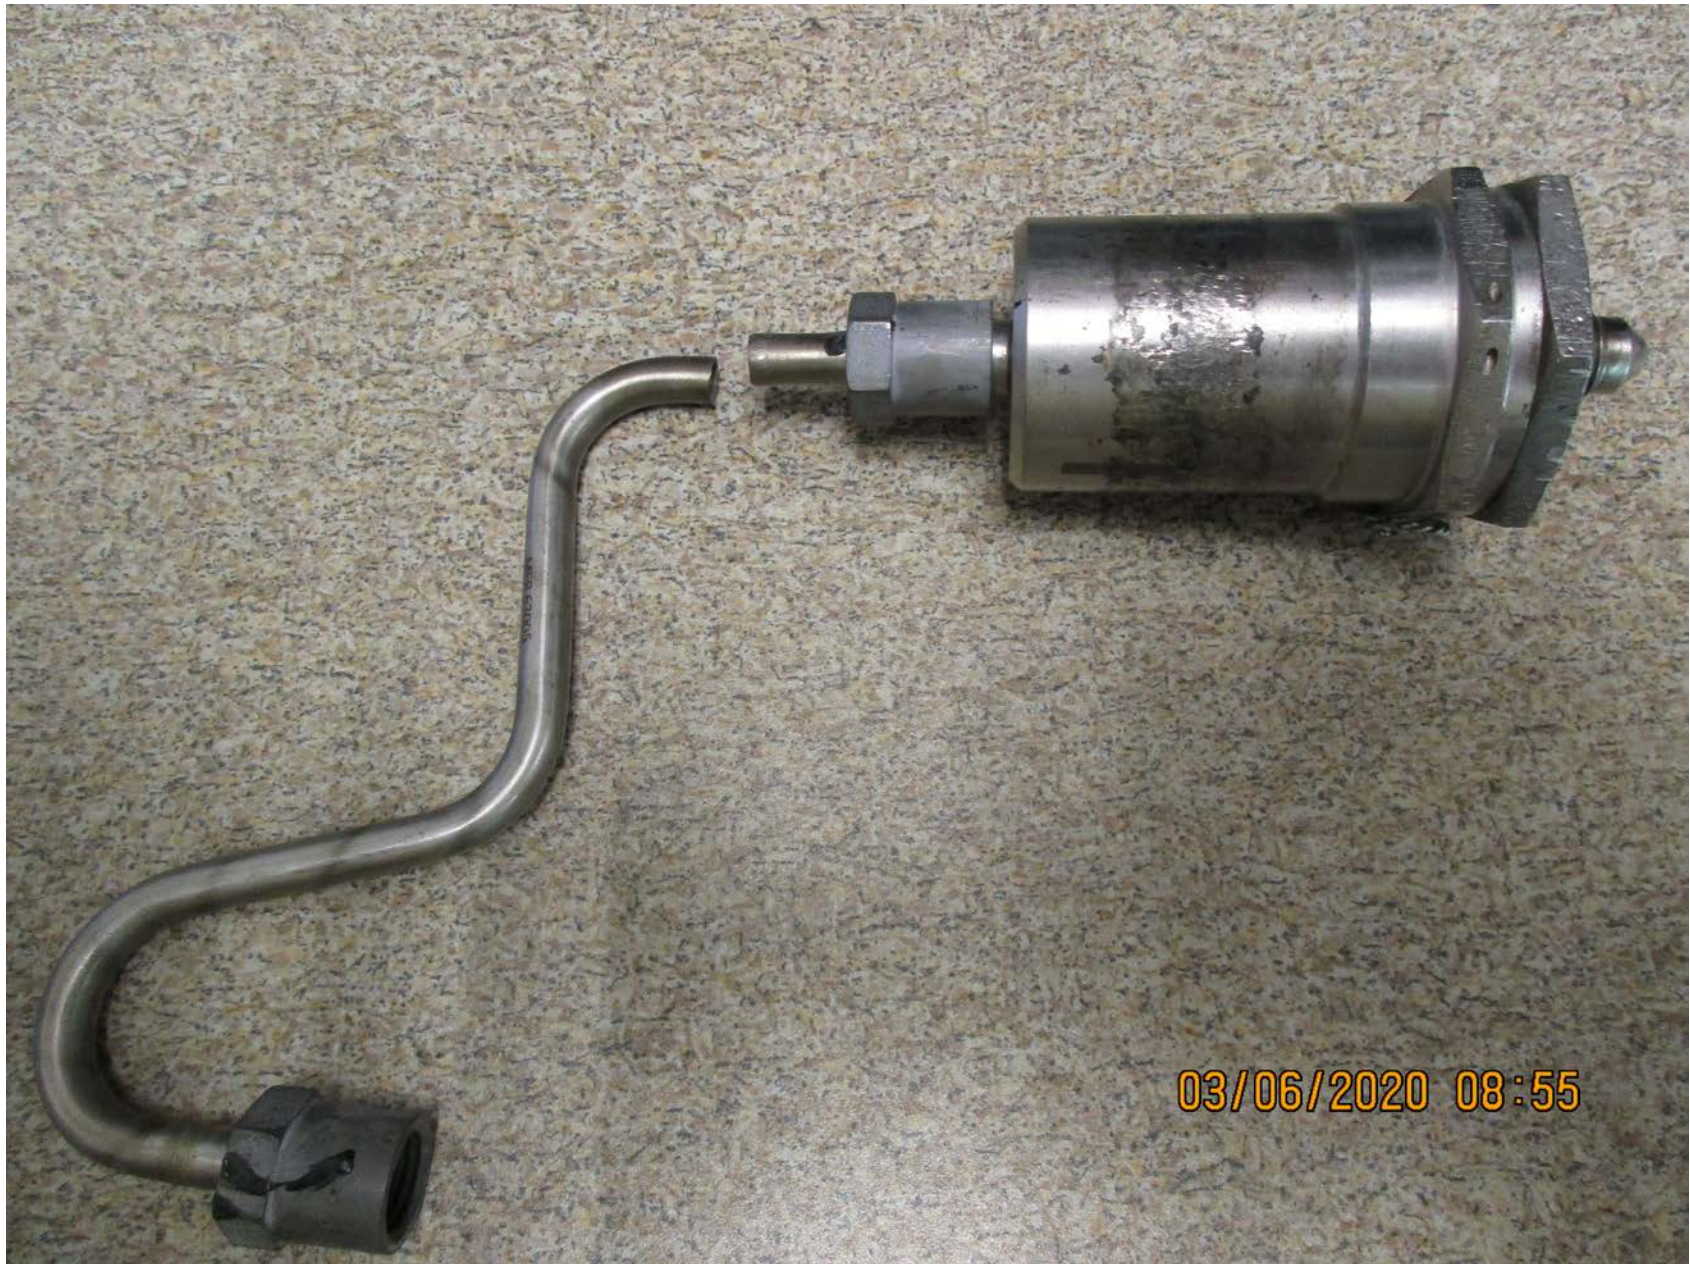
Photo 11 - Supplied photo with a view the Pc Line and its filter. There is a separation in the pneumatic line.

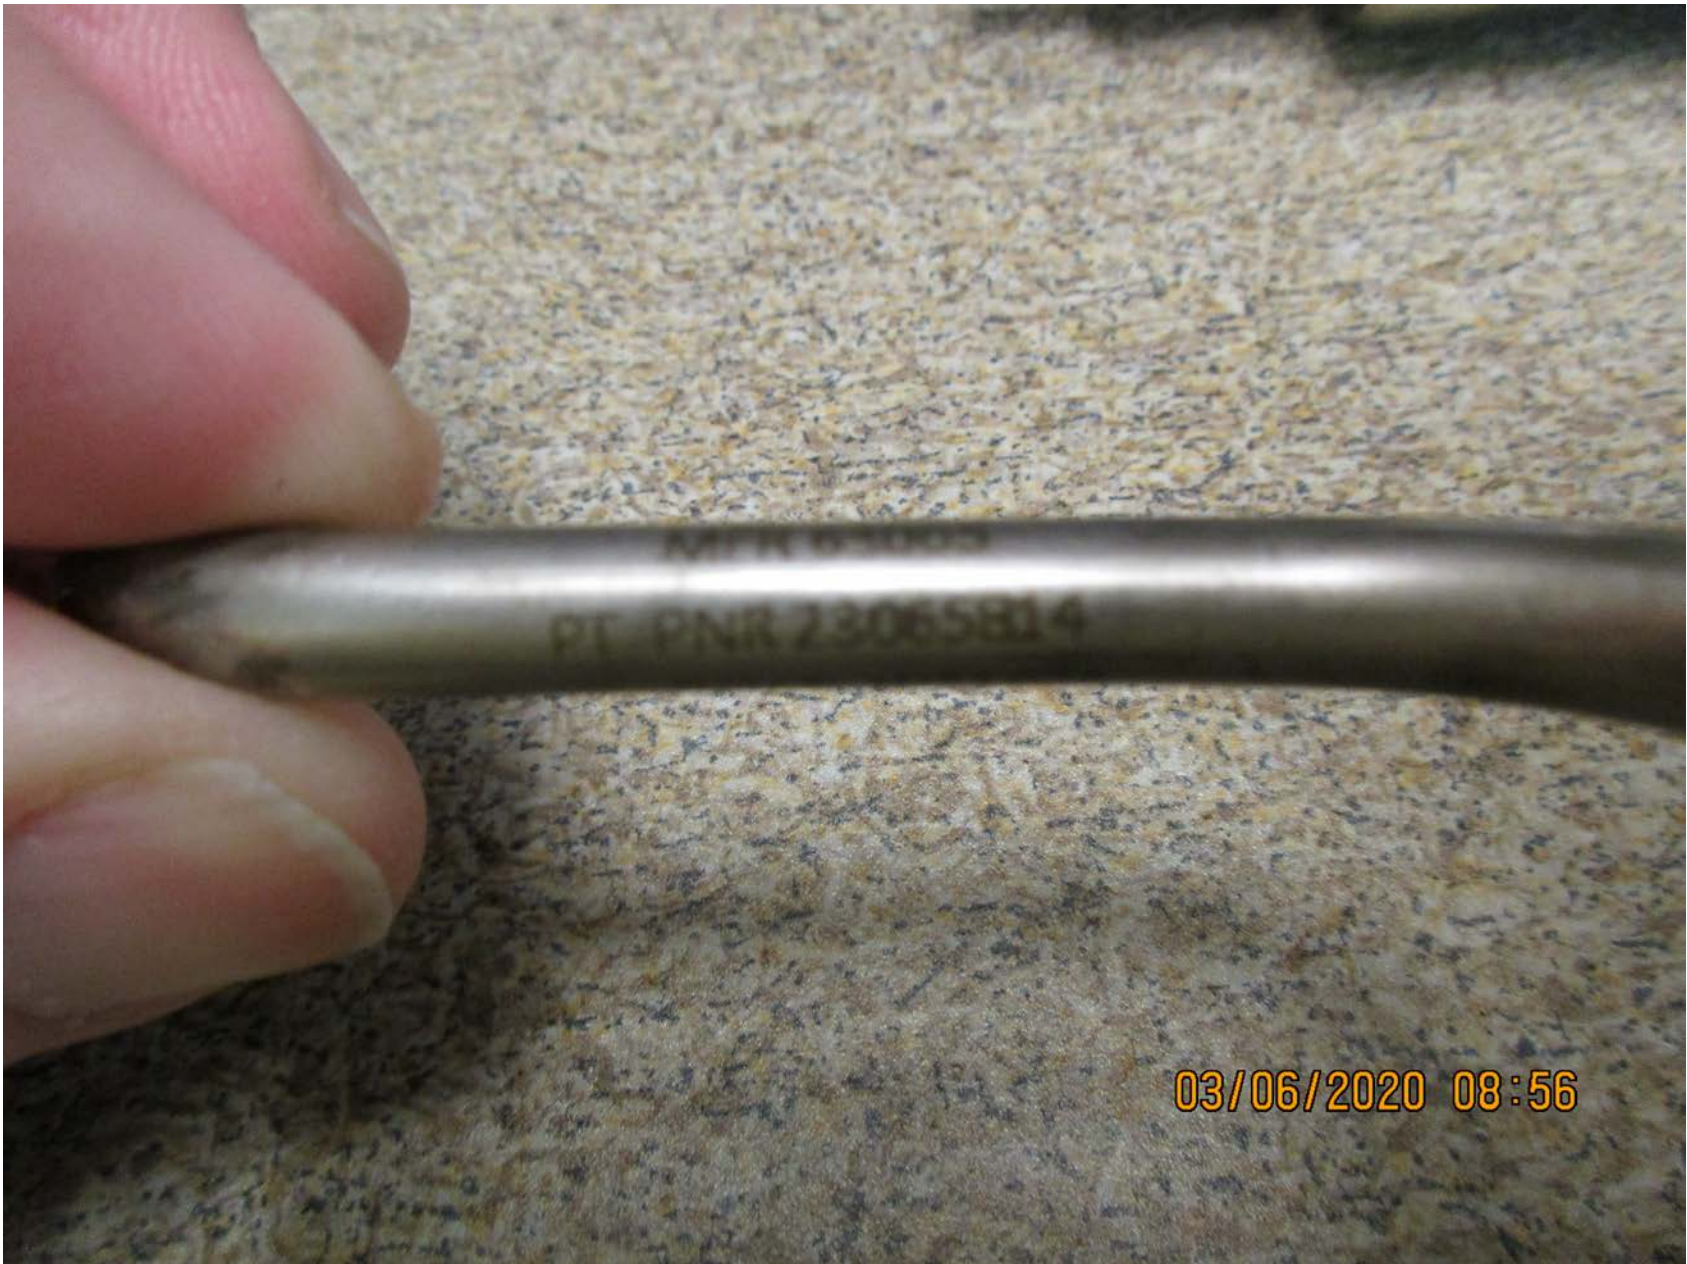
Photo 12 - Supplied photo with a view the Pc Line part number.
