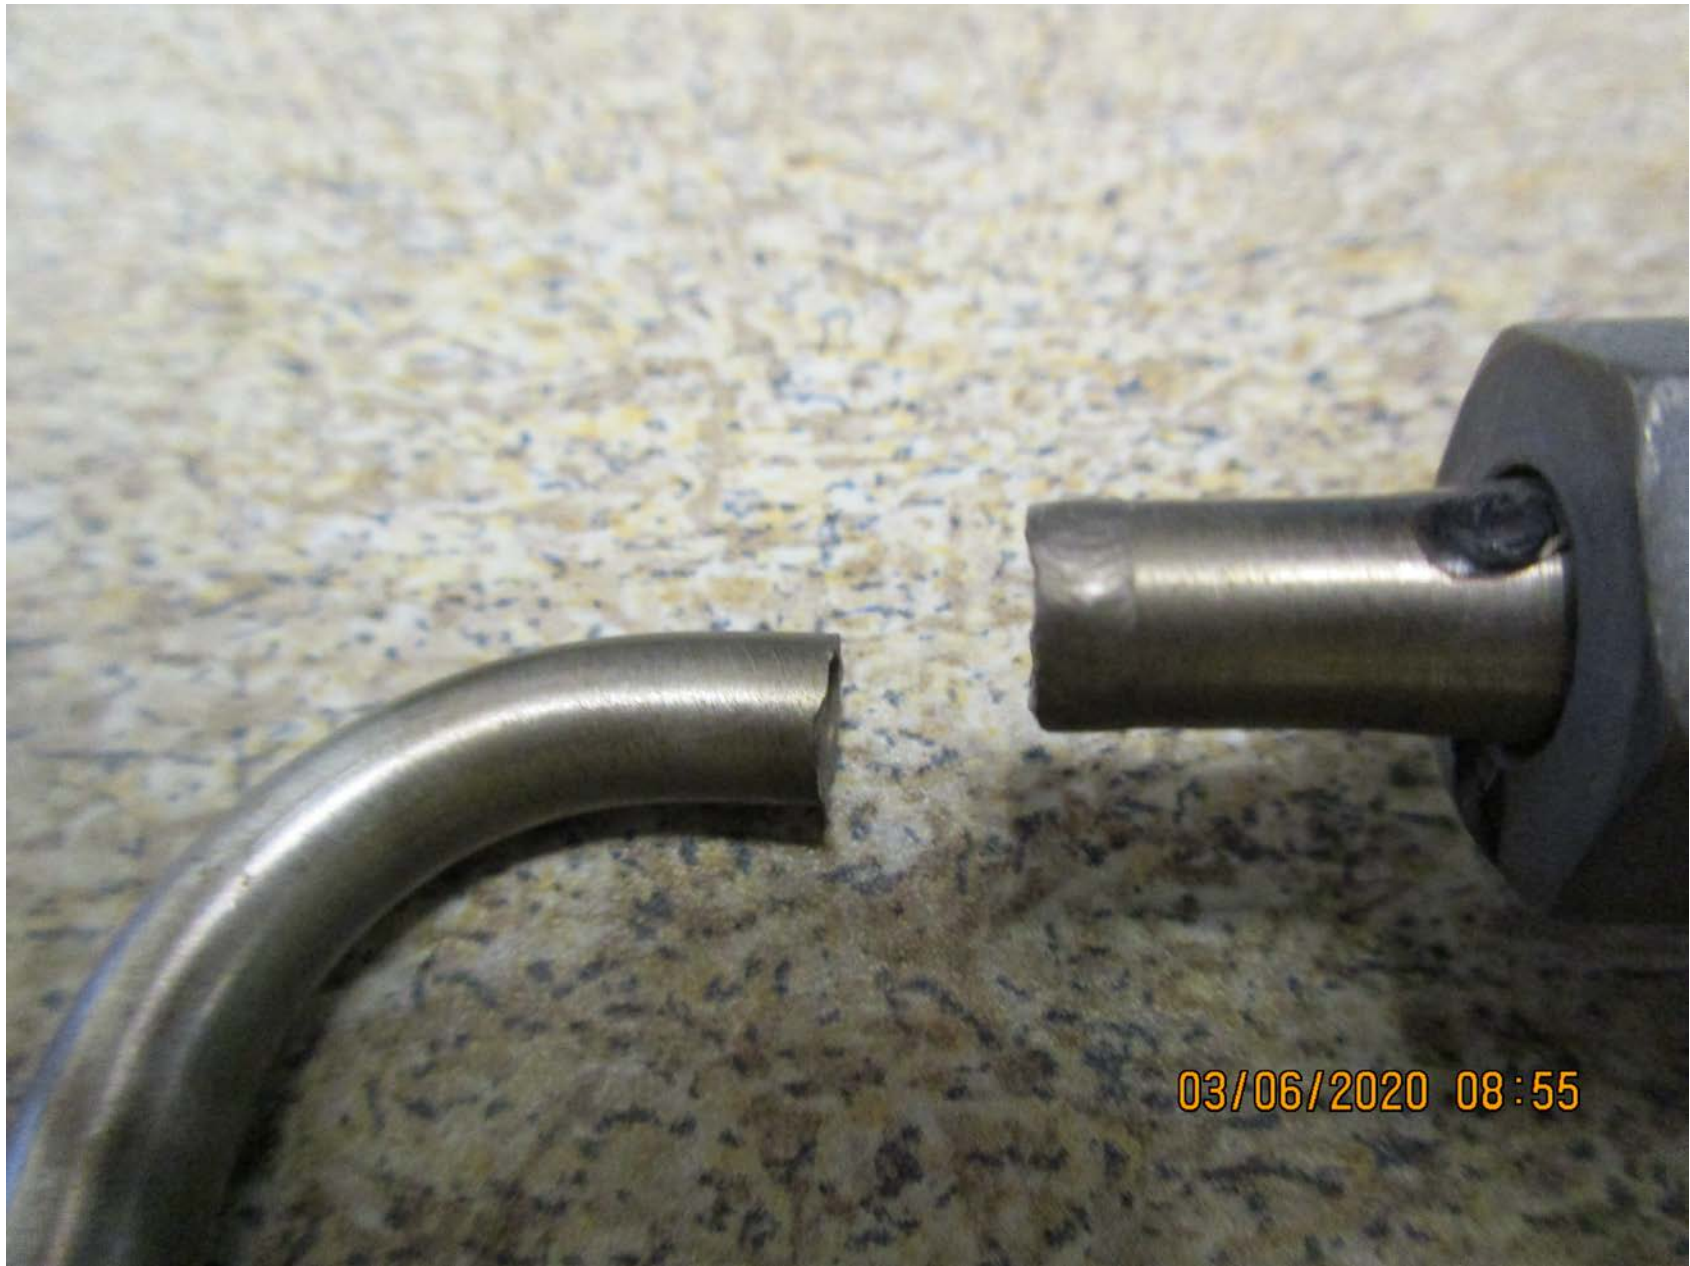
Photo 13 - Supplied photo with a close-up view the separation in th Pc Line.
