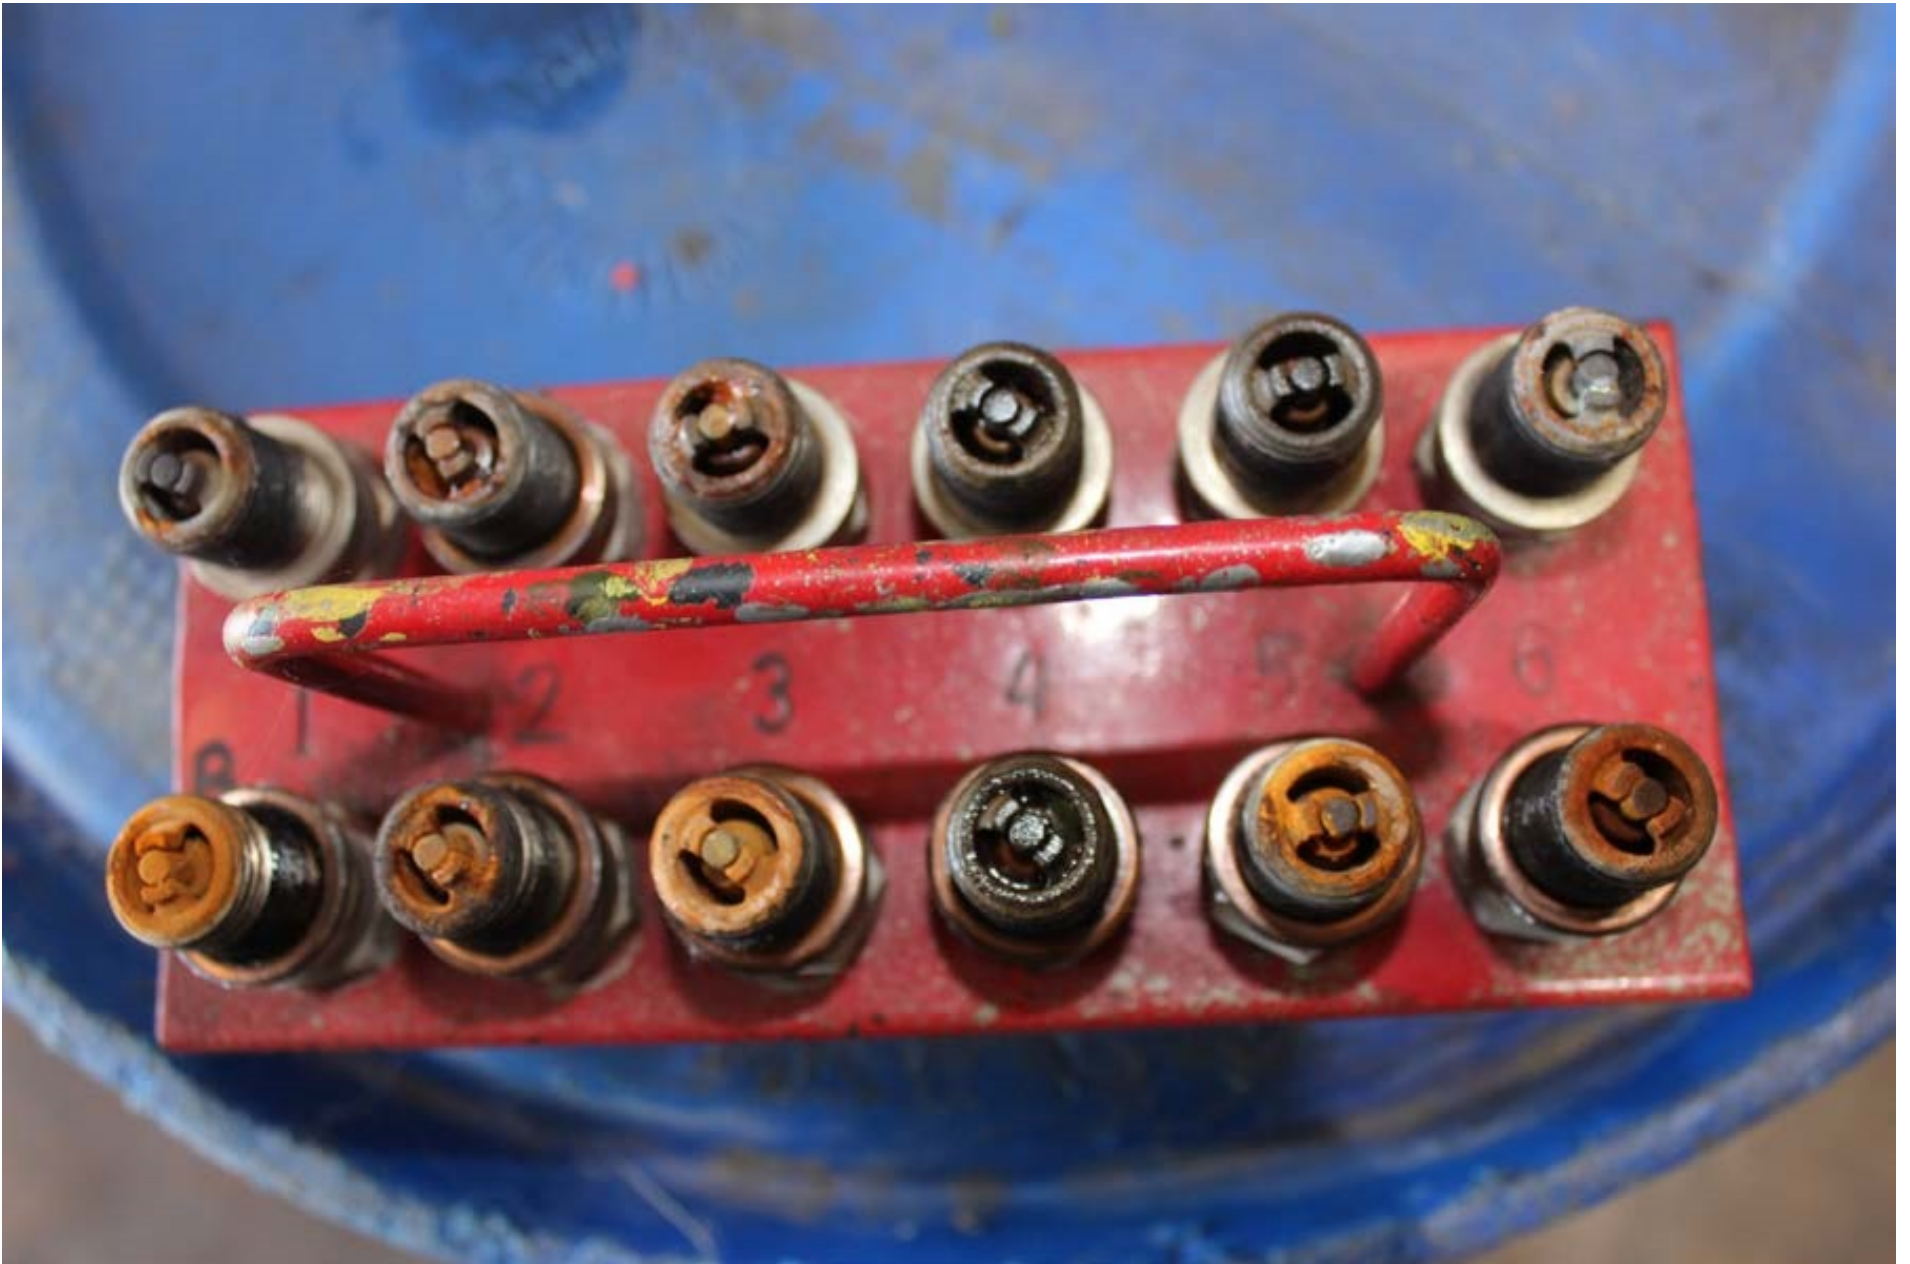
Photo 1 – Supplied photo of removed sparkplugs.

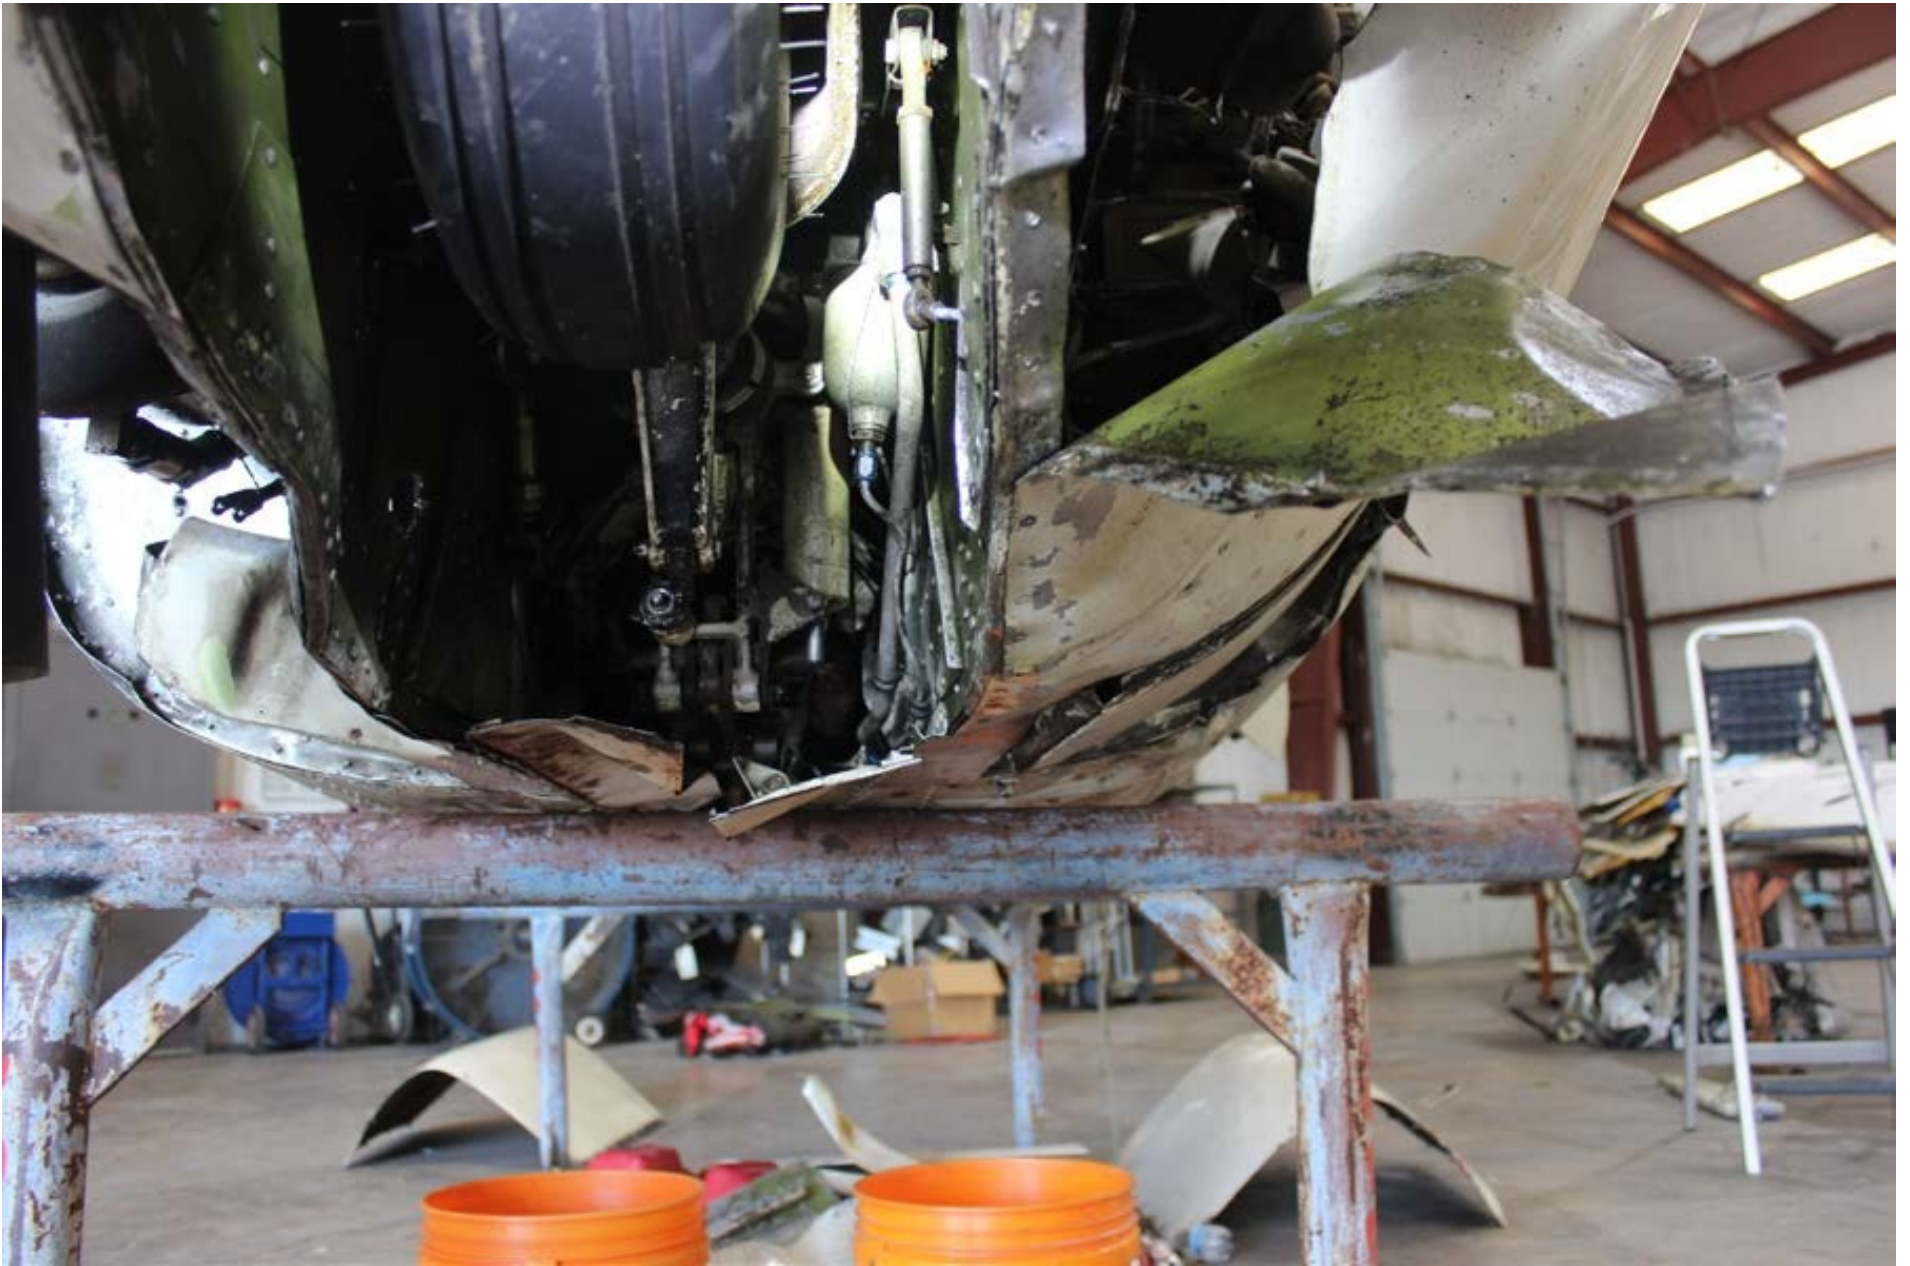
Photo 2 - Supplied photo of the fuel strainer in the nose wheel well.

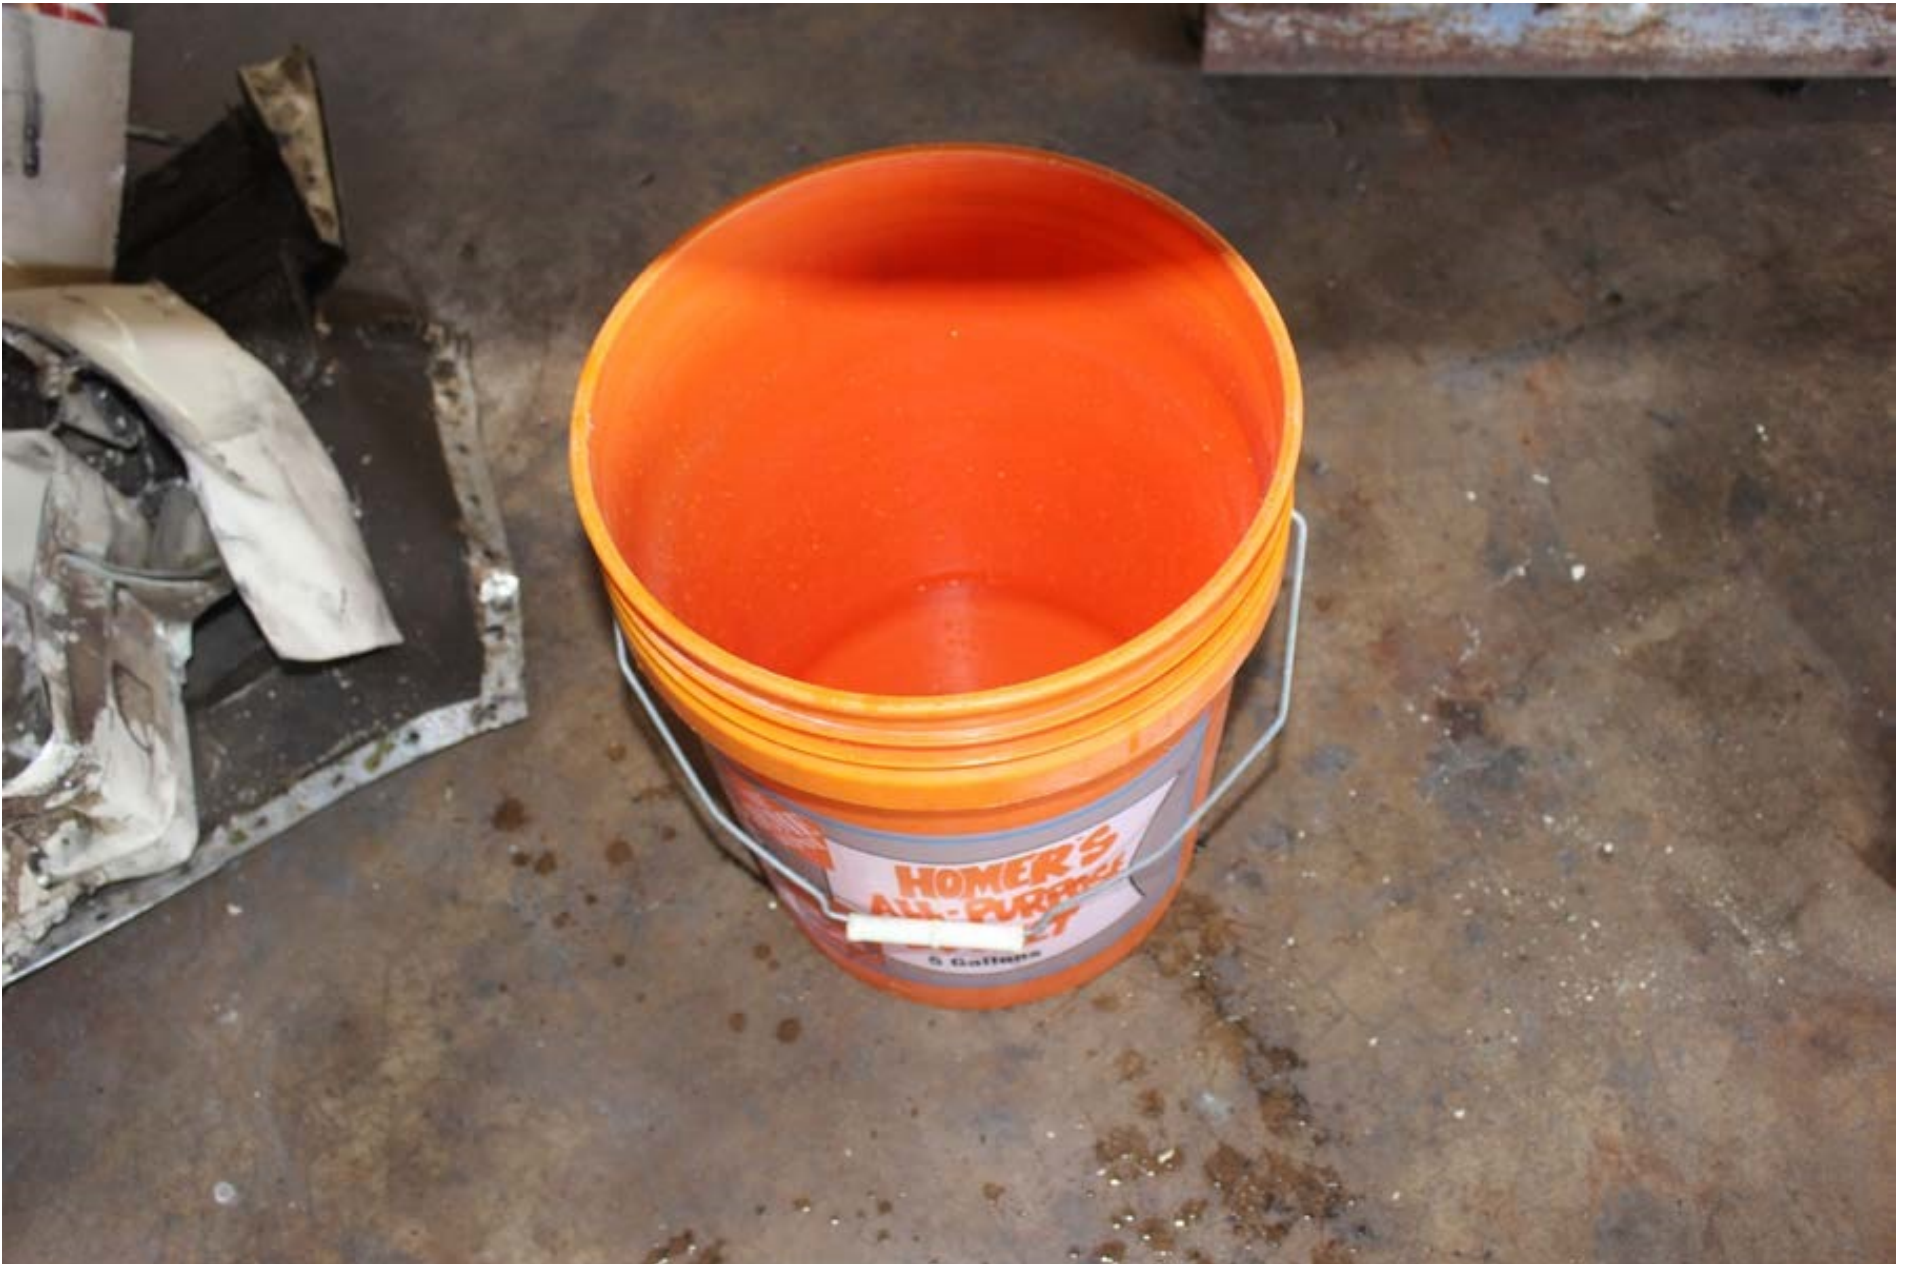
Photo 3 - Supplied photo of about 1/2 gallon of liquid consistent with water from the right header fuel tank.

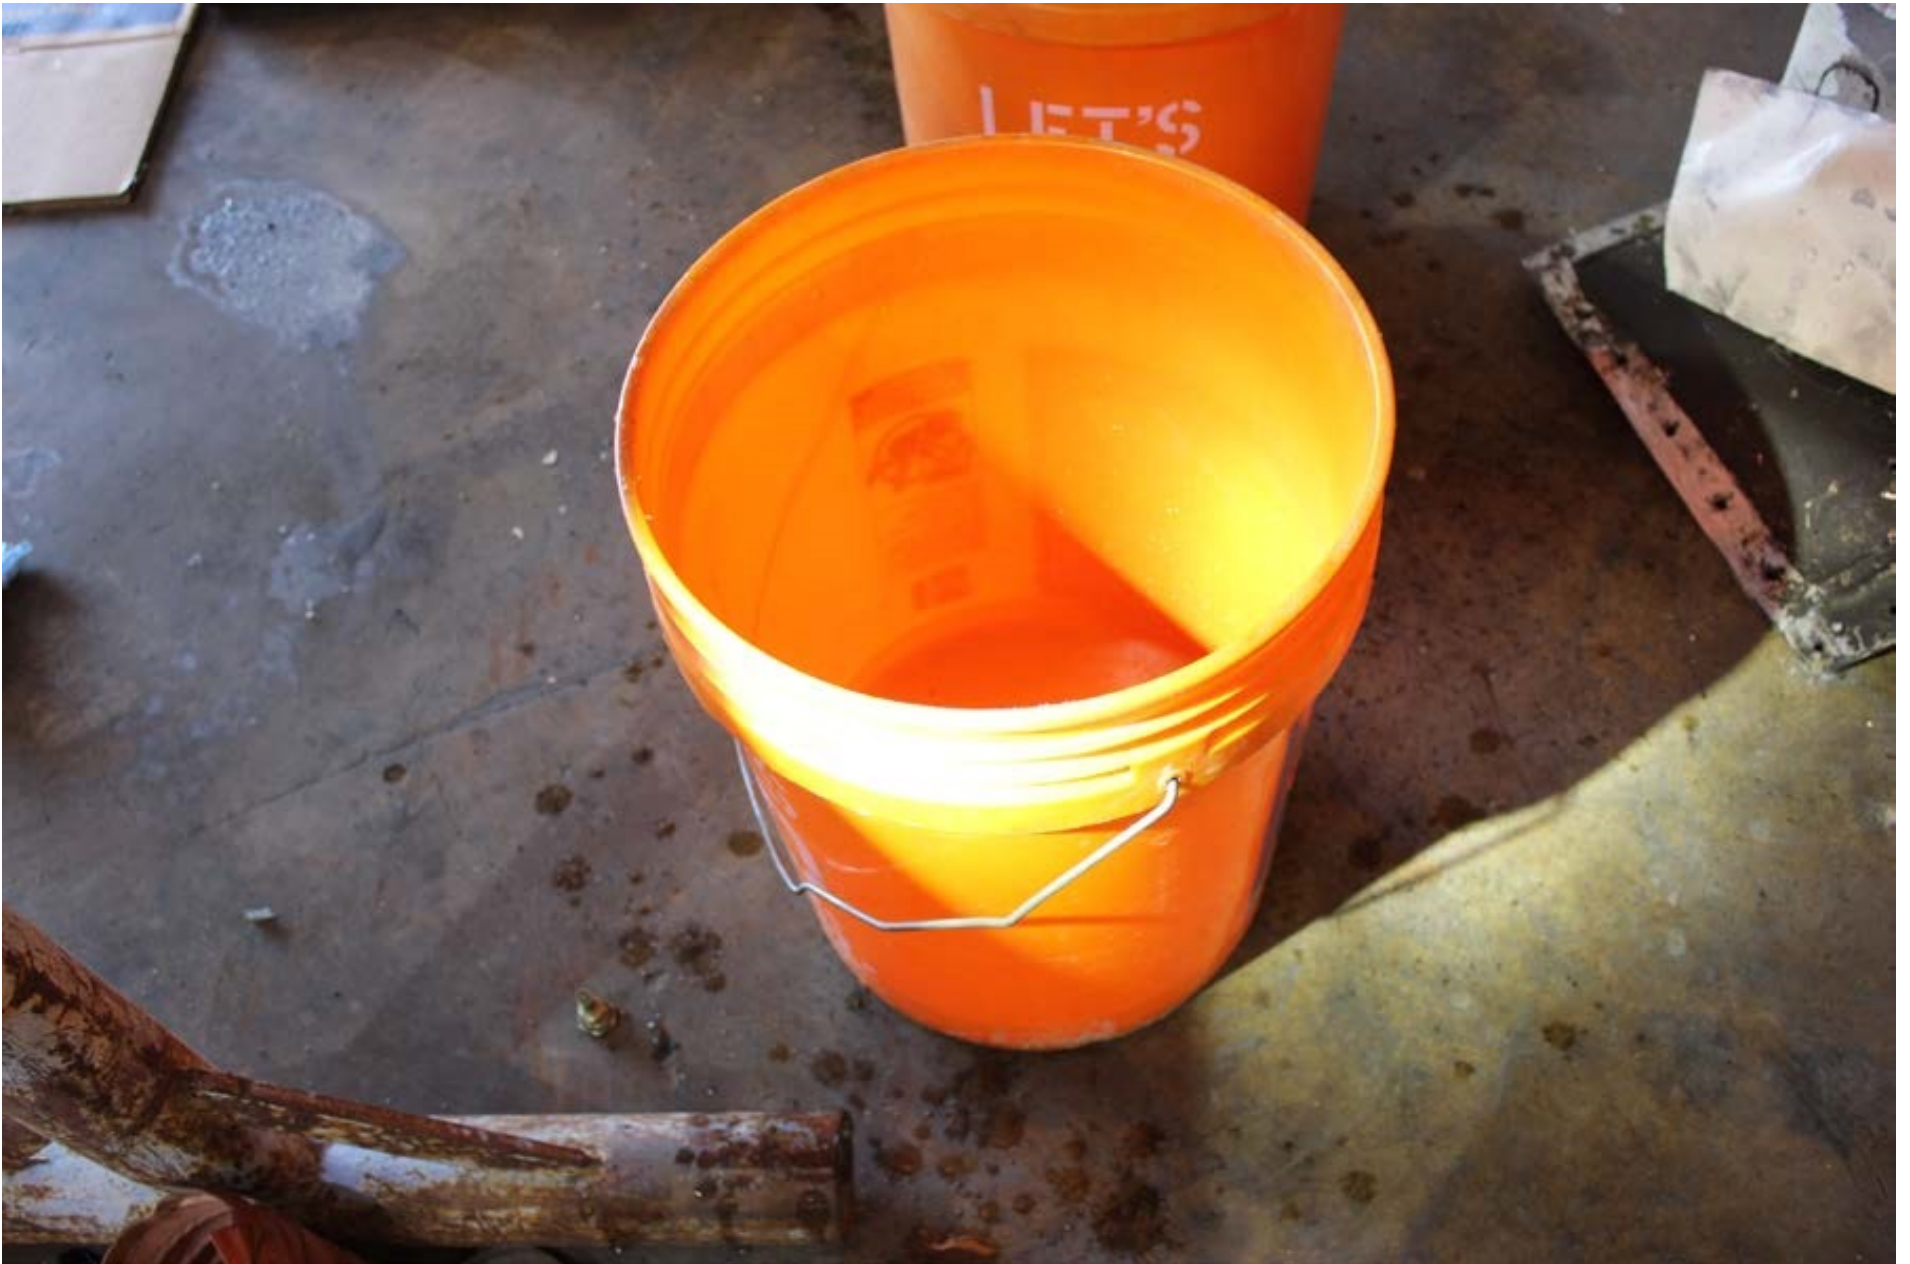
Photo 4 - Supplied photo of about 1/2 gallon of liquid consistent with water from the left header fuel tank.

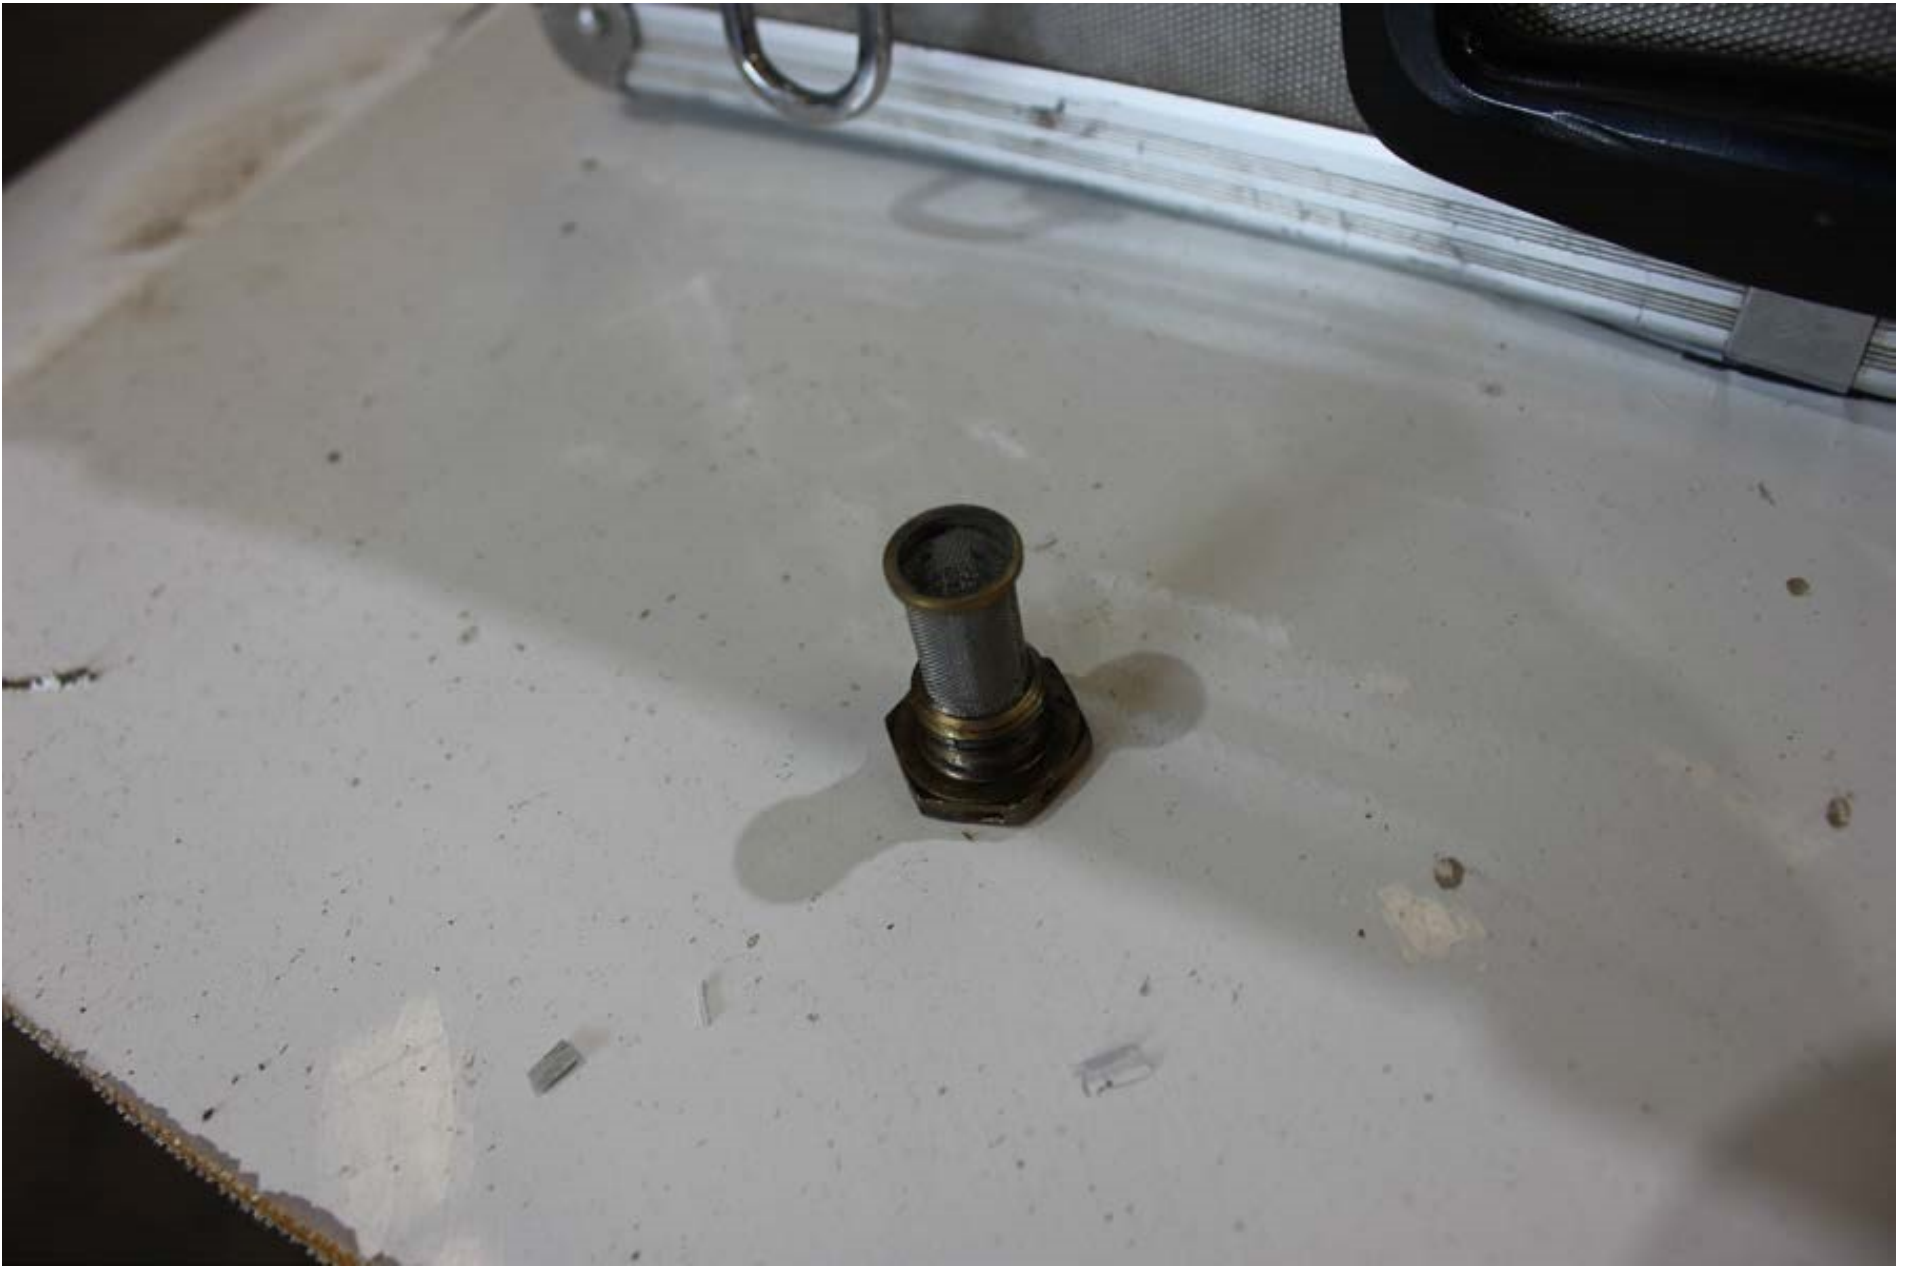
Photo 5 - Supplied photo of the fuel filter screen.

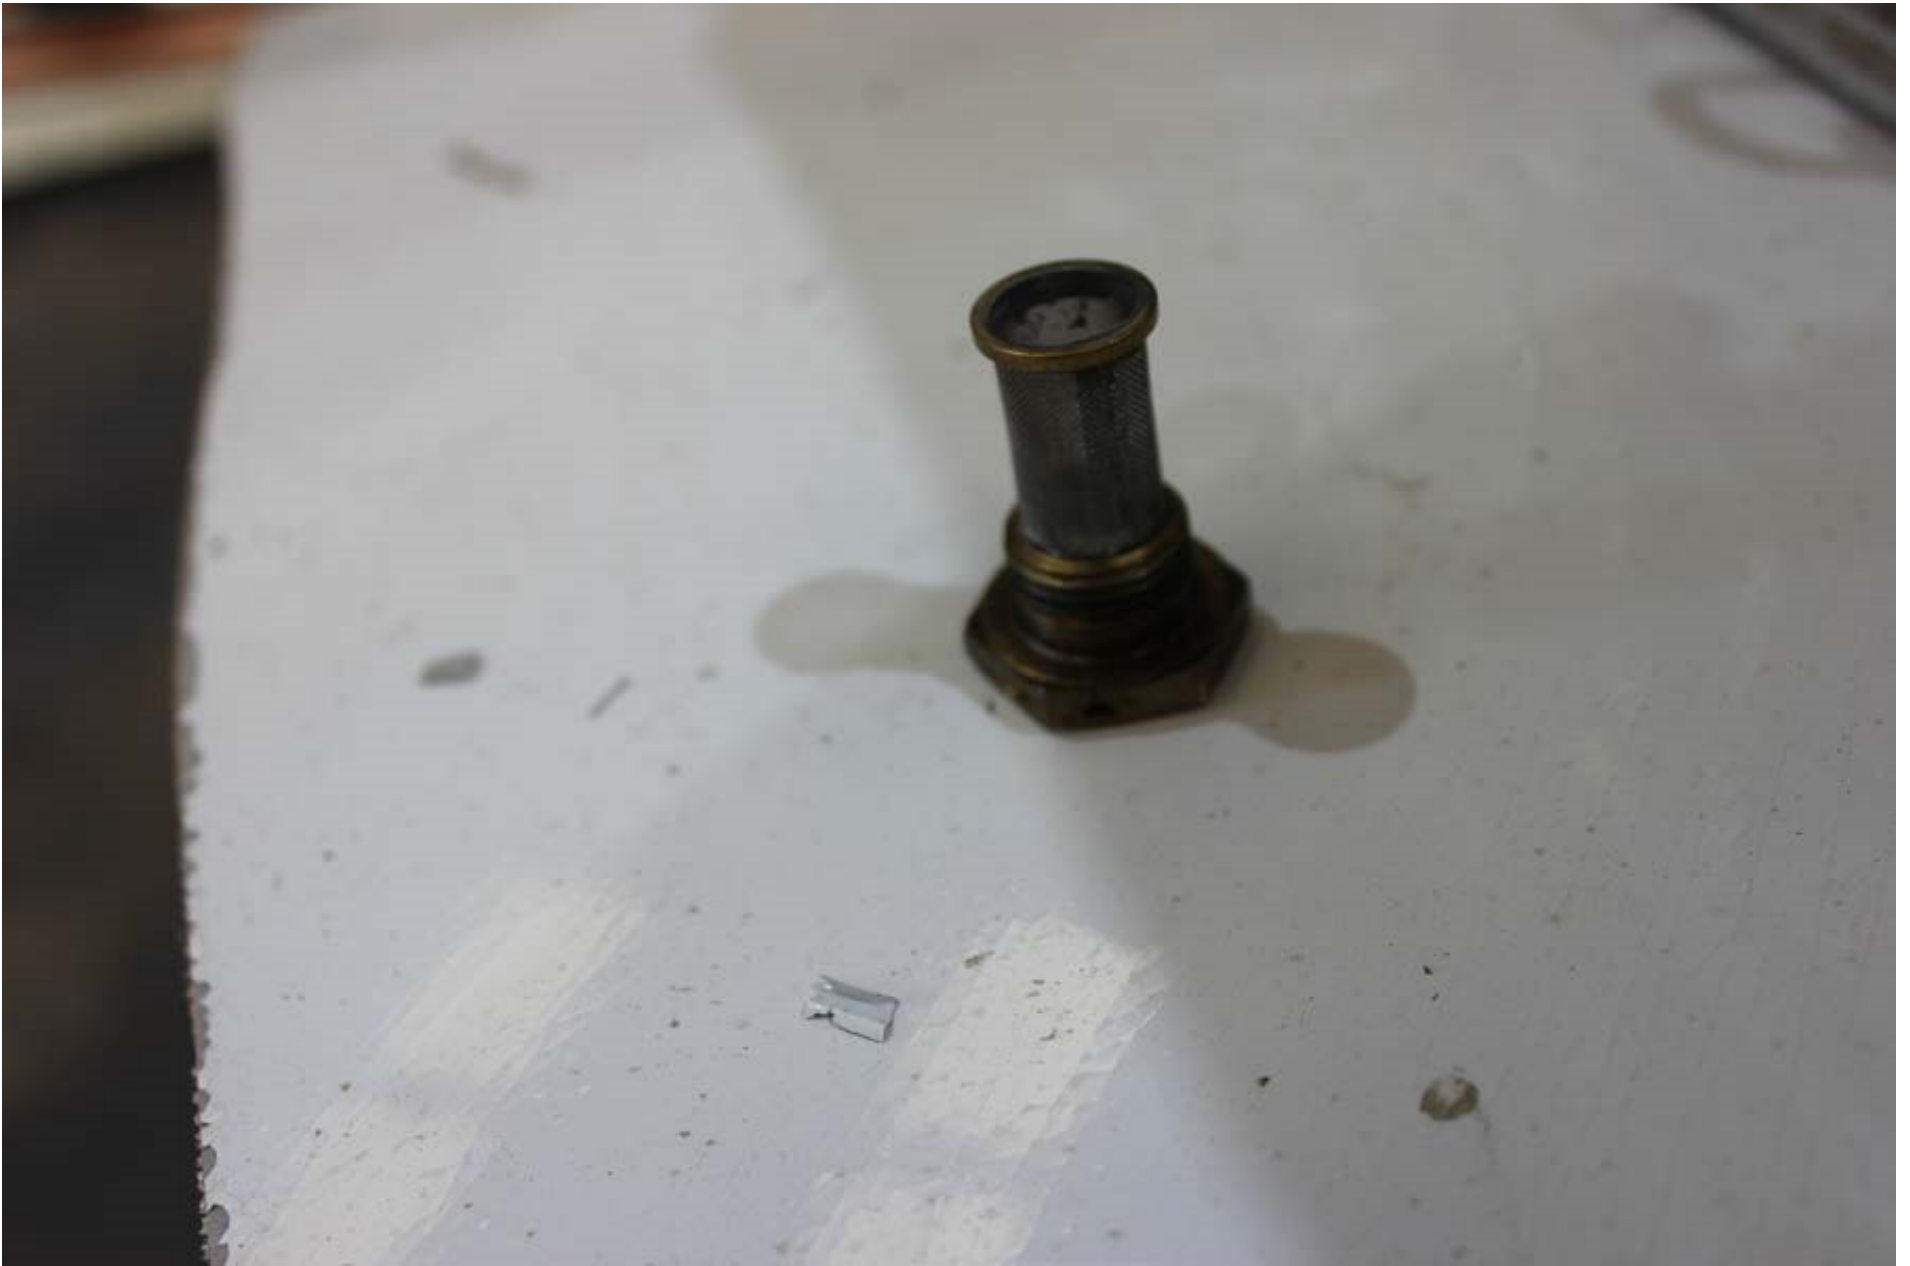
Photo 6 - Supplied close-up photo of the fuel filter screen.

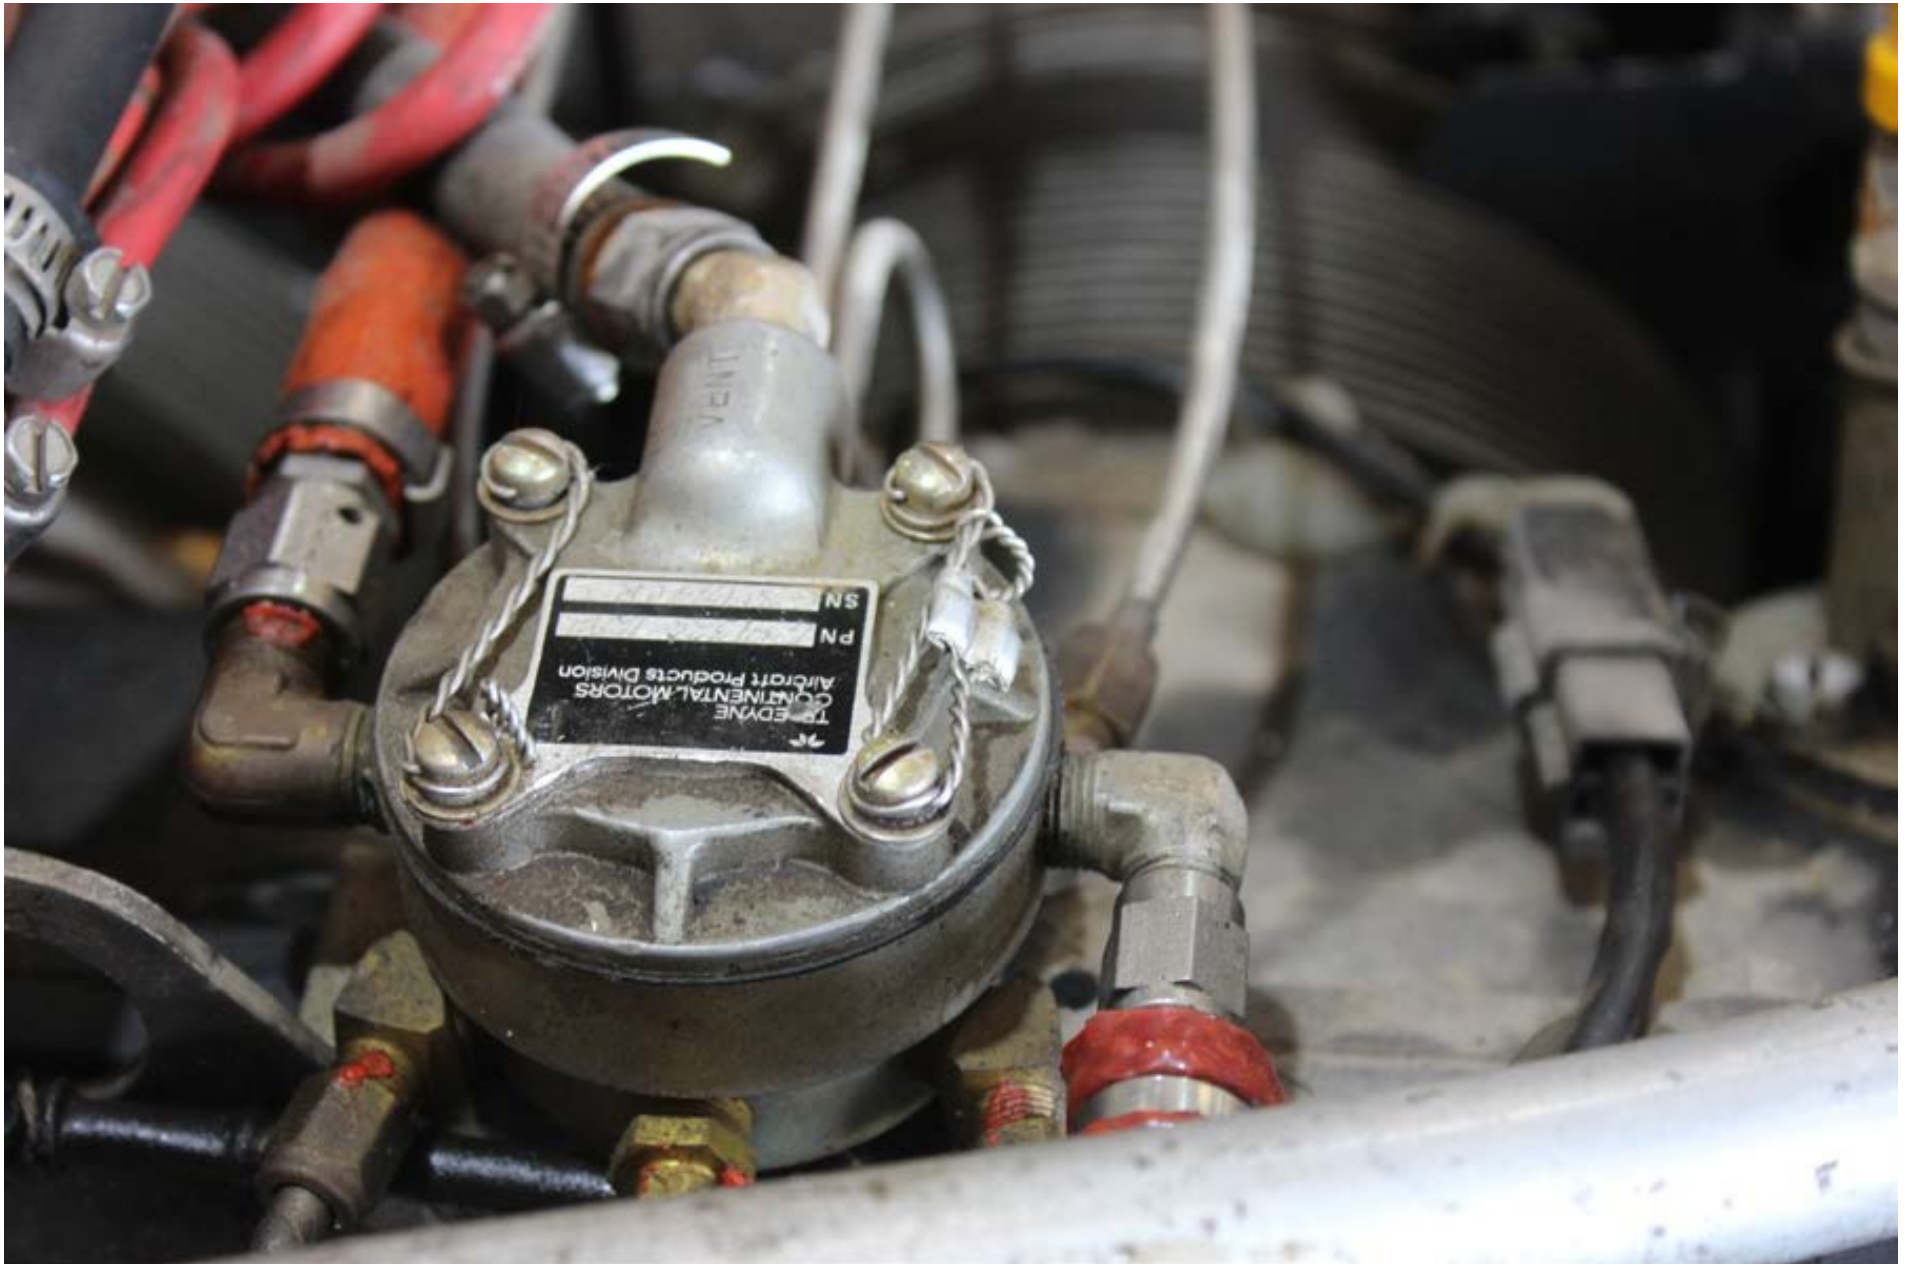
Photo 7 - Supplied close-up photo of the fuel manifold valve.

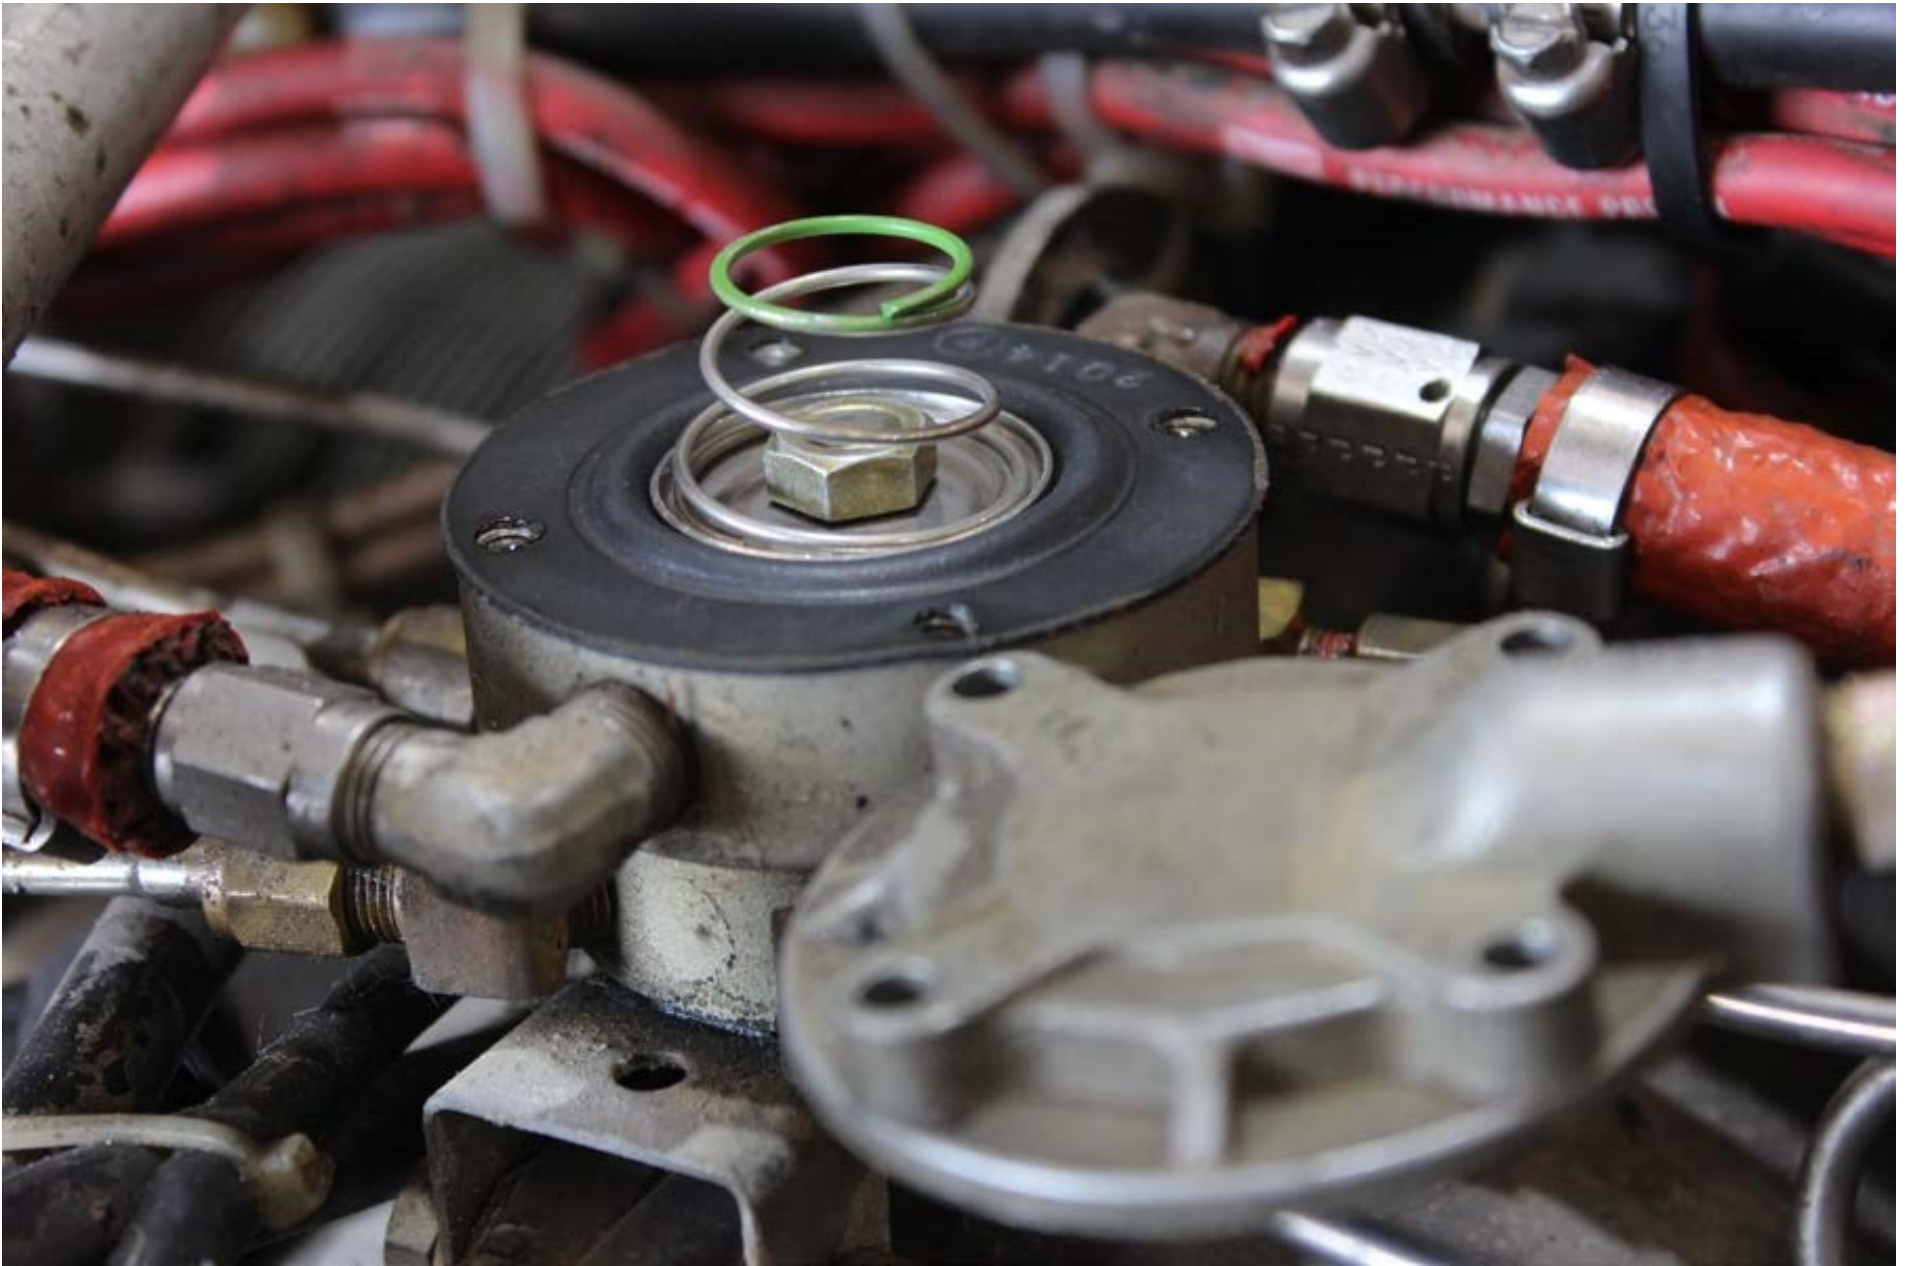
Photo 8 - Supplied close-up photo of the disassembled fuel manifold valve.

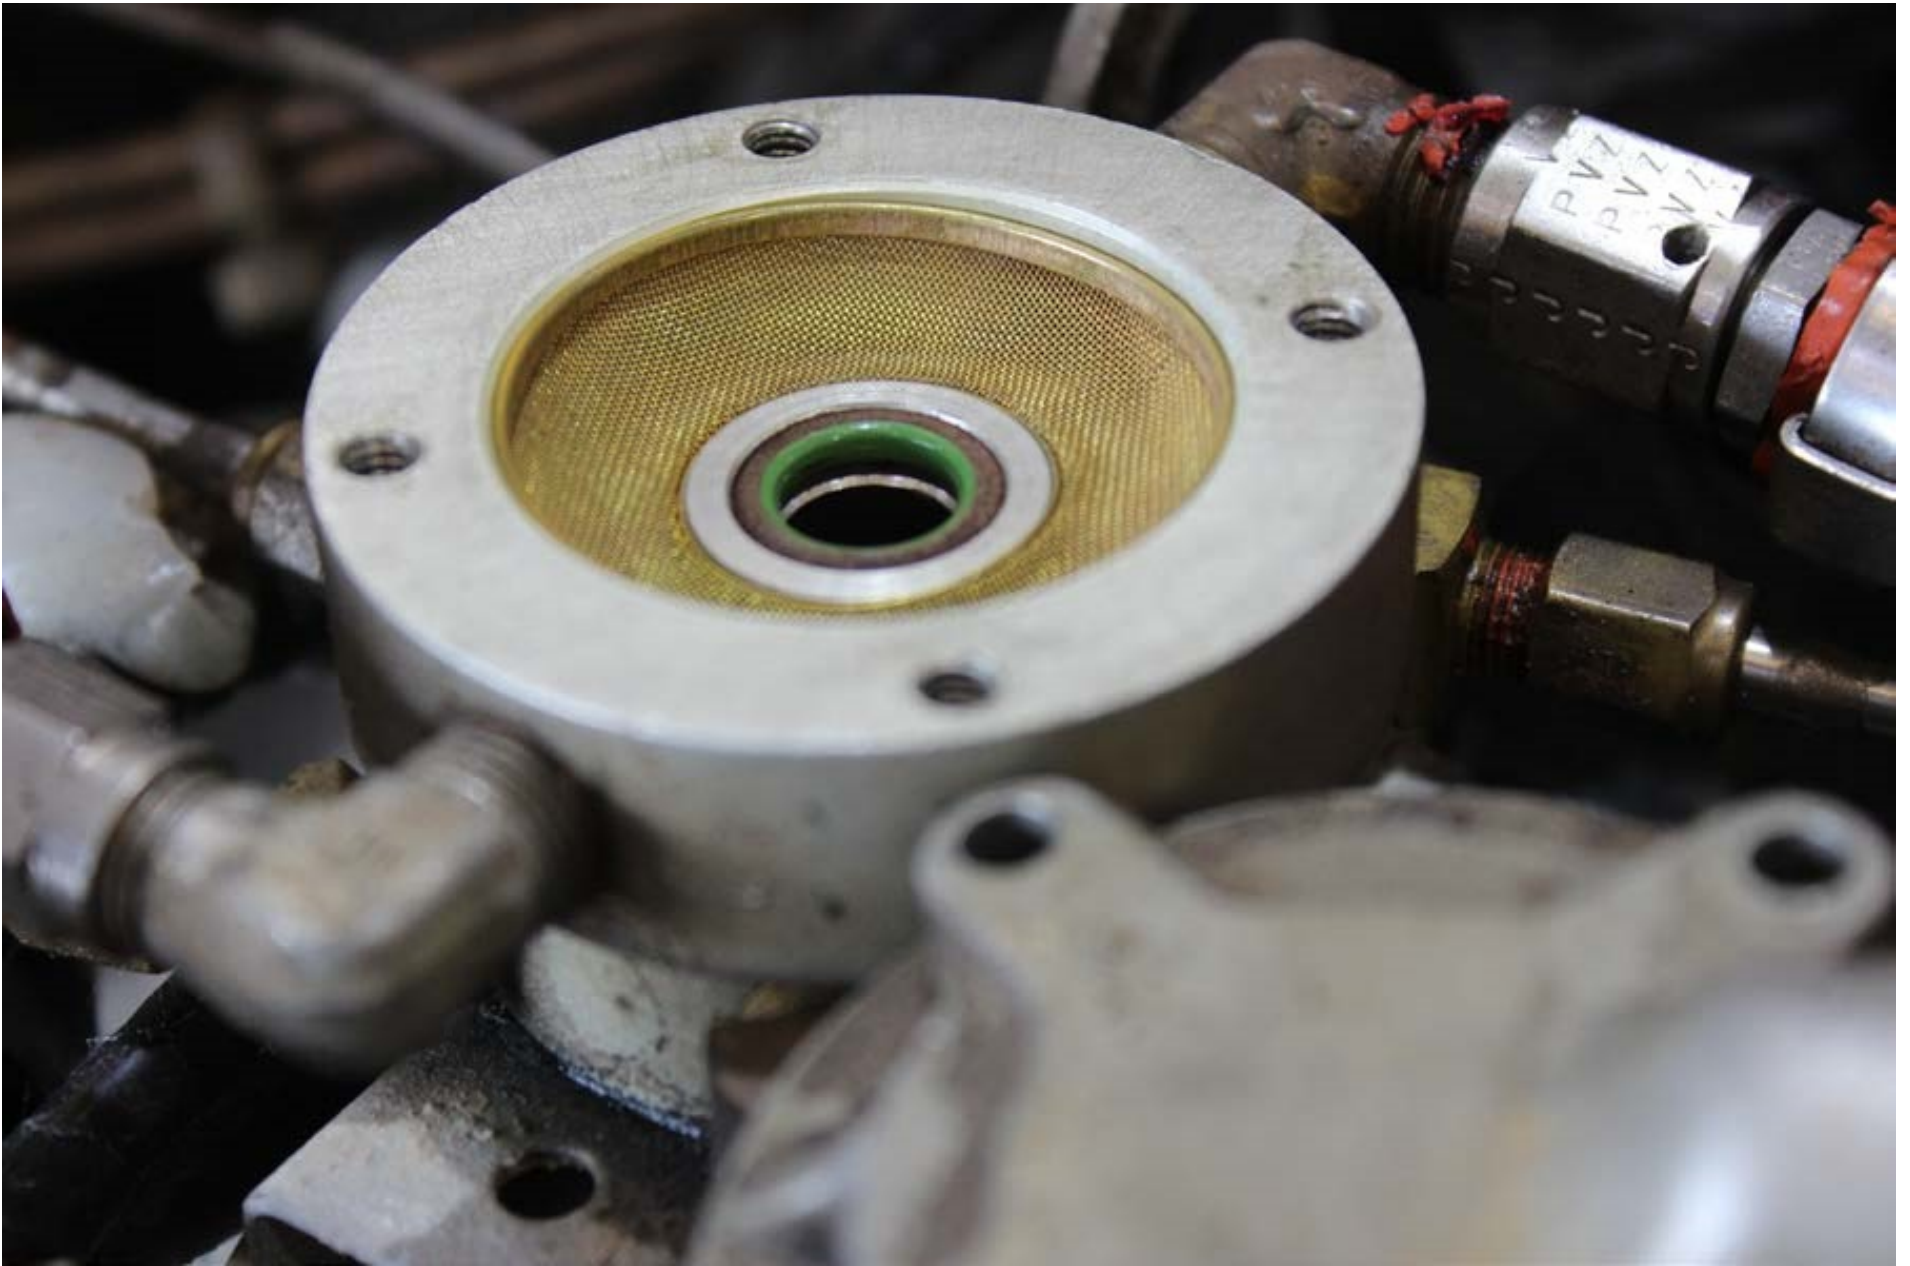
Photo 9 - Supplied close-up photo of the screen in the disassembled fuel manifold valve.
