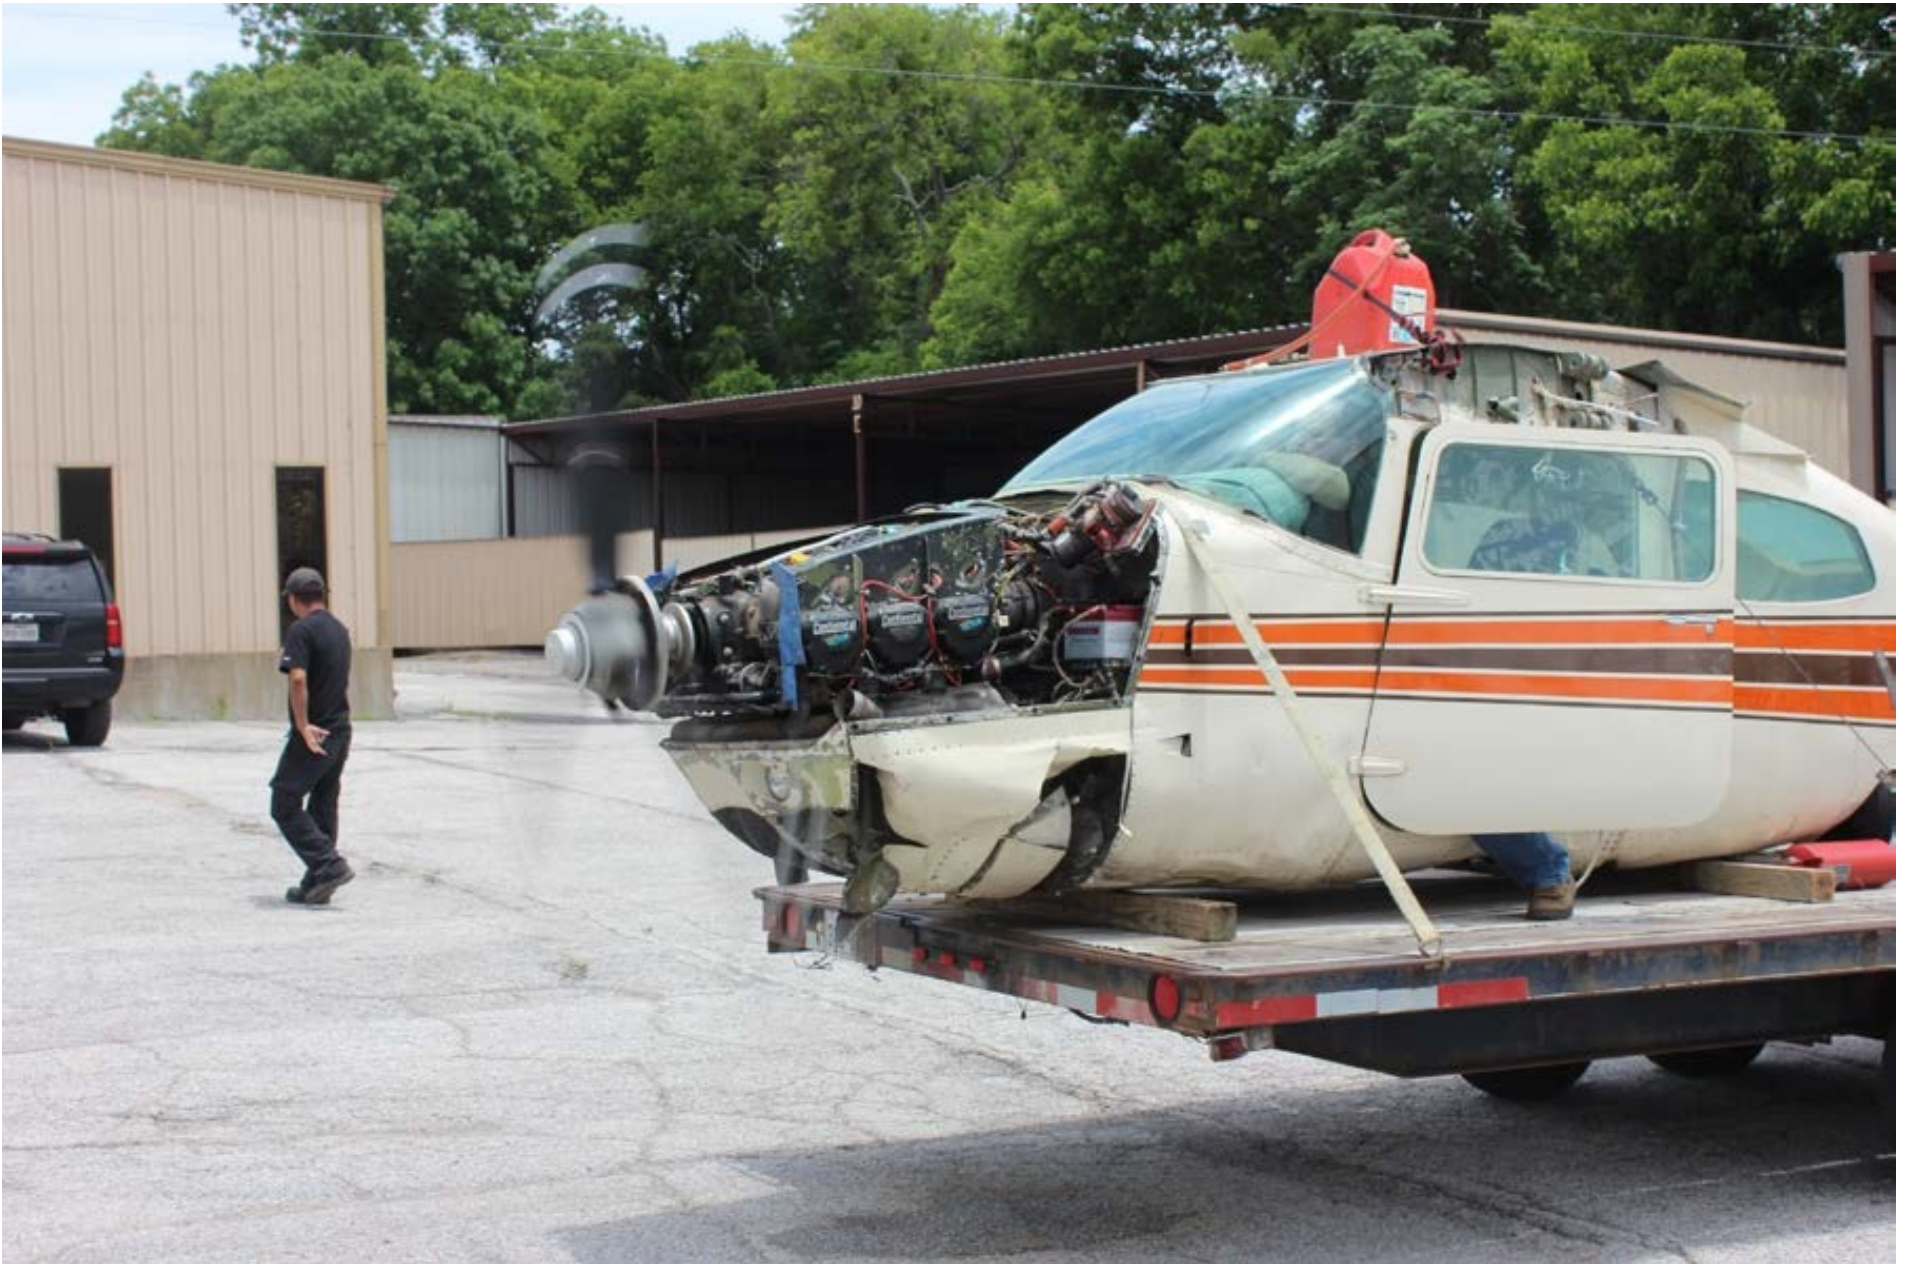
Photo 15 - Supplied photo of the engine start.

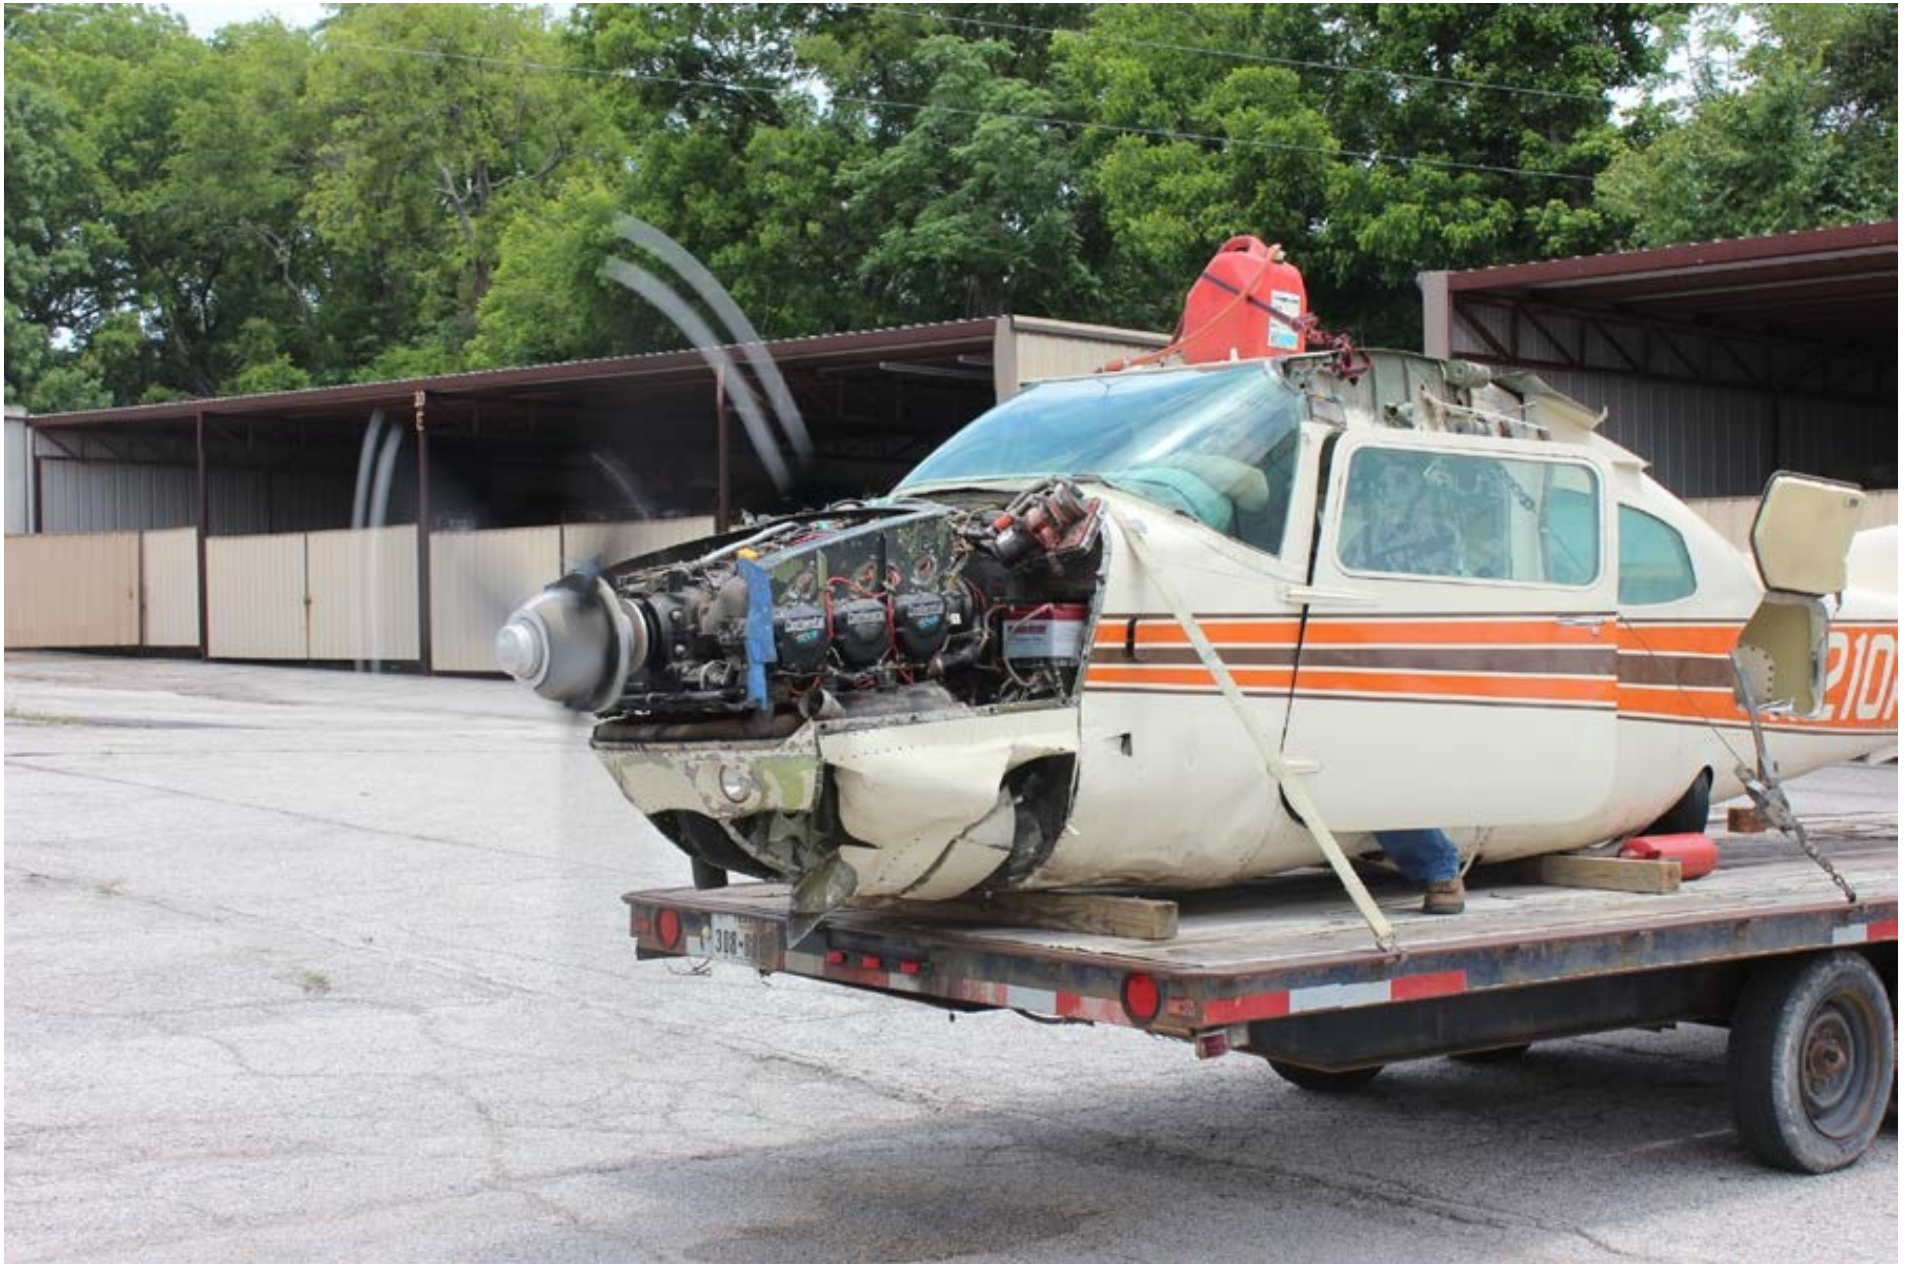
Photo 16 - Supplied photo of the engine run.
