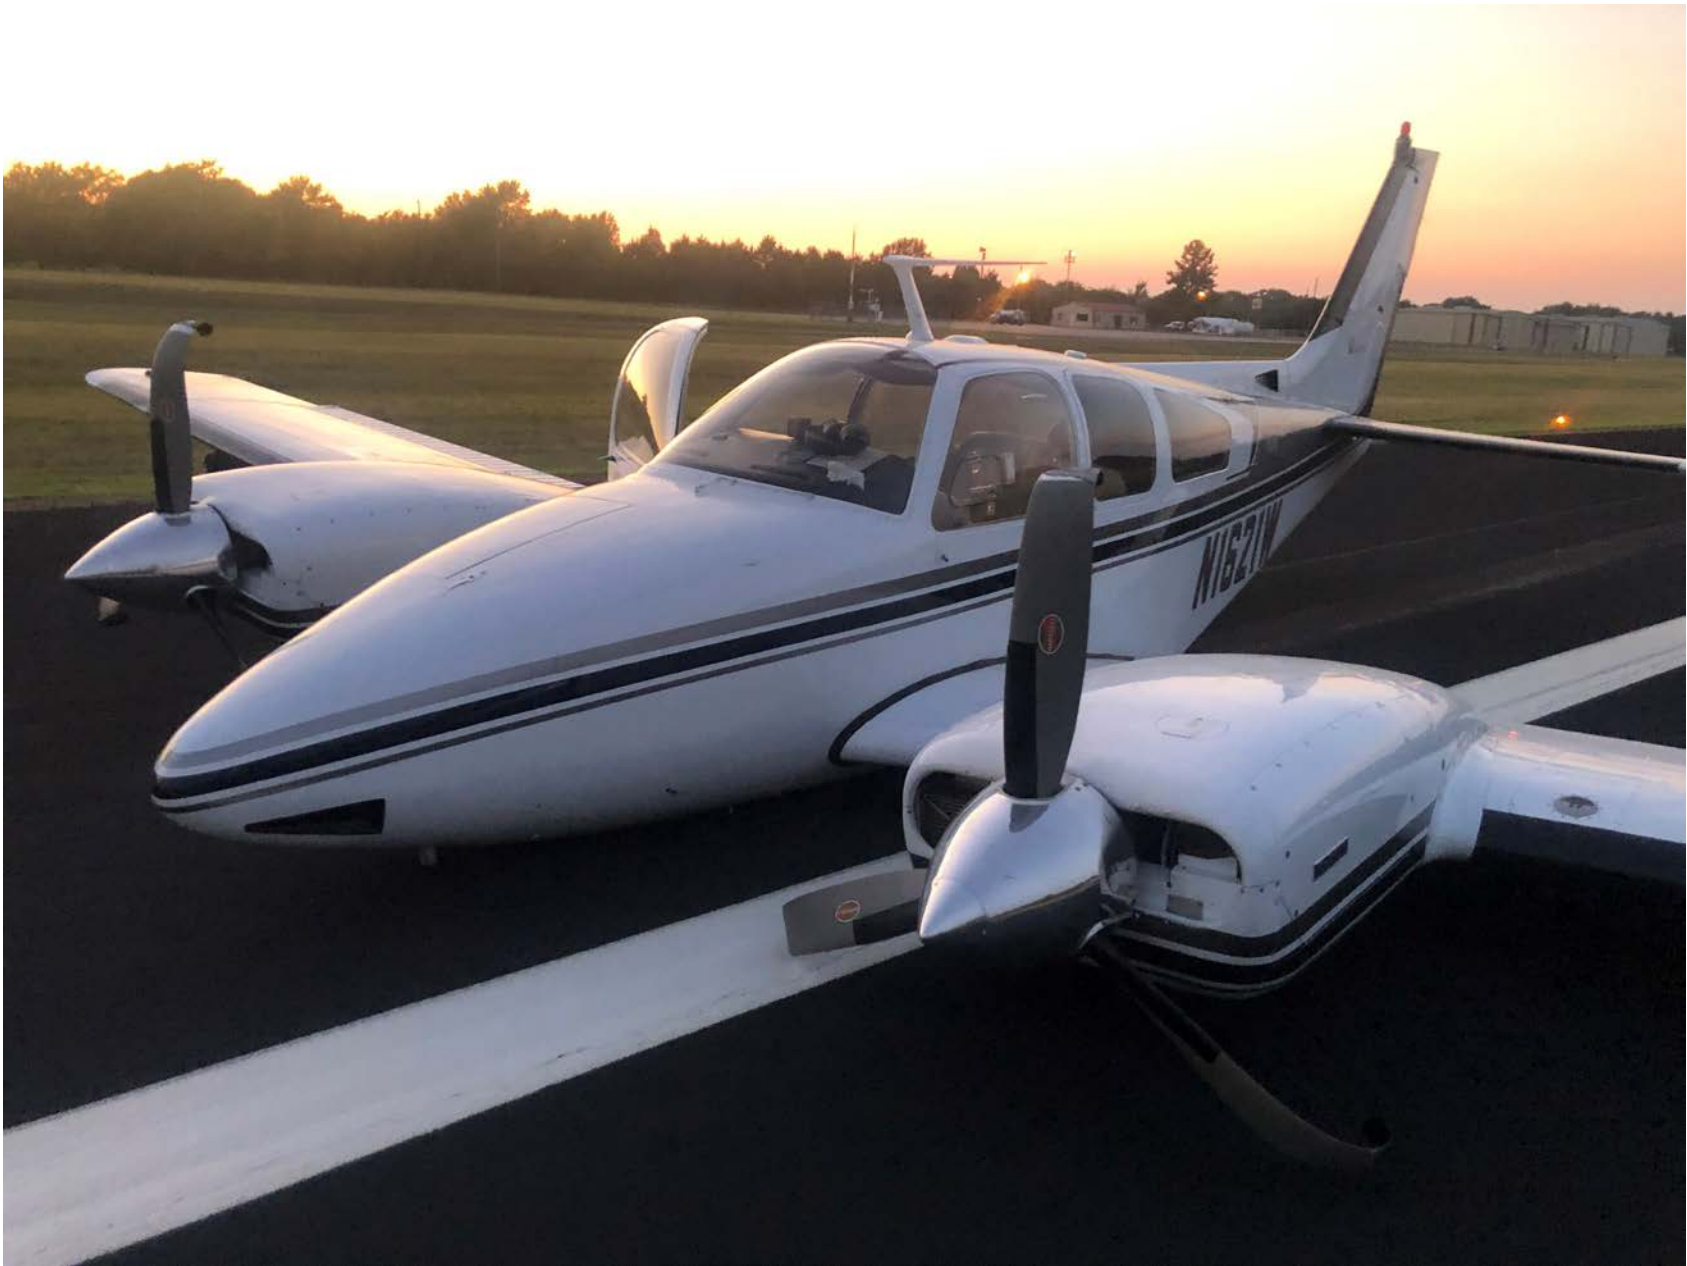
Photo 1 – Supplied view of the accident airplane on a runway. The landing gear are not extended and the propellers exhibit tip damage.

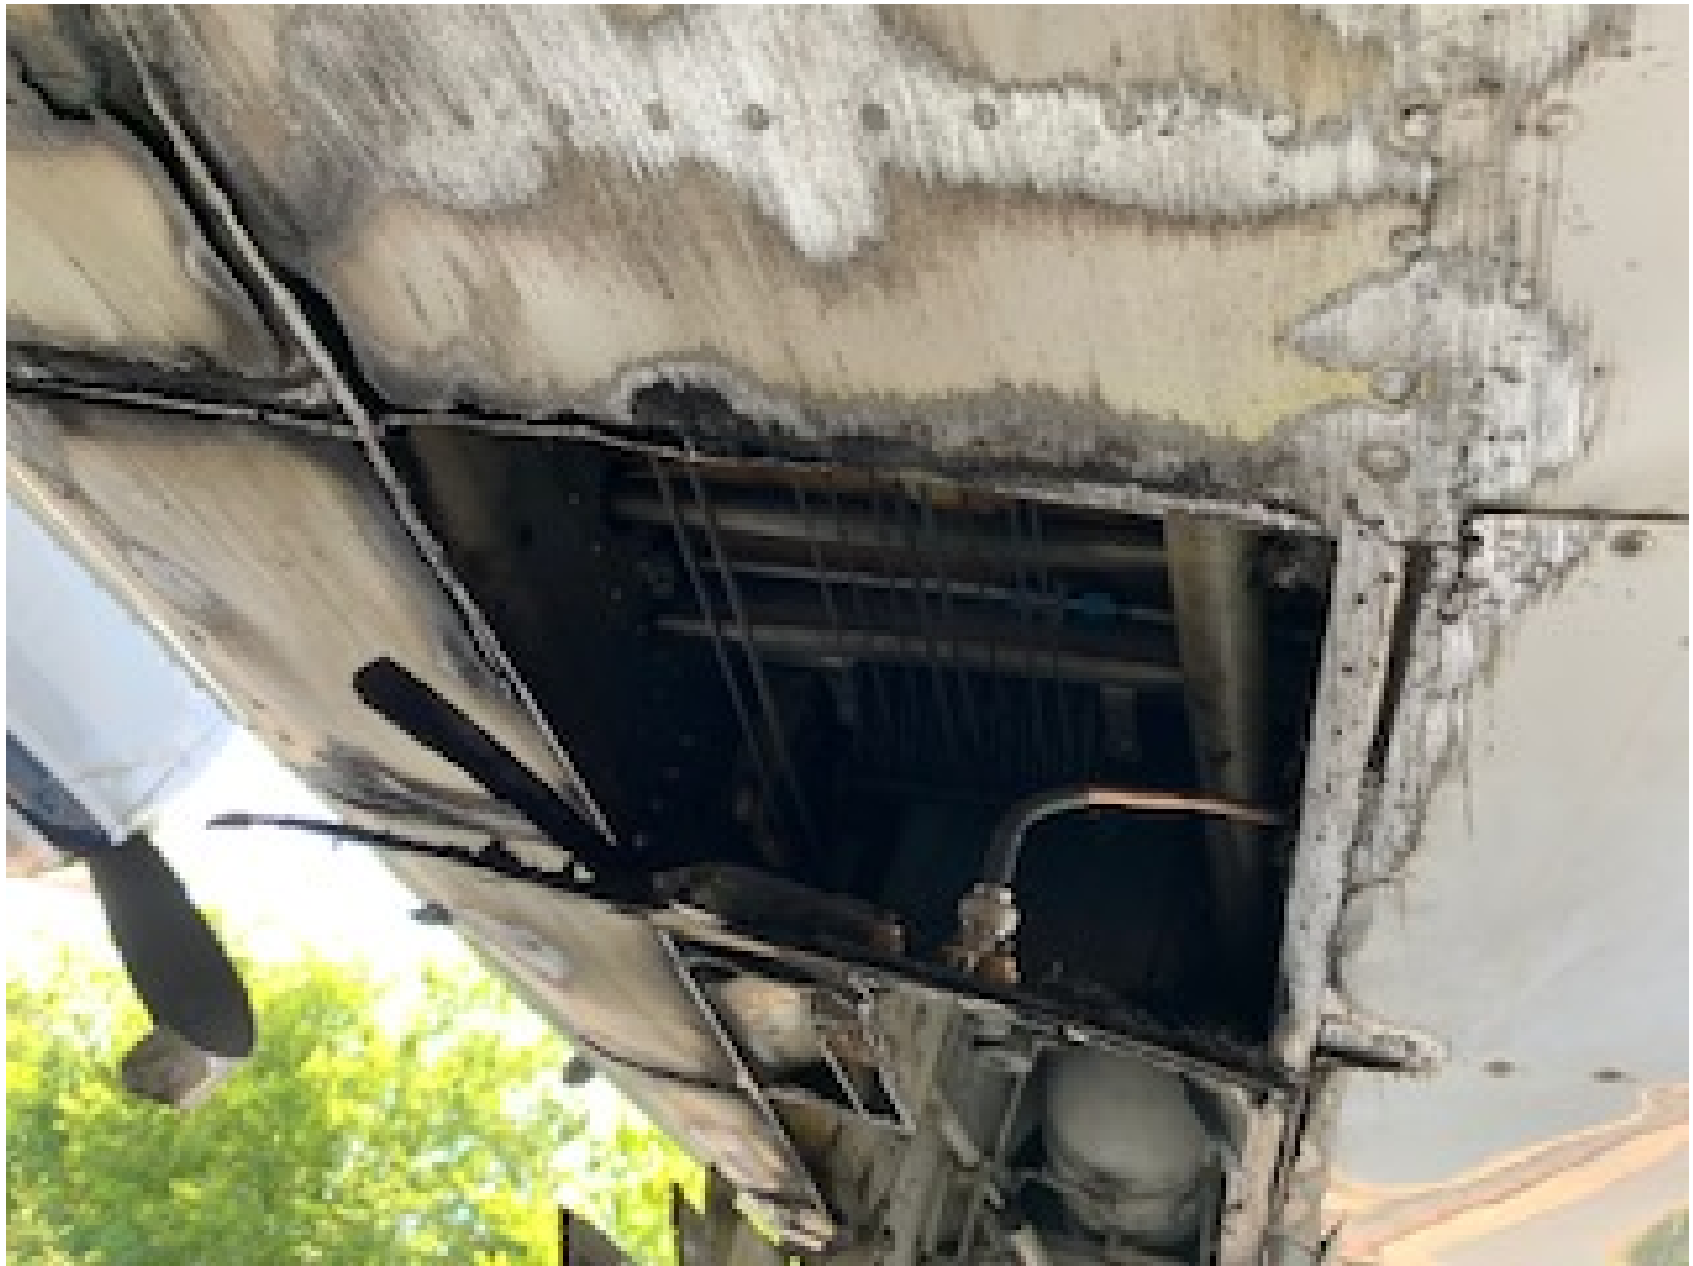
Photo 2 - Supplied view of the fuselage belly. A skin panel is detached from its damaged ribs and stringers.
