MEMO:

RE: November 16, 2023 – Collision on Yellow Line Between Revenue Train and Snow Fighter
CTA Infrastructure Division Report on Early Post-Accident Investigation Tasks and Data Gathering

Event Synopsis and Corresponding Infrastructure

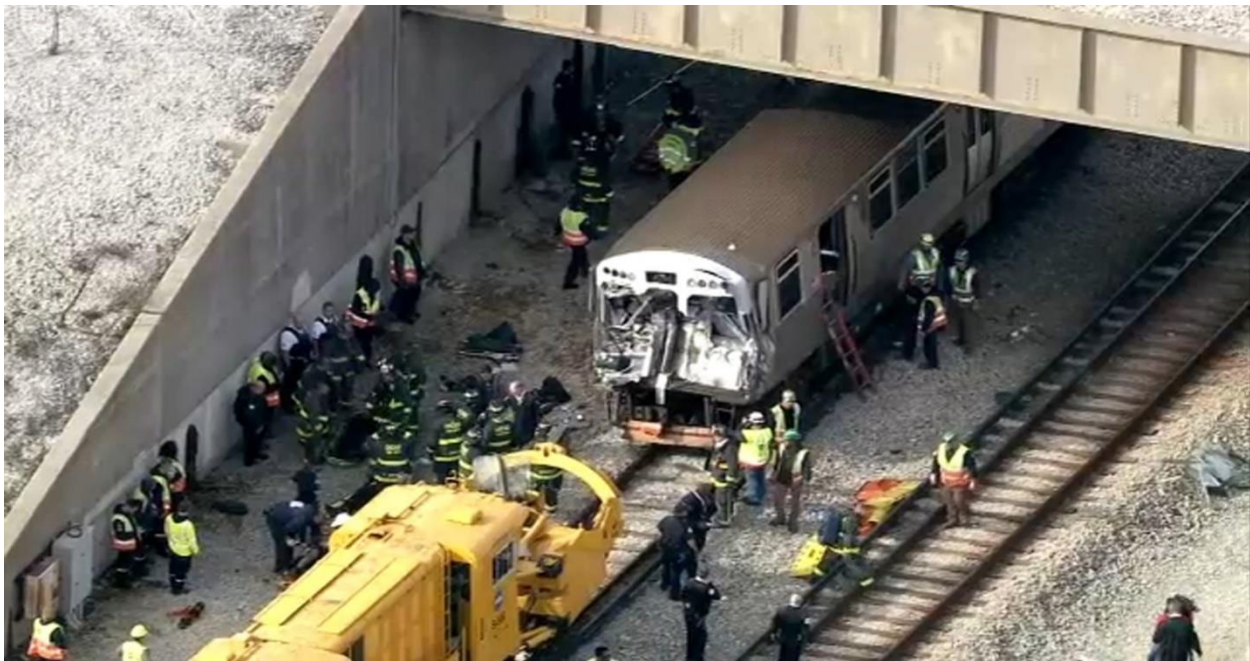
Figure #1: Photo of Accident Scene

Figure 1 shows an aerial view of the accident scene east of where southbound Yellow Line trains approaching Howard Terminal Facility pass under a CTA bridge supporting a turnback "loop" track. The Yellow Line passenger train collided with the southbound Snow Fighter as it was stopped and waiting for signal clearance into the terminal facility. Following the collision, the two vehicles "rebounded" away from each other and came to a stop approximately 20 feet apart. The passenger train sustained extensive damage to the front of the train, indicating a relatively high speed event had occurred. The Snow Fighter had less damage due to the presence of the broom attachment that absorbed much of the collision energy.

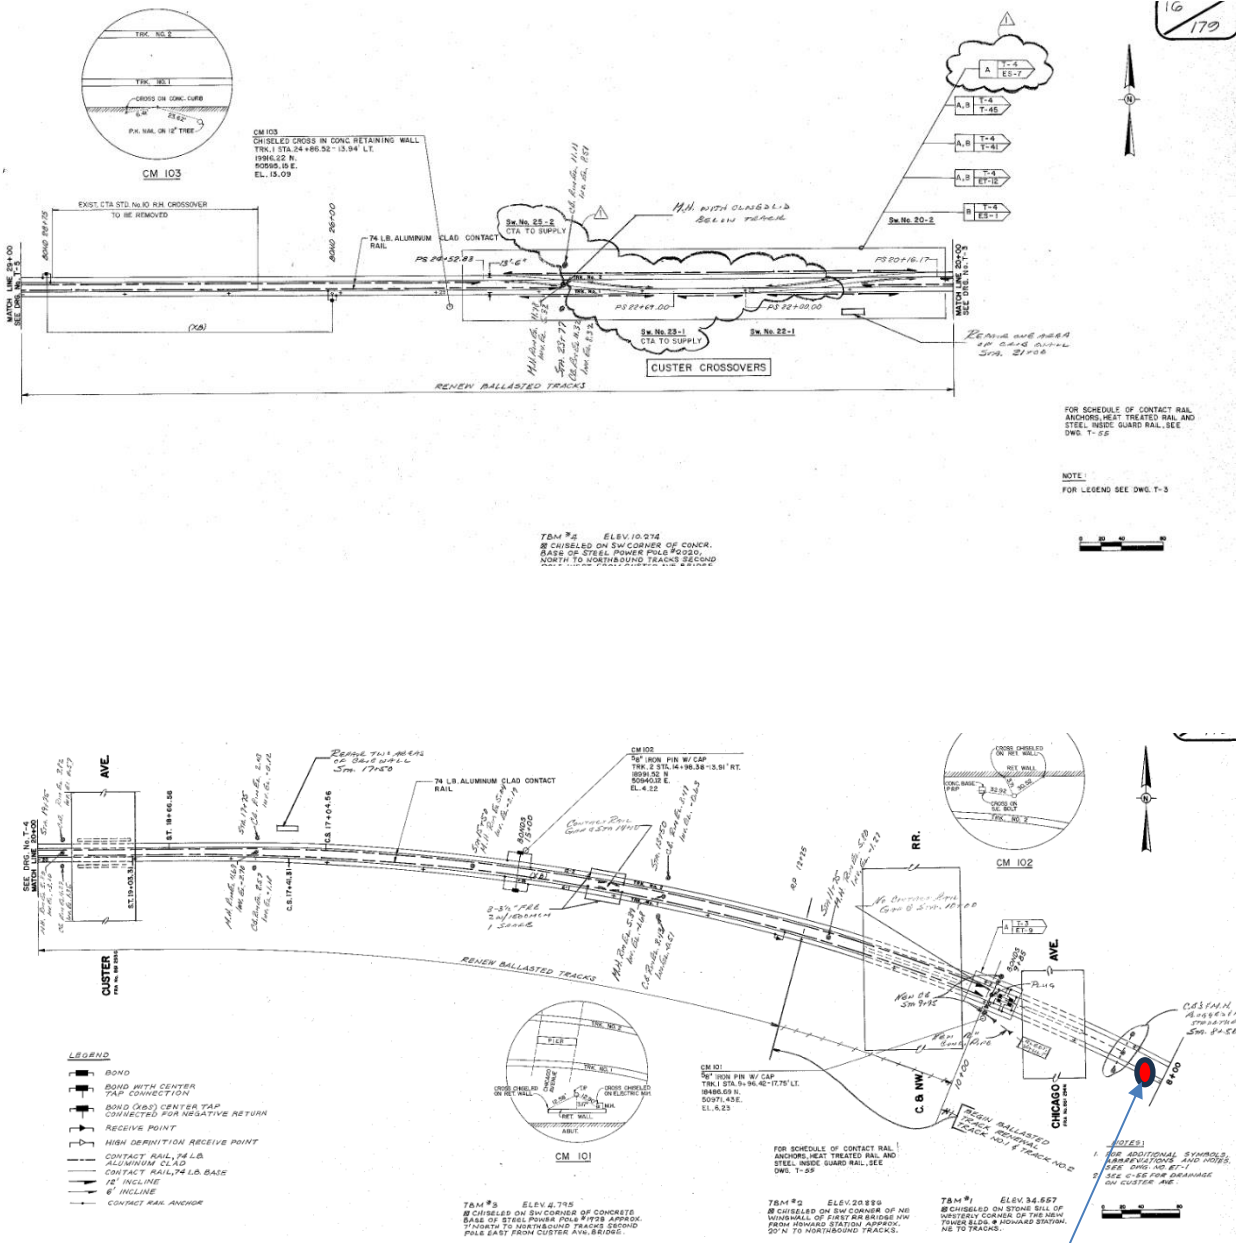
Figure #4: Track Plan of Yellow Line Approaching Howard Terminal

Figures 4, 5, and 6 on the following pages provide track plans for the Yellow Line tracks approaching Howard Terminal, and the tracks associated with the Howard Terminal and Yard. Note that southbound Yellow Line trains approaching Howard encounter an approximately 1400 foot radius curve that limits the line-of-sight for train operators (see Figure 7A for a photo showing the perspective of a train operator when approaching the curve). Figure 7 provides the track profile for the Yellow Line tracks approaching Howard Terminal. Note that southbound Yellow Line trains operate on a negative grade of -1.9% as they approach Howard, providing for a more challenging braking environment, coupled with the horizontal curve at the bottom of the grade.

Approximate Location of Collision

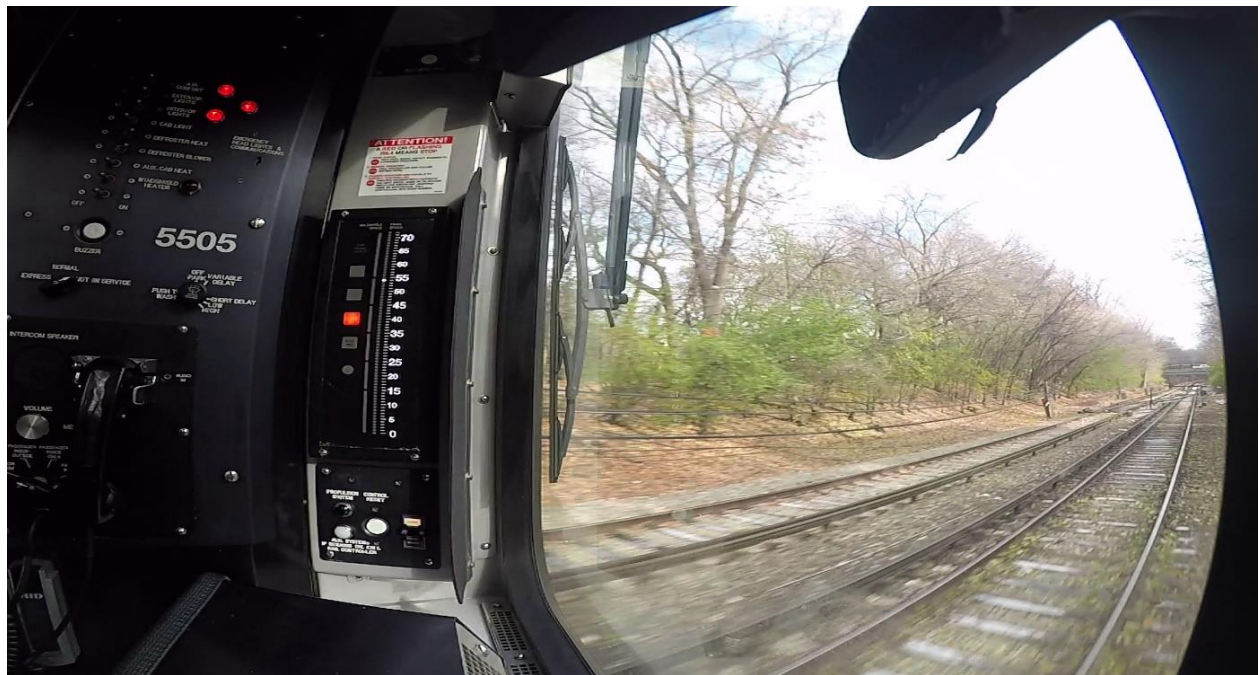
Figure #7A: Operator View of Downhill Grade Approaching Custer Avenue Bridge

Note horizontal curve at bottom of grade

- The train operator's ability to visualize the hazard ahead posed by the presence of the Snow Fighter was impeded by the horizontal curve in the track just prior to the collision point. Similarly, the operator's line of sight was impeded by the presence of multiple bridges and associated embankments for vehicular and railroad traffic spanning over the Yellow Line tracks approaching the collision point.

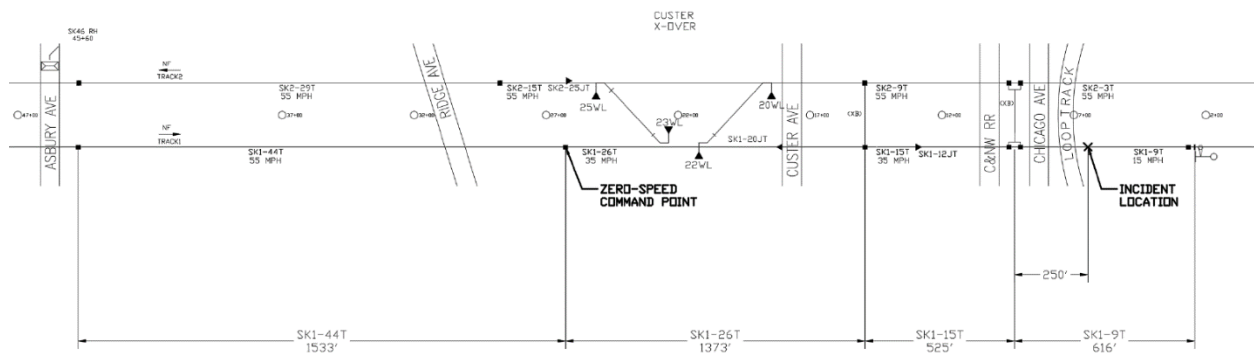
Figure #8: Train Control Blocks in Approach to Accident Location

In the conditions leading up to the accident, the Snow Fighter was stopped in the SK1-9T track circuit waiting for a permissive signal to enter the Howard Interlocking complex. The Incident train was travelling southbound and was approaching the Howard Terminal at a speed of 55 mph. When the SK1-9T track circuit is occupied, the signal system is designed to support an approaching train travelling at 55 mph through the SK1-44T track circuit. Upon reaching the SK1-26T track circuit, the cab signal system removes a permissive cab signal speed, thus telling the train to begin braking to zero speed in order to stop before reaching the western limits of the SK1-9T track circuit (note that at the time of the accident, the Snow Fighter was located 250 feet beyond the western limit of the SK1-9T track circuit).

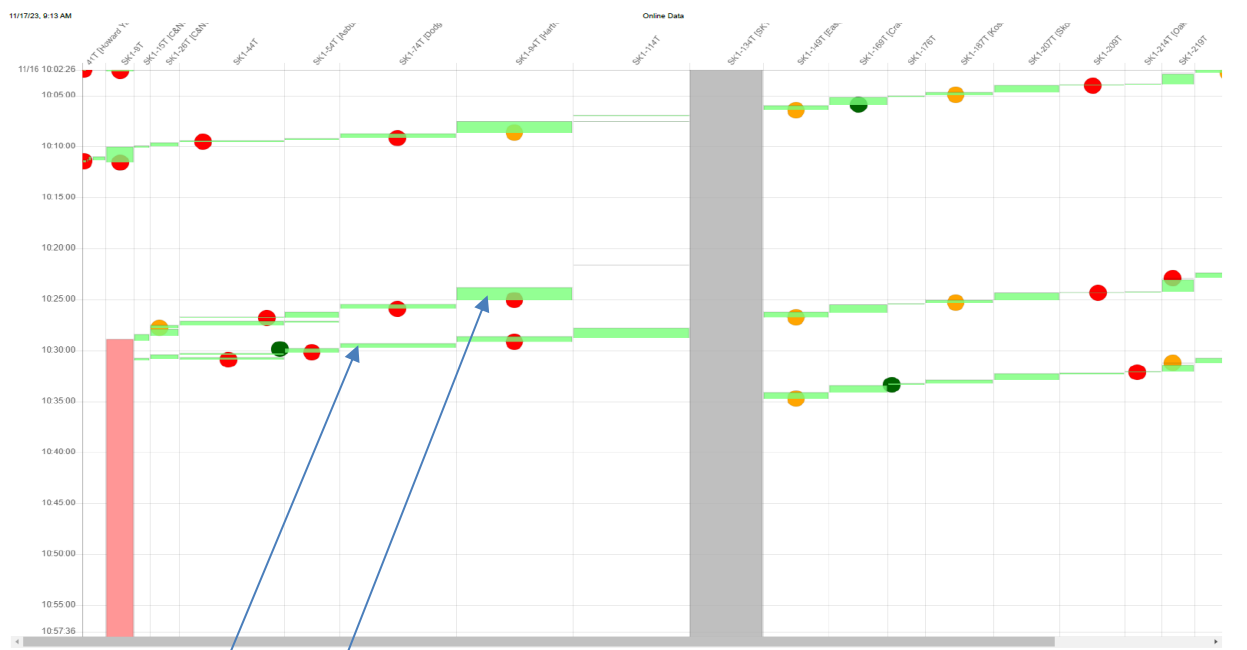
Figure 9 provides a copy of the TCM tool display for the southbound Yellow Line tracks at the time of the incident. Trains movements are tracked for the southbound direction of travel from right to left in the Figure 9 diagram (e.g., trains leaving the Dempster Terminal Station are shown on the right side of the diagram, and trains approaching Howard Terminal are shown on the left side of the diagram). As the train progresses southbound, it enters and leaves successive track circuits that are labeled at the top of the display. Time is shown on the vertical (“Y”) axis and progresses from top to bottom.

Sleet Fighter Leaving Skokie Shops

Incident Train Travelling Towards Howard

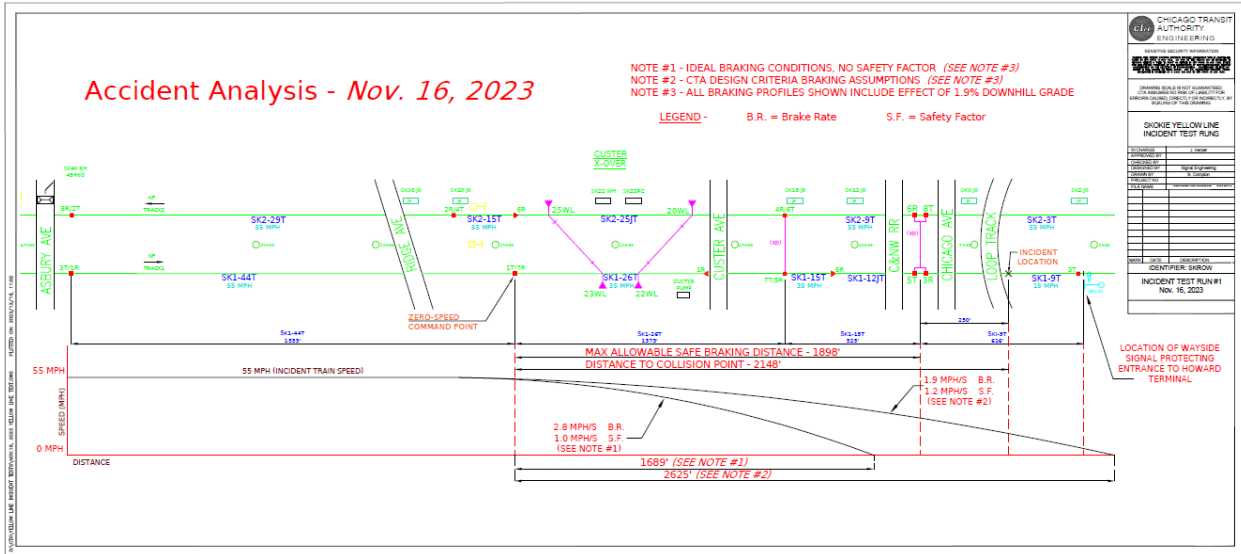
Figure #13: Calculations of Braking Distances Approaching Collision Site

Figure 13 below provides a sample of the braking distance calculations associated with “ideal” conditions (1,689 feet) versus the conservative braking distance associated with CTA’s current braking criteria (2,625 feet). Calculations revealed that the maximum safe braking distance that was present would only have resulted in a “safe stop” (stopping prior to the SK1-9T track circuit) had the braking conditions been near perfect (e.g. no need for safety factor and a non-degraded brake rate of 2.8 mph/s). As shown in Figure 11 above, the incident train’s brake rate was interpolated from the vehicle data recorder to be in the range of 0.91 mph/s (even lower than the conservative assumptions in CTA’s design criteria).

At this point, the NTSB had arrived, and data logs were available, as were highlights of the interview with the train operator. The investigation focus began to move away from a signal system functional failure, and towards the actual braking distance allowed by the signal system design, and the assumptions made in the design regarding rail adhesion and brake rates. It became apparent that the assumptions used in the braking distance design from the 1970’s did not match CTA’s current braking distance criteria, in particular given the downhill grade of 1.9% and the degraded brake rate value of 1.9 mph/s.

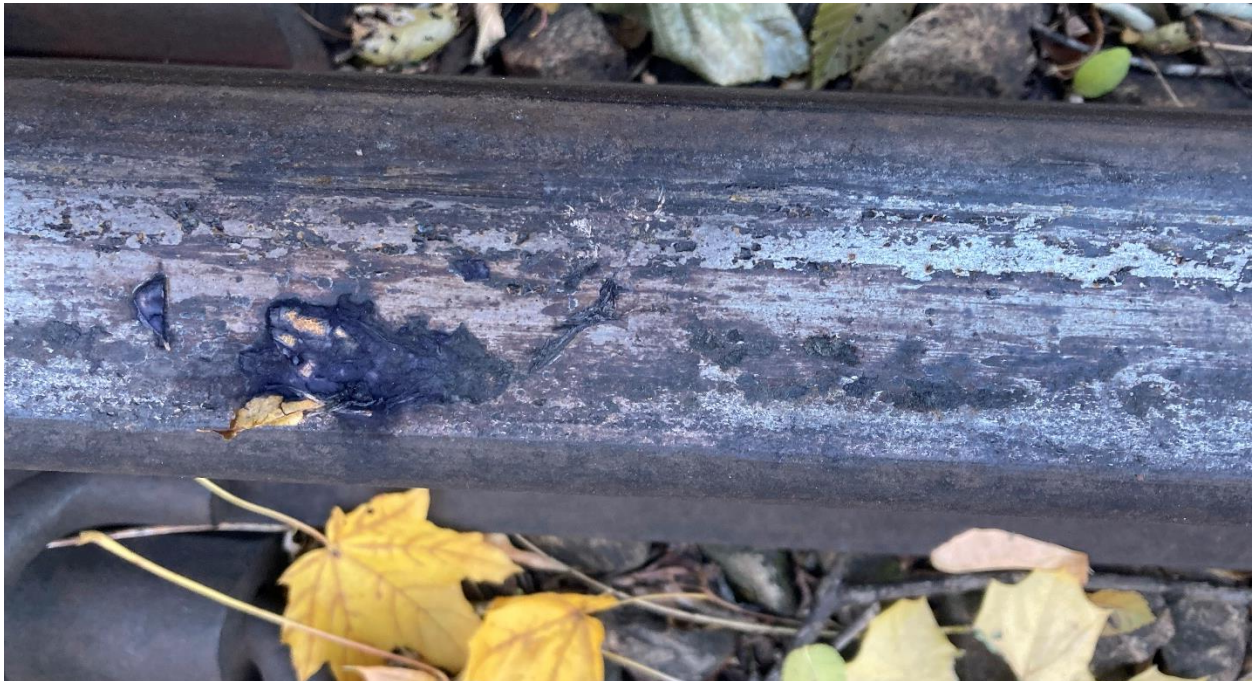
Figure #14: Leaf Residue on Top of Rail Approaching Accident Location

The investigation team then began looking for reasons why the brake rate may not have met current CTA design criteria, and focused on the condition of the top of the rail on the downhill grade. Figure 14 provides an example of what appeared to be a residue of leaf materials that had been “crushed” into the rail head over the previous days leading up to the accident. Leaf residue is a known contributor to loss of adhesion between train wheels and the rails.

- Once the accident vehicles have been removed from the site, accident re-enactment tests should be performed with a live two-car train from the same fleet (5000 Series). Re-enactment tests should attempt to replicate the conditions leading up to the collision, including simulated occupancy of the SK1-9T track circuit, replication of operator reactions, and replication of the environmental conditions present at the time of the accident. Data logs from the onboard recorders and wayside recorders should be captured. Attempts should then be made to clean the top of rails of the contaminates and re-run the re-enactment tests.

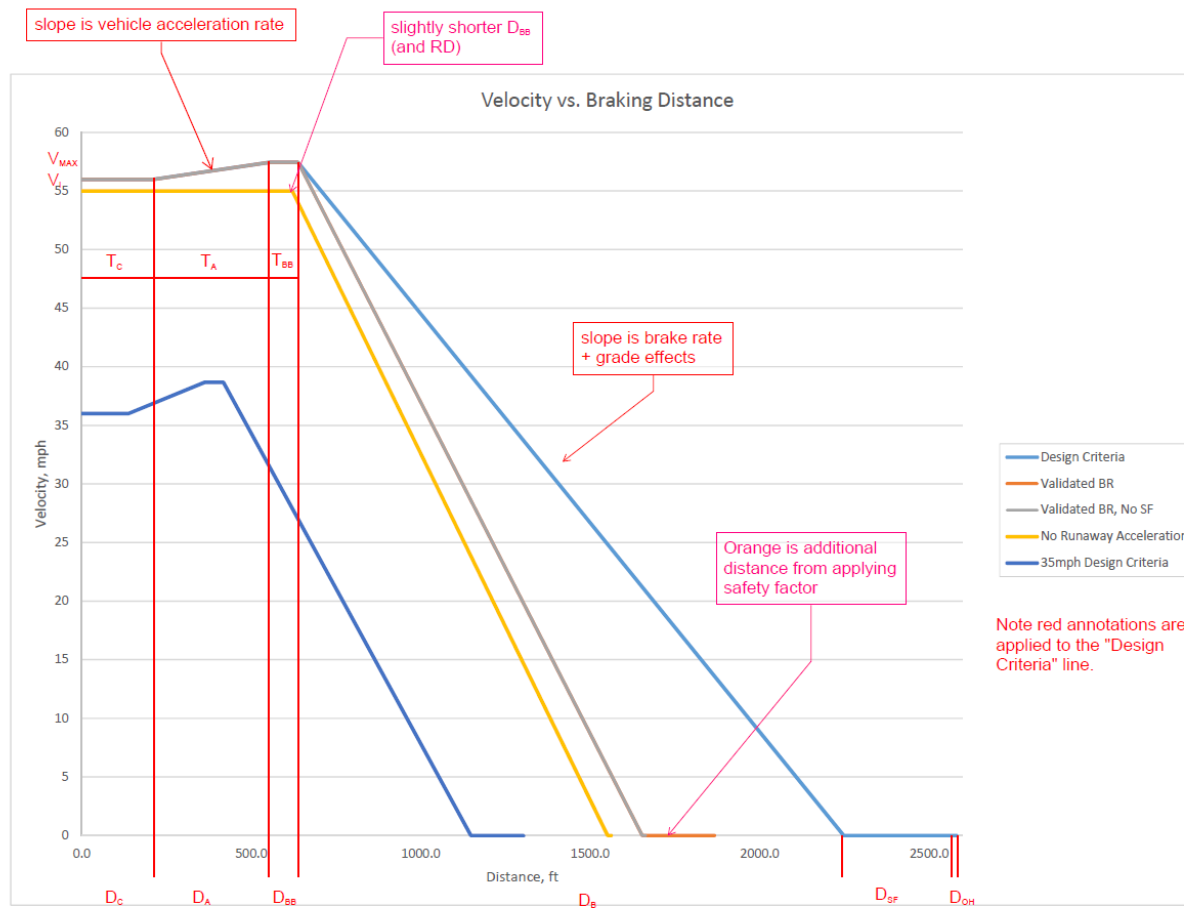
Appendix II: Braking Profiles for Various Braking Criteria Assumptions

Reaction Distance:
 $RD = D_C + D_A + D_{EE}$

Safe Braking Distance:
 $SBD = D_C + D_A + D_{EE} + SF(D_E) + D_{OH}$

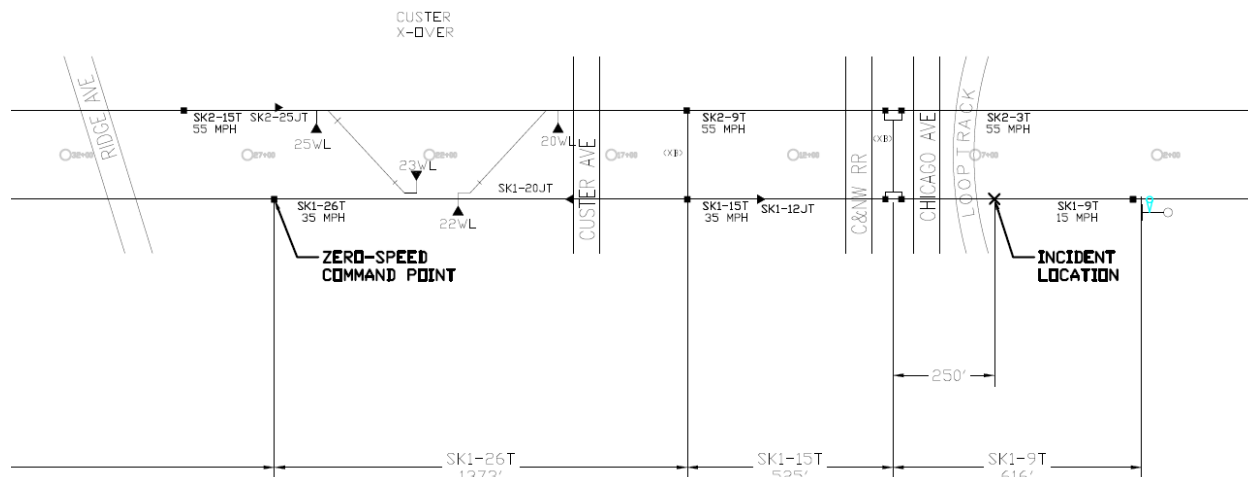
Figure #1: Track Circuits involved in the November 16, 2023 Accident

The signal system track circuits involved in the incident, and in the re-enactment test, are shown in Figure 1 below. The figure includes a note where the zero speed (stop code) command is received when a train occupies the SKI-9T track circuit, which was occupied by the Snow Fighter at the time of the incident. The figure also shows the length of each track circuit involved and the location of the accident relative to the start of the SKI-9T track circuit.

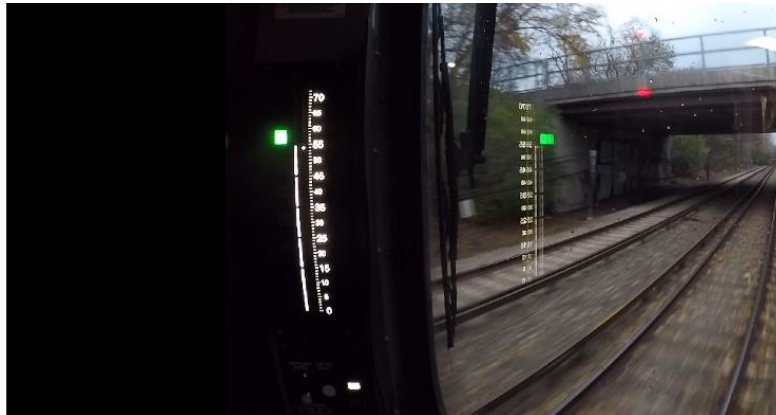
Figure #3: Test Run #1 – Maximum speed approaching Dodge Bridge

Test Run #1 was performed with a simulated train in the SK1-9T track circuit. The train approached Ridge Avenue Bridge with a green aspect, an allowable speed of 55 mph, and an actual speed of 55 mph on the cab's Aspect Display Unit (ADU) as seen in Figure 3 below.

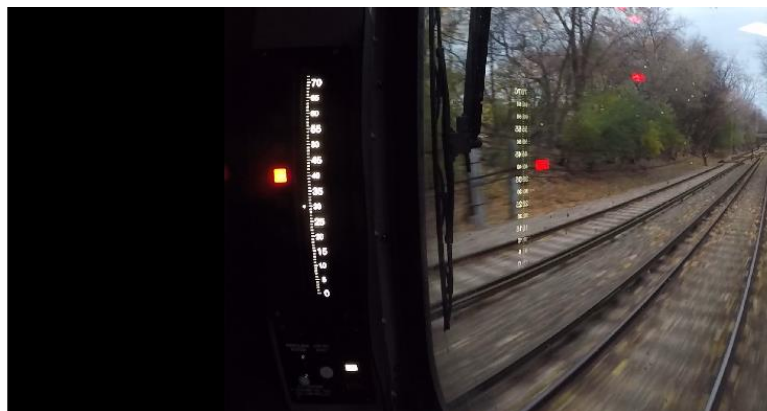
Figure #4: Test Run #1 – Speed when stop code command was received from signal system

Prior to entering the SK1-26R track circuit, the operator anticipated a stop code command condition and began to apply the Full Service Brake before reaching the command point. Figure 4 below shows the speed at the time the stop code command was detected by the train after entering the SK1-26T track circuit.

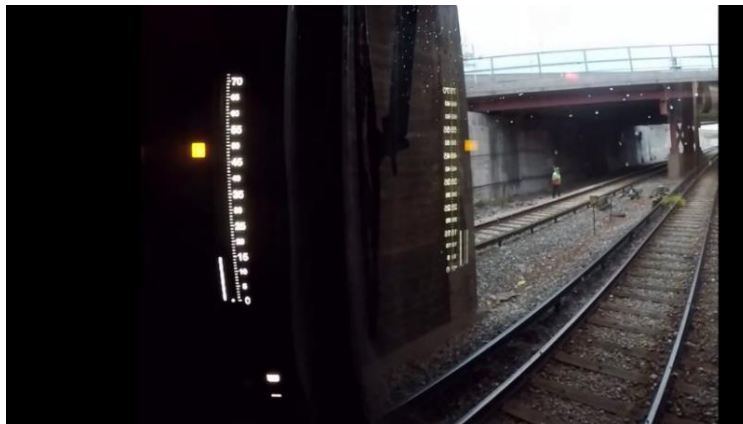
Figure #5: Test Run #1 – Location where train came to a stop

Figure 5 below shows the position where the train stopped at the completion of Test Run #1, which was 67 feet ahead of the occupied SK1-9T track circuit. Note that the train received a 15 mph allowable speed at this location due to the method that was used to simulate the occupancy of the track circuit ahead (the track circuit was not shunted).

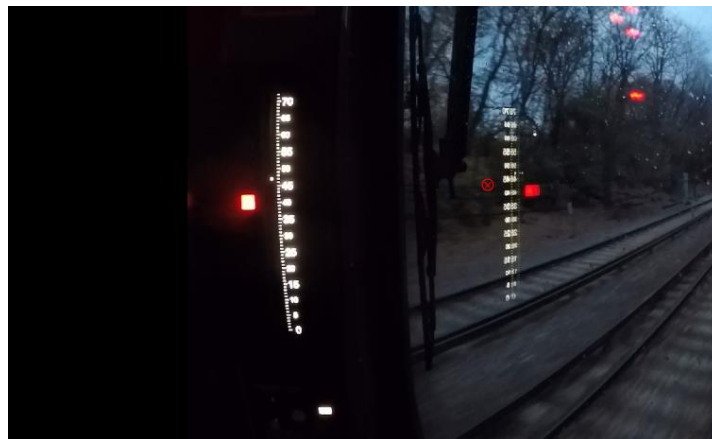
Figure 6: Test Run #2 – Speed when stop code command was received from signal system

Test Run #2 repeated the steps taken in Test Run #1. Again, the train did not achieve a speed of 55 mph before receiving the stop code command (actual train speed was 47 mph). In this case, the train never came to a full stop as the operator reacted to the 15 mph allowable speed when approaching the SK1-9T track circuit, and moved the train forward several hundred feet before stopping. As a result, this test run was deemed “invalid”.

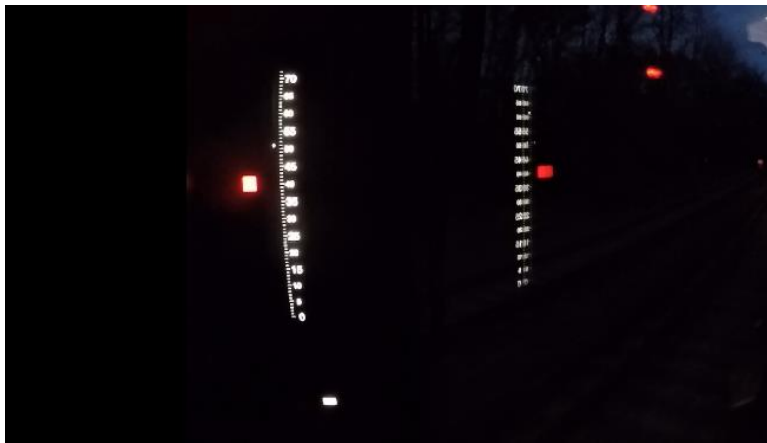
Figure 7: Test Run #3 – Speed when stop code command was received from signal system

Test Run #3 repeated the steps taken in Test Run #1. The train did not achieve a speed of 55 mph before receiving the stop code command, which was logged at 51 mph as seen in Figure 7 below.

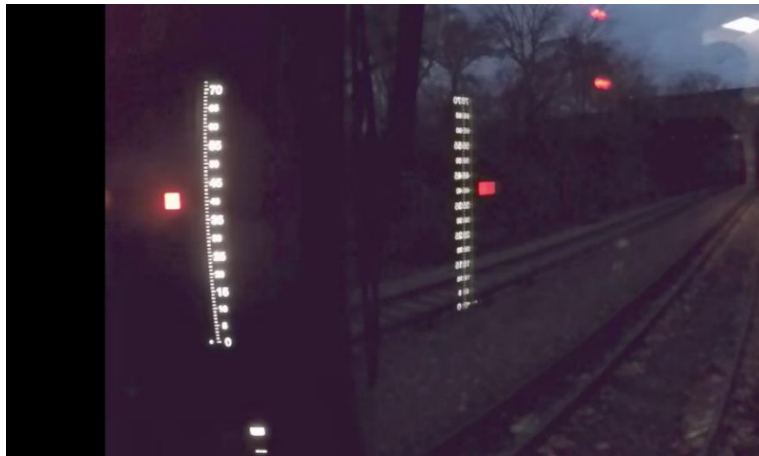
Figure 8: Test Run #3 – Location where train came to a stop

The train operator reacted to the stop code command by applying a Full Service Brake. The train came to a complete stop 324 feet ahead of the occupied track circuit, which is a significant margin of safety. Figure 8 below shows the location of the train where it came to a complete stop.

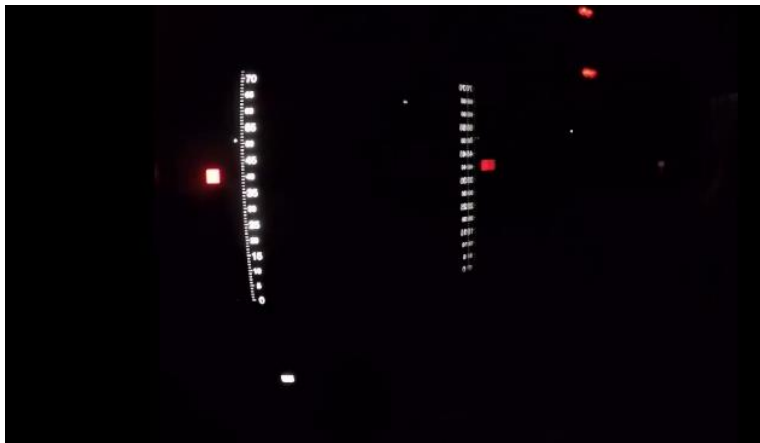
Figure 9: Test Run #4 – Allowable speed downgrade at 55 mph

Test Run #4 removed the simulated Snow Fighter in the SKI-9T track circuit and allowed the train to react to a downgrade in speed as it approached Howard Street Interlocking (as designed). Figures 9-11 below show the allowable speed downgrade from 55 mph to 35 mph to 15 mph. The test train experienced slip/slide conditions during this test run, but the operator maintained control of the train and stopped safely at the signal protecting the entrance to the interlocking (Signal 32).

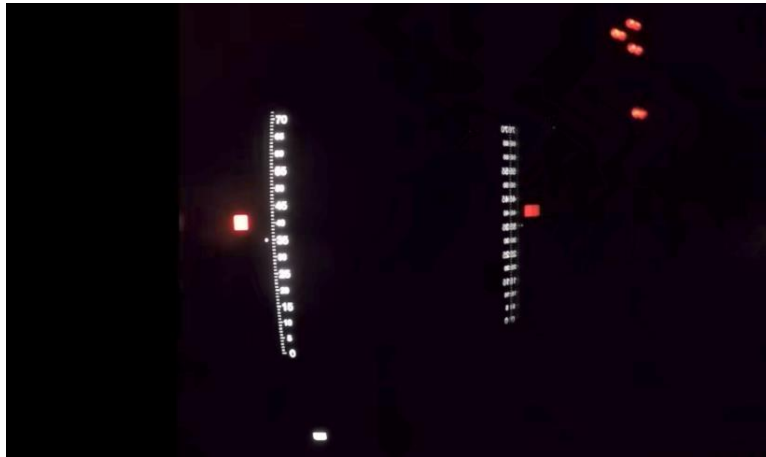
Figure 12: Test Run #5 – Speed when Zero Speed Command Received from Signal

Test Run #5 re-established the simulated Snow Fighter in the SK1-9T track circuit and reduced the maximum speed approaching the downgrade to 35 mph (from 55 mph). Figure 12 below shows the actual speed of 35 mph at the point where the stop code command was received.

The train operator reacted to the zero speed command by applying a Full Service Brake. The train experienced a slip/slide condition on this run and came to a complete stop 552 feet ahead of the occupied track circuit, which is a significant margin of safety. This test run was deemed “successful” and demonstrated that a 35 mph slow zone in advance of the downgrade will provide a significant safety buffer in terms of stopping well in advance of a train or vehicle ahead.

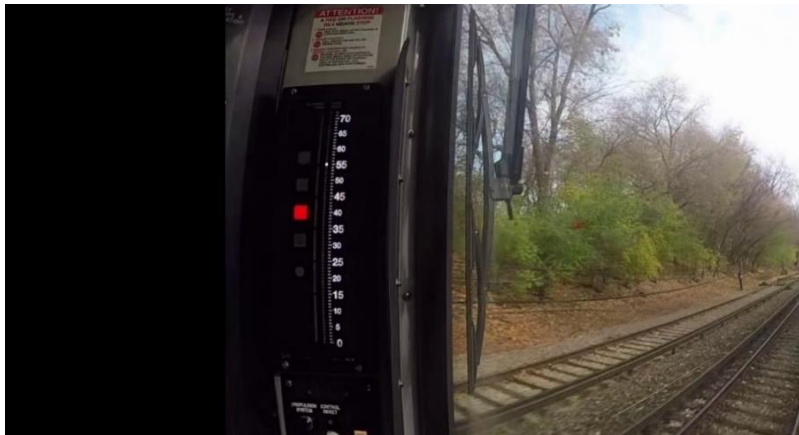
Figure #3: Test Run #1 – Speed when stop code command was received from signal system

Test Run #1 was performed with a simulated Snow Fighter in the SK1-9T track circuit. The train was given a maximum allowable speed of 55 mph, which it reached before receiving a red cab signal stop code as seen in Figure 3 below. The operator of the train did not apply a braking application (the operator retained the master controller in the propulsion position) and as a result the train received a penalty brake a few seconds after entering SK1-26T. The train came to a complete stop roughly 492 feet beyond the entrance of SK1-9T, which would have resulted in a collision with the simulated Snow Fighter. As seen in Figure 4 below, the Test Run #1 train nearly reached the Howard Interlocking X32 Home Signal (the allowable speed on the train's ADU was 15 mph because the test train had gone past the track shunt). The train experienced roughly 20 seconds of slip/slide conditions and the average brake rate was approximately 1.3 mph/s.

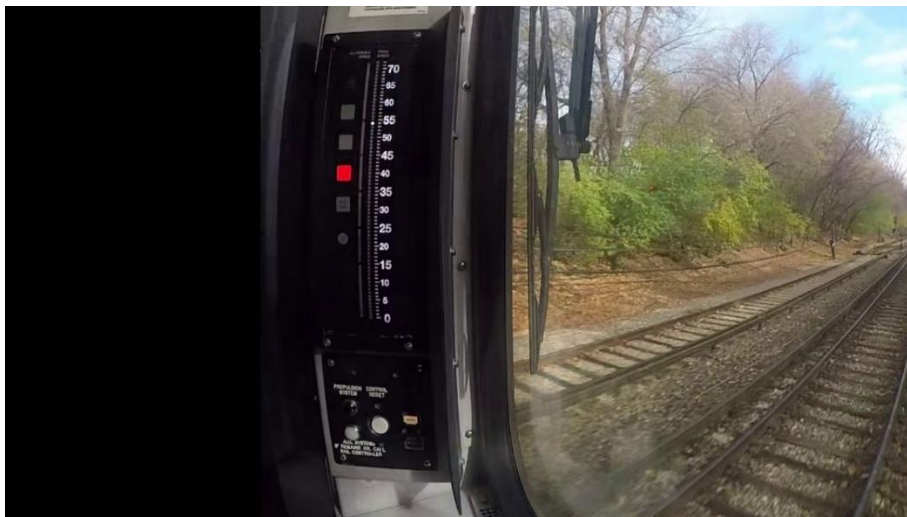
Figure #5: Test Run #2 – Speed when stop code command was received from signal system

Test Run #2 was performed with a simulated Snow Fighter in the SK1-9T track circuit. The train was given a maximum allowable speed of 55 mph, which it nearly reached before receiving a red cab signal stop code as seen in Figure 5 below. The operator of the train immediately applied the Full Service Brake. The train came to a complete stop (see Figure 6 below) roughly 479 feet beyond the entrance of SK1-9T, which would have resulted in a collision with the simulated Snow Fighter. The train experienced roughly 15 seconds of slip/slide conditions and the average brake rate was approximately 1.4 mph/s.

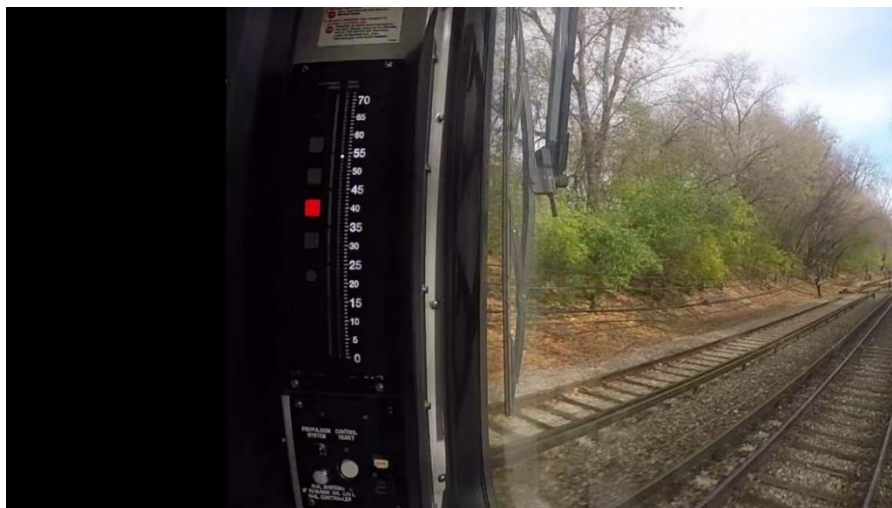
Figure #7: Test Run #3 – Speed when stop code command was received from signal system

Test Run #3 was performed with a simulated Snow Fighter in the SK1-9T track circuit. The train was given a maximum allowable speed of 55 mph, which it nearly reached before receiving a red cab signal stop code as seen in Figure 7 below. The operator of the train immediately applied the Full Service Brake and deployed the Track Brake when the simulated Snow Fighter came into view. The train came to a complete stop (see Figure 8 below) roughly 264 feet beyond the entrance of SK1-9T, which would have resulted in a collision with the simulated Snow Fighter. The train experienced roughly 18 seconds of slip/slide conditions and the average brake rate was approximately 1.6 mph/s.

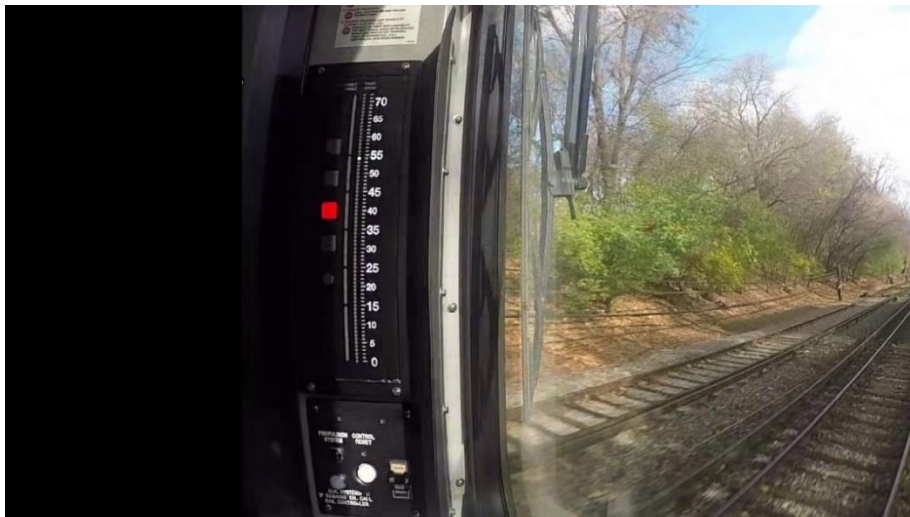
Figure #9: Test Run #3A – Speed when stop code command was received from signal system

Test Run #3A was performed with a simulated Snow Fighter in the SK1-9T track circuit. The train was given a maximum allowable speed of 55 mph, which it nearly reached before receiving a red cab signal stop code as seen in Figure 9 below. The operator of the train immediately applied the Full Service Brake and then moved the Master Controller to the Emergency Position when the simulated Snow Fighter came into view (the Emergency position causes the train's track and friction brakes to apply). The train came to a complete stop (see Figure 10 below) roughly 218 feet beyond the entrance of SK1-9T, which would have avoided a collision with the simulated Snow Fighter, but still violated the maximum safe braking distance assumed by the wayside signal system. The train experienced roughly 14 seconds of slip/slide conditions and the average brake rate was approximately 1.7 mph/s.

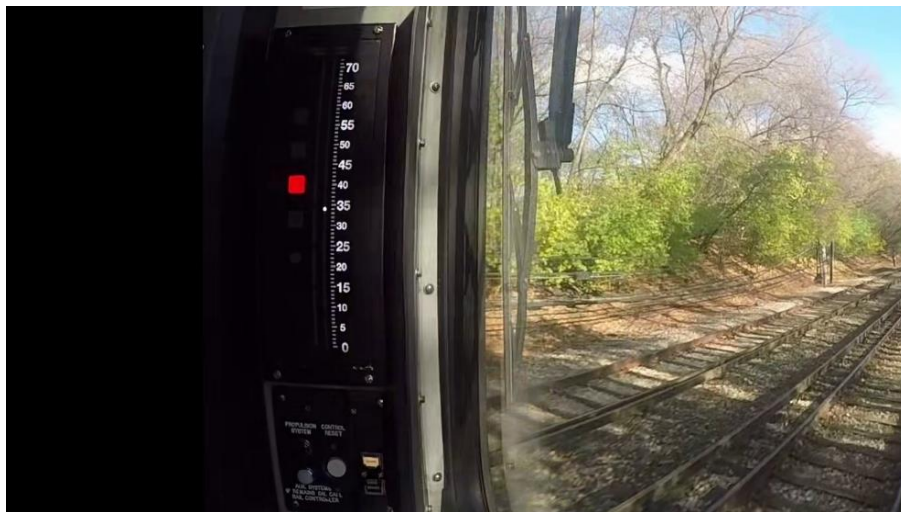
Figure #11: Test Run #4 – Speed when stop code command was received from signal system

Test Run #4 was performed with a simulated Snow Fighter in the SK1-9T track circuit. The train was given a maximum allowable speed of 35 mph, which it nearly reached before receiving a red cab signal stop code as seen in Figure 11 below. The operator of the train did not apply a braking application (the operator retained the master controller in the propulsion position) and as a result the train received a penalty brake shortly after entering SK1-26T. The train came to a complete stop (see Figure 12 below) roughly 261 feet before the entrance of SK1-9T, which would have avoided a collision with the simulated Snow Fighter and met the maximum safe braking distance. The train experienced roughly eight (8) seconds of slip/slide conditions and an average brake rate of 2.1 mph/s.

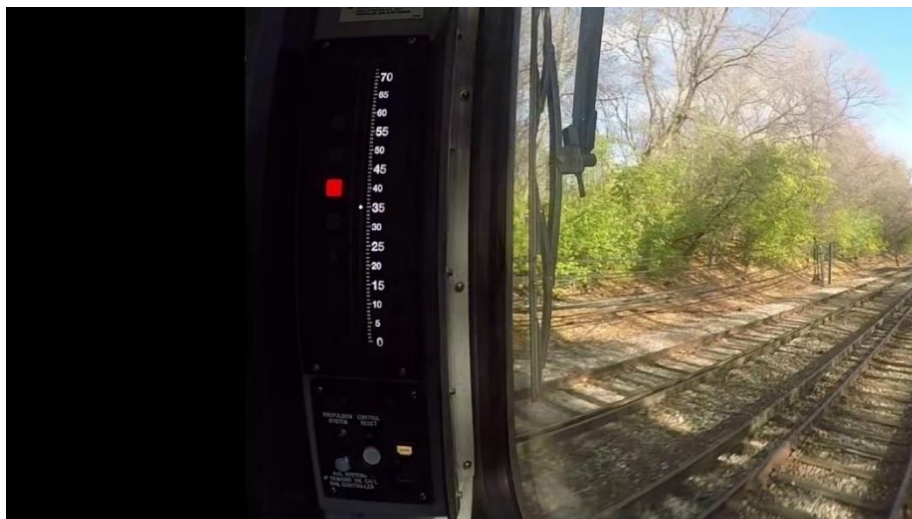
Figure #13: Test Run #5 – Speed when stop code command was received from signal system

Test Run #5 was performed with a simulated Snow Fighter in the SK1-9T track circuit. The train was given a maximum allowable speed of 35 mph, which it reached before receiving a red cab signal stop code as seen in Figure 13 below. The operator of the train immediately applied the Full Service Brake. The train came to a complete stop (see Figure 14 below) roughly 533 feet before the entrance of SK1-9T, which would have avoided a collision with the simulated Snow Fighter and met the maximum safe braking distance. The train experienced roughly 10 seconds of slip/slide conditions and an average brake rate of 2.9 mph/s.

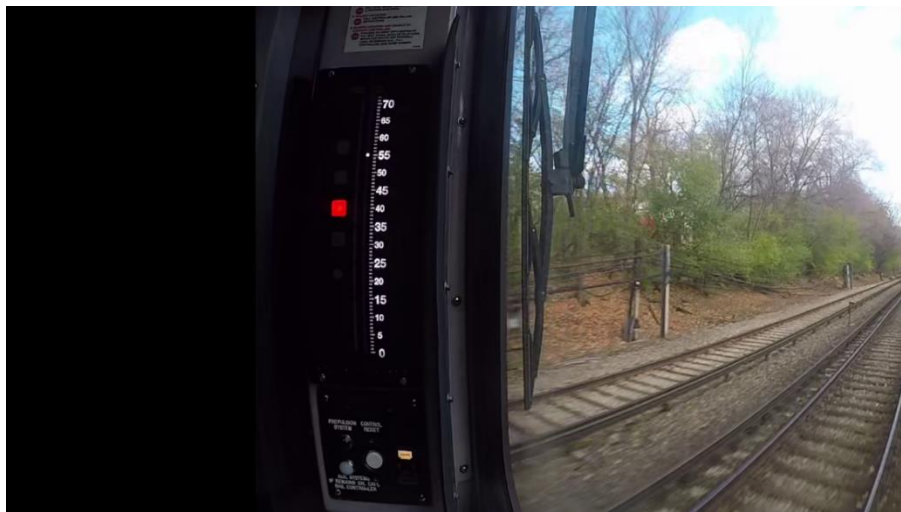
Figure #15: Test Run #6 – Speed when stop code command was received from signal system

Test Run #6 was performed with a simulated Snow Fighter in the SK1-9T track circuit. The train was given a maximum allowable speed of 55 mph, which it reached before receiving a red cab signal stop code as seen in Figure 15 below. The operator of the train did not apply a braking application (the operator retained the master controller in the propulsion position) and the train received a penalty brake shortly after entering SK1-26T as a result. The train came to a complete stop (see Figure 16 below) roughly 414 feet beyond the entrance of SK1-9T, which would have resulted in a collision with the simulated Snow Fighter. The train experienced roughly 15 seconds of slip/slide conditions and an average brake rate of 1.37 mph/s.

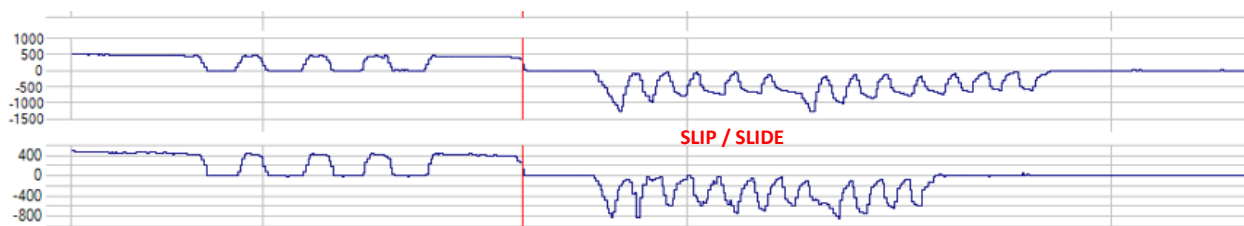
- When operating at 55 mph, all test runs experienced a “slip/slide” condition for a portion of the run on the downhill grade. Dynamic braking under the slip/slide mode appeared to result in a “pulsation effect” where the braking torque cycled between zero and -1500 ft-lbs (see the below excerpt of the ERU from Test Run #1).

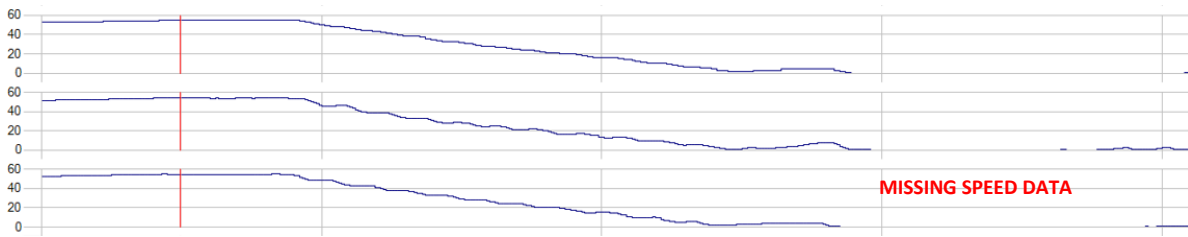
- When operating at 55 mph, all of the test runs sensed a zero speed well before the train came to a full stop. This appeared to be caused by the train wheels being “locked up” and “sliding”. When the zero speed was sensed, the dynamic braking ceased to function, and the friction brakes activated. One or both of the speed sensors sometimes transitioned back to sensing a higher speed, or disappeared altogether (see the below excerpt of the ERU from Test Run #2).

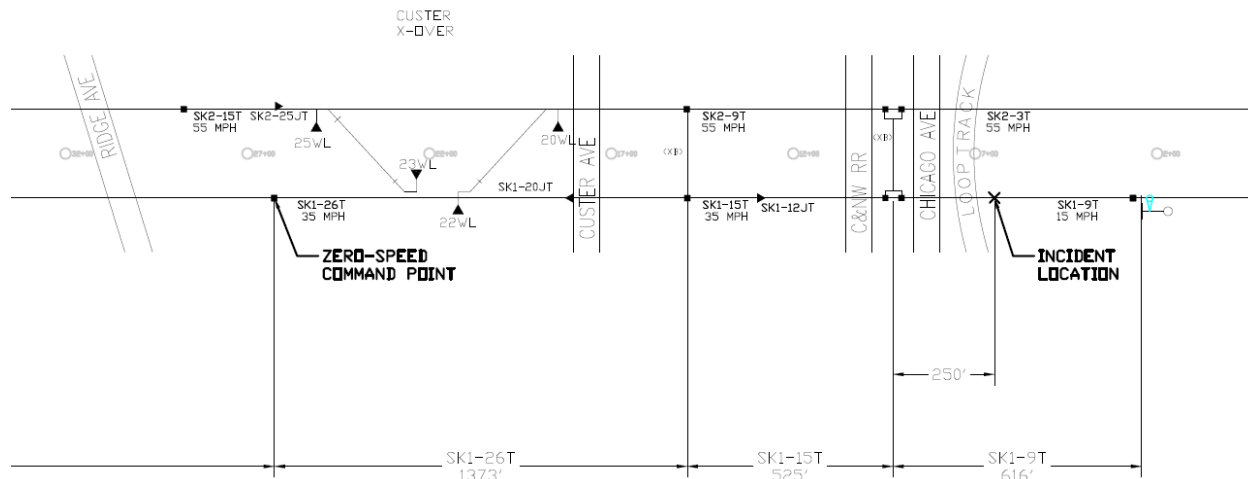
Figure #1: Track Circuits involved in the November 16, 2023 Accident

The signal system track circuits involved in the incident, and in re-enactment tests, are shown in Figure 1 below. The figure includes a note where the zero speed command is received when a train occupies the track circuit that was occupied by the Snow Fighter at the time of the incident (SK1-9T track circuit). The figure also shows the length of each track circuit involved and the location of the accident relative to the start of the SK1-9T track circuit.

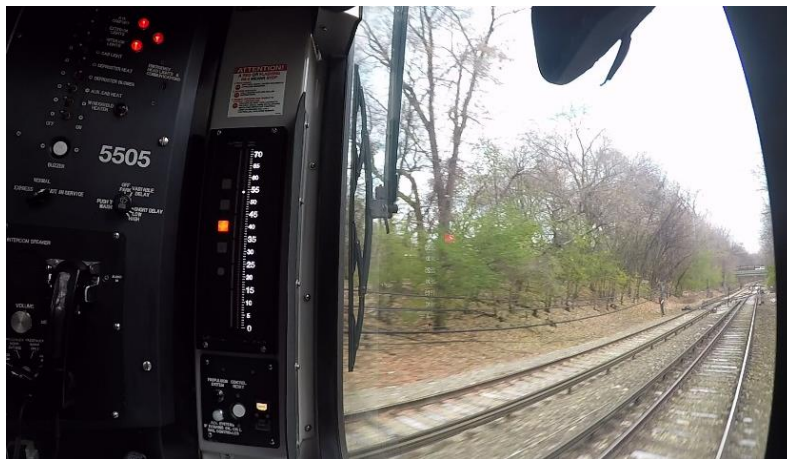
Figure #3: Test Run #1 – Speed when stop code command was received from signal system

Test Run #1 was performed with a simulated train in the SK1-9T track circuit. The train was given a maximum allowable speed of 55 mph, which it reached before receiving a red cab signal stop code as seen in Figure 3 below. The operator of the train did not apply a braking application (the operator retained the master controller in the propulsion position) and the train received a penalty brake after entering SK1-26T as a result. The train came to a complete stop (see Figure 4 below) roughly 236 feet ahead of the entrance of SK1-9T, which would have avoided a collision with the simulated Snow Fighter and met the maximum safe braking distance. The train experienced roughly nine seconds of slip/slide conditions and the average brake rate was approximately 1.8 mph/s.

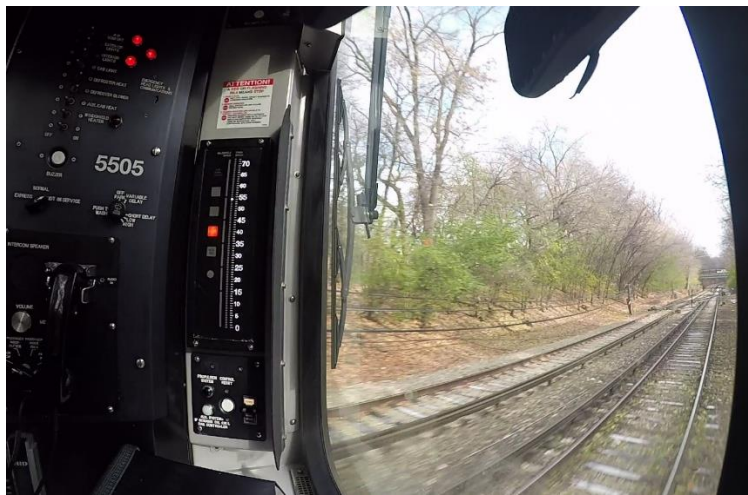
Figure #5: Test Run #2 – Speed when stop code command was received from signal system

Test Run #2 was performed with a simulated train in the SK1-9T track circuit. The train was given a maximum allowable speed of 55 mph, which it nearly reached before receiving a red cab signal stop code as seen in Figure 5 below. The operator of the train immediately applied the Full Service Brake. The train came to a complete stop (see Figure 6 below) roughly 168 feet beyond the entrance of SK1-9T, which would have avoided a collision with the simulated Snow Fighter, but still violated the maximum safe braking distance assumed by the wayside signal system. The train experienced roughly 16 seconds of slip/slide conditions and the average brake rate was approximately 1.6 mph/s.

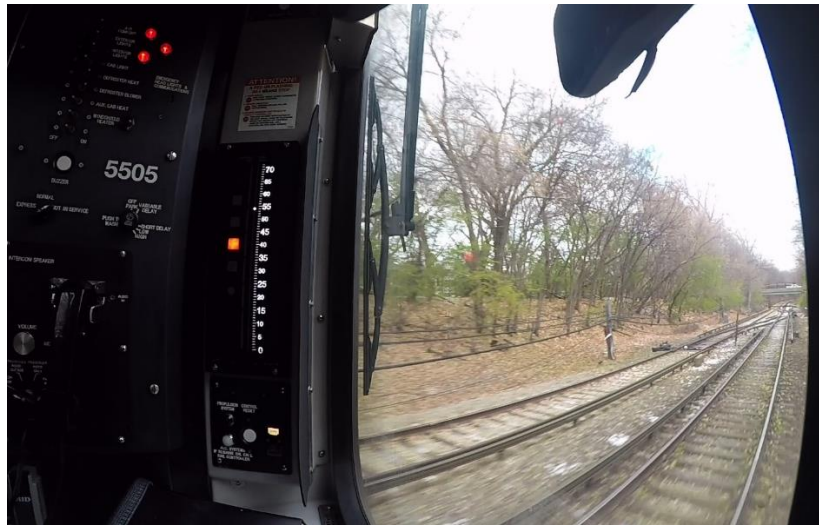
Figure #7: Test Run #2-Take 2 – Speed when stop code command was received from signal system

Test Run #2, Take 2, was performed with a simulated train in the SK1-9T track circuit. The train was given a maximum allowable speed of 55 mph, which it reached before receiving a red cab signal stop code as seen in Figure 7 below. The operator of the train immediately applied the Full Service Brake. The train came to a complete stop (see Figure 8 below) roughly 298 feet beyond the entrance of SK1-9T, which would have resulted in a collision with the simulated Snow Fighter. The train experienced roughly 16 seconds of slip/slide conditions and the average brake rate was approximately 1.58 mph/s.

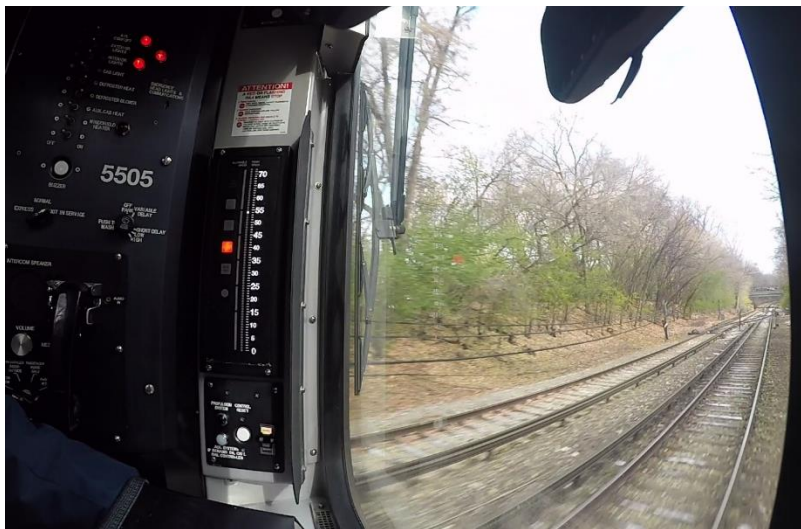
Figure #9: Test Run #3 – Speed when stop code command was received from signal system

Test Run #3 was performed with a simulated train in the SK1-9T track circuit. The train was given a maximum allowable speed of 55 mph, which it nearly reached before receiving a red cab signal stop code as seen in Figure 9 below. The operator of the train immediately applied the Full Service Brake and deployed the Track Brake ahead of when the simulated Snow Fighter came into view. The train came to a complete stop (see Figure 10 below) roughly 454 feet ahead of the entrance of SK1-9T, which would have avoided a collision with the simulated Snow Fighter and met the maximum safe braking distance. The train experienced roughly 10 seconds of slip/slide conditions and the average brake rate was approximately 2.3 mph/s.

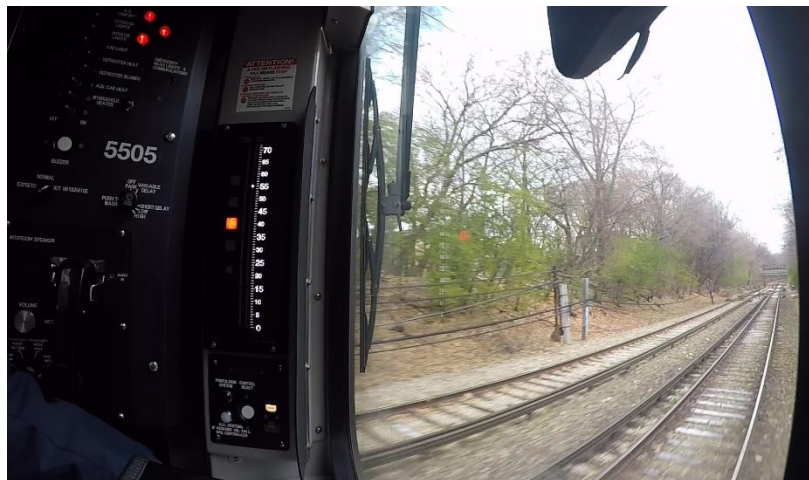
Figure #11: Test Run #3-Take 2 – Speed when stop code command was received from signal

Test Run #3, Take 2, was performed with a simulated train in the SK1-9T track circuit. The train was given a maximum allowable speed of 55 mph, which it reached before receiving a red cab signal stop code as seen in Figure 11 below. The operator of the train immediately applied the Full Service Brake and deployed the Track Brake when the simulated Snow Fighter came into view. The train came to a complete stop (see Figure 12 below) roughly 50 feet beyond the entrance of SK1-9T, which would have avoided a collision with the simulated Snow Fighter, but still violated the maximum safe braking distance assumed by the wayside signal system. The train experienced roughly 19 seconds of slip/slide conditions and the average brake rate was approximately 1.54 mph/s.
