MEMO:

RE: November 16, 2023 – Collision on Yellow Line Between Revenue Train and Snow Fighter
CTA Infrastructure Division Report on Early Post-Accident Investigation Tasks and Data Gathering

Event Synopsis and Corresponding Infrastructure

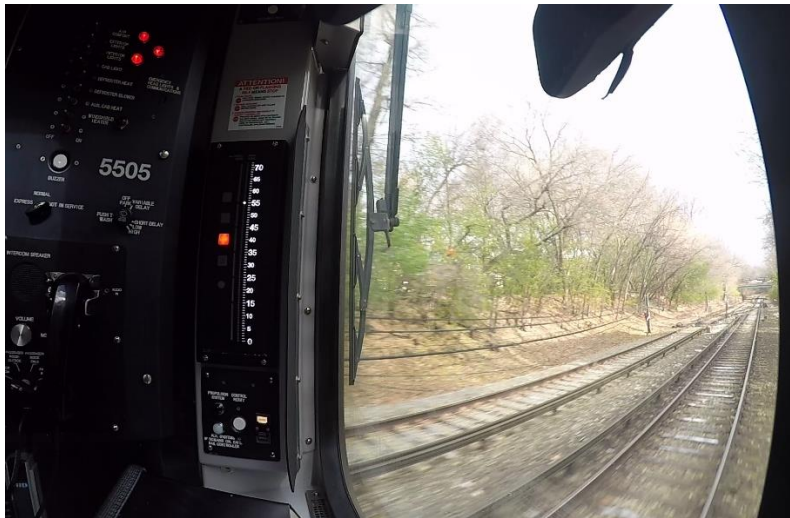
Figure #13: Test Run #3A – Speed when stop code command was received from signal system

Test Run #3A was performed with a simulated train in the SK1-9T track circuit. The train was given a maximum allowable speed of 55 mph, which it reached before receiving a red cab signal stop code as seen in Figure 13 below. The operator of the train immediately applied the Full Service Brake and entered Emergency when the simulated Snow Fighter came into view. The train came to a complete stop (see Figure 14 below) roughly 53 feet beyond the entrance of SK1-9T, which would have avoided a collision with the simulated Snow Fighter, but still violated the maximum safe braking distance assumed by the wayside signal system. The train experienced roughly 17 seconds of slip/slide conditions and the average brake rate was approximately 1.83 mph/s.

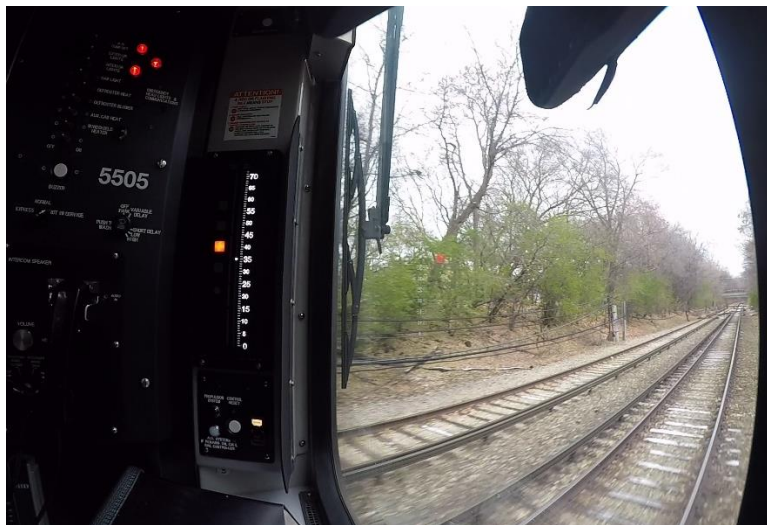
Figure #15: Test Run #4 – Speed when stop code command was received from signal system

Test Run #4 was performed with a simulated train in the SK1-9T track circuit. The train was given a maximum allowable speed of 35 mph, which it reached before receiving a red cab signal stop code as seen in Figure 15 below. The operator of the train did not apply a braking application (the operator retained the master controller in the propulsion position) and the train received a penalty brake after entering SK1-26T as a result. The train came to a complete stop (see Figure 16 below) roughly 518 feet ahead of the entrance of SK1-9T, which would have avoided a collision with the simulated Snow Fighter and met the maximum safe braking distance. The train experienced roughly nine seconds of slip/slide conditions and the average brake rate was approximately 1.83 mph/s.

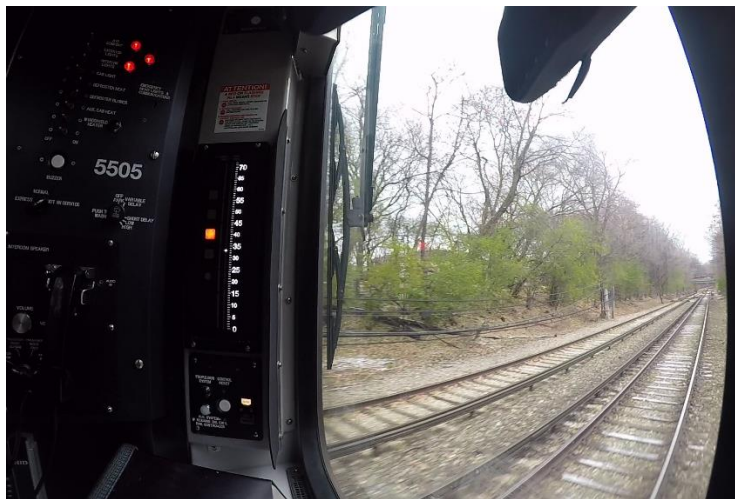
Figure #17: Test Run #5 – Speed when stop code command was received from signal system

Test Run #5 was performed with a simulated train in the SK1-9T track circuit. The train was given a maximum allowable speed of 35 mph, which it nearly reached before receiving a red cab signal stop code as seen in Figure 17 below. The operator of the train immediately applied the Full Service Brake. The train came to a complete stop (see Figure 18 below) roughly 628 feet ahead of the entrance of SK1-9T, which would have avoided a collision with the simulated Snow Fighter and met the maximum safe braking distance. The train experienced roughly eight seconds of slip/slide conditions and the average brake rate was approximately 1.94 mph/s.

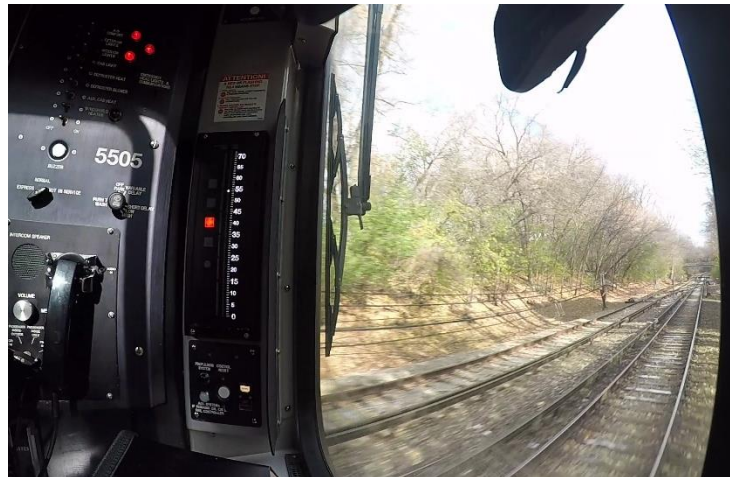
Figure #19: Test Run #6 – Speed when stop code command was received from signal system

Test Run #6 was a repeat of Test Run #1 and was performed with a simulated train in the SK1-9T track circuit. The train was given a maximum allowable speed of 55 mph, which it reached before receiving a red cab signal stop code as seen in Figure 19 below. The operator of the train did not apply a braking application (the operator retained the master controller in the propulsion position) and the train received a penalty brake after entering SK1-26T as a result. The train came to a complete stop (see Figure 20 below) roughly 257 feet beyond the entrance of SK1-9T, which would have resulted in a collision with the simulated Snow Fighter. The train experienced roughly 13 seconds of slip/slide conditions and the average brake rate was approximately 1.38 mph/s.

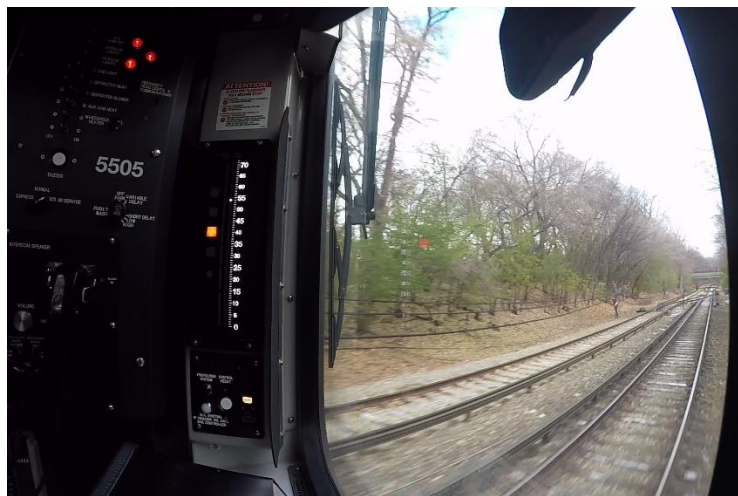
Figure #21: Test Run #7 – Speed when stop code command was received from signal system

Test Run #7 was performed with a simulated train in the SK1-9T track circuit. Vehicle Engineering modified the slip/slide software to introduce track braking during slip/slide detection. The train was given a maximum allowable speed of 55 mph, which it reached before receiving a red cab signal stop code as seen in Figure 21 below. The operator of the train did not apply a braking application (the operator retained the master controller in the propulsion position) and the train received a penalty brake after entering SK1-26T as a result. The train came to a complete stop (see Figure 22 below) roughly 532 feet beyond the entrance of SK1-9T, which would have resulted in a collision with the simulated Snow Fighter. The train experienced roughly 14 seconds of slip/slide conditions and the average brake rate was approximately 0.98 mph/s.

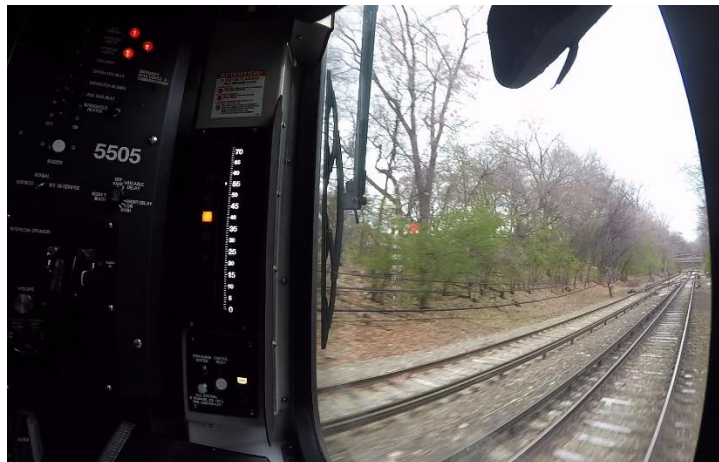
Figure #23: Test Run #8 – Speed when stop code command was received from signal system

Test Run #8 was performed with a simulated train in the SK1-9T track circuit. Vehicle Engineering modified the slip/slide software to introduce track braking during slip/slide detection. The train was given a maximum allowable speed of 55 mph, which it reached before receiving a red cab signal stop code as seen in Figure 23 below. The operator of the train did not apply a braking application (the operator retained the master controller in the propulsion position) and the train received a penalty brake after entering SK1-26T as a result. The train came to a complete stop (see Figure 24 below) roughly 81feet ahead of the entrance of SK1-9T, which would have avoided a collision with the simulated Snow Fighter and met the maximum safe braking distance. The train experienced roughly 11 seconds of slip/slide conditions and the average brake rate was approximately 1.37 mph/s.

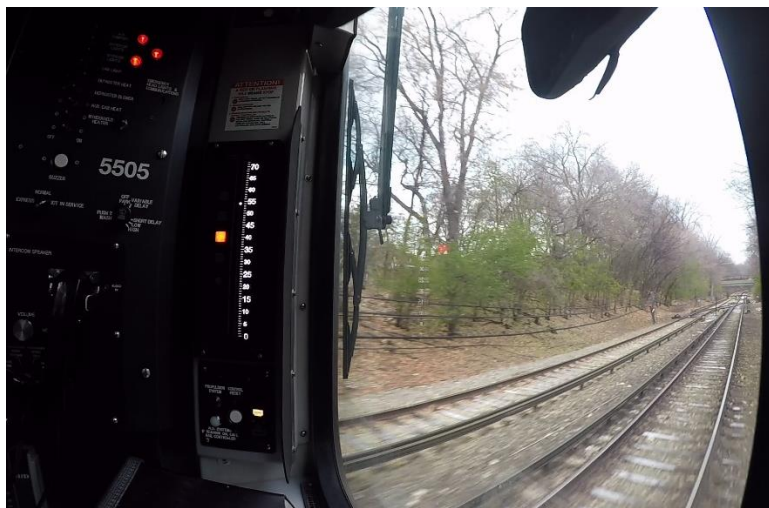
Figure #25: Test Run #9 – Speed when stop code command was received from signal system

Test Run #9 was performed with a simulated train in the SK1-9T track circuit. Vehicle Engineering modified the slip/slide software to introduce track braking during slip/slide detection. The train was given a maximum allowable speed of 55 mph, which it nearly reached before receiving a red cab signal stop code as seen in Figure 25 below. The operator of the train did not apply a braking application (the operator retained the master controller in the propulsion position) and the train received a penalty brake after entering SK1-26T as a result. The train came to a complete stop (see Figure 26 below) roughly 453 feet beyond the entrance of SK1-9T, which would have resulted in a collision with the simulated Snow Fighter. The train experienced roughly 10 seconds of slip/slide conditions and the average brake rate was approximately 0.88 mph/s.

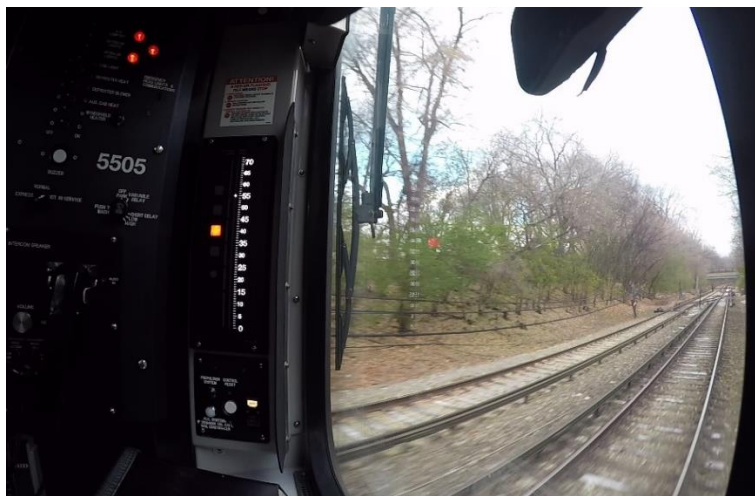
Figure #27: Test Run #10 – Speed when stop code command was received from signal system

Test Run #10 was performed with a simulated train in the SK1-9T track circuit. Vehicle Engineering modified the slip/slide software to introduce track braking during slip/slide detection. The train was given a maximum allowable speed of 55 mph, which it reached before receiving a red cab signal stop code as seen in Figure 27 below. The operator of the train did not apply a braking application (the operator retained the master controller in the propulsion position) and the train received a penalty brake after entering SK1-26T as a result. The train came to a complete stop (see Figure 28 below) roughly 49 feet ahead of the entrance of SK1-9T, which would have avoided a collision with the simulated Snow Fighter and met the maximum safe braking distance. The train experienced roughly 11 seconds of slip/slide conditions and the average brake rate was approximately 1.25 mph/s.
