Fatigue and Fracture Bridge Inspection Plan, Forbes Avenue over Fern Hollow and 9 Mile Run, Prepared for City of Pittsburgh Department of Public Works via Pennsylvania Department of Transportation Engineering District 11, CDM Smith, January 2016

FATIGUE AND FRACTURE BRIDGE INSPECTION PLAN

STRUCTURE BMS NUMBER: 02 7301 0000 3033

BRIDGE NAME: FORBES AVENUE OVER FERN
HOLLOW AND 9 MILE RUN

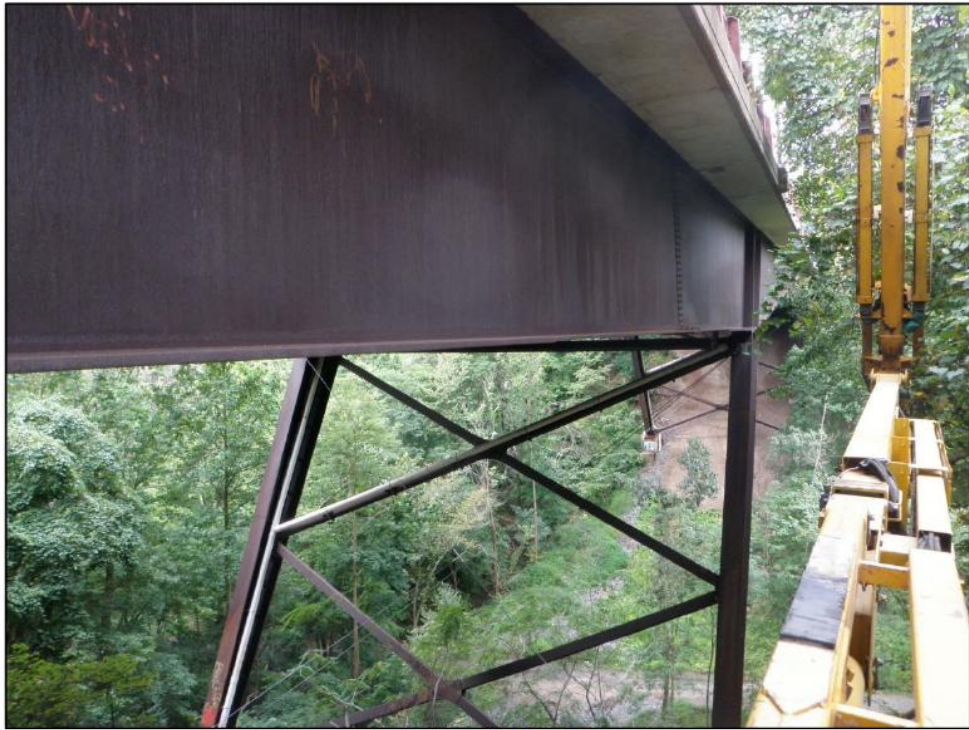
LEFT ELEVATION

The bridge is a three-span continuous rigid frame with a total structure length of 447'-0". The superstructure consists of two variable depth welded weathering steel girders, welded steel floorbeams, and rolled steel stringers, supported by two welded steel frames. The entire superstructure is weathering steel. The reinforced concrete deck, measuring 64'-0" out-to-out, is topped with a bituminous wearing surface. The four (4) lane undivided roadway measures 50'-0" curb-to-curb with a 7'-0" wide reinforced concrete sidewalk on each side. A pedestrian railing, 3'-6" in height including a 20" high single rail tubular steel bridge rail is mounted on top of each sidewalk and curb. The substructure consists of two (2) original stone masonry abutments with reinforced concrete caps, and weathering steel frame legs supported by reinforced concrete thrust blocks.

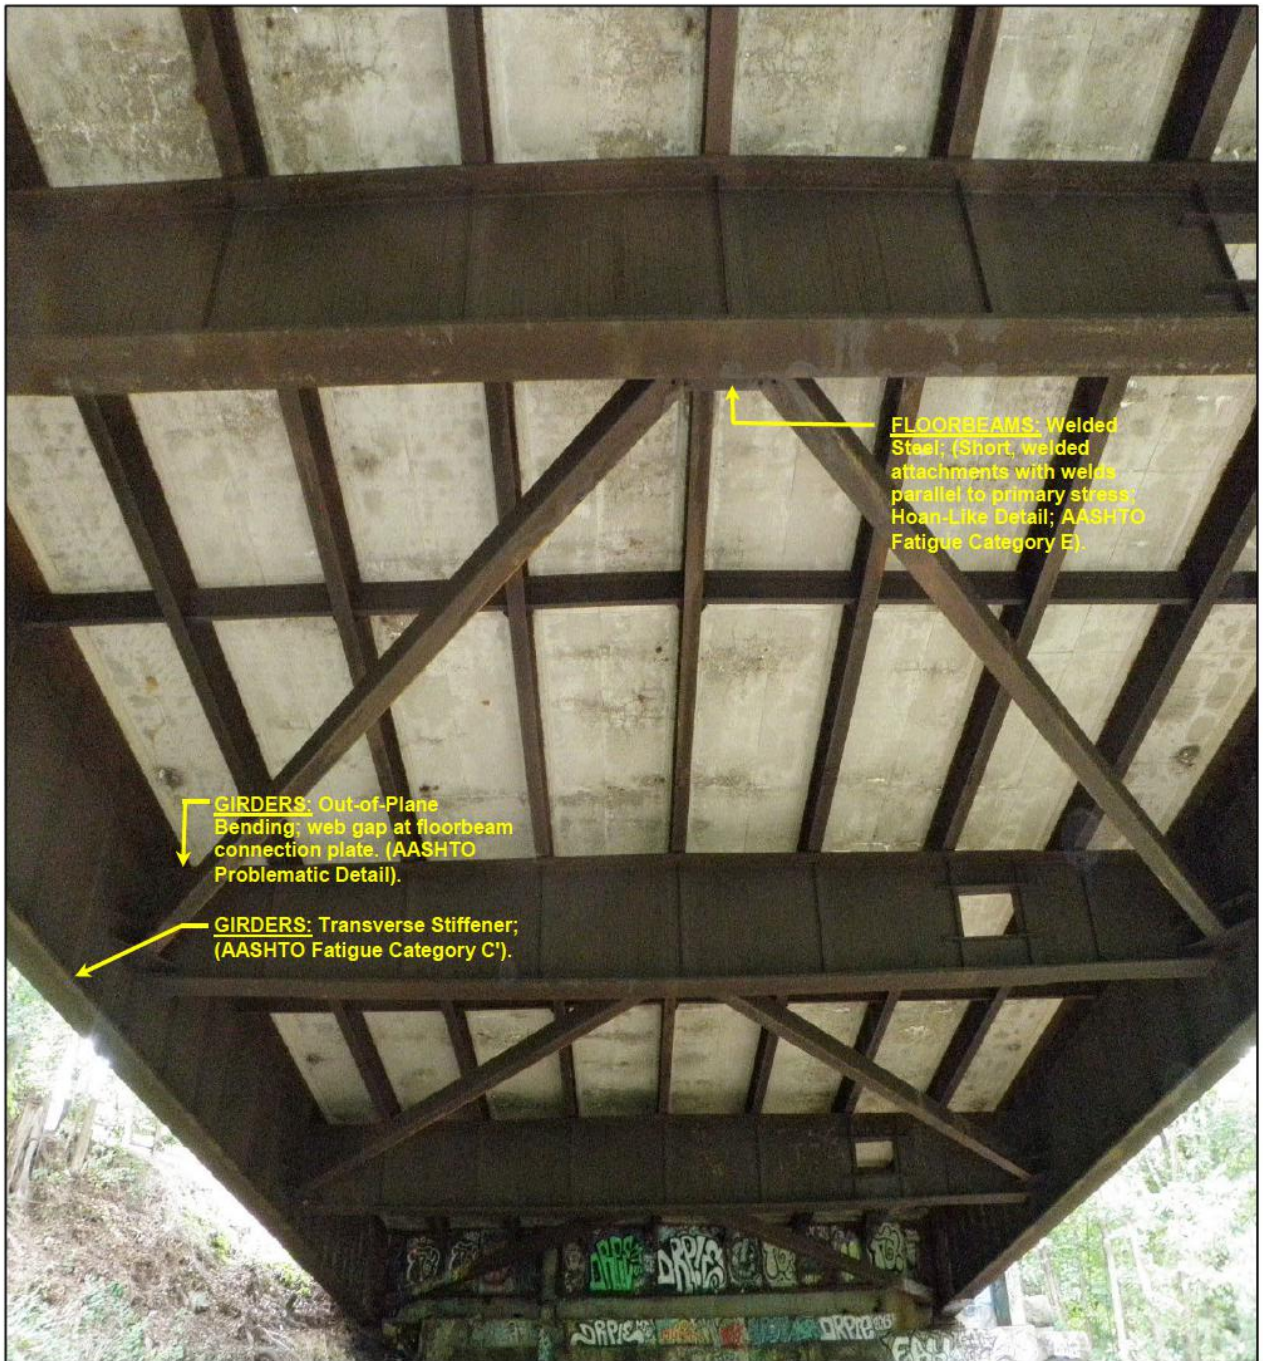
Photo 1 – Location of Fracture-Critical Members.

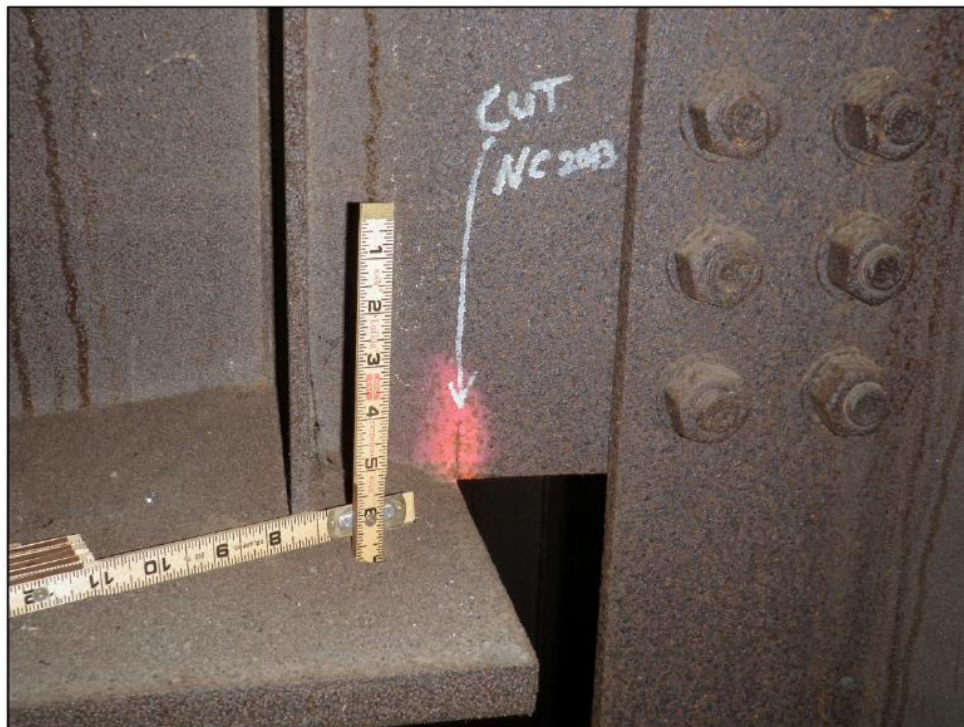
The welded, weathering steel floorbeams, spaced at greater than 14'-0", are also fracture-critical members. Short, welded attachments for the lateral bracing are present at the center of all floorbeams (AASHTO Fatigue Category E). The top and bottom flanges are cut short at the ends (AASHTO Fatigue Category E (Equivalent)).

Photo 5 – Location of Fracture-Critical Members. Cut-short floorbeam flange at girder connection (AASHTO Fatigue Category E (Equivalent)). Floorbeam was over-cut when fabricated).
