Highway Factors Photographs 1 through 20

Highland, IL

HWY23MH015

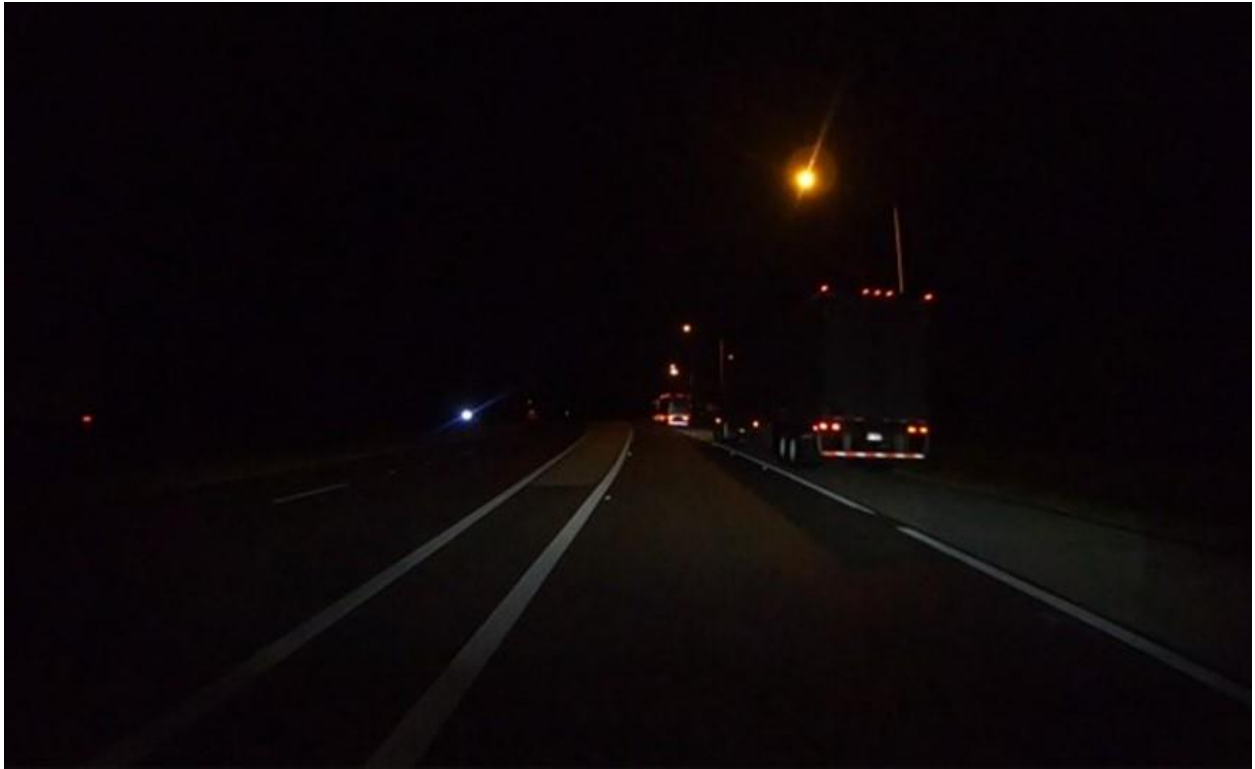
Highway Factors Photo 1 – View of screen shot of two of the five truck-tractor semi-trailer combination units parked on the exit ramp shoulder to the westbound Silver Lake rest stop taken on Saturday, July 15, 2023, at approximately 9:30 p.m. looking to the west

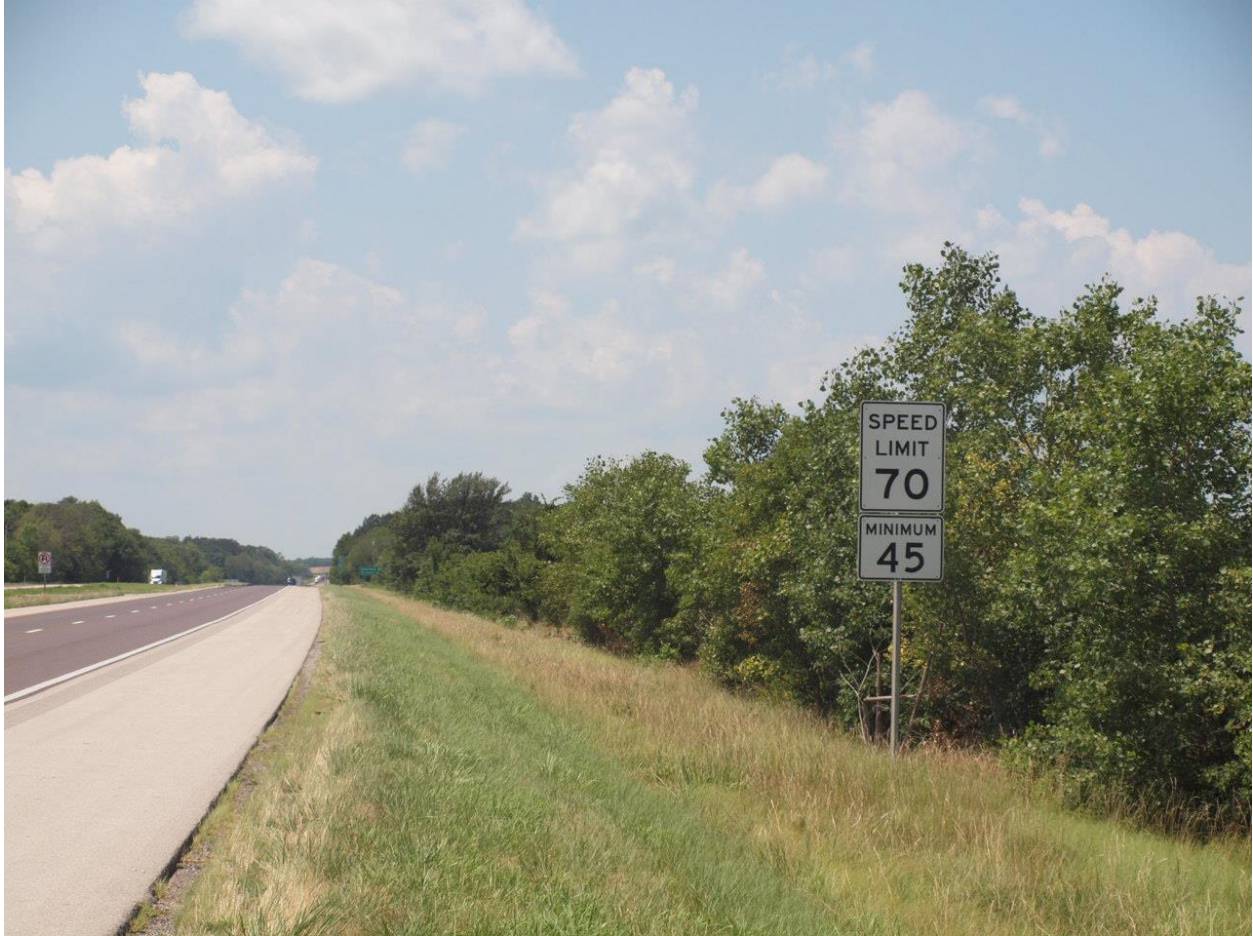
Highway Factors Photo 2 – View of the regulatory speed limit sign posted approximately 2.3 miles prior to the crash, indicating a 70-mph speed limit and 45-mph minimum speed limit looking to the west

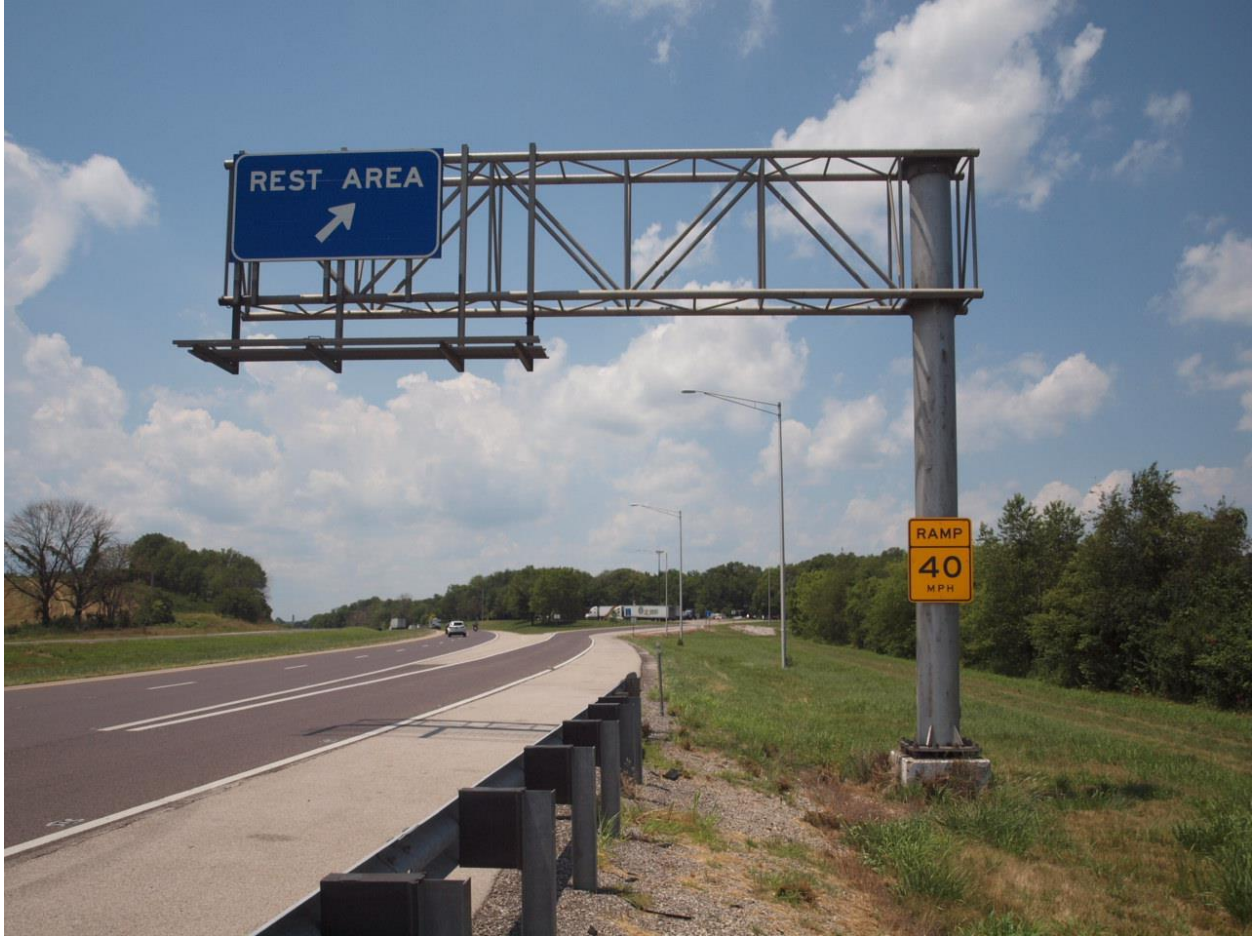
Highway Factors Photo 3 – View of the 40-mph advisory speed limit sign for the exit ramp to the westbound Silver Lake rest stop posted approximately 350 feet prior to the crash looking to the west

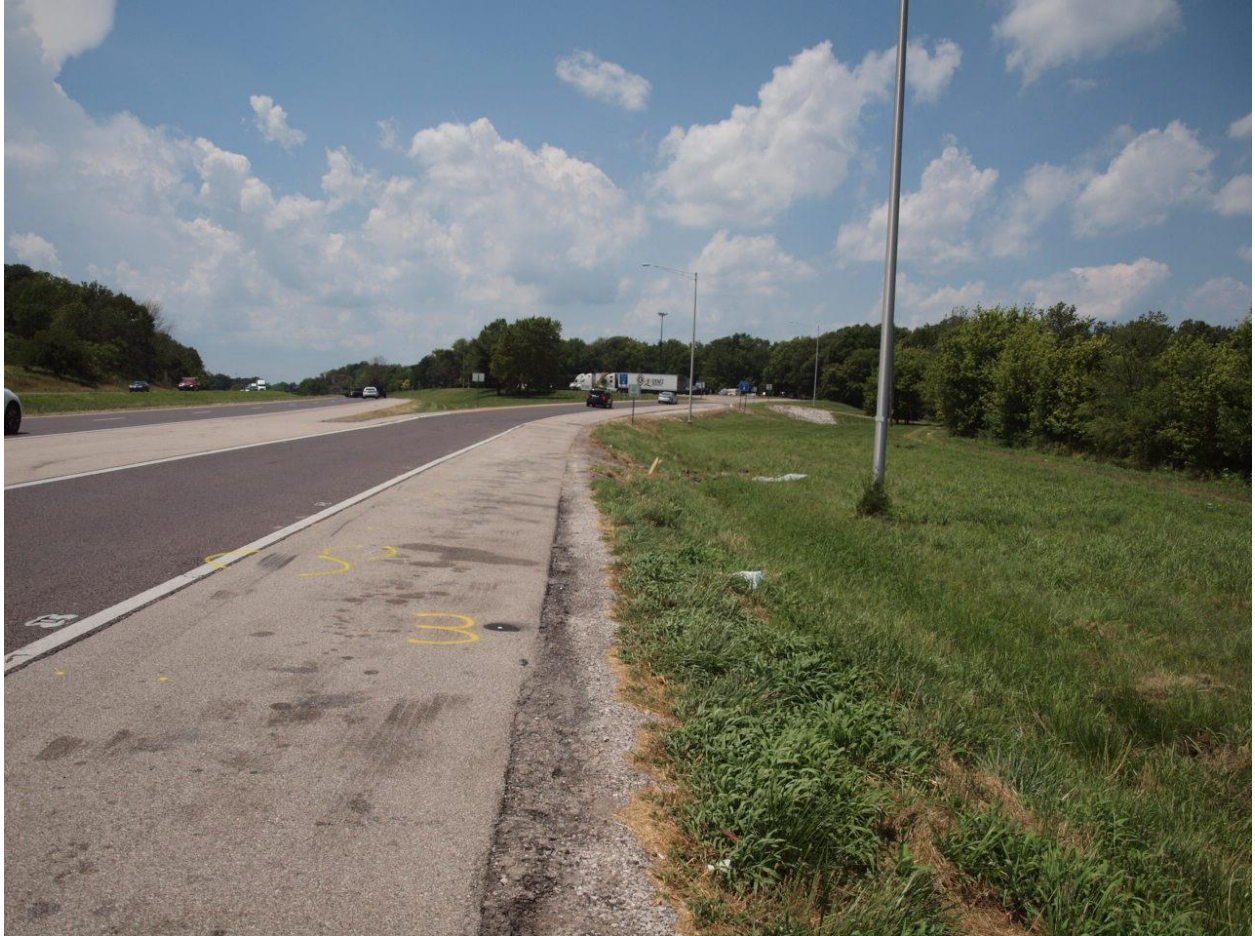
Highway Factors Photo 4 – View of the exit ramp to the westbound Silver Lake rest stop in the vicinity of the crash location standing on the edge of the paved right shoulder looking to the west

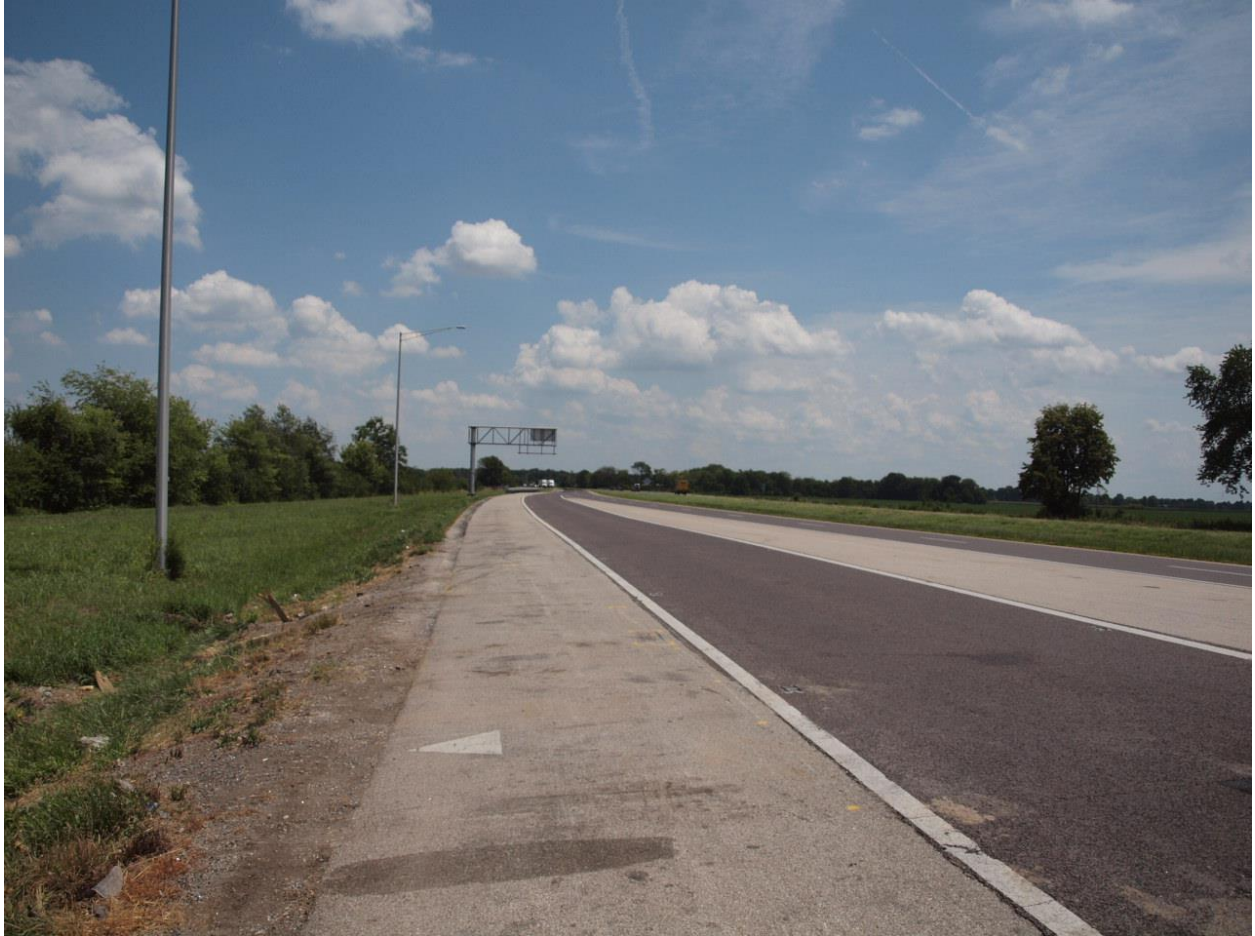
Highway Factors Photo 5 – View of the exit ramp to the westbound Silver Lake rest stop in the vicinity of the crash location standing on the paved right shoulder looking to the east

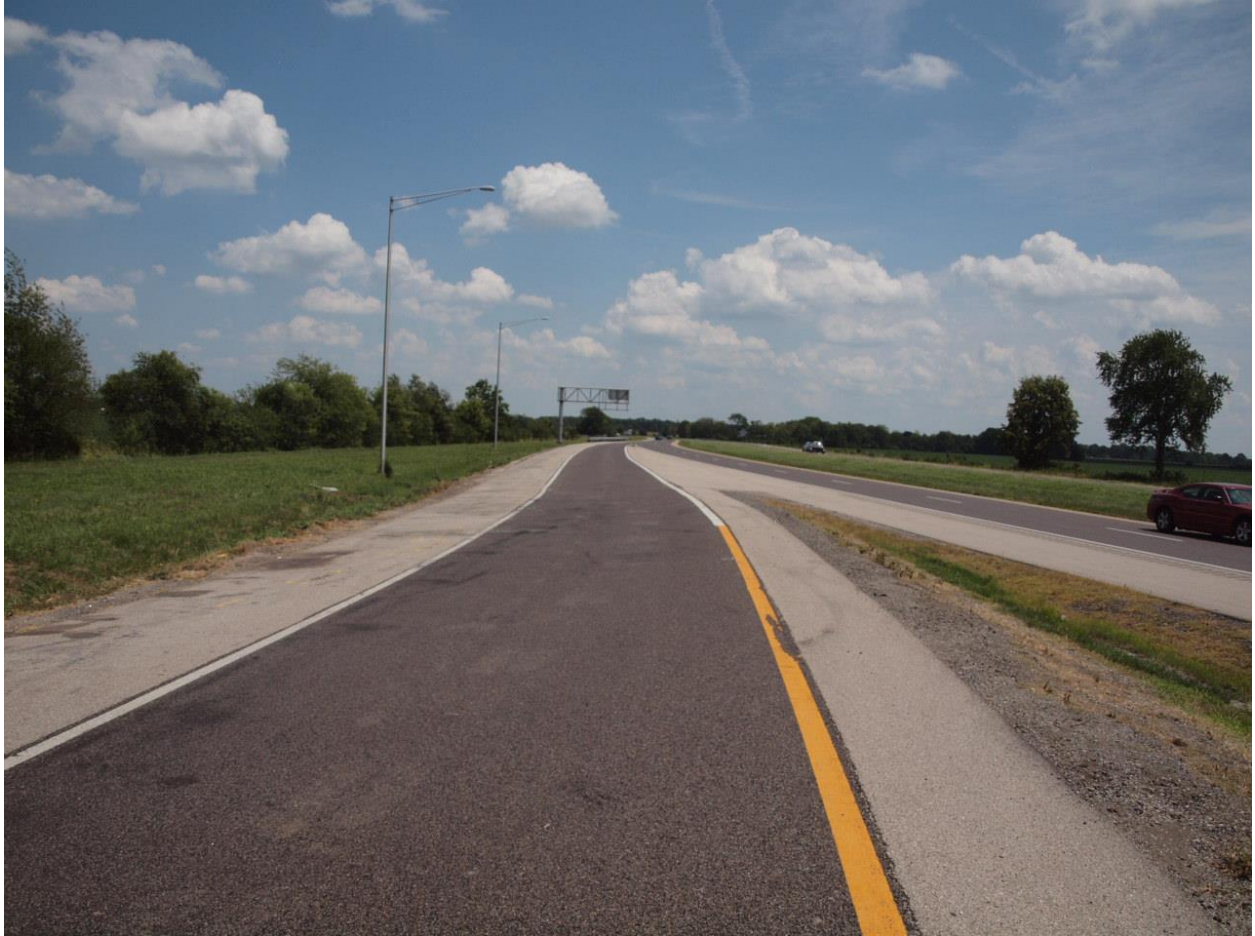
Highway Factors Photo 6 – View of the exit ramp to the westbound Silver Lake rest stop immediately west of the crash location standing on the exit ramp looking to the east

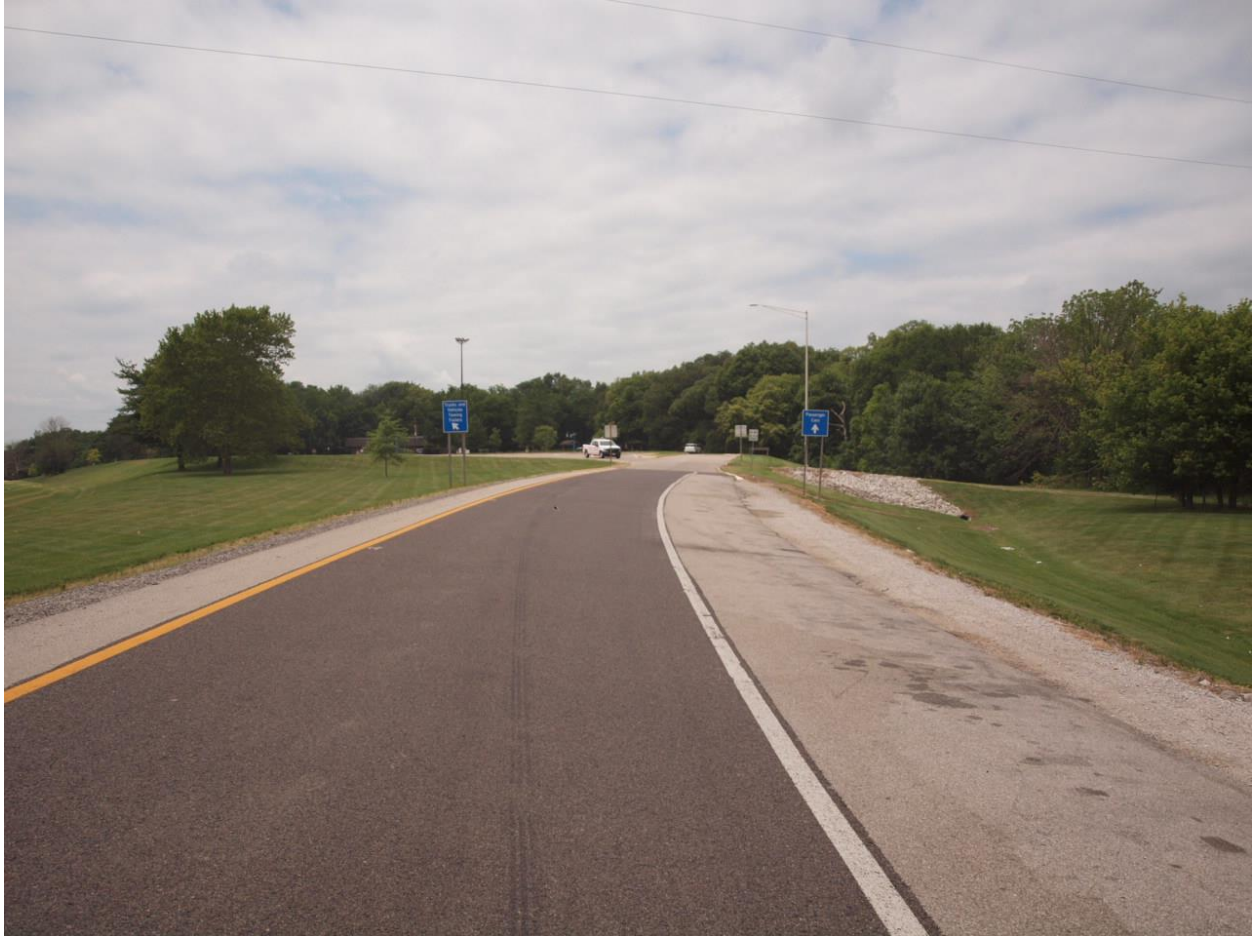
Highway Factors Photo 7 – View of the exit ramp to the westbound Silver Lake rest stop immediately west of the crash location standing on the exit ramp looking to the northwest

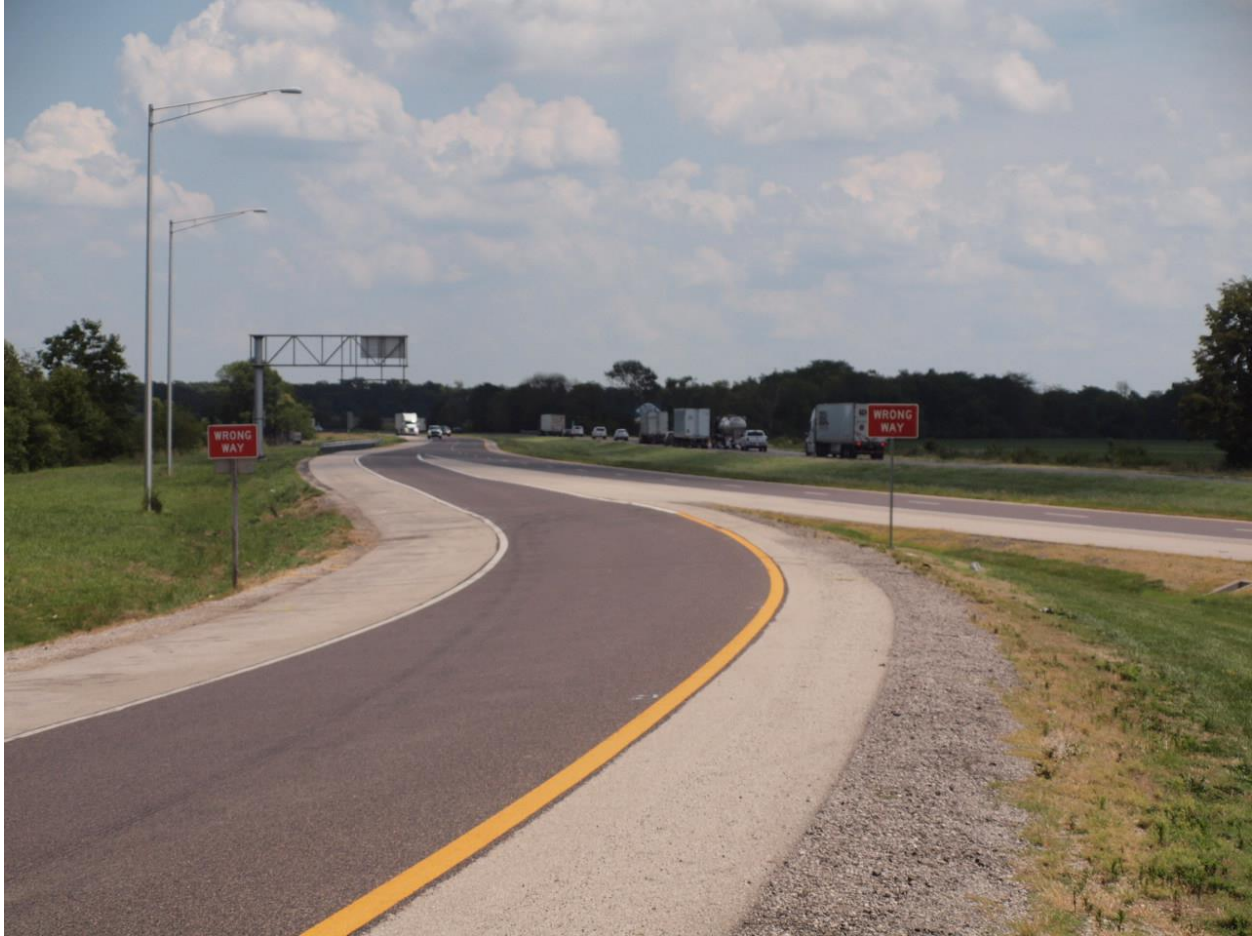
Highway Factors Photo 8 – View of the exit ramp to the westbound Silver Lake rest stop west of the crash location standing on the edge of the paved left shoulder looking to the east with “Wrong Way” signs located in the background

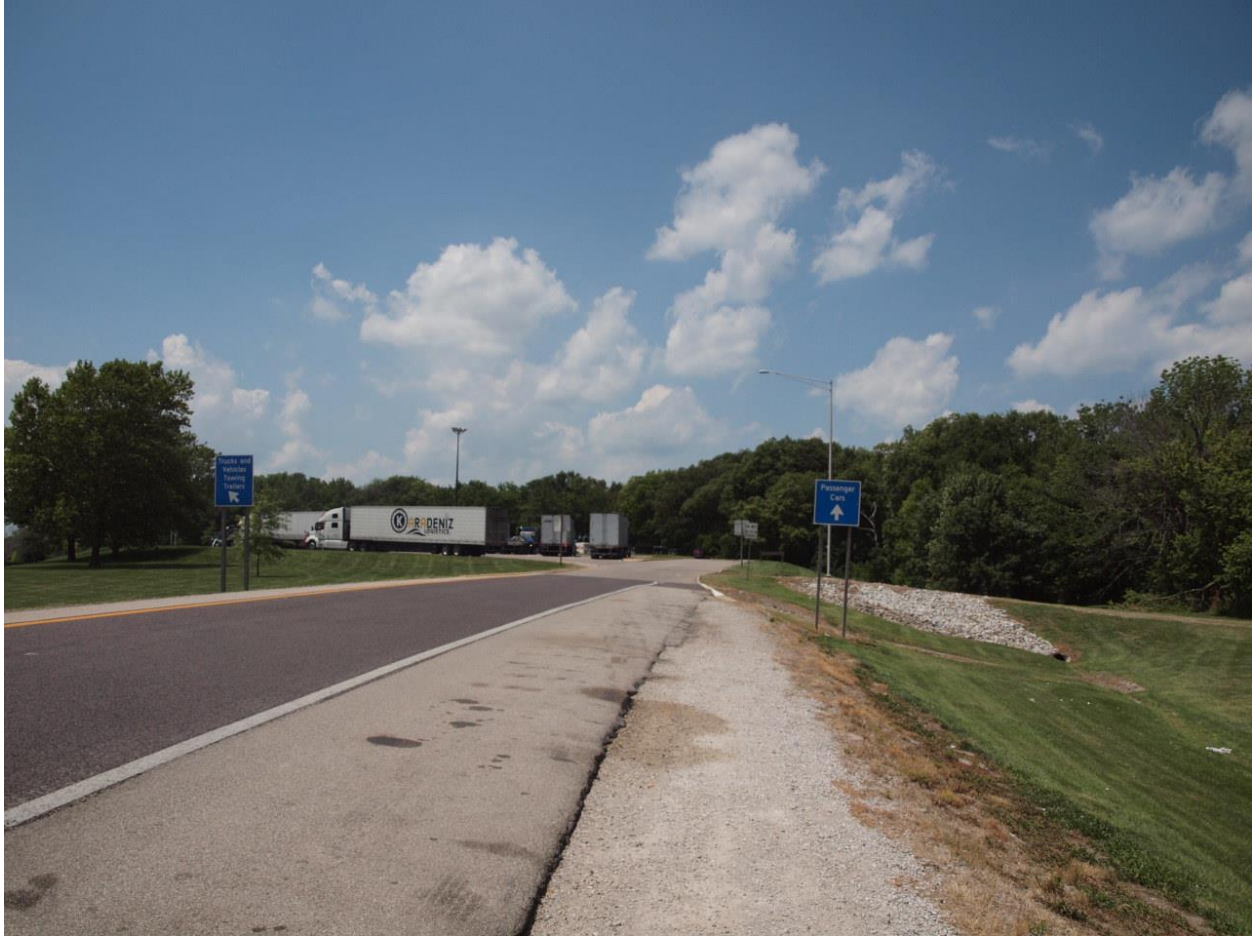
Highway Factors Photo 9 – View of the exit ramp to the westbound Silver Lake rest stop west of the crash location standing on the edge of the paved right shoulder looking to the northwest with directional signs for “Passenger Cars” and “Trucks and Vehicles Towing Trailers” located in the background

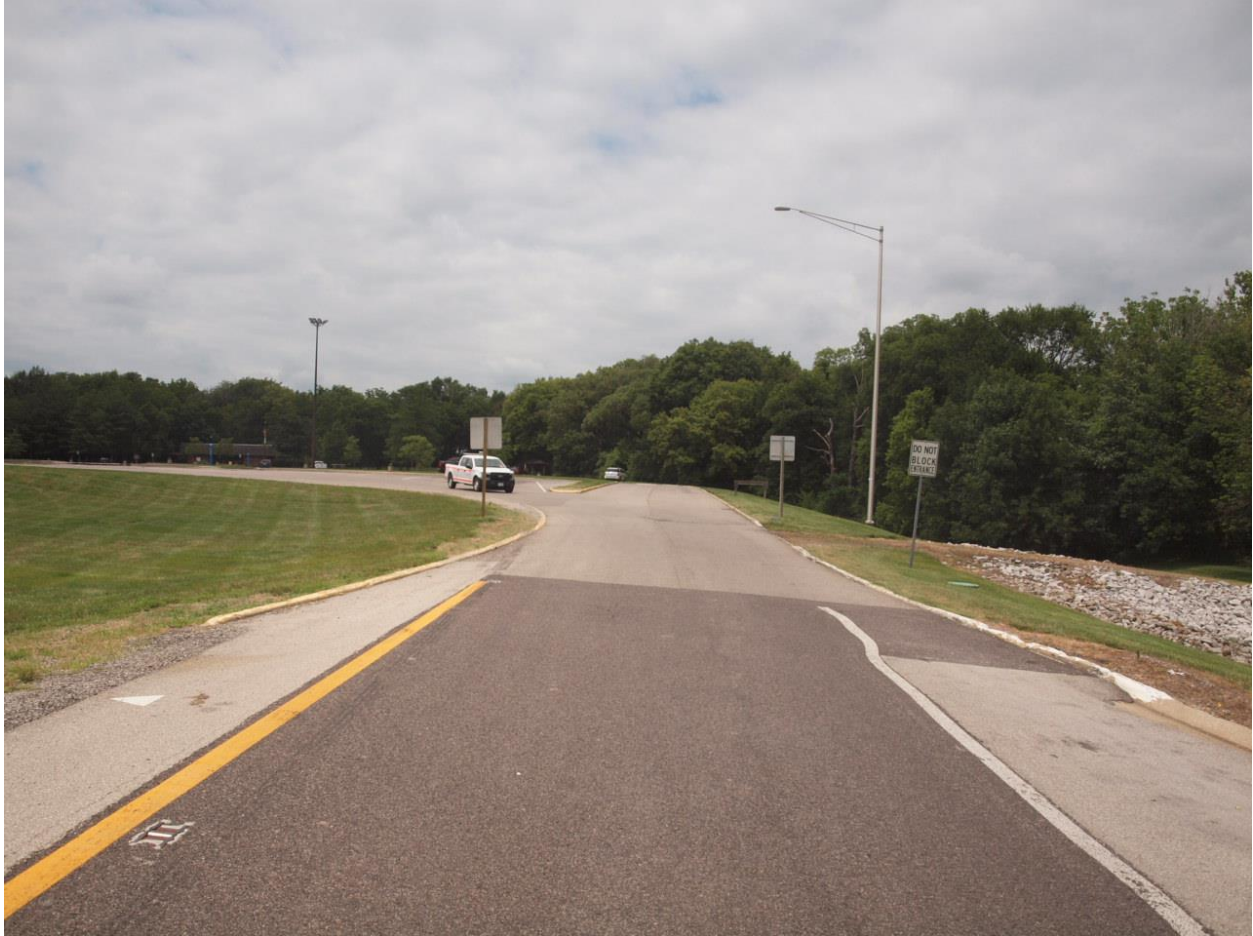
Highway Factors Photo 10 – View of the exit ramp to the westbound Silver Lake rest stop west of the crash location standing on the exit ramp looking to the northwest with the rest stop parking lot and building located in the background

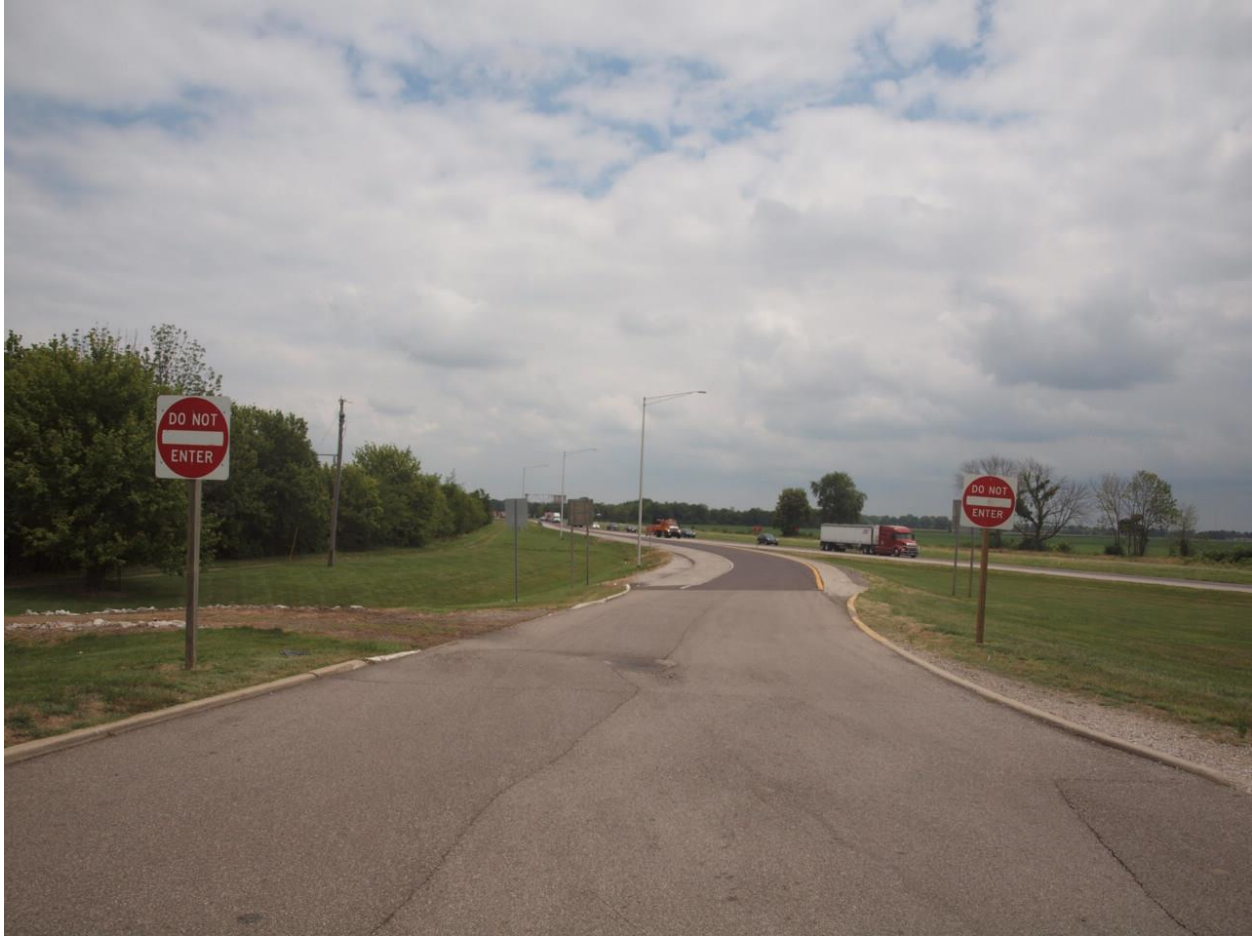
Highway Factors Photo 11 – View of the exit ramp to the westbound Silver Lake rest stop west of the crash location standing at the entrance to the rest stop parking lot looking to the east with “Do Not Enter” signs located in the foreground

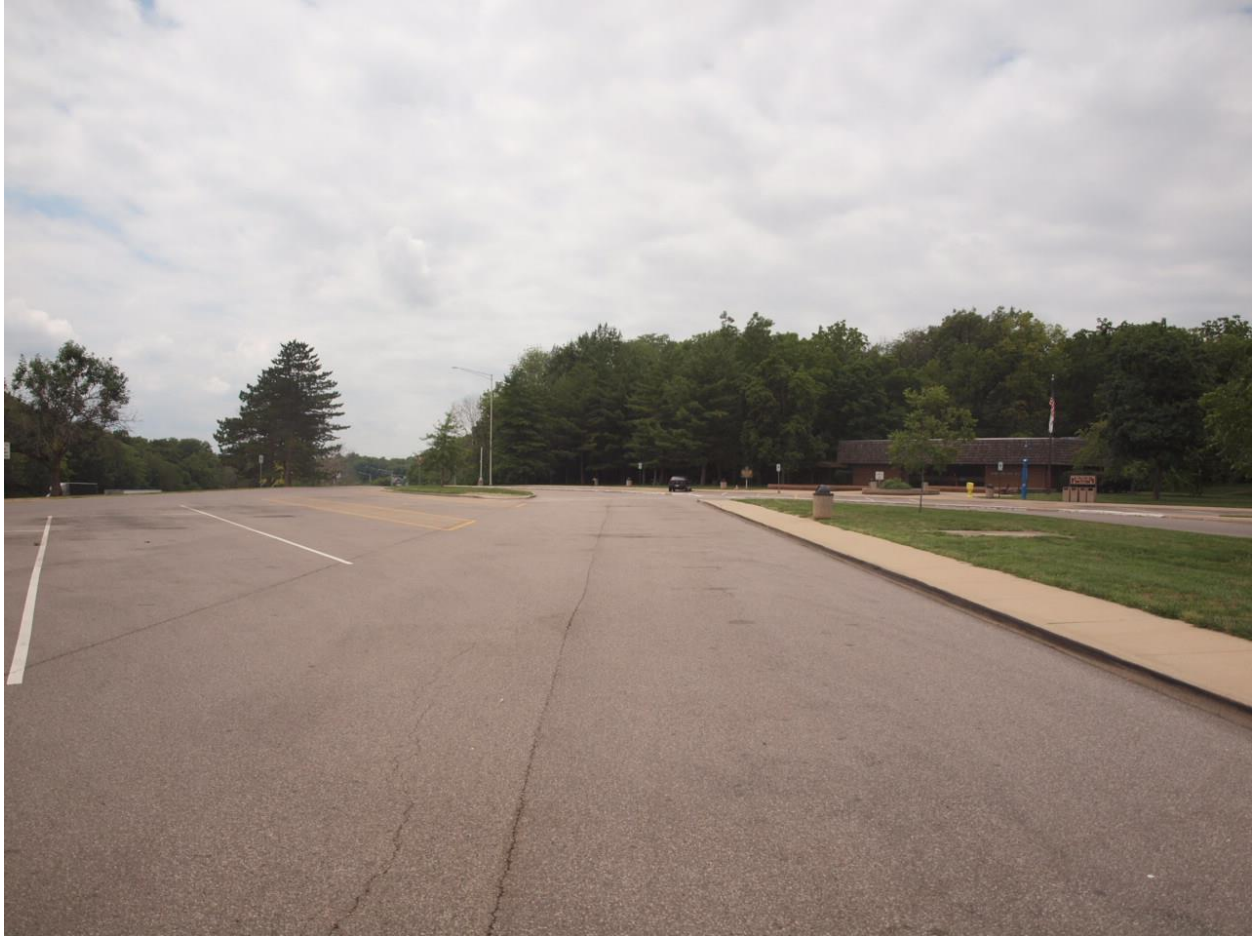
Highway Factors Photo 12 – View of the westbound Silver Lake rest stop parking lot standing in the aisle adjacent to the truck parking spaces looking to the west with the rest stop building located in the background

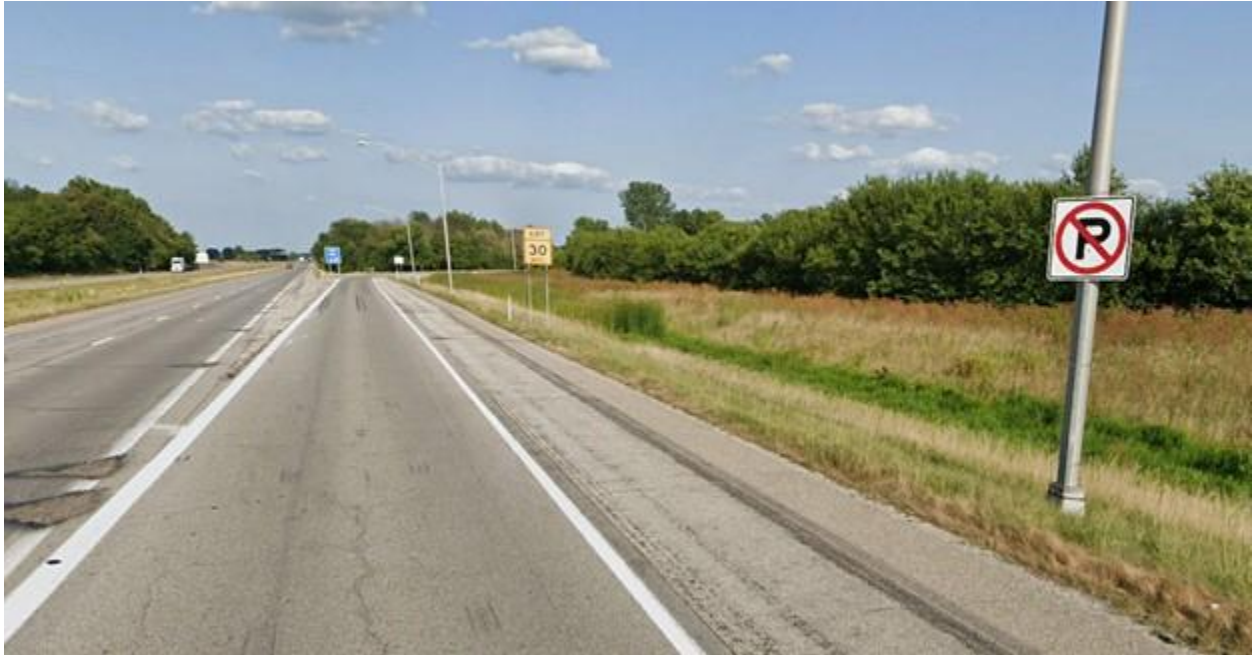
Highway Factors Photo 13 – View of the no parking symbol sign on the exit ramp to the Spring Creek rest stop area near Covington, IN on I-74 (Source: Google Street Maps)

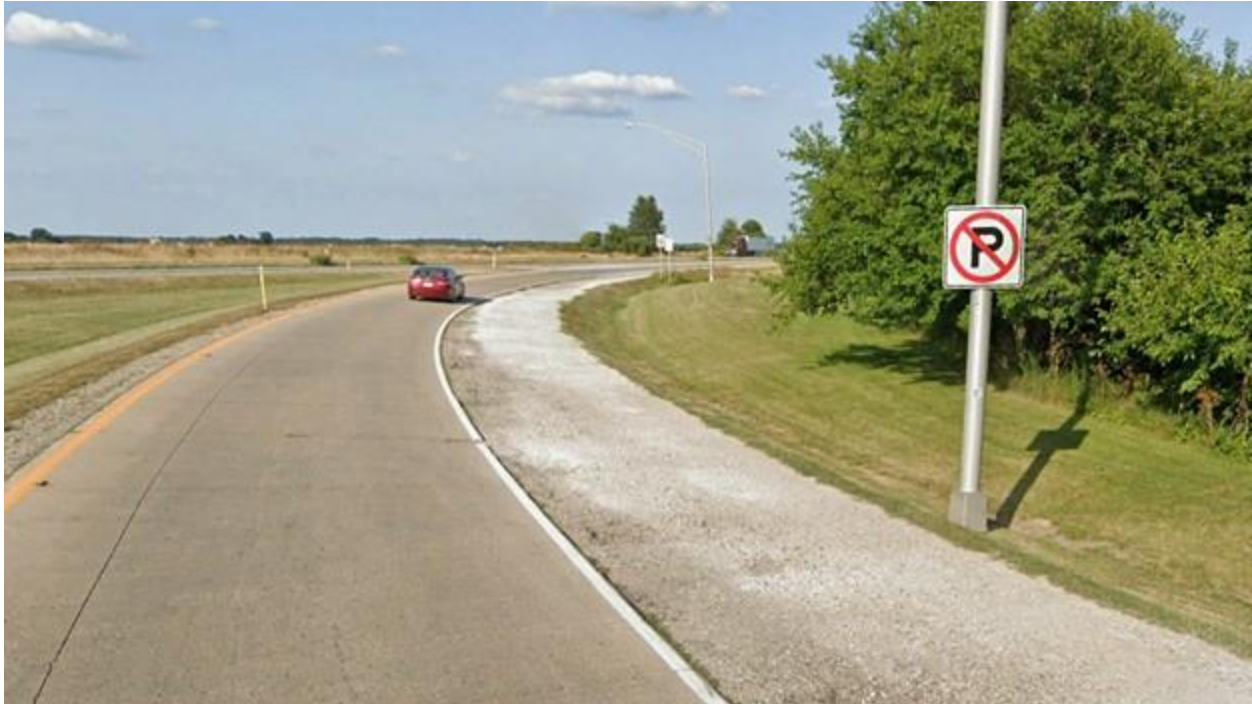
Highway Factors Photo 14 – View of the no parking symbol sign on the entrance ramp from the Spring Creek rest stop area near Covington, IN on I-74 (Source: Google Street Maps)

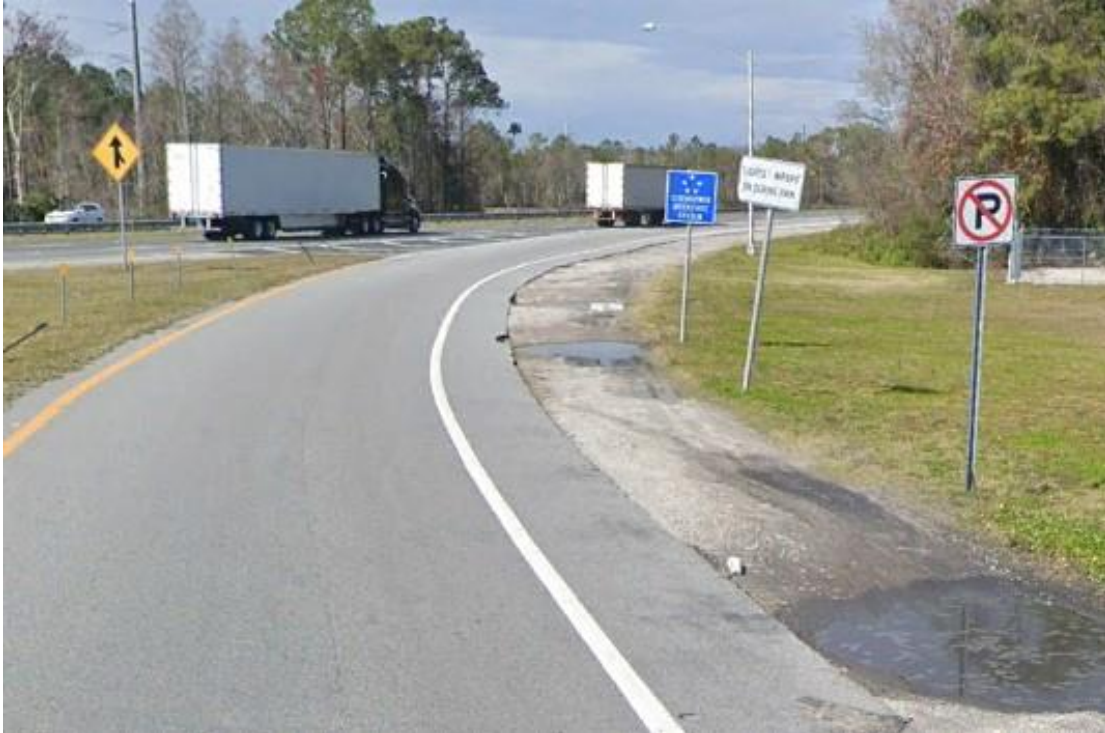
Highway Factors Photo 15 – View of the no parking symbol sign on the entrance ramp from the rest stop area south of St. Augustine, FL on I-95 (Source: Google Street Maps)

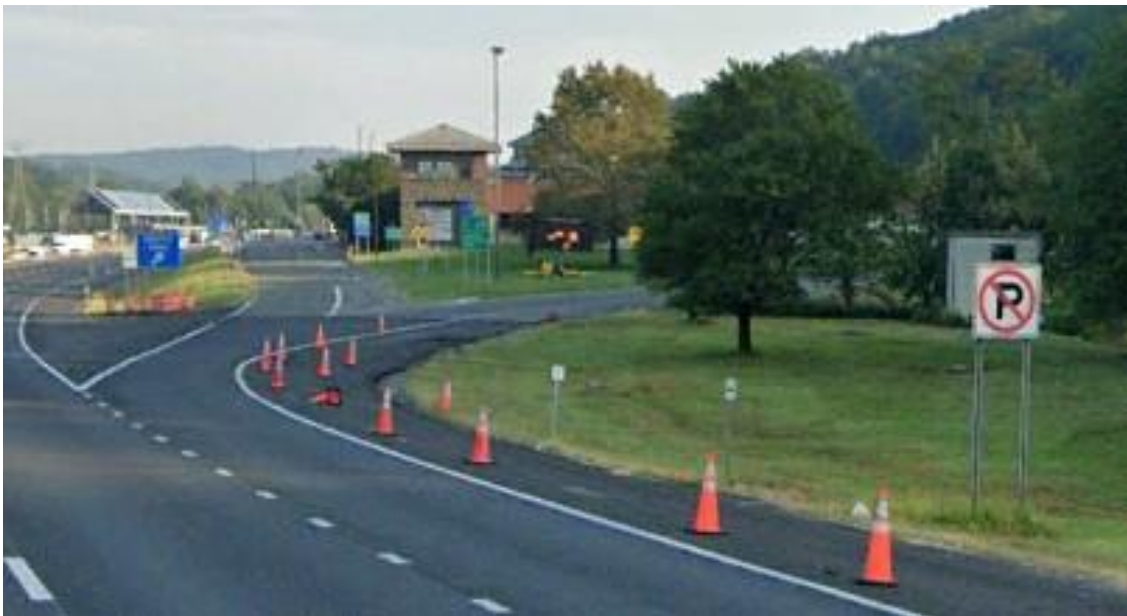
Highway Factors Photo 16 – View of the no parking symbol sign on the exit ramp and traffic cones on the shoulder to the Ramapo rest stop area near Sloatsburg, NY on I-87 (Source: Google Street Maps)

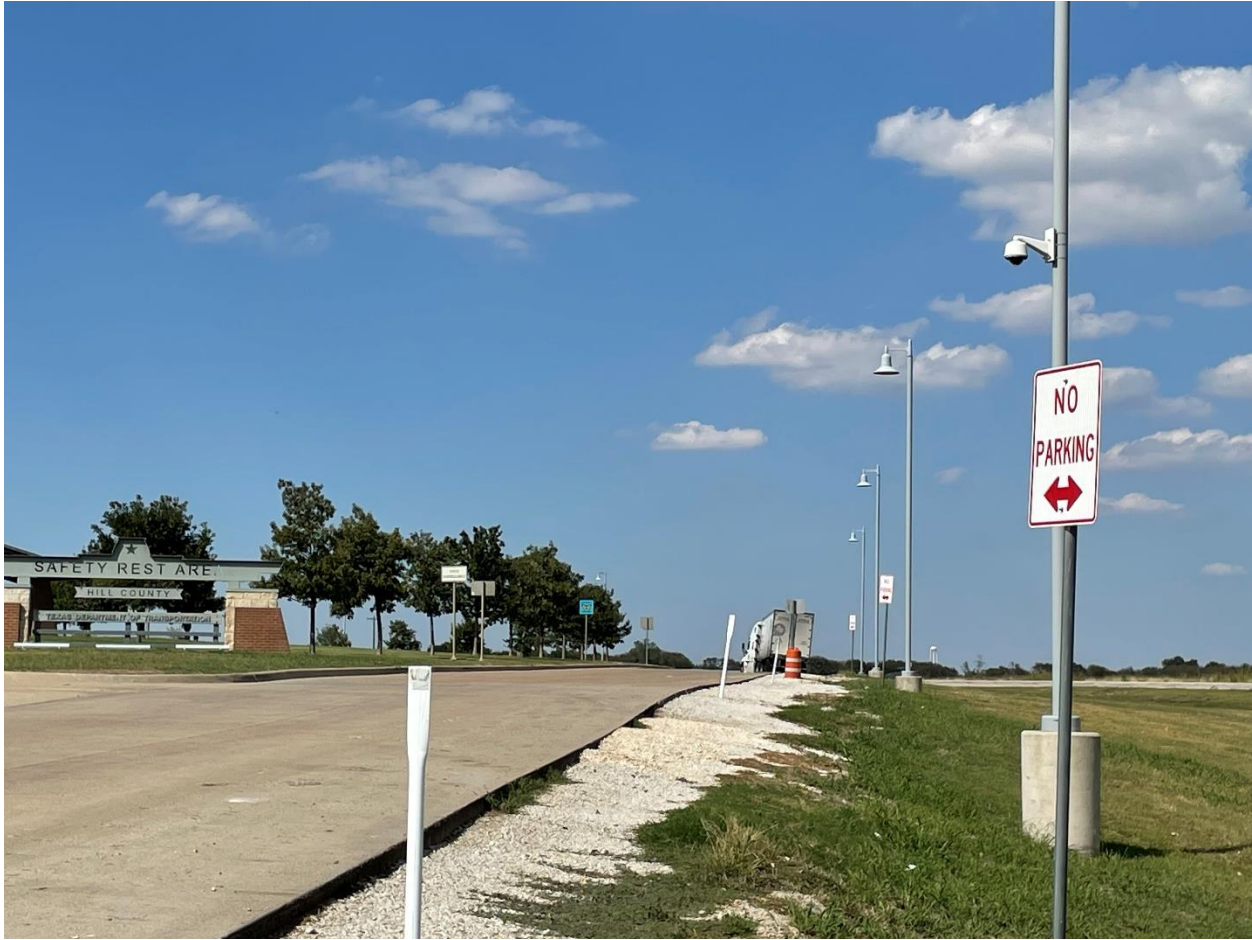
Highway Factors Photo 17 – View of the “No Parking” sign on the exit ramp and flexible delineator posts on the shoulder to the Hill County safety rest area south of Hillsboro, Texas on I-35

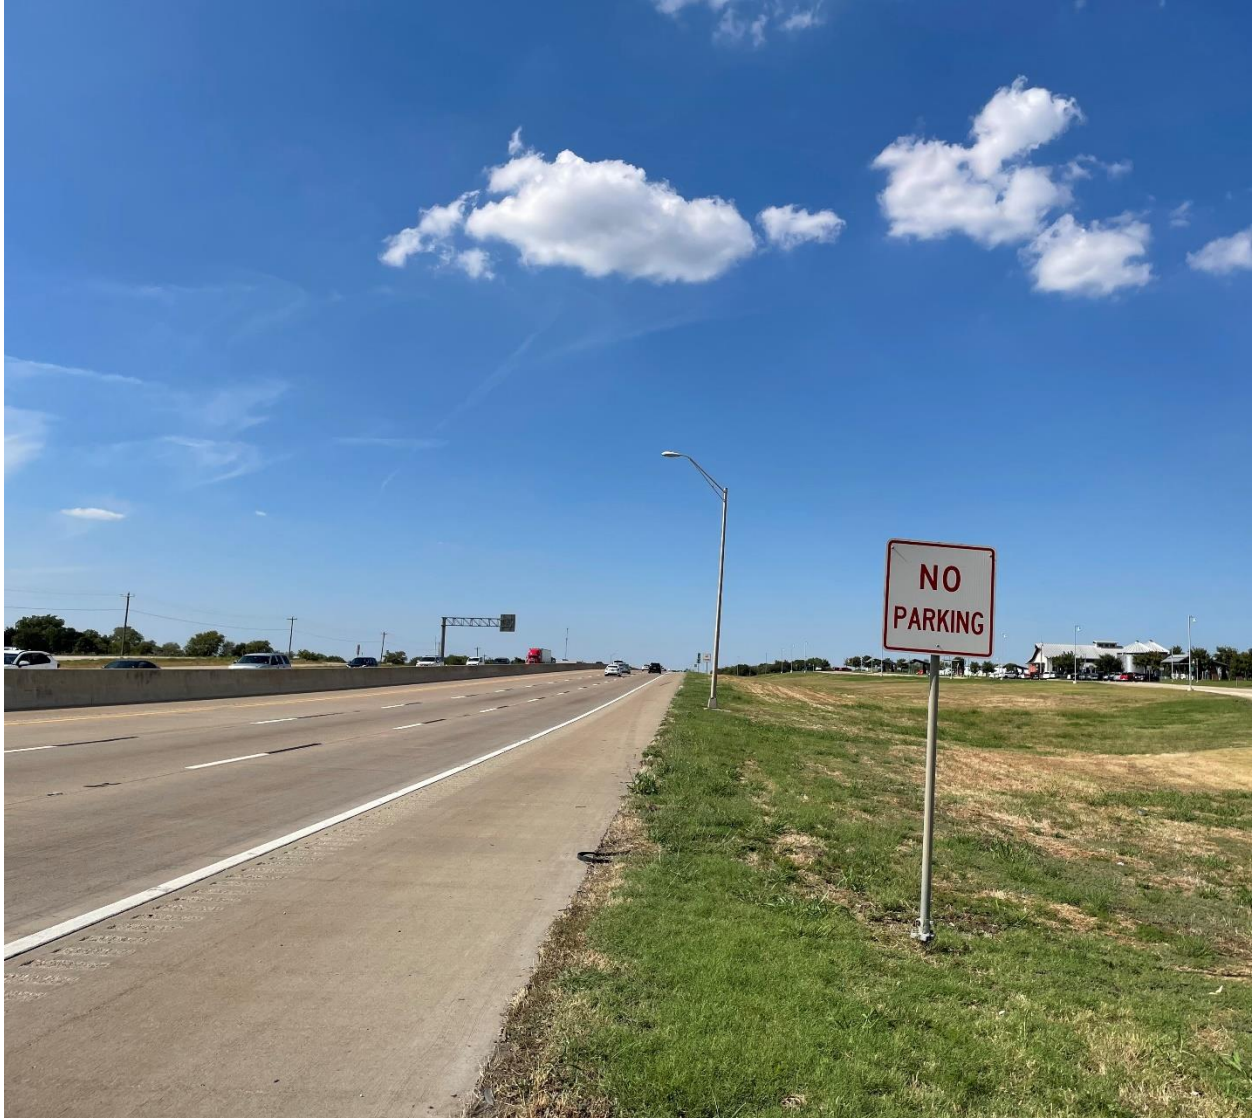
Highway Factors Photo 18 – View of the “No Parking” sign on the shoulder of the I-35 mainline travel lanes adjacent to the Hill County safety rest area south of Hillsboro, Texas on I-35

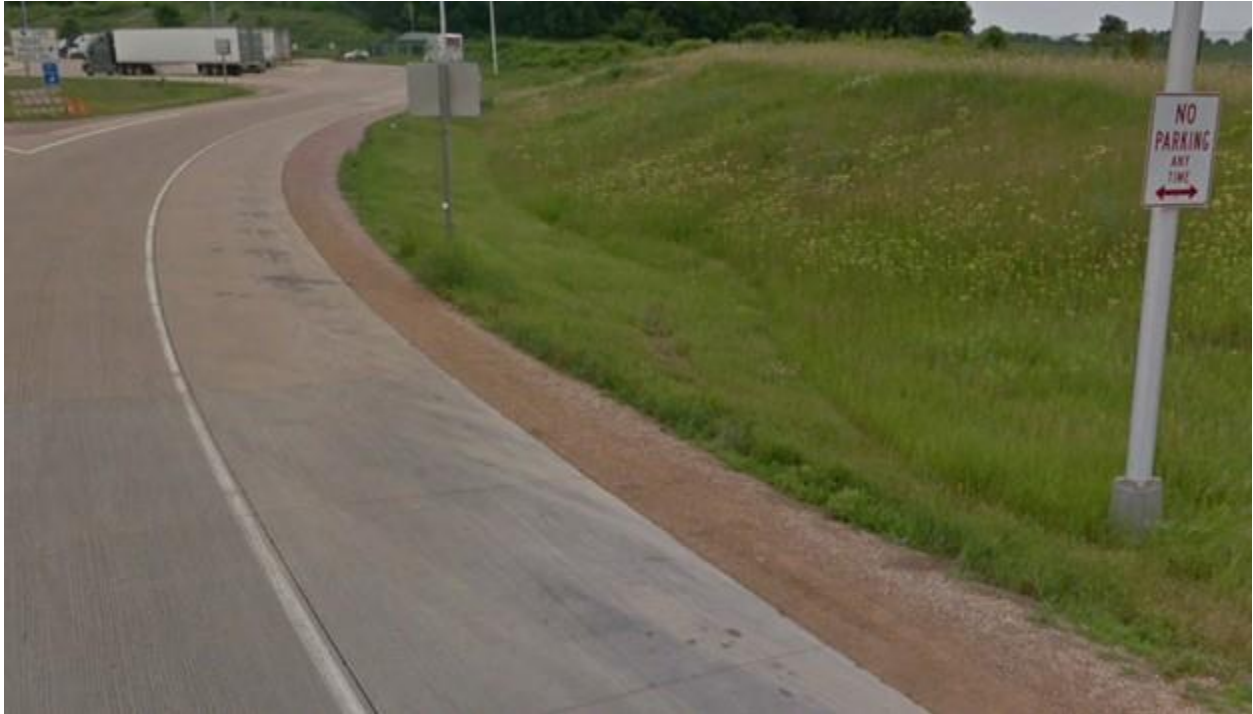
Highway Factors Photo 19 – View of the “No Parking Any Time” sign on the exit ramp to the Portage rest stop area northwest of Poynette, WI on I-90 (Source: Google Street Maps)

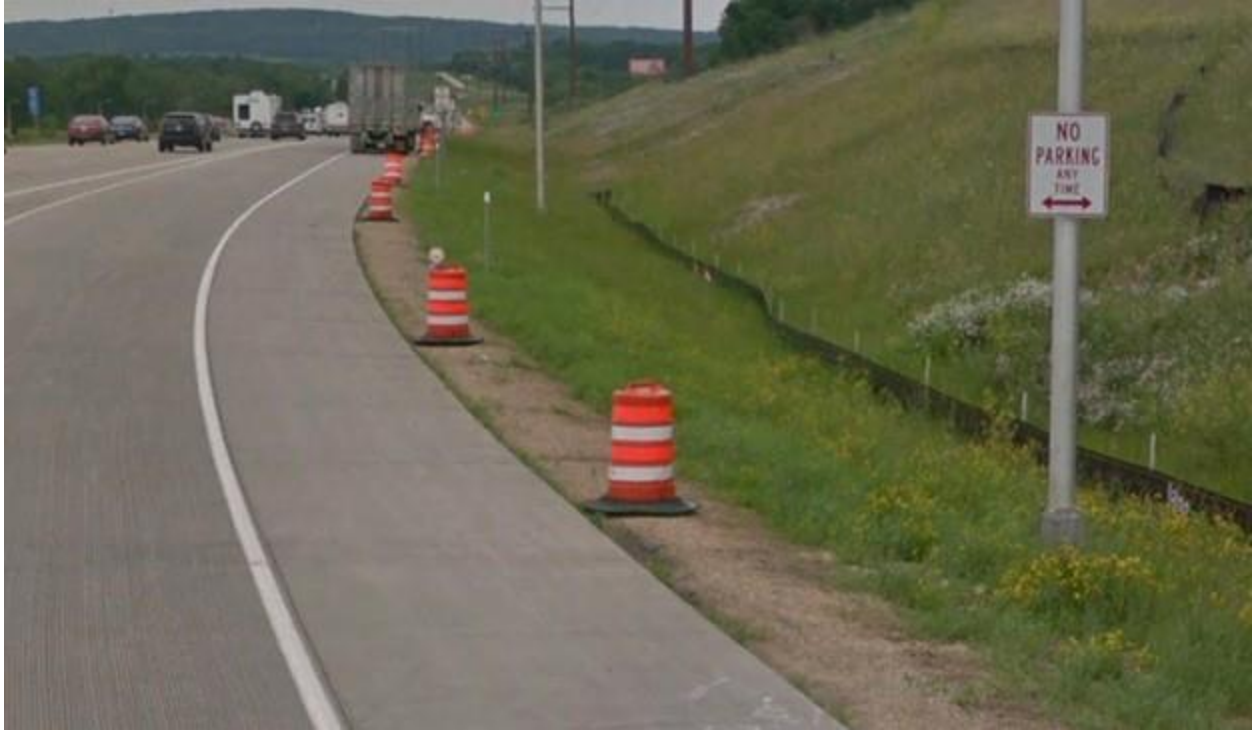
Highway Factors Photo 20 – View of the “No Parking Any Time” sign on the entrance ramp and plastic drums placed at the edge of the shoulder from the Portage rest stop area northwest of Poynette, WI on I-90 (Source: Google Street Maps)
