GEOTECHNICAL DATA REPORT
Slide MP CFP-102.9
ALEXANDRIA, VIRGINIA

Slide MP CFP-102.9
Alexandria, Virginia

Geotechnical DATA Report

Shannon & Wilson participated in this project as a consultant to CSX Transportation, Inc. (CSXT). Our scope of services was directed to obtain six borings in the vicinity of the slide area and to develop alternatives to the slide repair including a new slope and a retaining wall.

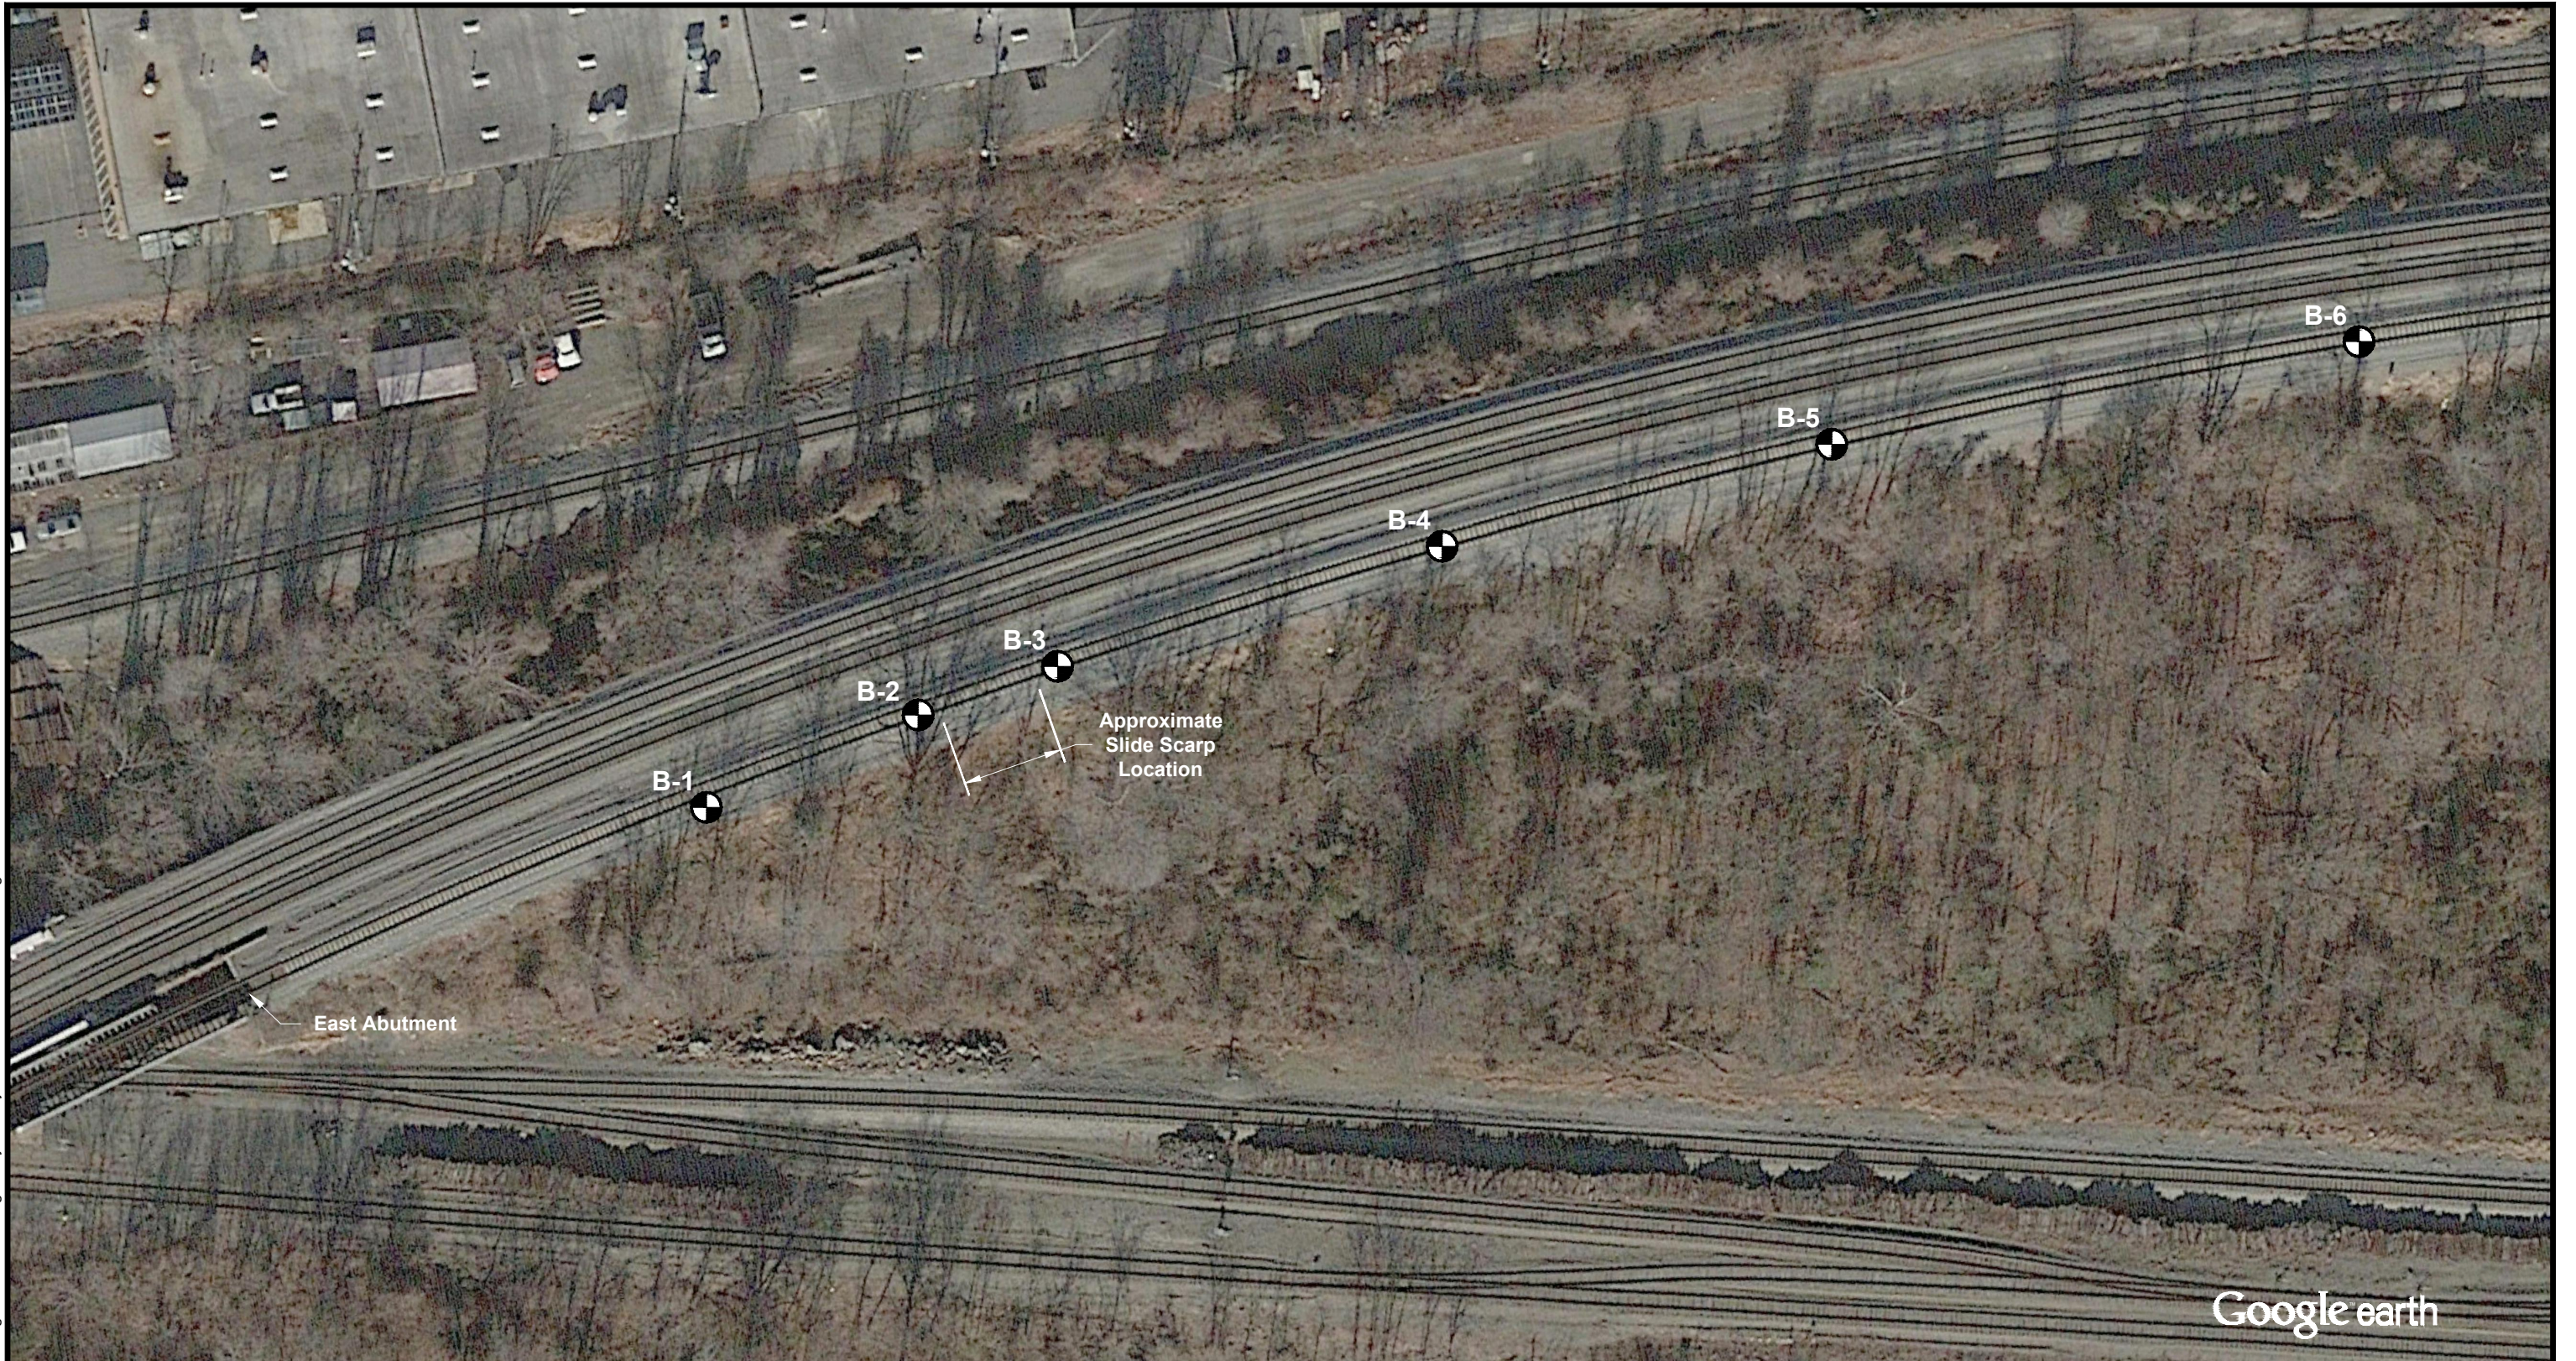
FIG. 2

The site is located south of Wheeler Avenue, as shown in Figure 1. The triple track is supported on an approximately 27-foot-high embankment that leads to the overpass bridge. The overpass bridge, the slide and boring locations are shown in Figure 2.

To evaluate the soil conditions that caused the slide, we first evaluated initial estimates of the soil strength properties using the borings adjacent to the approximate slide scarp location, Borings B-2 and B-3 (see Figure 2), and our experience with similar soils. We then varied these properties until the stability analyses produced a critical failure surface with a factor of safety of 1.0 that matched the failure geometry as observed in the field. A summary of our assumed soil properties is as follows:

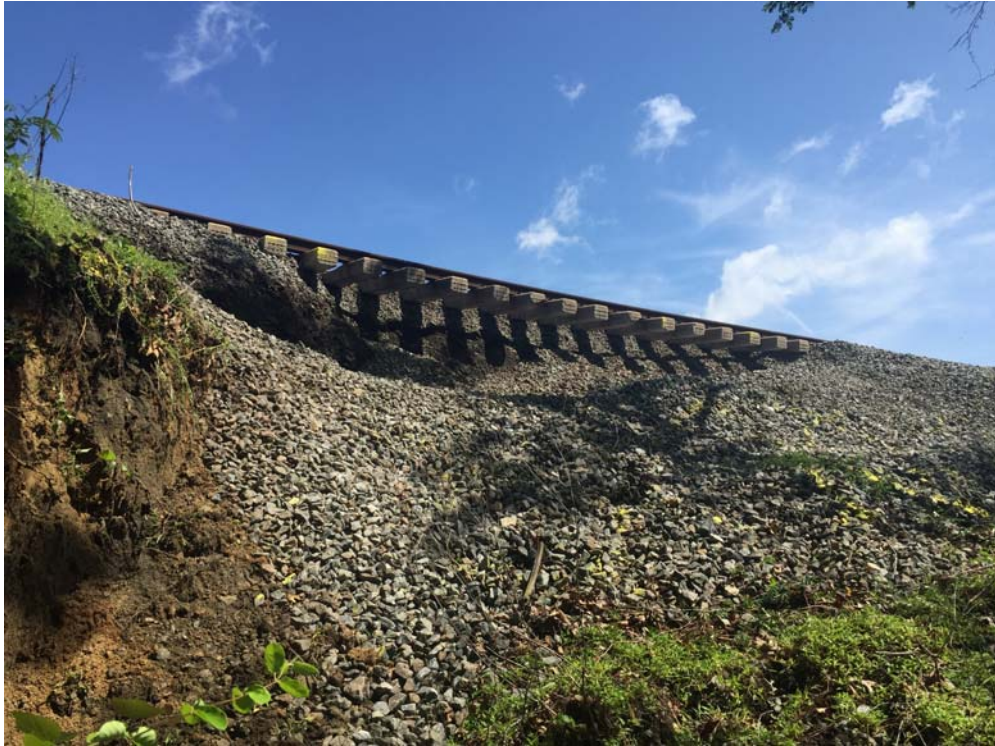
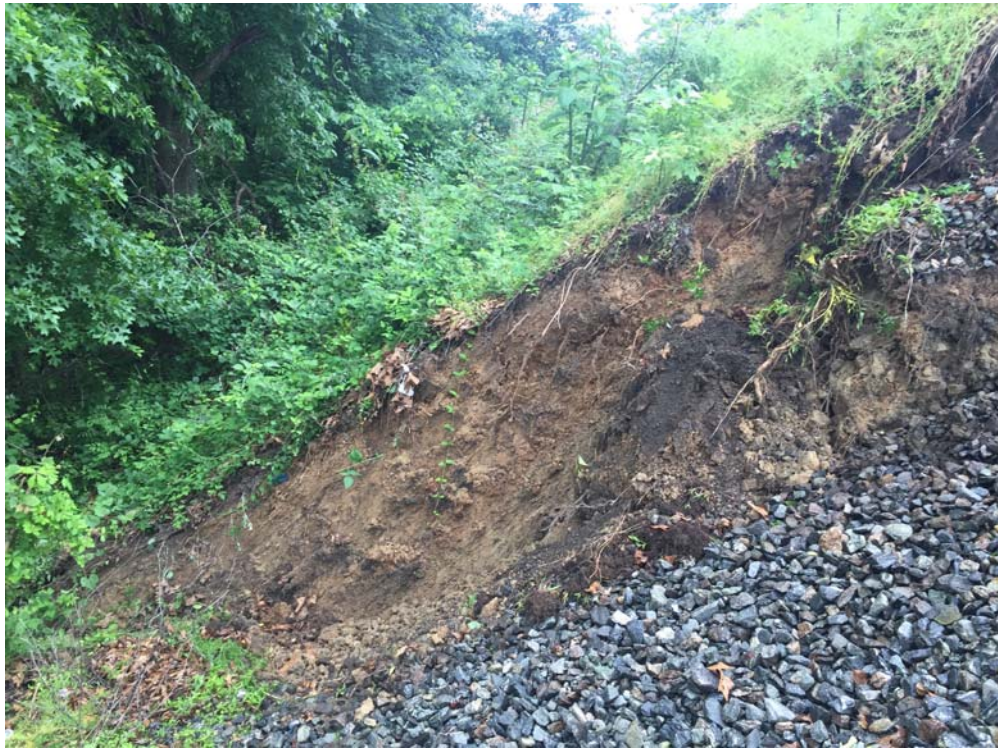
FIG. 3

in the bulging soil. Figure 3 shows photos of the top of the slide undermining the track and the scarp on the left side of the slide. Figure 4 shows the right scarp of the slide and the seepage observed near the bottom of the ballast pocket. Figure 5 shows the slide scarp at the top of the slide and a view of the toe of the slide.

Top – Overall View of Slide
Bottom – Right Flank of Scarp

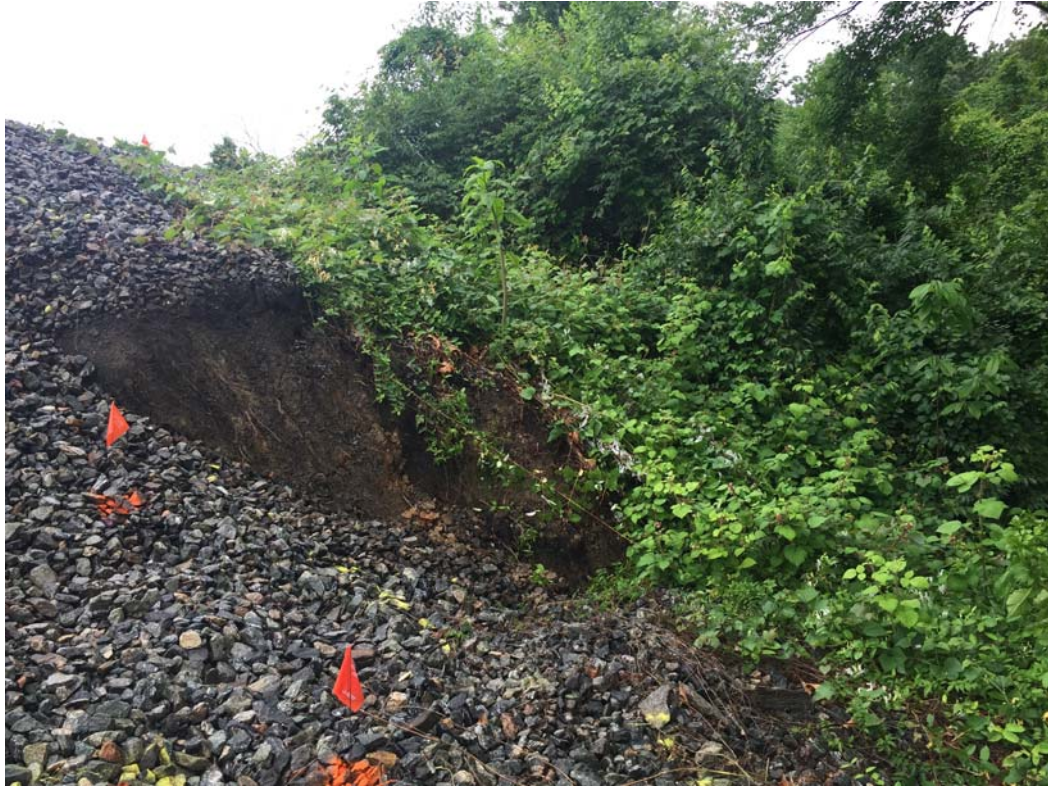
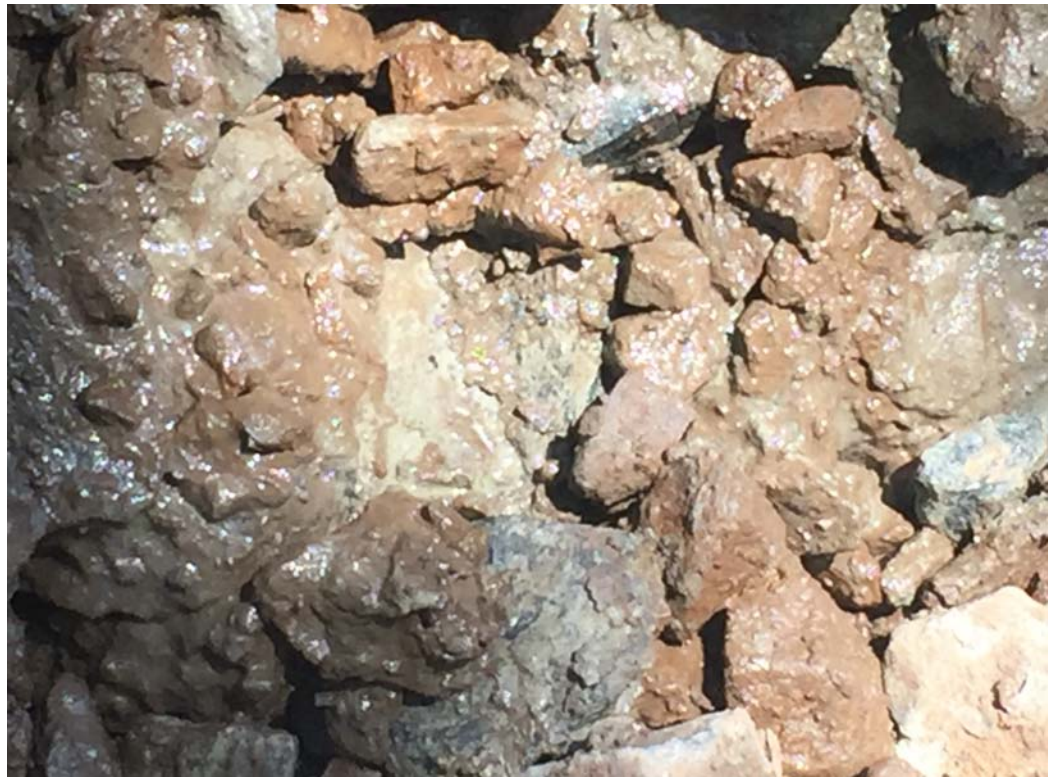
FIG. 4

Top – Right Flank Scrap
Bottom – Seepage at Ballast Pocket

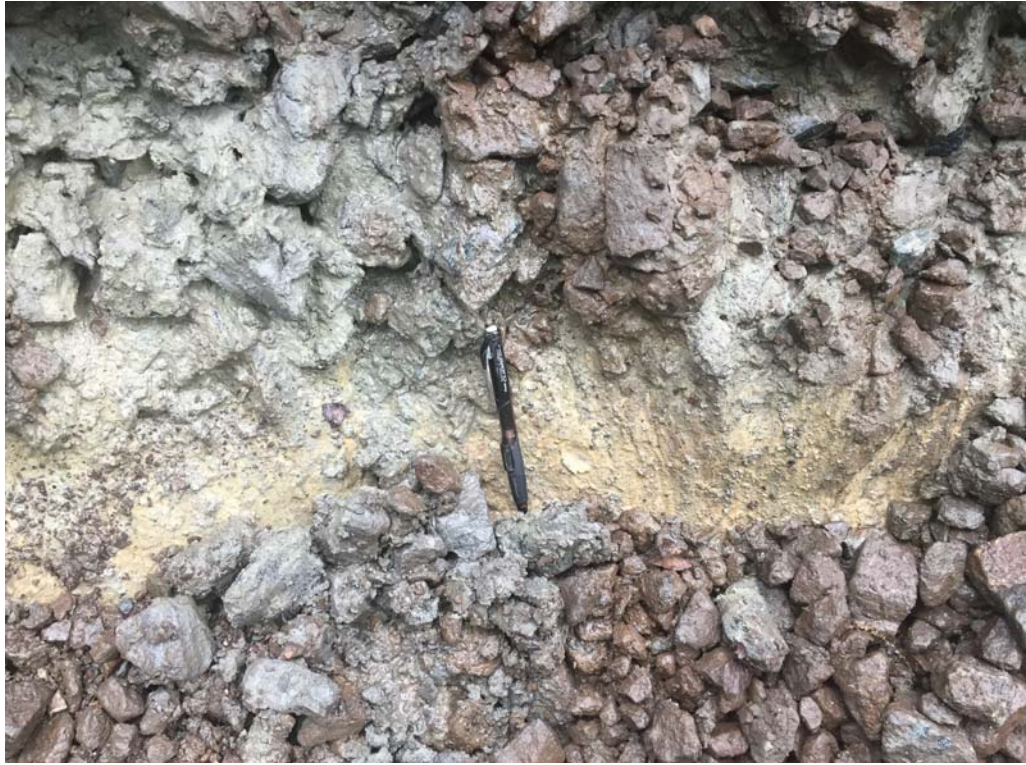
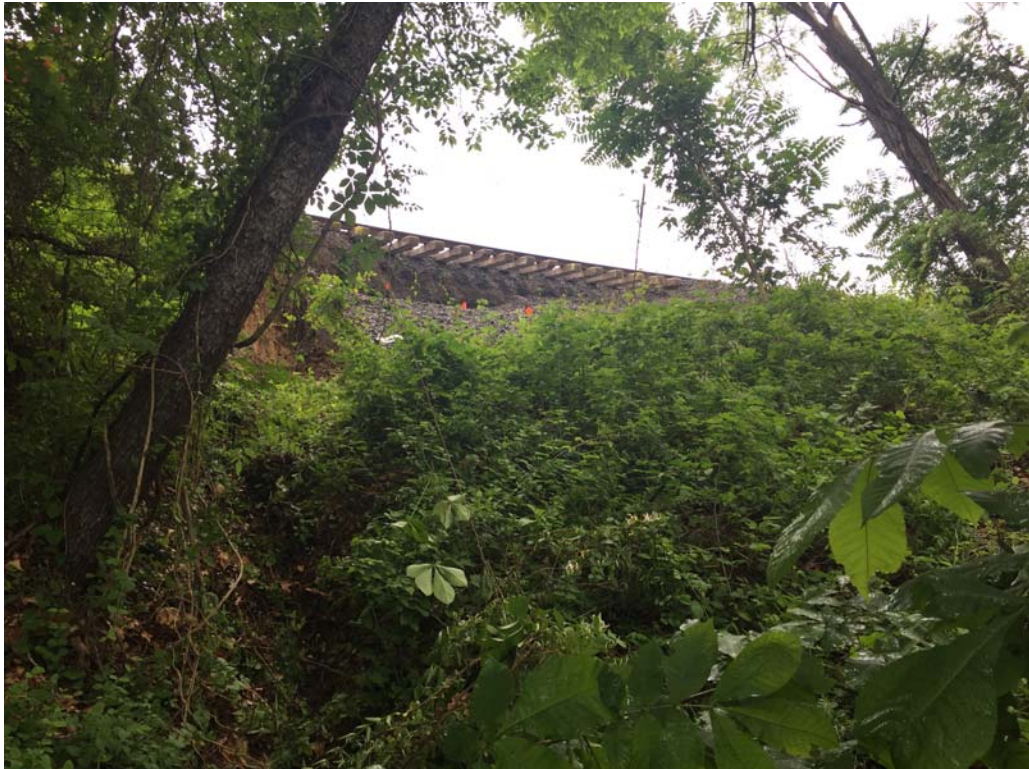
FIG. 5

Top – Top slide plane
Bottom – View from Toe

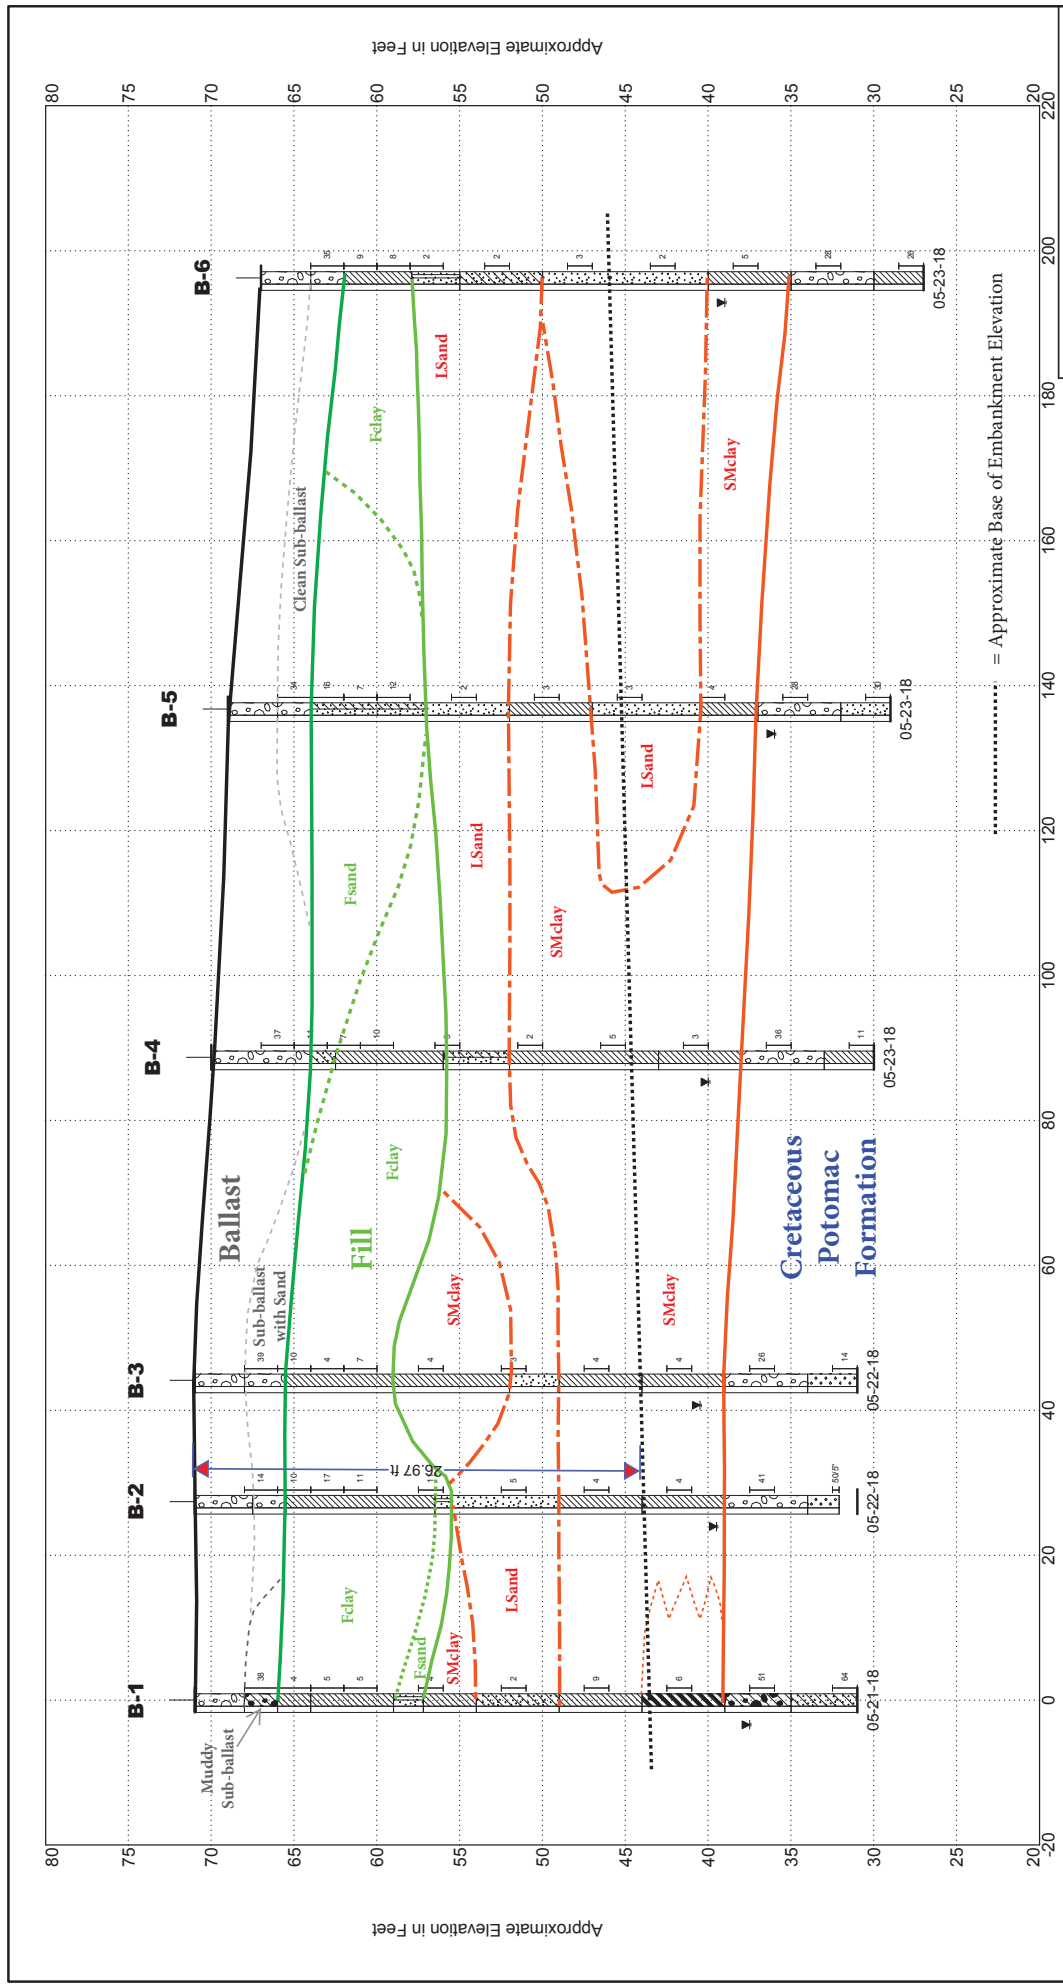
FIG. 6

At the slide location (Borings B-2 and B-3) the embankment fill consists of 10 to 14 feet of soft to stiff lean clay, underlain by a 3 to 7.5-foot layer of loose, poorly graded sand and a 10-foot-thick layer of soft lean clay.

Compacted Fill
 Fclay - Fill clay
 Fsilty sand - Fill sand/clayey sand and silty sand
 Reworked and In Place Quaternary Sediments
 SMclay - Soft to Medium stiff clay
 Lclay - Loose sand/clayey sand and silty sand

The boring logs in Appendix A provide more detail about the conditions encountered at each boring. Our interpretation of the available subsurface information is provided in the generalized subsurface profile shown in Figure 6.

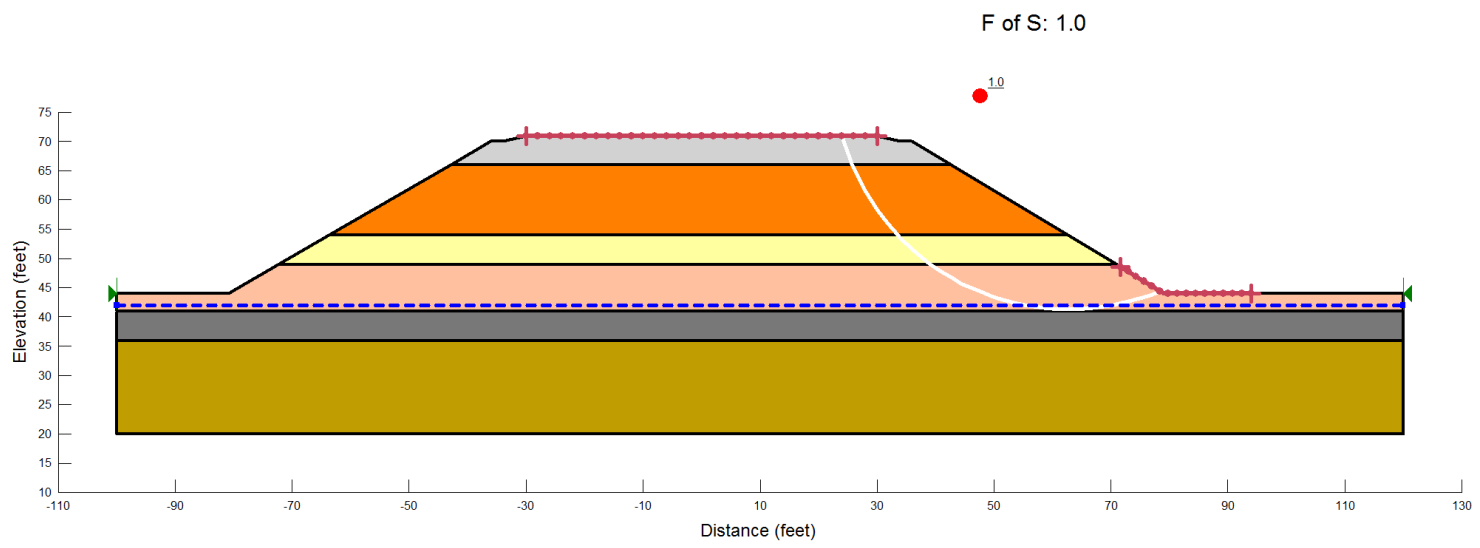
CSXT Slide MP CFP-102.9 Alexandria, Virginia	
STABILITY ANALYSIS EXISTING CONDITIONS	
June 2018	100749-001
SHANNON & WILSON, INC. Geotechnical and Environmental Consultants	FIG. 7

The results of our back-analyses of the existing conditions are provided in Figure 7. The results show a failure plane that begins approximately 6 feet back from the top of the slope, and an exit point just above the toe of the slope. This result is in agreement with our field observations, and supports the assumed soil properties provided above.

Color	Name	Model	Unit Weight (pcf)	Cohesion (psf)	Phi' (°)	Tau/Sigma Ratio	Minimum Strength (psf)
Grey	M. Dense GP	Mohr-Coulomb	125	0	38		
Orange	M. Stiff CL	Mohr-Coulomb	120	700	0		
Yellow	Loose SP	Mohr-Coulomb	120	0	30		
Light Orange	Soft CL	S=f(overburden)	110			0.22	150
Dark Grey	Dense Native GP	Mohr-Coulomb	130	0	40		
Dark Yellow	Dense SW	Mohr-Coulomb	125	0	35

We performed slope stability back-analysis to evaluate the conditions that caused the slide on May 19, 2018. The ground surface profile was based on observations at the site that included slide dimensions, measured adjacent slopes with a compass/inclinometer, and Google Earth aerial photography and elevations. Based on the conditions observed in the field, we modeled the existing embankment with a top width of 60 feet, a height of 27 feet, and side slopes at 1.73H:1V. The top of the embankment was assumed to be approximately +71 feet in elevation, and the toe of the embankment was assumed to be at approximately +44 feet in elevation.

- **Loose SP:** We assumed the embankment fill soils from elevation +54 to +49 feet consist loose poorly graded sand (SP). The measured SPT blow counts in this unit was generally between 3 and 5 bpf. Based on the SPT blow counts and our experience with similar soils we assumed a unit weight of 120 pcf and a friction angle of 30 degrees.

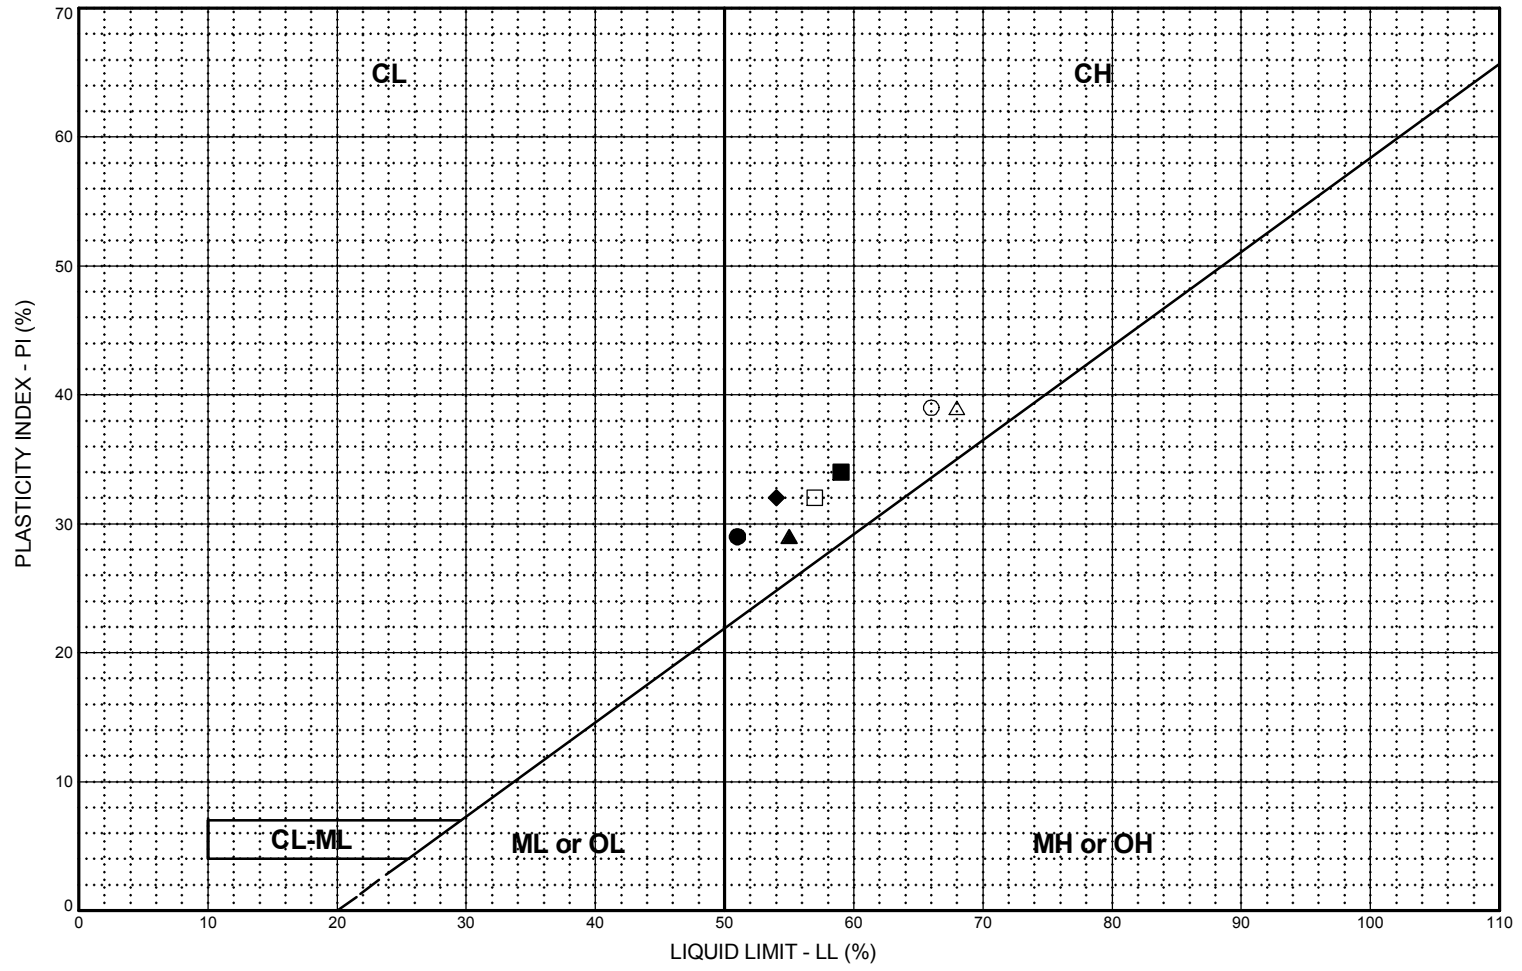
- CL:** Low plasticity inorganic clays; sandy and silty clays
- CH:** High plasticity inorganic clays
- ML or OL:** Inorganic and organic silts and clayey silts of low plasticity
- MH or OH:** Inorganic and organic silts and clayey silts of high plasticity
- CL-ML:** Silty clays and clayey silts

Atterberg limit determinations were performed on selected samples in general accordance with ASTM D 4318, Standard Test Methods for Liquid Limit, Plastic Limit, and Plasticity Index of Soils. Atterberg Limits test results are shown on the logs in Appendix A and on Figure B1 of Appendix B.

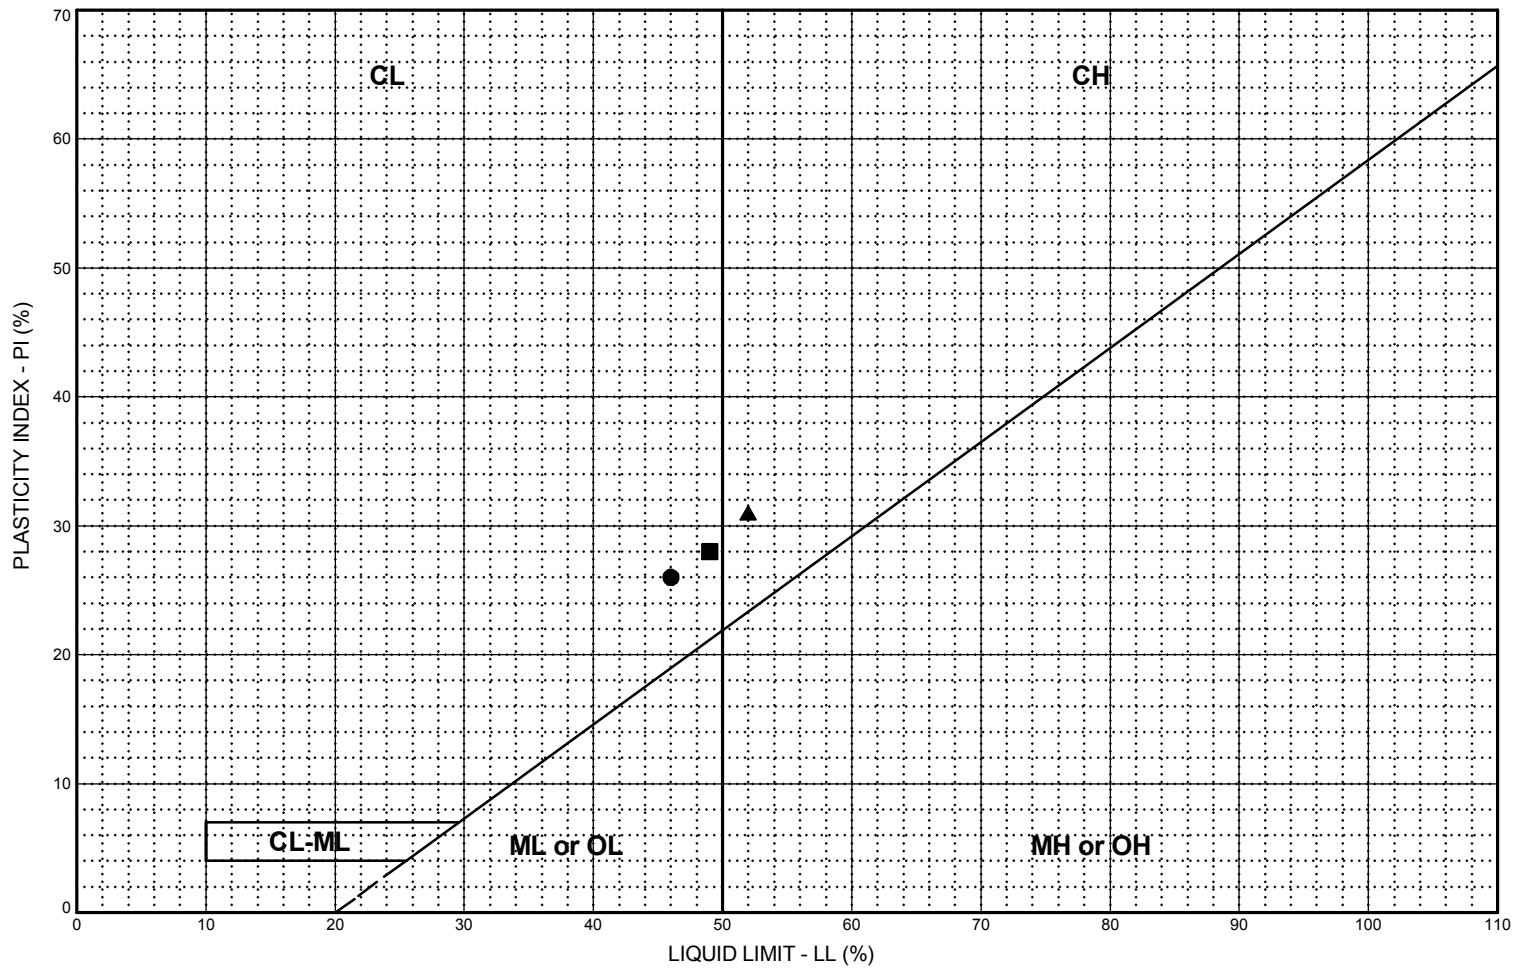
BORING AND SAMPLE NO.	DEPTH (feet)	U.S.C.S. SYMBOL	SOIL CLASSIFICATION	LL %	PL %	PI %	NAT. W.C. %	PASS. #200, %		
● B-4, S-6	19.3	CL	Red-brown to grey-brown, <i>Lean Clay with Sand (CL)</i> .	46	20	26	25.2		CSXT Slide MP CFP-102.9 Alexandria, Virginia PLASTICITY CHART June 2018 100749-001 SHANNON & WILSON, INC. Geotechnical and Environmental Consultants FIG.	
■ B-4, S-7	24.3	CL	Red-brown to grey-brown, <i>Lean Clay with Sand (CL)</i> .	49	21	28	30.7			
▲ B-5, S-6	19.3	CH	Grey-brown to red-brown, <i>Sandy Fat Clay (CH)</i> .	52	21	31	26.0

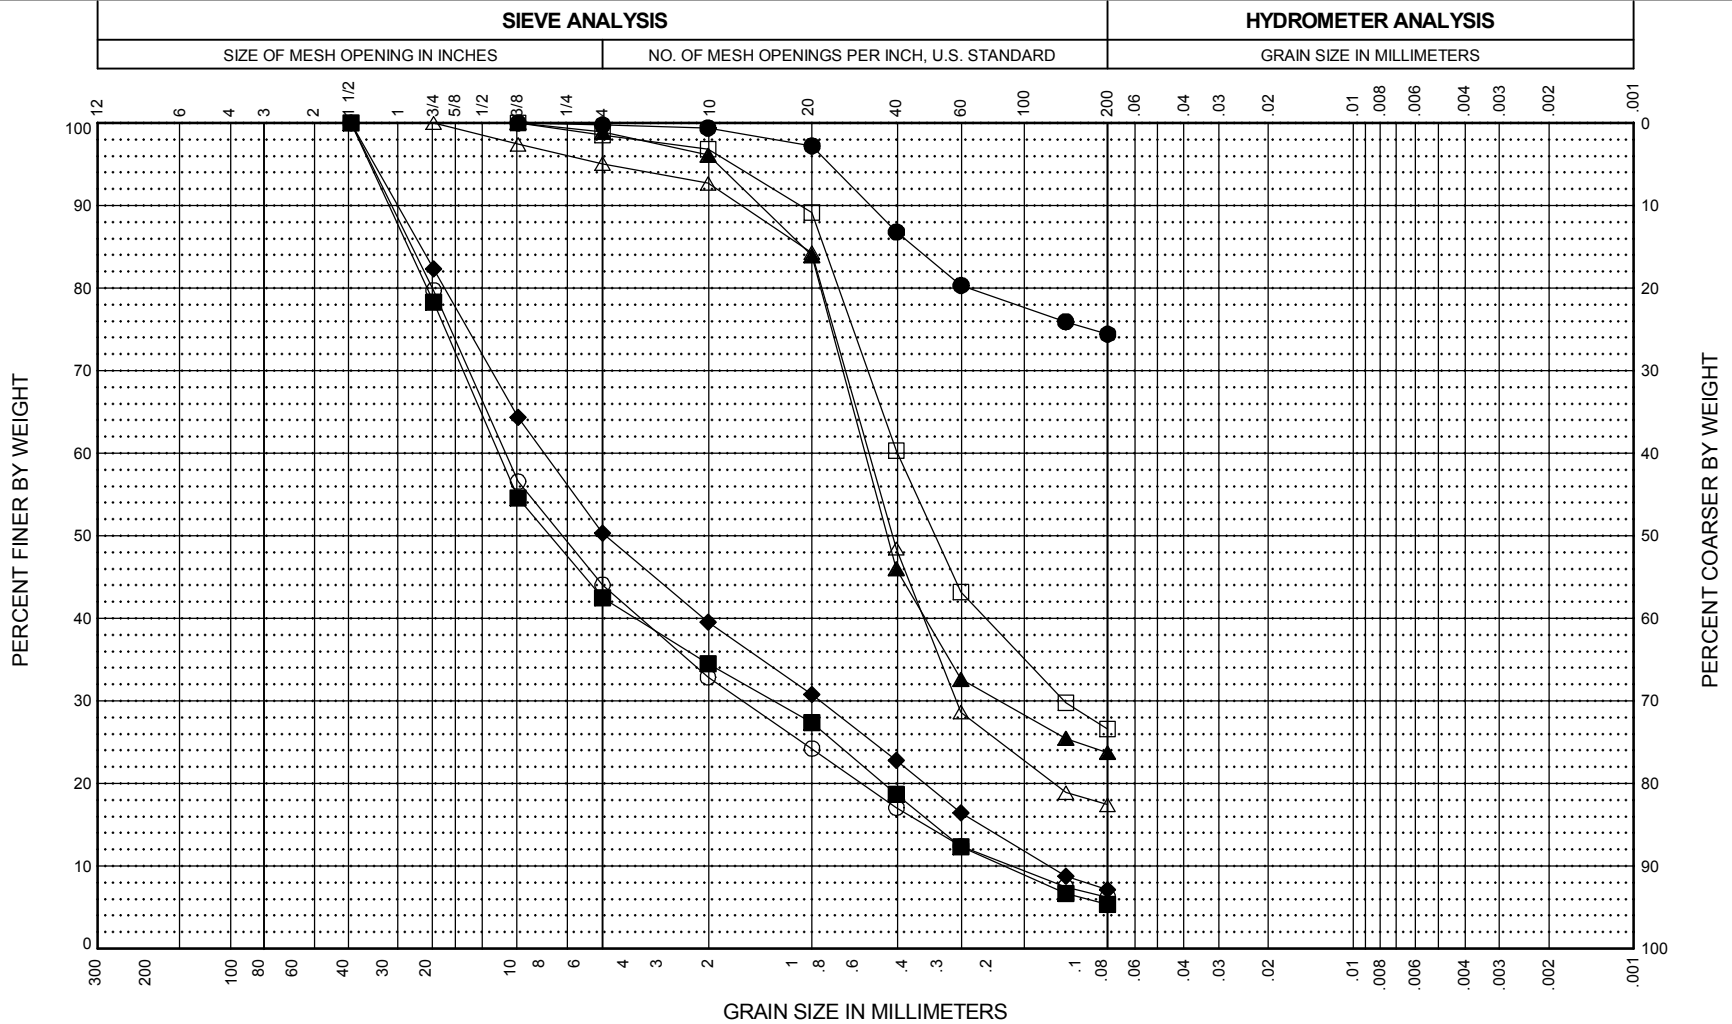
BORING AND SAMPLE NO.	DEPTH (feet)	U.S.C.S. SYMBOL	SAMPLE DESCRIPTION	FINES %	NAT. W.C. %	LL %	PL %	PI %
● B-1, S-8	29.3	CH	Light grey, <i>Fat Clay with Sand (CH)</i> .	74.4				
■ B-1, S-9	34.3	GP-GC	Light grey-brown, <i>Poorly Graded Gravel with Clay and Sand (GP-GC)</i> .	5.3	8.3			
▲ B-2, S-6	19.3	SM	Red-brown to red-yellow, <i>Silty Sand (SM)</i> .	23.7				
◆ B-2, S-9	34.3	GP-GM	Light grey to grey-brown, <i>Poorly Graded Gravel with Silt and Sand (GP-GM)</i> .	7.1				
○ B-3, S-9	34.3	GP-GM	Light grey, <i>Poorly Graded Gravel with Silt and Sand (GP-GM)</i> .	6.2				
□ B-5, S-5	14.3	SM	Grey-brown, <i>Silty Sand (SM)</i> .	26.6				
△ B-5, S-7	24.3	SM	Yellow-brown, <i>Silty Sand (SM)</i> .	17.4
