National Transportation Safety Board

HWY24MH005

MOTOR CARRIER FACTORS

Group Chair's Factual Report

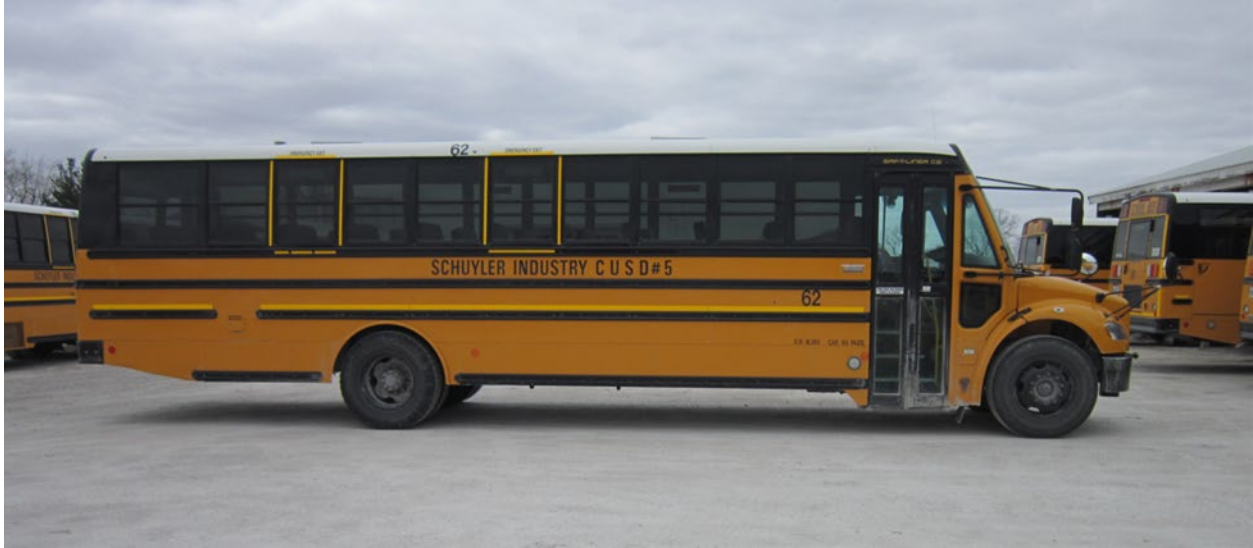
Figure 4. School bus #62 used for first route.

As mentioned, the school bus driver operated three daily routes, a morning, mid-day, and afternoon route. For the morning route the driver operated school bus # 62 and picked up pre-kindergarten, elementary, middle school, and high school students. That bus route started between 6:00 am and 6:30 am and ended at approximately 8:00 am. Bus # 62 was identified as a 2022 65-passenger Thomas Built school bus. See Figure 4 for additional details. For the mid-day route, the school bus driver operated a smaller school bus that would start at 10:30 am and would end at 11:30 am. The bus used for the mid-day route was identified as bus # 89. Figure 5 depicts an exemplar school bus, similar to the bus involved in the crash. For the last route of the day, the school bus driver returned to operating bus # 62 and began her route at 2:30 pm and ended approximately 5:00 pm. From available information, NTSB investigators determined the driver was off duty on Saturday and Sunday March 9-10, 2024.

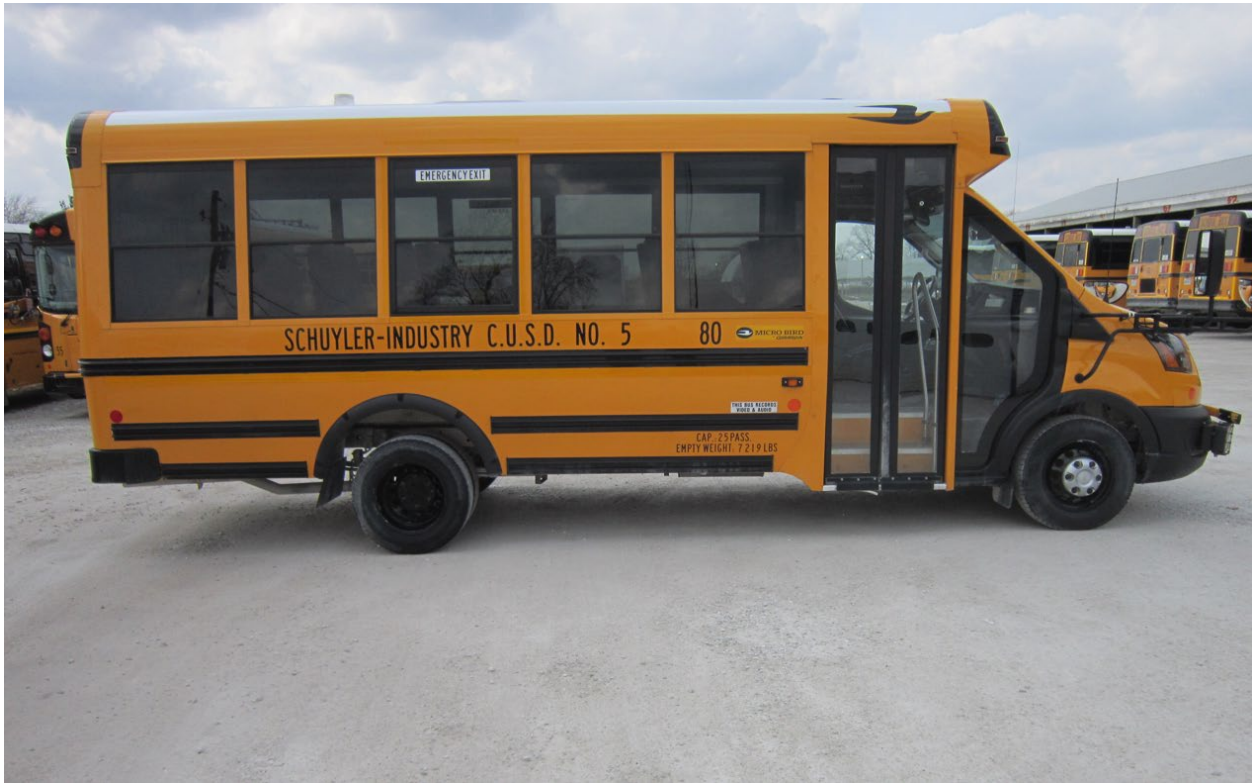
Figure 5. Exemplar school bus similar to the crash-involved bus.

The crash-involved bus was identified as a 25-passenger 2020 Ford Transit Chassis with Micro Bird MB-II bus body. The director of transportation produced a singular document which recorded several repairs and services, but could not produce any work orders, repairs, receipts for parts, or other records for vehicle maintenance.²⁵

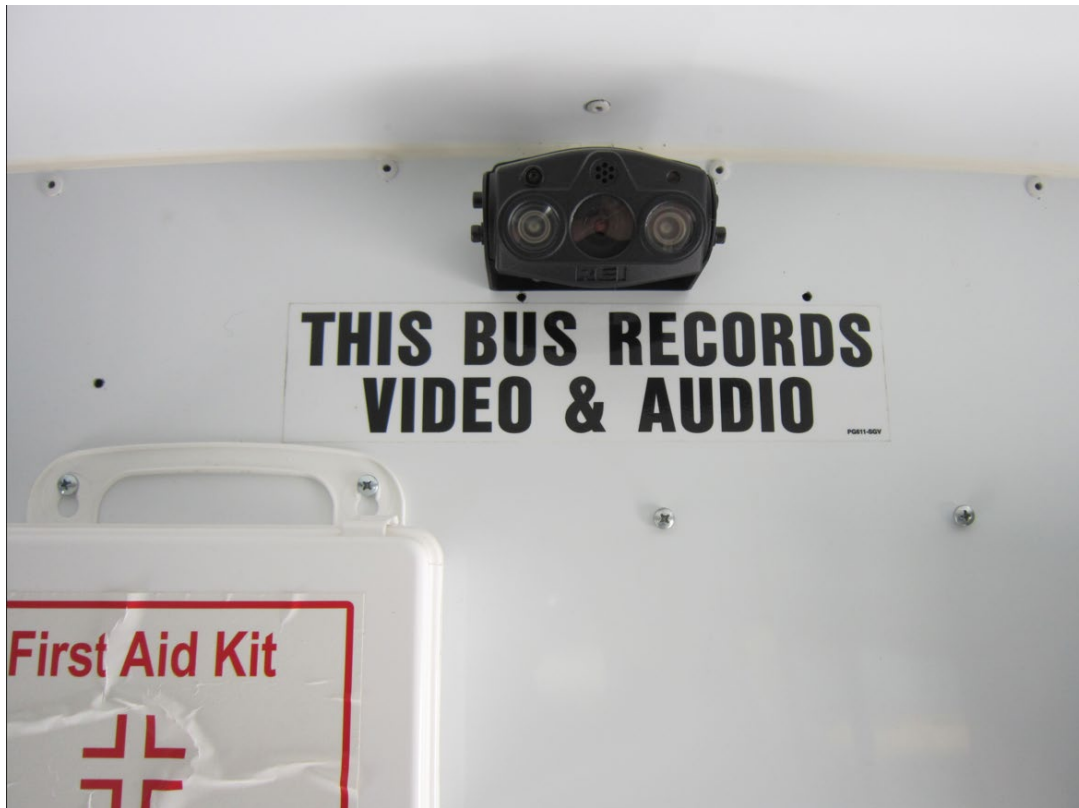
Figure 8. Driver facing video camera.

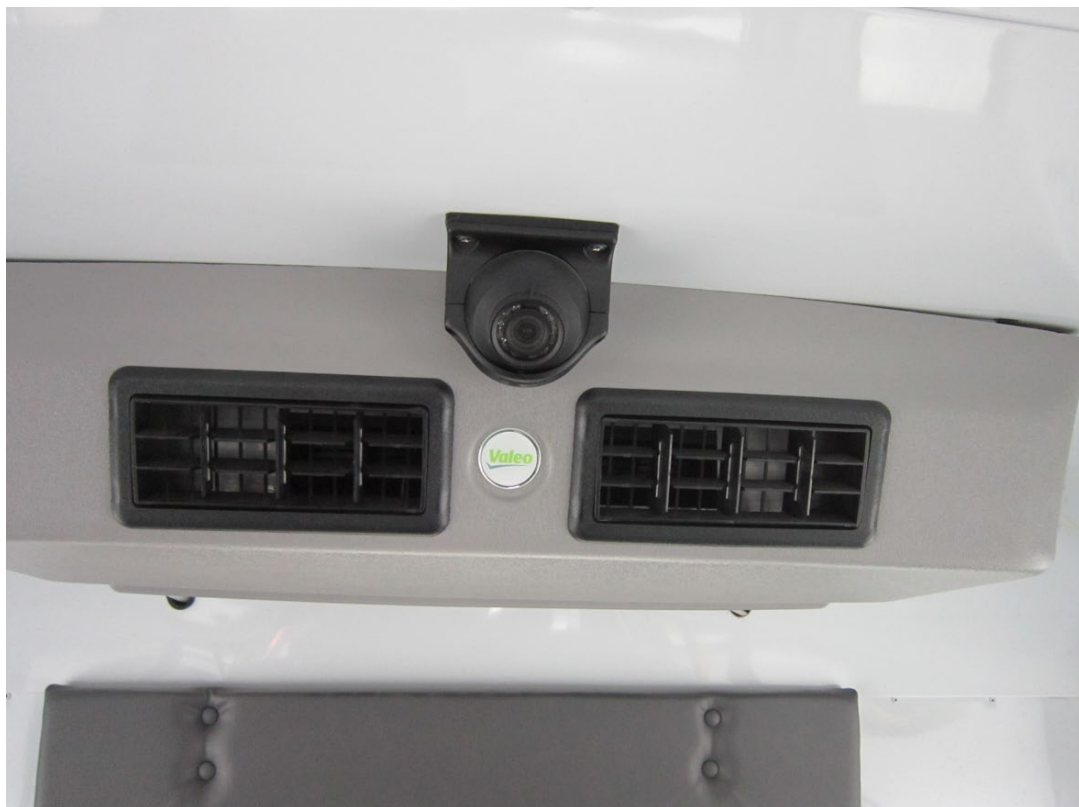
Figure 9. Forward facing video camera mounted at rear of bus.

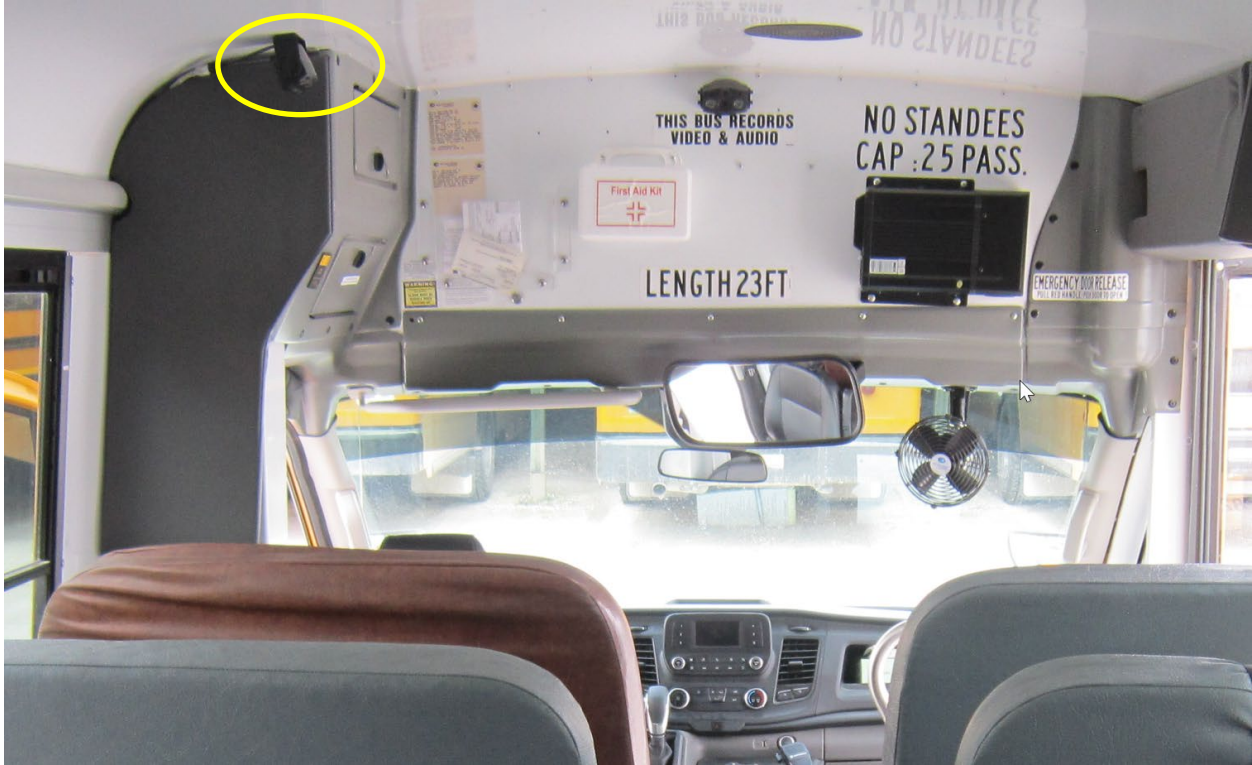
Figure 10. Camera mounted left side of driver (highlighted in the yellow oval).

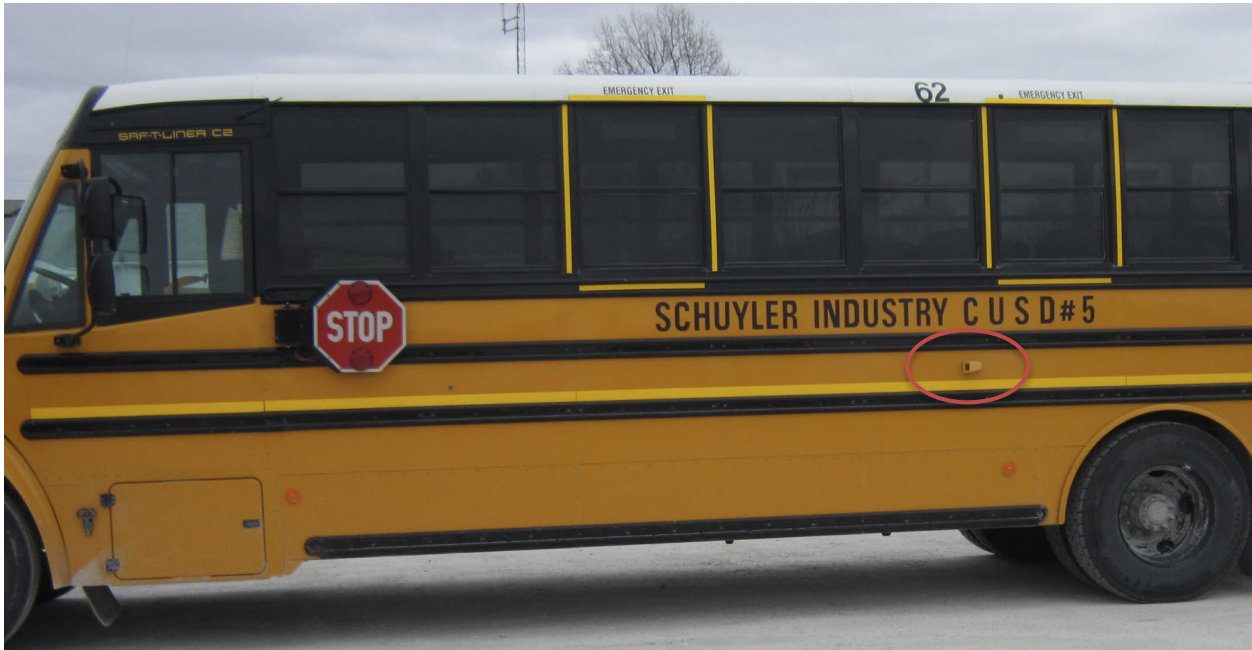
Figure 11. External camera for stop arm violators (highlighted in red oval).

The school buses were also equipped with an external camera that could record violators that failed to stop when the school bus "STOP" arm was activated. See Figure 11 for more details.

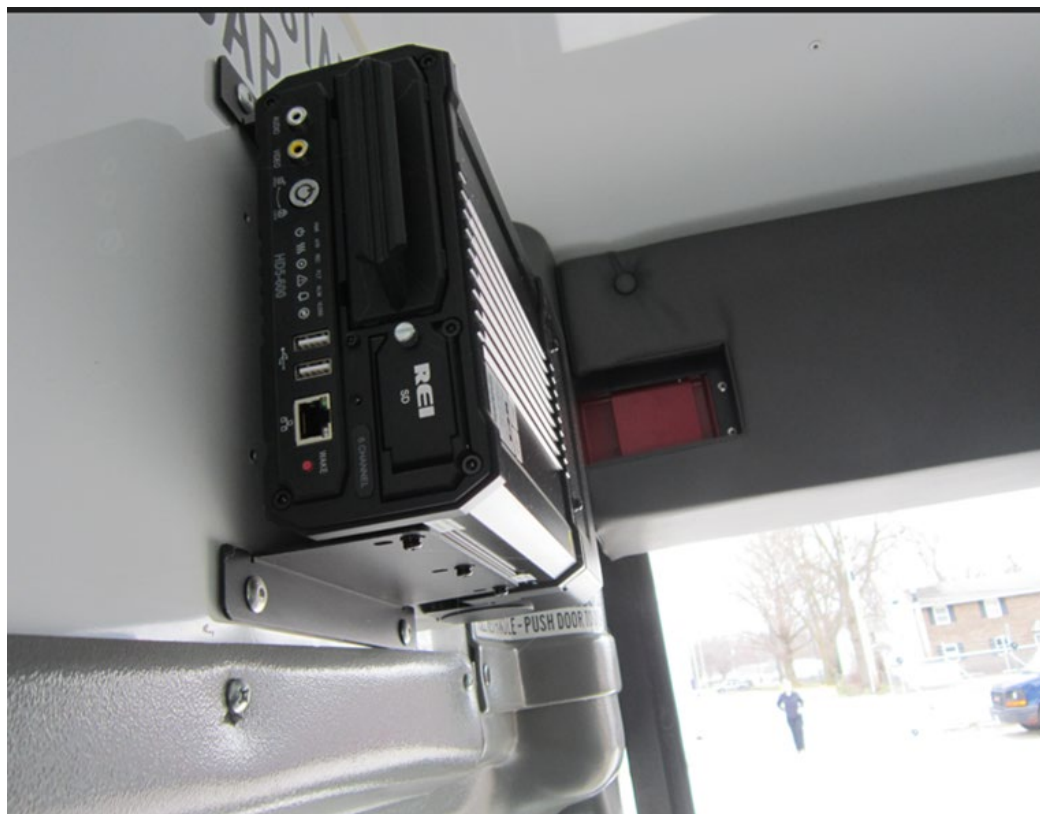
Figure 12. REI hard drive recording system in exemplar school district school bus.

NTSB investigators requested any/all data from the video recorder for the crash-involved school bus. The superintendent stated that the video system had a mounted hard drive in the crash-involved bus that did not have the capability to transmit data wirelessly. The REI system recorded all four camera video feeds. An REI hard drive recording system from an exemplar bus is shown in Figure 12.
