National Transportation Safety Board

HWY23FH014

MOTOR CARRIER/HAZARDOUS MATERIALS

Group Chair's Factual Report

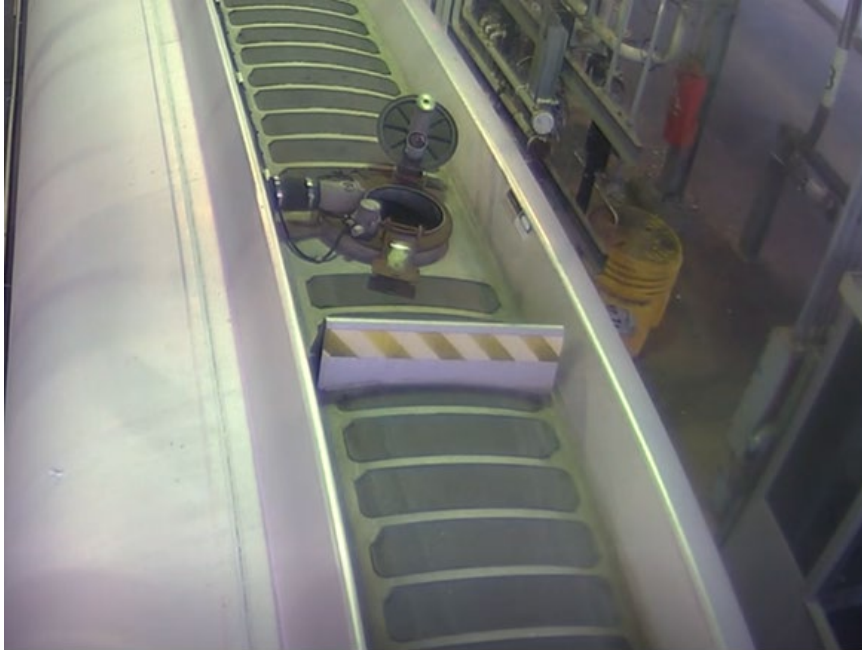
Figure 3 - Open Manhole Compartment #1 (Source: Buckeye Terminal)

As part of this investigation, NTSB investigators examined the security video from the Buckeye loading facility in Wilmington, Delaware, where the driver received his last load of product prior to the crash. Video evidence indicated, the cargo tank was placarded and marked with Flammable Liquid placards, and the United Nations (UN) identification number 1203 was displayed on a panel within those placards. NTSB investigators noted that the manhole closure for Compartment #1 (forward most) of the cargo tank was open when the vehicle arrived at the terminal and remained opened throughout the loading process and when the truck left the loading facility onto the highway. Under 49 CFR 177.834(j)(1) it is required that all manhole closures be closed and secured while in transport. **Figure 3** shows the open manhole of compartment #1 that was discovered by NTSB investigators’ review of the Buckeye security video.

Penn officials provided the following measurements: Compartment #1's interior measured 62.5 inches from bottom to top. The measurement from the bottom of the compartment to the scully sensor was 58.5 inches. At the temperature and amount of gasoline in the compartment at the time of the crash, the top of the gasoline was calculated to be at 55.0 inches, 3.5 inches below the Scully sensor and 7.5 inches from the top of the compartment.

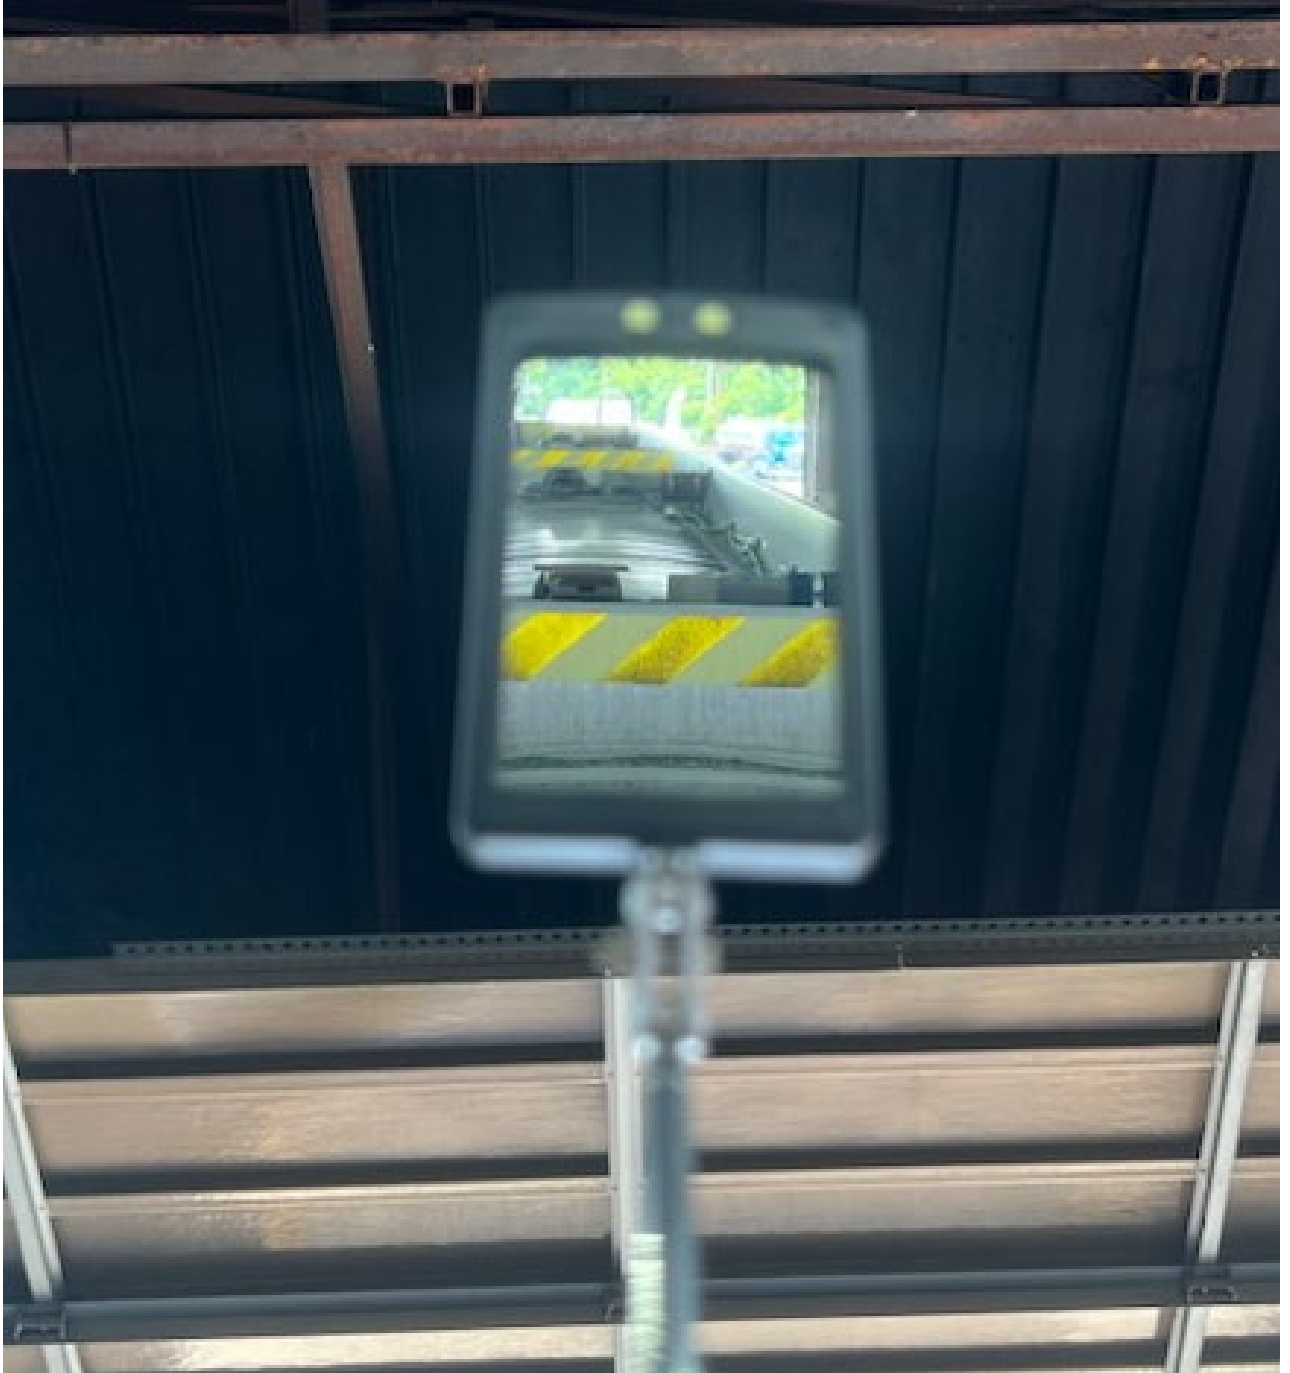
Figure 4 - View through inspection mirror (TK Transport)

NTSB investigators reviewed photographs of the Penn inspection process described in their manhole inspection policy. **Figure 4** shows a view of the top of the cargo tank viewed through the mirror as seen by the inspector. **Figure 5** shows an example where the manhole cover is open on Compartment #1 similar to the cargo tank involved in this crash.
