# National Transportation Safety Board

HWY23MH017

## **UNMANNED AIRCRAFT SYSTEM AERIAL IMAGERY**

Group Chair's Factual Report

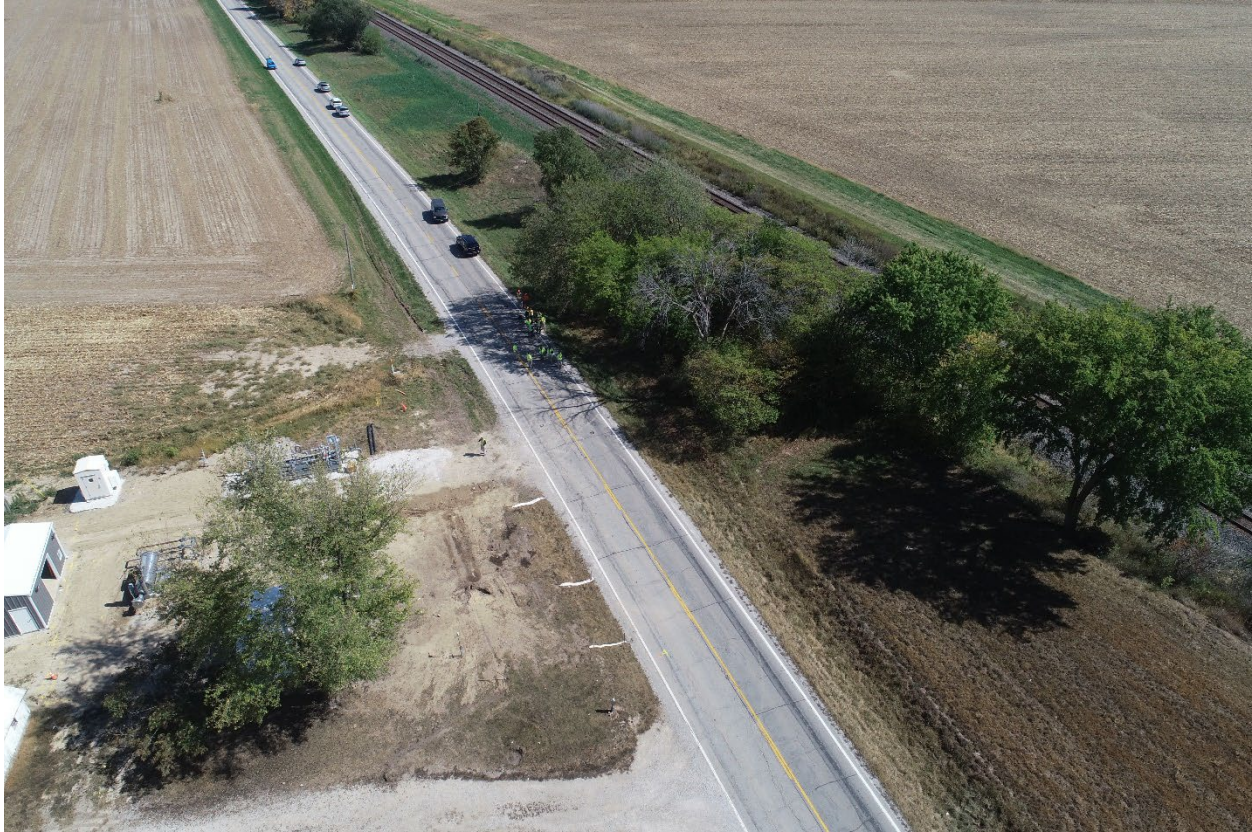
**Figure 1.** Aerial image of US Route 40 looking southeast.

On October 3, 2023, a third mapping mission was requested by NTSB Hazardous Materials investigators. The request was to map the area of vegetation that had been affected by the release of the anhydrous ammonia. Approximately 117 acres was mapped resulting in 993 aerial photographs obtained. The fourth mission was flown to document the tanker involved in the crash. Approximately 111 aerial photographs were obtained at varying heights. Figure 1 is an aerial image taken above the crash scene looking southeast.

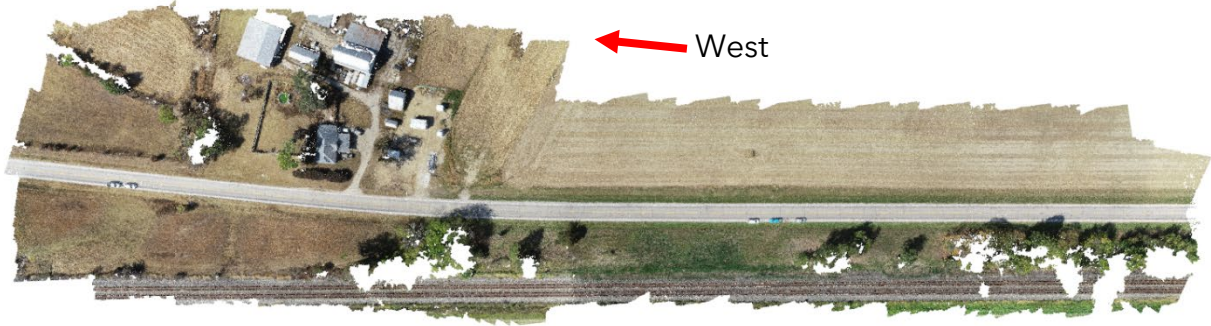
**Figure 2.** Image of the generated point cloud of the crash scene.

The sUAS was used to capture 348 high resolution, georeferenced photographs of the crash scene suitable for processing in the Pix4D photogrammetry software.<sup>4</sup> An additional 99 perspective photographs were taken of an overview of the crash location and were not included in the photogrammetry processing. Figure 2 is a nadir view of the three-dimensional point cloud generated from the images.

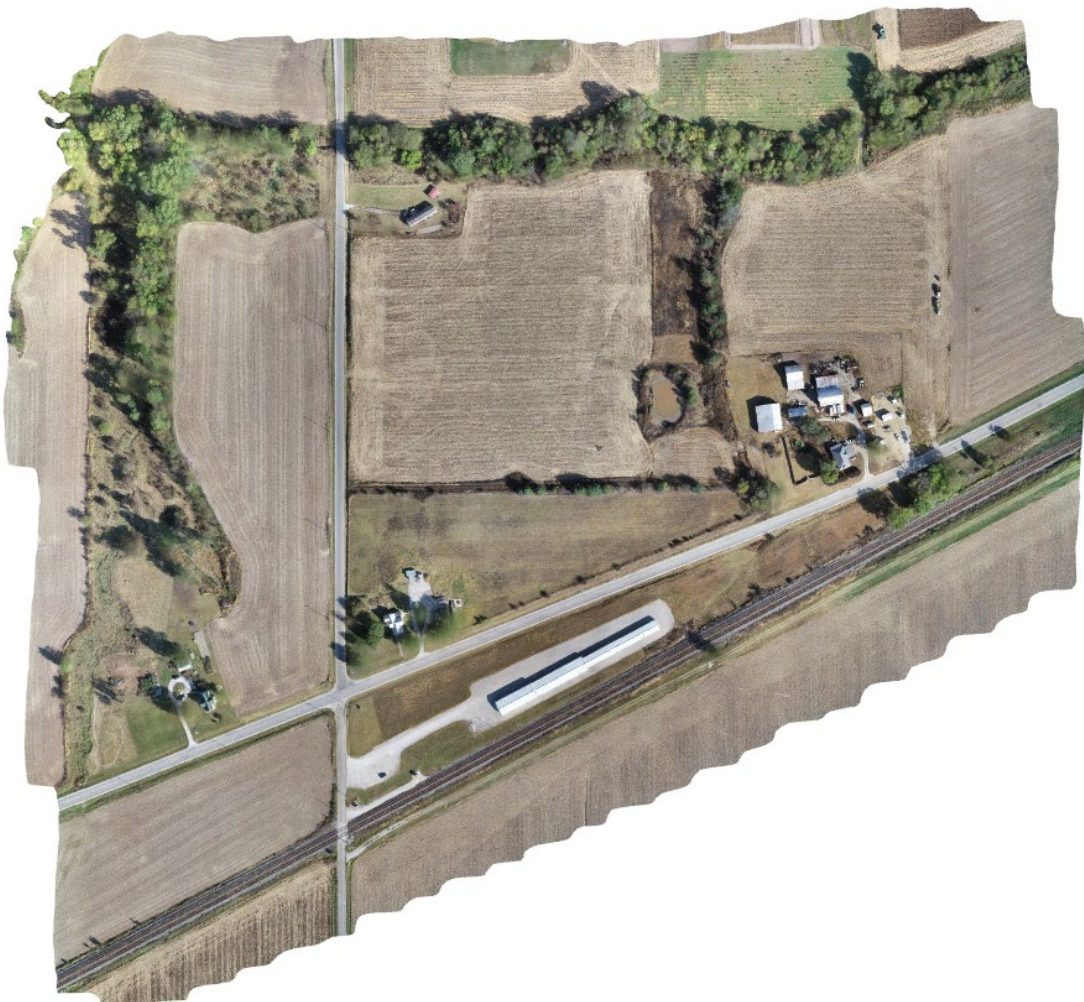
**Figure 3.** Nadir view of the area of vegetation affected by the release of anhydrous ammonia.

The sUAS was used to capture 993 high resolution georeferenced photographs of the field adjacent to the area of the crash and release of the anhydrous ammonia, suitable for processing in the Pix4D photogrammetry software. The resulting point cloud of the area can be seen in Figure 3.

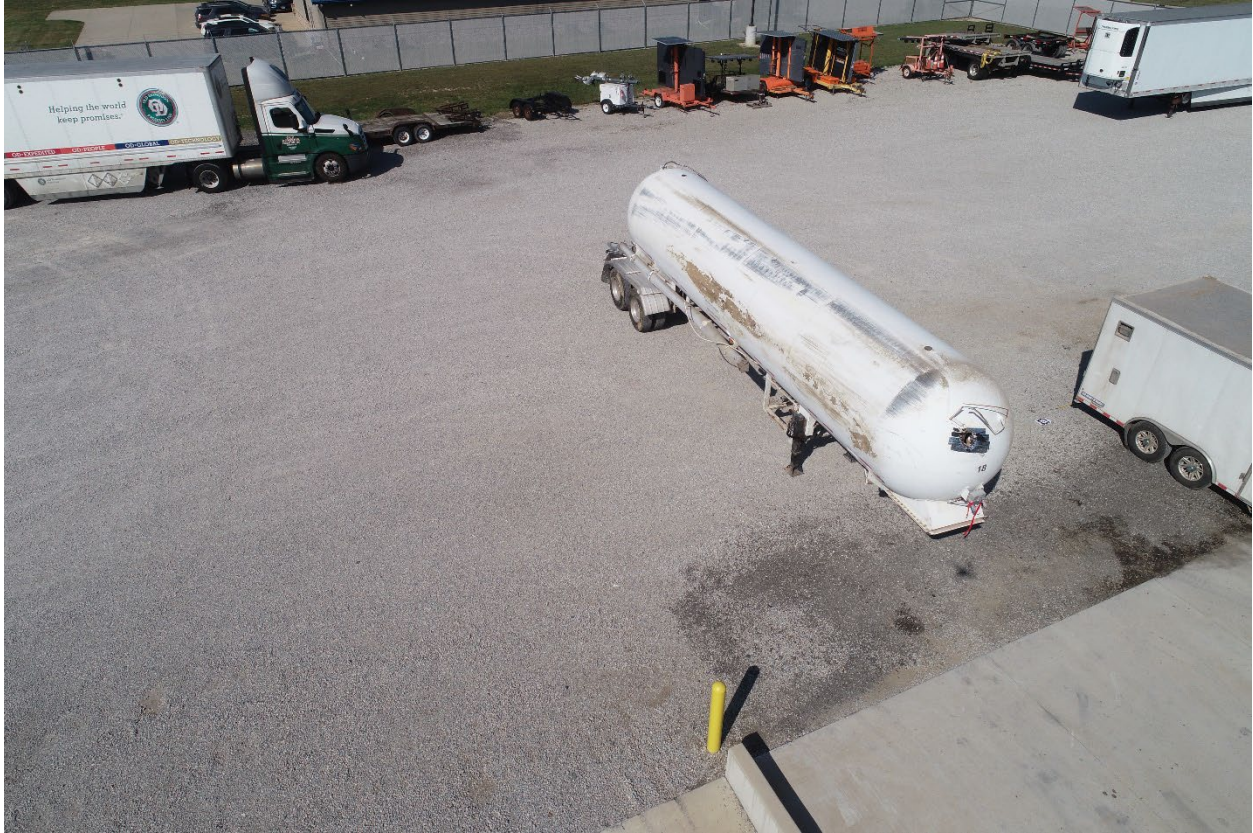
**Figure 4.** Aerial image of the tanker involved in the crash.

Finally, the sUAS was utilized to capture aerial images of the tanker involved in the crash. There were 111 georeferenced photographs captured that was suitable for processing in the Pix4D photogrammetry software. Figure 4 is an aerial image of the tanker involved in the crash. Figure 5 below is an image of the generated three-dimensional point cloud of the tanker trailer.

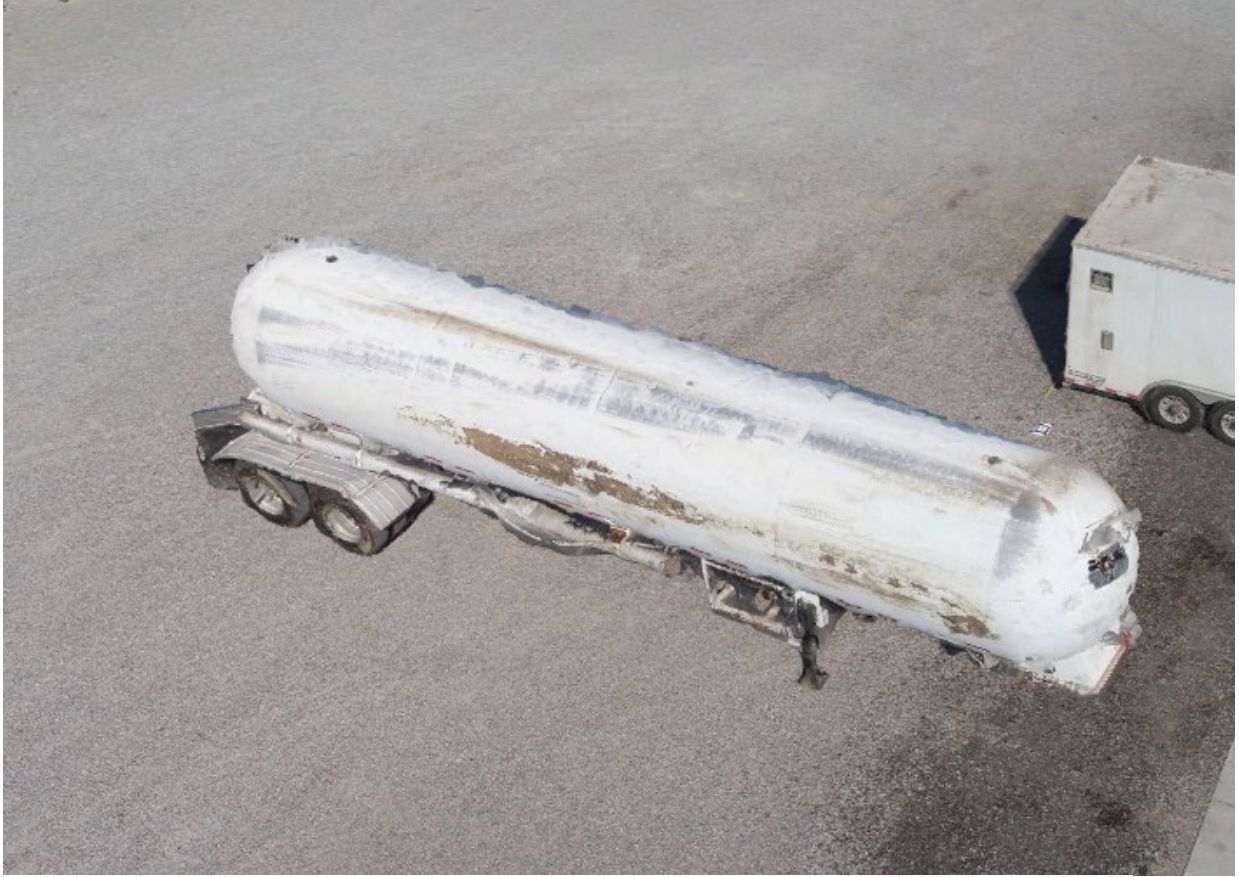
**Figure 5.** Image of the generated three-dimensional point cloud of the involved tanker trailer.
