Edwardsville Failure Analysis

Final Report

**Marathon Pipe Line
LLC**

100440-RP01-Rev1-071723

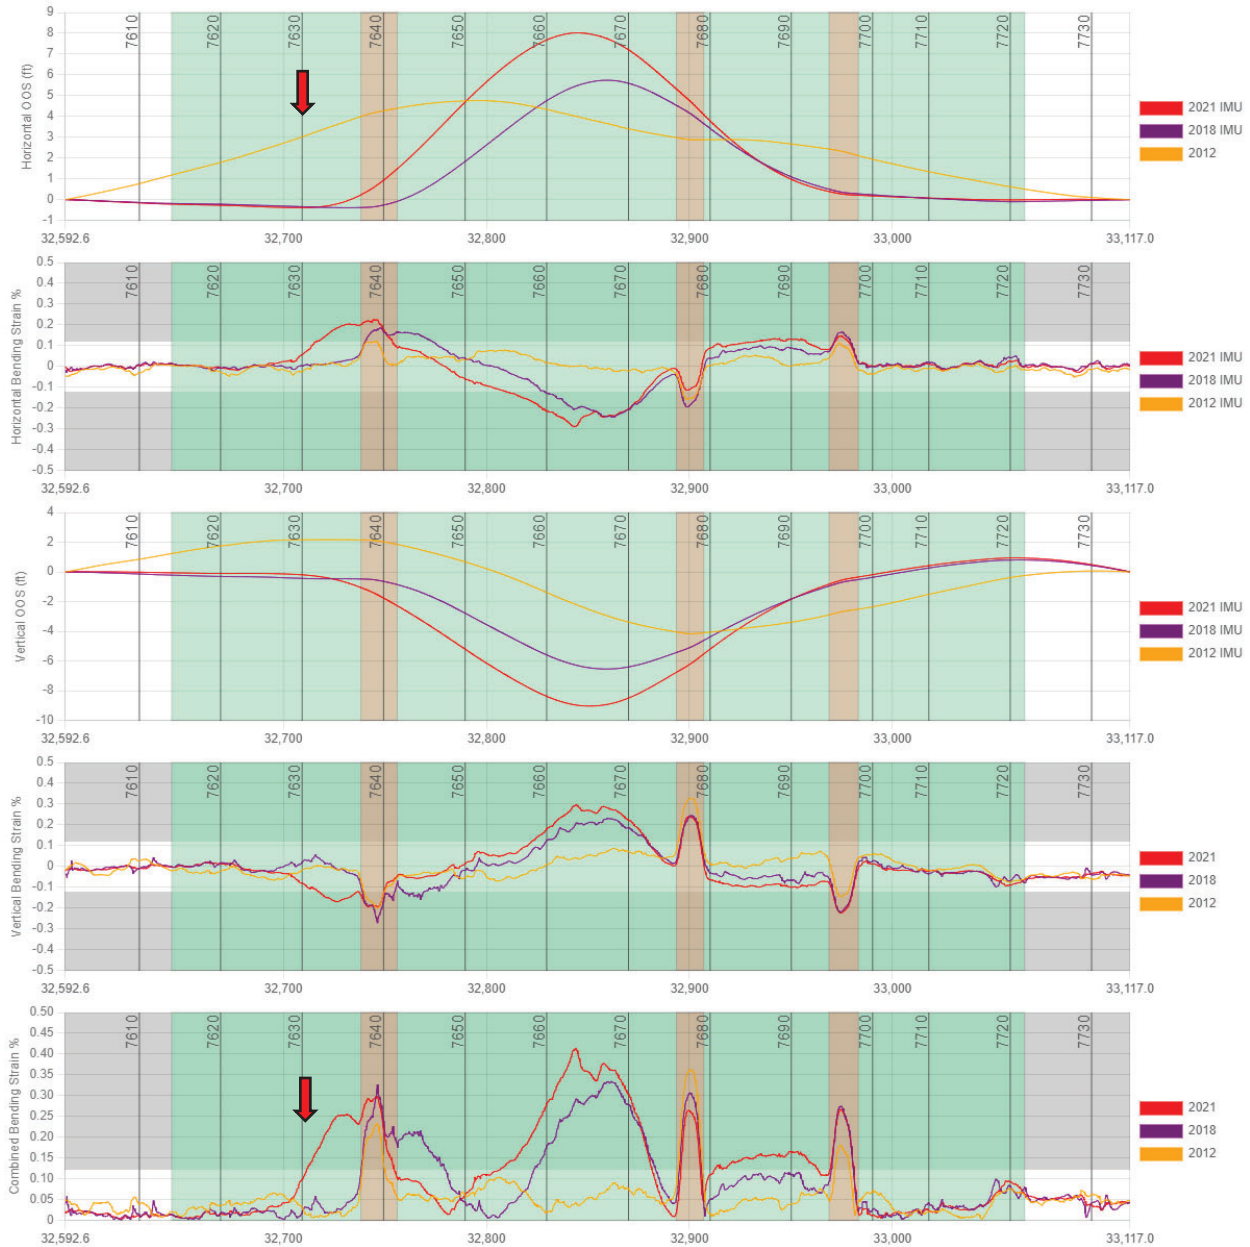
ADV aligned and compared all the available IMU data sets as shown in Figure 3.2. ADV observed that the out-of-straightness (OOS) profiles from the 2012 IMU data do not appear plausible. When the IMU data was examined outside of the area of interest in stable locations, the horizontal and vertical geospatial information from 2012 often showed deviations that were inconsistent with the information from the inspections in 2018 and 2021. However, the bending strain profiles calculated from the pitch and azimuth did appear consistent with the other two data sets. These types of issues with geospatial accuracy are

When comparing the strains in Figure 3.2, a clear progression in the horizontal, vertical, and combined strains is evident from 2012 to 2018 and from 2018 to 2021. This data confirms that the pipeline was experiencing external loads and being subjected to both horizontal and vertical movement in the time between 2012 and 2021.

Figure 3.2: IMU Comparison for 2012, 2018, and 2021
