# NATIONAL TRANSPORTATION SAFETY BOARD

## Electronic Devices

### Specialist's Factual Report

Location: Lihue, Hawaii  
Date: December 26, 2019  
Aircraft: Airbus AS350 B2  
Registration: N985SA  
Operator: Private  
NTSB Number: ANC20MA010

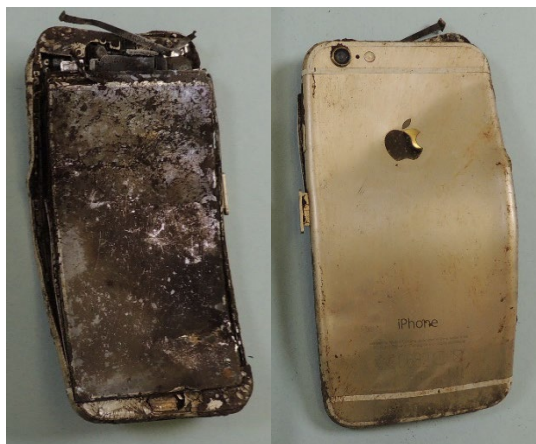
Figure 1. Front and Back of iPhone 6 as received.

Upon arrival at the Vehicle Recorder Laboratory, external examinations revealed the devices had sustained significant impact damage, as shown in Figures 1 through 4, rendering them inoperable. The logic boards were removed and tested for functionality using surrogate parts. The boards were determined to be unrecoverable due to damage with exception to the iPhone X. Tests indicated the device was potentially recoverable and the logic board was sent to an external data recovery facility for attempted recovery. The device was able to power on and was protected by a 6-digit numeric passcode. Potential passcodes obtained were unable to unlock the device, thus no data were recovered. Figure 5 shows the iPhone X board powered on using surrogate laboratory equipment at the data recovery facility.

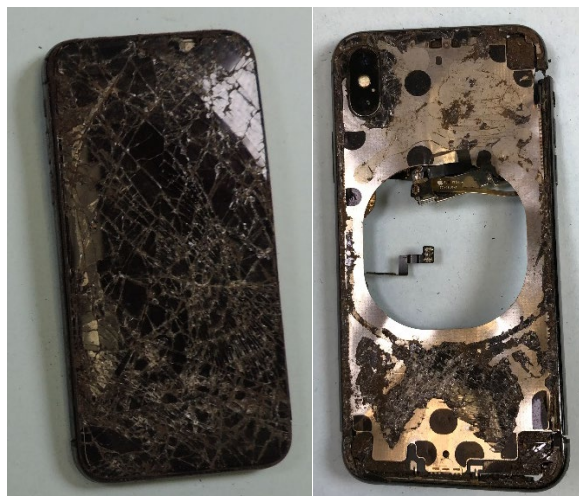
Figure 2. Front and Back of iPhone X as received.

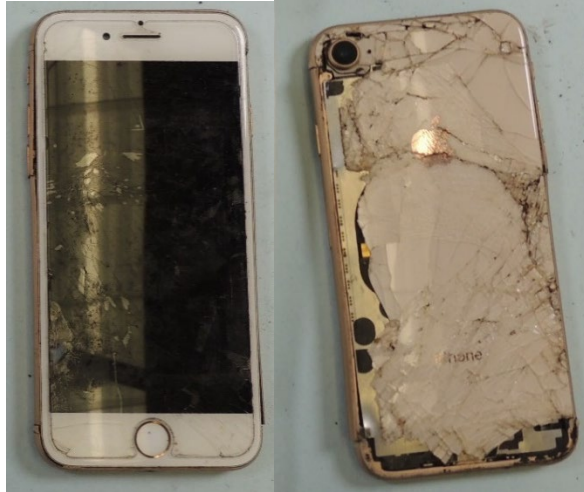
**Figure 3. Front and Back of iPhone 8 as received.**

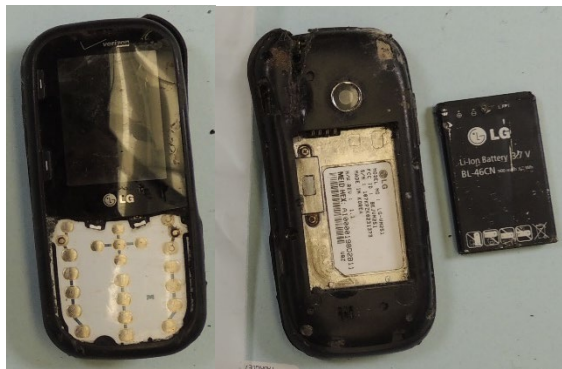
**Figure 4. Front and Back of LG Cosmos 2 as received.**

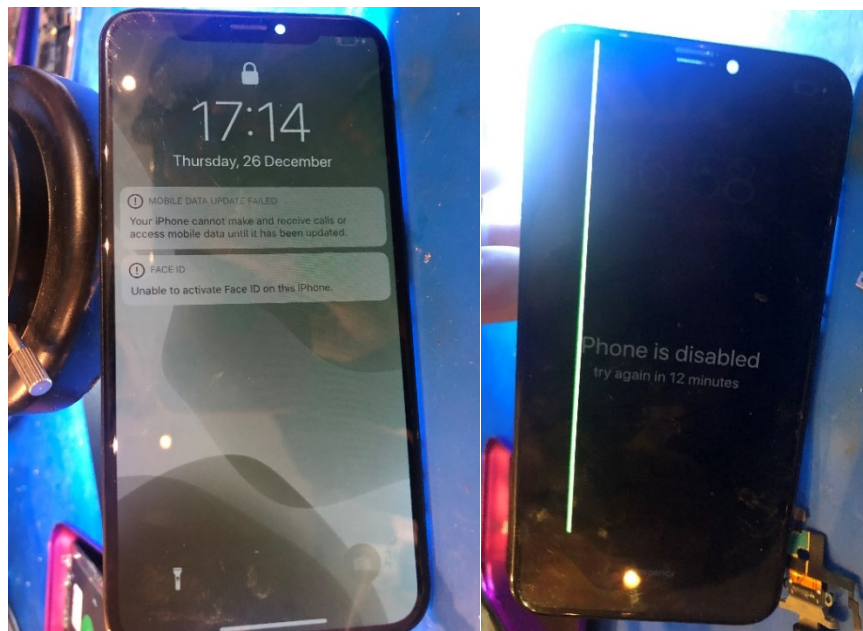
**Figure 5. iPhone X board powered on in test equipment at data recovery facility.**

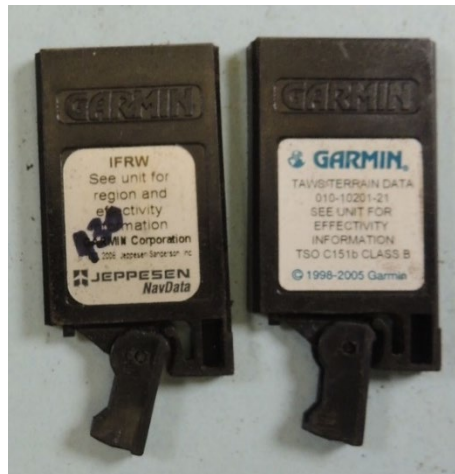
Figure 6. Garmin Data Cards as received.

The data cards were in good condition upon arrival at the Vehicle Recorder Laboratory, as shown in Figure 6, and card information was viewed by installing them in a functioning Garmin GNS 430. Figure 7 shows the Database Versions Page with the cards installed in the functional unit. The two bottom lines highlighted in yellow represent databases not within their effective dates.

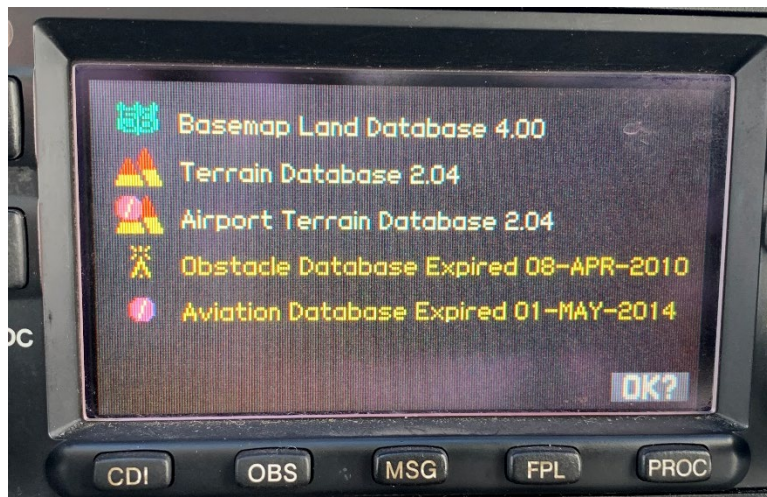
Figure 7. Database Versions Page.

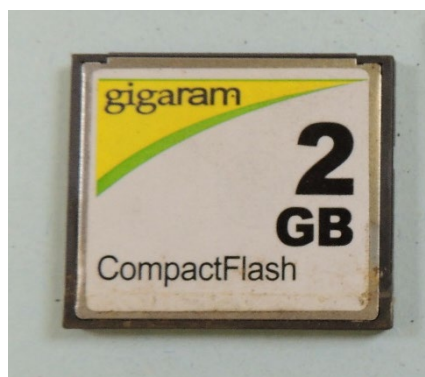
The 2 GB Compact Flash card was in good condition upon arrival at the Vehicle Recorder Laboratory, as shown in Figure 8. The card was readout and included a total of 28 MP3 files. The files were not recorded during the accident event. The files primarily consisted of music with exception of one file that was consistent with a standard safety briefing recording.

**Figure 8. Compact Flash card as received.**
