National Transportation Safety Board

DCA23LA125

AIR TRAFFIC CONTROL

Group Chair's Factual Report

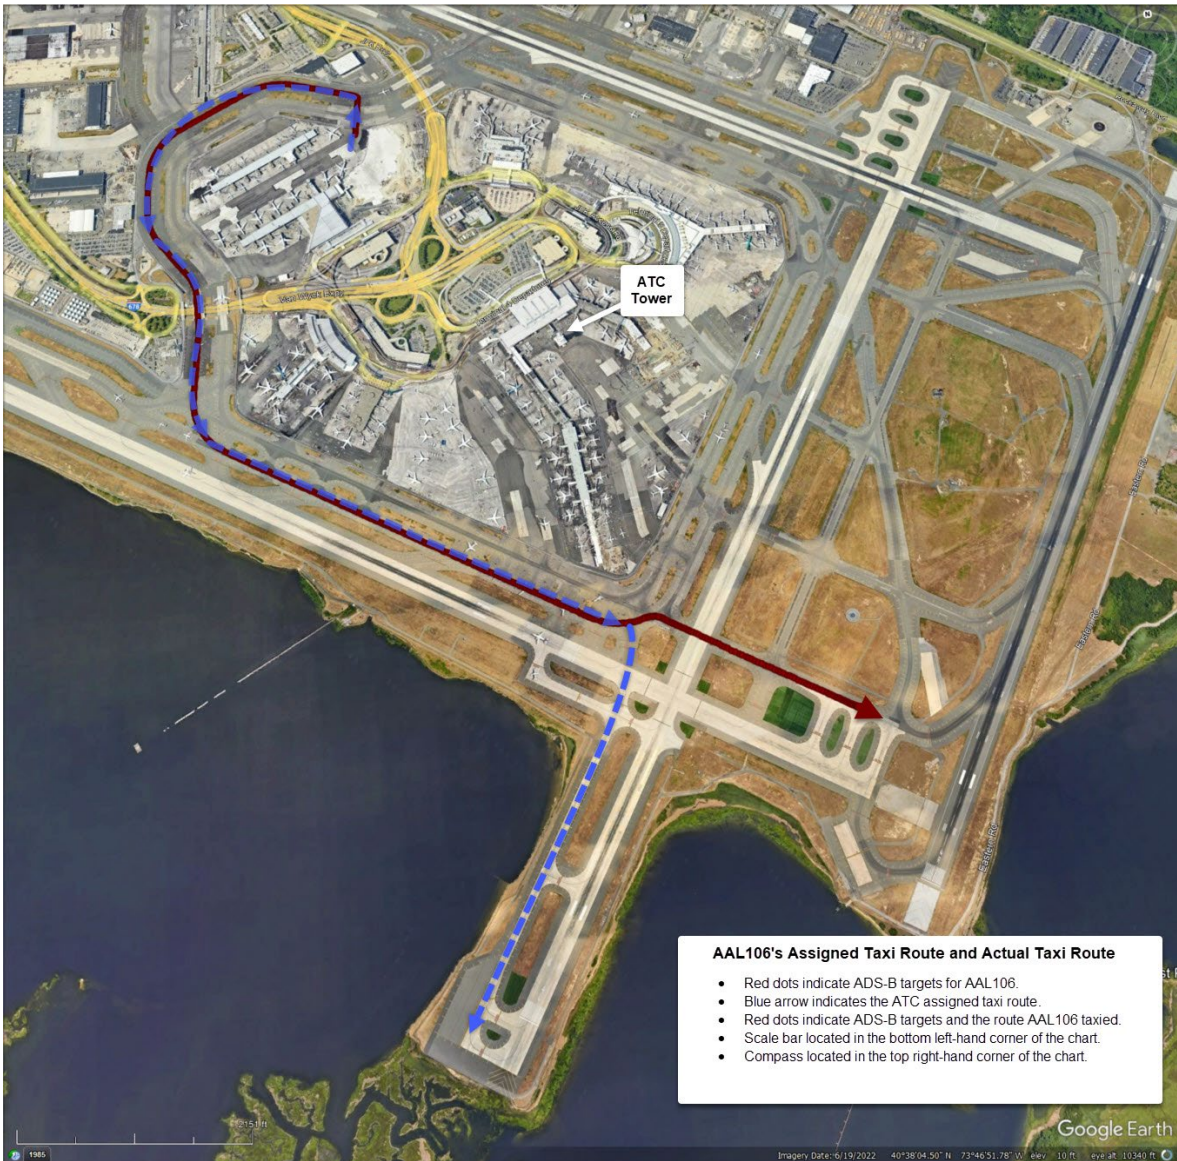
Figure 2 illustrates the assigned taxi route of AAL106 indicated by the blue dashed line compared with the route the aircraft traveled according to ADS-B data and indicated by the solid red line. This information has been overlaid on satellite imagery of the pertinent area of the JFK airport.

Figure 2. The assigned (blue) and actual (red) taxi routes of AAL106 overlaid on satellite imagery of the JFK airport.

About 2033, the crew of AAL106 contacted the GC controller, reporting they were at taxiway TA, and ready to taxi. The GC controller instructed the crew to taxi to runway 4L, via a left turn on taxiway B, and hold short of taxiway K. The crew responded, to hold short of taxiway Kilo.

About 2040, the GC controller instructed AAL106 to cross runway 31L at taxiway K. The crew acknowledged cross runway 31L at kilo.

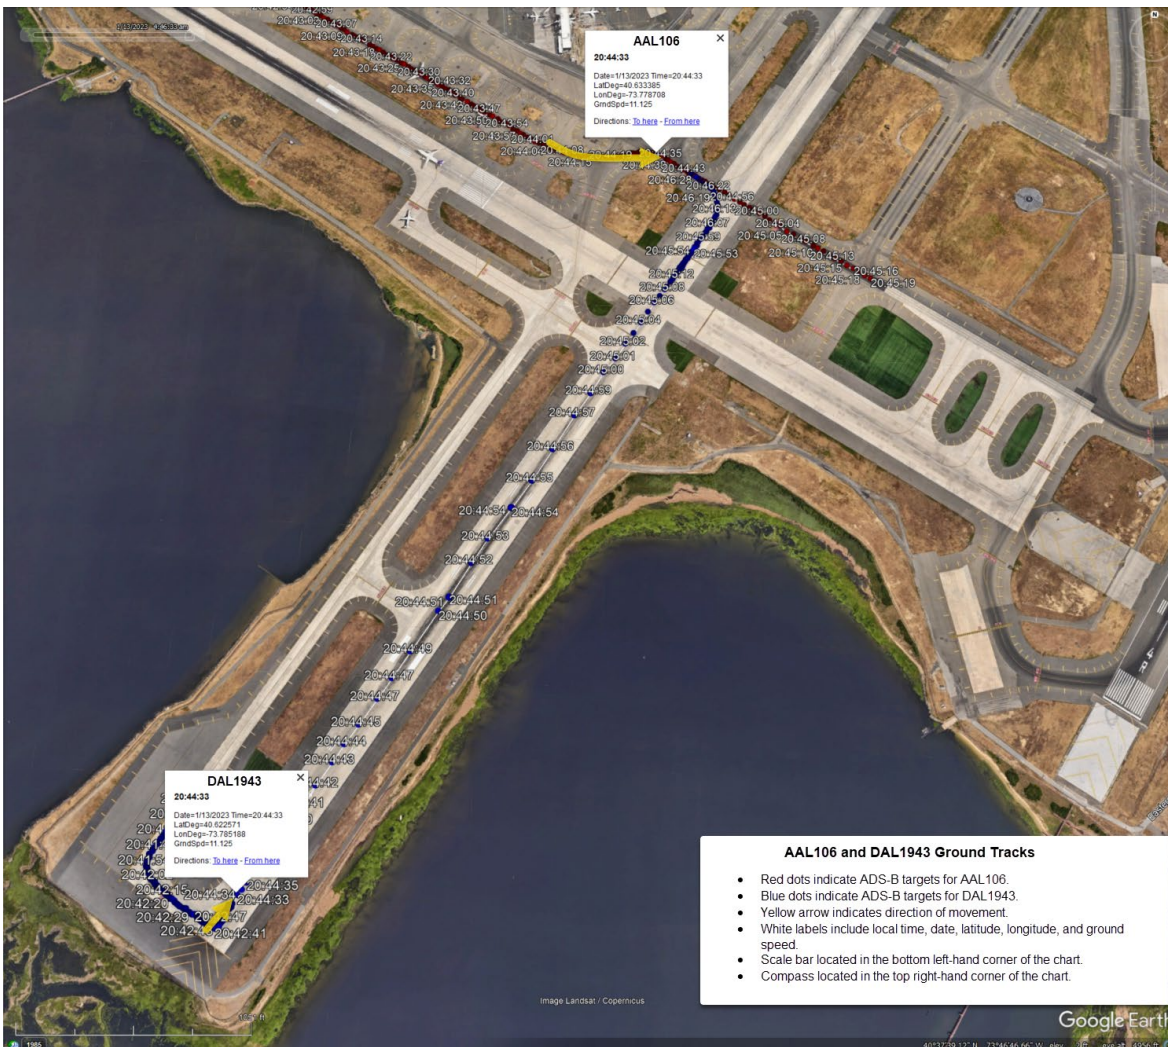
FAA ADS-B data showed that DAL1943 began takeoff roll at 2044:33. At that same time AAL106 was turning from taxiway B to taxiway J. Figure 3 illustrates the location of both airplanes as DAL1943 began their takeoff roll by overlaying the ADS-B ground tracks of both AAL106 (red dots) and DAL1943 (blue dots) onto satellite imagery (yellow arrows are provided for directional reference only).

Figure 3. ADS-B ground tracks of AAL106 (red) and DAL1943 (blue) illustrating the location of both airplanes as DAL1943 began their takeoff roll.

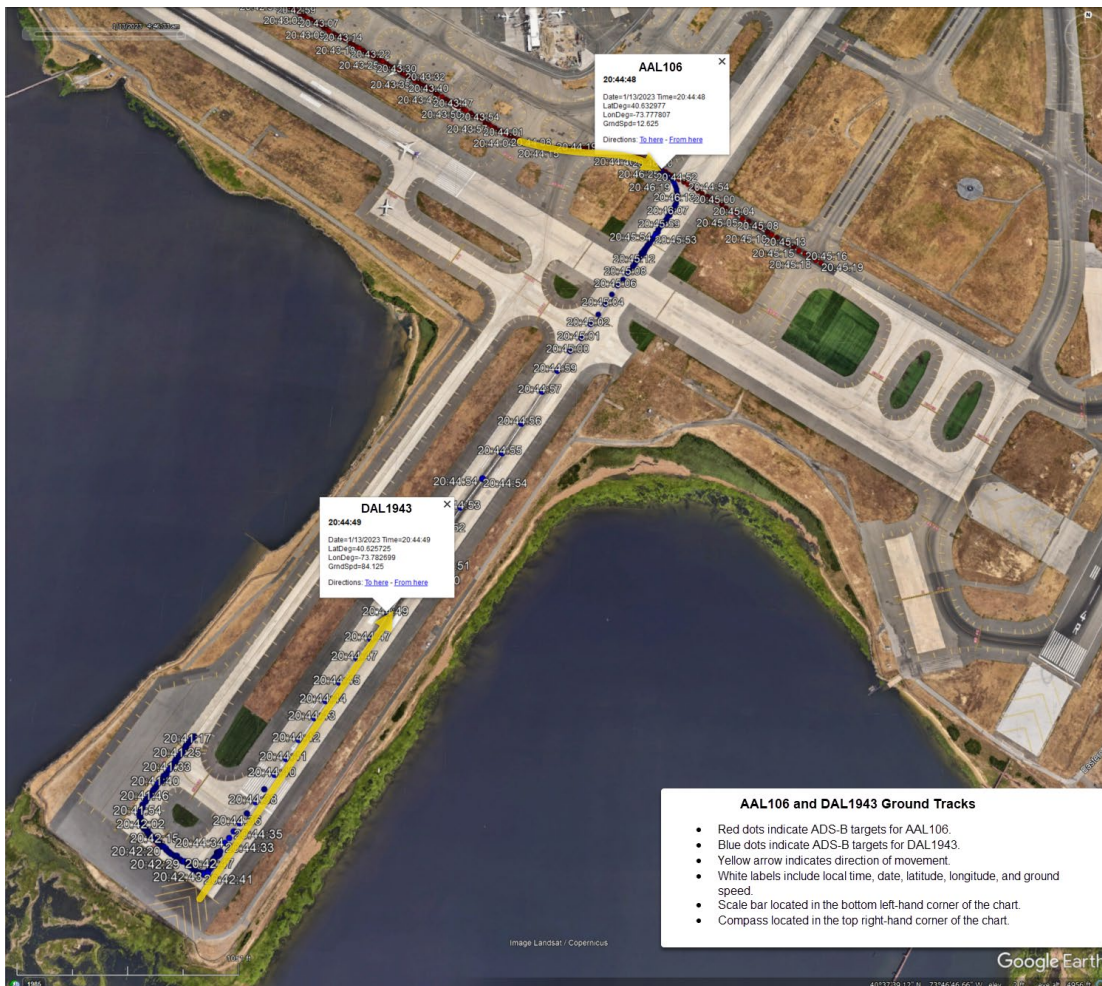
Five seconds later at 2044:48, the LC controller advised DAL1943 their takeoff clearance was cancelled. The crew responded immediately that they were rejecting (cancelling takeoff). Figure 4 illustrates the location of both airplanes at the time ATC cancelled DAL1943's takeoff clearance with overlaid ADS-B ground tracks of both AAL106 (red dots) and DAL1943 (blue dots) onto satellite imagery.

Figure 4. ADS-B ground tracks of AAL106 (red) and DAL1943 (blue) illustrating the location of both airplanes when ATC cancelled the takeoff clearance for DAL1943.

Nine seconds later, at 2044:42, the Airport Surface Detection Equipment model-X (ASDE-X)⁷, annunciated a *runway occupied alert* involving DAL1943 and AAL106.

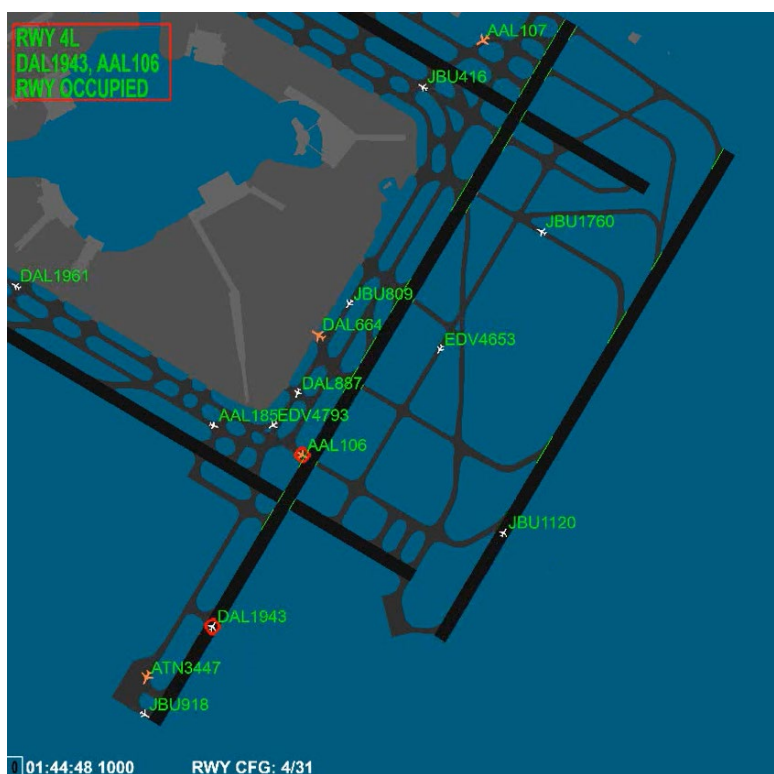
The ASDE-X system is also equipped with visual and aural alarms that will alert controllers of possible runway incursions or incidents. The safety logic system is an integral part of the software system for ASDE-X. This software predicts the path of aircraft landing and/or departing, and/or vehicular movements on runways. ⁸ Figure 10 is a screen capture of the JFK ASDE-X display while the runway occupied alert was active for DAL1943 and AAL106.

Figure 10. Screen capture of the JFK ASDE-X system display while the runway occupied alert was active for DAL1943 and AAL106.

JFK airport was equipped with the ASDE-X system. The ASDE-X alerts air traffic controllers of potential runway conflicts by providing detailed coverage of movement on runways and taxiways. Controllers are presented this information on a color display depicting aircraft and vehicle positions as icons overlaid on a map of the airport's runways/taxiways and airport approach corridors. The system continuously updates the map of the airport movement area that controllers can use to enhance their situational awareness. It's particularly beneficial at night or during inclement weather when visibility is poor.
